Historic Building Recording and Fieldwalking at

# **LOACHBROOK FARM CONGLETON**

Client:	CgMs
Local Authority:	Cheshire East Council
NGR:	383125,363225
Planning App:	APP/R0660/A/11/2158727
Author(s):	B. Poole
Doc Ref:	LPI607C-HBR-v1.2
Site Code:	CON/LBF 13
Date:	October 13

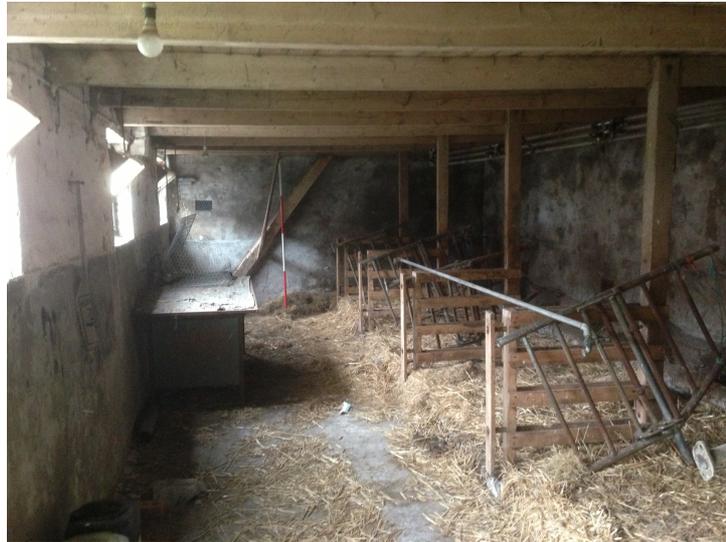
Plate 22 - G1, looking north

6.54. Room G1 is located in the eastern outbuilding range (FIGURE 16) and is an open plan space with screed floor and plastered walls. The eastern side has a raised floor and has been subdivided by wooden partitions (PLATE 22). A feeding trough is located along the eastern wall. A rough, open, wooden stairwell leads to room F1 at the northern end of the room.

6.55. The raised floor, feeding trough, plastered walls, and screed floor are all late 20<sup>th</sup> century modifications to the room. No original furniture was identified within G1.

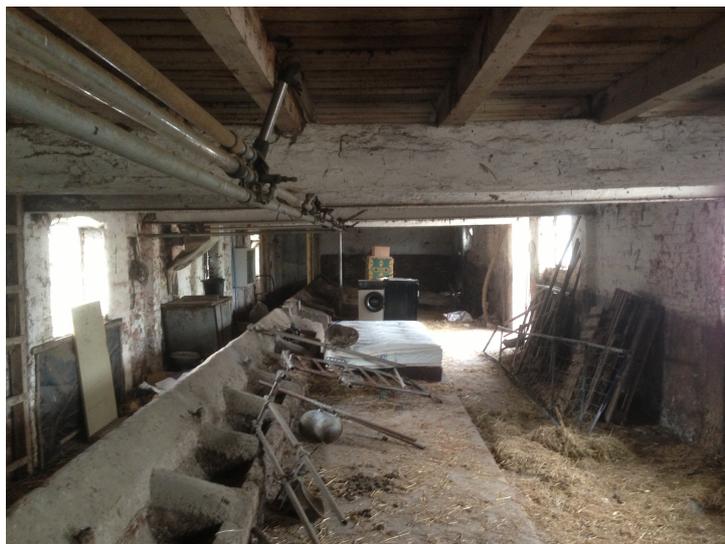
Plate 25 - Room G6, looking south

6.64. Room G6 is a large open plan barn area in the western range. The central area has

been raised and a brick, rendered, dwarf wall forms feeding pens (PLATE 25).

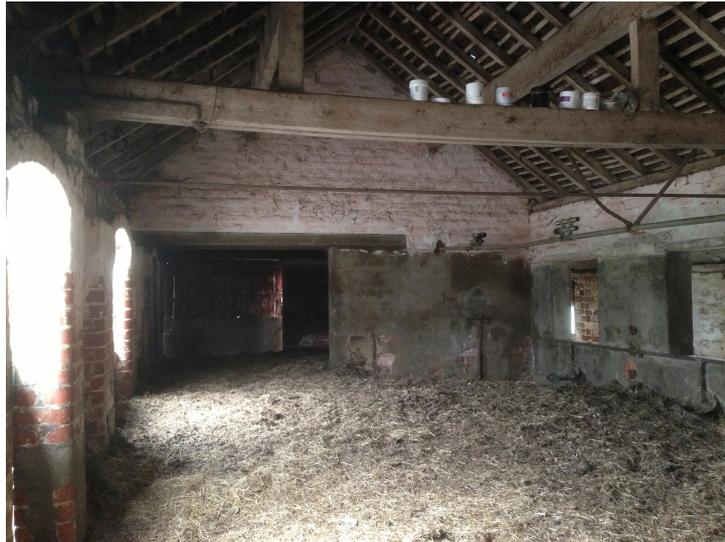
Plate 27 - G7, looking north

6.67. Room G7 is the late 19<sup>th</sup> to early 20<sup>th</sup> century extension to the north of G6. To the east of G7 is the enclosed walkway, dating from the late 20<sup>th</sup> century. The wall between these two areas has a series of windows showing that this would have once been an external wall (PLATE 27).

6.68. The floor in this area has been raised and appears to have been used for livestock in recent times. The roof form differs from the rest of the structures in the complex with dwarf side posts supporting the purlins and no central post supporting the ridge board, and no principal rafters.

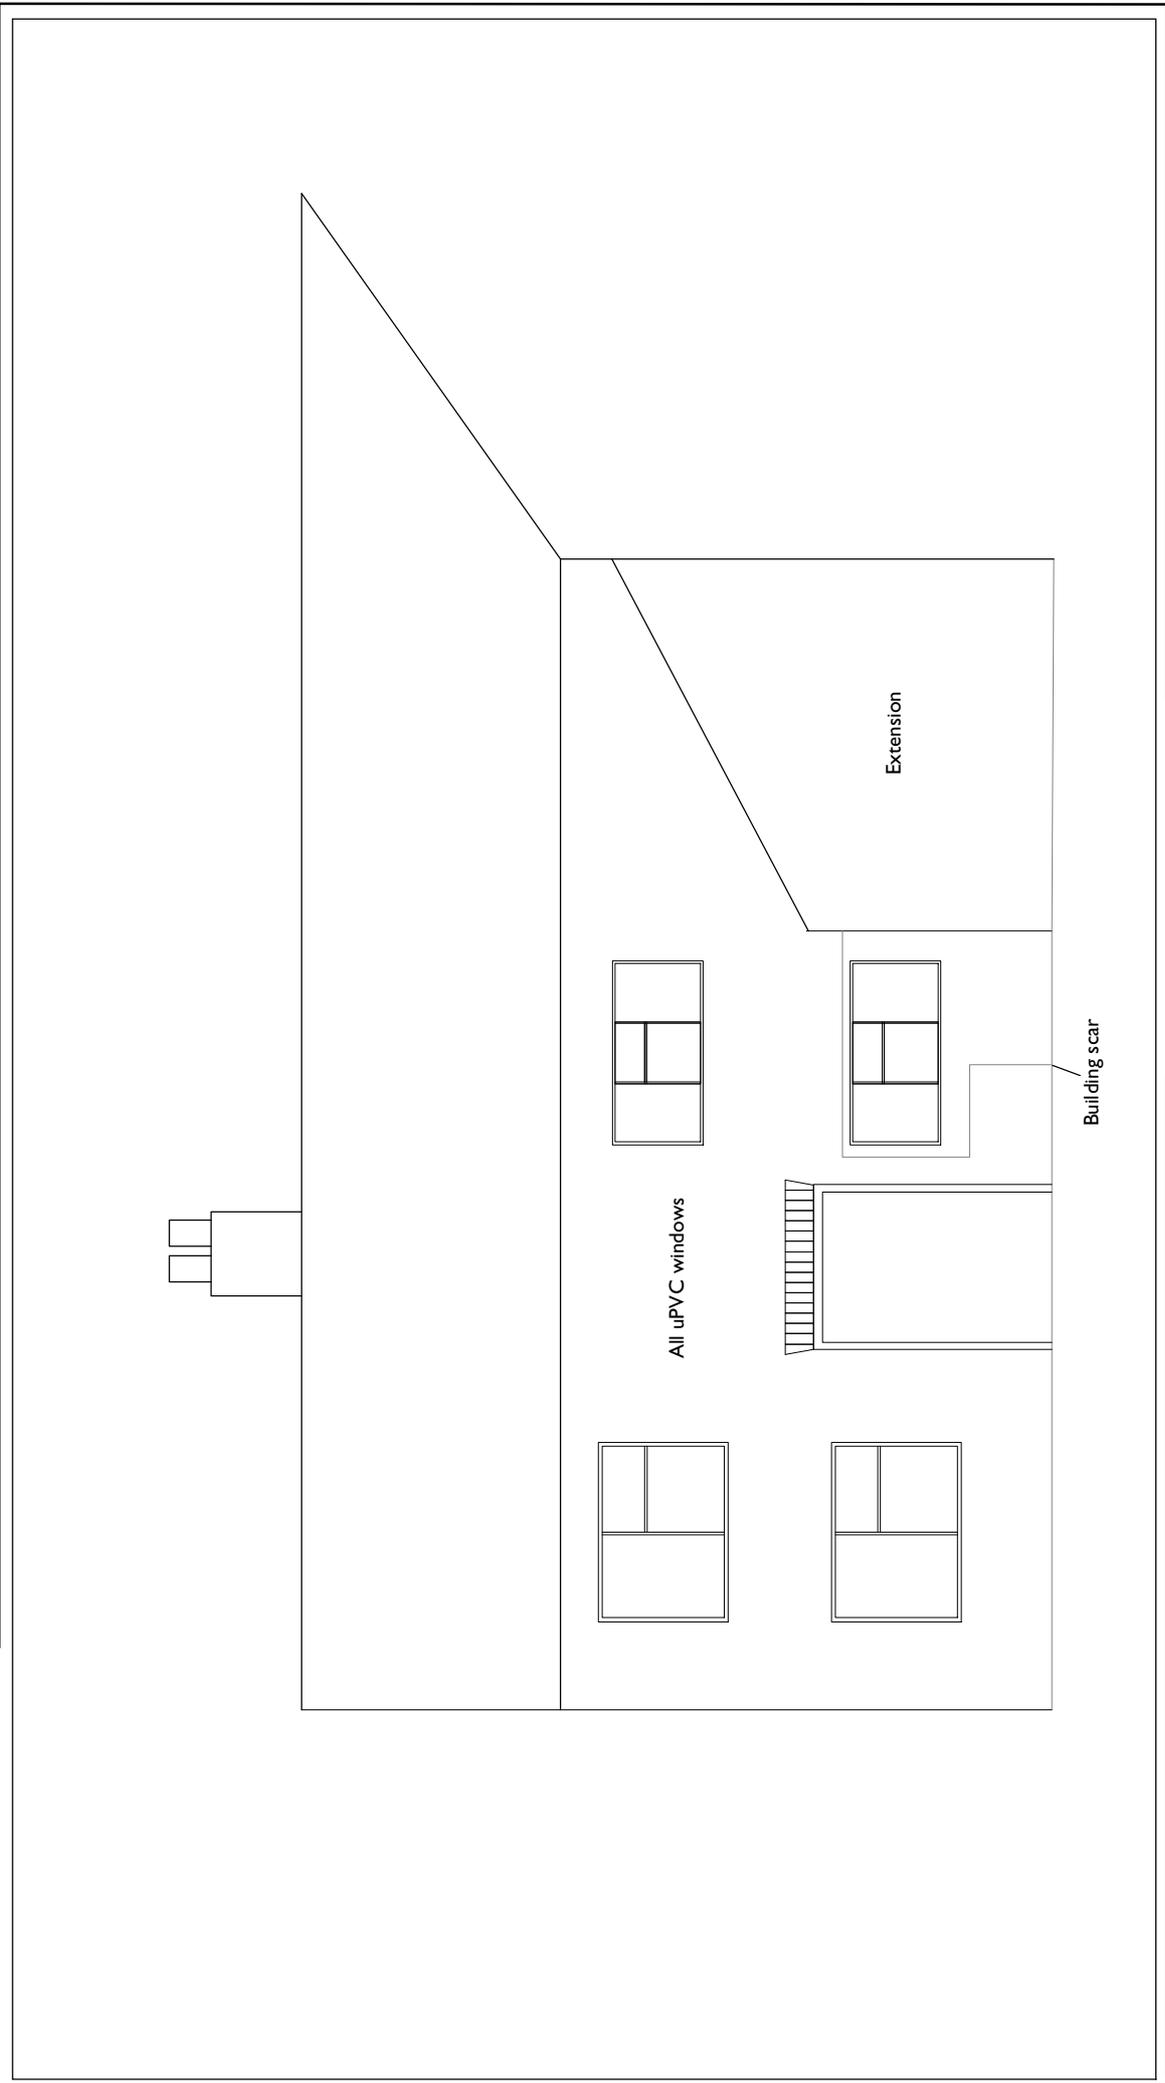
FIGURE 13 // Courtyard - North Elevation

bands below the eaves and an English garden wall brick bond. All of the windows on this elevation have been replaced by late 20<sup>th</sup> century uPVC double glazed units. The eastern window can be seen to replace an earlier doorway and window unit (FIGURE 13). The central doorway has an on end brick lintel in a fan style. This appears to be an original feature of the property.

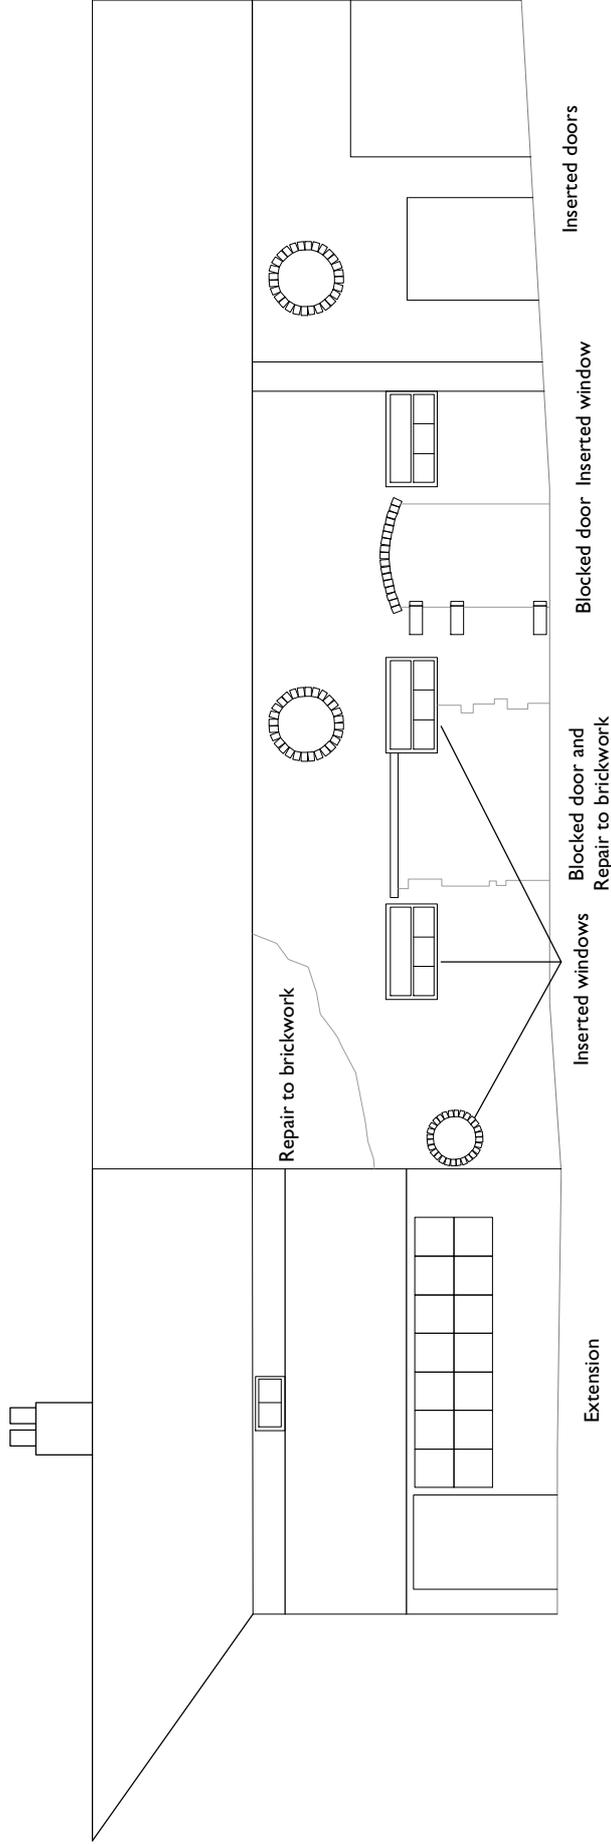
FIGURE 14 // Courtyard - East Elevation

6.41. The eastern elevation of the courtyard has been heavily modified (FIGURE 14). At the northern end extent of the elevation a single storey extension has been added (PLATE 17). This dates to between 1840 and 1873. Although the dates are close to that of the original construction it is clearly a later addition. The doorway and windows are all wooden framed and single glazed units.

6.44. Two blocked doorways can be seen on the elevation (FIGURE 14). The southern

blocked doorway matches the style seen on the other original elevations of the structure, with shallow header brick arched lintel and recessed brick doorway, with stone hinge blocks on the northern jamb (PLATE 18).

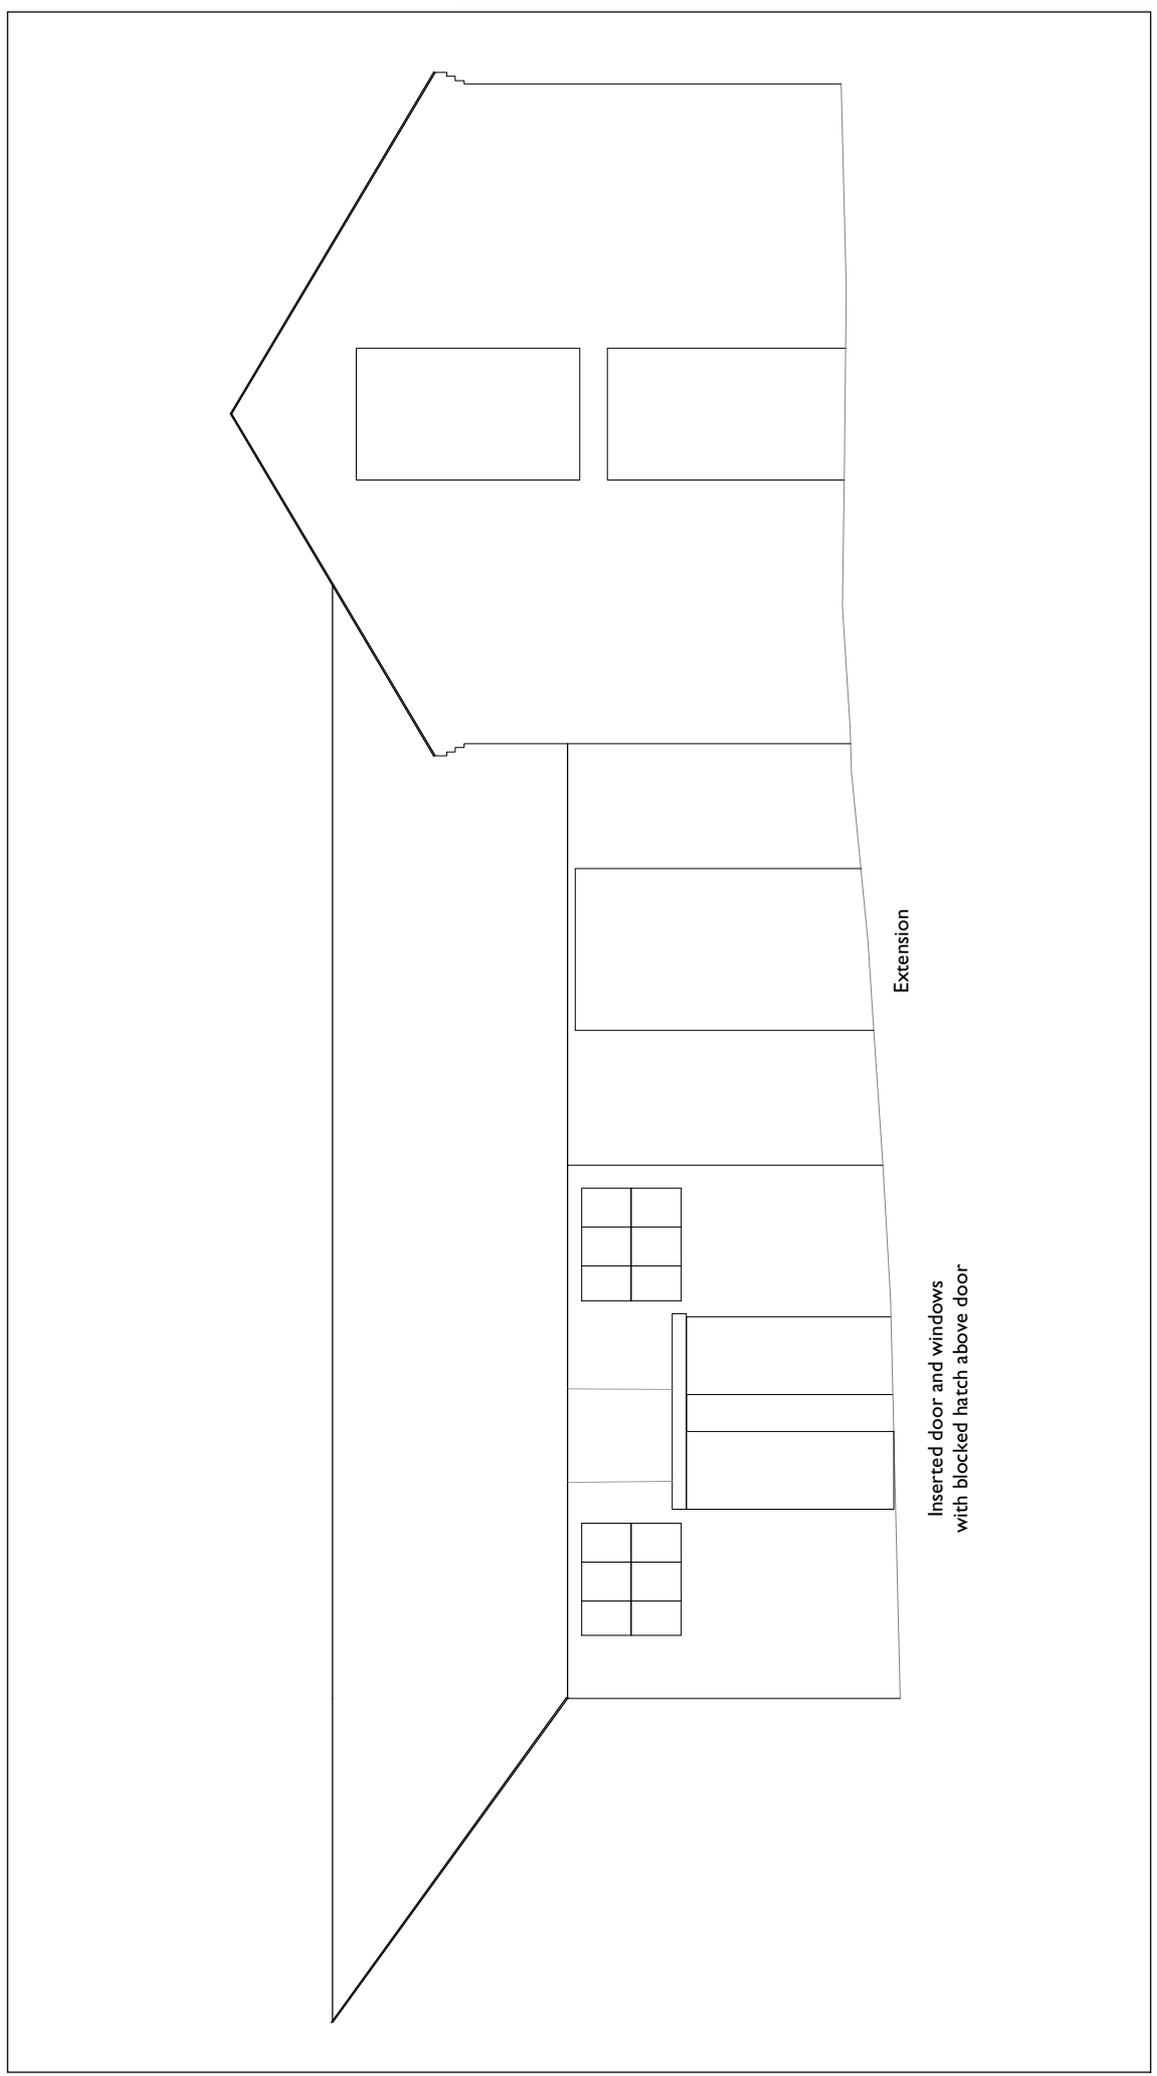
FIGURE 15 // Courtyard - South Elevation

6.48. The southern elevation of the courtyard is of red brick in an English garden wall bond, with a central single doorway, which has had a later sliding door installed (FIGURE 15). Set higher than the doorway, to either side of it, are two large metal frame six pane windows. These are thought to be 20<sup>th</sup> century in date (PLATE 21).

6.49. Above the doorway is an area of brick repair. Although the appearance of this suggests a blocked hatch, internally there is no evidence for a hatch. Therefore, it is likely that this just represents a phase of brick repair.

Inserted door and windows  
with blocked hatch above door

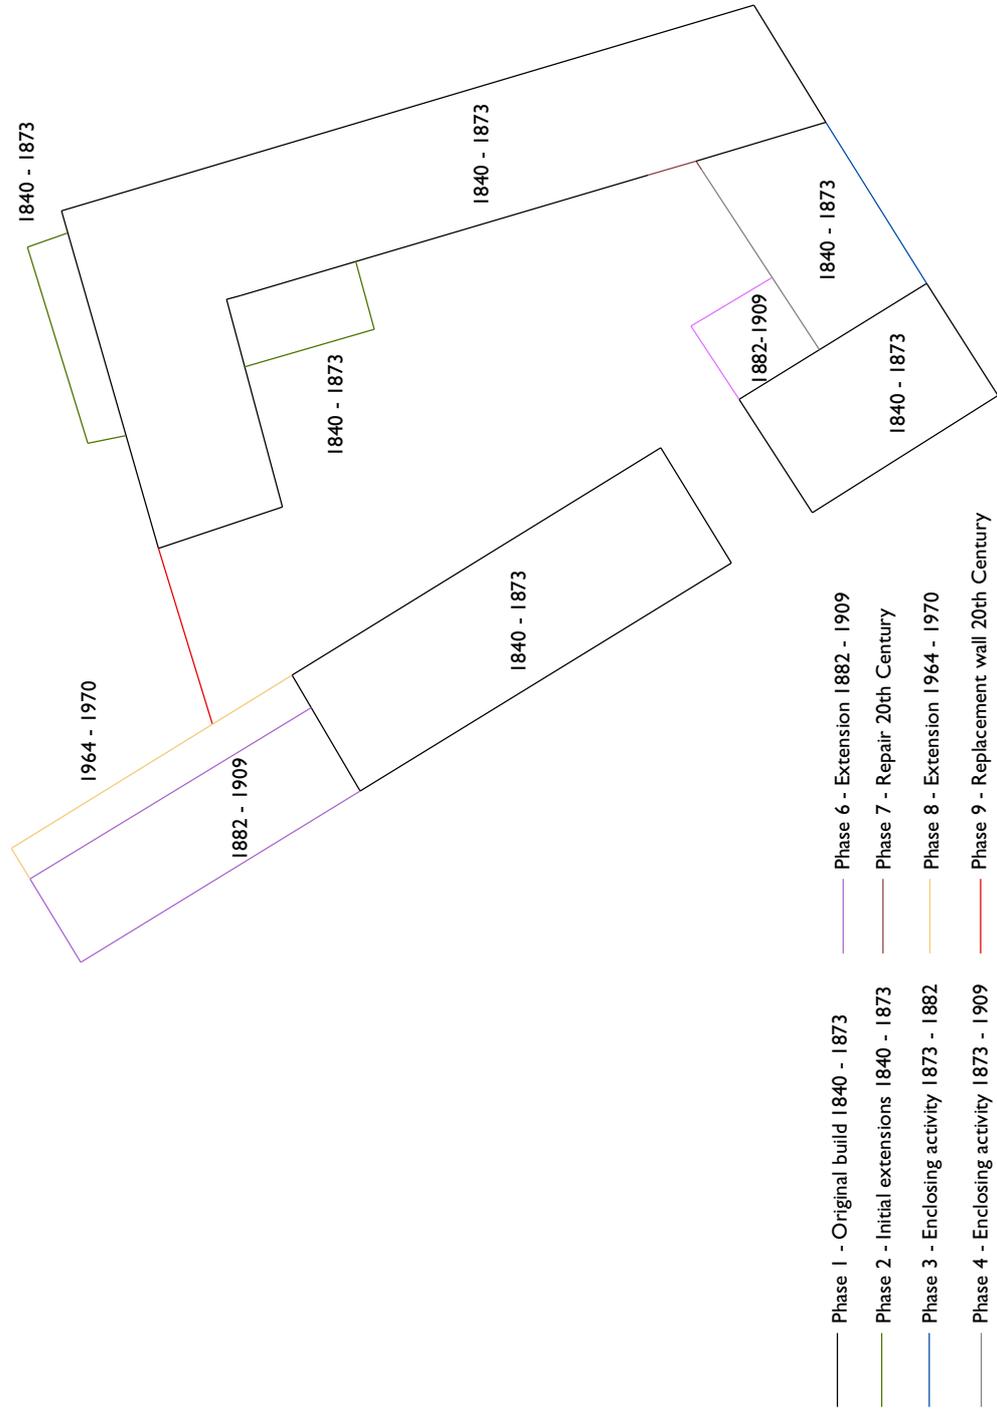
FIGURE 19 // Phasing

- 7.4. The results of the historic building survey and associated research indicate that nine phases of development can be identified (FIGURE 19). Many of these took place in rapid succession after the construction of the building. However, some phases represent later 20<sup>th</sup> century activity. Of note is that the same family, the Hill's, occupied the site from at least the late 18<sup>th</sup> century into the late 19<sup>th</sup> century, if not longer.
