Historic Building Recording at

OSEA ISLAND MERSEA

For Matrix Complex

Client:	Matrix Complex
Local Authority:	Maldon District Council
NGR:	591491, 206241
Planning App:	FUL/MAL/12/00657
Author(s):	J. Duffy
Doc Ref:	LPI686E-HBR-v1.1
Site Code:	HTOI 15
Date:	October 15

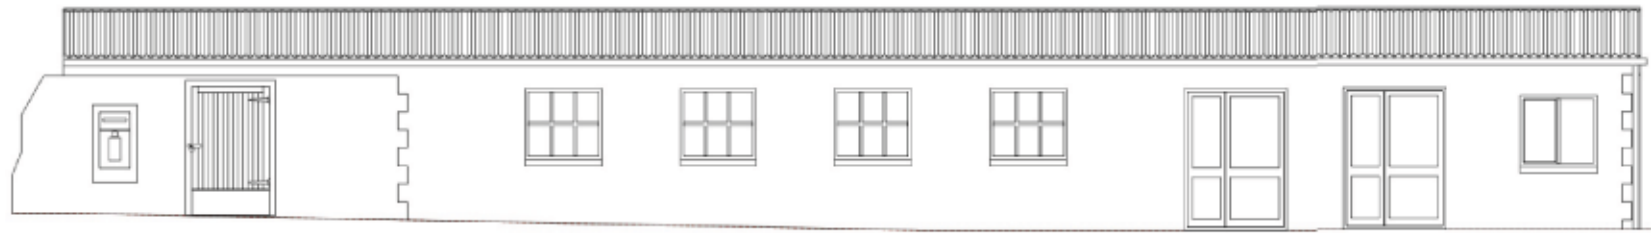
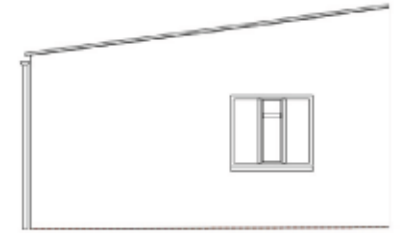
FIGURE 3 // Structure 6 Elevations

- 6.9.1. Structure 6 was a single storey building located at the eastern side of the farmyard area (PLATE 22). It was constructed of red brick and breeze blocks and measured 25m by 6m (FIGURE 3). The structure has a wood frame roof covered by corrugated iron and slopes from the west elevation down to the east.

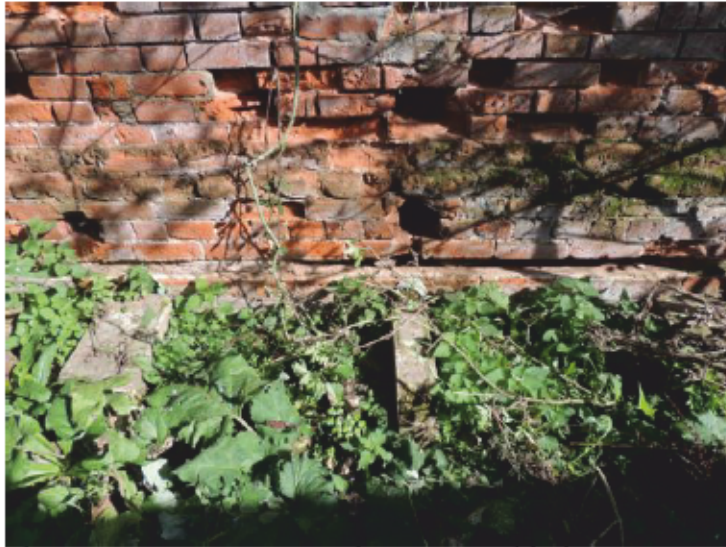
Plate 15 - Structure 3 West Elevation Detail looking east

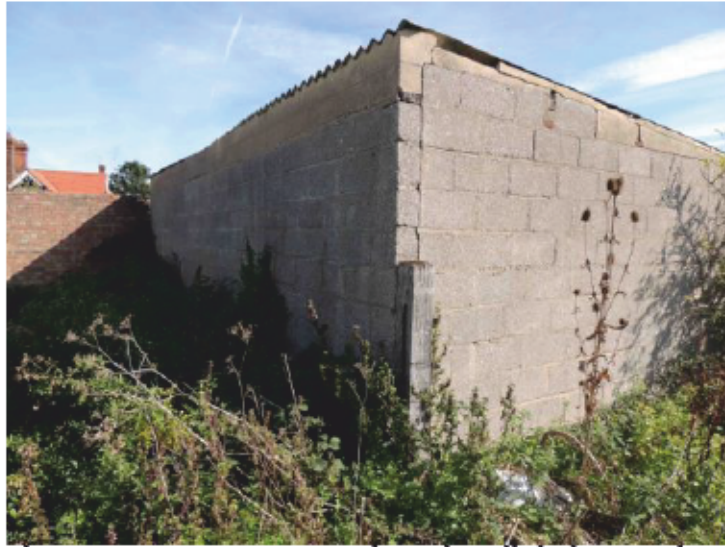
- 6.7.1. Structure 4 measured 9m by 5m and was formed by three breeze block walls with an open face to the south (PLATE 16). The structure was 11 courses high and each breeze block measured 450mm by 220mm (PLATE 17).
- 6.7.2. The roof structure was collapsed into the building but was of a timber frame with asbestos sheet covering.
- 6.7.3. The inside of the structure was not safe to examine in detail due to the collapsed roof structure but the building appeared to be for farm use possibly as a shelter for livestock.

Plate 16 - Structure 4 looking north

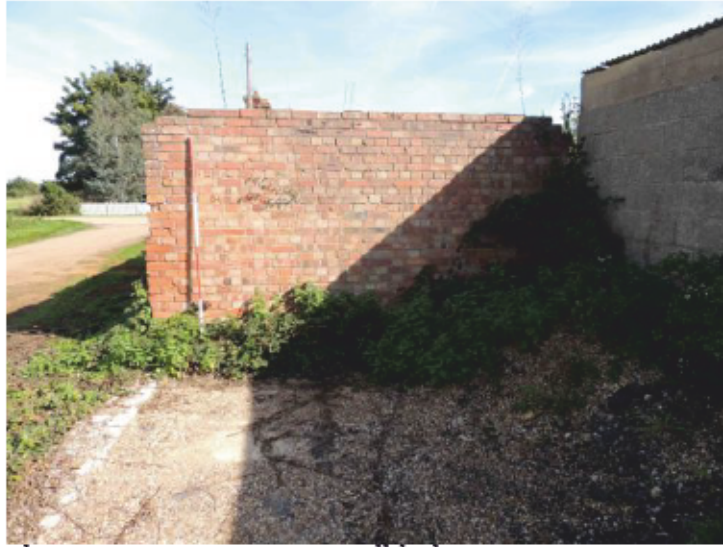
- 6.8.1. Structure 5 is a red brick wall extending north from the north east corner of Structure 4 and then extending east to Structure 6 (PLATE 18).
- 6.8.2. The western wall of the structure is red brick laid in English bond, although the top three courses are laid as stretchers only, with a light grey mortar (PLATE 19). The bricks measure 240mm by 110mm by 60mm with a total of 29 courses visible.
- 6.8.3. The north wall ran 14m east to west and was also red brick with light grey mortar and the remains of a white wash on some of the brick work (PLATES 20 AND 21). The lower 15 courses were English bond and the upper 12 courses were Flemish bond. The lower English bond courses protruded from the upper courses in a similar manner to Structure 3.
- 6.8.4. The structure appears similar to Structure 3 in its form and was a similar boundary or garden wall.

Plate 18 - Structure 5 looking east

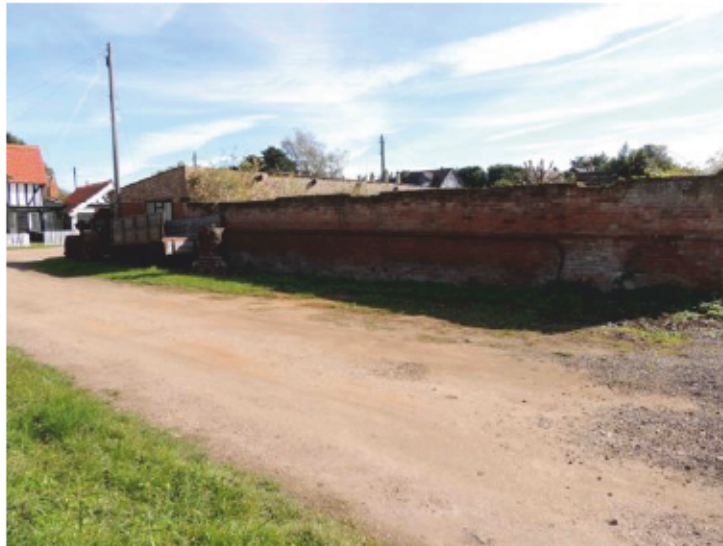
Plate 19 - Structure 5 West Wall looking east

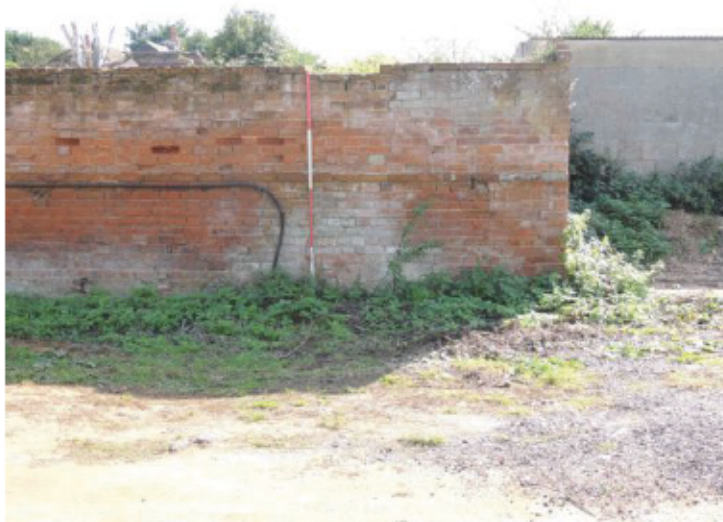
Plate 20 - Structure 5 North Wall looking south east

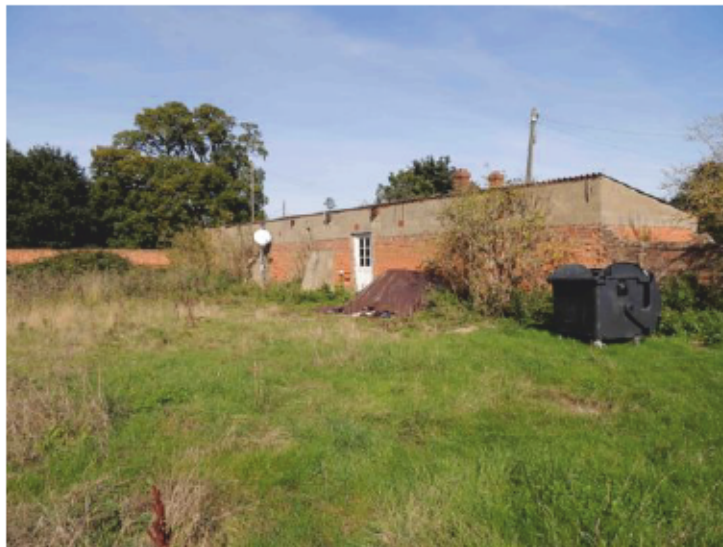
- 6.9.7. The south elevation is a continuation of the brick work from the east elevation with no distinctive features (PLATE 29). The brick work from the east and west elevations continue beyond the south elevation. The continuation of the east elevation forms a corner buttress and the continuation of the west elevation is a boundary wall.
- 6.9.8. The brick work is topped by between one and four courses of breeze blocks supporting the roof structure.

Plate 29 - Structure 6 South Elevation looking north

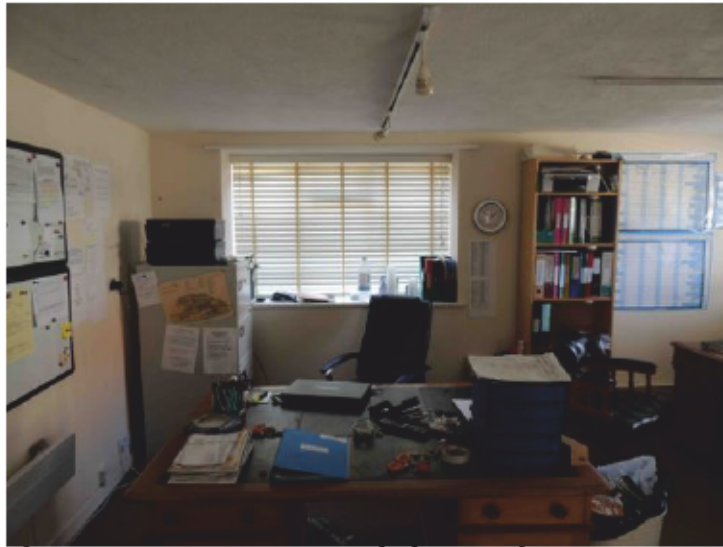
6.10.2. Room 1 is currently in use as a small office and is accessed through the northernmost door in the east elevation through a small hallway. The walls and ceiling are plastered and the floor carpeted (PLATES 32 AND 33). The windows in the north elevation and the northernmost window in the east elevation provide light into the room.

Plate 32 - Structure 6 Room 1 looking south east

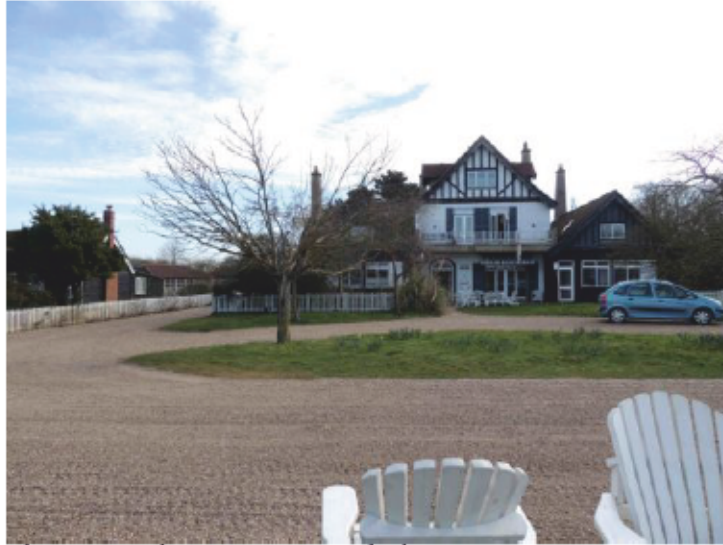
- 7.5. The structures recorded appear to be buildings and walls associated with a farmyard and probably associated with the Grade II listed building of the Old Farmhouse and Pine Cottage (APPENDIX 1) on the southeast corner of the farmyard (FIGURE 2). The farmhouse is early 19th century and earlier and of a weatherboarded timber framed construction (PLATE 44). The farmyard structures appear to all post date the farmhouse and date from the mid to late 19th century onwards. There appears to be no break in continuation of the use of this area as a farmyard.
- 7.6. Osea Island became an important naval base during World War One and the historic maps indicate the increase in construction at this time, although some structures were already built as part of Charrington's temperance mission (PLATE 45). The purpose built military buildings are of a different construction style (PLATES 46 AND

Plate 44 - Old Farmhouse and Pine Cottage looking north west

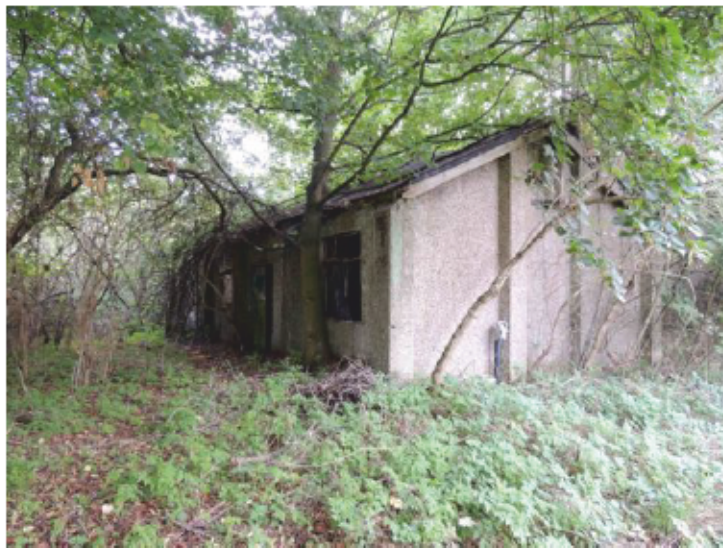
Plate 45 - Charrington House looking east

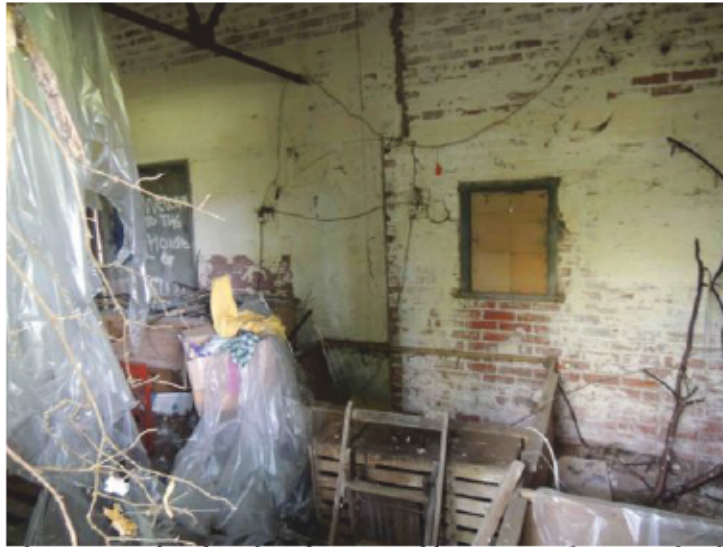
Plate 46 - Abandoned Military Building Osea Island
