Winchester City Mill

INTERPRETIVE HISTORIC
BUILDING SURVEY

Commissioned by
THE NATIONAL TRUST

Archaeological Standing Building Recording Report

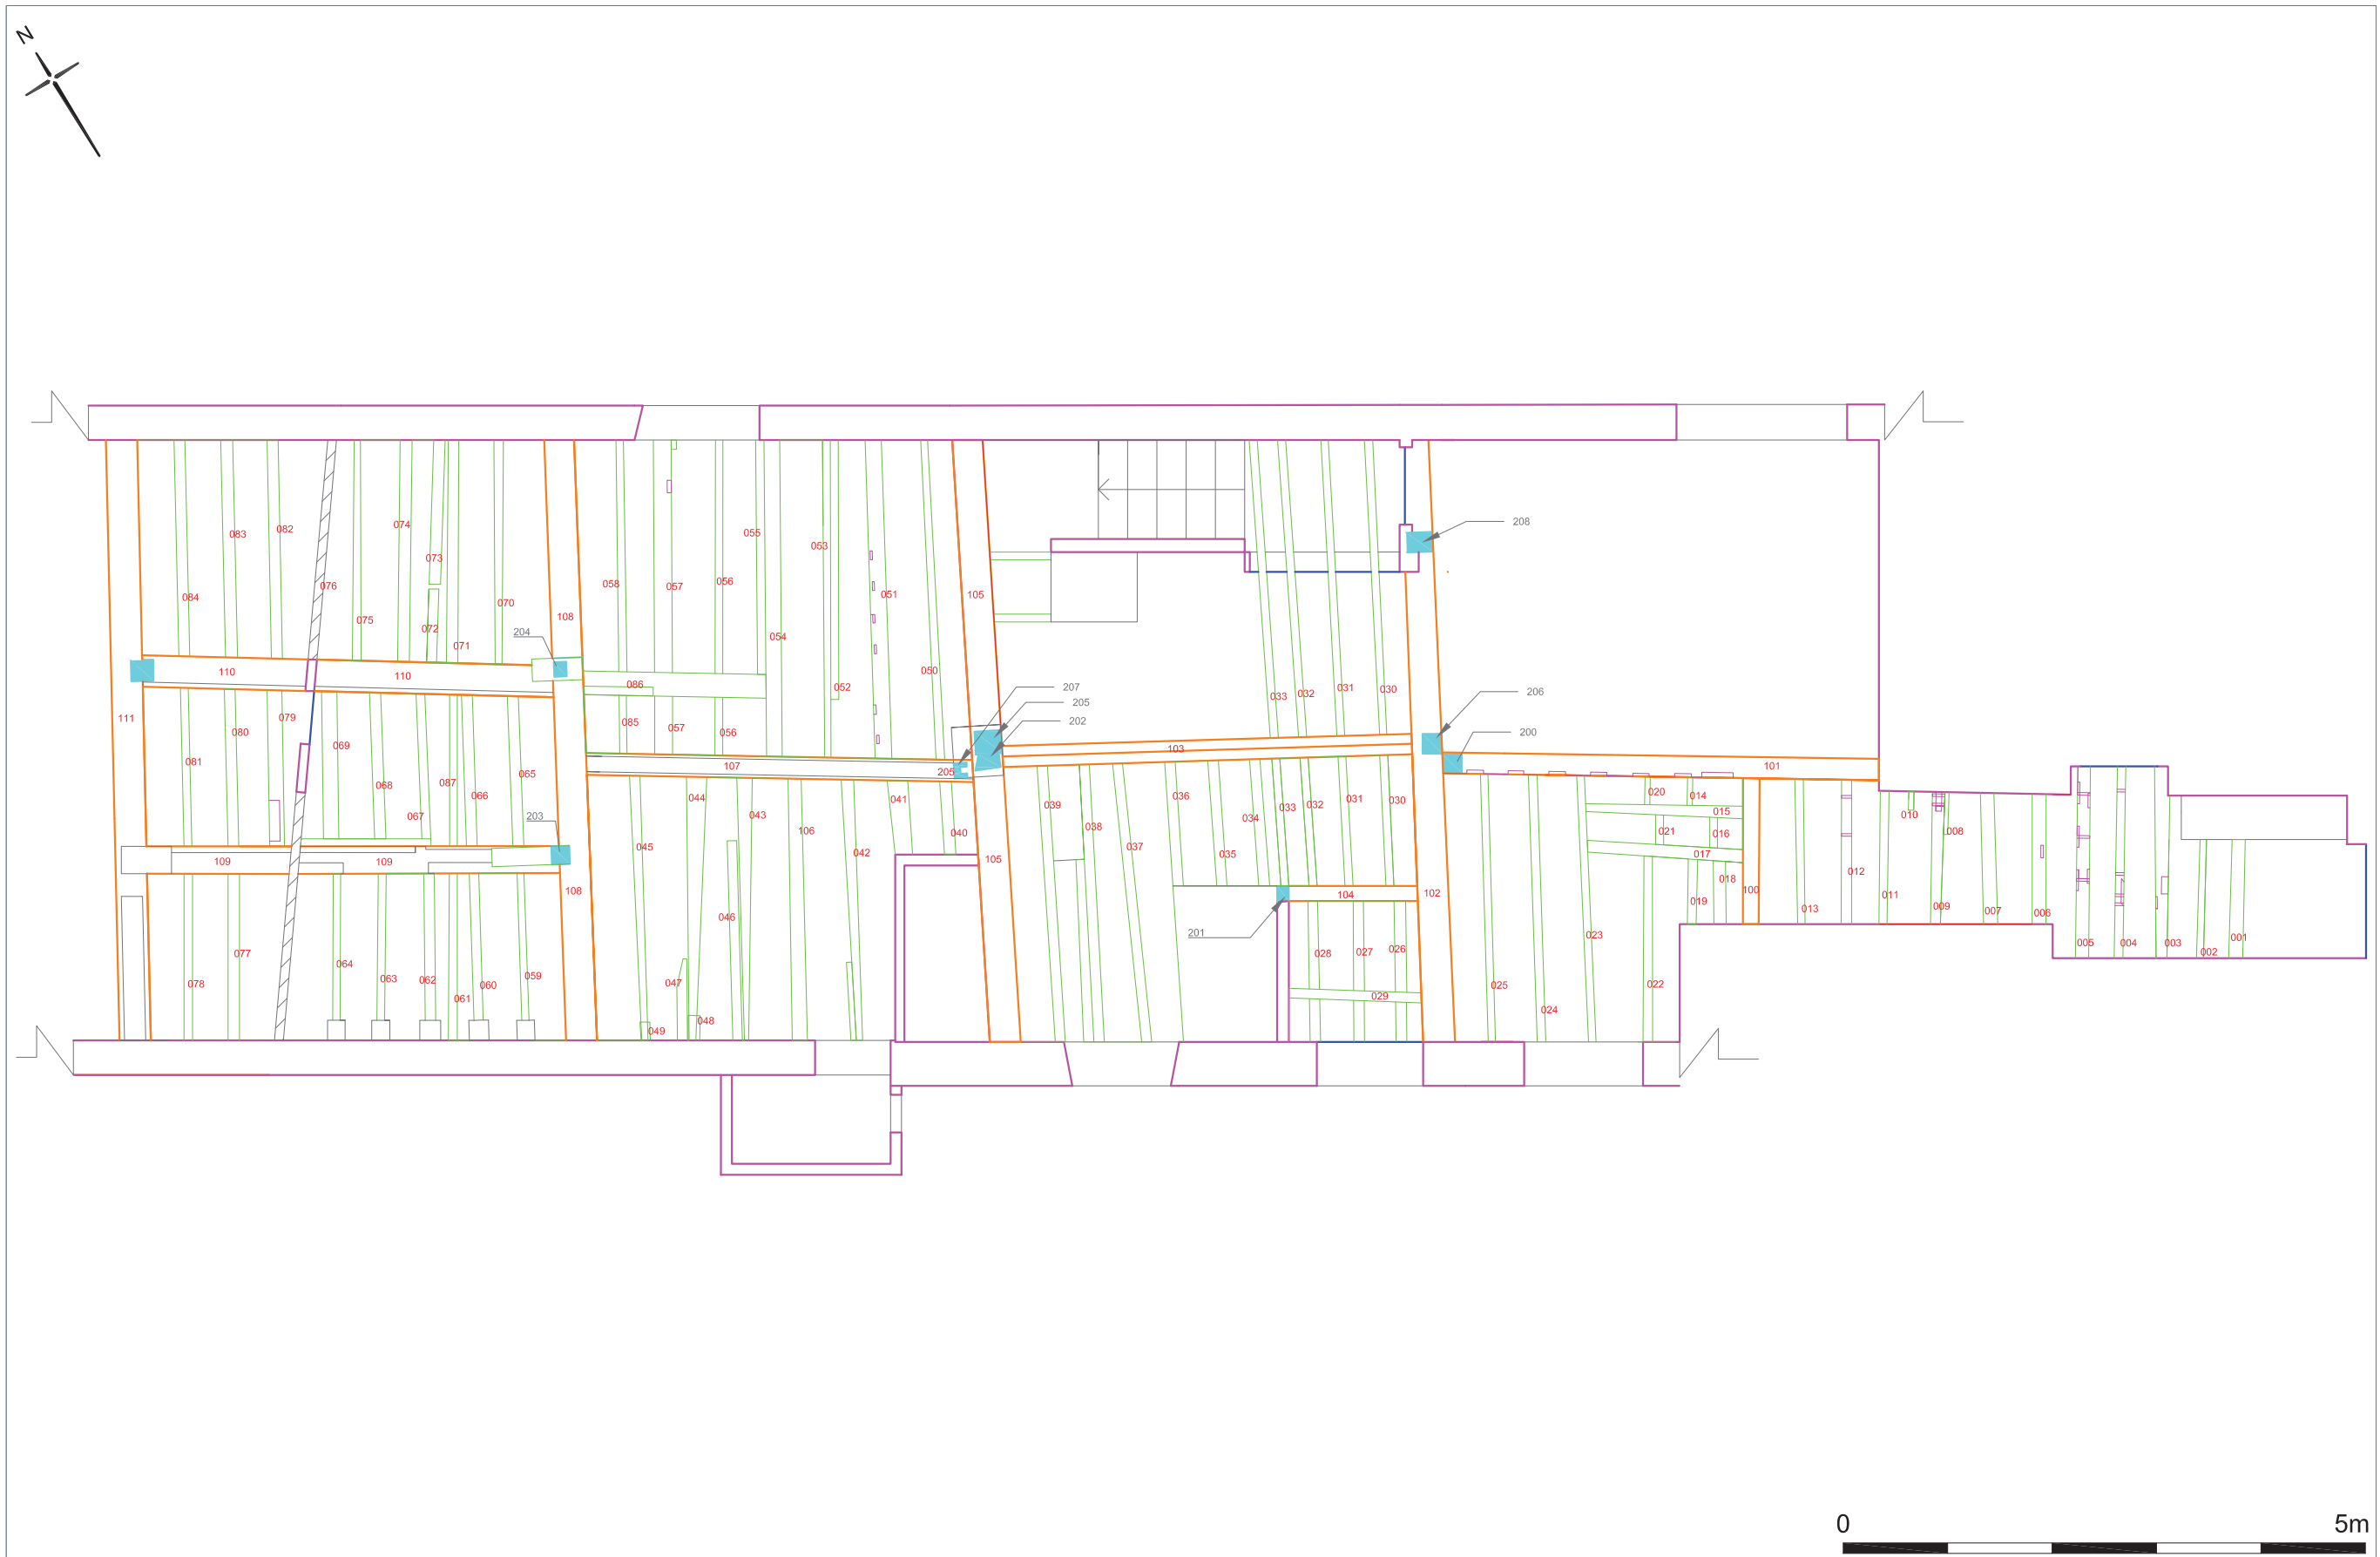
Drawing 1 Reflective plan of the ground floor beams and joists

- 2.1.5 The basic layout of the floor frame is illustrated in the main plan (See Drawing 1) and comprises four substantial oak bridging beams each c. 6m long, set across the width of the building. Thus, these beams could also have acted to a limited extent as tie beams. Each end of these beams is embedded into the brick walls, often supported by timber chocks. Unsurprisingly decay has taken place at several of these locations with some recent steel reinforcement being carried out locally. Tenoned into these roughly N-S bridging beams were a total of five, similar sized or slightly smaller, E-W secondary bridging beams which supported the internal ends of the common joists, except in the eastern entrance corridor where they were set in the brick walls either side (See main floor plan). These E-W beams were also boxed heart beams of oak except for beam [103] which was a composite beam including sawn conifer timber later than the initial framing work. This basic form of framing is commensurate with what would be expected of a mid-18th industrial building in the south of England.

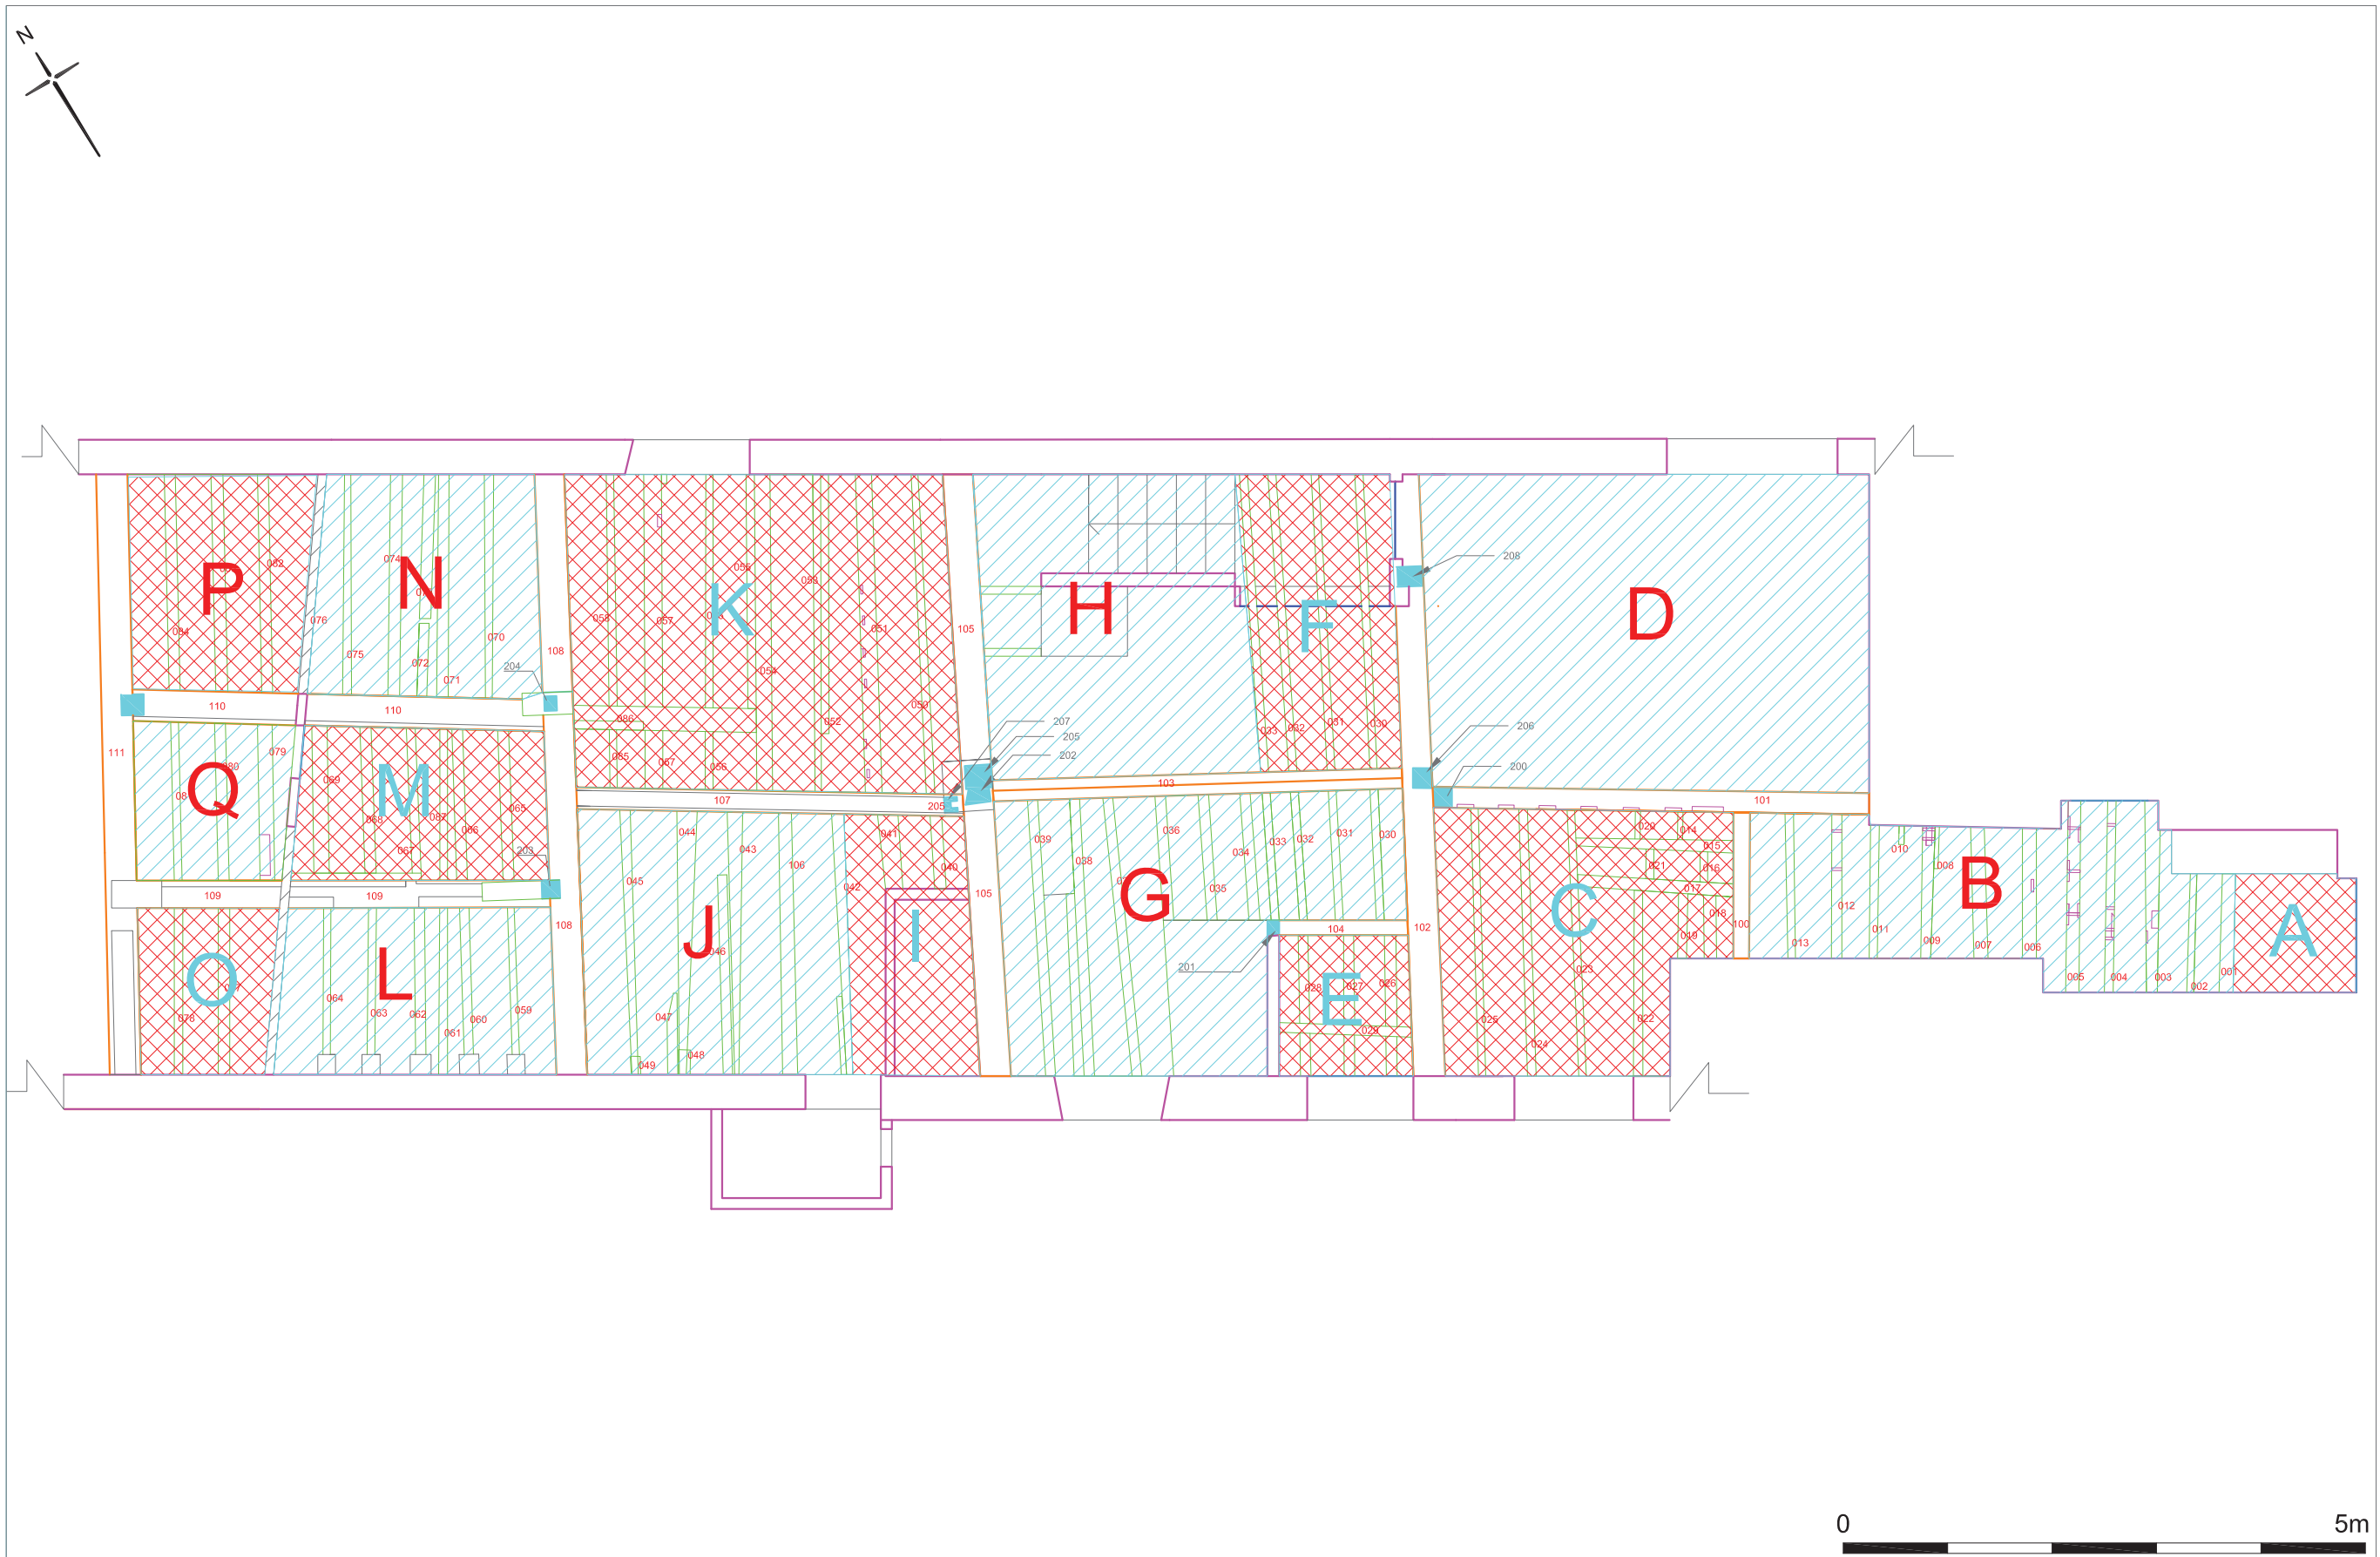
Drawing 2 Plan of Ground Floor showing individual areas

- 2.1.2 The timbers were divided into different areas based on internal divisions created by bridging beams and cross beams. The portion of the building looked at was composed of 5 bays and it was broken into 17 areas, A-Q.

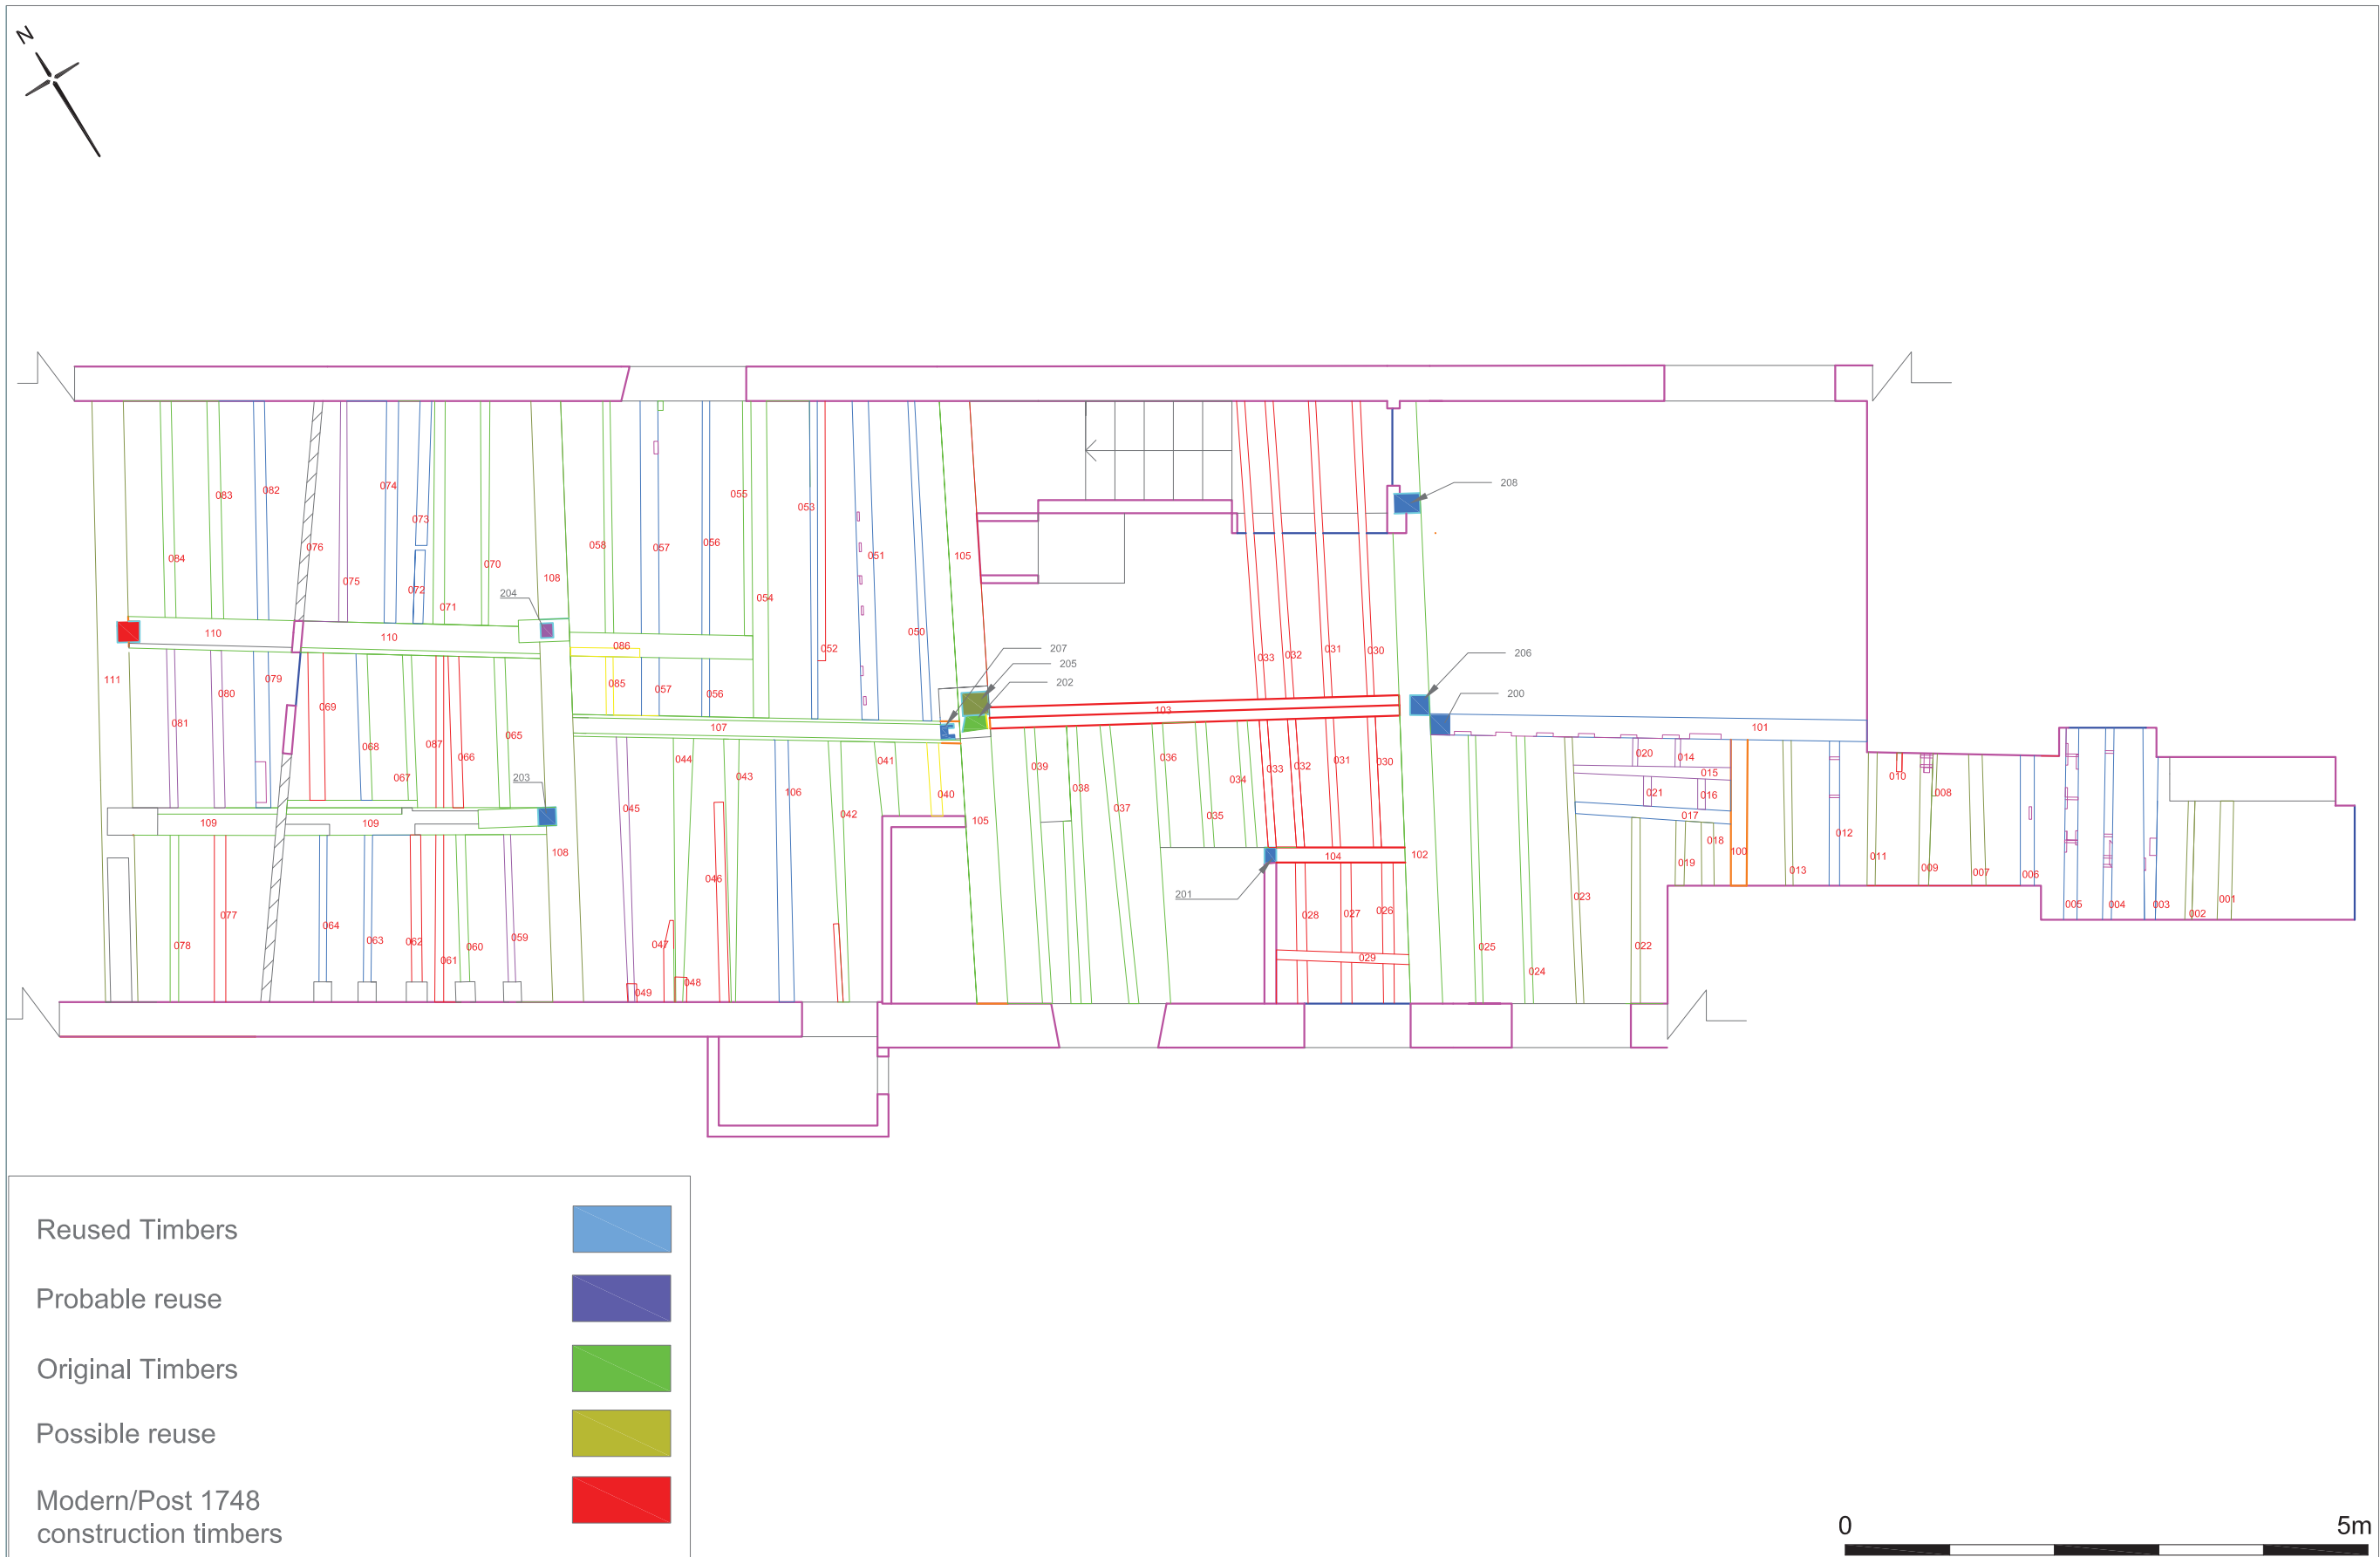
Drawing 4 Reflective plan of the ground floor showing reuse patterns

- 2.2.1 The timbers were broken down into 5 categories of use. Reused, Probable reuse, possible reuse, original to the 1748 structure, and modern/replacement.
- 2.2.2 In total there were 108 recorded timbers of which:
 - 34 were deemed to be original to the 1748 floor i.e. cut and prepared specifically for the 1748 construction.
 - 29 timbers by virtue of redundant construction marks and features were deemed to be reused timbers, having previously been used in another building or construction prior to 1748.
 - 11 timbers were probably reused timbers but because there was no definitive evidence there remains some doubt.
 - 13 timbers were possibly reused timbers, this meant they had a suspicious extra mark or feature that could suggest reuse but a definite conclusion could not be reached.
 - 21 timbers were either relatively modern replacement timbers or dated

2.2.3 It should be noted that of the 34 timbers thought to have originated during the 1748 construction it is likely some of them were reused timbers where the obvious reuse features could not be seen or had been removed.
