**Northey Island  
River Blackwater  
Maldon  
Essex**

**ARCHAEOLOGICAL SURVEY REPORT**

Site Code MDNI 15  
NGR 587770 206530

Archaeological survey report

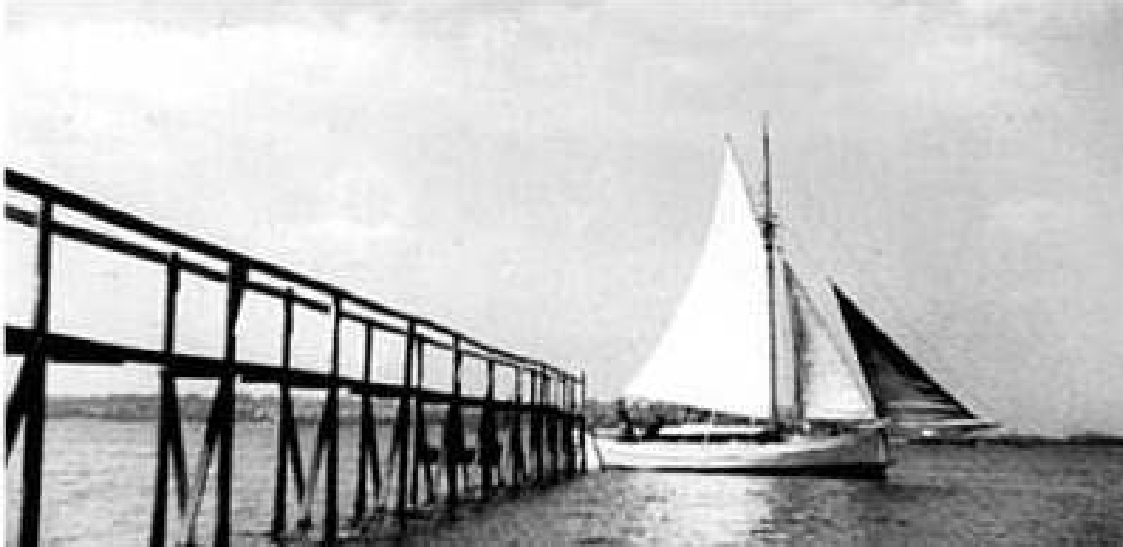
- 5.1.7 A linear timber structure was observed on the foreshore in the south-west of the site which possibly represents a landing stage. Historic photos show a timber landing stage in this area, which was constructed shortly after the island was bought by Norman Angell in 1923, and the posts visible today could be the remains of this structure.

*View of landing stage looking west with Norman Angell's yacht, from Ardley, N. 2011 The Jottings of a Thames Estuary Ditch-Crawler*

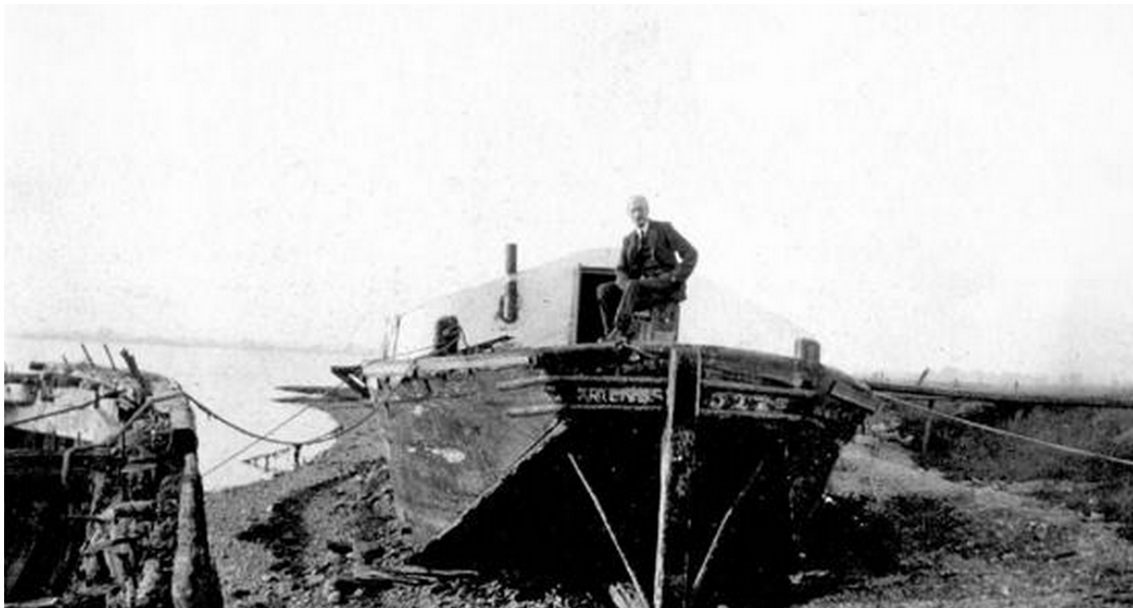
- 5.1.8 Another timber jetty is shown in the background of a photo of a houseboat moored on the 'beach' in the south-western corner of the site. No traces of this jetty or the houseboat could be seen during the site surveys.

*Norman Angell's lighter, No. 527, Friends, in about 1930, from Ardley, N. 2011 The Jottings of a Thames Estuary Ditch-Crawler*

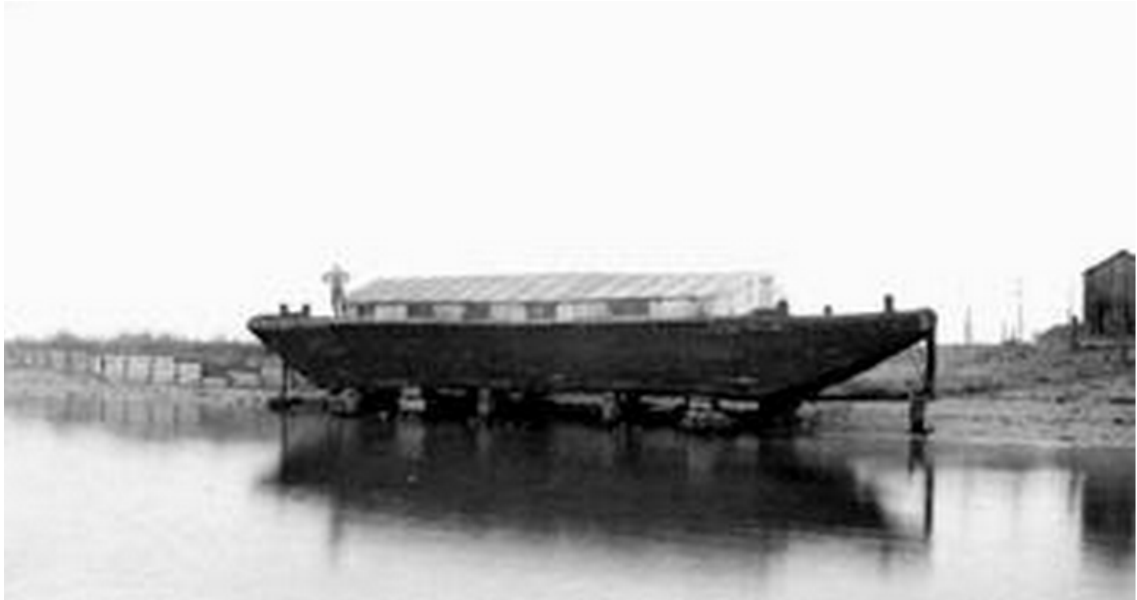
- 5.1.11 Earthworks recorded to the south-west of the pool, comprising a slight bank and depression c 2m<sup>2</sup>, could have been a platform for a small building or terrace. A photograph of the 'beach' in the south-western corner of the site looking towards the pool show a timber structure in the location of these earthworks, which may have been a changing room for the pool, or an unrelated outbuilding such as a storage shed. This photograph also shows timber revetments along the seaward edge of the sea wall, which can no longer be seen.

*The final position of Norman Angell's accommodation lighter, showing timber structure in the background to the right, and timber revetments to the left, from Ardley, N. 2011 The Jottings of a Thames Estuary Ditch-Crawler*

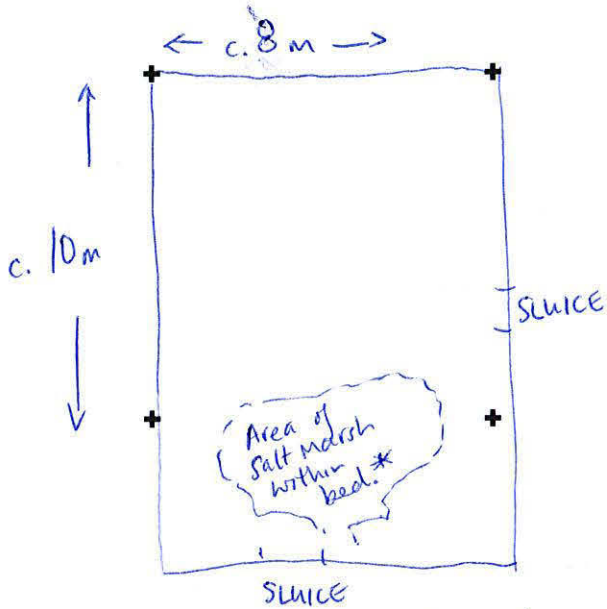
RECTANGULAR OYSTER BED WITH REGULARLY SPACED QUARTER SAWN 3" sq. ~~THE~~ TIMBER POSTS. TIMBER PLANKING\* LINED THE OYSTER BED, BEING HELD IN PLACE BY THE POSTS. THIS IS MUCH DEGRADED THOUGH THE LOWER PLANKS ARE STILL IN PLACE IN THE SOUTHERN END OF THE BED. THERE ARE 2 SLUICES - ONE IN THE W SIDE + ONE IN THE N END. IN THE W SIDE THIS HAS ONE CERAMIC PIPE, IN THE N END THERE ARE TWO PLASTIC PIPES (SEE OVER)  
\* EXANT PLANKING = 8" wide by 1/2" thick.

\*c. 50cm lower than surrounding Salt Marsh.

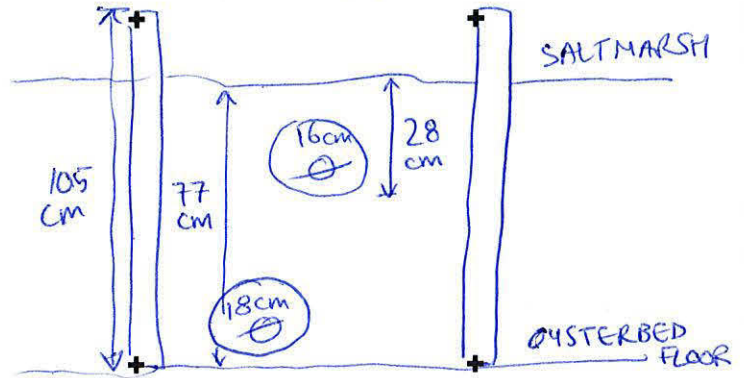
NORTH END SLUICE

connects to a possibly natural channel to the North.

Both pipes are plastic + conform to metric measurements.

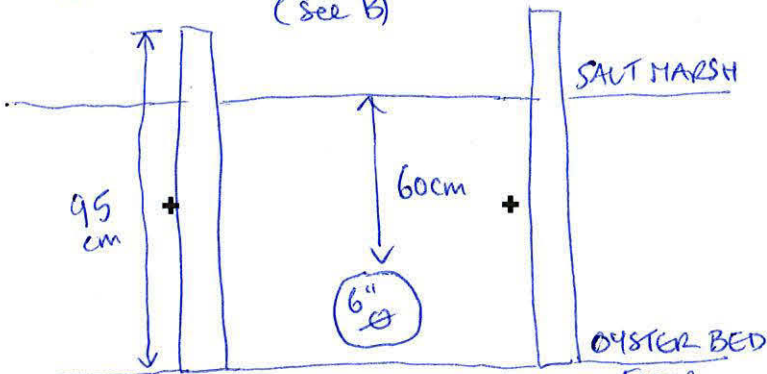
WEST END SLUICE

connects to another oyster bed to the West (See B)

Single ribbed ceramic pipe conforms to imperial measurements.  $\frac{1}{2}$ " thick with ribs  $\frac{1}{2}$ " apart

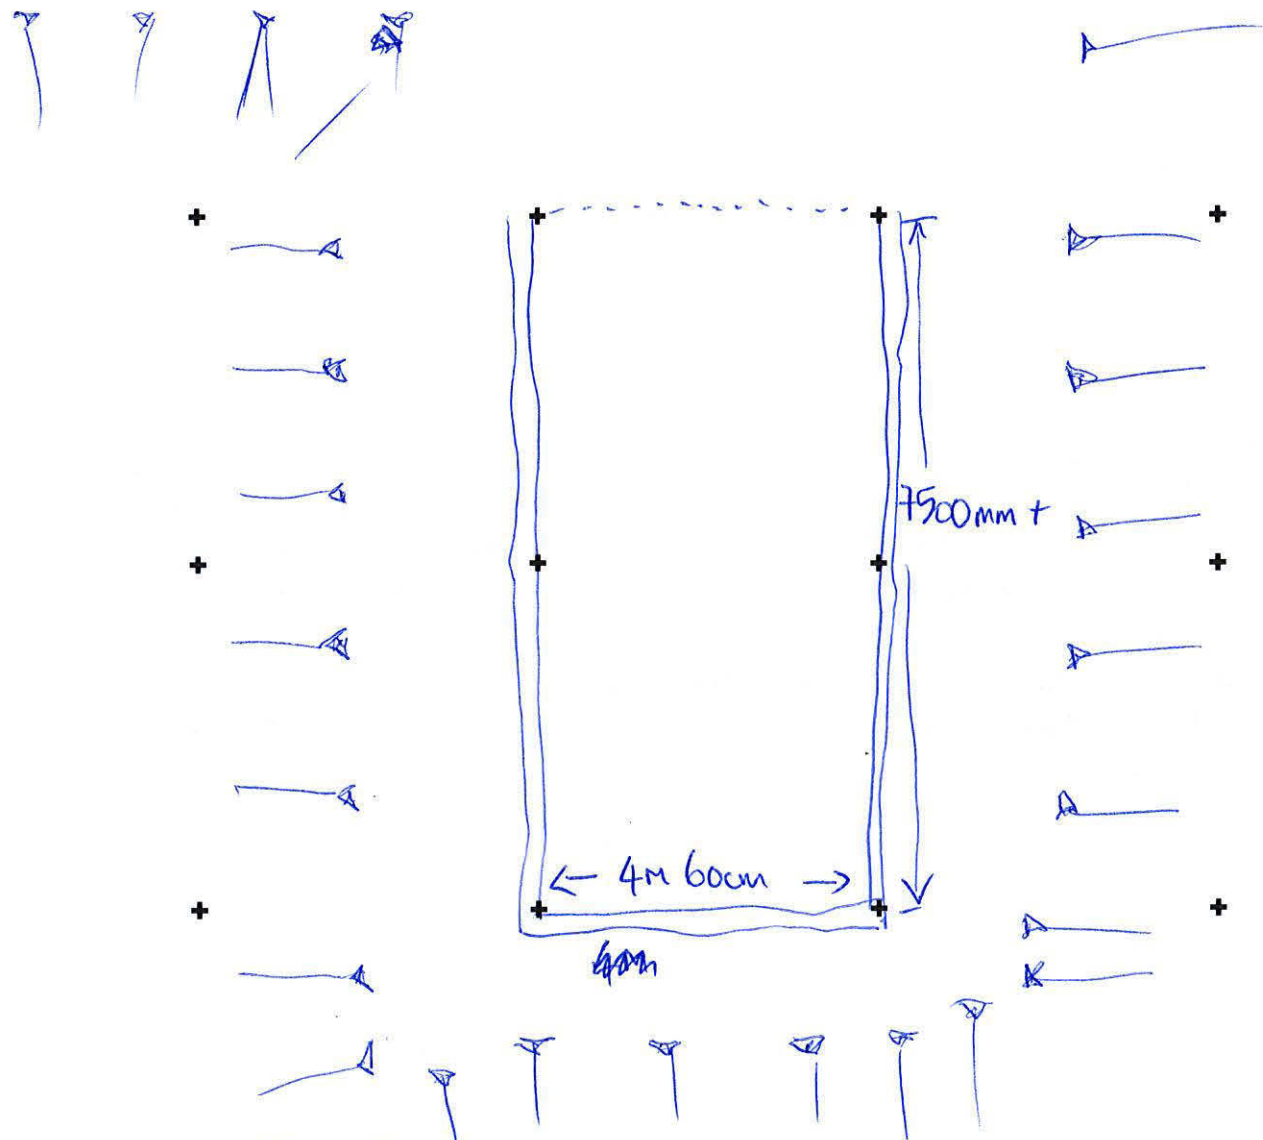
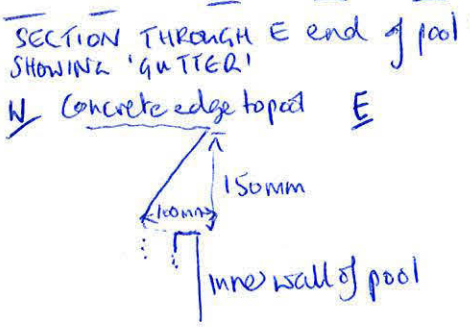
CURVED CONCRETE CAPPING STONES\* <sup>LIGHT</sup> BLUE PAINTED CAST CONCRETE SIDES.  
VISIBLE THOUGH MUCH OVERGROWN \* 2 VISIBLE, MOST APPEAR TO BE MISSING  
**Date range**      20th Century. Drainage feature W in pool at east end.

Possible area  
of feature  
associated with  
the pool.

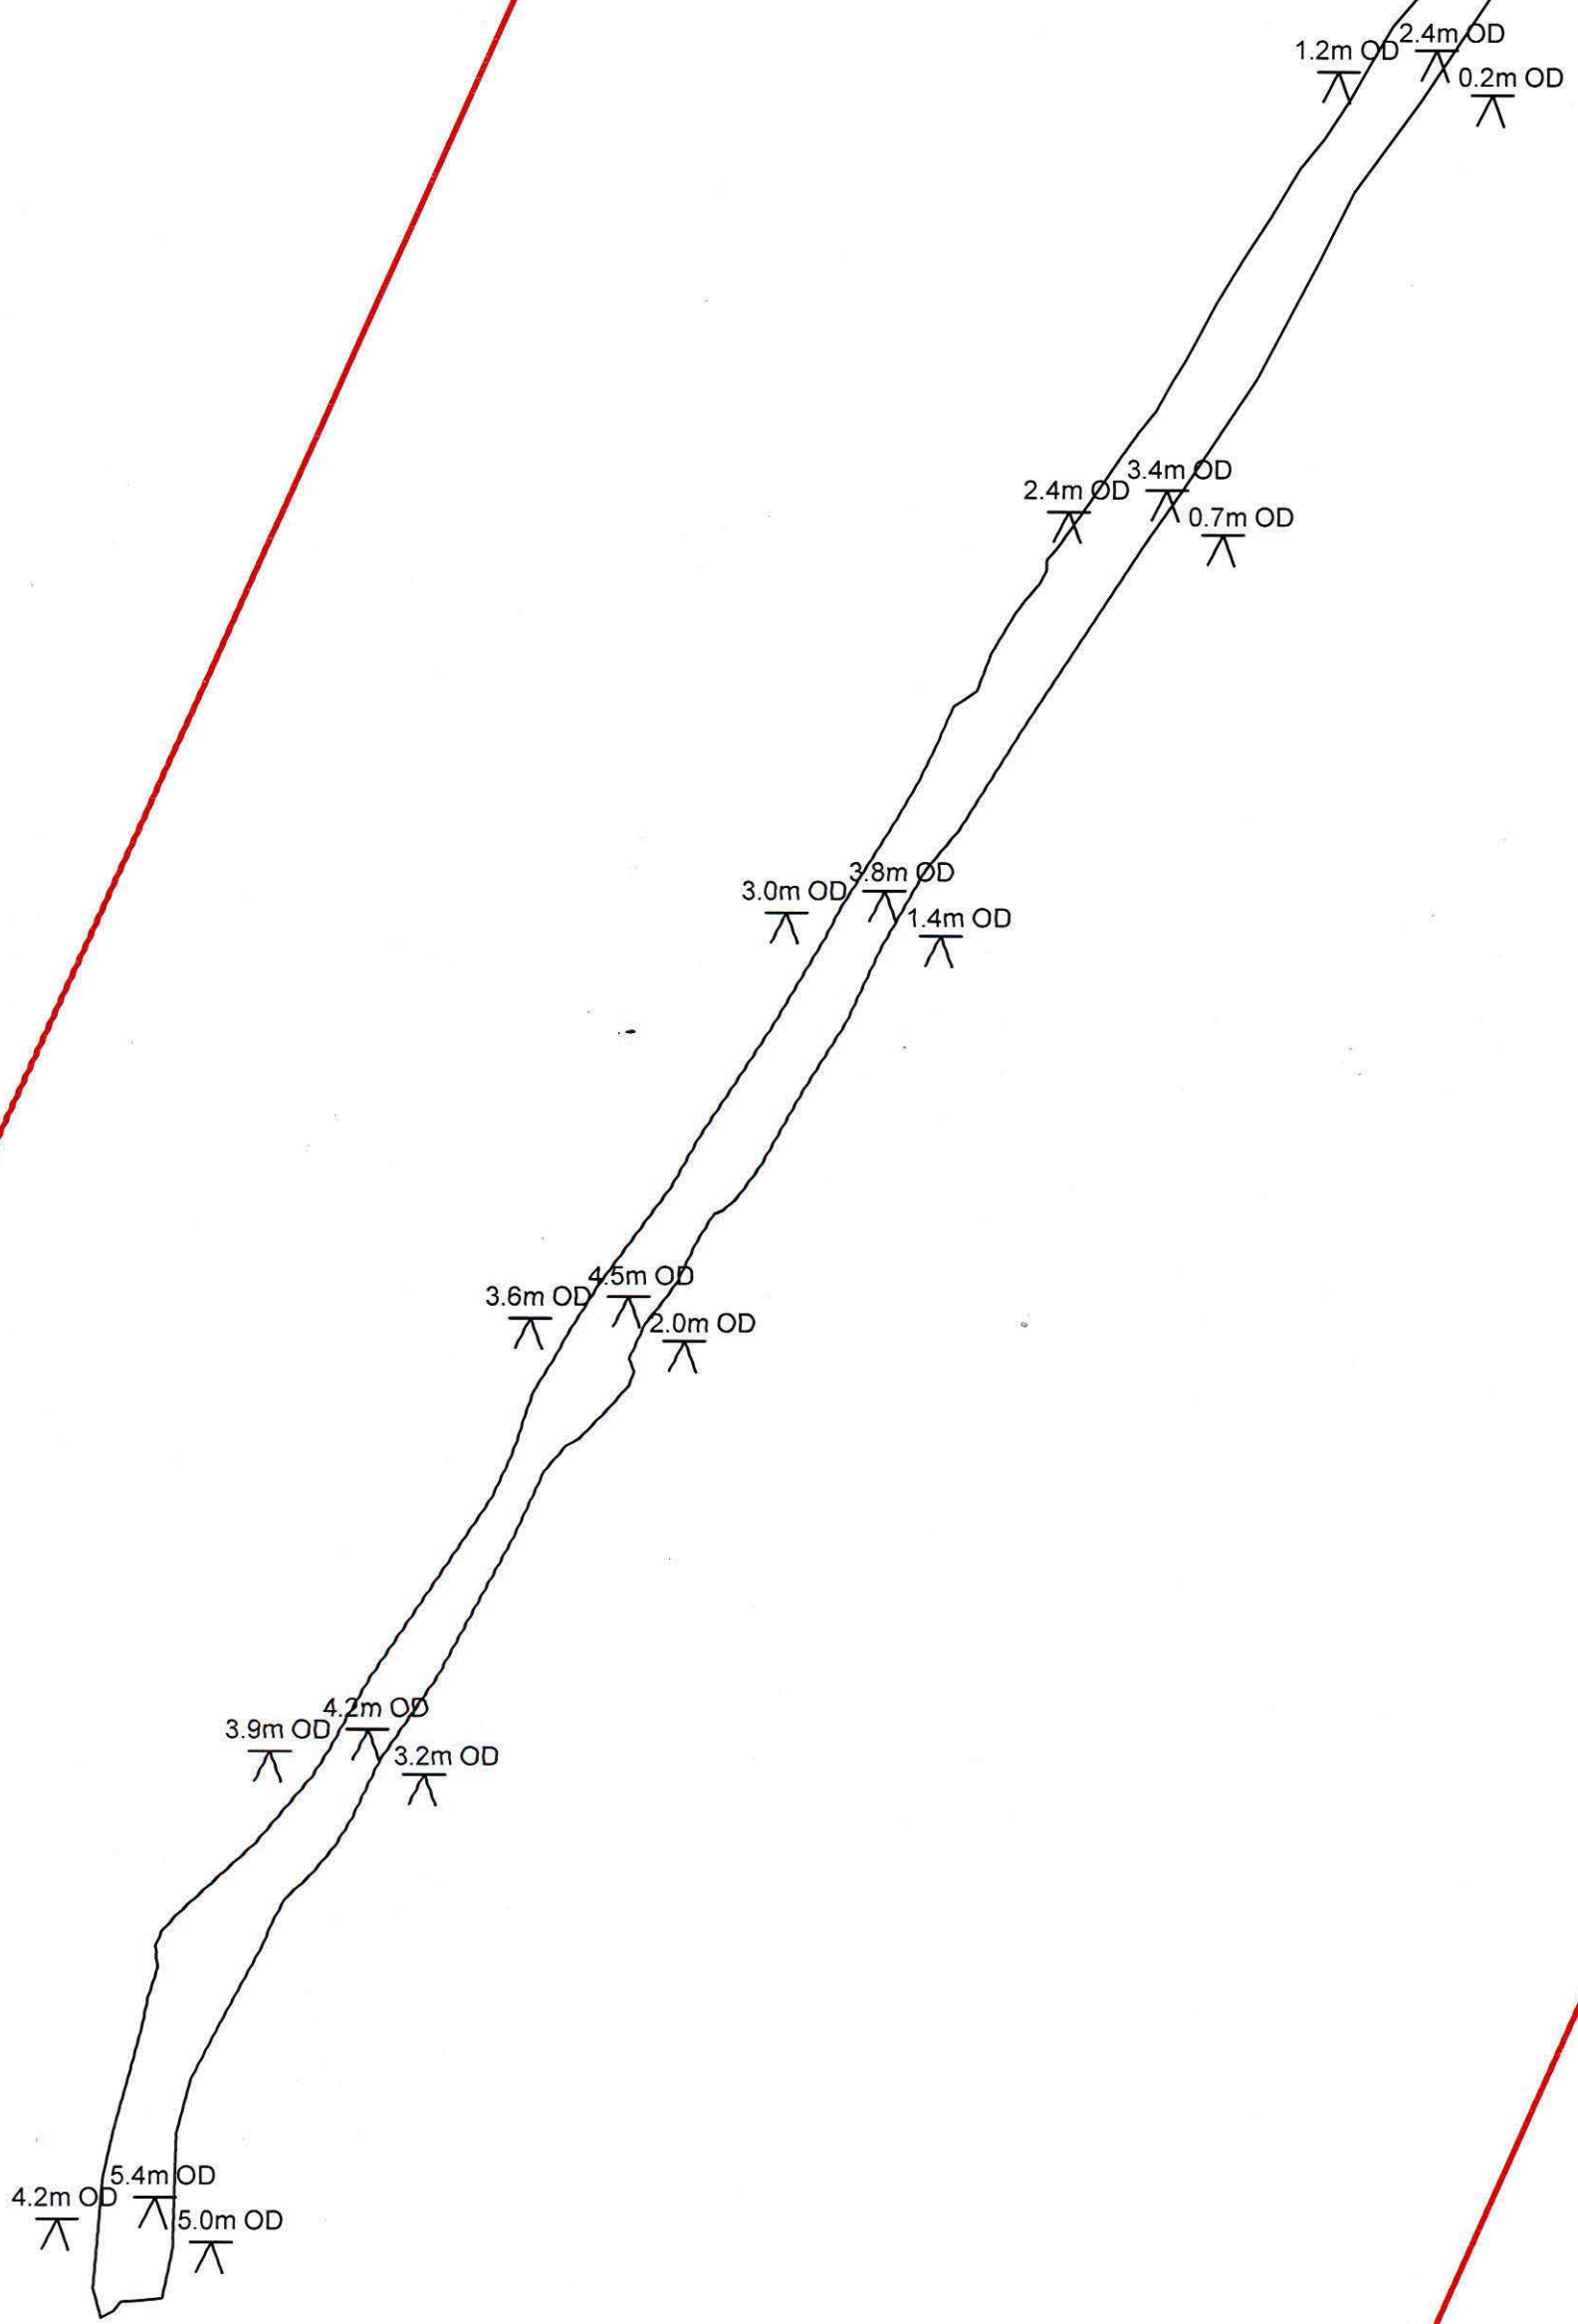
Fig 7 Sea wall with levels taken at 50m intervals, in metres above Ordnance Datum

- 4.6.1 Most of the sea wall comprised an earthen bank with vegetation ranging in height from 0.75m to 1.50m on the landward side and from 0.30m to 1.20m on the seaward side. The southernmost side has been partially faced in concrete. The sea wall with levels is shown on Figure 2.
