Archaeological building and desk-based
assessment of the Courthouse, Long Crendon,
Buckinghamshire

Joe Prentice and
Charlotte Walker
Report 11/101
April 2011

**ARCHAEOLOGICAL BUILDING AND DESK-BASED ASSESSMENT
OF THE COURTHOUSE, LONG CRENDON,
BUCKINGHAMSHIRE
APRIL 2011**

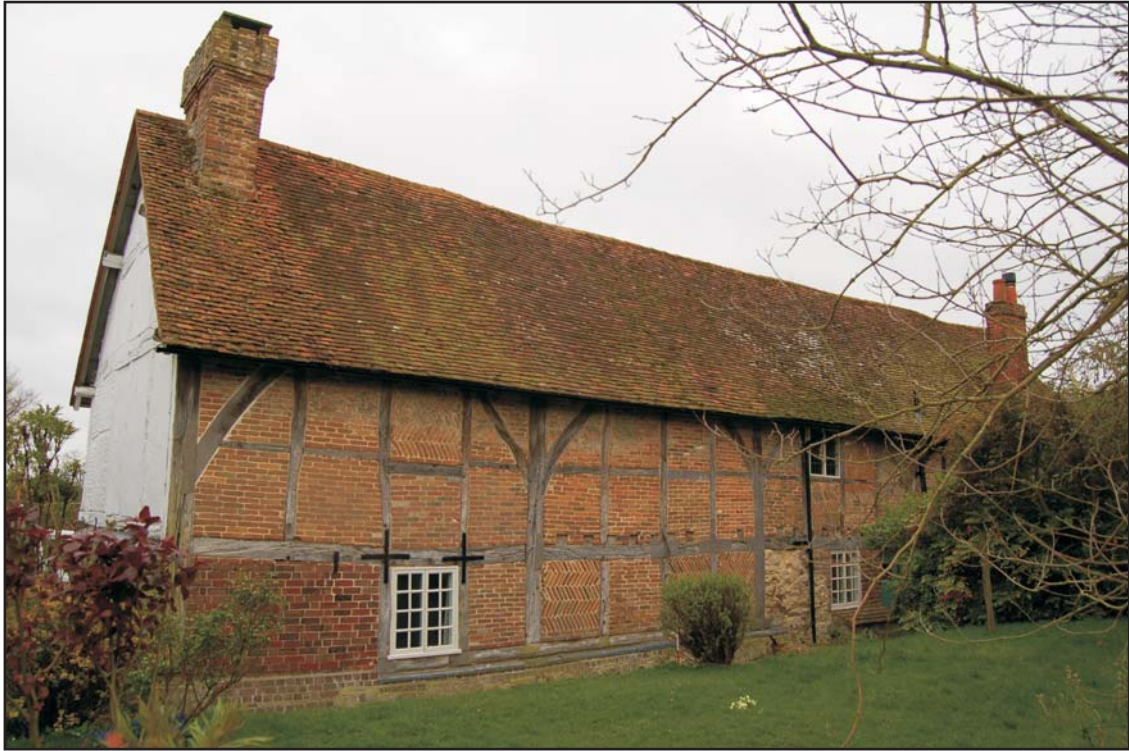
The north elevation, looking south-west Plate 6

- 4.4 The north elevation. The north elevation is unpainted along its entire length and therefore the different phases of intervention and structural detail are easier to identify (Plate 6). Whilst constructed in essentially the same way as the south facade, there appear to be more alterations and changes in this elevation, particularly at ground floor elevation where there are different panels of infill and the line of the plinth beneath the sole plate is less consistent. Only the eastern end was photographed clearly due to the proximity of outbuildings and shrubbery at the western end, though the whole was observed on site.

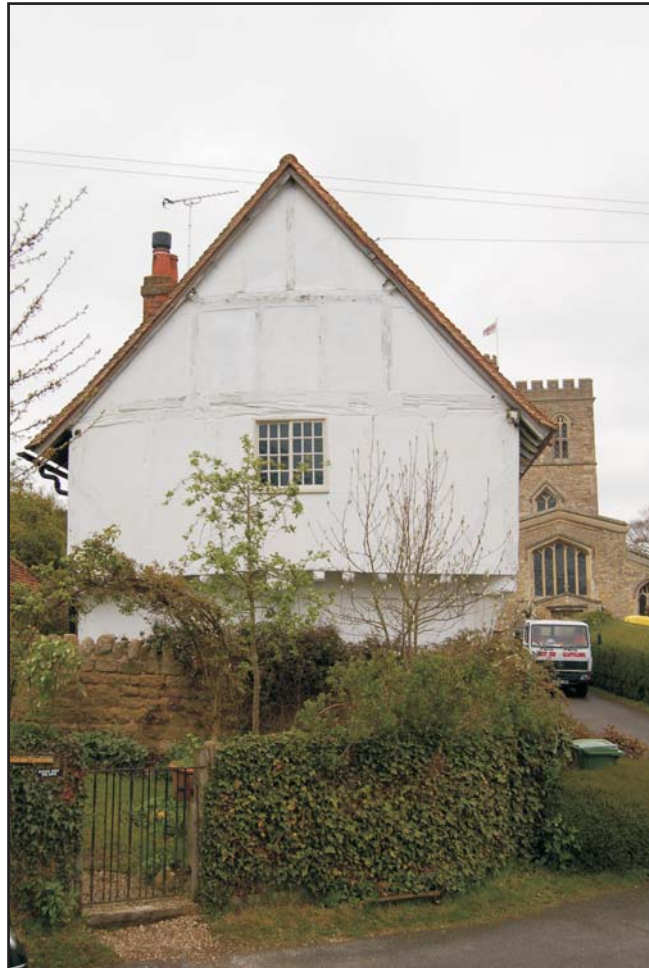
The west elevation, looking east Plate 7

4.5 The west elevation. This elevation could only be photographed from the adjacent triangular green to the west since a narrow passageway precluded photographs being taken except at an extremely oblique angle (Plate 7). The elevation is jettied above the ground floor and the whole elevation is painted white. There are no windows at ground floor level, although it is thought that there may have been one at some stage as there is a roughly square panel in the centre of the wall which could have held a frame. The whole of the ground floor infilling is plastered so it has not been possible to comment on the nature of the structure. The first floor and gable is much the same. It can be seen that there has been replacement of some of the oak frame due to the sharpness of the timber, but all of the panels are plastered so it is assumed that the infilling must be either wattle and daub, brick or woodwool. The first floor has a centrally placed horizontal sliding sash window.

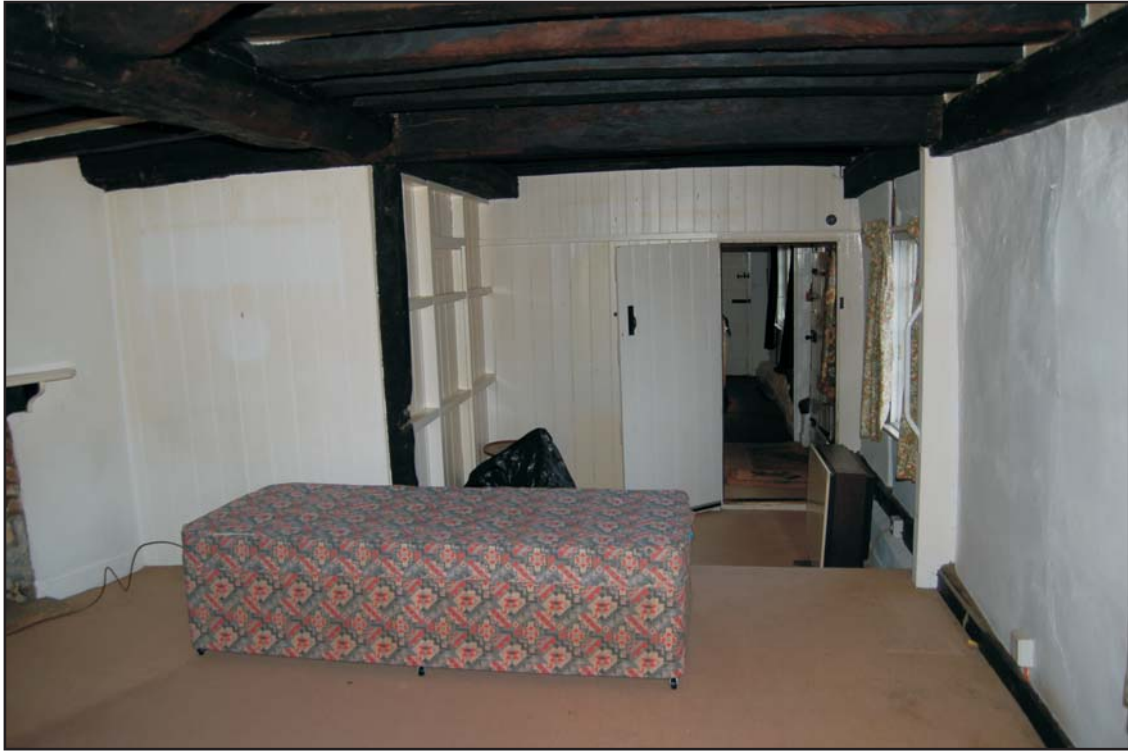
Room 1, looking east Plate 8

4.7 Room 1, sitting room. This room occupies all of Bay 1 and the south-west quarter of Bay 2 which lies at a lower level, the two parts of this L-shaped room linked by two steps rising from east to west (Fig 3, Plate 8). The reason for these two steps is presumably to allow for the cellar beneath, which if not raised in this way would not allow sufficient headroom. The north wall contains a fireplace set at an angle to the walls, though not completely across the corner at 45 degrees; it is not original. The chimney breast and exposed west side are plastered and painted, the fireplace opening was exposed which showed a mixture of limestone and brick to the jambs and back, the hearth was covered in modern clay tiles (22 cms square). The fire opening contained a modern coal effect gas fire in a vaguely Victorian style. There was a black painted (oak?) lintel with a simple mantle shelf comprising an un-moulded plank set horizontally on two simple brackets. The remainder of the north wall was plastered and painted white, a vertical post and a short part of the sole plate could be seen, both of which were painted black.

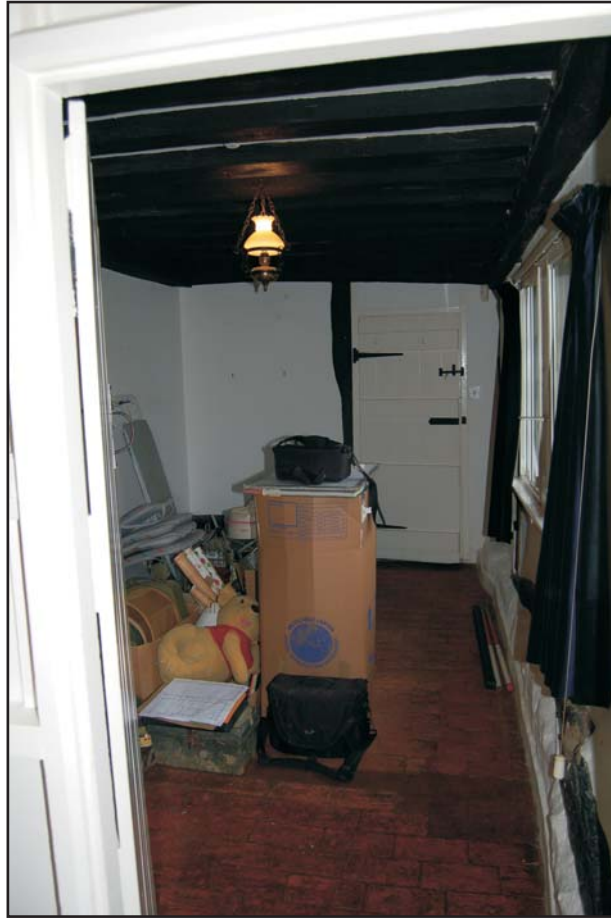
Room 4, the hall, looking east Plate 11

The east wall of the room appears to be an original division, a single thick post is present immediately to the north of the doorway into Room 6. The lower edge rests on and is presumably tenoned into the sole plate which is also partly visible (Plate 11). The panel to the north is plastered and may be wattle and daub; it is painted white.
