Archaeological building assessment of the stable
block at 2 Kings Lane, Flore, Northamptonshire
March-May 2011

Report 11/116

May 2011

**ARCHAEOLOGICAL BUILDING ASSESSMENT OF
THE STABLE BLOCK AT 2 KINGS LANE, FLORE,
NORTHAMPTONSHIRE
MARCH-MAY 2011**

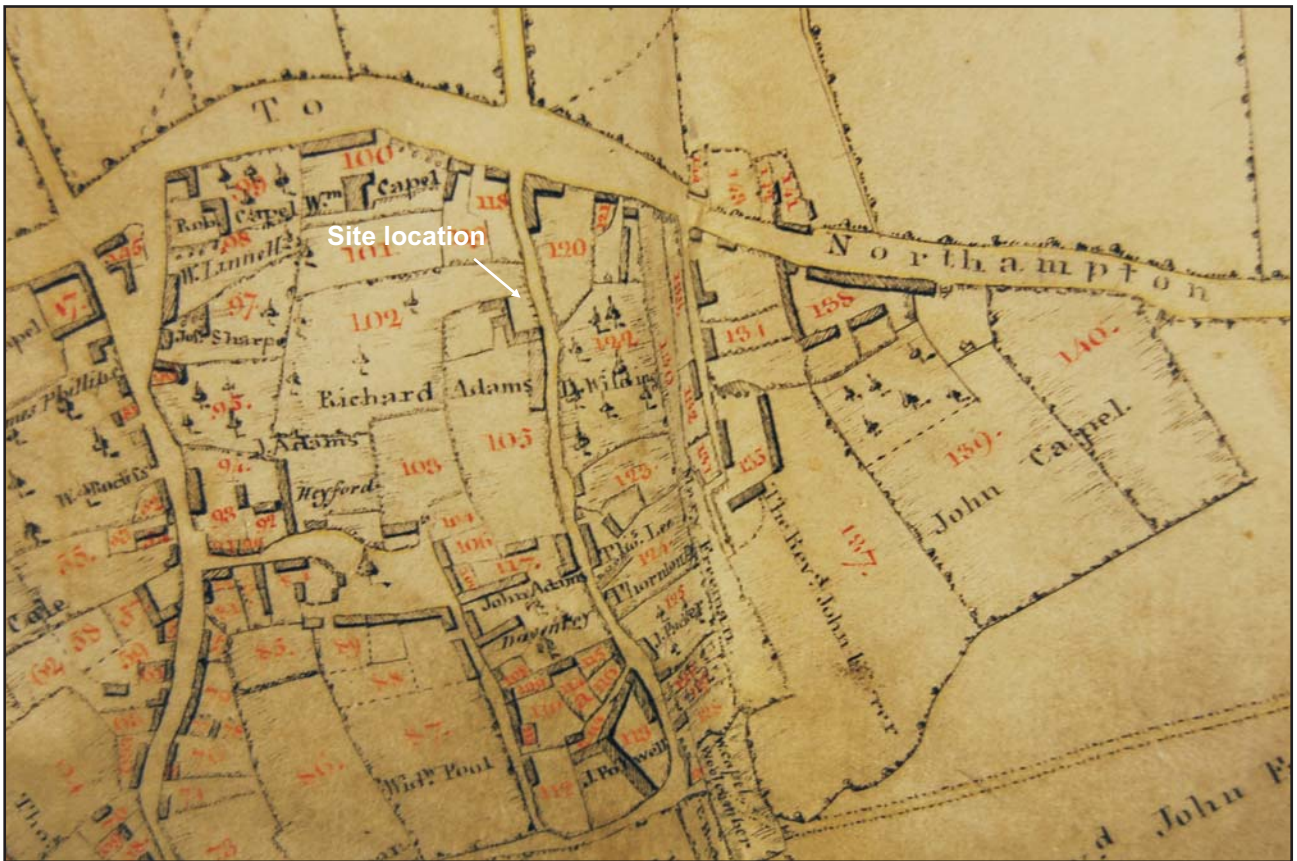
1779 map of Flore Fig 2

- 3.2 The Enclosure Map for Flore no longer survives, but the enclosure of the open fields was carried out in 1778 (RCHME 1981). The NRO holds a map of c1779 [NRO Map 5259] which shows the village and surrounding fields in good detail, with the manor house shown, albeit a different shape to that which it retains today (Fig 2). There is no building to the north where the stable now stands. The 1810 Ordnance Survey Preparatory Map held in digital format by NA was referred to but the scale is insufficient to determine whether there is a building in the location of the stable block.

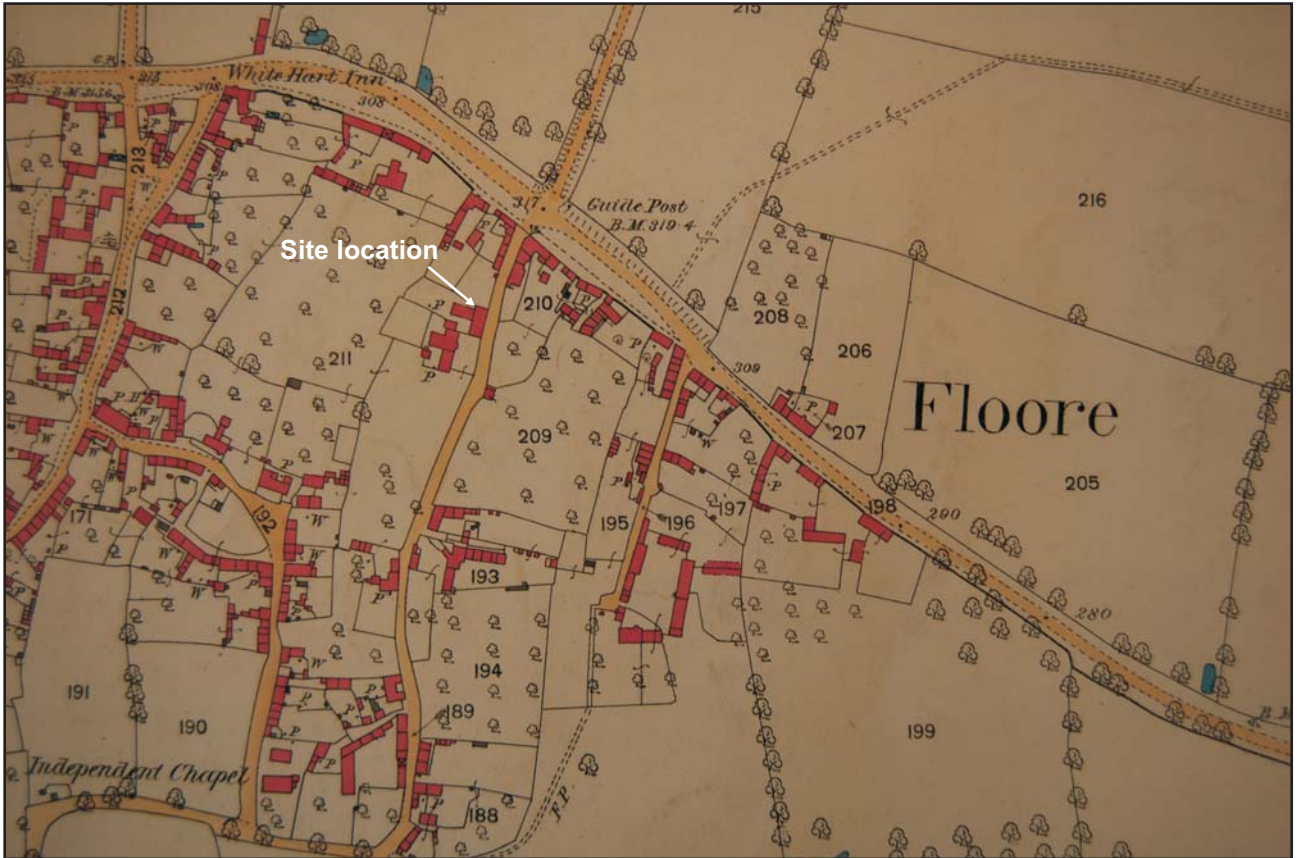
1885 25 inch Ordnance Survey map Fig 3

The 1885 edition 25 inch Ordnance Survey map [NRO Map XLIV 9, 1885] shows a different building on the stable site comprising two parts laid out in a T-shape (Fig 3). By the 1900 edition [NRO Map XLIV 9, 1900] that T-shaped building has been replaced by the existing building although almost certainly without the single storey addition at the west end as it appears to be too short, and does not reach close enough to the boundary wall located at the west end which divides the stable yard from the garden, nor is there any distinction made between the two storey and single storey structures (Fig 4).
