Building recording of a coach house at Mortimers
33 Rectory Lane, Milton Malsor, Northamptonshire
September 2011

Report 11/204

October 2011

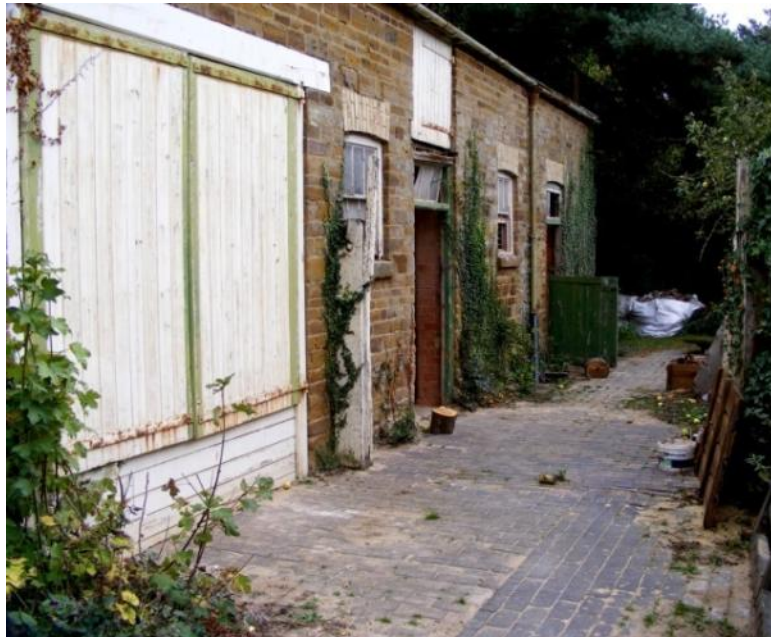
Brick yard along south frontage, looking east Fig 6

Along the frontage there is narrow yard, paved with blue engineering bricks, sloping away from the frontage (Fig 6). A gate hung on a wooden post bolted to the building wall separated the carriage house from the stable yard to the east.

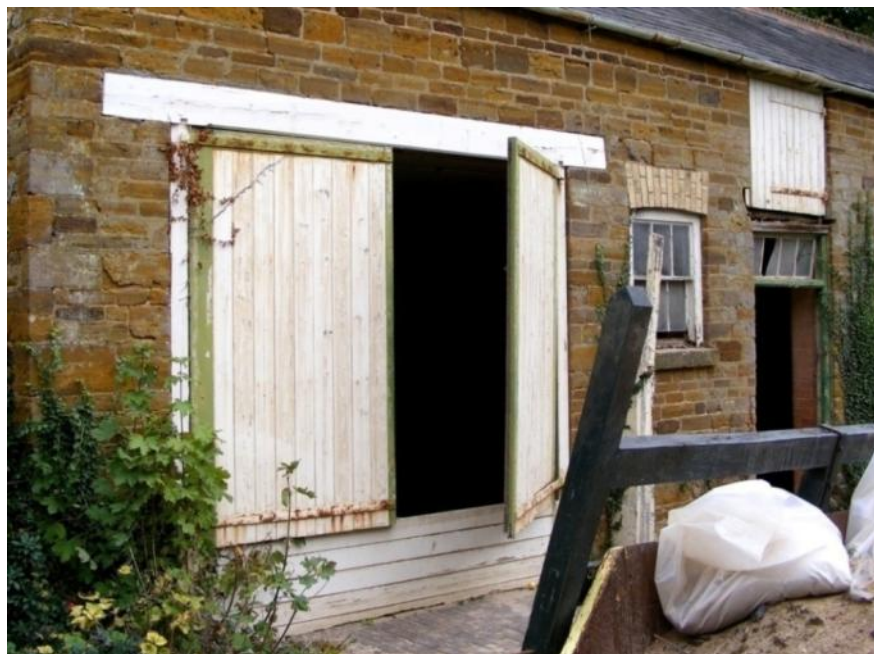
Fig 7

To the west the double doors of the carriage house are 2.94m wide (Figs 7 and 8). The two vertical plank doors are ledged with one thin brace, painted white on the outside and framed in green. They are hung on a wooden frame with plain strap hinges extending the full width of the door, and set beneath a timber lintel. The frame and lintel are both painted white. The internal door jambs are bright orange and red bullnose bricks. Inside the carriage house, the west door is fastened by a vertical bolt to the frame and the east door by a bolt to the west door. The bottom 0.57m of both doors has been removed, probably due to decay, and replaced by part of another door laid horizontally across the whole opening, and recessed against the jambs to be removable.

The carriage house doors, looking north-east

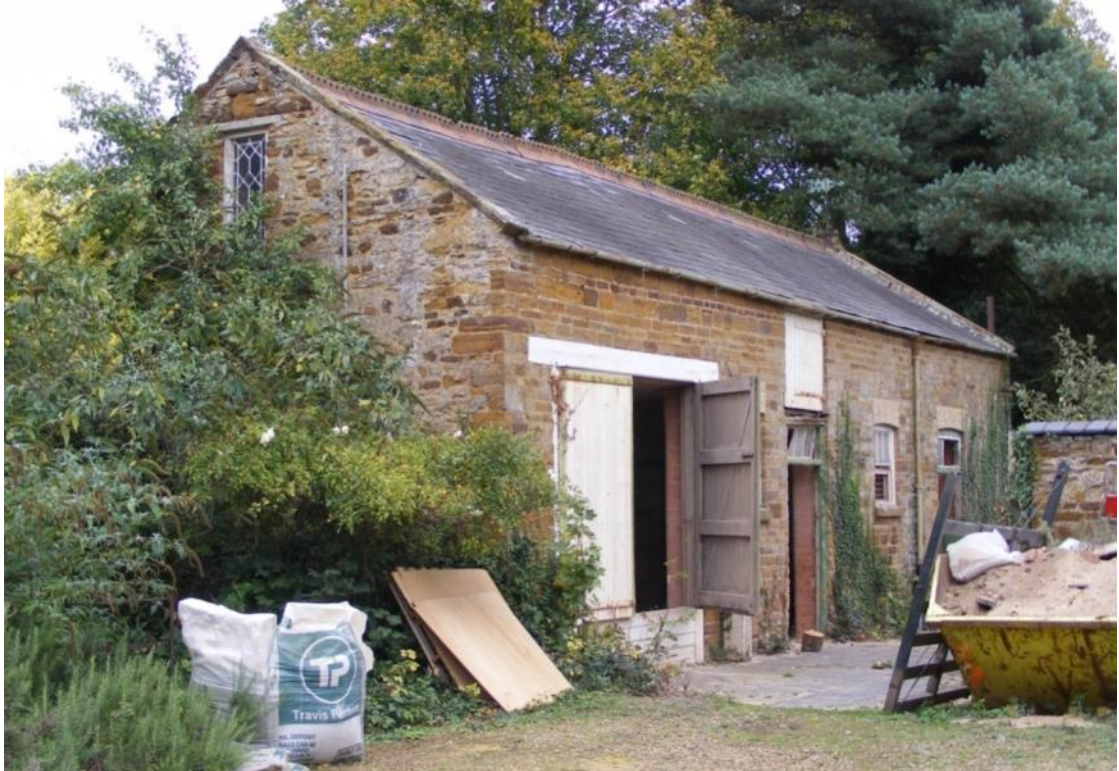
The south elevation and the western gable end Fig 4

This elevation is built in dressed ironstone laid in neat courses and bonded in white lime mortar (Figs 3, 4 and 5). It contains three doors: the double carriage house doors and the doors to the stables; and windows for the carriage house and the second stable, Stable 2. The tool shed at the eastern end is set back from the main elevation.

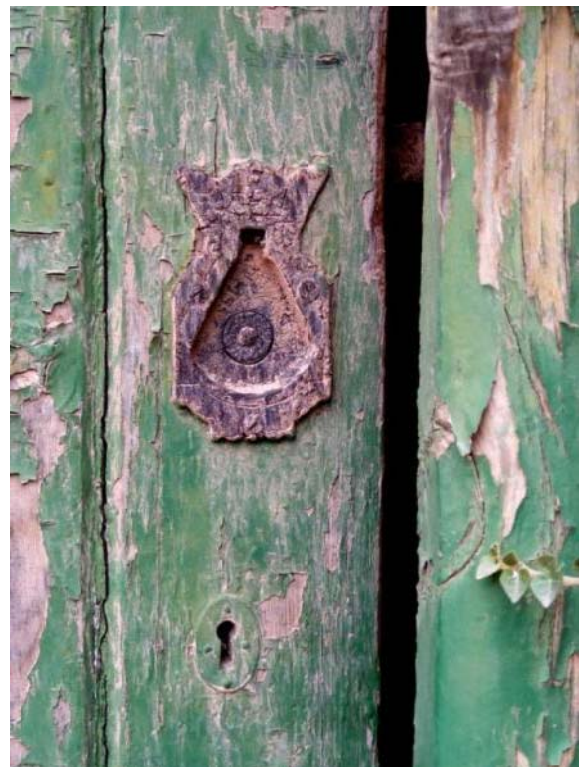
Decorative latch-lifter plate on the door to Stable 1 Fig 10

timber frame by plain strap hinges top and bottom on the inside (see Fig 35). The bottom of the door is plain wood and slightly damaged having lost a ledge from the bottom. On the east side of the door there is a decorative latch-lifter plate, probably original (Fig 10). Underneath there is an oval metal keyhole escutcheon set into the door, and below that there is a lock on a wooden block that has been added recently.

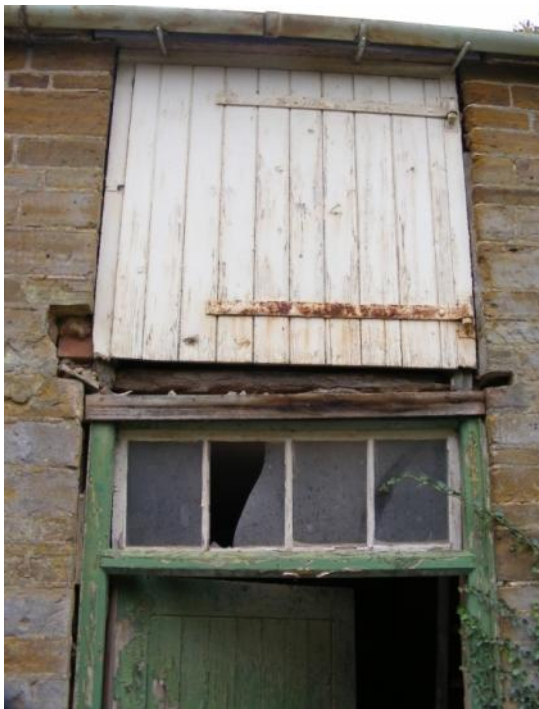
The hayloft door, with strap hinges Fig 11 The carriage house window Fig 12

The hayloft door, directly above the entrance to Stable 1, is vertically planked, ledged and half braced inside, and hung on plain strap hinges. It is painted white outside and bolted closed inside (Figs 11 and 55). The base of the internal brick partition wall can be seen in a gap at bottom left of the hayloft door.

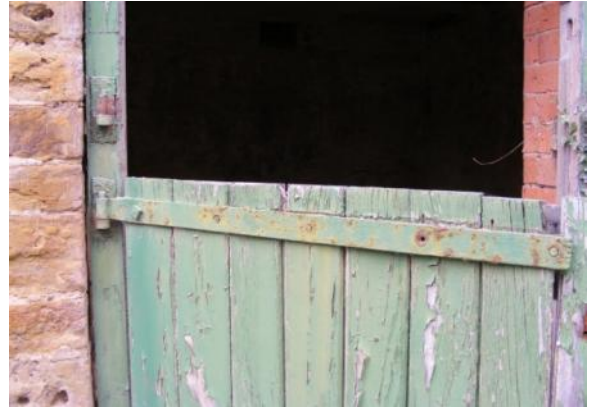
Lower door and strap hinge, Stable 3
Fig 14

The entrance to Stable 3 is a two-leaf stable door, with the upper leaf missing (Fig 13). The lower leaf is vertically-planked, ledged and braced; painted green on the outside and hung on the outside with plain strap hinges, extending the width of the door, on a green-painted wooden frame (Fig 14). The four-light overdoor panel, which appears to

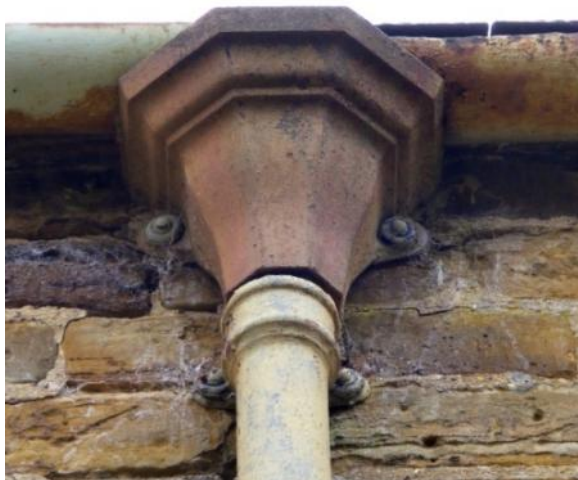
Cast iron rainwater head Fig 15

The rainwater goods are cast iron, with one downpipe between the window of Stable 2 and the door to Stable 3 (Figs 13 and 15). The downpipe has a kite mark (Fig 16). The kite mark was originally registered in 1903 but only came fully into use by about 1929 (www.kitemarks.com). This suggests that the goods were put in place during middle decades of the 20th century.

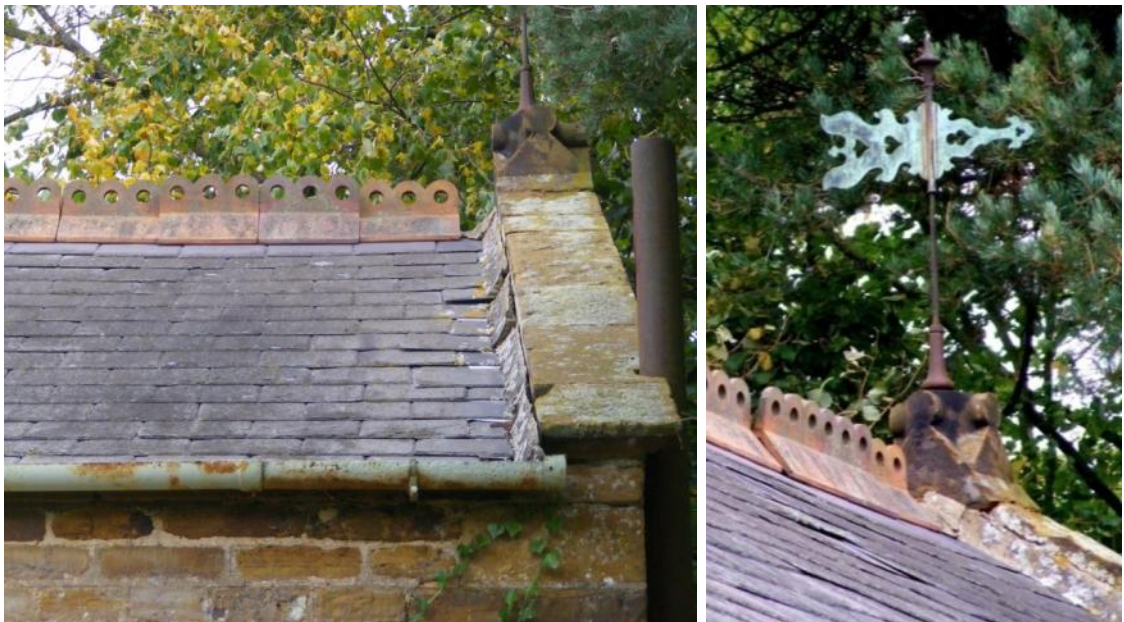
Detail of roof showing the ironstone coping and the decorative ridge tiles (left), and weather vane mounted on a stone finial at the eastern gable (right) Fig 18

The building is roofed in Welsh slate with decorative red ceramic ridge tiles with three-hole crests (Fig 18). A range of decorative ridge tiles and finials were made by firms around the country during the 19th and early 20th centuries. The finial on the eastern gable appears to be of carved sandstone and is surmounted by a decorative metal arrow weathervane (Fig 18).

Each gable end comprises ironstone coping on top of the walls and standing proud of the roof; there are no kneelers (Fig 18).

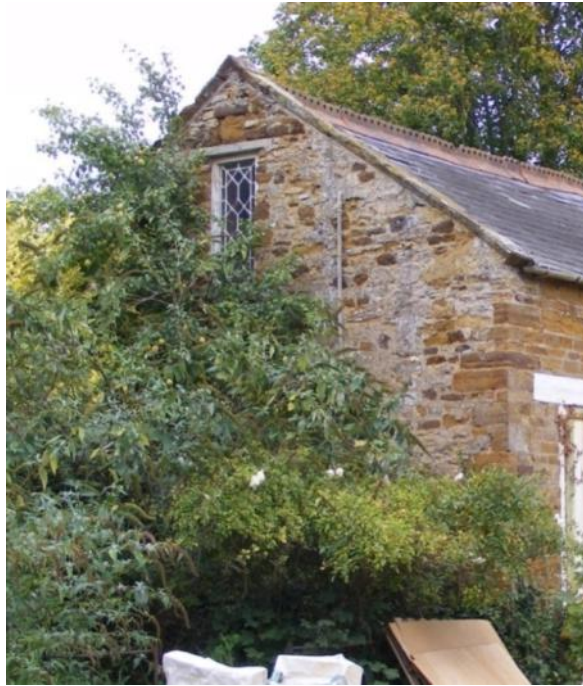
West elevation Fig 19

This elevation is roughly coursed ironstone, heavily mortared and partially obscured by tree growth (Fig 19). There is one window on the first floor designed to look like leaded lights, but in a cast iron frame. The window is set in a white painted frame with a wooden lintel over, the sill was not seen (detailed in section 4.7, the hayloft).

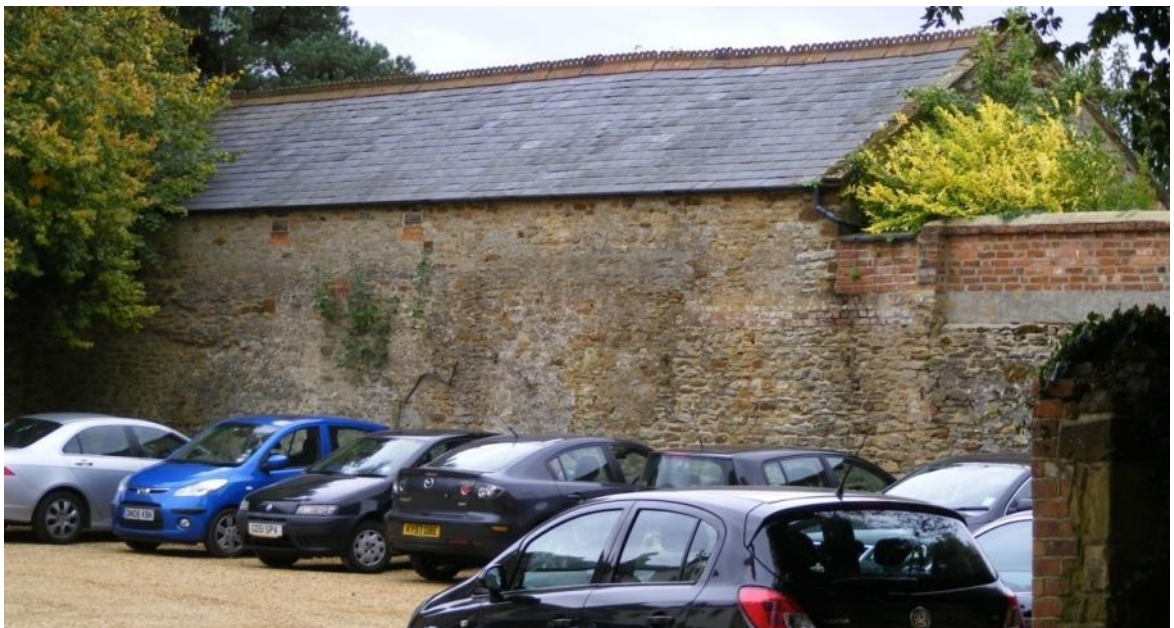
The north elevation, showing the roughly coursed ironstone wall Fig 20

This is built in roughly coursed ironstone with an occasional red brick infill. It is of one build with the boundary wall continuing to the west (Fig 20). To the east the boundary wall only abuts the building (Fig 3). There are modern red bricks beneath the metal ventilation grilles serving the stables (Fig 21). When the coach house was built there were buildings on the adjacent property standing against the boundary wall (Fig 68).

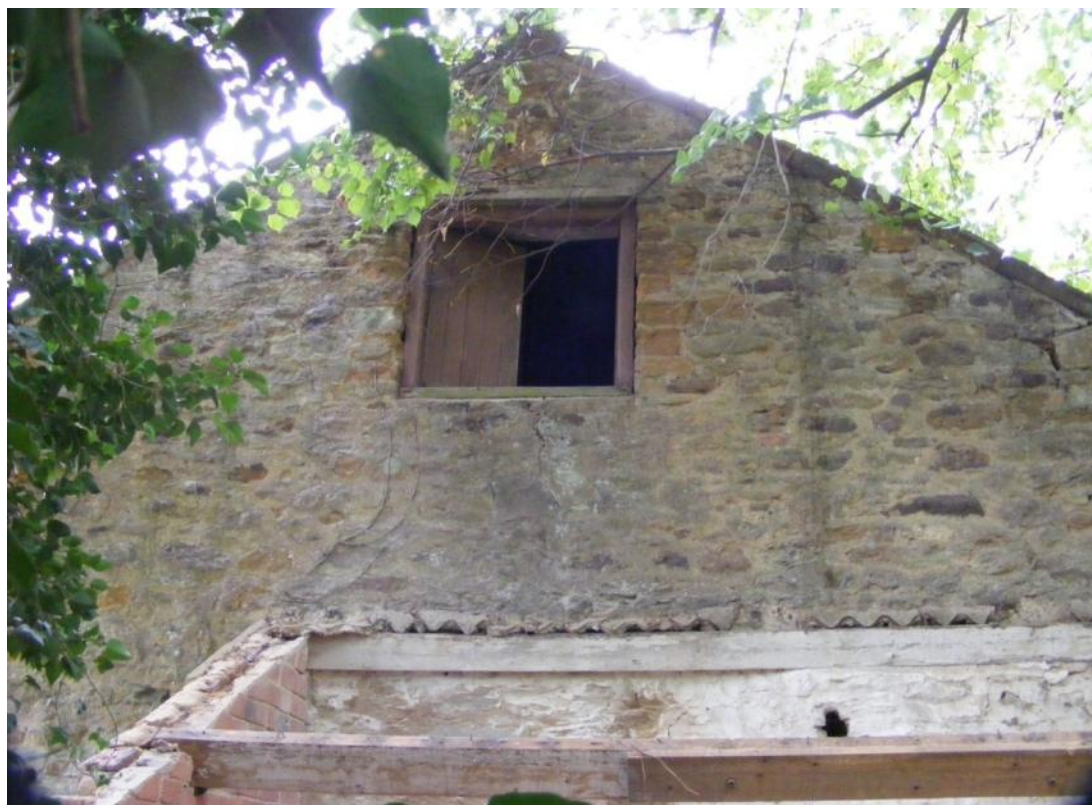
The eastern gable end above the tool shed roof Fig 22

The wall is of roughly coursed ironstone (Fig 22). The northern end of the lower part of the wall bulges out and is covered with whitewash within the abutting tool shed (Fig 23). An apparent straight joint to the south, in line with the end of the whitewashed wall, suggests the former presence of a doorway, although this is not visible within Stable 3.

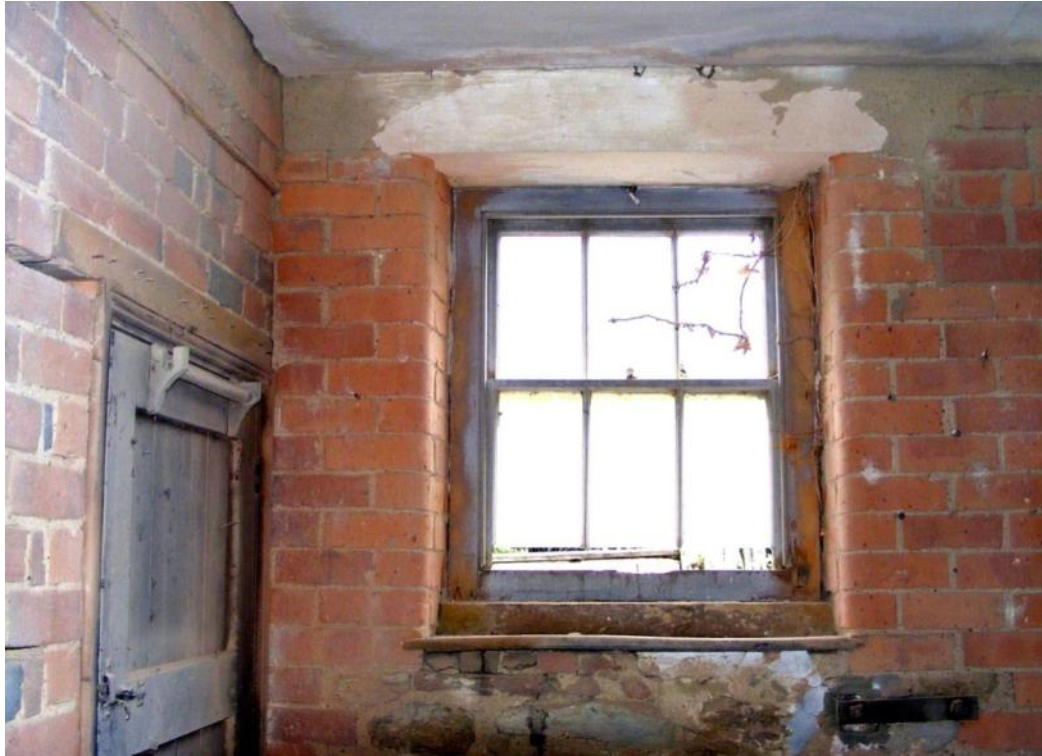
The carriage house window Fig 25

The windows for the carriage house and Stable 2 are identical six-light, three over three sashes in wooden white-painted frames with ironstone sills beneath flat-topped segmental arches of edge-laid buff coloured bricks. The frame at the bottom of the carriage house window is not in good condition and the bottom rail of the sash is missing (Fig 12).

The south wall is in ironstone with orange and red bullnose brick surrounds for the double doors (Fig 8) and the window (Fig 25). The window has a timber sill and the sash is secured by a decorative knob (Fig 26). A metal plate bolted horizontally below and to the side of the window secures the gatepost outside.

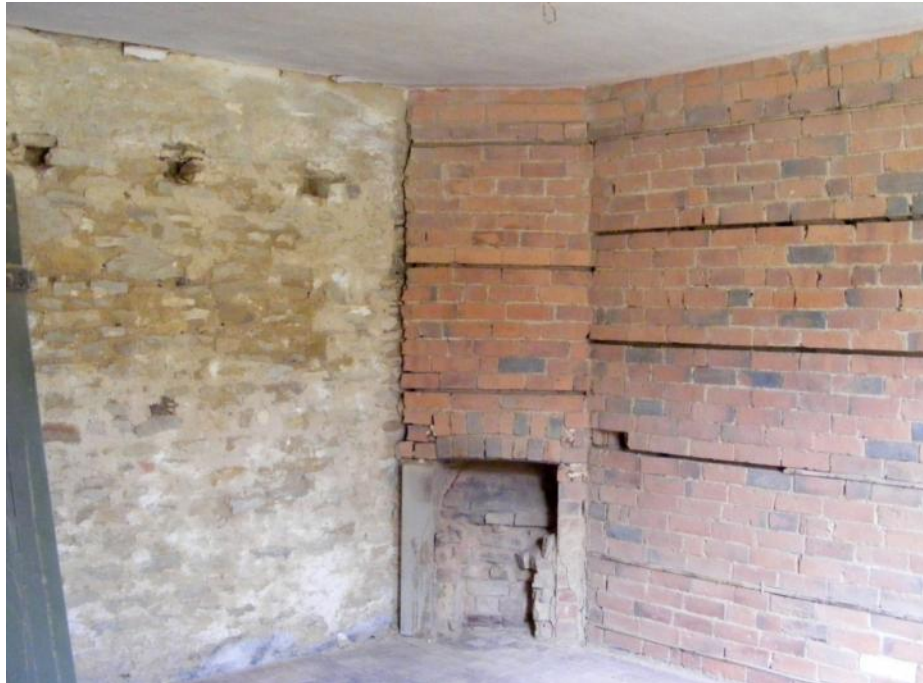
The carriage house, showing corner brick fireplace Fig 27

The west and north walls are of roughly coursed ironstone with the occasional brick or half brick, all heavily mortared with pinkish lime mortar, with remnant whitewash surviving. There are three small square holes or sockets high in the north wall towards the east side, which perhaps once held brackets for hanging larger pieces of tack (Fig 27).

The partition wall between the carriage house and Stable 1 is of perforated brick, mainly laid in Flemish/Sussex Garden Wall Bond, with three stretchers to one header (Figs 27 and 29). All these bricks are 210x100x75mm (8½ x 4 x 3 inches) and vary in colour from red-brown to purple to black.

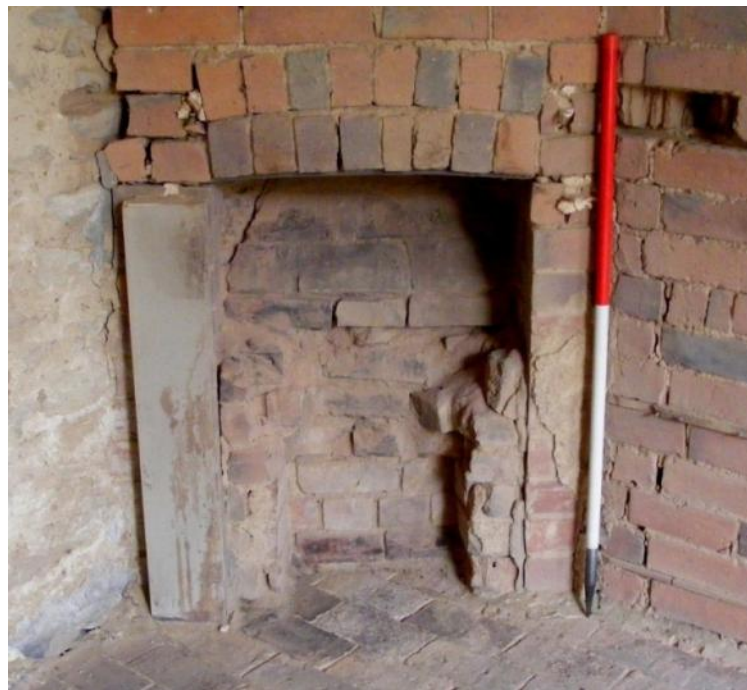
The carriage house fireplace Fig 28

In the north-east corner a brick fireplace is set in the angle of the walls. It is surmounted by a shallow two course header brick arch (Figs 27 and 28). On the north side a vertical block of stone replaces the original bricks. The floor in front and bricks at the back are blackened, but the former grate is missing. There are slots for three battens in the wall over the fireplace.

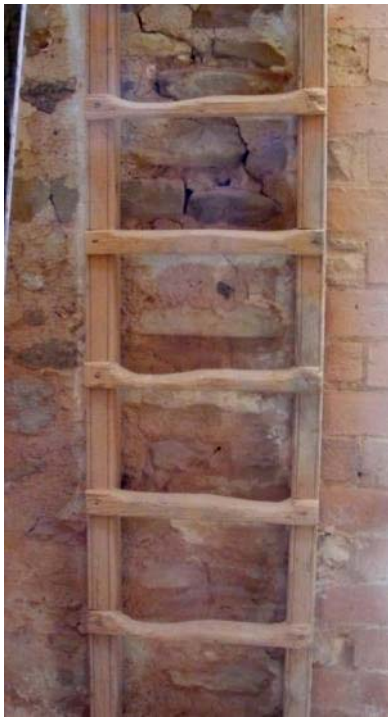
A wooden hayloft ladder is fixed to the south wall, by metal brackets, next to the external door. The treads show an alternating, left, right, left, right, wear pattern from long usage (Fig 34).

The rungs of the hayloft ladder, showing alternating wear pattern
Fig 34

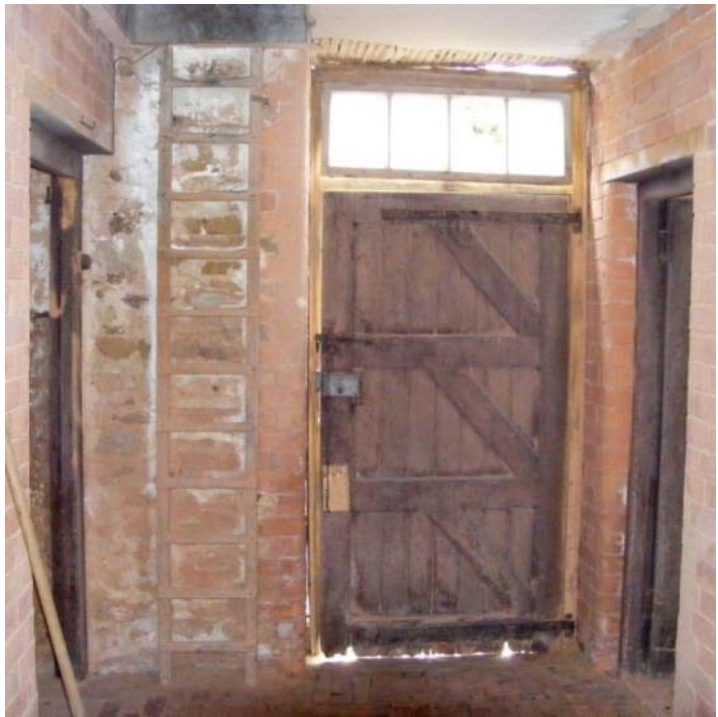
Stable 1, the front door and hayloft ladder Fig 35

The ironstone north wall has remnant whitewash surviving. The east partition wall with Stable 2 is built with perforated bricks, measuring 220x100 (8⁵/₈ x 4 inches), laid in Flemish/Sussex Garden Wall Bond, as is the partition wall with the carriage house. There are orange and red bullnosed bricks forming all three door surrounds, to prevent injury to the horses as they are moved through the doorways (Fig 35).

The ceiling is plaster, which has fallen off over the door exposing the laths (Fig 35).

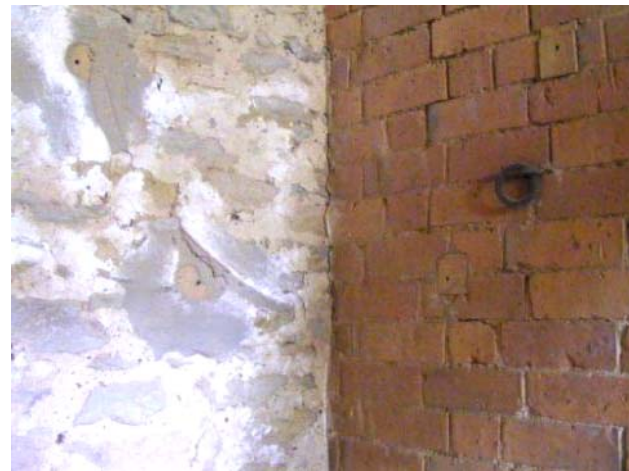
Stable 1, the fittings for a corner manger Fig 37

Towards the northern end of the east wall, an iron tethering ring, 80mm in diameter and 20mm thick, held in an iron staple, is embedded in the wall at a height of 1.60m (Fig 36). Above and below the ring, two wooden blocks are embedded in the wall to hold a corner manger, c 1.90m high from the floor, c 0.60m deep and 0.62m long at the top. Another two blocks are set in the stone north wall, and here the curve of the lost manger is preserved in the whitewash (Fig 37).

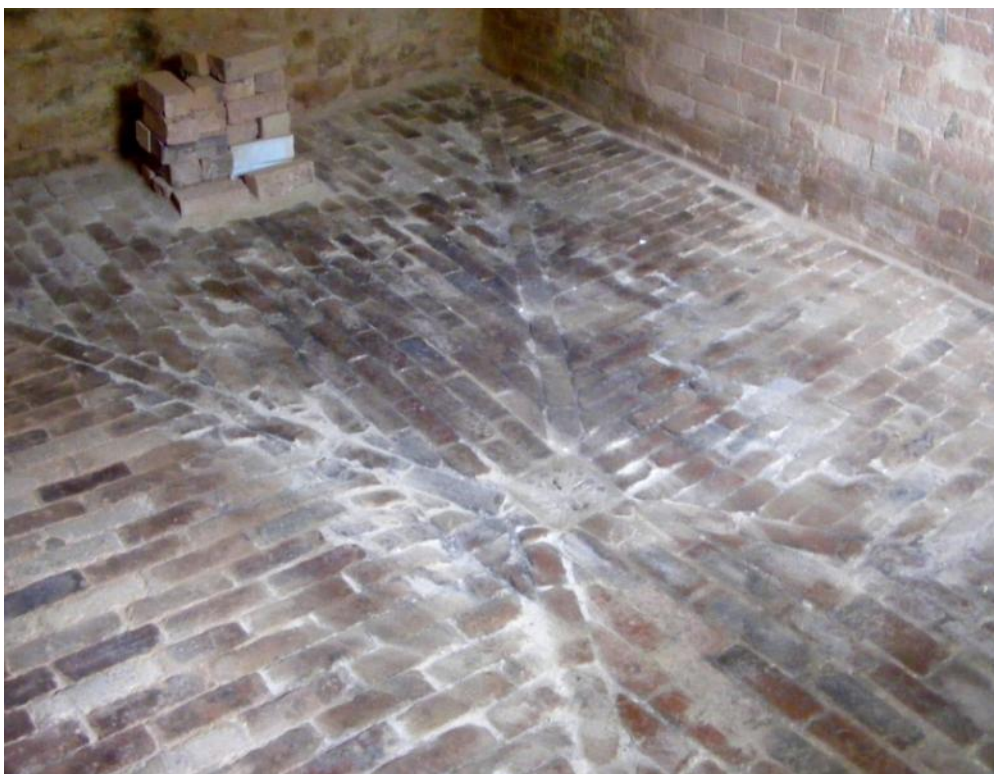
Stable 2, brick floor with central drain Fig 40

The floor comprises stretcher-laid bricks, as in Stable 1, but here single bricks are laid in a saltire cross meeting in the middle at a drain with a decorative metal grille. The bricks in the front and rear triangles are laid north to south, and those in the side triangles are laid east to west (Fig 40).

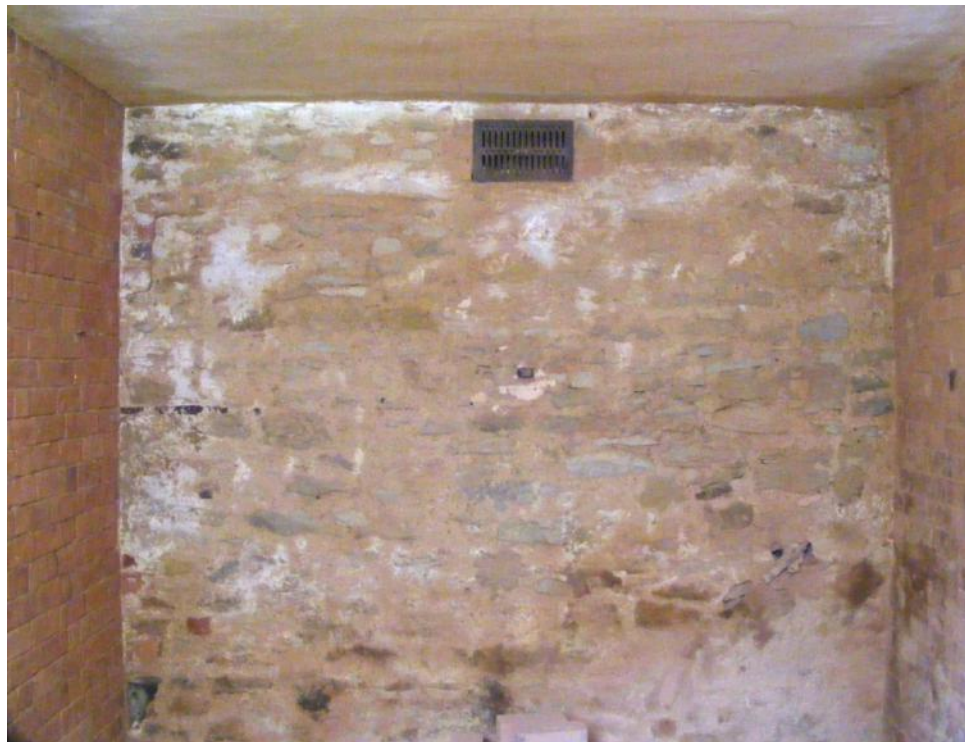
Stable 2, north wall, showing ventilator grille and painted band Fig 41

On the north wall, and on the south wall under the window, are the remnants of an inch-wide painted black band, 1.46m from the floor (Fig 41). In the centre of the north wall is an iron staple, c 1.90m from the floor. Above that is a metal ventilation grille for a periscope-style vent opening in the north elevation (Fig 42).

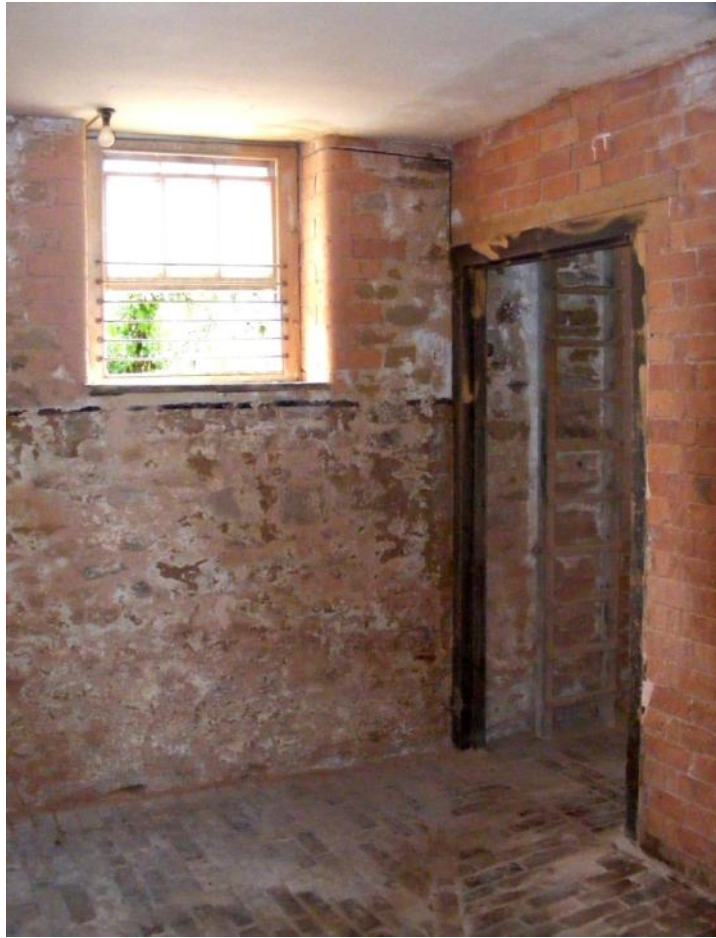
Stable 2, showing doorway and window Fig 43

The window surrounds are bullnosed bricks. Six thin metal bars have been fixed horizontally across the three bottom lights of the sash window, which has a plain metal catch (Figs 43 and 44).

The ceiling is plaster. A single bare lightbulb is fixed to the ceiling just in front of the window (Fig 43).

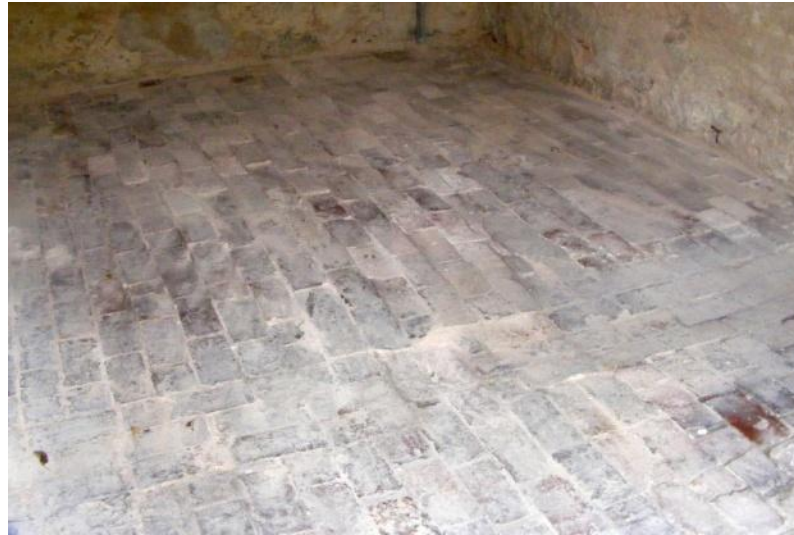
Stable 3, the brick floor Fig 45

This room is 4.90m long by 3.15m wide. It has its own external stable door, but no tethering ring or signs of a corner manger; so it may have been used as a loose box. (Fig 3). The floor is flat-laid brick aligned north to south with three courses aligned east to west leading to a central drain with a decorative metal grille (Fig 45). These bricks measure 220x100mm, and are a different type to those in the floors in Stables 1 and 2. One area had been patched using perforated bricks.

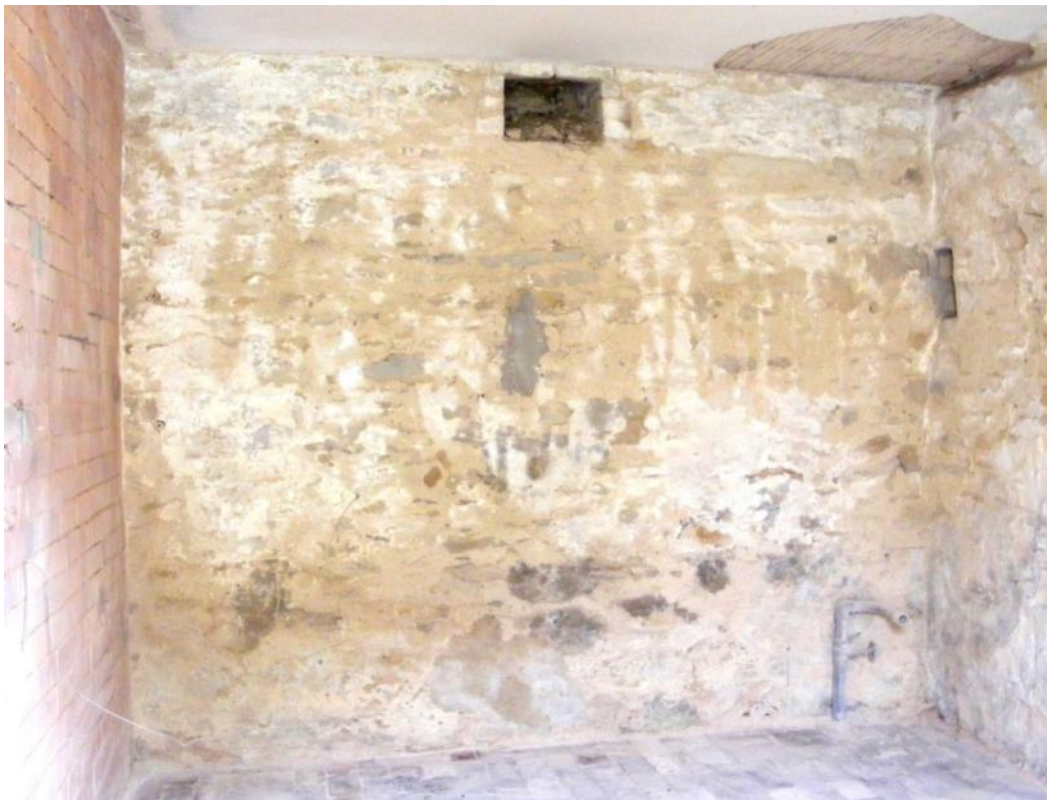
Stable 3, the north wall, with ventilator, slot and water pipe Fig 46

The west wall is the brick partition with Stable 2. The north, east and south walls, in ironstone, retain remnant whitewash, but no painted band (Fig 46).

At the centre of the north wall there is a metal ventilation grille for a periscope-style vent opening high in the north elevation. In the north-east corner there is a vertical slot, the size of a brick, at head height through the width of the wall (Fig 46). Orange bullnosed bricks frame the east side of the door opening.

In the north wall near the floor there is a vertical pipe with a stopcock (Fig 46), and there is a horizontal pipe with a stopcock at the south end of the east wall.

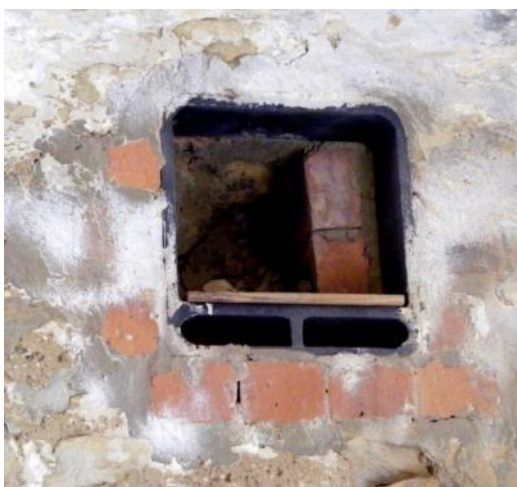
Stable 3, modern fitting Fig 48

Two modern metal settings, 300mm square, have been inserted high in the east and west walls, with modern brick patching around the one in the east wall (Figs 47 and 48).

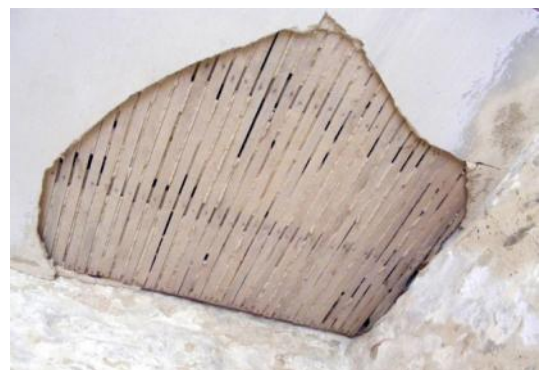
Stable 3, lath and plaster ceiling Fig 49

The ceiling is plaster but an area of lath has been exposed in the north-east corner (Fig 49). There is a hatch in the ceiling above the door (Figs 47 and 50). At the top of the

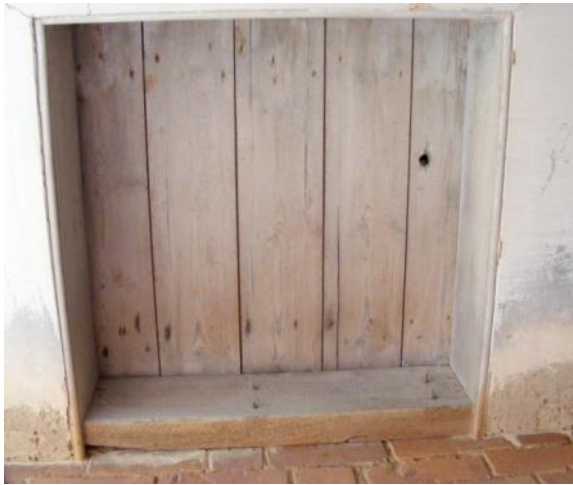
Stable 3, the hayloft hatch Fig 50

The hatch over Stable 3, in the angle between the south wall and the partition wall, is lifted by a fingerhole, seen more clearly from below, rather than being hinged (Figs 50 and 56). This probably served as a hatch through which fodder was passed to the stable below.

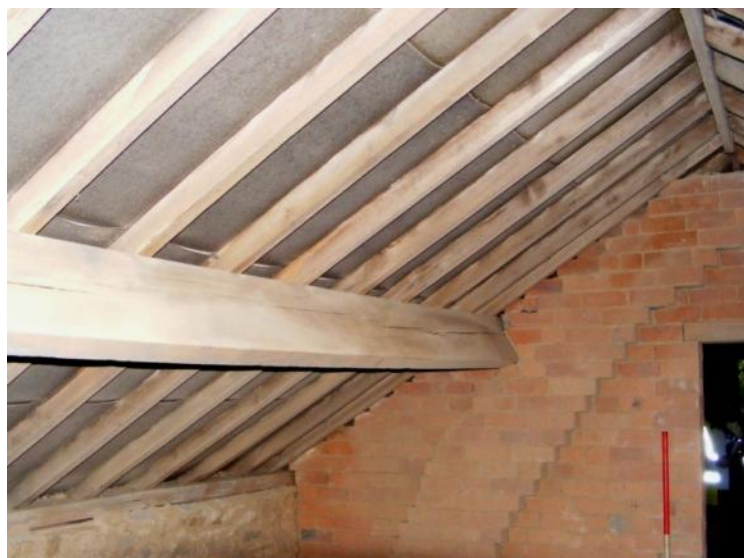
The hayloft, showing wall plate, purlin and rafters, looking east Fig 52

The north side of the roof has felt lining above the rafters (Fig 52). The laths supporting the roof slates are visible on the south side. There are three glass 'slates' on the south side of the roof, over the carriage house room and the hayloft over Stables 1 and 2 (Figs 3 and 53).

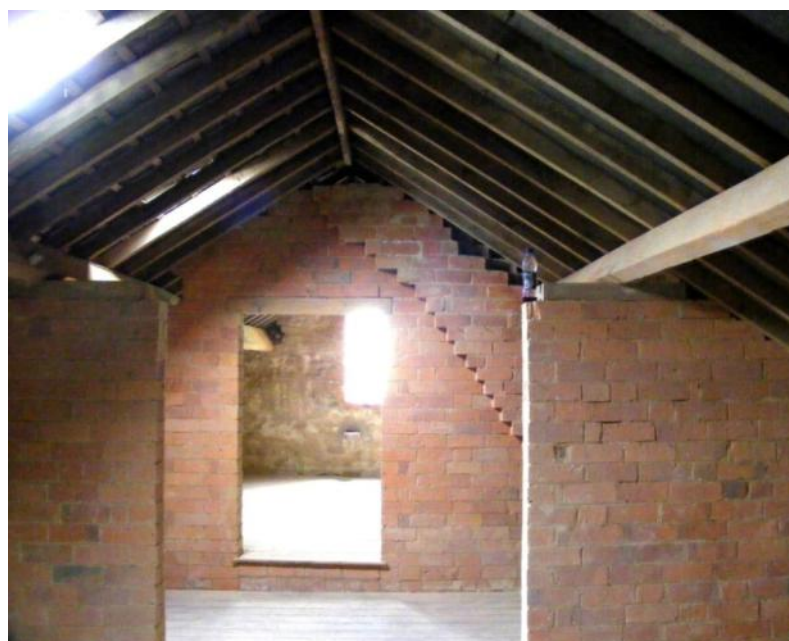
The hayloft, looking west, showing step above carriage house Fig 54

The floors are planked, laid north to south, and there is a step down from the room above the carriage house to the hayloft (Fig 54).

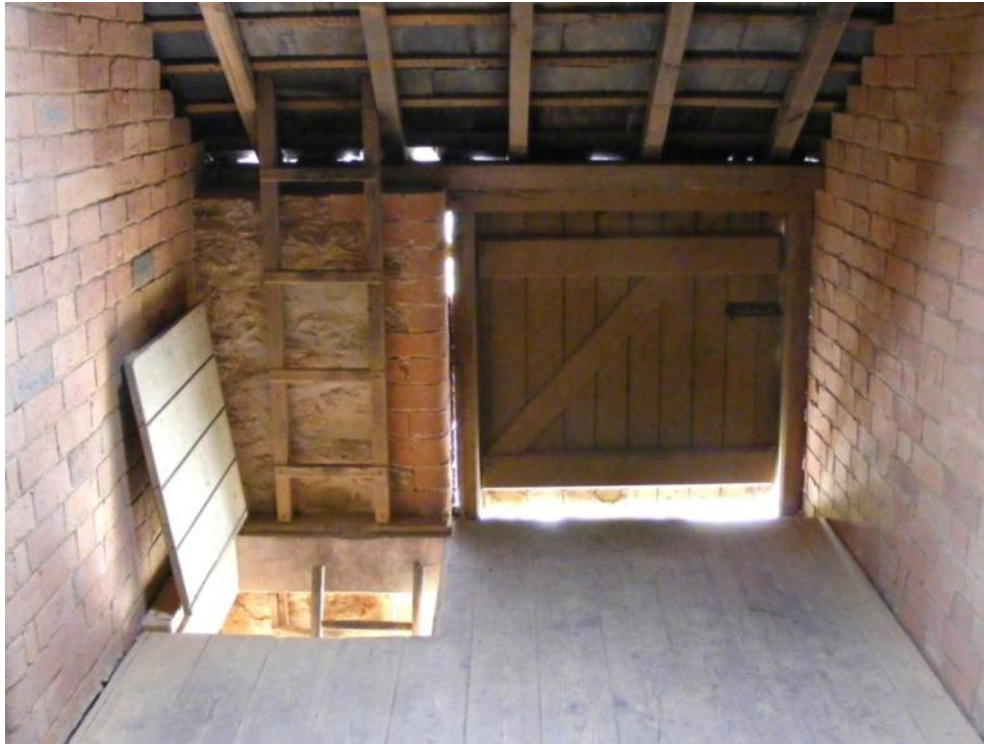
The hayloft door, trapdoor and ladder Fig 55

The hay door in the south wall, over Stable 1, is vertically-planked, ledged and braced and secured with a bolt (Fig 55). It is set in a plain wooden frame, and the bullnosed bricks on the inner side of the surround continue from the ground floor.

The hinged trap door over Stable 1 has four planks ledged. Adjacent to it is a short length of loft ladder fixed to the south wall (Fig 55).

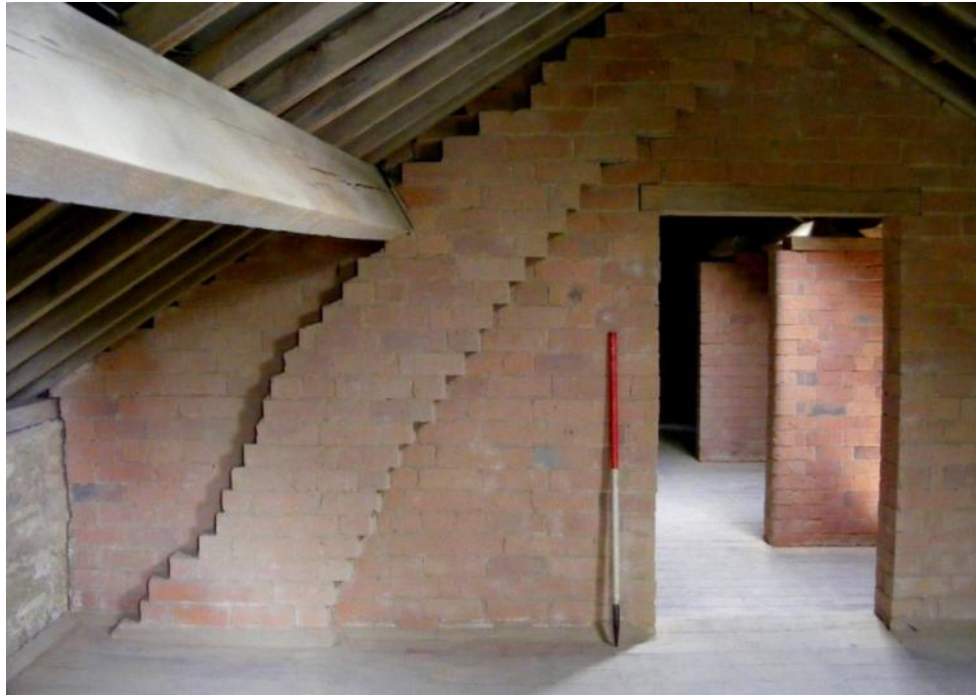
The hayloft, looking east, showing the chimney flue in the partition wall Fig 57

The room above the carriage house is divided from the rest of the hayloft by a wall of perforated bricks carried up to the roof, and laid mainly stretcher with the occasional header. A number of nails had been left protruding from this wall. There is a central opening with a timber lintel and a threshold, but no indication that there has ever been a door (Figs 54 and 57). The chimney for the corner fireplace in the carriage house comprises a flue stepped on either side of the wall, which would allow for a flue about the width of two bricks. The flue runs to the apex of the roof, but the chimney has been removed for some time.

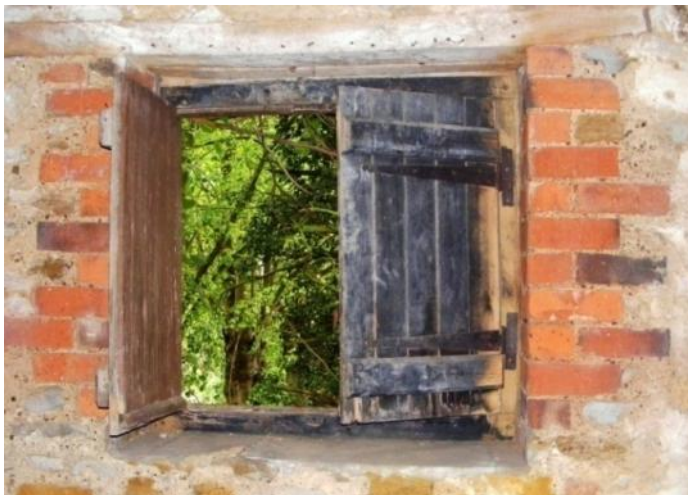
The hayloft, east window shutter Fig 58

The window in the east wall is timber-framed, below a timber lintel, with a cement sill and brick jambs. The shutters are vertical planks ledged top and bottom with beading on the outside, and are hung on plain strap hinges top and bottom (Fig 58). Each shutter is secured by simple wooden swivel catches (Fig 59).

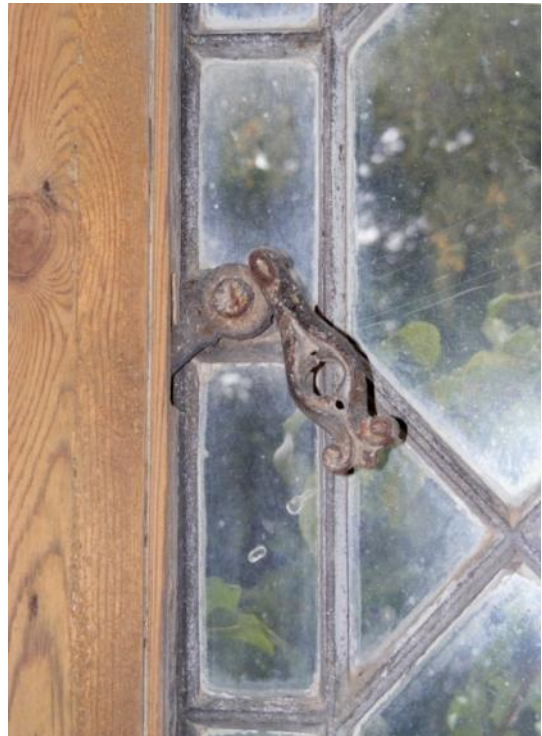
West window, decorative catch Fig 61

The west window is set within a pine frame, with a brick jamb and a timber lintel. The cement sill is nearly worn away. The framing of the lights are cast iron designed to look like leaded lights, and it is fastened with a decorative handle (Figs 60 and 61).

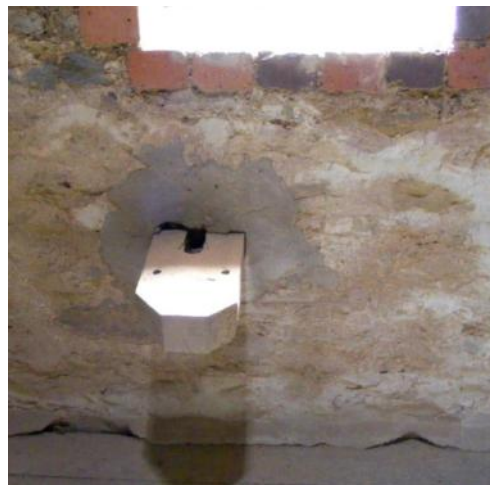
The hayloft, wooden bracket below west window Fig 62

Below the window a large wooden bracket has been set into the wall more recently (Fig 62).

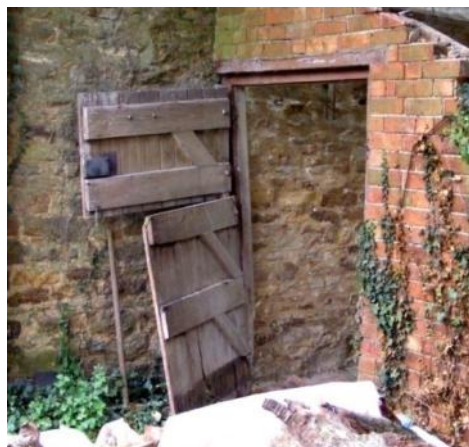
The tool shed door Fig 64

The stable door comprises a lower leaf with three ledges and two braces and an upper leaf of two ledges and one brace, with strap hinges on the outside. It is set in a timber frame under a narrow lintel, all painted red on the outside. The upper leaf is fitted with an iron lock box on the interior, which has replaced an earlier larger lock (Fig 65).
