## Archaeological building recording at Easton Neston House, Northamptonshire

Report 11/261

**ARCHAEOLOGICAL BUILDING RECORDING  
AT EASTON NESTON HOUSE, TOWCESTER,  
NORTHAMPTONSHIRE  
2007- 2009**

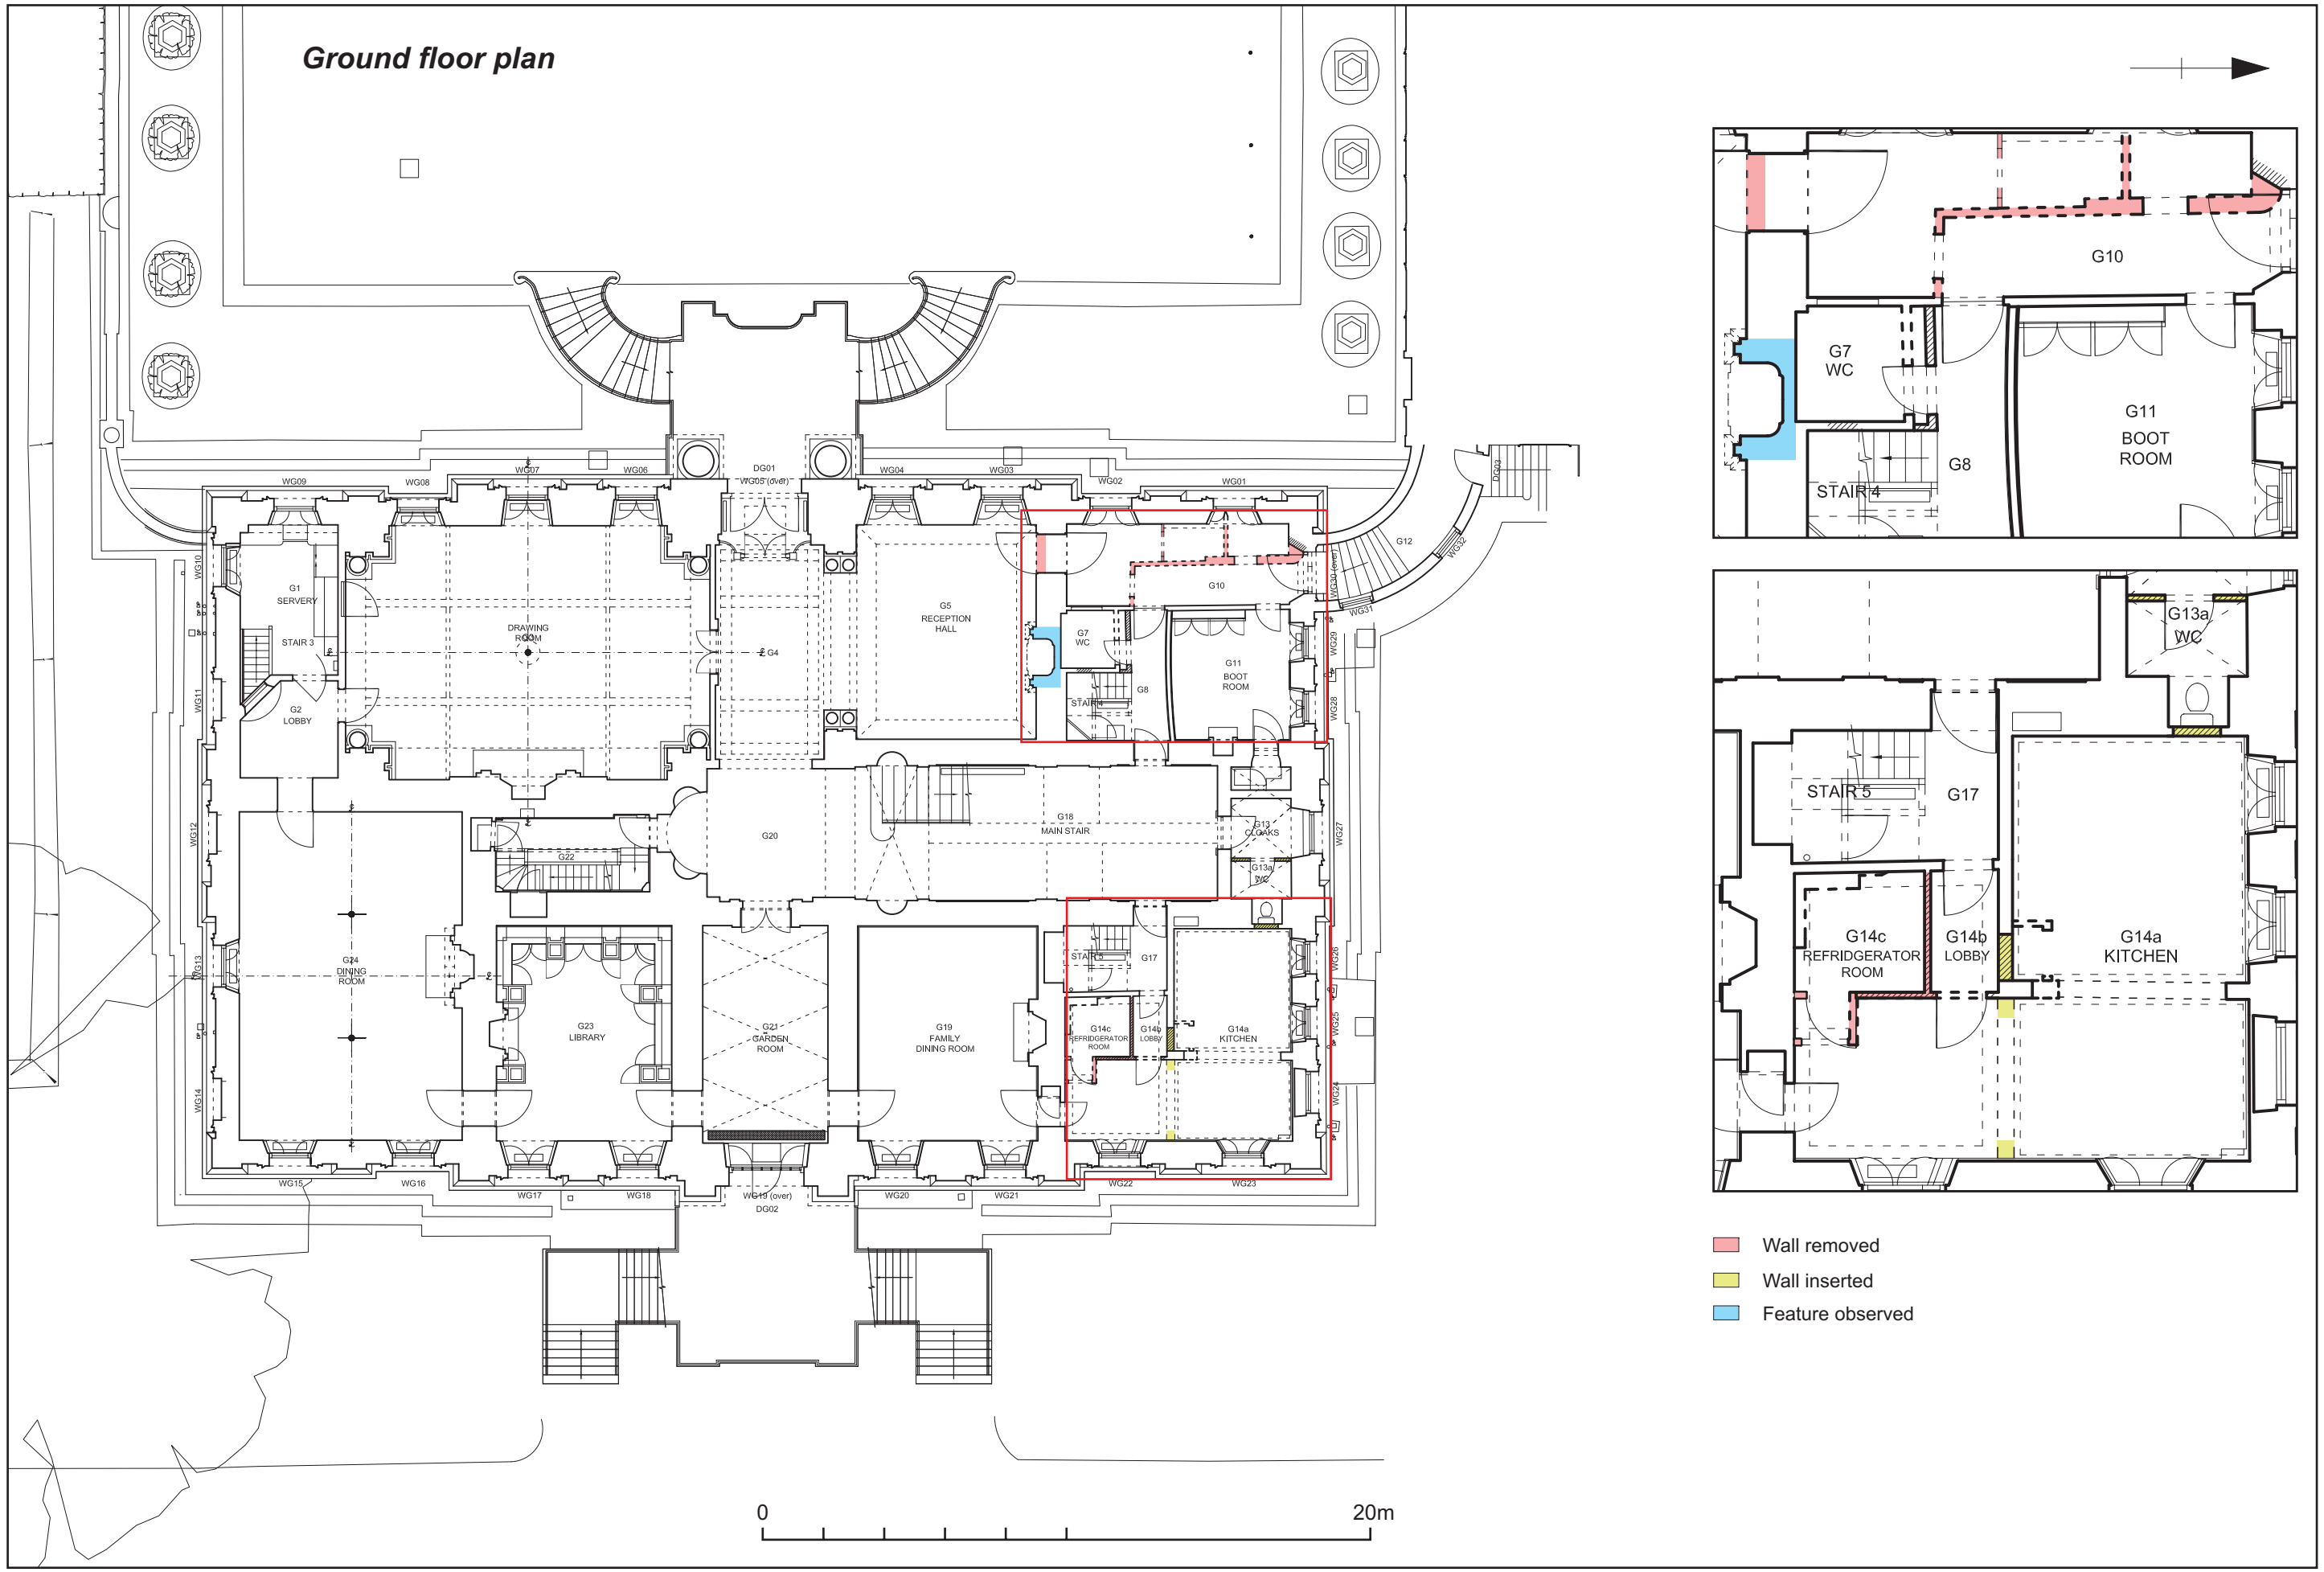
Ground floor plan of the house Fig 3

The area beneath the stair half-landing located at the north end of the house was formerly a single room, or vestibule, visually divided into three sections by groin vaulting heavily overpainted with gloss paint (Fig 3, Plate 4). It was not known if this vaulting is constructed of stone or plaster, nor was the date of its installation clear, though it is thought to be of late eighteenth-century date (Dean 2006). The western end of the room has been lost by the insertion of a built-in safe which has required a wall to be inserted which cuts across the west end of the vaulted space; it is accessed from the room situated to the immediate west. The central and eastern sections of the remainder of the room are intact apart from the loss of decorative stops at the lower ends of some of the ribs of the vaults. None of the vaulting was to be altered in the proposals for the room which were to block the doorway at the eastern end currently leading into the present kitchen and to add a toilet in the recess created. A partition screen was then to be added to form a private cubicle within the vestibule. The original floor of the vestibule was of square stone slabs, alternately light and dark stone to form a chequerboard pattern laid diaper-wise though this has been lost toward the eastern end where modern ceramic tiles have been laid.

Originally three separate, but interlinked, rooms which perhaps originally formed a bedroom suite but which were probably made into one space during the twentieth century (Fig 3). The space formed from the three rooms was occupied by a kitchen and pantry, all fitted with standard late twentieth century mass produced units and appliances. The external walls of the original rooms retain most, or all, of the original wall coverings which comprises panelling between the windows below dado level and plaster above. The windows in these rooms only make use of the lower portion of the external height of the window openings as these rooms have a mezzanine floor above, and both are fitted into the high ground floor proportions of the house. Only two of the internal walls were fully exposed, the south and west walls of the westernmost of the original three rooms adjacent to the vaulted vestibule (Fig 3). Following the removal of the kitchen units the wall plaster was removed from the two walls. This proved to be relatively modern, either of nineteenth- or twentieth-century in date laid on sawn laths or directly onto pine boards at cornice level which indicated that the corning was not original, or at least, not in its original location. The corning comprised a box section made up of variously moulded flat sections of vaguely Tuscan profile although the relatively crude detail and roll mouldings are more suggestive of nineteenth-century date (Plate 6). There were large areas of very modern patching where electricity cables and plastic (polyurethane) pipework had been inserted. In the south wall of the original north-west room there were two blocked doorways, both of which formerly gave access to the stairwell to the south of this room; one was filled with modern breeze blocks, the other with plasterboard over a studwork frame, both indicating that the blocking occurred during the twentieth century. To either side the removed plaster had been laid on a studwork frame nailed to the original wall surface which was also plastered but which retained no paint or paper. The west wall had contained a fireplace, this had been infilled with brick at some stage, perhaps during the nineteenth century given the size of the bricks. More recently a hole had been knocked into the flue above into which an extractor fan had been fitted (Plate 7). The plaster on this wall had been laid on laths nailed to a studwork frame nailed to the wall, although here any original plaster had been removed. In the south-west corner a recess had been formed for some reason but which had until recently been hidden behind the most recent plaster surface. The reason for this is unclear and there is no such recess on the Vitruvius Britannicus plan. To the north of the fireplace was the doorway into the vaulted vestibule. The doorway beneath was fitted with a simple un-moulded oak frame comprising jambs and lintel. The floor to the kitchen rooms was formed of nineteenth-century pine boards.

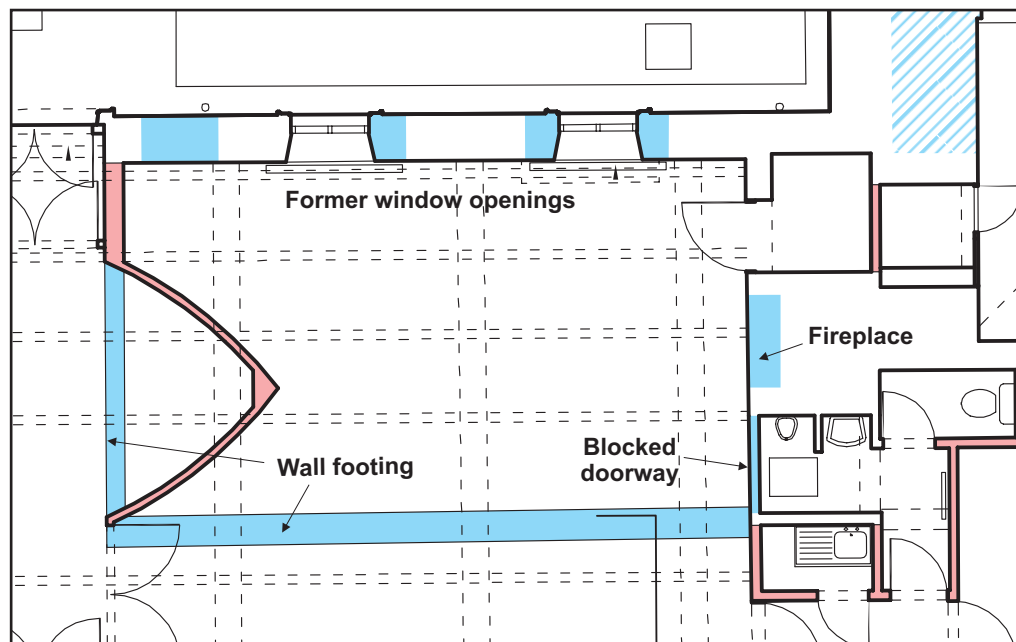
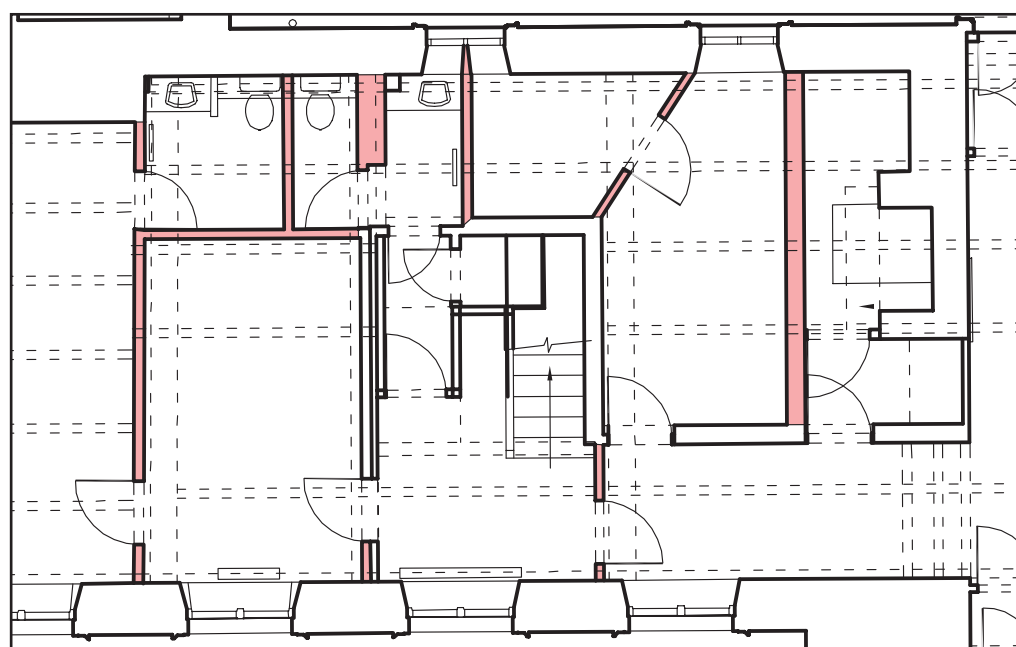
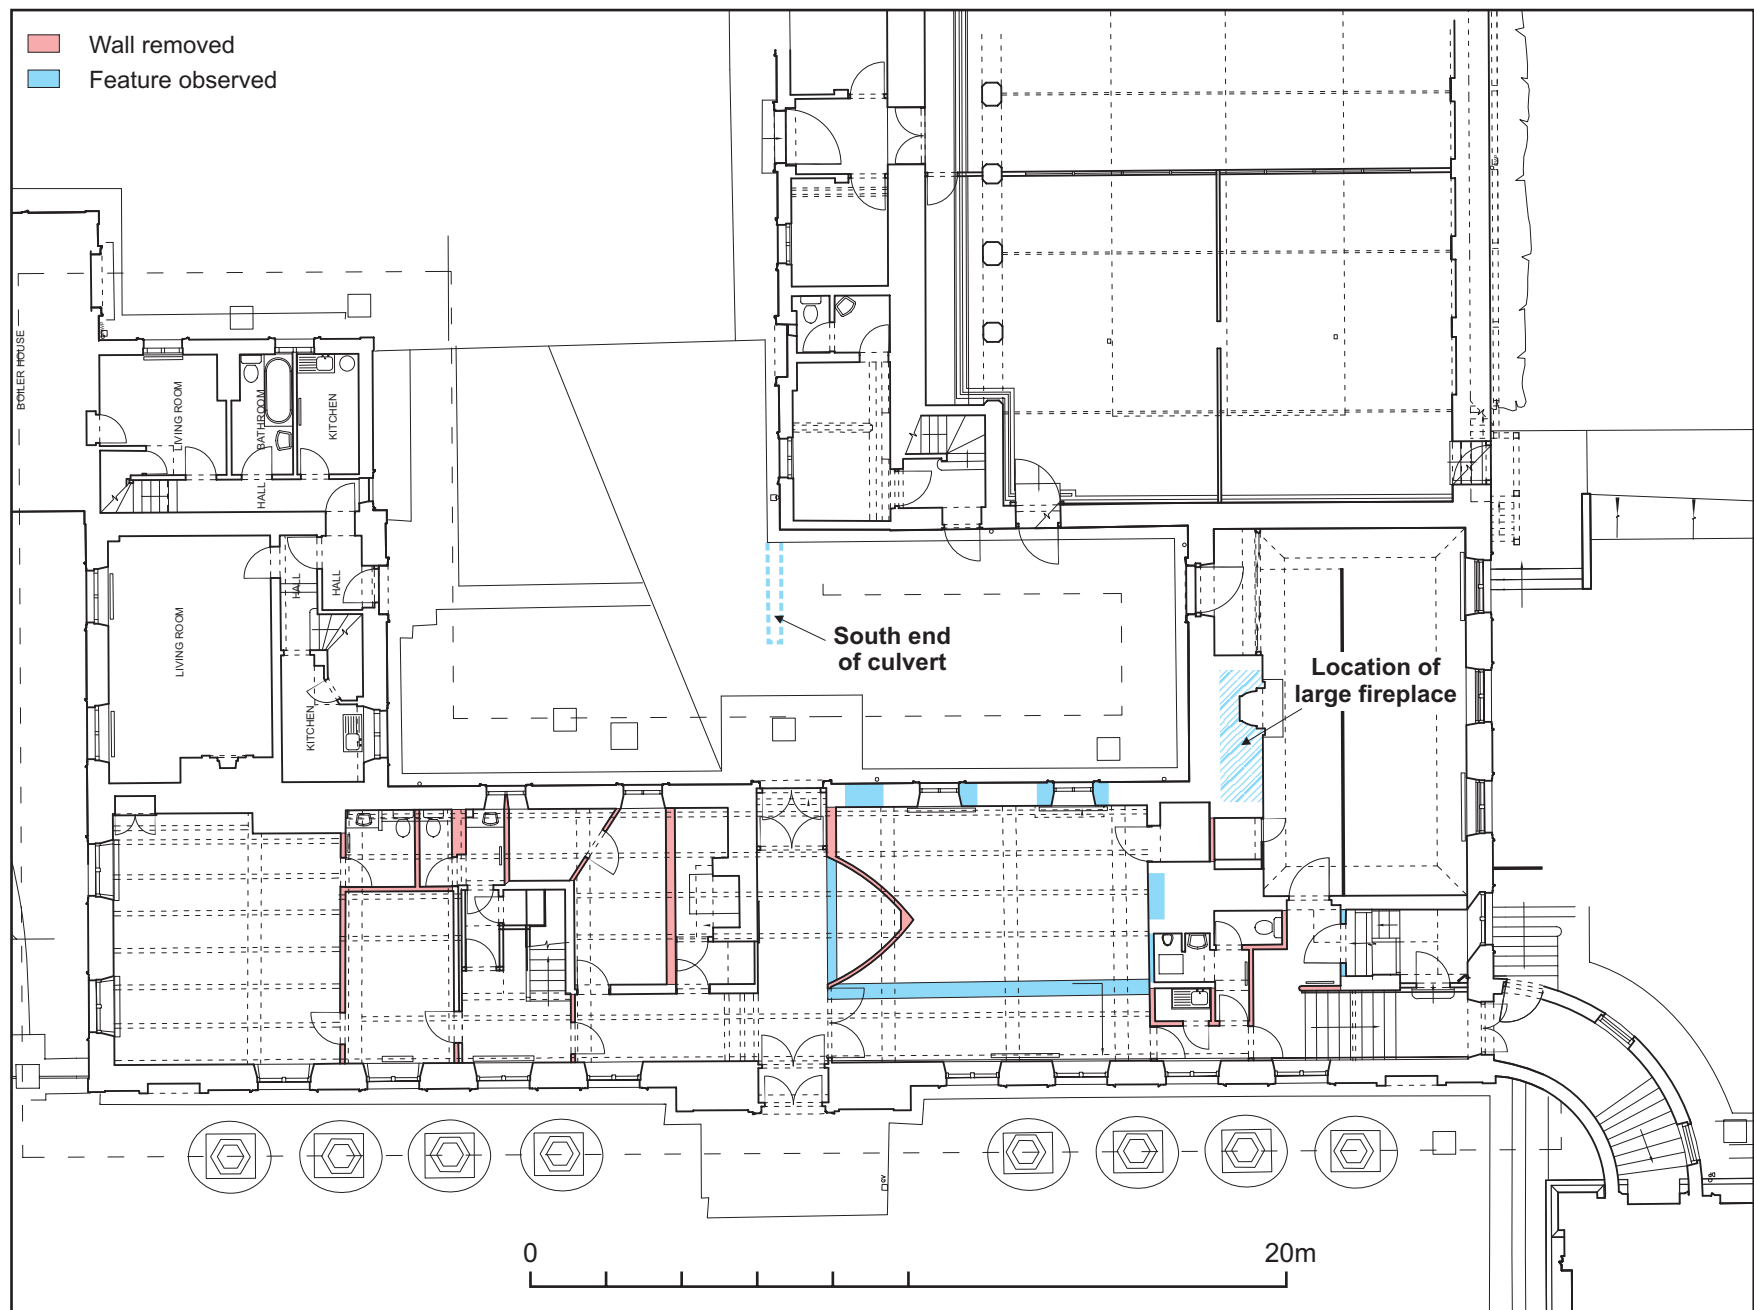
Ground floor of the Wren Wing Fig 6

Trenching by mini-digger for new services on the north side of the Wren Wing revealed a much disturbed soil with many pipes, drains and ducts of mostly of modern date (Fig 6). The full extent of these features was not revealed since only parts of each were uncovered, and modern elements such as manhole covers and clearly modern services were not recorded. However, there was also revealed a stone drain or culvert of apparently earlier date which was truncated by one of the new service trenches (Fig 6). Approximately 0.25m wide by 0.30m high, the culvert was constructed from roughly dressed pieces of stone of varying sizes up to blocks of c0.2m though mostly smaller (Plate 21). The top of the drain was capped by thin slabs of what appeared to be pieces of York paving which in turn was overlain by more recent brickwork although the latter appears to be unrelated. The floor of the drain appeared also to be formed of thin slabs and the interior was partly choked with soil indicating that it did not function, there being no indication of water having flowed through it recently. Probing of the culvert suggested that it ran northwards for approximately 2.6m before either turning or becoming blocked. It is thought that the fall of the culvert was from north to south. The size of the culvert suggests it most likely served as a drain to carry rainwater away from downpipes located on nearby buildings.

On the south side of the Wren Wing within the north-east corner of the entrance court a service trench was excavated to conduct new services to and from the basement of the house through the centre of the Wren Wing and into the courtyard on the north side (Fig 6). This trench was excavated by mechanical excavator. Beneath the modern turf and topsoil a layer of disturbed, although remarkably homogenous, mixed clay and gravel was uncovered which appeared to represent a levelling layer (Plate 22). This clay and gravel mixture contained occasional pieces of mortar, tile and red brick along with stone fragments indicating that it was not a natural soil, and given that to the west, outside the entrance forecourt the apparently natural ground level drops away, this supports the theory that this layer represents an artificial build-up to create the level western court surface. Apart from other modern services, made obsolete by the installation of the new ones, no features were uncovered. This is what would be expected in this location
