Archaeological building recording at 23 Regent  
Street, Northampton  
June 2013

Report 13/113

July 2013

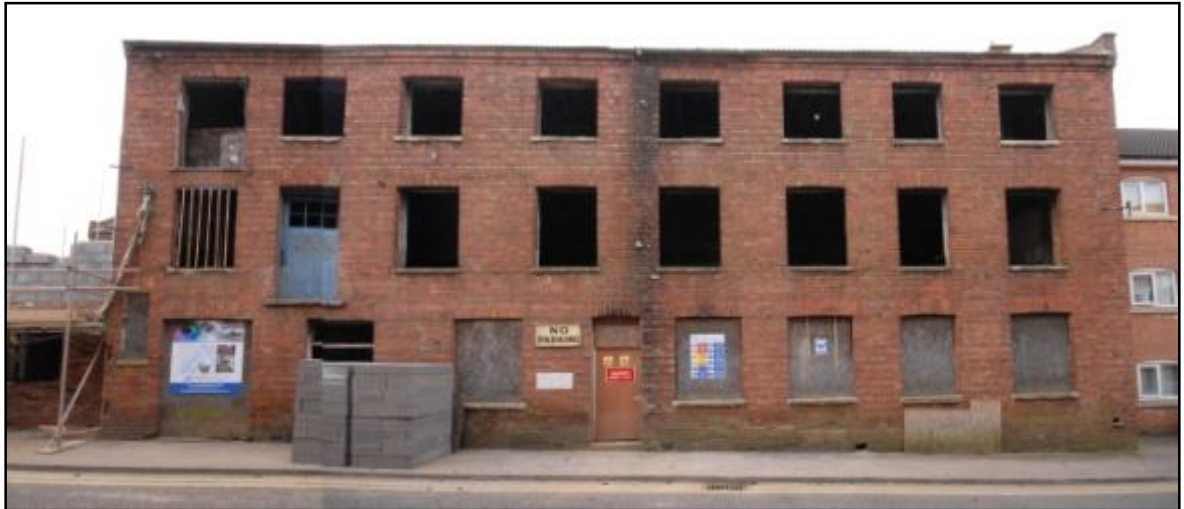
Main access to Building 2 was through the north elevation (Figs 7 & 10). This door was later widened and a lobby created. A secondary door on the same elevation allowed access to the offices. A door on the north elevation of the first floor was originally a window which has been lengthened to form a door (Fig 7). The bottom of the current door encroaches into the lintel of the ground floor window below. The main entrance on ground floor level has been widened.

North elevation, Building 2 (Photocomposite), looking south Fig 10

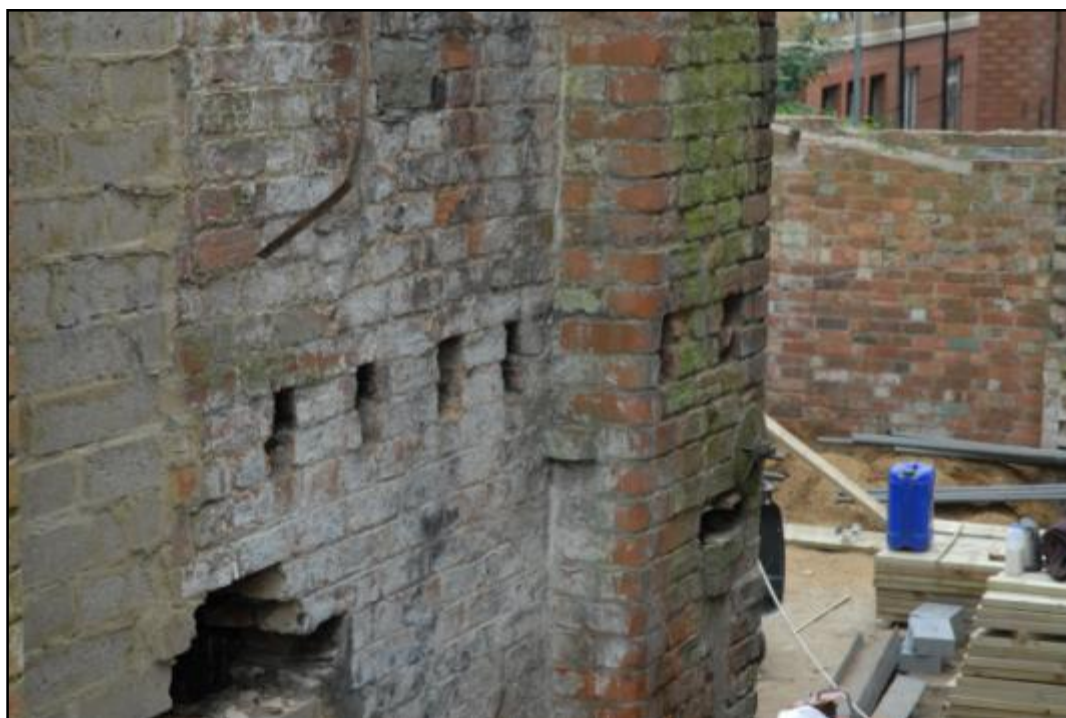
Building 1, north elevation, beam slots Fig 21

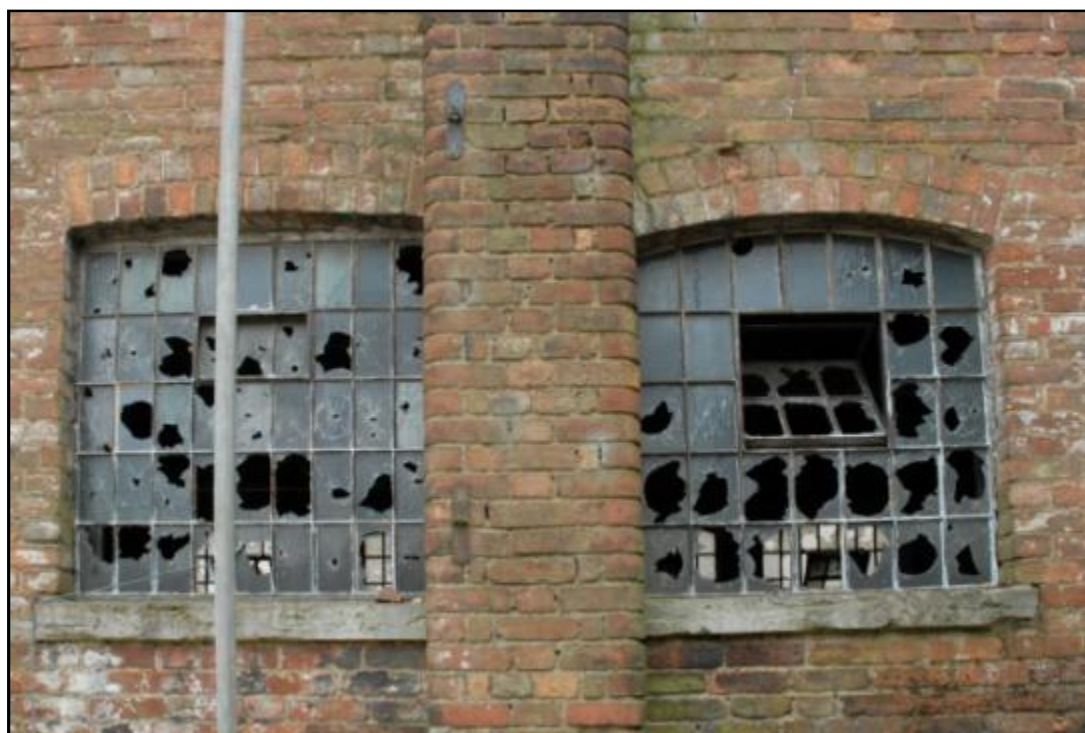
Building 1, north elevation, different window types Fig 23

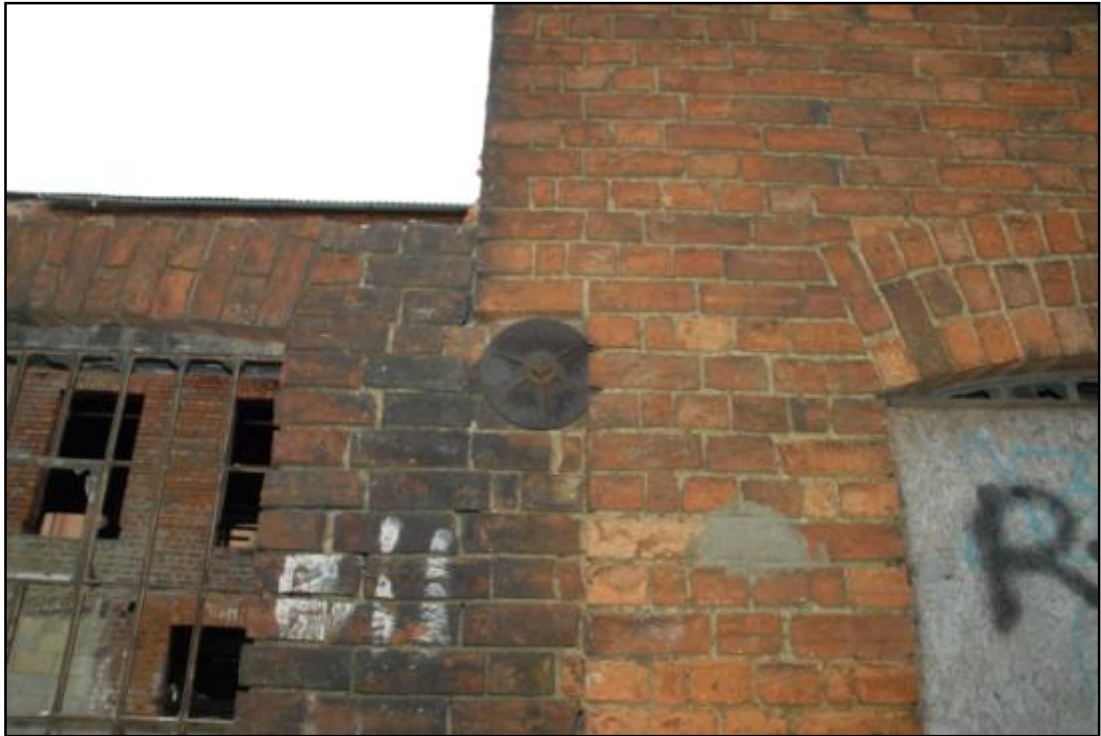
Building 1, south elevation, showing the join between the annex and Building 1 with iron tie plate Fig 24

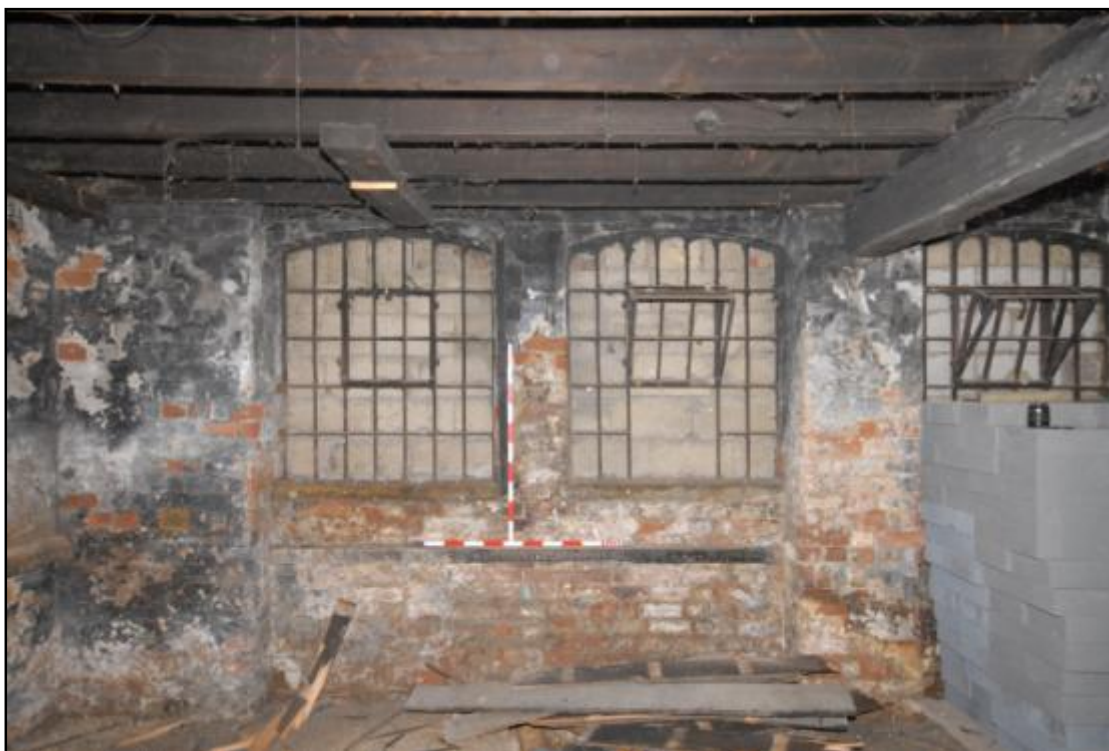
The room is lit by large windows in the south and north walls. These windows are fitted with cast iron 29 light windows with central, inward opening hopper (Figs 28 & 29). They have segmental arched lintels externally. It is probable that electric lights were also fitted on this floor. Nothing remains in the working area to indicate the past function of this room.

Building 1, ground floor, south wall Fig 28

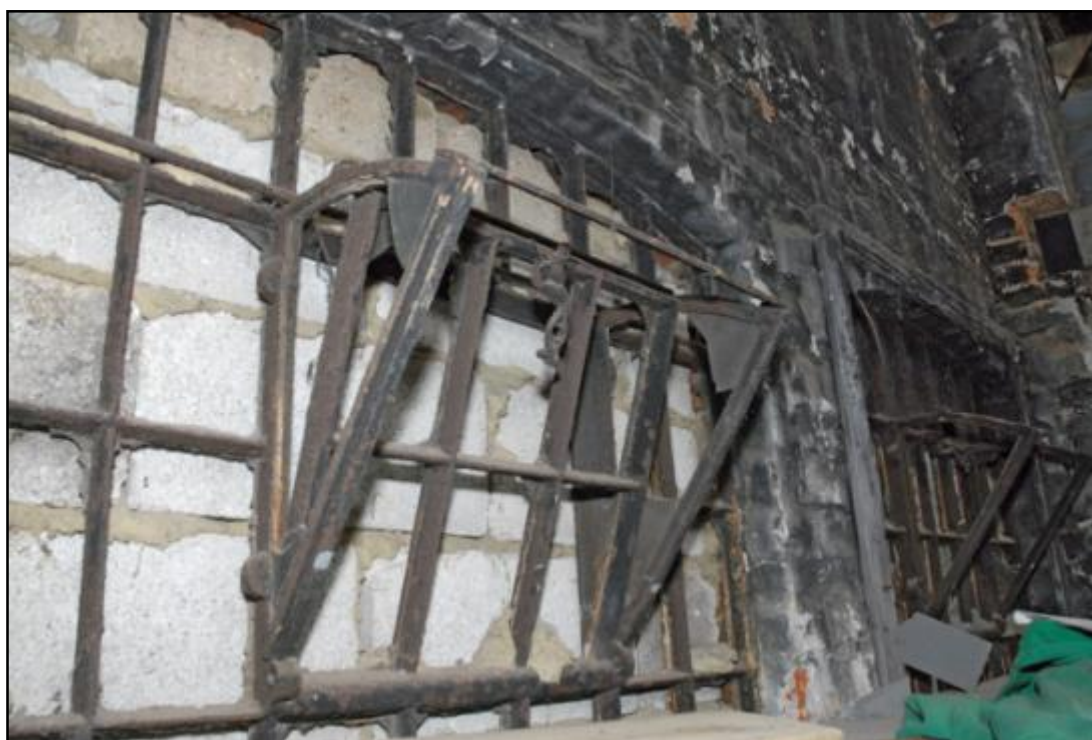
Building 1, ground floor, detail of the window hoppers Fig 29

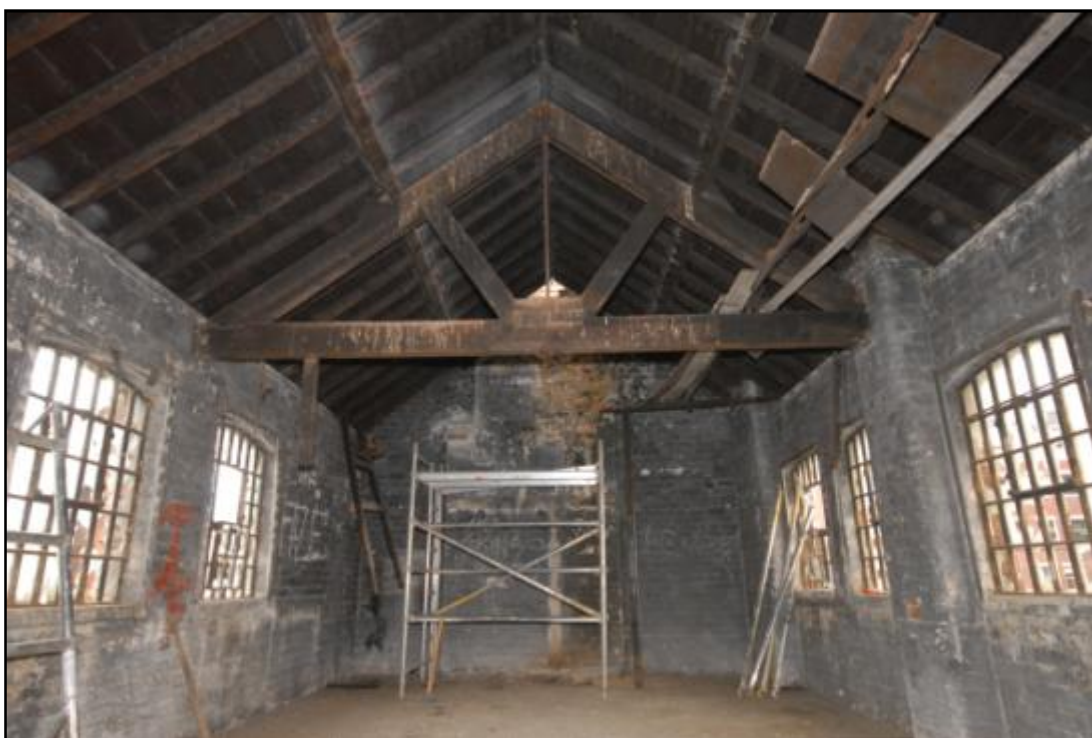
This floor, accessed by the lift in the north-west corner of the room, housed the lift hoist, fitted atop an iron frame over the lift shaft (Figs 40 & 41). A trapdoor beside the lift shaft could be raised and lowered to close off this floor (Figs 25 & 43). The remains of a drive shaft with “paddles” radiating along its length was held suspended above the three trusses, running east-west, off centre to the room (Figs 25, 34 & 36). The drive shaft likely increased ventilation in the room, vital for the preparation of leather. The mechanism which powered the driveshaft is no longer in the building though scars on the east and west walls indicate the presence of a former supporting structure at either end of the room (Figs 34 & 35).

The roof is made of simple pine trusses carrying purlins and rafters (Fig 35).

Building 1, second floor, looking east, showing chimney flue Fig 35

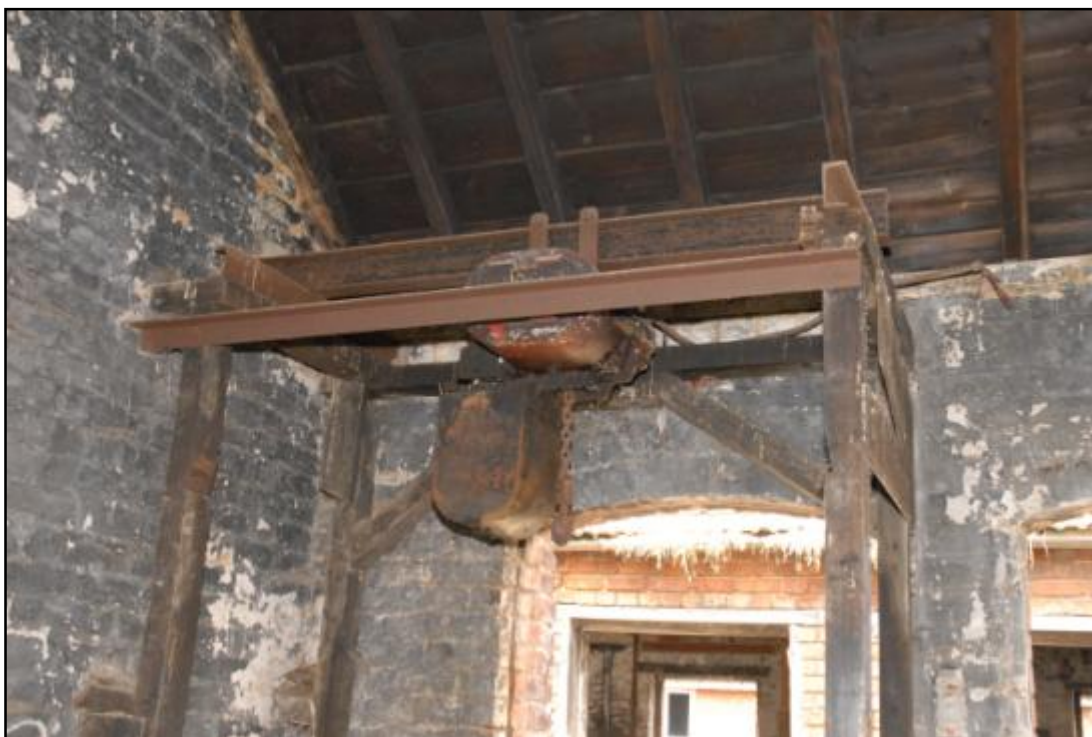
The top of the lift shaft Fig 40

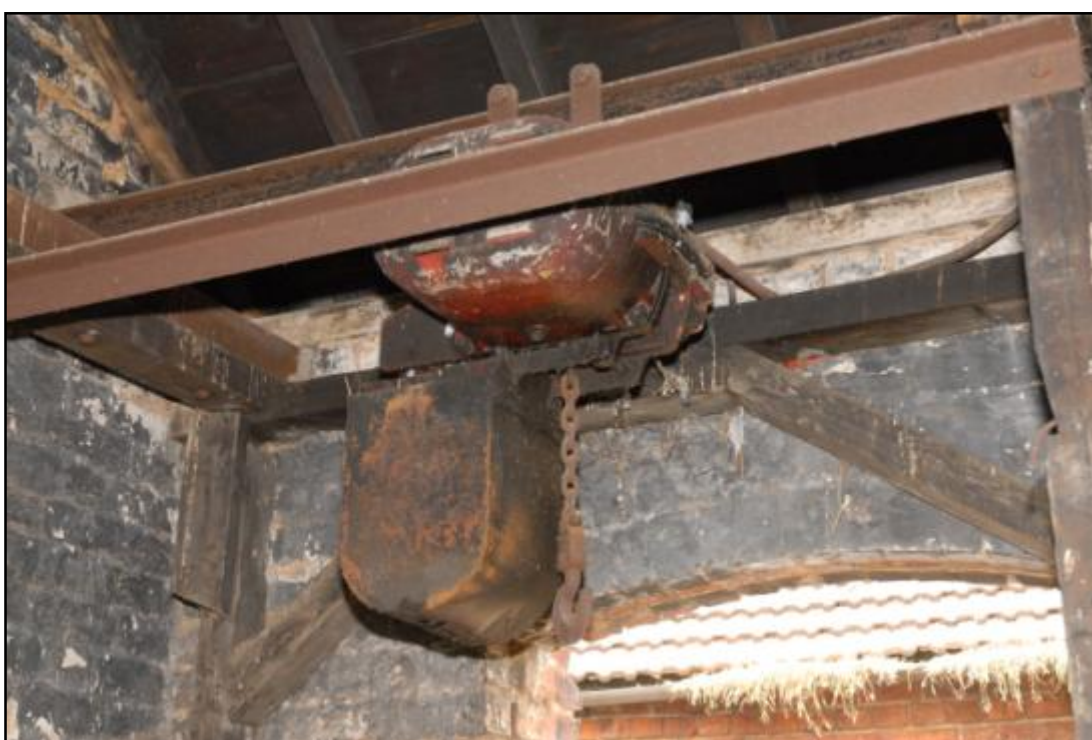
Detail of the lift hoist Fig 41

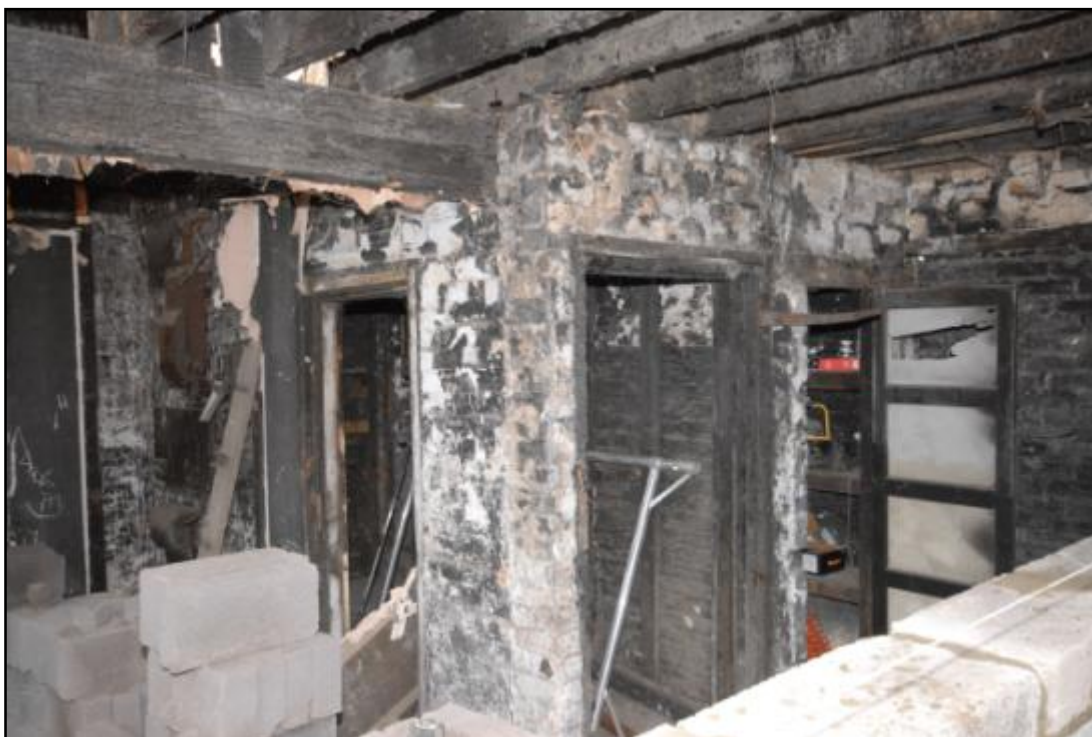
The main door has been widened from its original dimensions. The current width of the door is wider than the original lintel above. This door opens into a narrow lobby / stairwell which is aligned with the widening of the door, indicating that it is a later addition to the structure or was also widened to accommodate the new door (Figs 44 - 46). Two doors open into the main room through the lobby. Fire damage and subsequent securing and demolition have removed all evidence of interior partitions and layout on this floor. The partition walls forming the lobby are of lath and plaster. Outside the main stairwell, in the south-east corner of the room are stairs leading down to the basement. A spine beam runs the length of the building, east-west and passes over and is supported by the lobby walls. A small cupboard is present in the space between the lobby and the east wall of the building.

Building 2, ground floor, the lobby and stair Fig 44

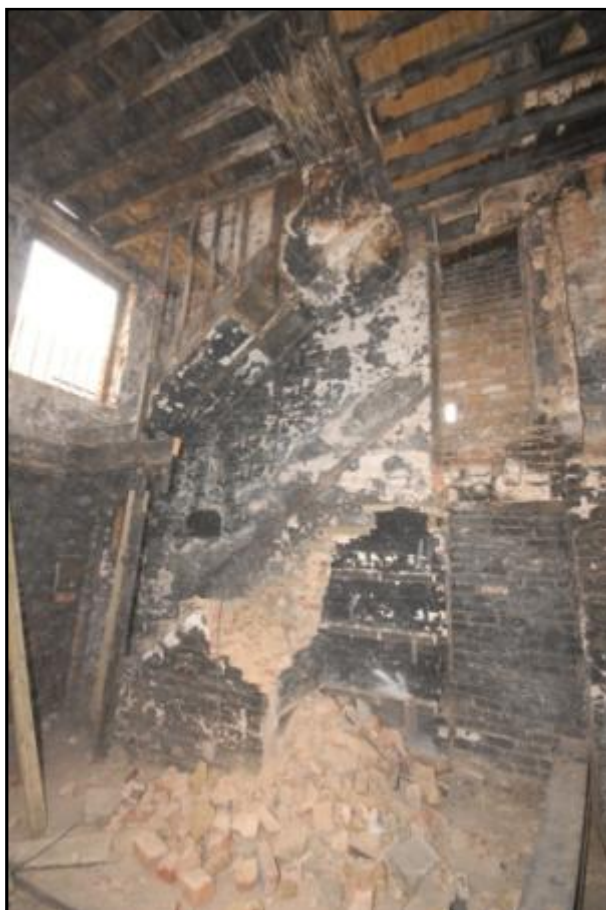
View of the stair from ground to first floor after demolition Fig 46

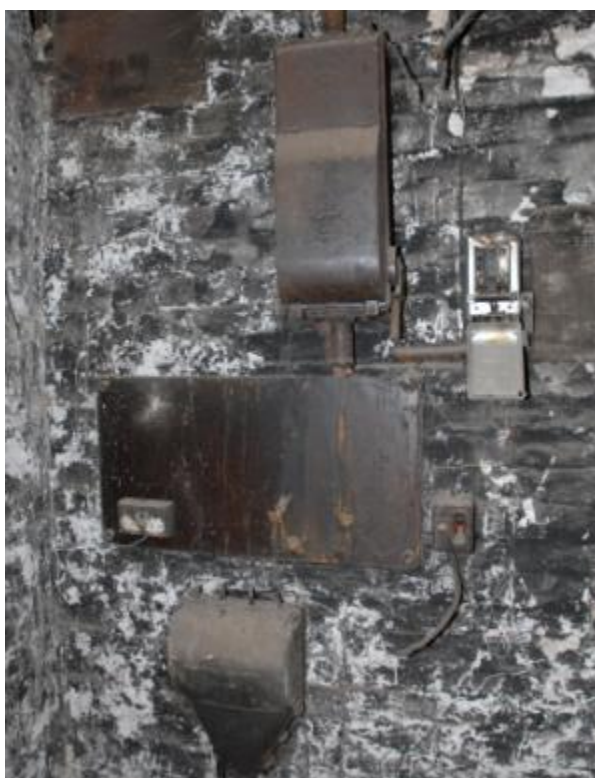
The room was formerly lit by the north and south facing windows. No window glass or cast iron frames survive in this building but the fire damaged remains of a sash window frame could be seen to the right of the secondary door (Figs 48). The presence of a sash window in this part of the building suggests that this area functioned as offices rather than as a factory floor. All windows in the building had tapered, slightly arched lintels and stone sills. No evidence for electrical lights survived in the room but it can be assumed that these were fitted (Fig 47).

Detail of electric and utilities boxes in the lobby Fig 47

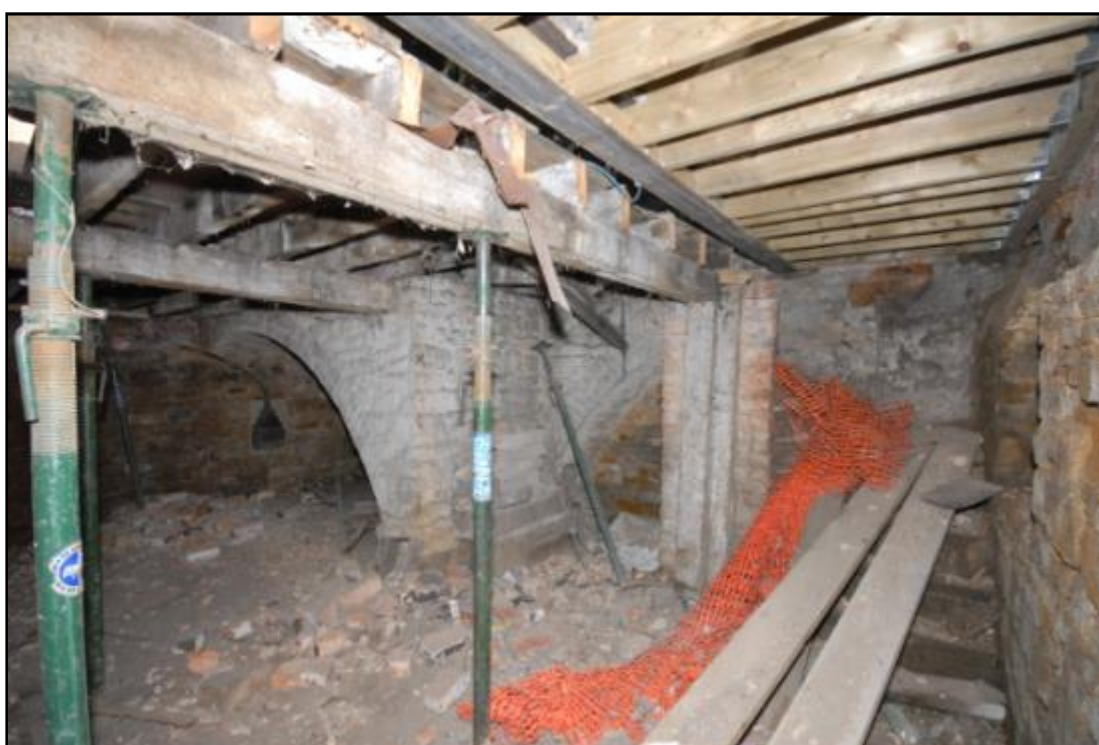
The stairs are carried over relieving arches in the basement supported on a central wall (Figs 49, 51 & 52). A light well adjacent to the stairs was blocked in brick (Fig 50).

Building 2, Room B1, looking east, showing the stair down and relieving arches for the stair above Fig 49

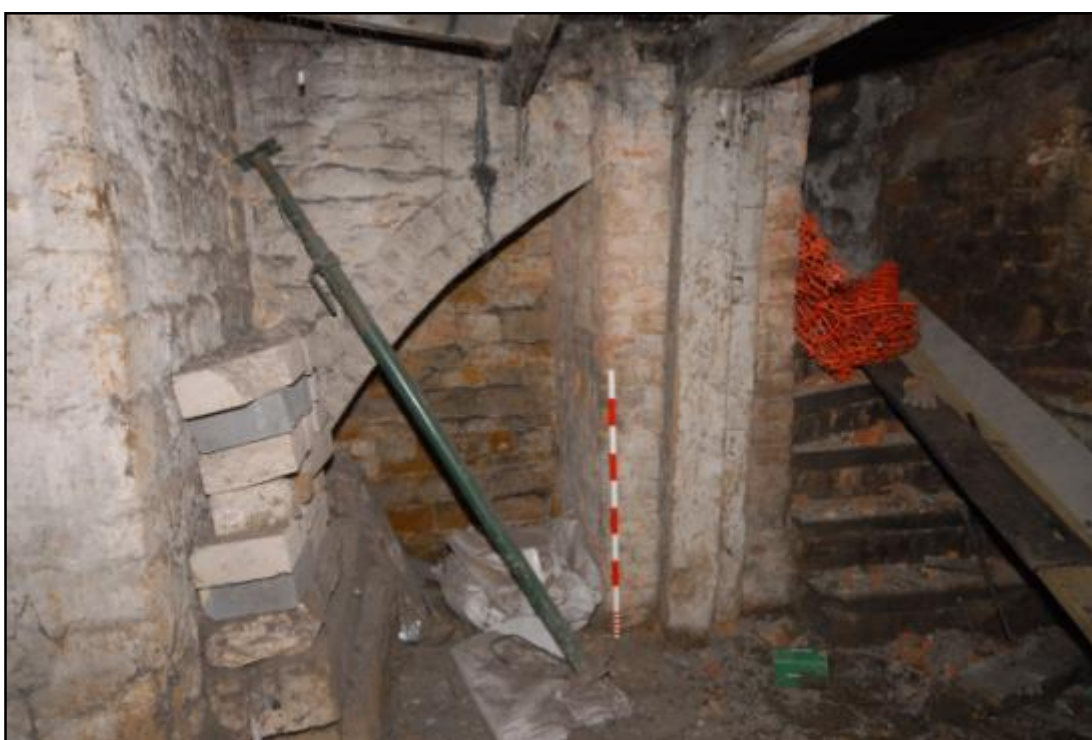
Relieving arch adjacent to basement stair Fig 51

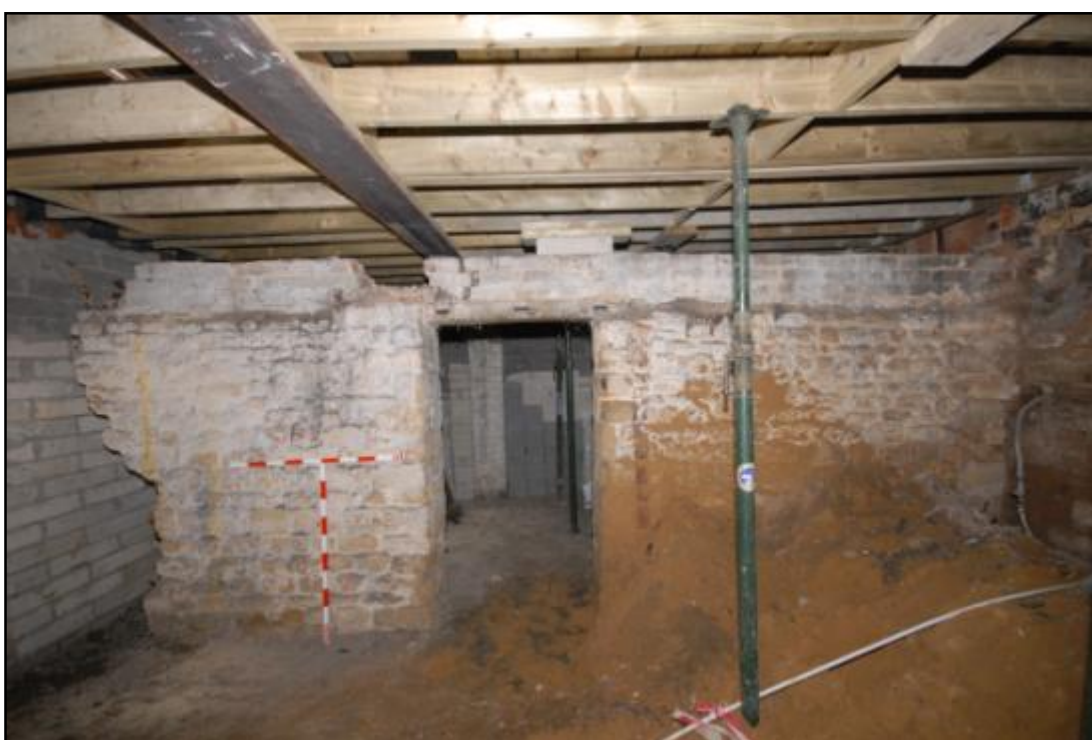
A central wall of dressed ironstone, which divides Rooms 1 and 2, was partially demolished by the time of this survey (Fig 53). A pair of arched openings, most likely serving as storage are in the south-west corner of Room 1, built against the west wall (Fig 55). An electrical switch is fixed to the wall in the north-west corner of the room (Fig 56 & 57). The remains of a metal boiler or heater are present in this room, though not *in situ* (Fig 62).

Room B1, the central basement partition wall with door through, looking west Fig 53

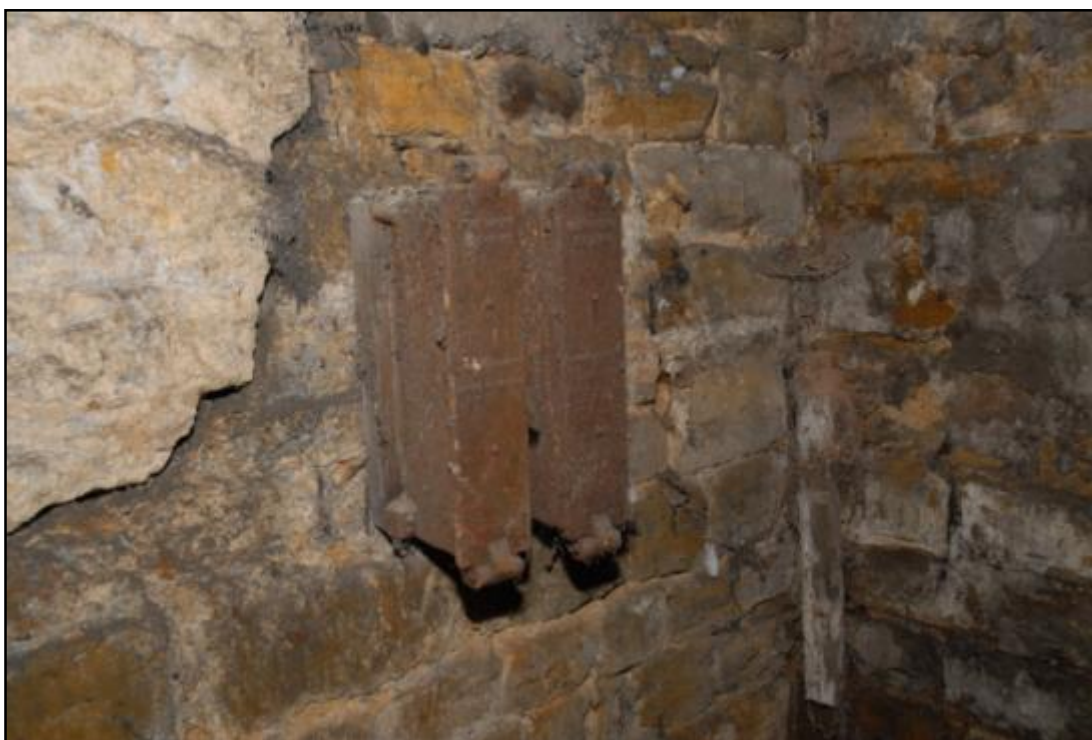
Room B2, detail of the electric box Fig 57

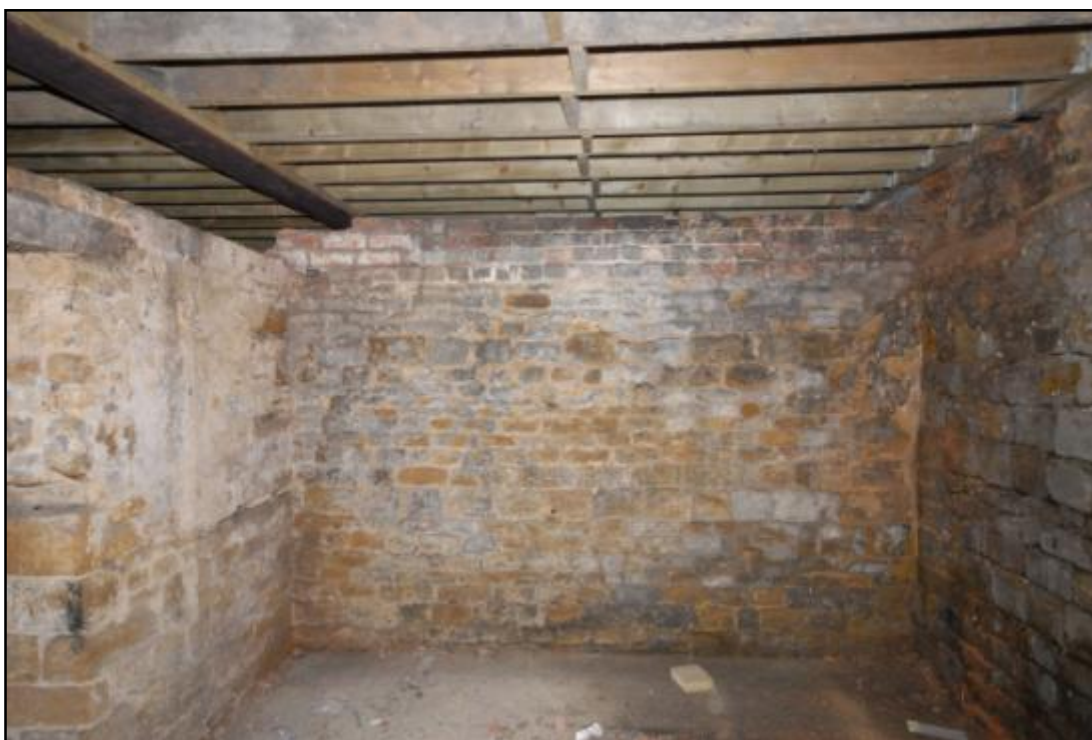
Room B3, the west wall, looking west Fig 59

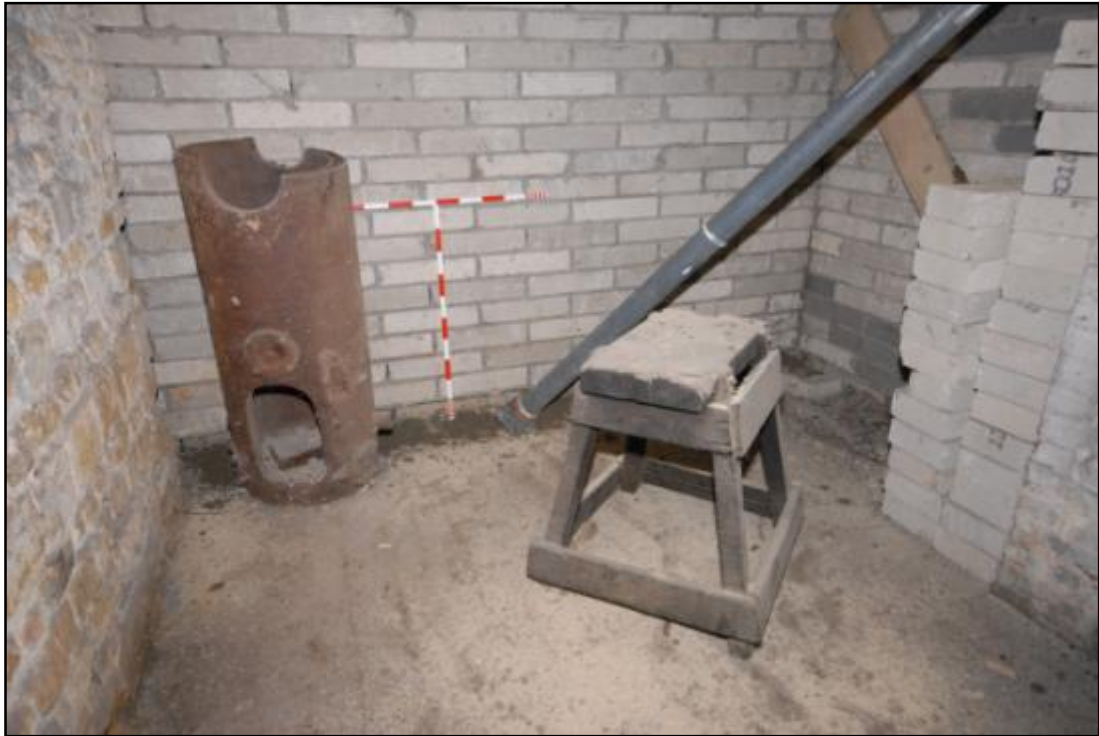
Boiler or heater and work bench in Room B2 Fig 62

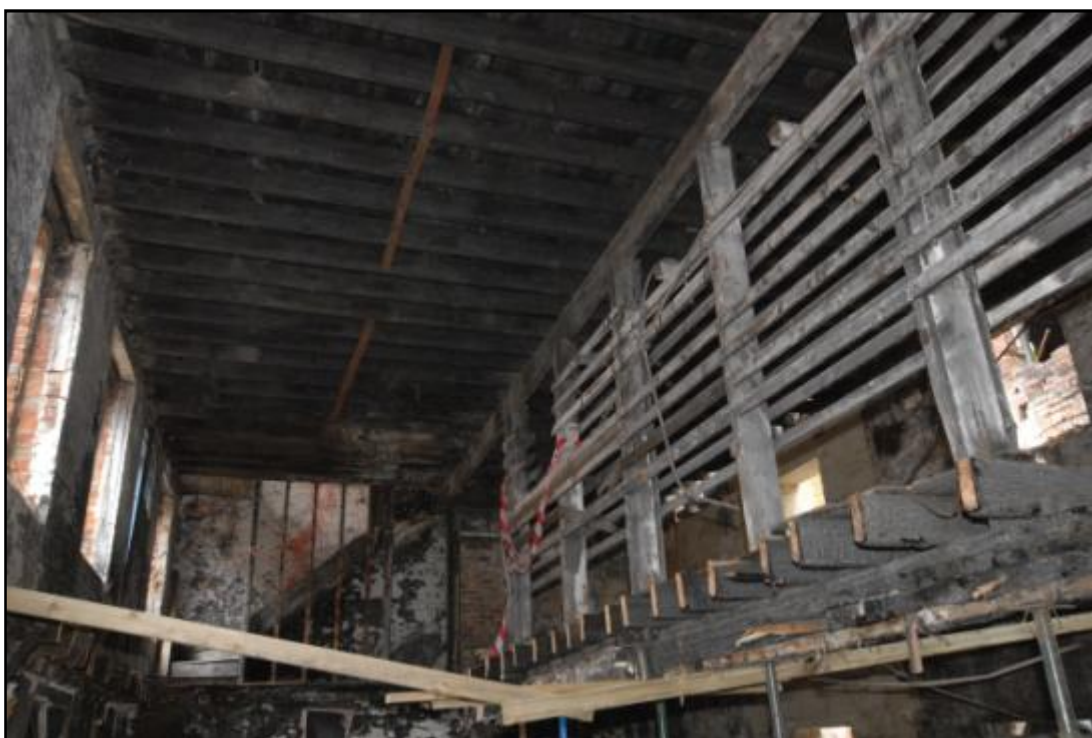
Off centre to the west wall, a chimney flue with fireplace ascends upwards to the second floor. The scar of a second flue can be seen on this wall, further to the left of this. The room was lit by windows in the north and south and by electric lights which were added later (Fig 64).

Building 2, the remains of the central first floor partition with the stairwell in the background, looking east Fig 64
