ARCHAEOLOGICAL WATCHING BRIEF

AT EASTBURY MANOR

BARKING, ESSEX

JULY 2003

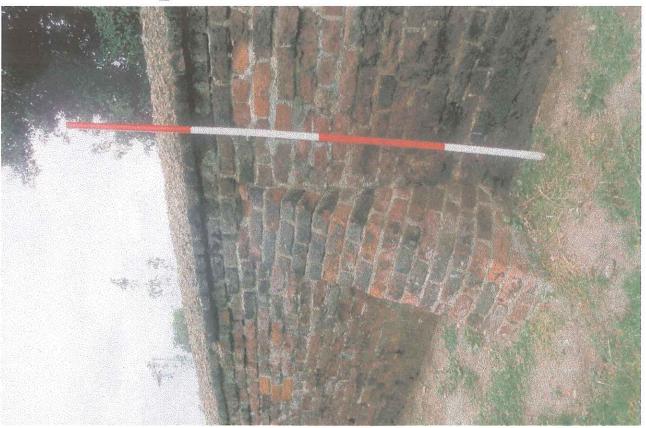
Plate 5 Detail of brickwork

On the south elevation, near the centre of the wall, there were traces of limewash (Plate 5). One small patch covered an area of roughly $0.3m^2$, a larger patch covered an area of approximately $3.1m^2$. From the thickness of the flakes, this part of the wall appears to have been limewashed a number of times.
