Archaeological Buildings Assessment at

Eastbury Manor, Barking

November 2009

Report 09/156

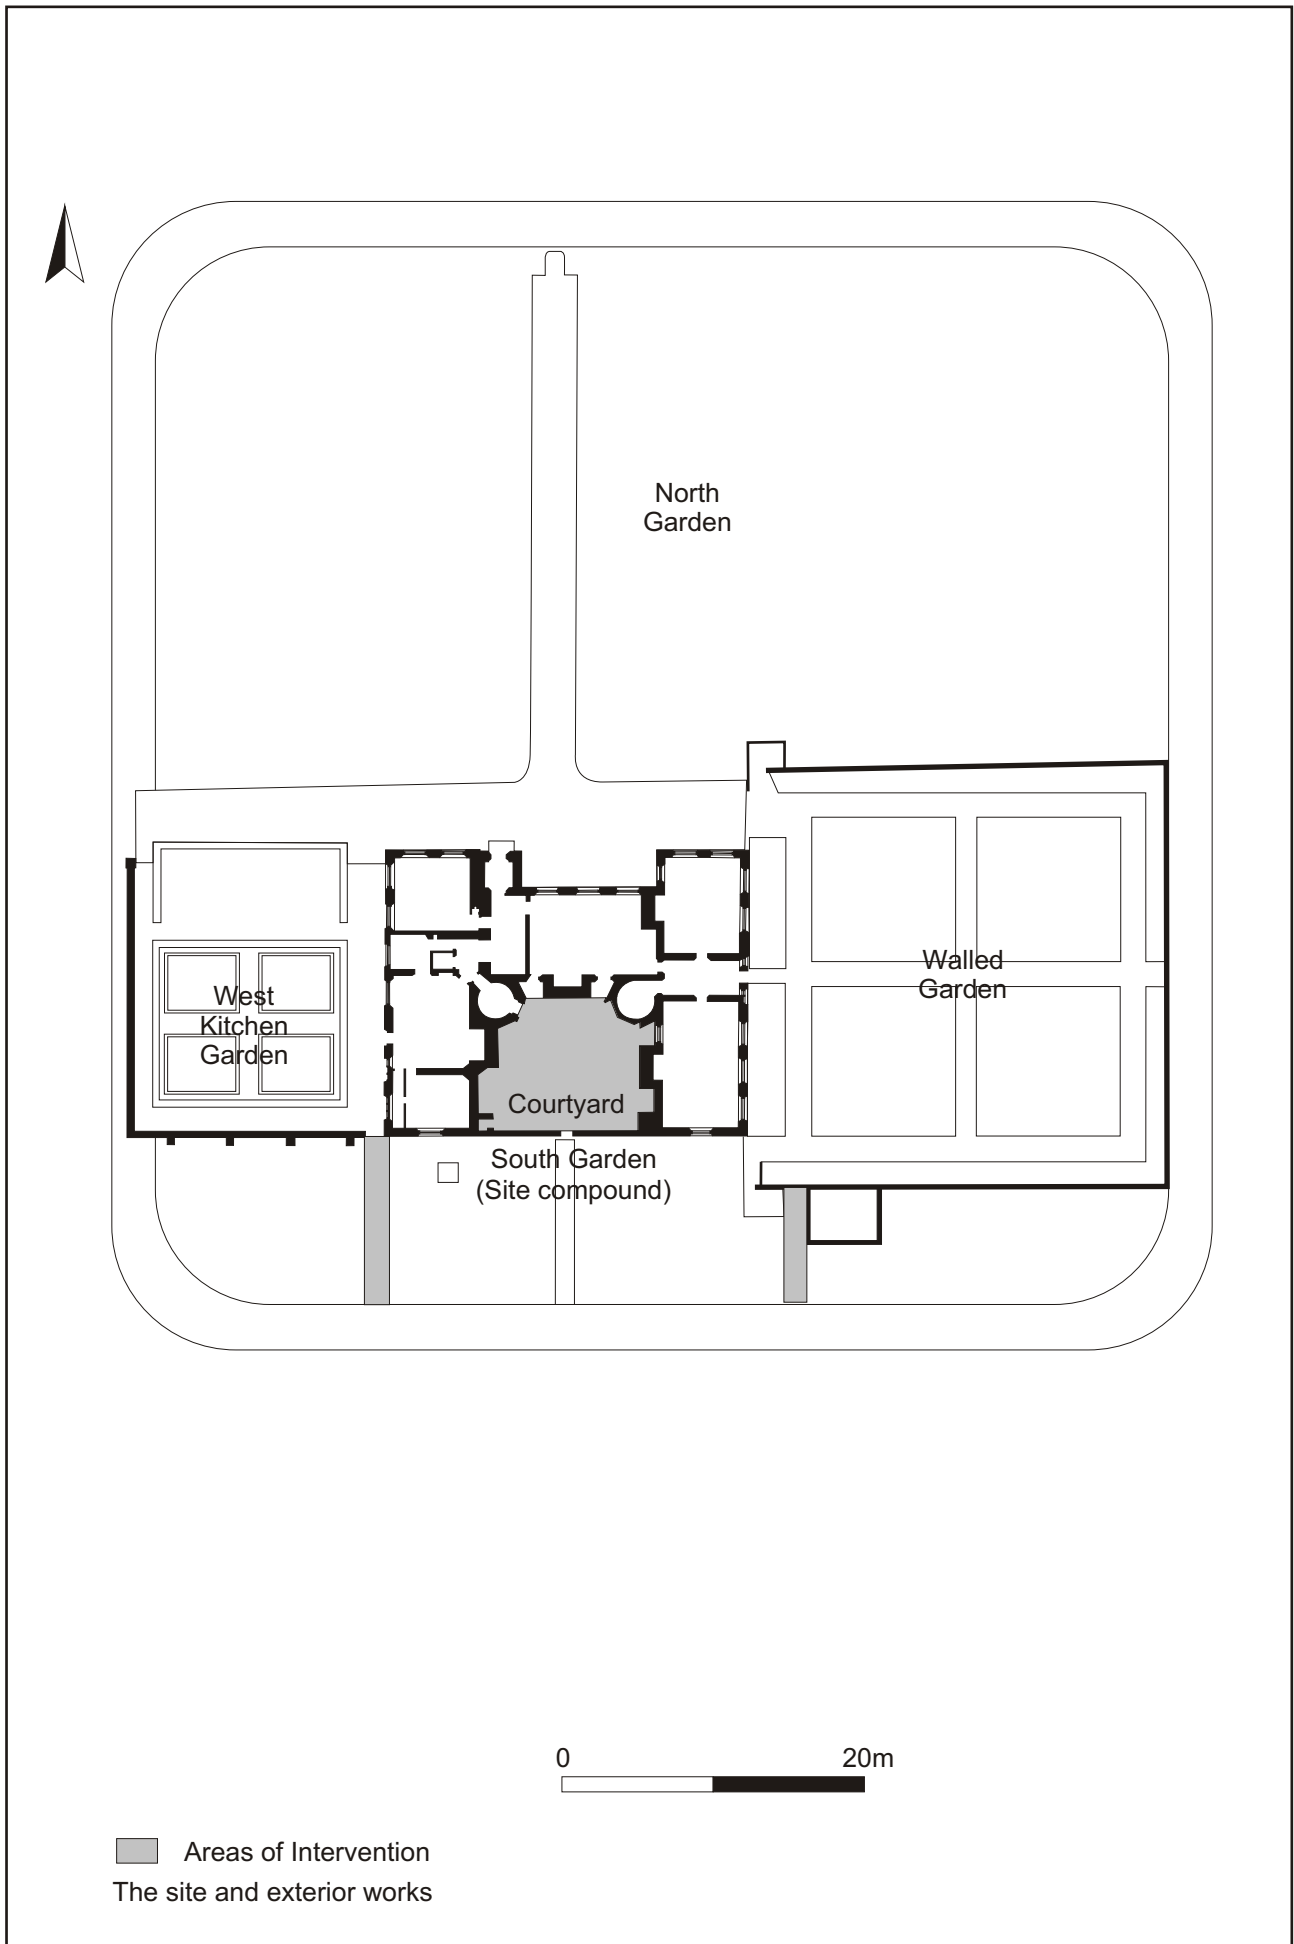
Plan showing areas of external investigation Fig 2
Plans showing areas of internal investigation Fig 3a

To both west and east sides of the South Garden two lines of postholes were hand-dug, into which were set the fence posts of the contractors' compound hoarding (Fig 2). These measured up to 540mm deep and were c300mm in diameter. None of them penetrated below the gravelly topsoil and no archaeology was exposed or disturbed. Their exact locations are retained in archive.

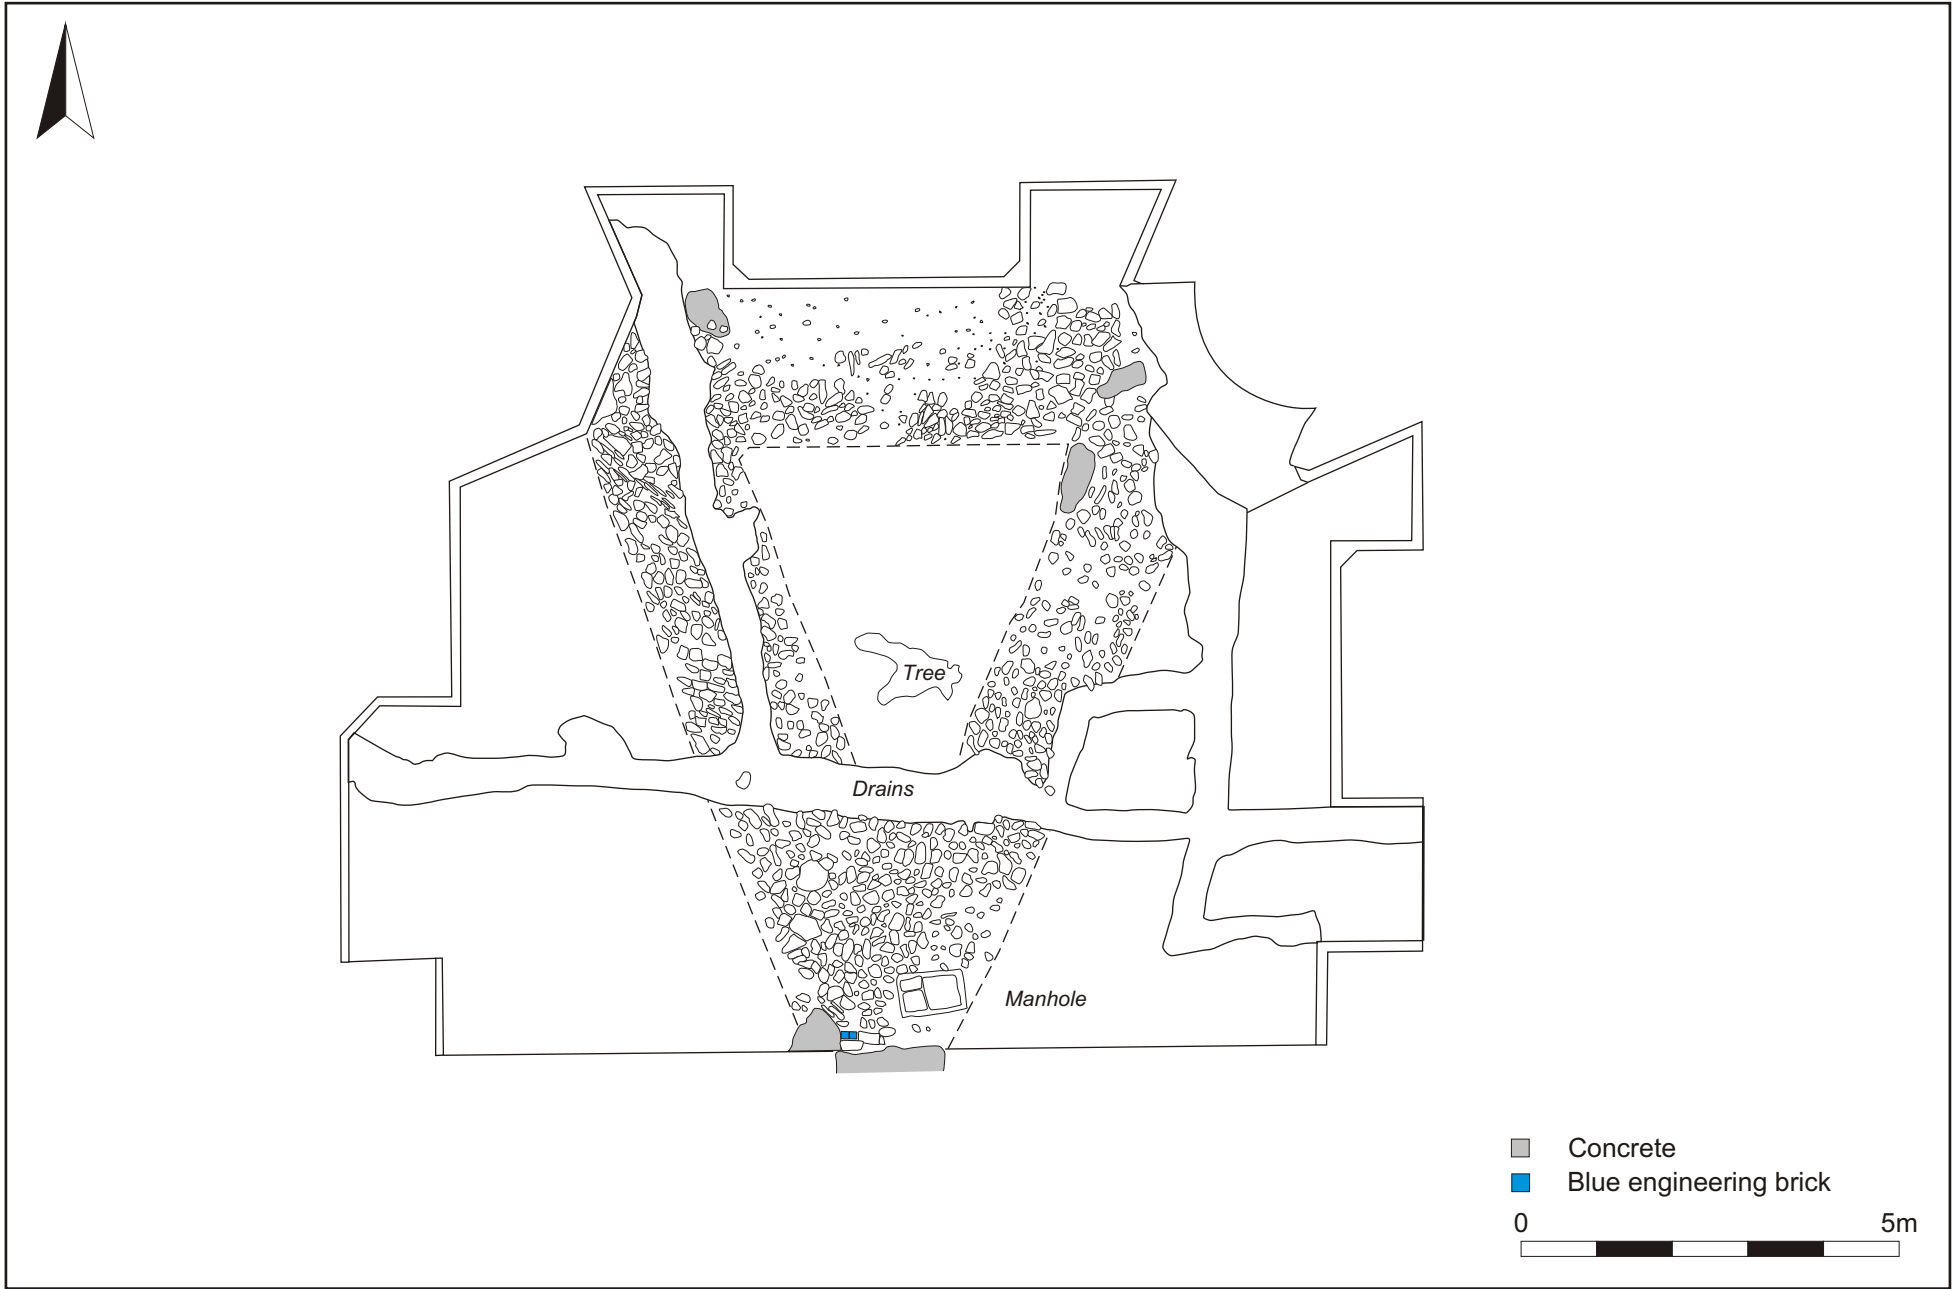
Plan of cobbled courtyard Fig 4

While the result may be superimposed upon the final drawing produced by MoLAS in 2006, the completion of the previously unrecorded areas shows that the complexity of nine courtyard cobbling phases suggested by MoLAS was probably due to disturbance from later drain runs which were not visible. In fact there is such a uniformity of the cobbling under the paths, if only to say that it is all very irregular, that it is proposed that the entire central section is of a single phase (yellow on the MoLAS fig 3) and that adjacent areas, such as their phases 2, 3, 4 and 5 do not exist as separate entities. In addition it is clear that the MoLAS phases were all purported to predate the tower collapse, while in contrast the previous (much smaller scale) works by Newham Museum

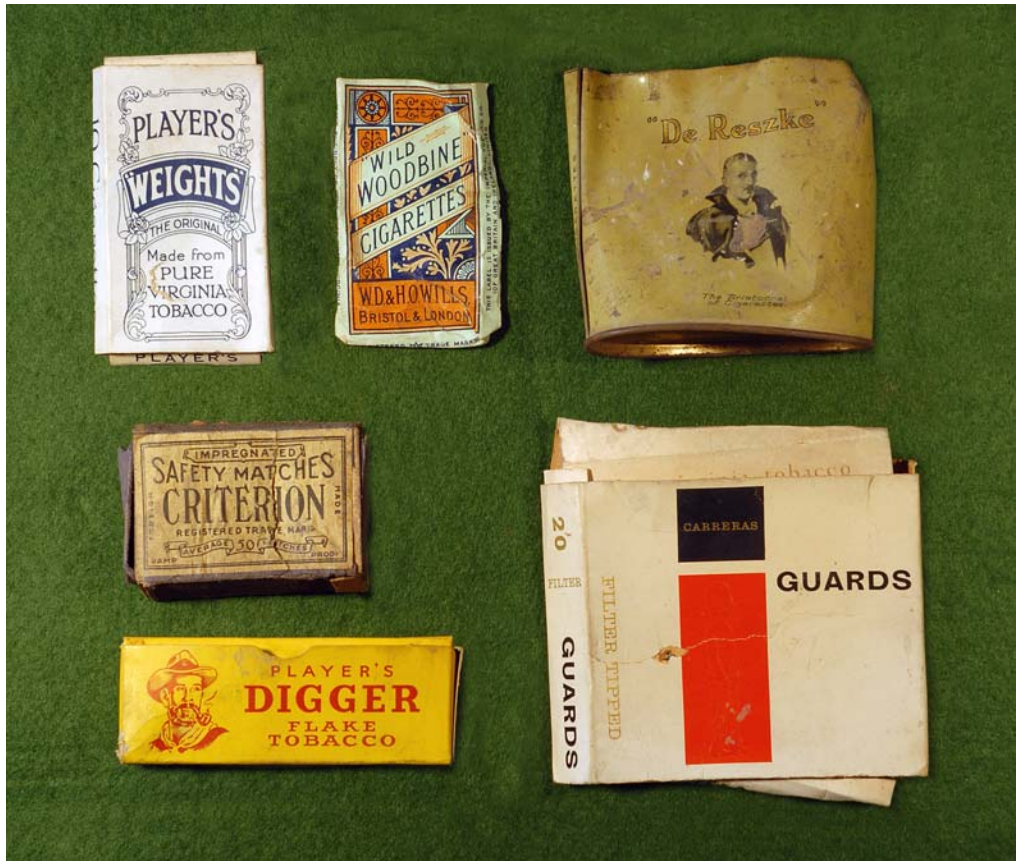
Fig 17: Cigarette packets and match box from first floor search

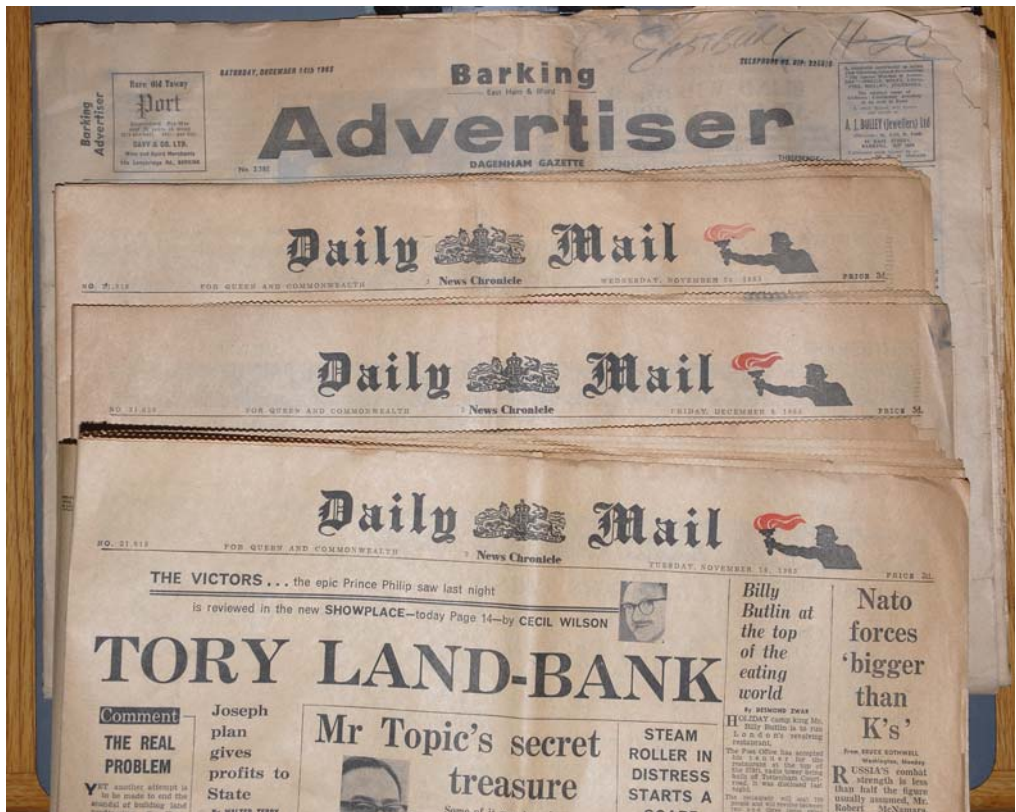
Fig 18 November/December 1963 Newspapers from first floor search
