Archaeological building assessment
and desk-based research on
Pump Cottage, Coombe Abbey,
Warwickshire.

Revised November 2007

Report 07/179

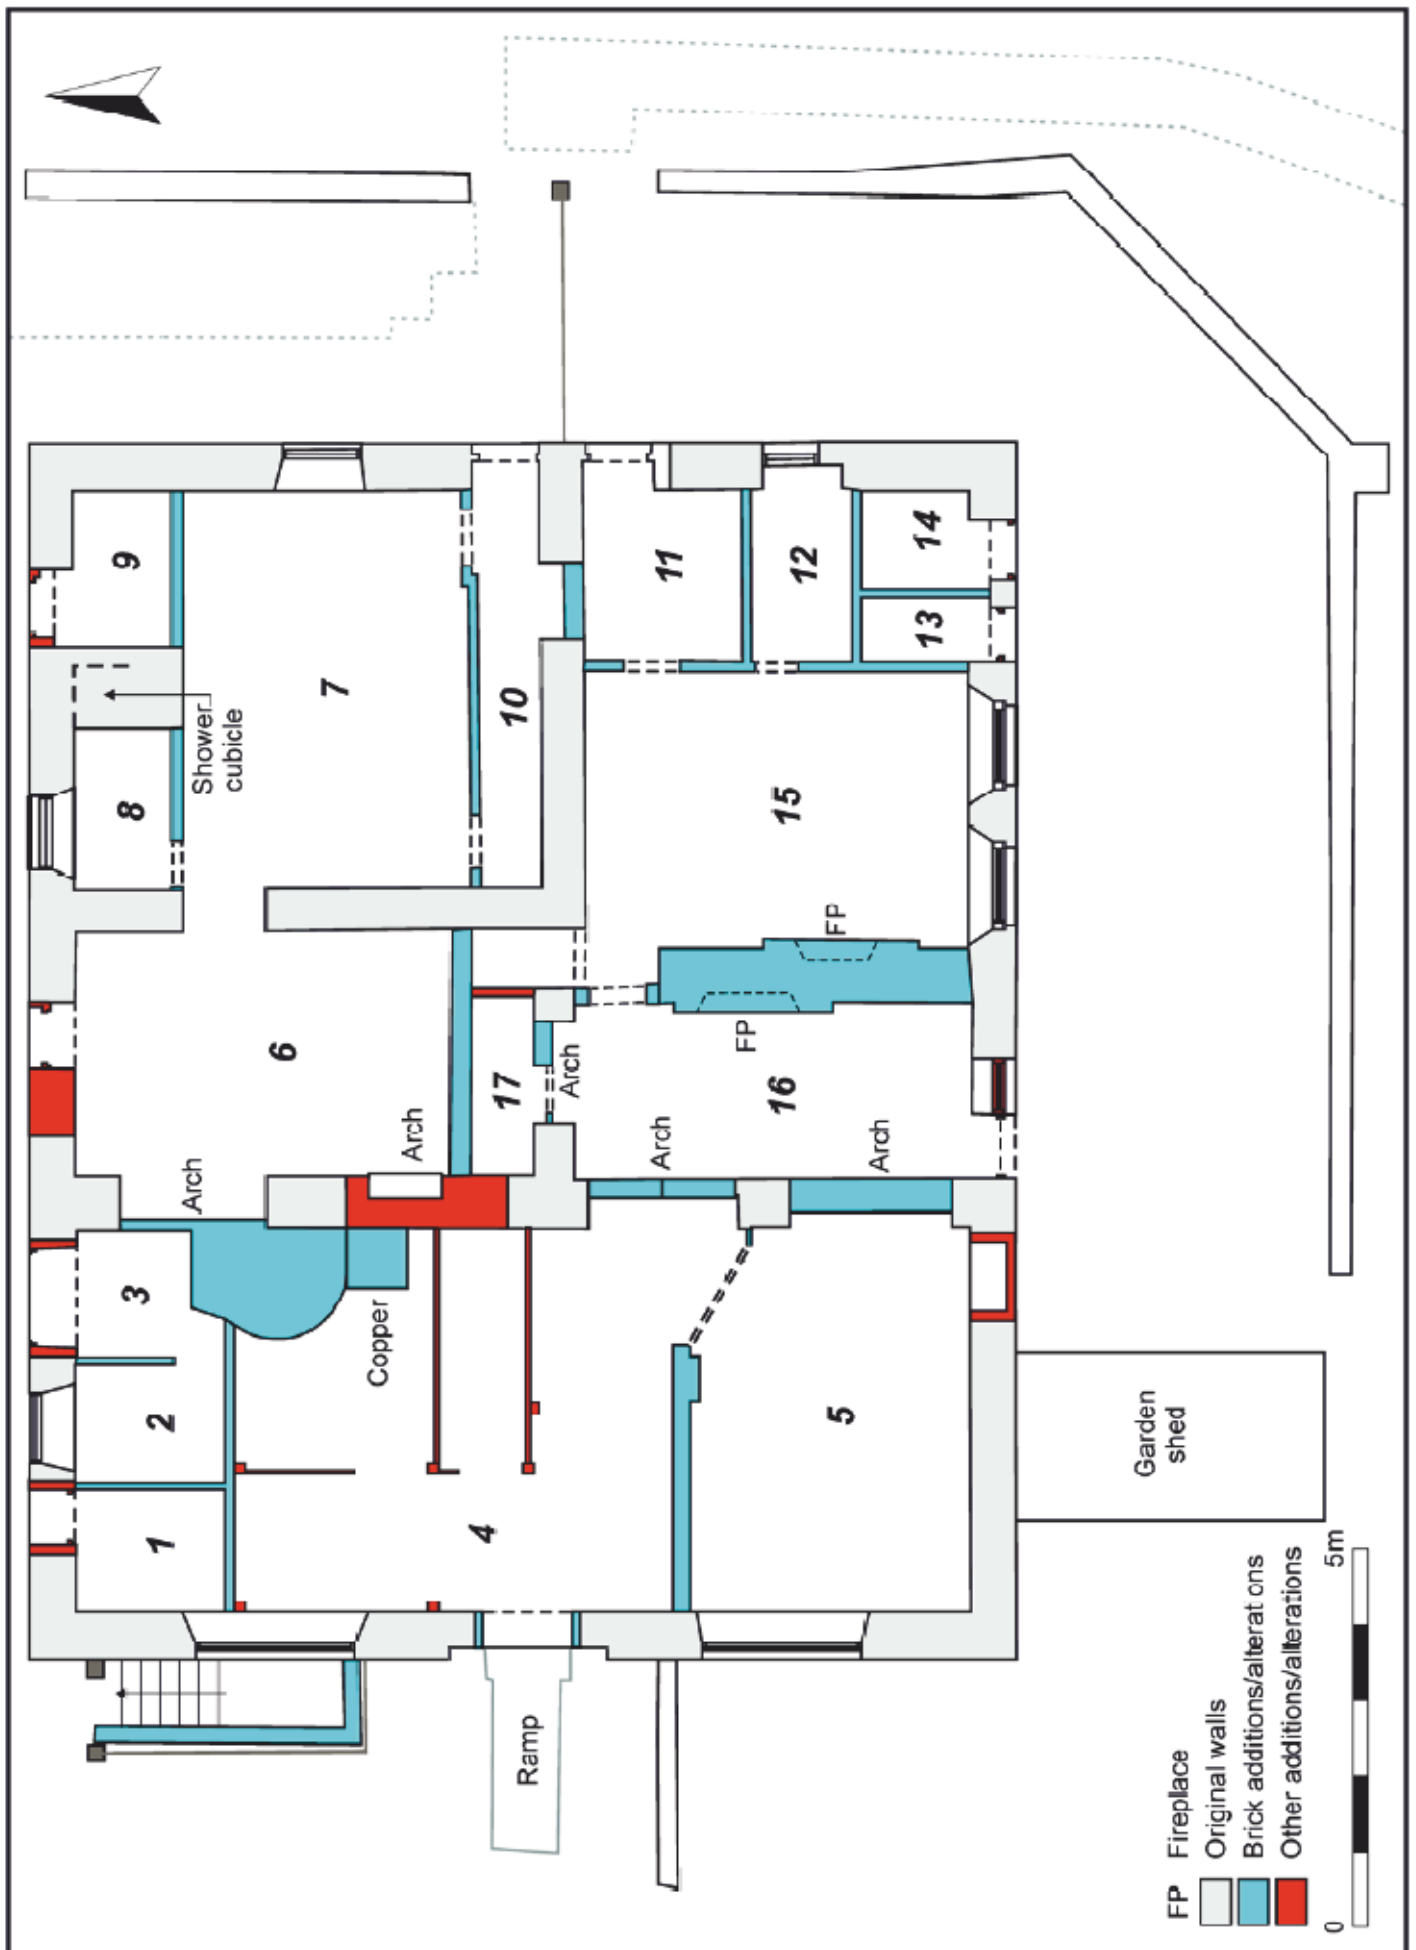
Ground floor plan of the building Fig 3

- 3.4 By the nineteenth century the building had been amalgamated into a large range of kitchen or service building which extended northwards from the main house (Fig 3). The long east-west range shown on the 1778 map did not survive and just the present building remained, unchanged in outline. By the early twentieth century the house was coming to end of its time as a family home; the last of the Craven family, owners since 1622, put the house, contents and estate to auction in 1923. Shortly after, in 1925, the north kitchen range was demolished but the present building survived.

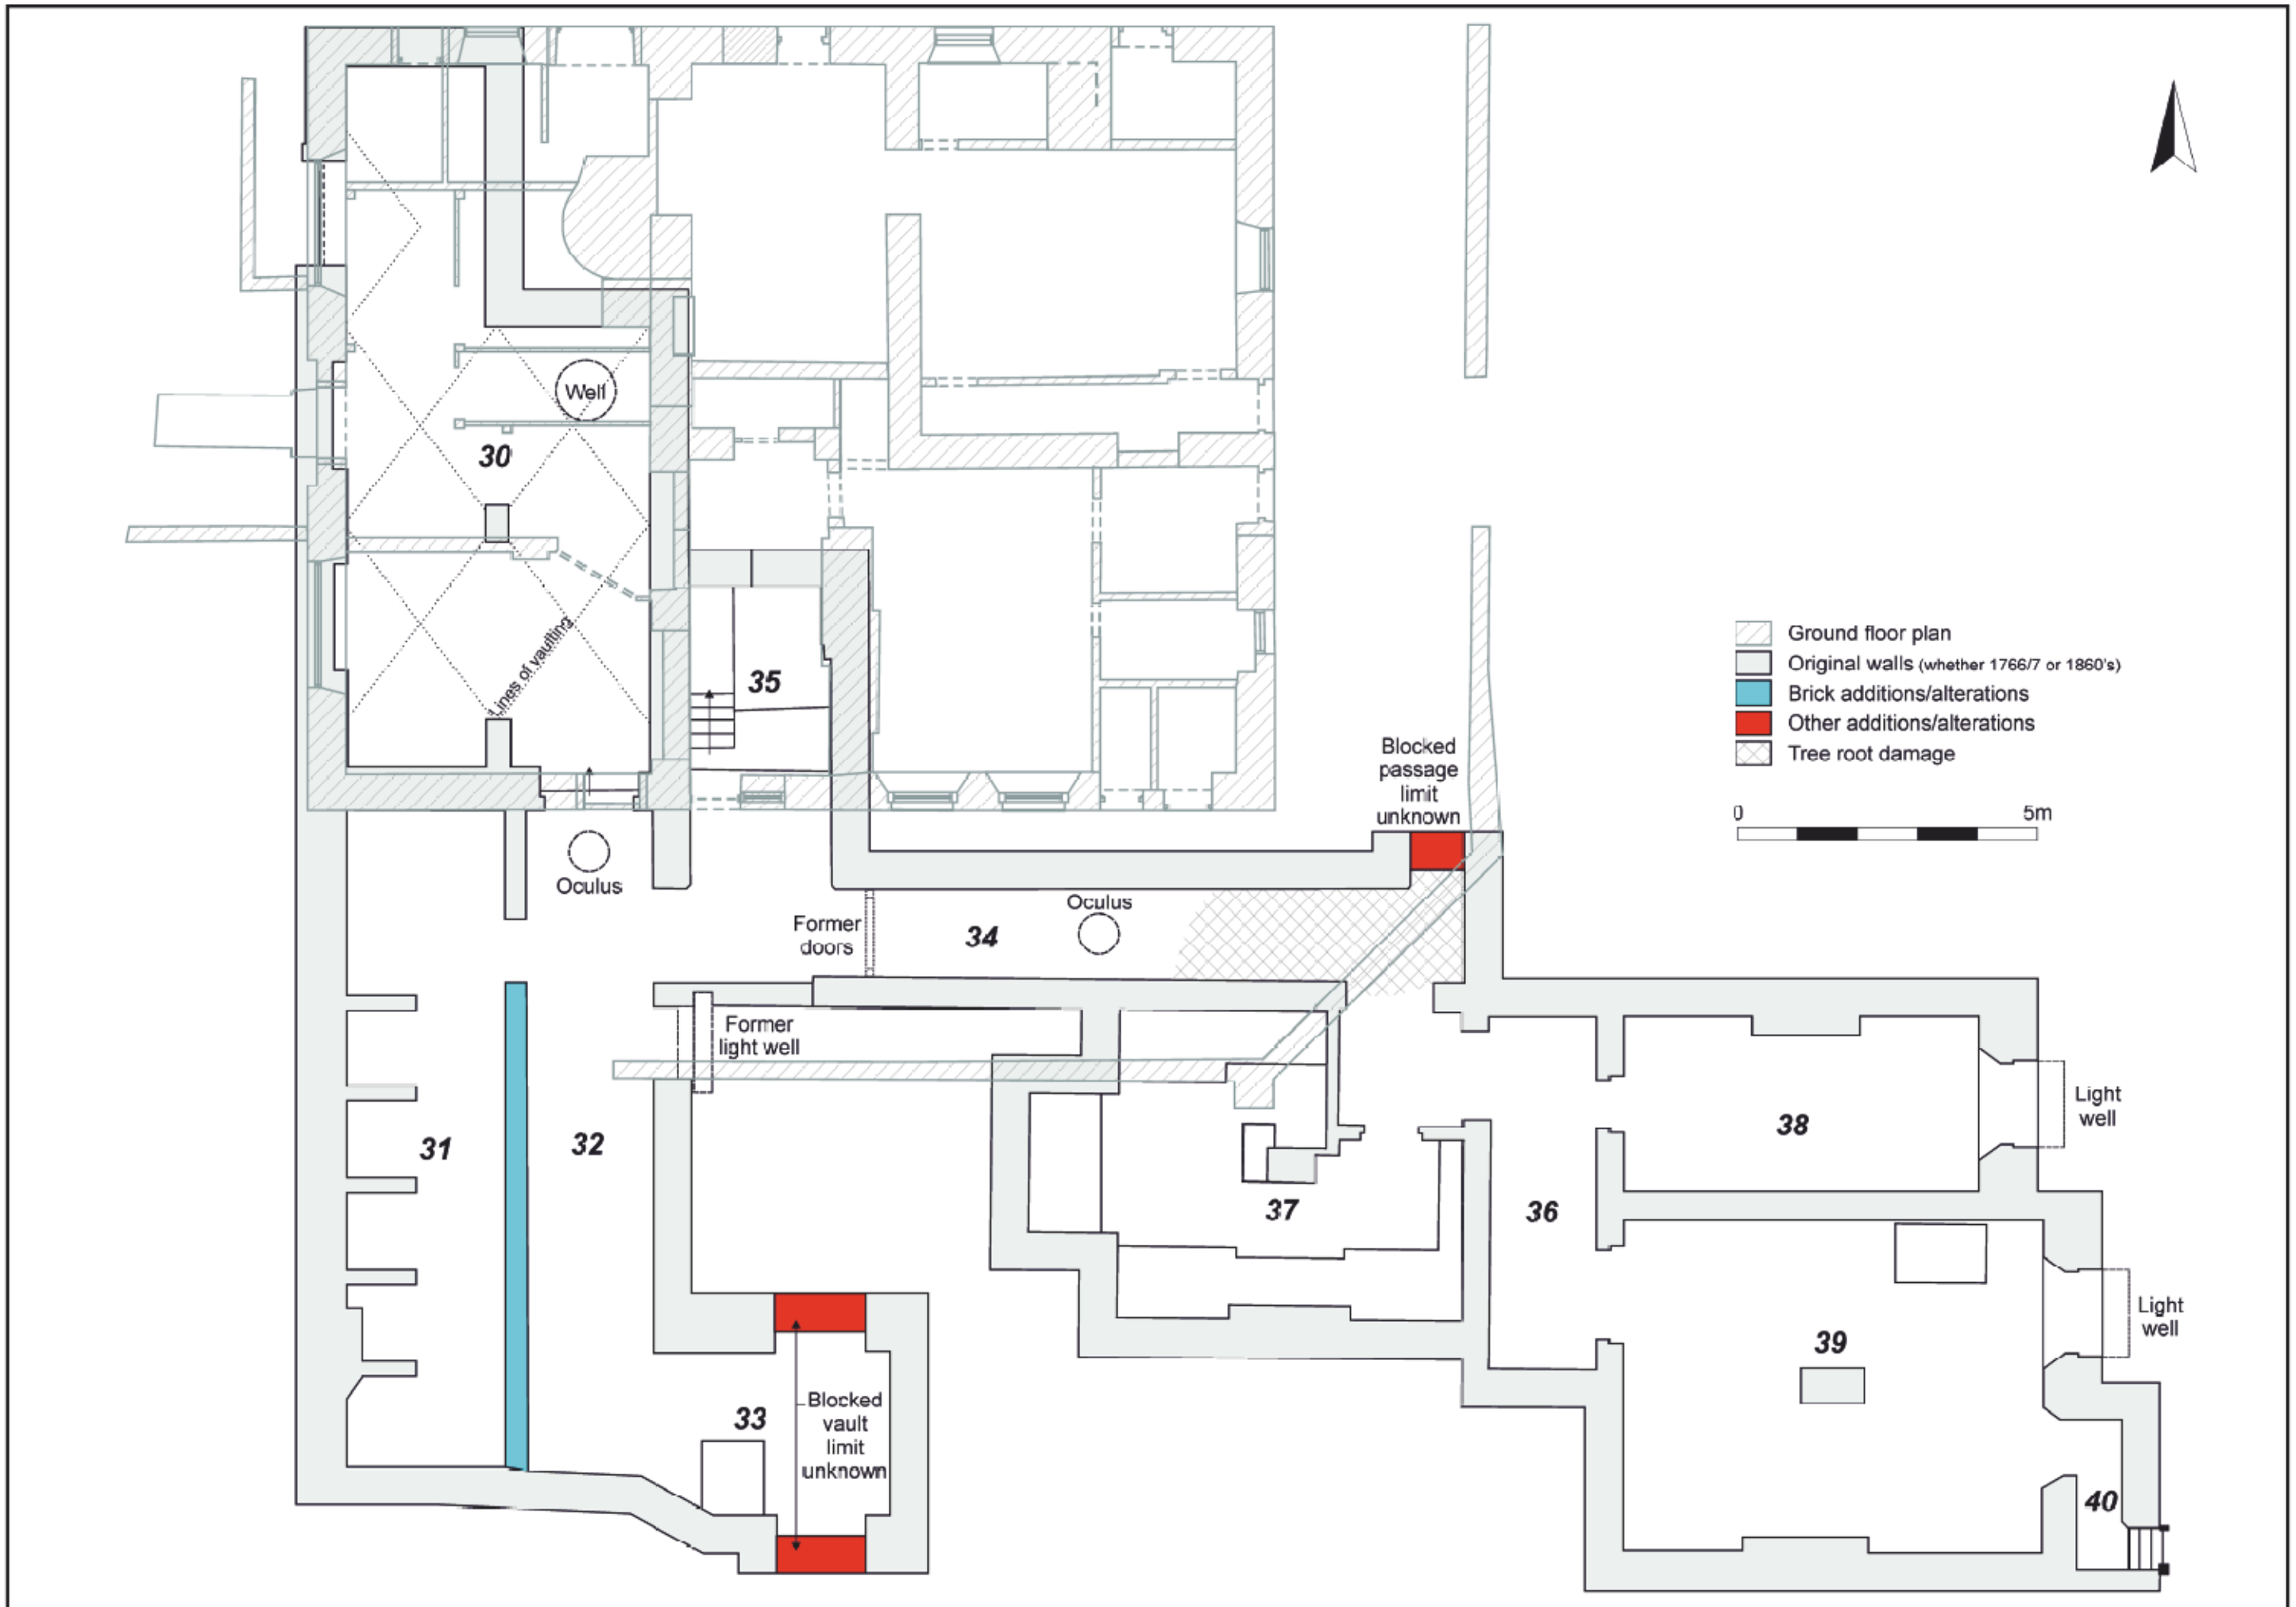
Cellar floor plan of the building with ground floor overlying Fig 5

- 3.5 The cellars. Almost nothing is known of the cellars other than that they were once even more extensive than they are today (Fig 5). No plans or descriptions, if they were ever made, survive today. Rodwell included them in his 1991 report, but he did not have full access to them. He records that they lie partly beneath Pump Cottage and also beneath the former courtyard of the demolished range; light wells survive as does a flight of steps from the courtyard end, now set within a grassed area to the south-east of the cottage. He comments that they were originally linked to the former north-west wing of the abbey but this linkage has been long blocked.

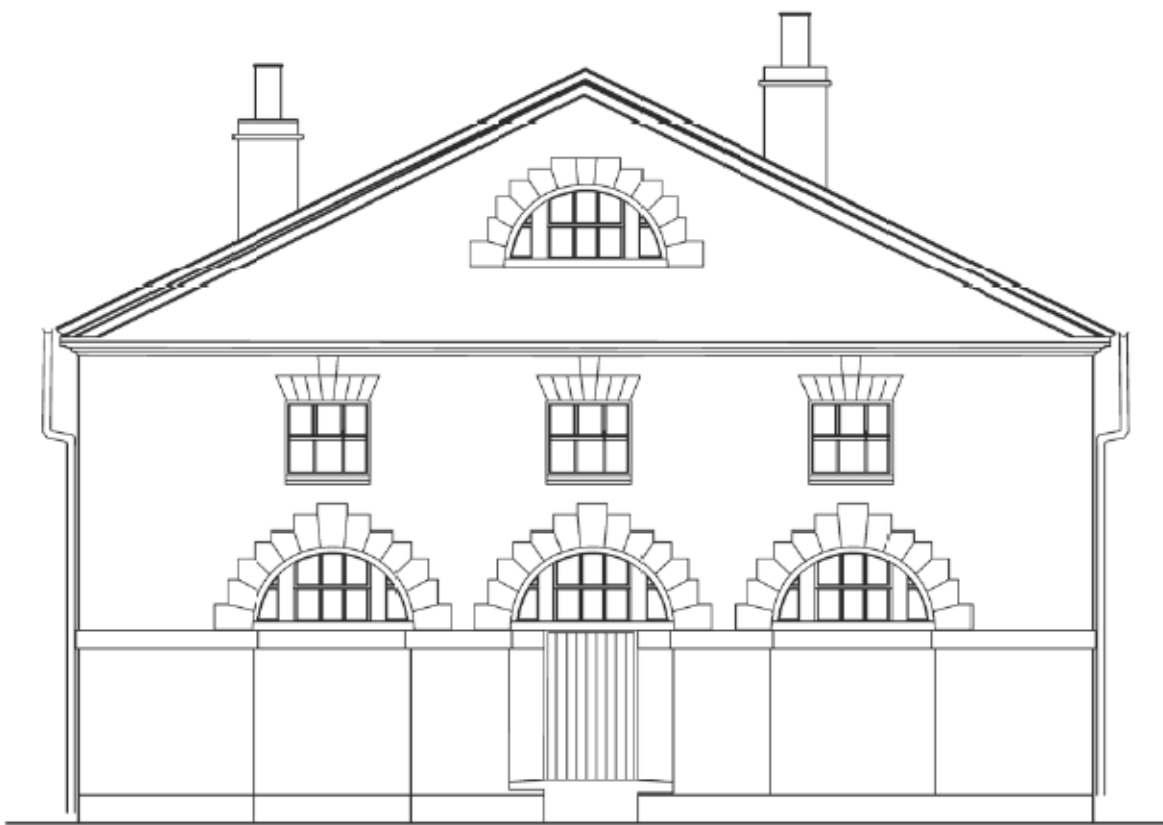
West Elevation

The west façade is the most architecturally accomplished comprising a symmetrical arrangement of three arches at ground floor level, each glazed in their upper parts, and with a simple flat string course at the height from which the arches spring. Three square windows are arranged above at first floor level and sit below a simple stone cornice which is also used to define the gable ends forming a pediment at the centre of which lies a semi-circular window (Plate 1). The whole façade is built of finely dressed buff coloured sandstone.
