Archaeological building recording of Dinton Castle Aylesbury, Buckinghamshire

March – October 2009

Report 09/174

ARCHAEOLOGICAL BUILDING RECORDING OF DINTON CASTLE AYLESBURY, BUCKINGHAMSHIRE

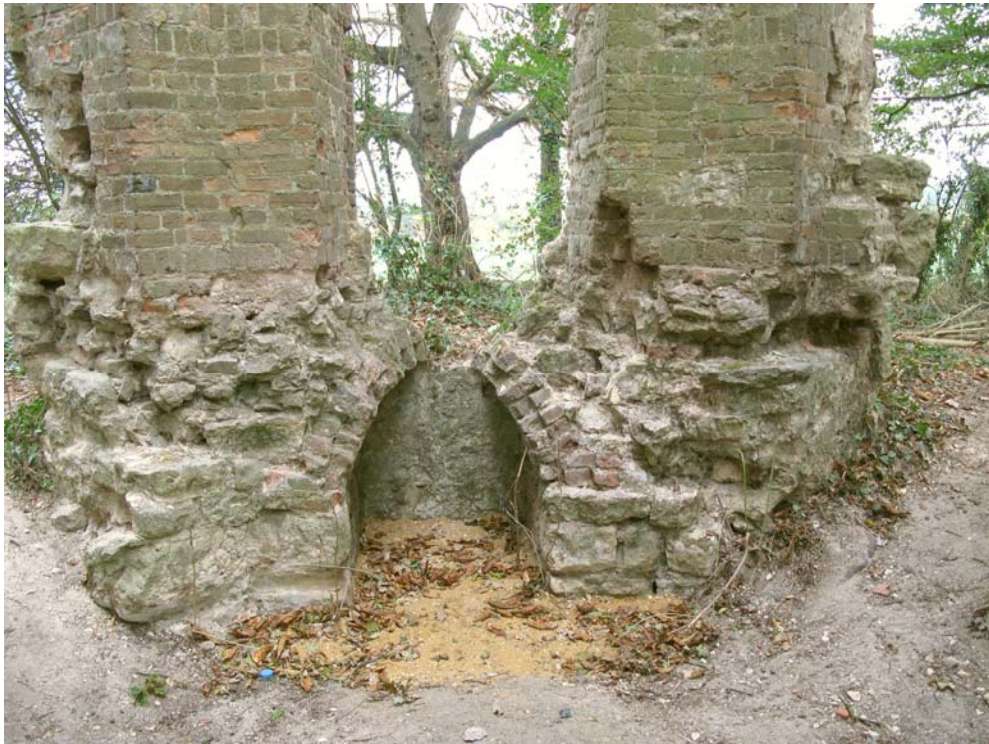
Recessed arch in half-basement in the northern Bay Fig 18

It is not quite clear how the half-basement was accessed; a break in the north-east cant of the north bay appears to be a constructed rather than broken through opening which may have been a doorway (Figs 5 and 17). There is no indication at present of steps. In the central north facet of the octagon there is a round arched recess, the arch constructed of brick (Fig 18). There is a brick-built fireplace at the base of the west turret, the segmental arch of which is now missing, though the springers are still present on either side (Fig 19). It is not known at what level the half-basement floor was situated, but it is believed to be much deeper than the 200mm suggested previously from inspection of the test-pits dug by the owner, since at that level there would not be enough head room to make this a usable space. The half-basement appears to be filled with rubble from the collapse of the upper sections of the building.

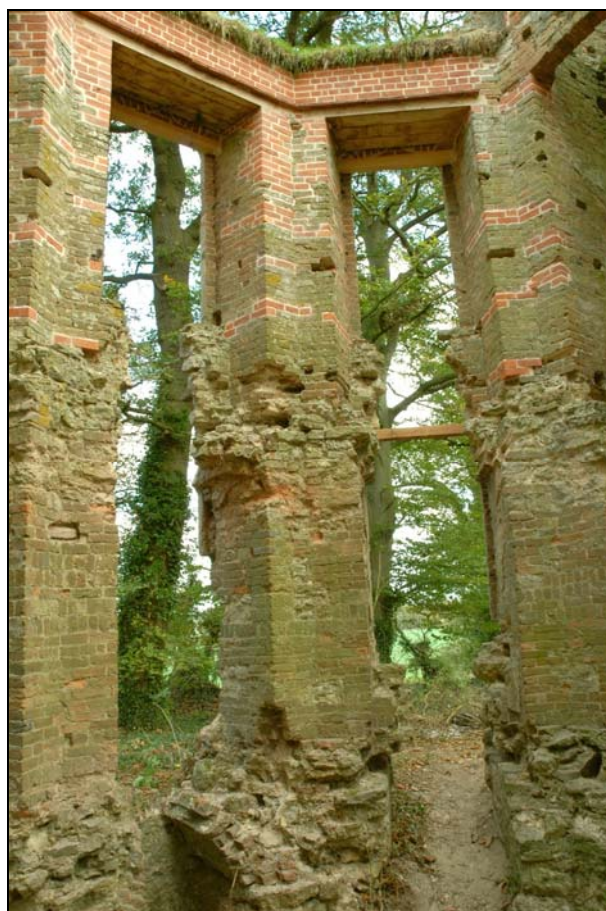
Internal view of windows in the northern Bay Fig 25

The upper floor was constructed in the same way as the lower floor. On the north side were three windows, each with splayed jambs and space below the sills internally for seats or cabinets (Fig 25). The central facet of the south side of the octagon is differently configured; the jambs are straight instead of being splayed. The opening rises from floor to ceiling and there is no window sill. The soffit of the arch is lower and the external surround is finished in stone rather than stuccoed brick (Fig 26). The external stone surround is rebated and retains iron hinge pins, which indicate the presence of either a door or shutters which opened outwards and apparently gave access onto a balcony above the roof of the porch. External two square sockets on either side suggest the presence of a handrail at roughly the same level as the flanking window sills (Fig 26).
