Project Designs and Client Reports No. CP/451/07

REPORT ON AN ARCHAEOLOGICAL BUILDING RECORDING PROJECT AT THE HAGG ALLENDALE NORTHUMBERLAND

NY 8306 5360 Planning Application Ref: 20060898

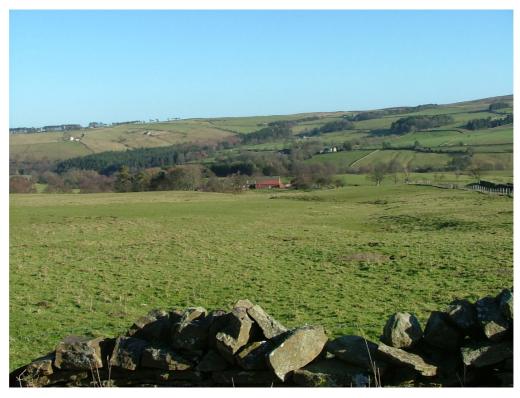
- 1.2.2 The farmstead commands views to the west of Green Hill (Plate 1) and to the south of the valley towards Allenheads. Faint earthworks of ridge and furrow were observed in a field to the south of The Hagg, as well as on the opposite side of the valley to the east; possibly indicating that arable cultivation was historically an important part of the economy of the scattered farmsteads in this locality.

Plate 1 – The Hagg, Allendale as seen from the road to the west. The red corrugated shed is located on the west side of the site; the farmhouse and buildings are hidden behind it

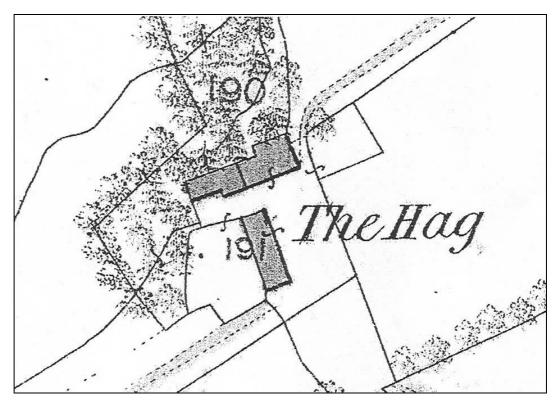
Figure 3 – First Edition Ordnance Survey map of *c*.1860 (Scale = 25" to 1 mile)

- 4.2 The Hagg is shown on Armstrong's Plan of Northumberland 1769 (Figure 2).
- 4.3 The First Edition Ordnance Survey map of *c*. 1860 shows the farmhouse with adjoining outbuildings orientated east-west at the north of the site, with the building that is the subject of the present survey shown to the south orientated north-south (Figure 3).

- 6.4 At the date of publication of the First Edition Ordnance Survey map *c*.1860 (Figure 3), The Hagg consisted of the farmhouse with adjoining stable, a further building to the west, which may have been a small threshing barn, and the byre to the south. The ridge and furrow earthworks observed in one of the fields to the south-east suggests that cereals were grown historically, perhaps when the farm was operating at subsistence level, in which case these crops would have needed to be threshed. By 1898 a large building had been constructed to the west of the site (Figure 4); this may have been to store hay. The farmstead continued to expand during the twentieth century with the addition of block work and corrugated iron buildings, and brick-built stables.

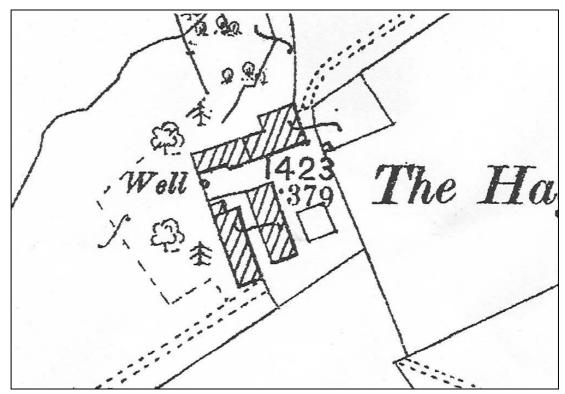
Figure 4 – Second Edition Ordnance Survey Map 1898 (Scale = 25" to 1 mile)

- 4.4 The Second Edition Ordnance Survey map of 1898 shows an additional building on the west side of the site, as well as showing the location of the well (Figure 4).

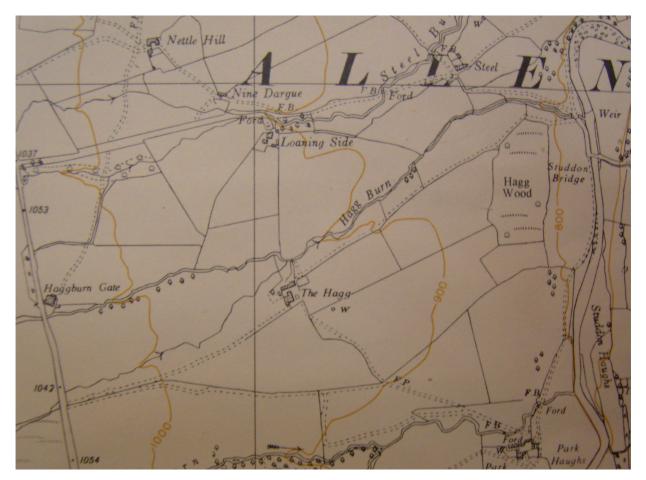
Figure 5 – Ordnance Survey Map of 1956 (Scale = 6" to 1 mile)

- 4.5 The Ordnance Survey map of 1956 (6 inch to one mile sale) shows that the byre and hay barn are now linked by a further building (Figure 5).
- 4.6 The Hagg ceased to function as a working farm approximately 15 years ago. It has been used as an equestrian centre until one year ago when it was bought by the present owner along with c.80 acres of land.⁴

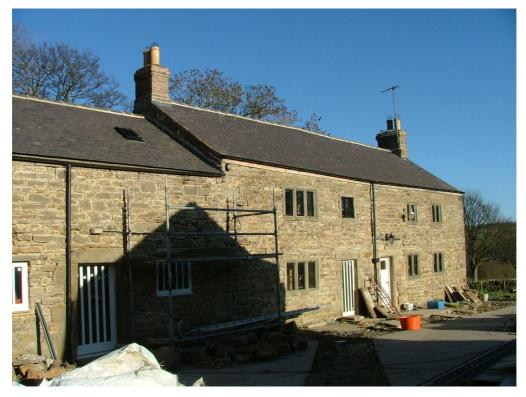
- 5.3.2 The farmhouse is orientated east-west at the north of the site with the outbuildings at its western end (Plate 17). There is a date stone of '1691' set above the bolection-moulded door surround on the south elevation (Plates 18 and 19).

Plate 17 – South elevation of farmhouse and outbuilding (left-hand side)

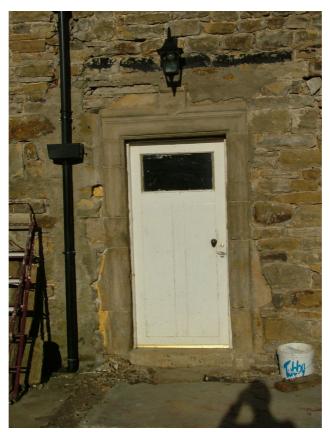
Plate 19 – Door surround with date stone above, south elevation of farmhouse

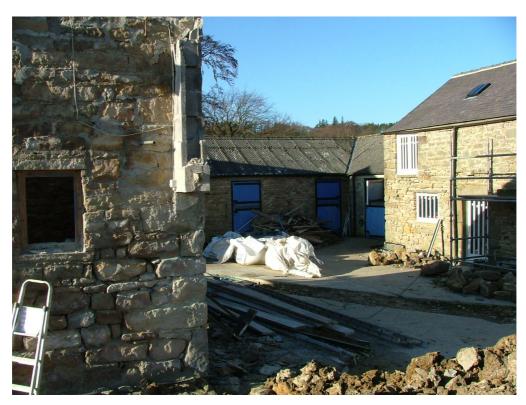
- 5.3.3 The outbuilding may originally have been a stable with hayloft above (Plate 20); it has recently been converted to residential use.
- 5.3.4 To the west of the byre is a large barn which appears to have been constructed some time between the 1860s and 1899 as shown by the First and Second Edition Ordnance Survey maps (Figures 3 and 4). This large building measures approximately 13.50 metres long by 6.50 metres wide externally and is constructed of roughly-coursed masonry (Plate 21). Internally the building is divided into five bays by four king-post roof trusses. There is a large doorway on the east elevation, with a later doorway inserted at the northern end of the same elevation. Interestingly, the west elevation has no doorways or windows and may reflect, firstly the fact that this building was designed for storage so such apertures were not required, but secondly may be as a way of protecting the farmstead from the wind coming from the west, which was commented on by the present owner of The Hagg. Writing in 1794, Bailey an Culley observed that in Northumberland in the autumn the westerly winds *'often blow with tempestuous fury, dash out the corn and disappoint the just hopes of the industrious*

Plate 20 - South elevation of former stable (RH side of photograph) with modern stables in background

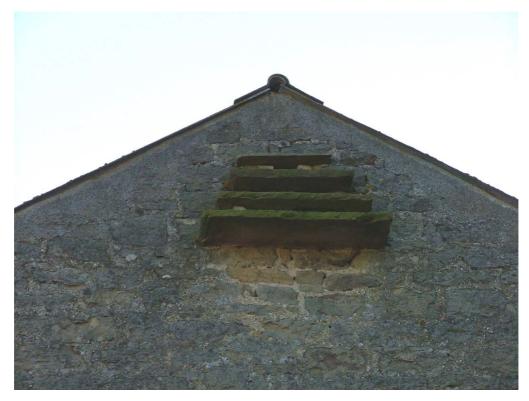
farmer^{*8}. In the north elevation of this building is a bird nesting box built into the gable end (Plate 22).

Plate 22 – Nesting boxes, north gable of hay barn

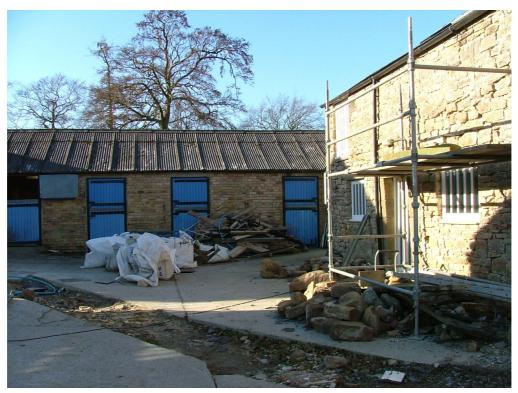
- 5.3.5 The single-storey L-shaped stable block located at the north-west side of the site is an indication of the farms most recent use as an equestrian centre (Plate 23).
- 5.3.6 To the south and west of the buildings already mentioned are buildings constructed of corrugated sheeting (Plates 24 and 25).

Plate 23 – East elevation of modern stable block

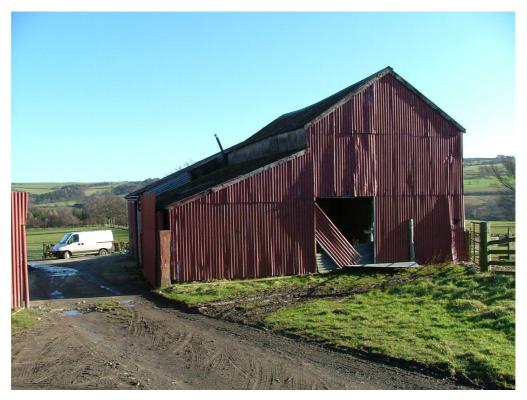
Plate 24 - Corrugated iron sheet building, south side of site

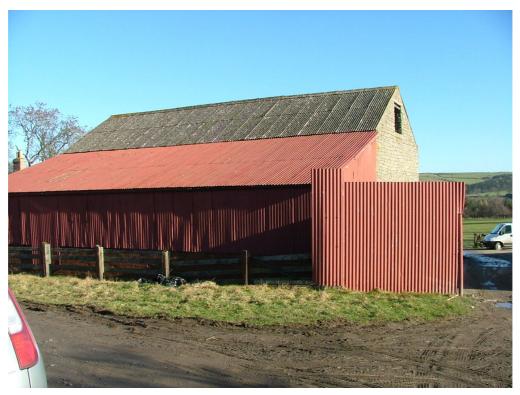
Plate 25 - Corrugated sheet building against the west elevation of hay barn
