Valleyfield, Fife: Historic Building Recording

Data Structure Report

RATHMELL  
ARCHAEOLOGY LTD

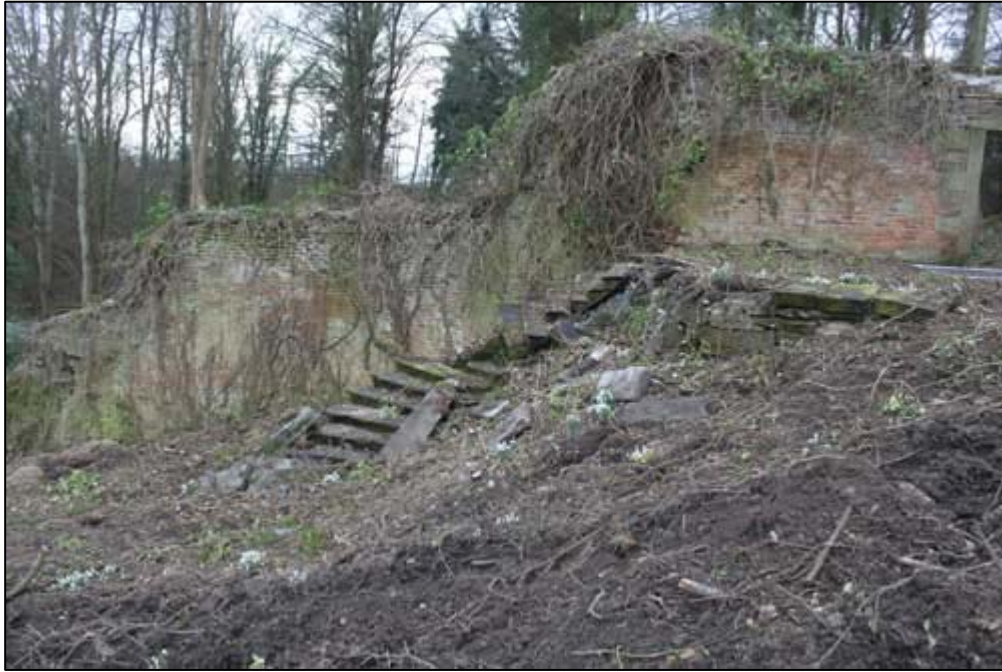
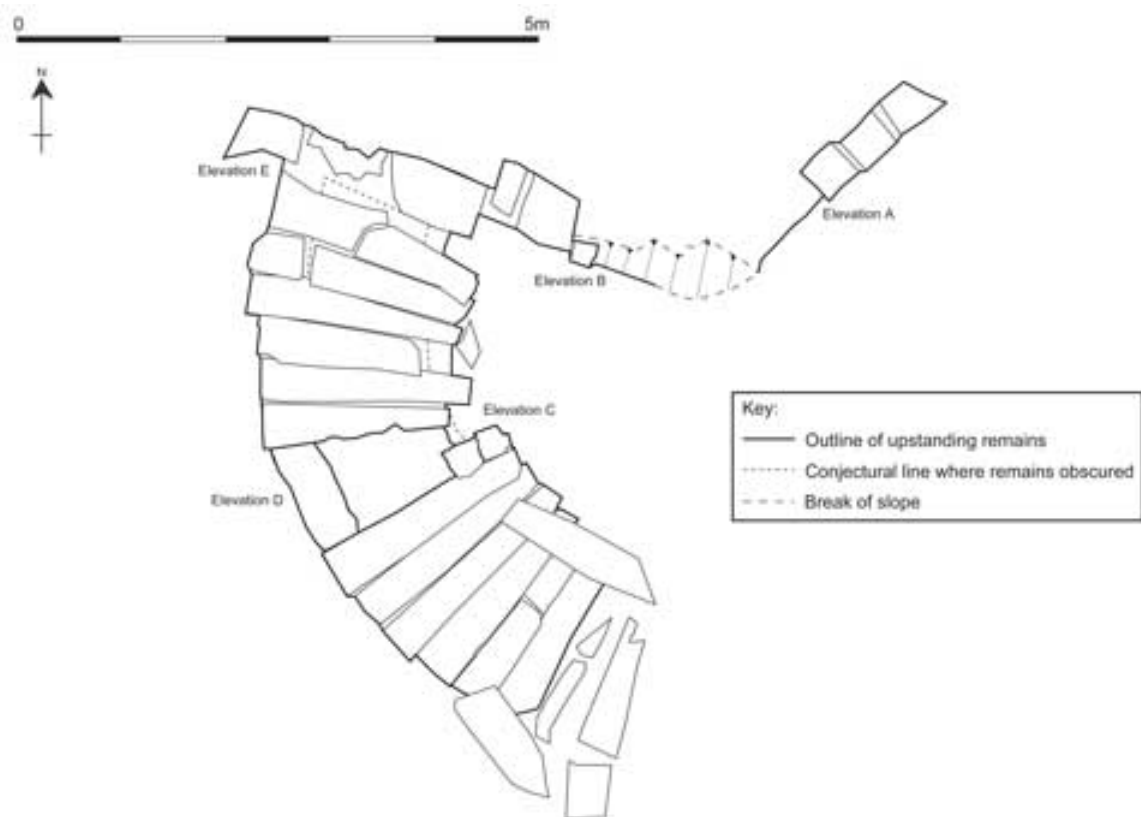
38. The first structure to be surveyed was the westernmost stair (Figures 6a & b), which comprised a roughly 'L'-shaped revetment wall, terraced into the slope and abutting the adjacent boundary wall. Projecting south from this revetment wall was a flight of stone steps which curved around to the east as it descended.

Fig. 6a: Structure 1 – West Stair, Flower Garden: General View From East

Figure 6b: Structure 1 – West Stair, Flower Garden: Plan

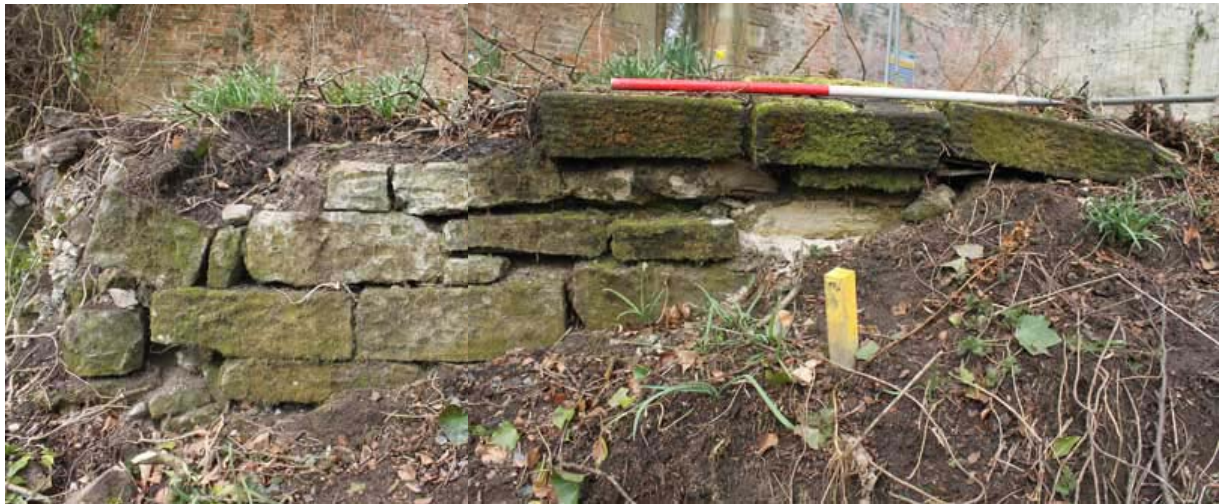
Figure 7a: Structure 1, West Stair: Elevation a (East-facing revetment)

39. The character of the revetment wall, represented by Elevations a, b and e, varied markedly across its extent. The eastern elevation, Elevation a (Figures 7a & b), survived in reasonable condition throughout, though the quoins had been displaced at the south end, and the coping stones were also absent in this location. The masonry comprised 4 courses of coursed rubble, with no mortar present. Each block had been roughly squared, and the faces coarsely finished by way of horizontal broaching. Two sizes of chisel had evidently been used in dressing the stones, a narrow-bladed form and a broad-bladed form, as shown in Figure 7b. In some places, the surface of the rubble blocks had been obscured by moss, while in several examples, the surfaces had entirely spalled due to environmental damage. Fragments of slates were occasionally to be found, bedded within the existing mortar.

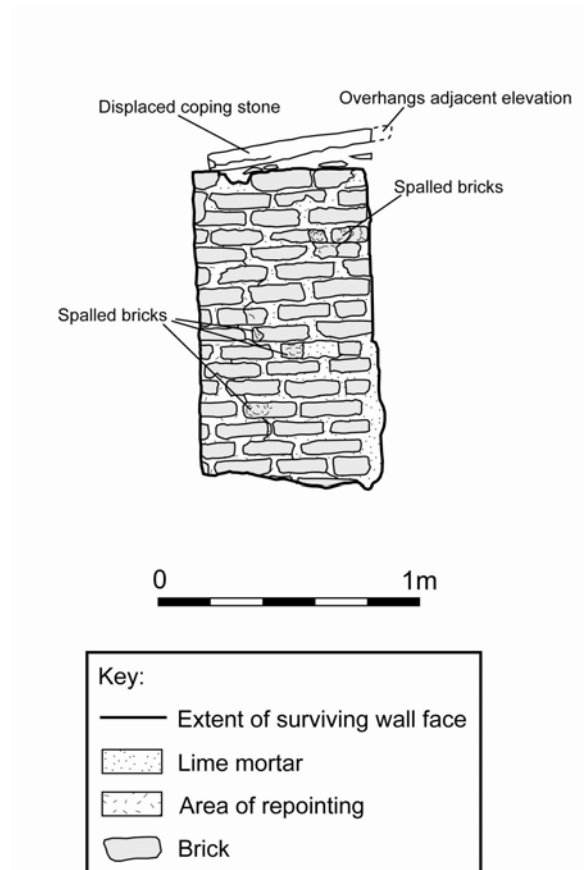
Figure 9b: Structure 1, West Stair: Elevation e (South-facing revetment)

41. The third elevation of the revetment was Elevation e (Figures 9a and b). This elevation had to be hand-drawn, as access for the machine was limited due to the narrow nature of the gap between the western wall of the stair and the nearby boundary wall of the Flower Garden. This elevation was composed entirely of hand-made bricks, standing to a height of 17 courses. This was considerably lower than its counterpart on Structure 2 (East Stair) which suggested that a significant amount of soil may have built up here, obscuring the lower courses. Some spalling of the outer surfaces of the brick had occurred, and there was evidence of re-pointing in places, concentrated in particular in the lower western corner. This repair work appeared to have been carried out using cement, as opposed to lime mortar, and the modern pointing could be distinguished by its darker greyish hue.

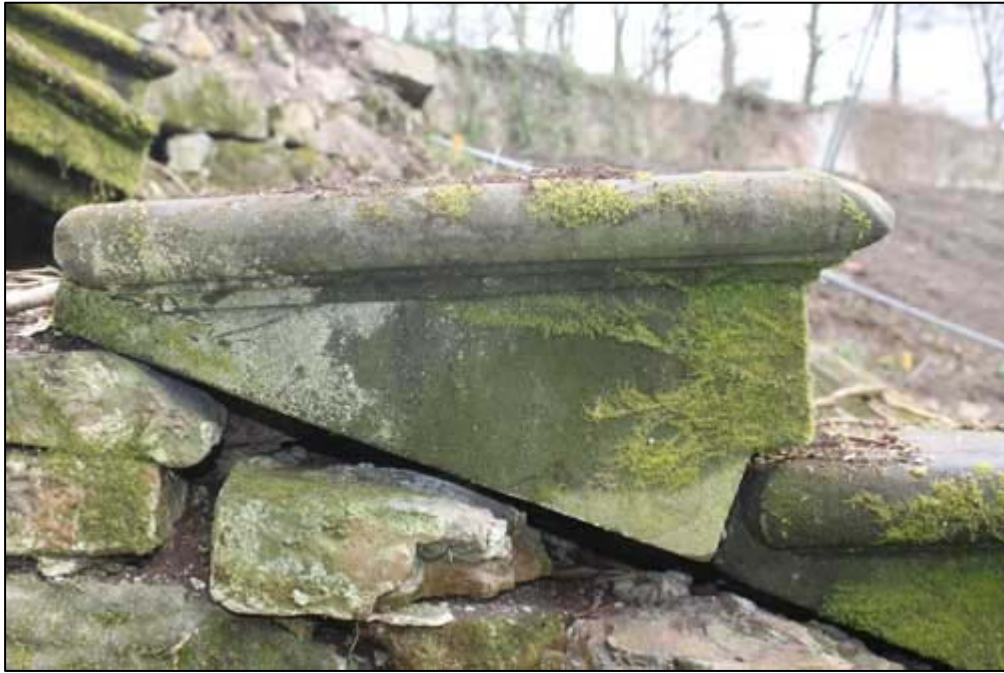
Figure 10a: Structure 1, West Stair: Elevation d – Profile of Step

42. The second element of the structure was the stair itself, which abutted the south edge of the revetment wall and then curved smoothly round to the east. The steps were made up of individual wedge-shaped blocks sandstone, of which twelve remained *in situ* with several displaced examples surviving nearby. Each step had been polished to a fine smooth finish with rounded edges to front and sides and two mouldings beneath, the upper beaded, the lower squared (Figure 10a). Originally, iron banister rails ran down either side of the stair – the stumps of these still survived *in situ* (Figure 10b).

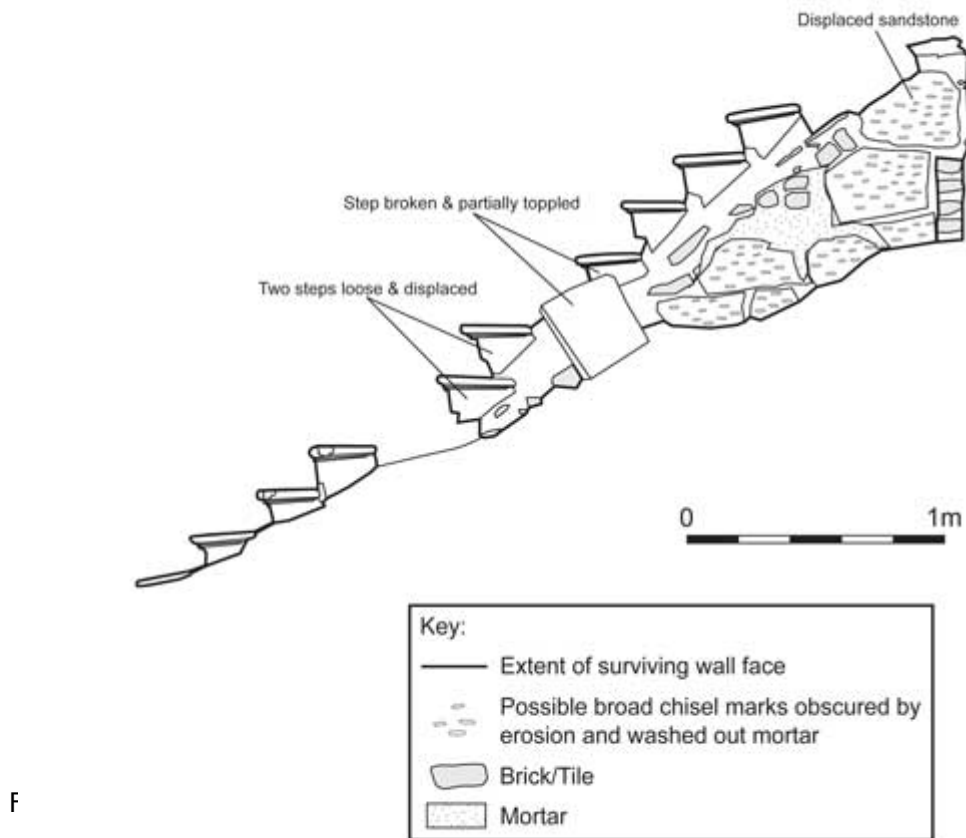
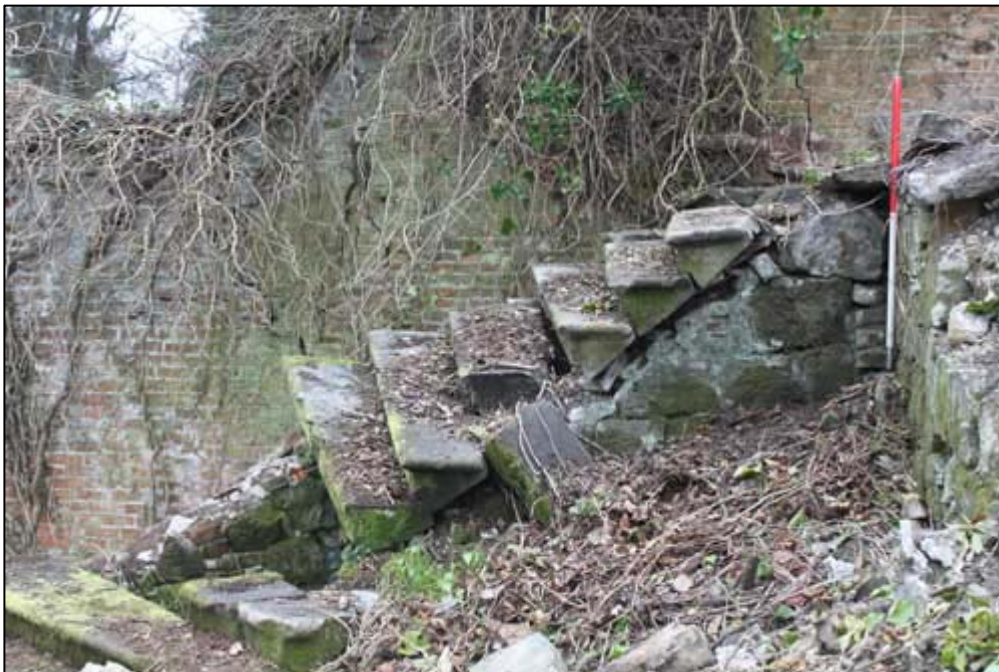
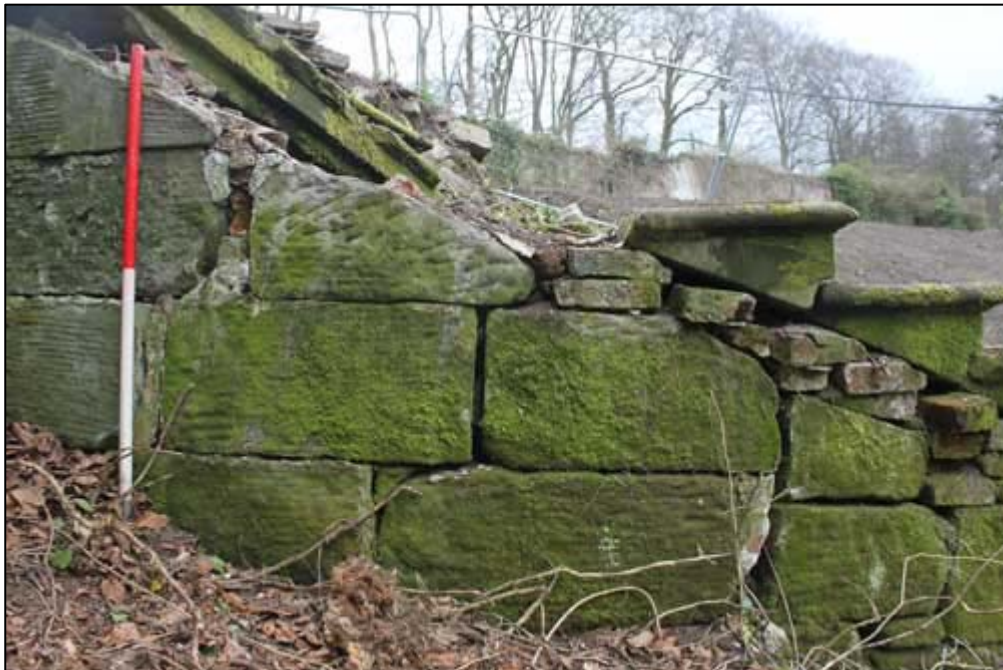
Fig. 11a: Structure 1, West Stair: Elevation e (South-facing revetment)

Fig. 11b: Structure 1, West Stair: Elevation e (South-facing revetment)

Figure 12b: Structure 1, West Stair: Elevation e (South-facing revetment)

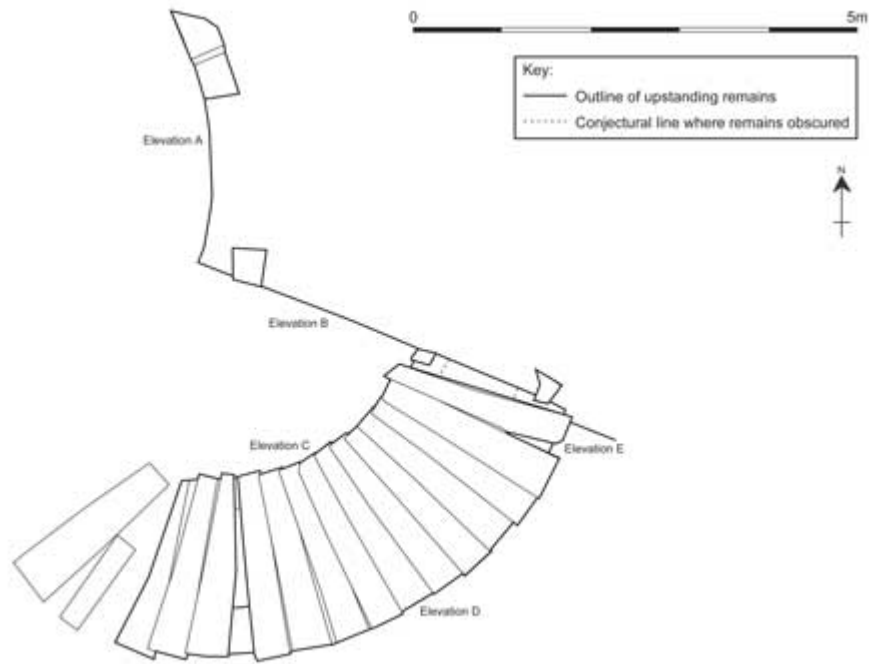
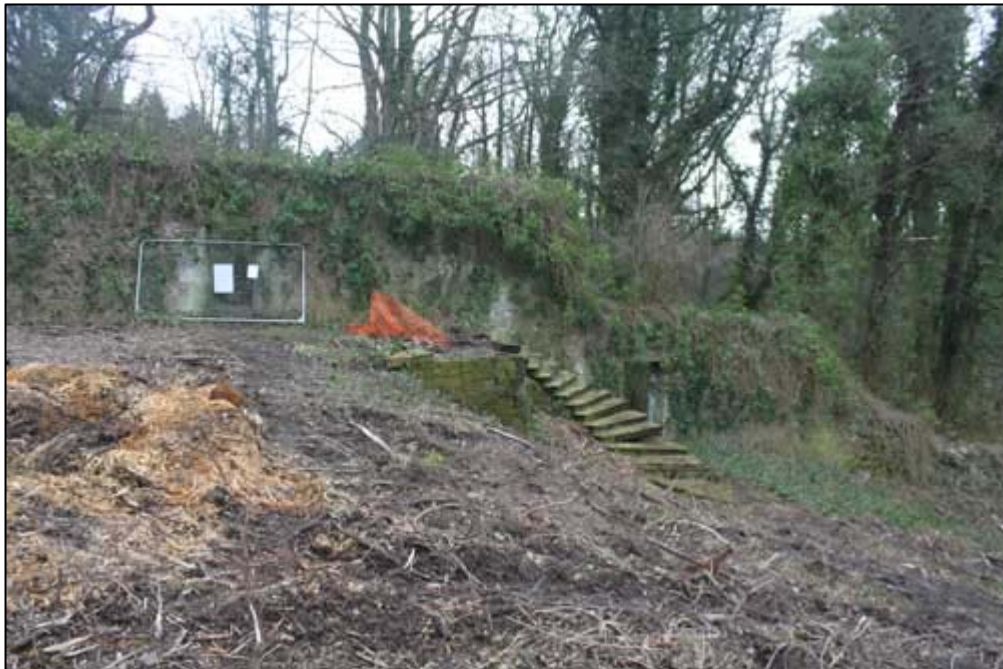
46. The second of the two ornamental stairs is located on the eastern side of the enclosed Flower Garden (Figures 13a & b). Both features would originally have been identical, but it is clear that this particular structure survives in better condition than its western counterpart, particularly with regards to the revetment wall (Elevations a, b and e).

48. With the quoins still in place, the integrity of the revetment wall has been retained, and as a result, it is clearly evident that Elevation a possesses a pronounced batter, a characteristic which is clearly visible in the abutting Elevation b (Figures 13 a & b). This batter would probably have been duplicated in Structure 1, the west stair. However, even though the wall itself survives in a better level of preservation, the coping stones survive in smaller numbers on this particular structure.

Figure 13a: Structure 2, East Stair: Plan

Figure 13b: Structure 2, East Stair: General View, in Wider Setting of Flower Garden

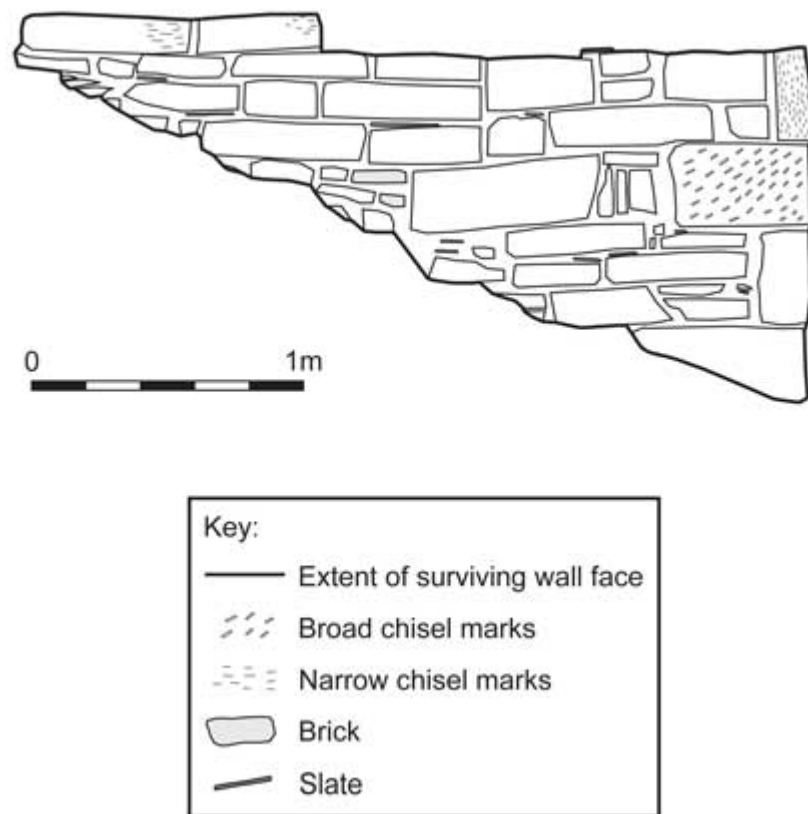
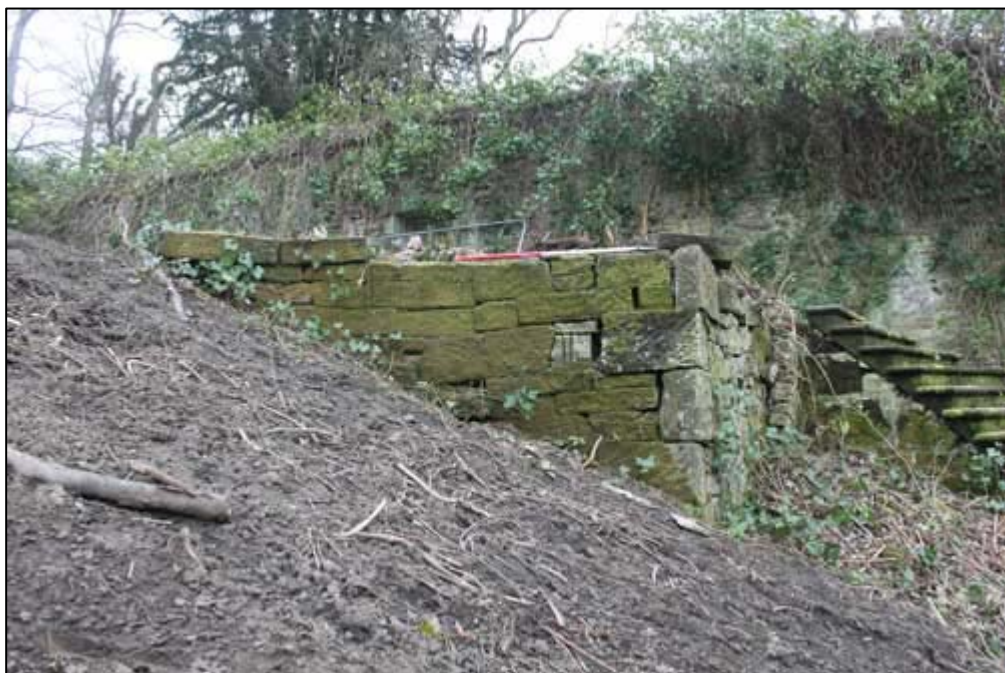
Figure 14a: Structure 2, East Stair: Elevation a (West-facing Revetment)

49. Elevation b, the south revetment wall, is similarly better preserved, again thanks to the retention of the quoins (Figures 14 a & b). The batter has already been commented upon, but there are other features of note which deserve a mention. Firstly, the courses appear to be less well-defined here than they were in Elevation a, particularly in their upper levels, which may indicate that partial collapse and rebuilding once took place here. Secondly, this particular structure mirrors Structure 1 (West Stair) in that it possesses an outer skin of hand-made bricks, abutting the west wall of the stair (Elevation c) and obscuring some of Elevation b, which lies behind. The use of hand-made bricks indicates an early (i.e. early 19th century date) but again the relationship with the adjacent curving stair wall is hard to define.

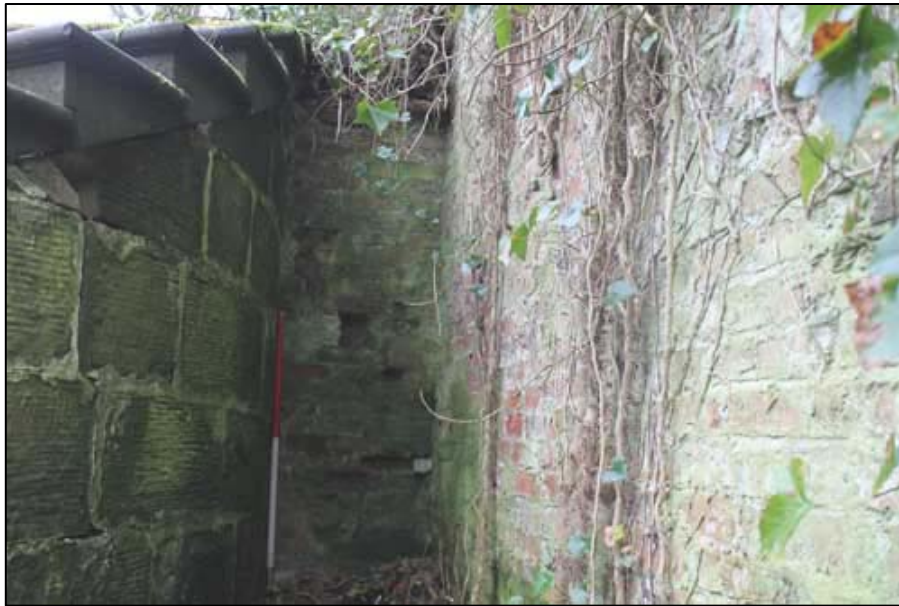
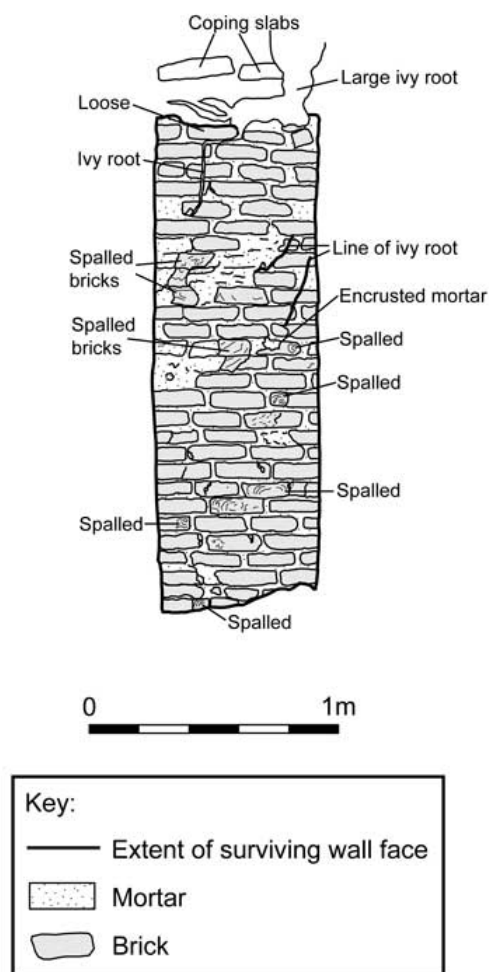
Figure 16a: Structure 2, East Stair: Elevation e (South-facing Revetment)

50. The final element of the revetment wall is elevation e, a short length of wall which lies between the curving stair and the nearby external wall of the Flower Garden (Figures 16a & b). It survived to a much greater height than its corresponding elevation in Structure 1 (West Stair) upstanding to a height of 28 courses in total. Again, it was composed of hand-made brick mortared with lime mortar: the wall remained in relatively good condition over much of its extent, though the condition of the bricks themselves was doubtful at times, with considerable amounts of spalling evident. An ivy plant had seeded itself between the uppermost course of bricks and the coping stones above, and this had grown to a considerable height, creating a substantial void between wall face and coping.

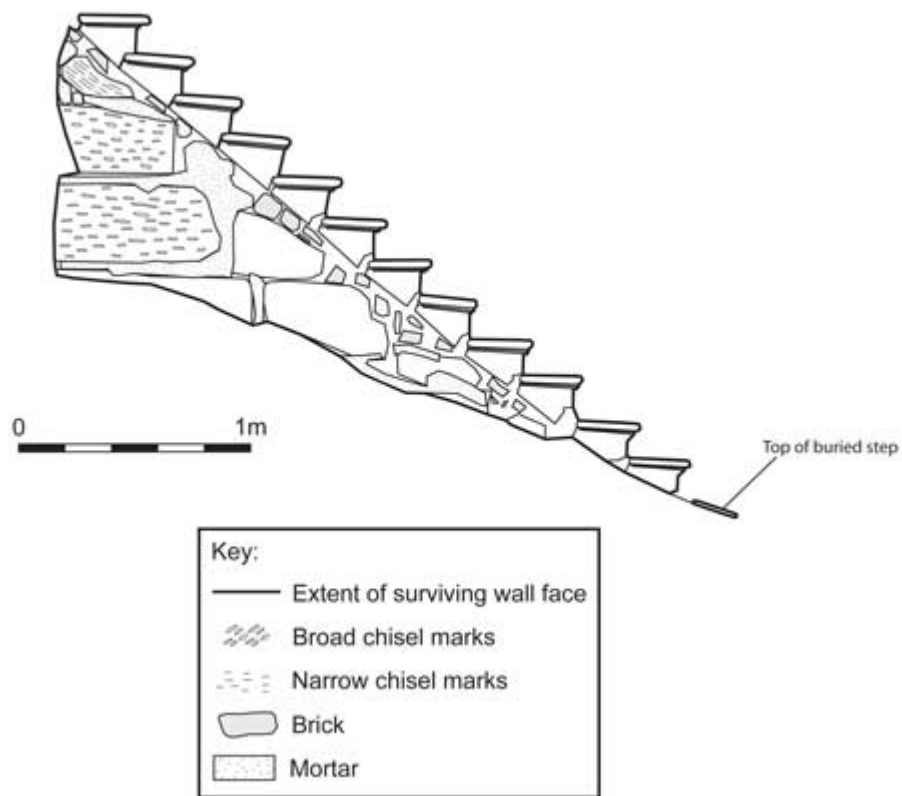
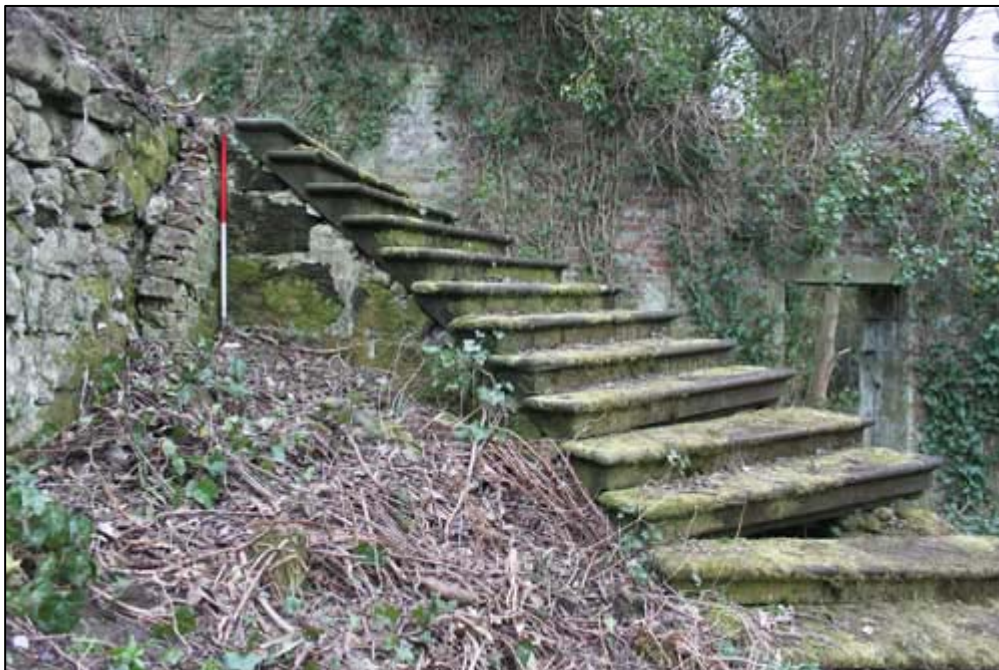
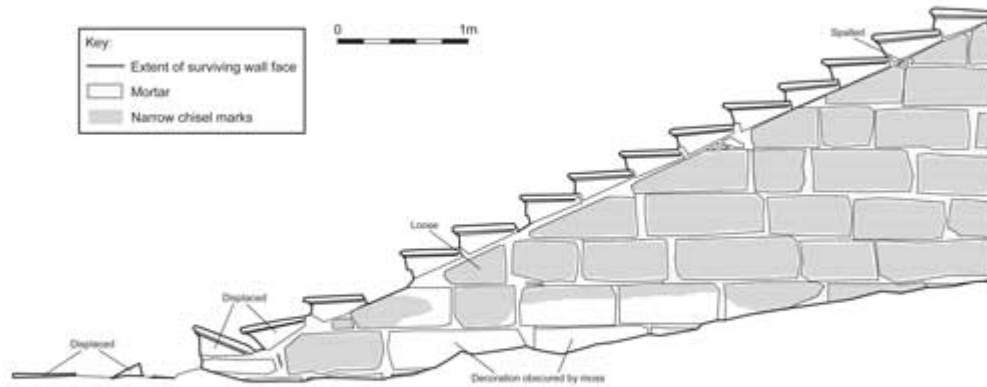
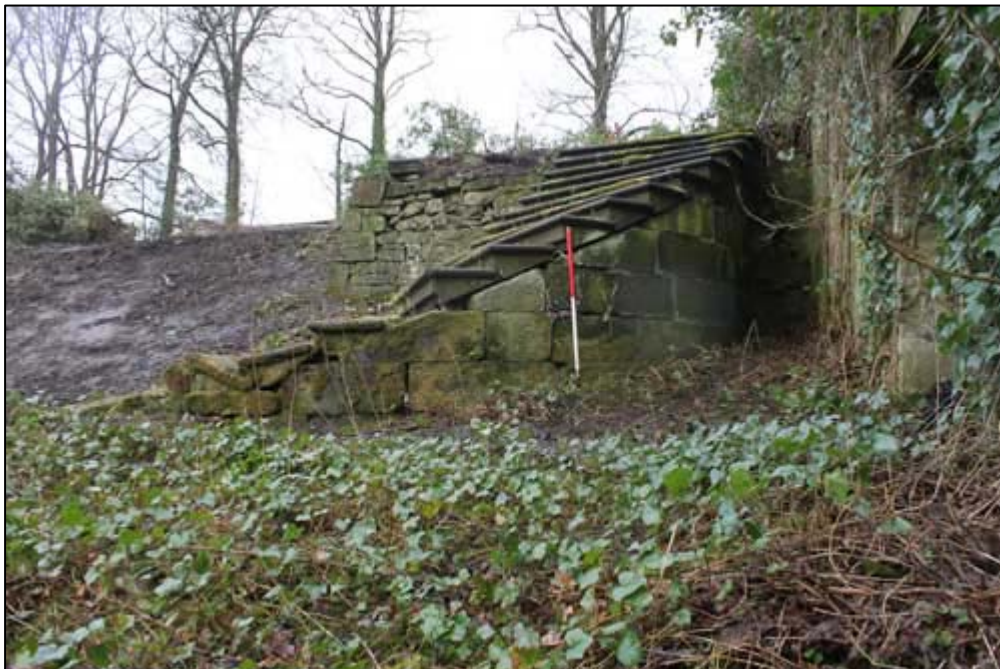
52. In terms of their fabric, Elevations c and d were once again similar to those previously described in Structure 1 (Figures 17 & 18, a & b). They were made up of substantial blocks of squared masonry, built with an integral curve to each block, and there was frequent evidence that the external surfaces were finished off by broaching, with a narrow-bladed chisel used to carry out this work.

53. As with the steps themselves, the supporting walls survived in much better condition than their counterparts in Structure 1, with none of the cracking and slumping evident at the latter replicated here. One interesting point of note was the lack of bedding material – in the form of fragmented bricks, small blocks of sandstone and slate fragments – evident in Elevation d. In Elevation c, however, such material was frequently encountered. Whether this represents a later repair to rectify an unlevel surface to the stair or something contemporary with the structure's original construction cannot, however, be established.

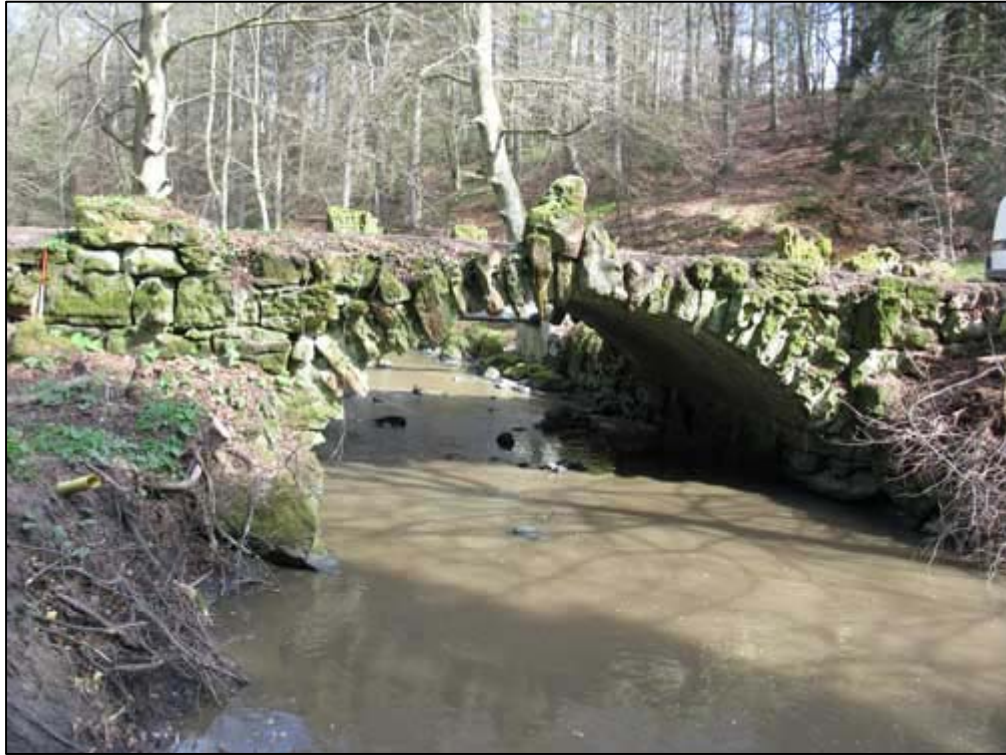
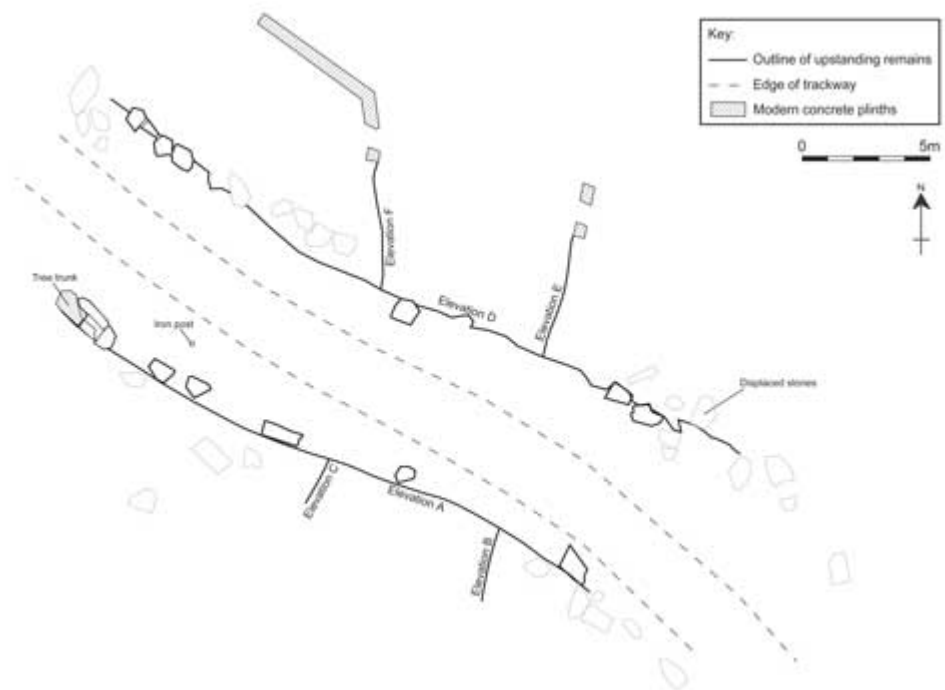
Figure 20a; Structure 3, Rusticated Bridge #1 (Upper Bridge)

56. This bridge possesses a single span, with the underside built of rectangular blocks of ashlar. These remain in good order, and have not been included within this survey. The majority of the structure appears to comprise a mortared rubble core, with a coursed rubble face on either external elevation. It is this coursed rubble face which gives the structure its unusual character: the sandstone blocks are often of unusually massive size, and the external surfaces treated (presumably using chemicals) to give the appearance of naturally weathered limestone. This gives the structure its rusticated character, reminiscent of Mediterranean structures. On both main elevations, the voussoirs make use of alternating blocks of squared and rusticated sandstone, with the keystone comprising an extremely large and heavily rusticated block which projects beyond its fellows.

57. Throughout most of their extent, both elevations survive in good order, though some areas of facing stones have now been lost (see in particular, the north-west end of the north-facing elevation, Figure 18c), revealing the rubble core beneath. The parapet is surviving only in vestigial form throughout its length, with only isolated remnants upstanding. The rest have been displaced, with a number still located nearby, and others located within the water.

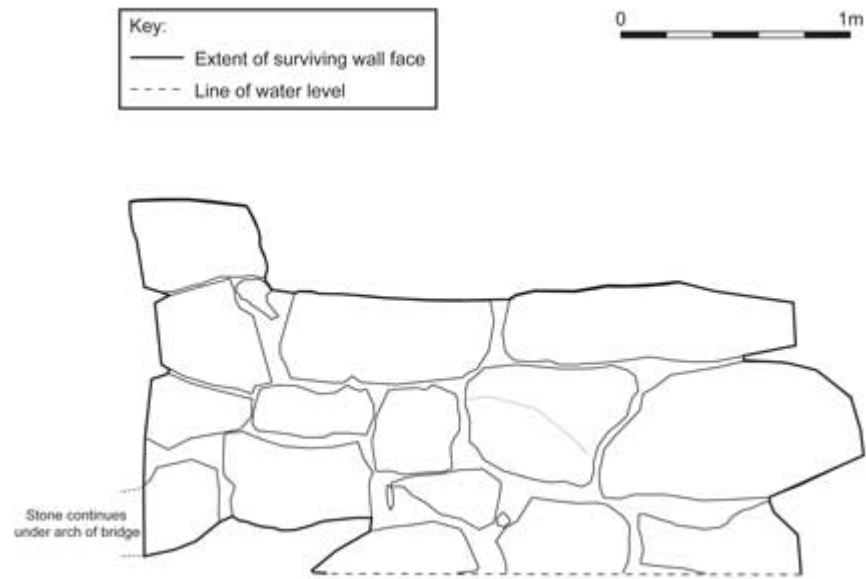
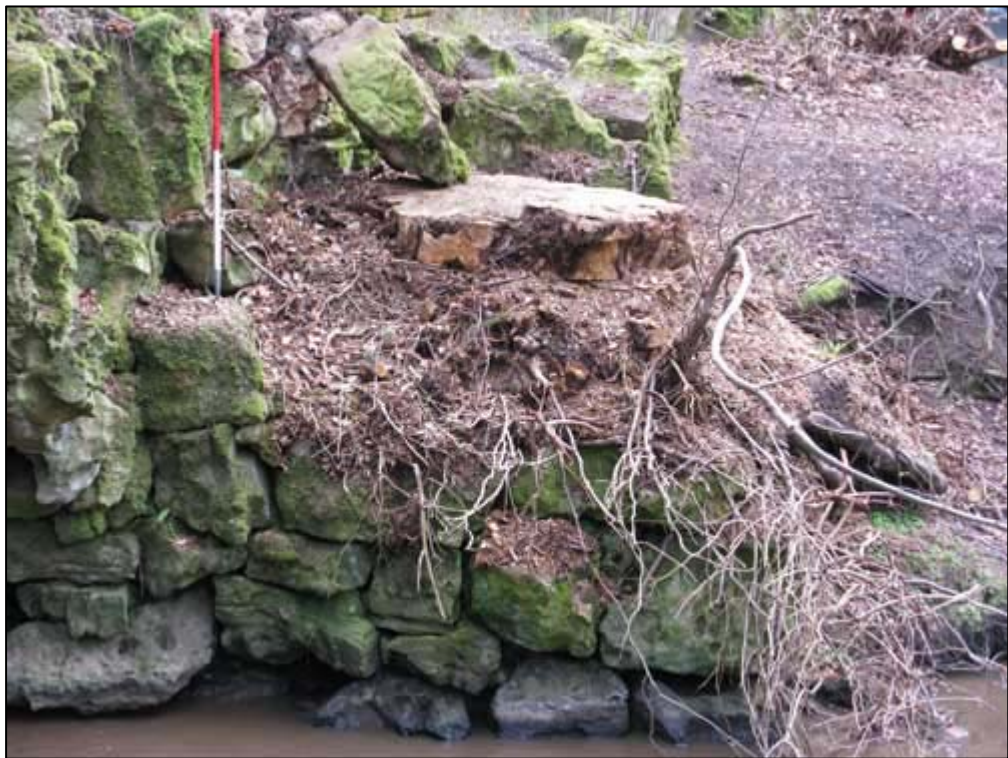
Figure 23a; Structure 3, Rusticated Bridge #1 (Upper Bridge): Elevation b

Figure 23b; Structure 3, Rusticated Bridge #1 (Upper Bridge): Elevation b

58. The main bridge structure also incorporates four revetment walls, created to help secure the banks on either side of the bridge structure. Their conditions varied throughout. On the south side of the bridge, the east revetment (Elevation b) survived in good condition reaching a height of four courses (Figures 23a & b), while the west revetment (Elevation c) had been subject to substantial collapse and was now only partially complete (Figures 24a & b).

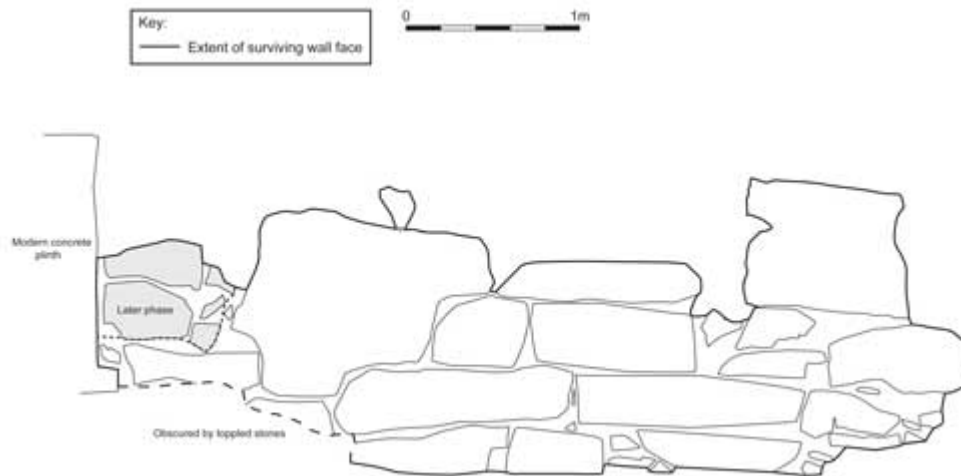
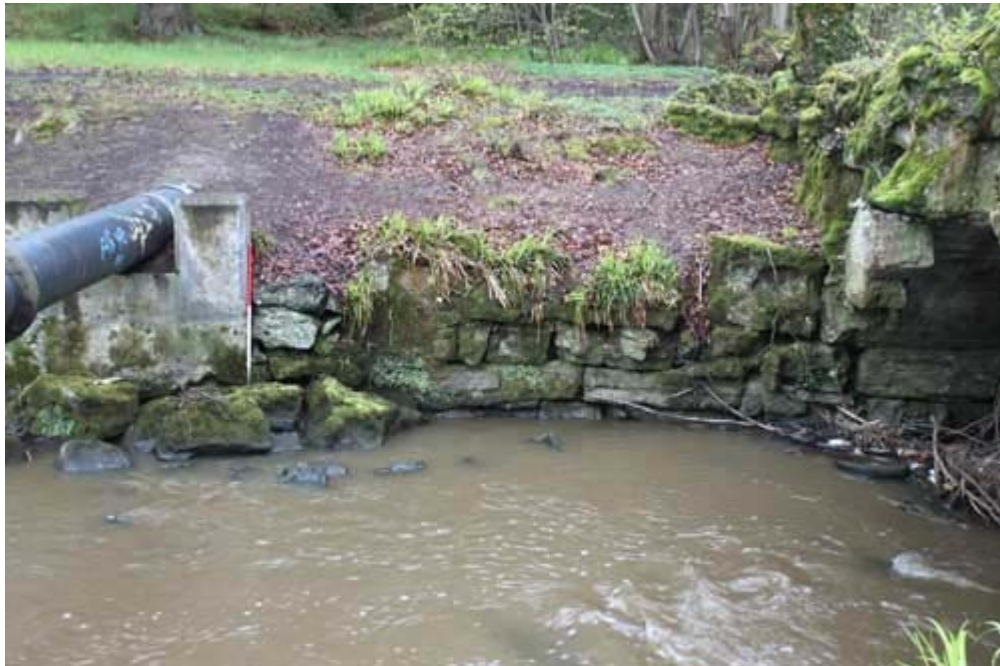
Figure 25a; Structure 3, Rusticated Bridge #1 (Upper Bridge): Elevation e

Figure 25b; Structure 3, Rusticated Bridge #1 (Upper Bridge): Elevation e

59. On the north south of the bridge, both revetment walls abutted a recent concrete plinth, which functioned as the support for carrying a modern sewage pipeline across the Bluther Burn. In both examples, the revetment walls remained in good order, upstanding to a height of four courses (Elevation e: Figures 25a & b; Elevation f: Figures 26a & b). However, it was possible that the ends of the revetments lying closest to the concrete plinths had been rebuilt in recent times, most probably at a period contemporary with the construction of the pipeline. This was particularly marked in Elevation e, where the larger worked sandstone blocks contrasted with smaller, roughly shaped blocks of a material that may have been whinstone.

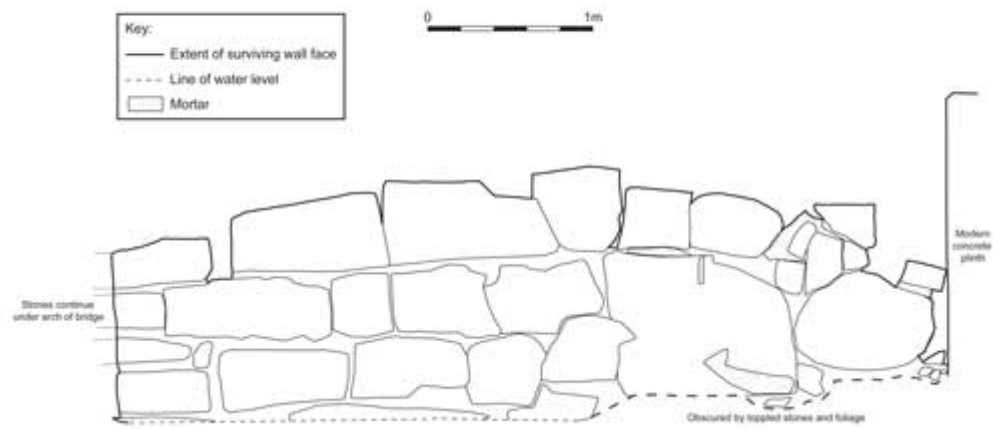
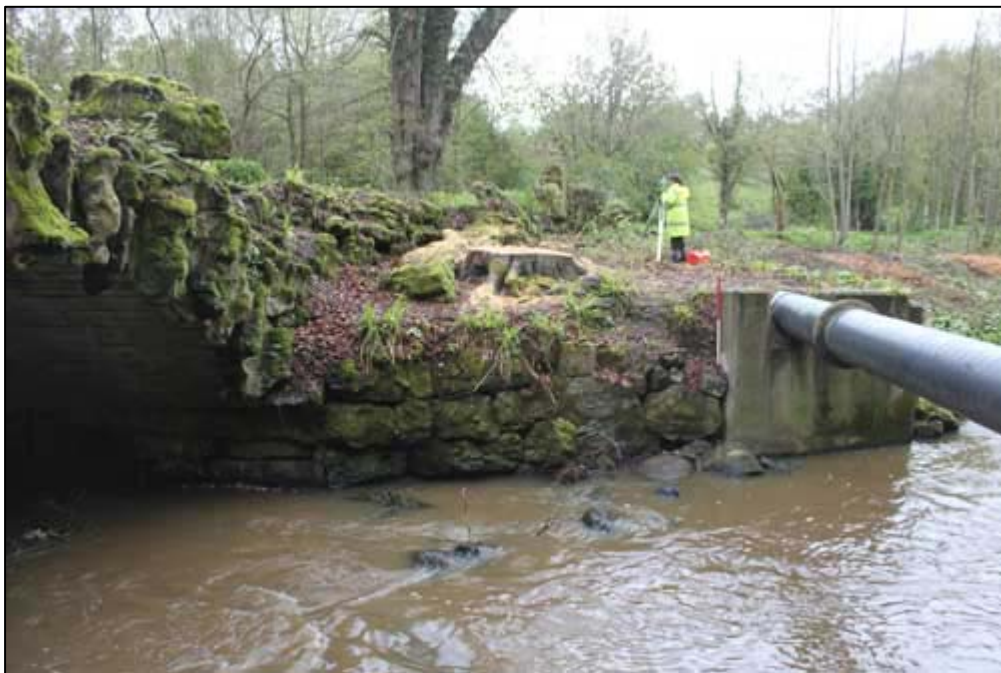
Figure 26a; Structure 3, Rusticated Bridge #1 (Upper Bridge): Elevation f

Figure 26b; Structure 3, Rusticated Bridge #1 (Upper Bridge): Elevation f

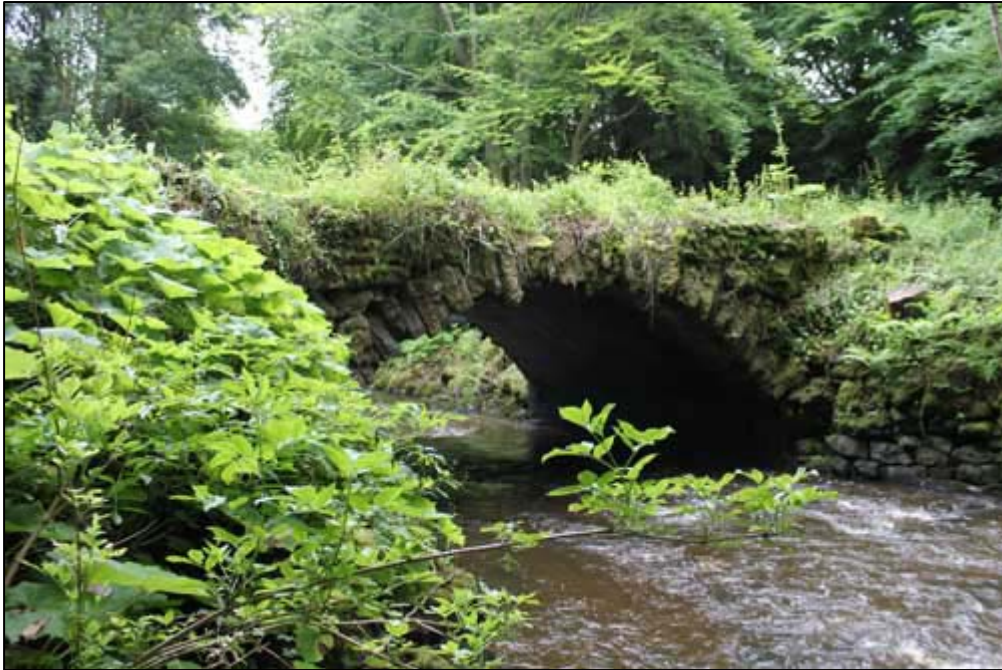
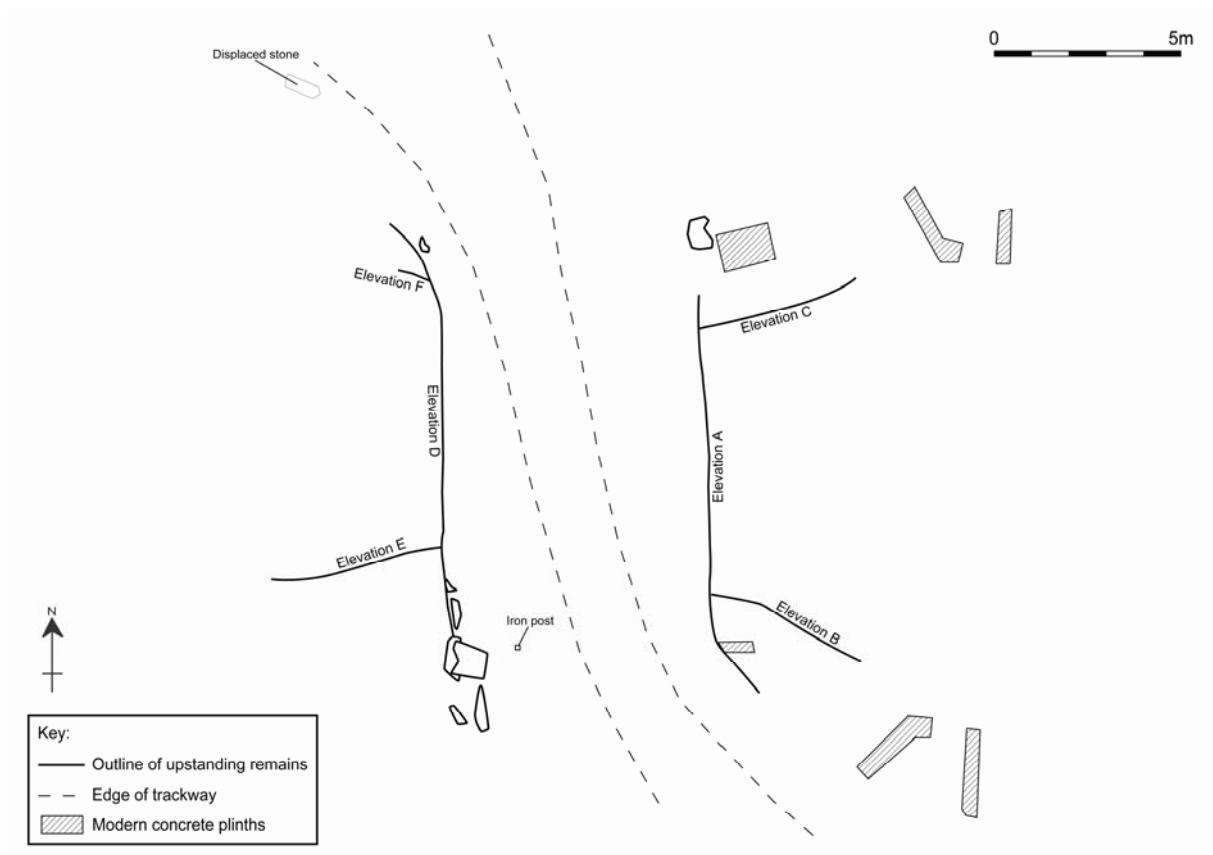
61. This particular bridge contrasted with its fellow in its much smaller size on plan (Figures 27a & b). While the scale of the span was similar, it lacked the long parapet wall that formed an integral part of Rusticated Bridge #1. No traces of such a feature could be identified, though there were a number of large displaced rusticated blocks present in the vicinity which suggested that a parapet wall might once have been present, and that it had now been entirely removed. This possibility was supported by the depiction of the structure on the 1810 estate plan, where a thin solid line on either side of the roadway, similar to that shown in association with the Upper Bridge, where a parapet wall is still upstanding, suggests that such a feature was originally present.

Figure 27a: Structure 4, Rusticated Bridge #2 (Lower Bridge): General View

Figure 27b: Structure 4, Rusticated Bridge #2 (Lower Bridge): Plan of Structure

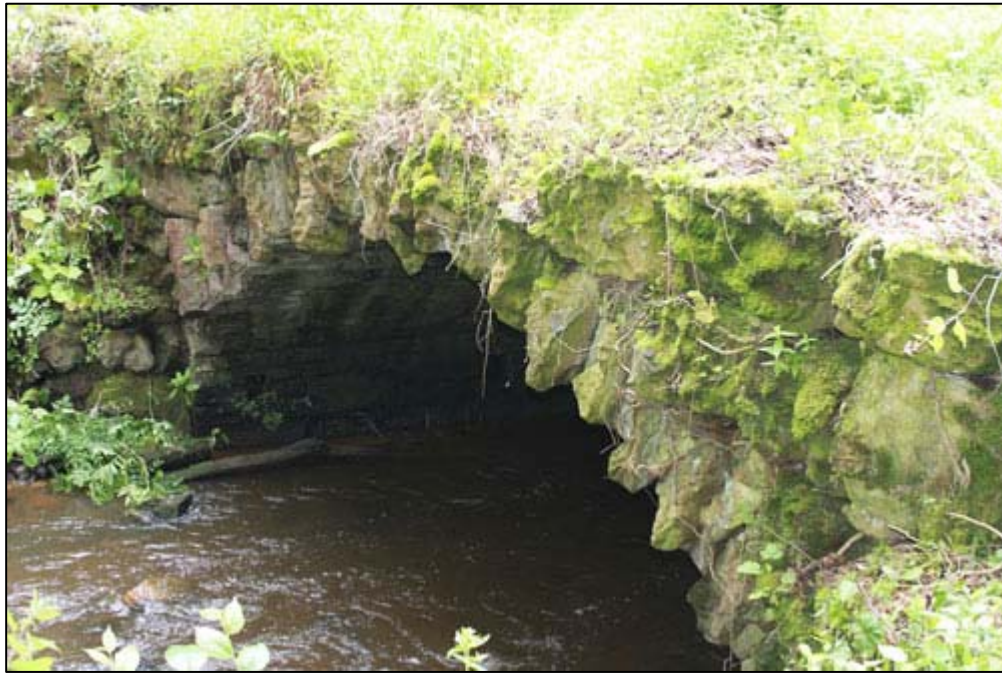
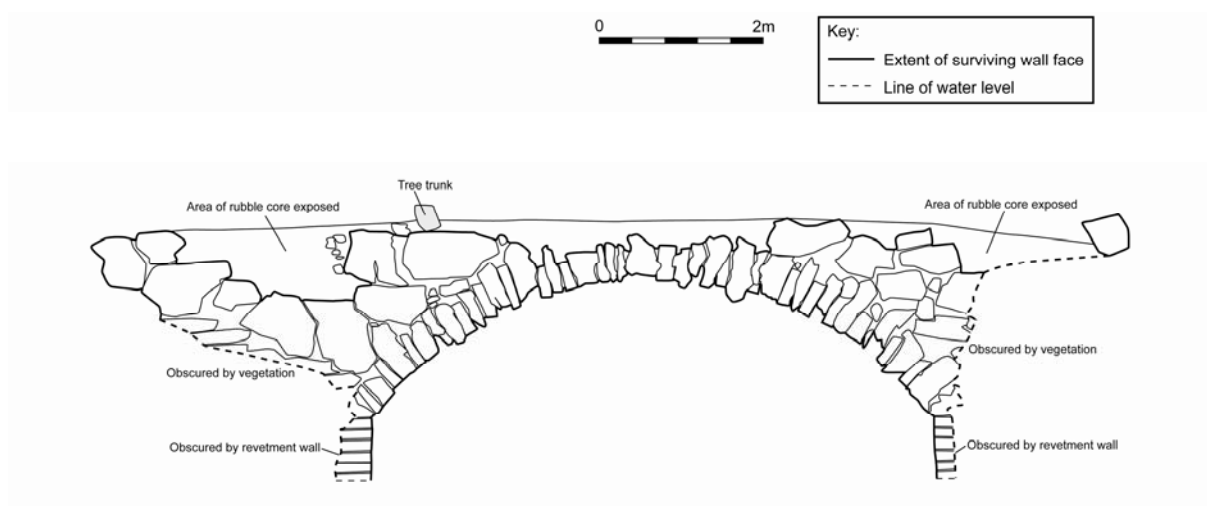
62. The main elevations (Elevations a and d) clearly show the character of the masonry (Figures 28 & 30, a & b), and reveal a similar construction technique to that employed in the building of Rusticated Bridge #1 which has previously been discussed. The interior of the span is composed of squared ashlar blocks, which extend downwards to form the abutments on either side. This portion of the bridge remains in good condition throughout.

Figure 28a: Structure 4, Rusticated Bridge #2 (Lower Bridge): Elevation a

Figure 28b: Structure 4, Rusticated Bridge #2 (Lower Bridge): Elevation a
