Valleyfield, Fife: Historic Building Recording

Data Structure Report

RATHMELL  
ARCHAEOLOGY LTD

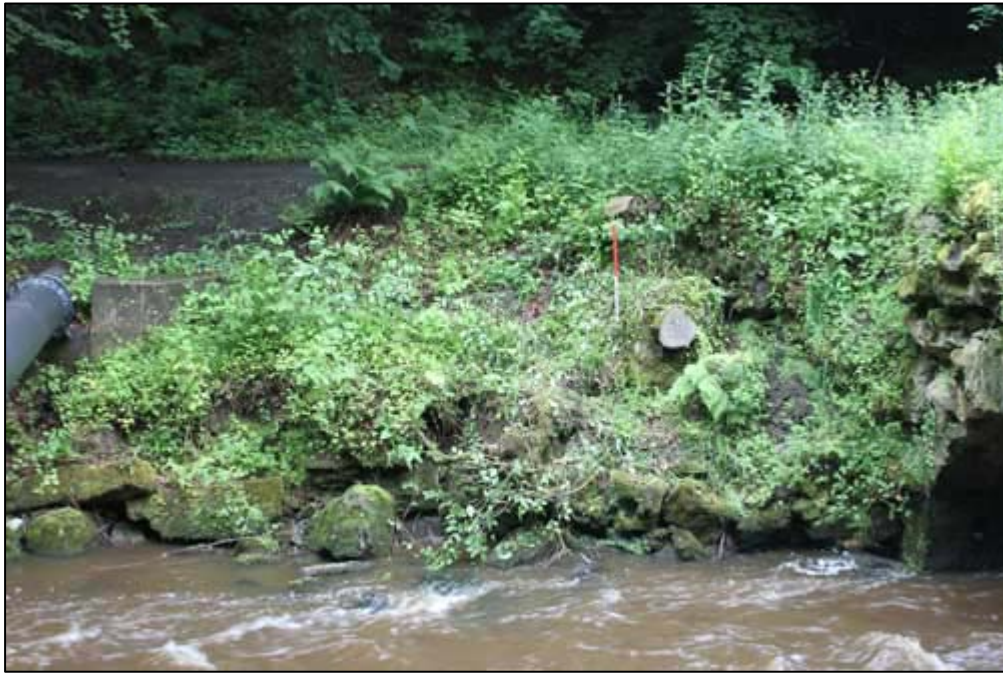
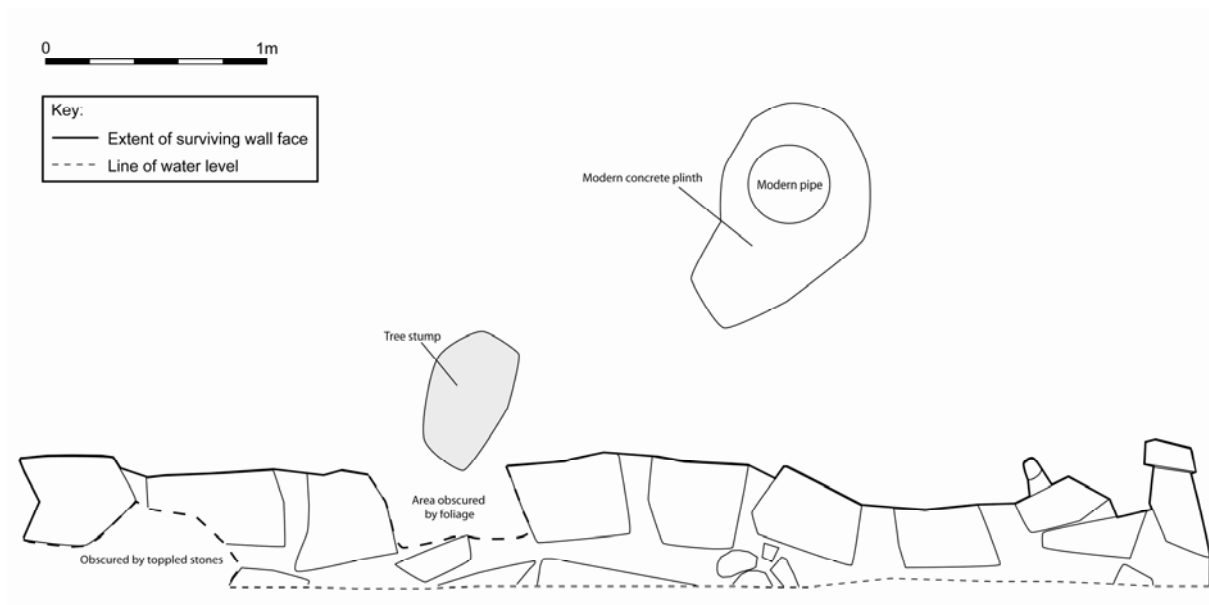
64. At either side of the bridge, the banks were again supported by revetment walls. The condition of these varied considerably throughout. On the east side, the construction of concrete pipes to support a sewage pipe had slighted the revetment wall on either bank. Elevation b, the SW revetment wall, survived in very poor condition (Figures 29 a & b), upstanding to a height of two courses. In addition to the nearby concrete plinth, located immediately to this feature, there was another smaller concrete plinth located immediately above it, the construction of which may have resulted in the partial dismantling of the revetment. This had once supported a pipe, but had now been superseded, presumably by the larger plinth located adjacent.

Figure 29a: Structure 4, Rusticated Bridge #2 (Lower Bridge): Elevation b

Figure 29b: Structure 4, Rusticated Bridge #2 (Lower Bridge): Elevation b

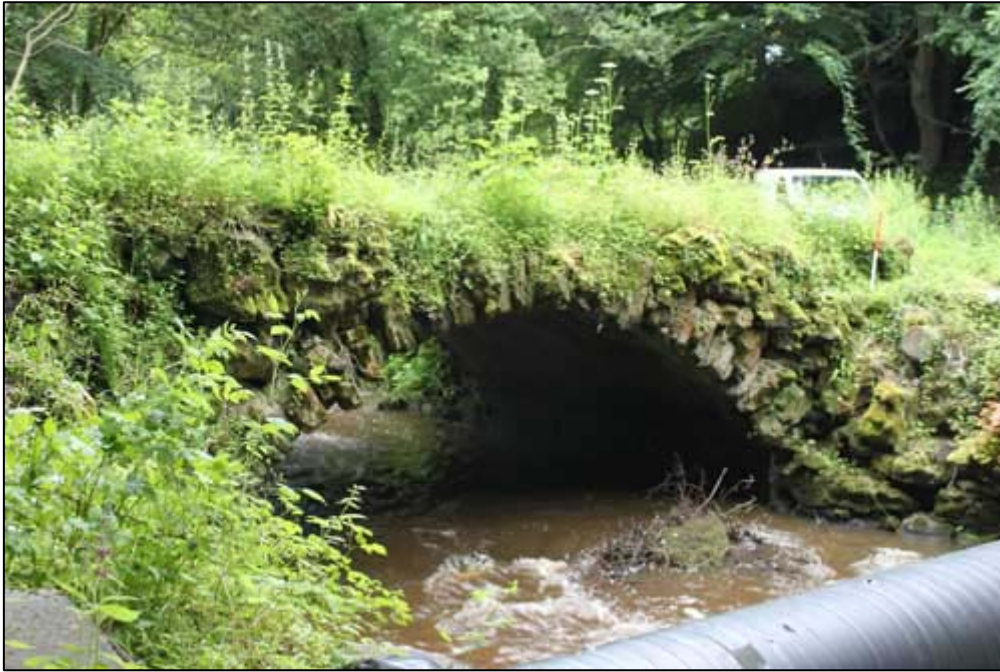
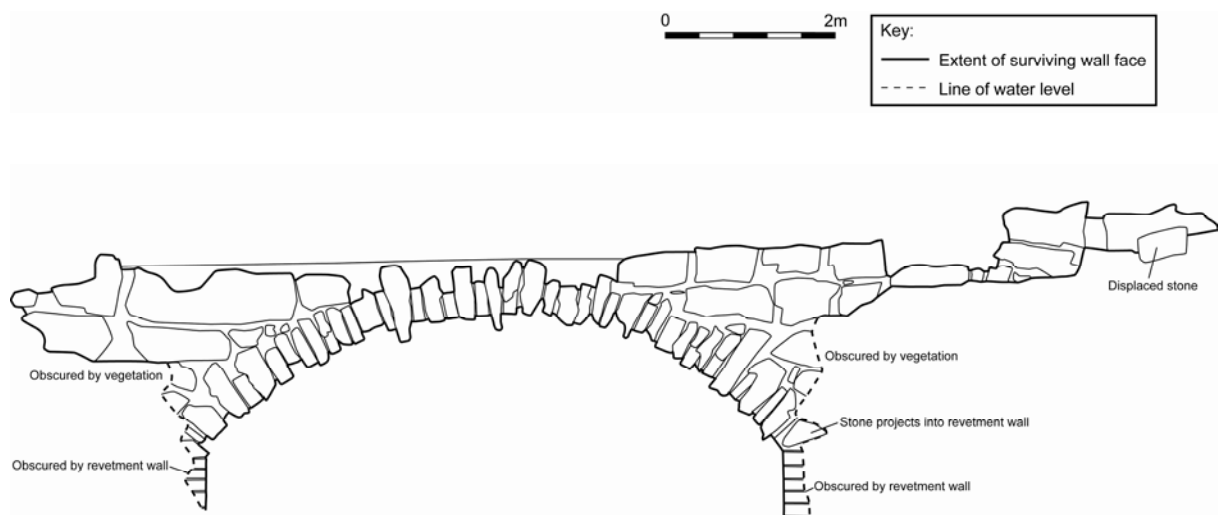
62. The main elevations (Elevations a and d) clearly show the character of the masonry (Figures 28 & 30, a & b), and reveal a similar construction technique to that employed in the building of Rusticated Bridge #1 which has previously been discussed. The interior of the span is composed of squared ashlar blocks, which extend downwards to form the abutments on either side. This portion of the bridge remains in good condition throughout.

Figure 31a: Structure 4, Rusticated Bridge #2 (Lower Bridge): Elevation d

Figure 31b: Structure 4, Rusticated Bridge #2 (Lower Bridge): Elevation d

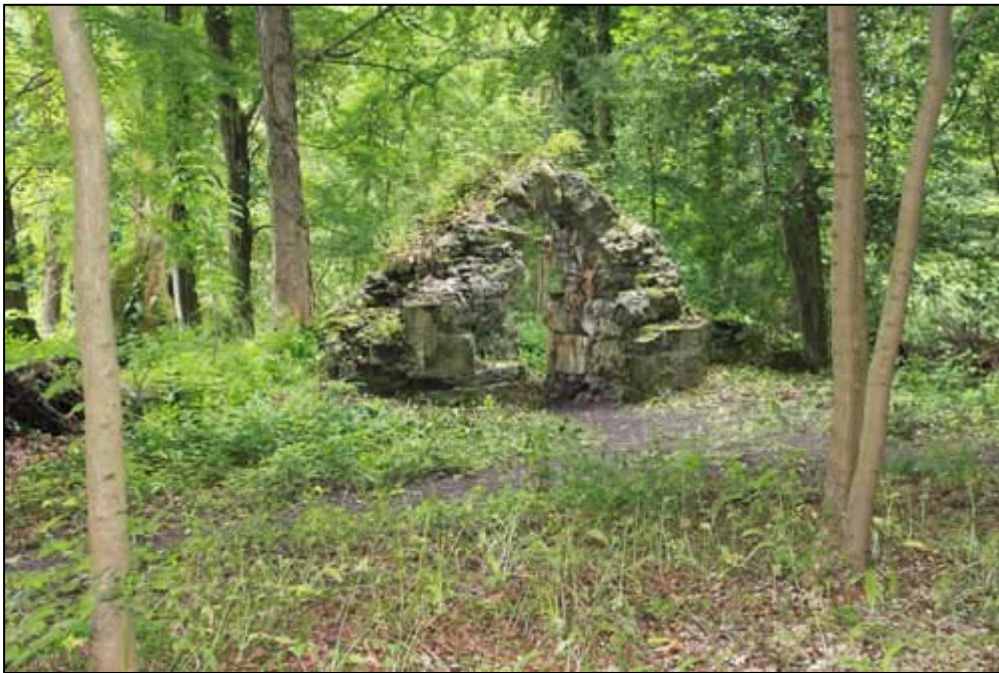
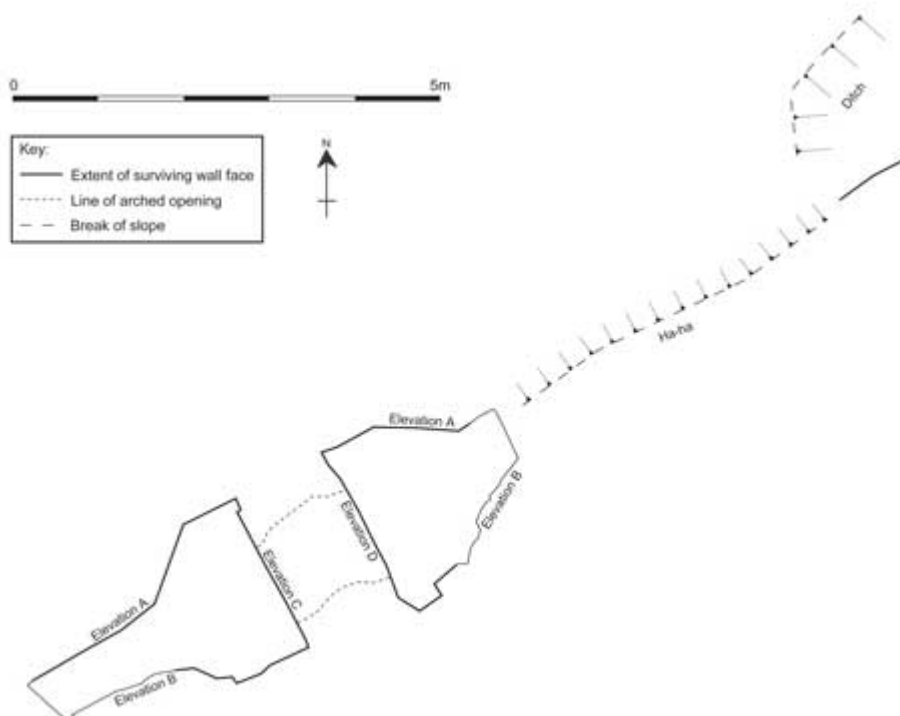
68. The final structure of the five was a rusticated archway which stood northwest of the walled Flower Garden and which would originally would formed part of an access path to this structure (Figure 34a). On its south side, it was associated with several 'standing stones', also of rusticated character, which helped define the line of the path and to enhance the rustic nature of the route.

69. Seen on plan (Figure 34b), this structure's role in the wider designed landscape can be seen more clearly. It sits at the south-west end of a ha-ha, comprising a low ditch, the rear (south) wall of which features a surviving stone revetment in places. The remains of a beech hedge still survive here, the beeches in question now surviving as upstanding mature trees. This feature was not included in the survey.

Figure 34a; Structure 5, Rusticated Arch: General View

Figure 34b; Structure 5, Rusticated Arch: Plan

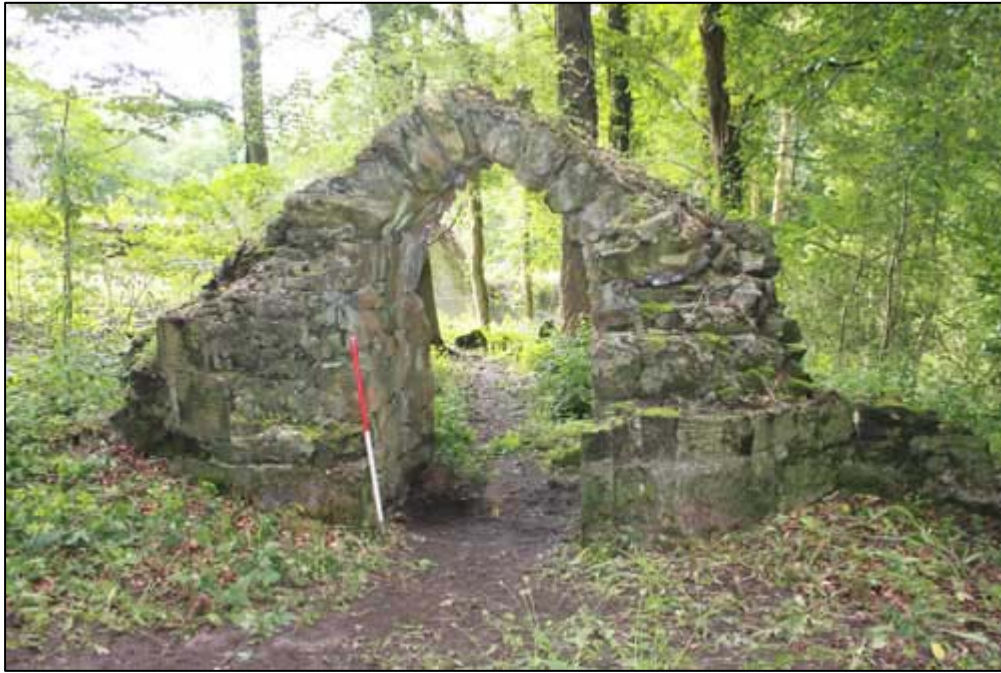
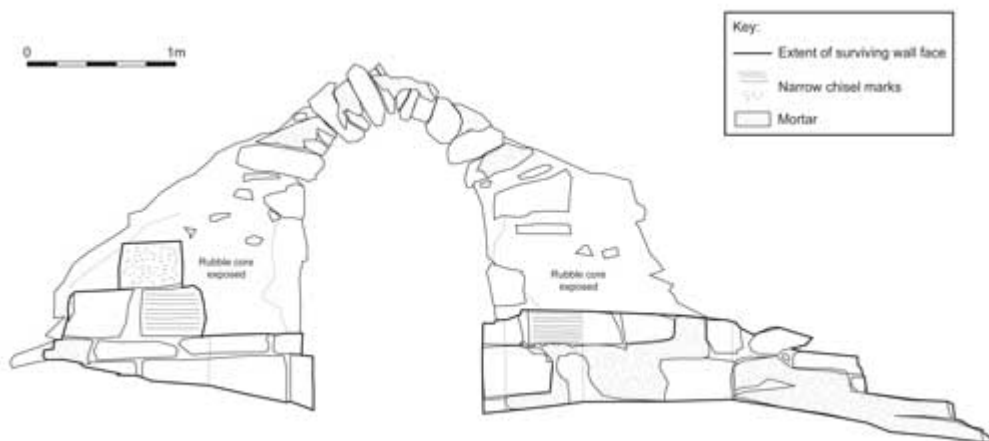
71. Seen from the north-east, Elevation a is dominated by an amorphous mass of random rubble, heavily mortared to keep it in place (Figures 35a & b). This gives the appearance of an exposed rubble core, dominated by small fragments of sandstone, with some occasional fragments of slate also present. There are some larger blocks within this rubble core – these have been represented in the elevation drawing.

72. Blocks of facing stone still survive in places, forming a low wall around the base of the monument and establishing its shape on plan, with two virtually straight faces extending back from the arched opening for roughly 0.6m before turning sharply back to form wing walls. Some of these facing stones bear horizontal broaching over their surfaces and may even be derived from other buildings, and rustication is absent from these features.

Figure 35a; Structure 5, Rusticated Arch: Elevation A

Figure 35b; Structure 5, Rusticated Arch: Elevation a

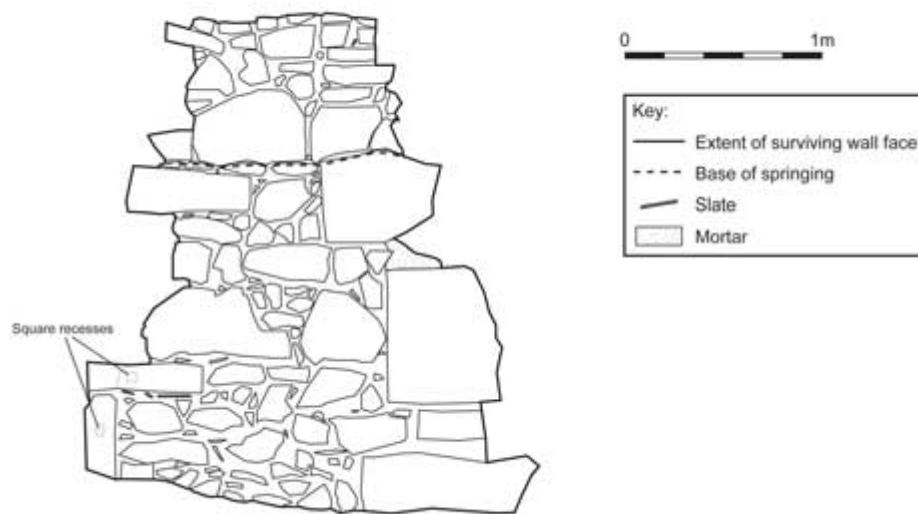
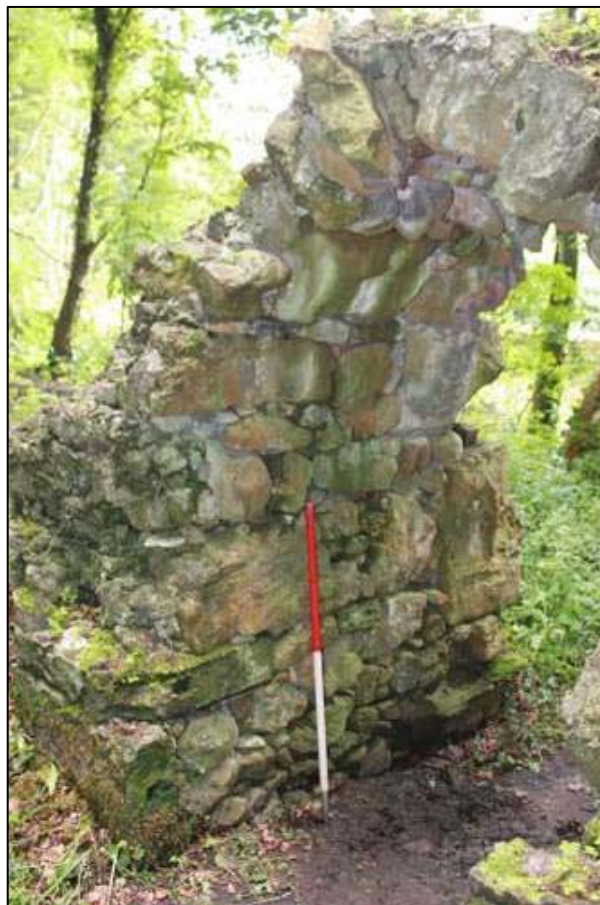
Figure 38a; Structure 5, Rusticated Arch: Elevation d

Figure 38b; Structure 5, Rusticated Arch: Elevation d

76. One last observation which was worthy of note was the presence of square recesses on two of the broached facing stones in the wall face of Elevation d (Figures 38 a & b). These might represent former door checks or similar features, and their presence may further support the possibility that this broached stonework might represented masonry derived from an earlier building located elsewhere on the Valleyfield estate and demolished during the period when the estate was subject to large-scale building works in the late 18th and early 19th century.
