Brandon Cottage, Tiree: Archaeological Mitigation

Data Structure Report

by Diane Gorman

issued 23rd February 2012

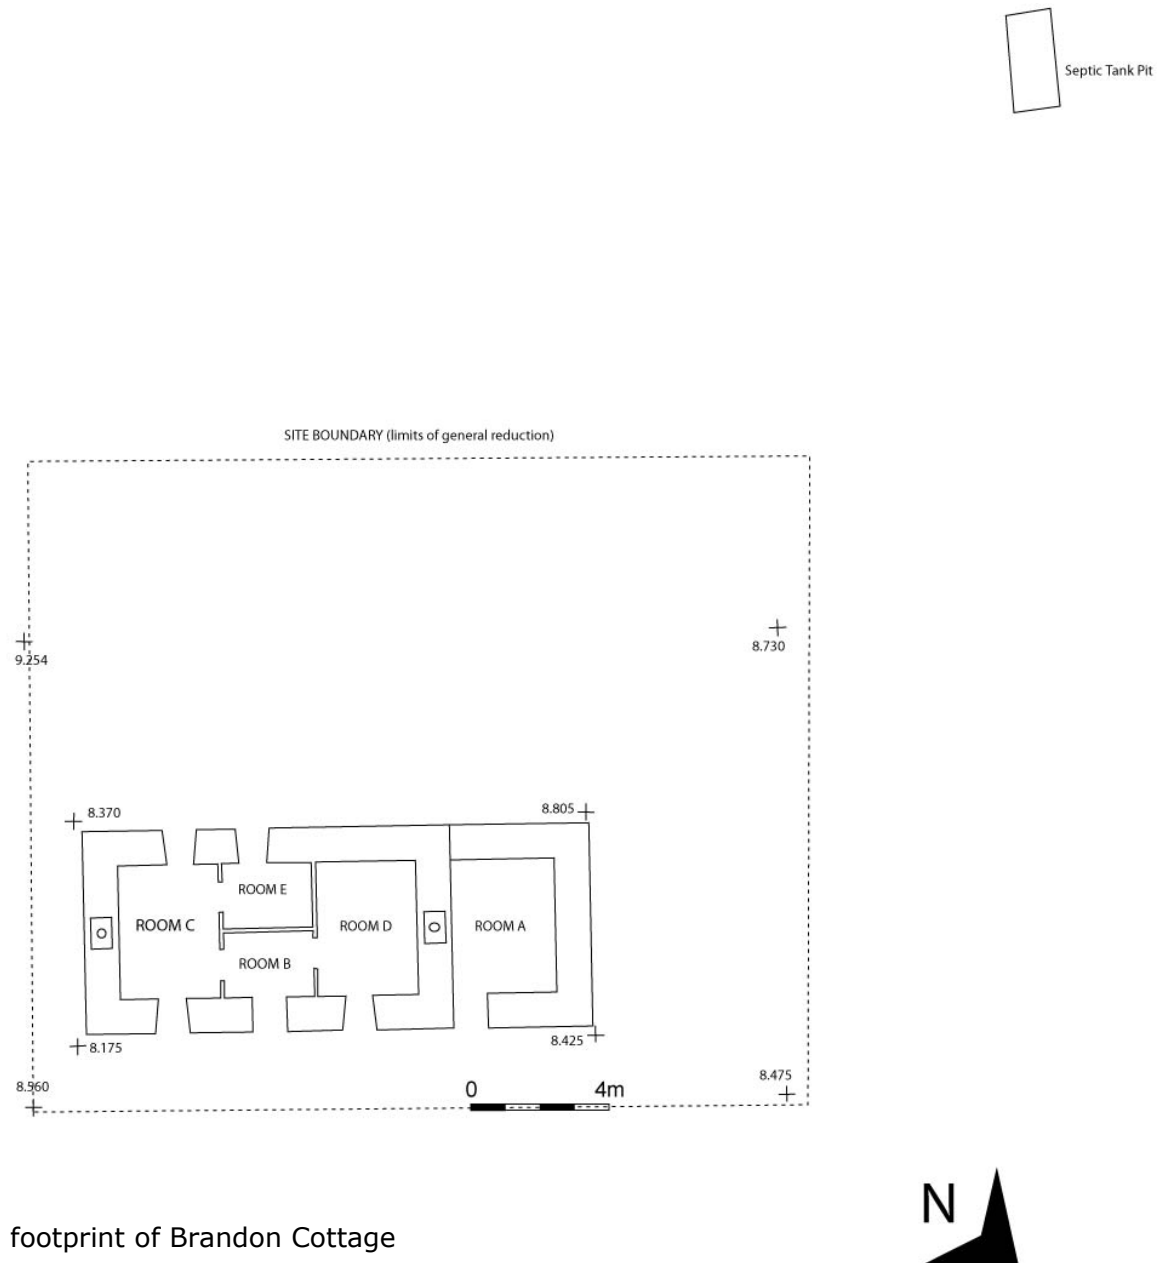
Figure 2: Site Plan, including footprint of Brandon Cottage

13. Brandon Cottage was rectangular in plan, measuring three by one bays, with an additional unroofed enclosure located at the northwest end (Figures 2 & 3a). The structure was ruinous, with only the ground floor remaining and the roof collapsed; fragments of the roof remained attached to the structure, and amongst the general modern debris within the interior. The quantity of debris was such that recording was limited in areas.

17. The interior plan of the main building (Figure 2) comprised four rooms which included a small entrance hallway (Room B), a small room at the west side of the building (Room E) and two main rooms located at the north (Room D) and south (Room C) sides of the cottage. The flooring of each room consisted of a base layer of modern concrete with a coating of bitumen on top.

25. The footprint of the new extension is located over the entirety of the footprint of Brandon Cottage. It also extends to the west and slightly to the south of this area (Figure 2). Thus, a larger area of ground was reduced in order to accommodate this. The area encompassing the footprint of the new structure was reduced to the level of deposit (002). The area was excavated through the current ground surface (003) and (001) immediately below this. A lower buried ground surface (006) was exposed below (001); this was slightly clayey, light-mid brown/grey sand. This deposit is likely to represent a buried turf level, similar to the current ground surface (003). White-glaze pottery sherds were removed from this context.
