Black Bull Close, Brechin: Archaeological Mitigation

Data Structure Report

by Liam McKinstry
issued 29th November 2016
on behalf of Mr Aaron Souttar

RATHMELL  
ARCHAEOLOGY LTD

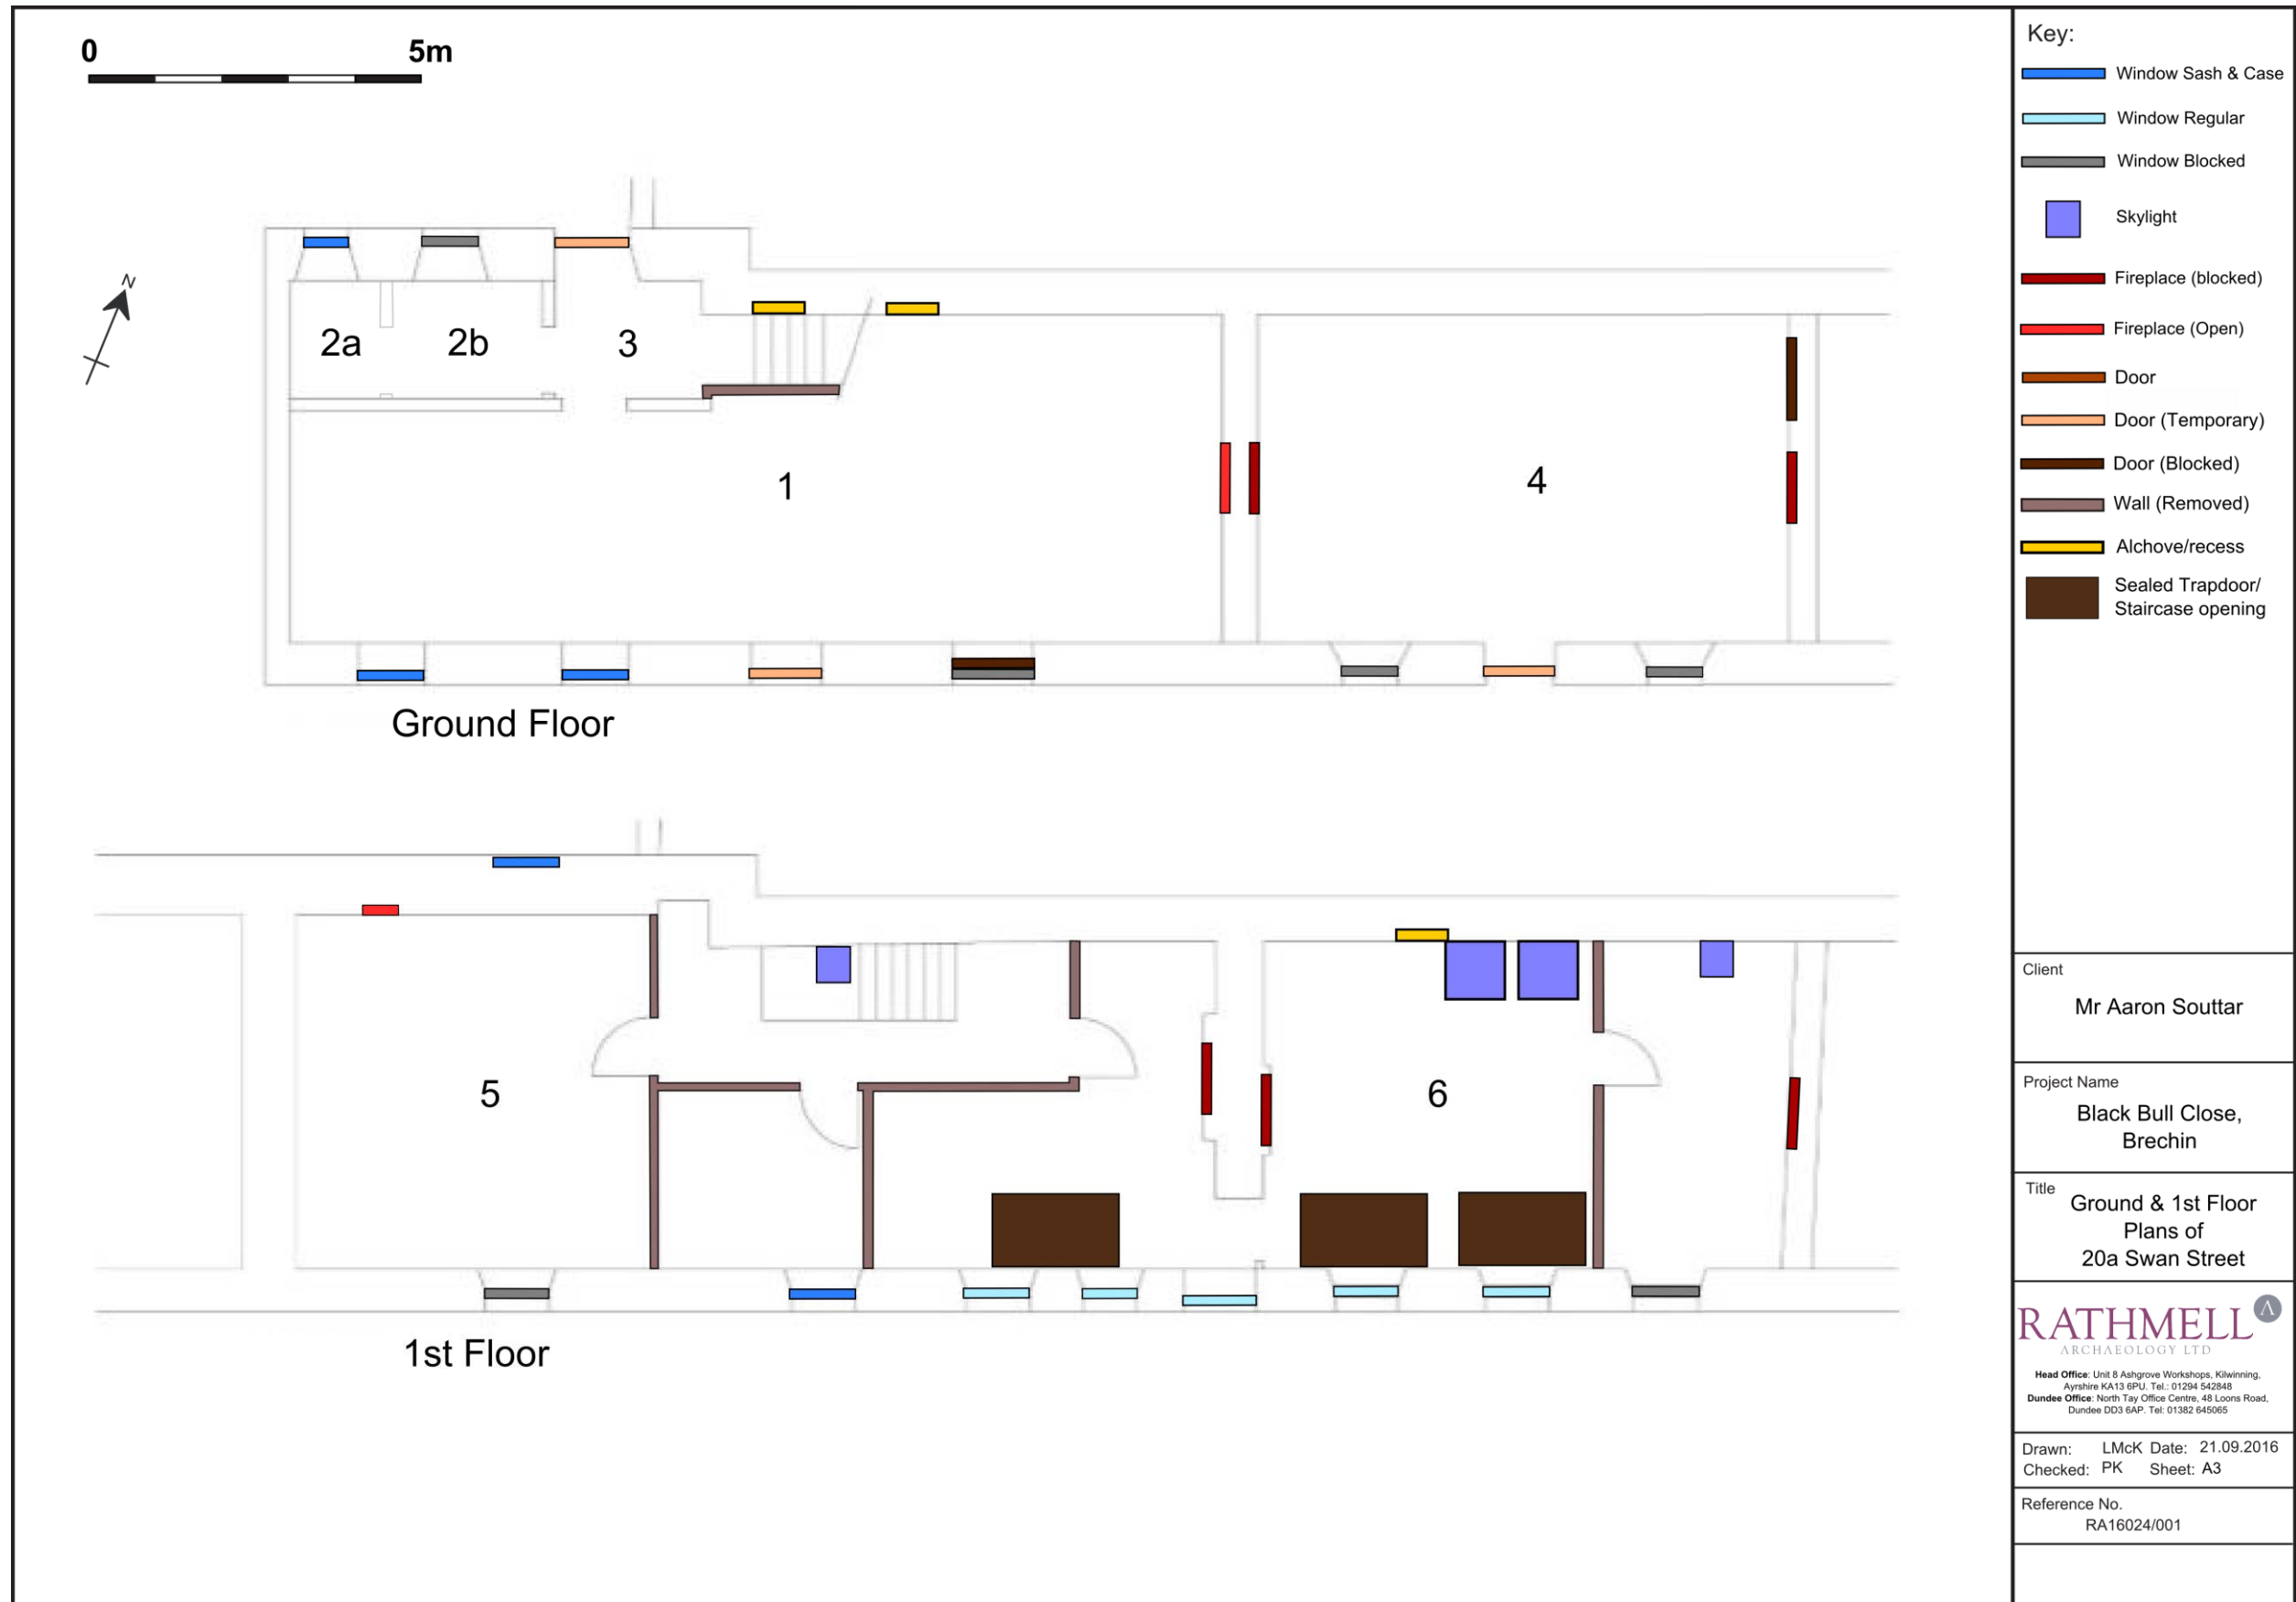
Figure 5: Plan of Ground and 1st Floors of 20a Swan Street (Store Room).

19. In total there are six rooms within the building at 20a Swan Street; 4 on the ground floor and 2 on the 1st floor. Figure 5 is based on the measured plan supplied by J. W. Souttar Architectural Services and Building Construction.

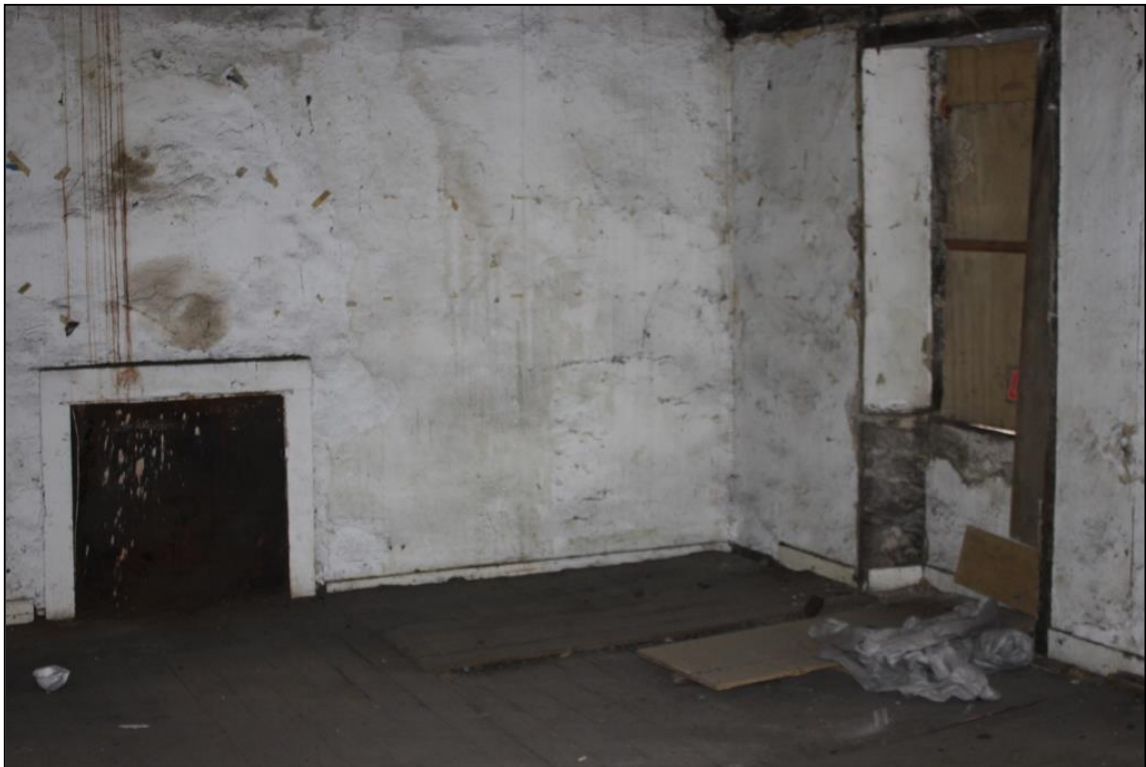
Figure 13b: View of fireplace & blocked floorboards, Room 6, 1st Floor, 20a Swan St. From WNW

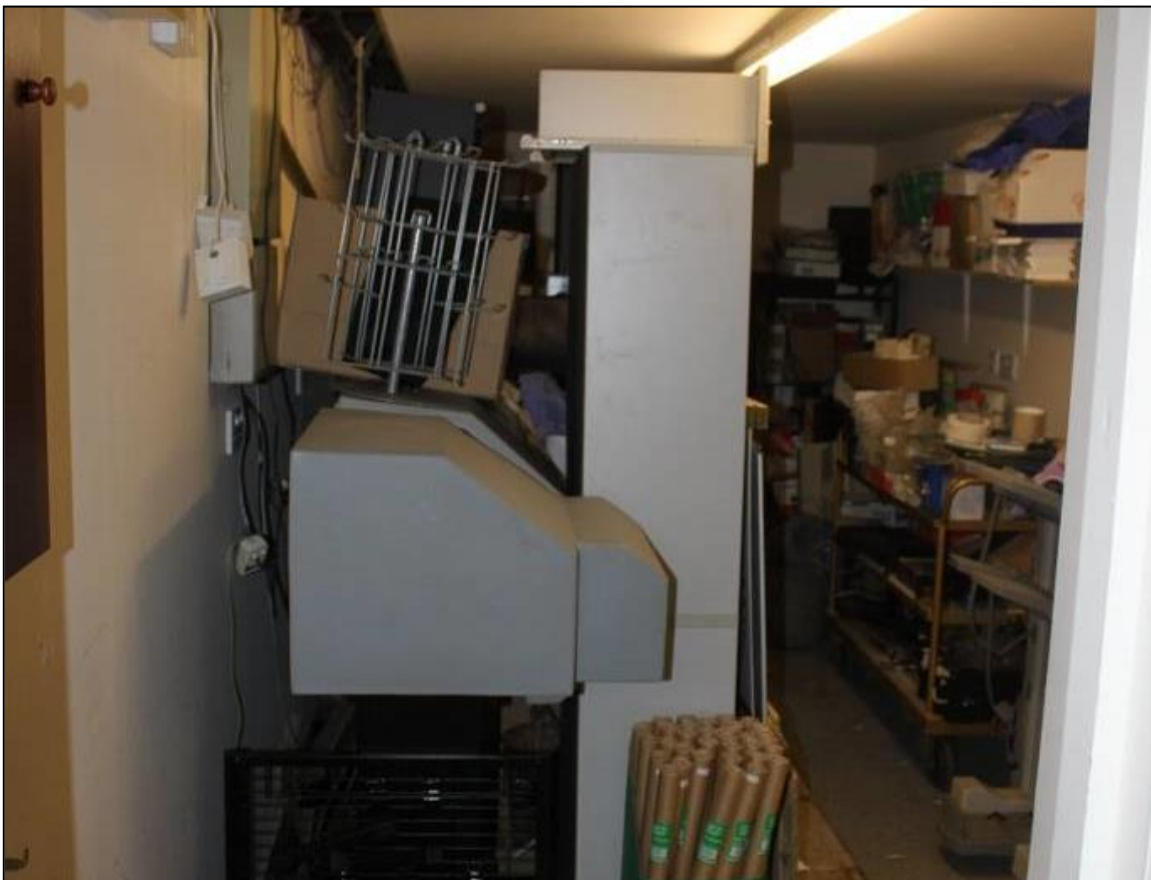
Figure 19b: View of Room 2a, Basement, 20 Swan St. From W

32. Access into Room 2 (Figure 19a & 23b) was via a narrow set of stairs located close to the WSW door where it accessed Room 1 through the NNW wall. Room 2 was rectangular on plan and subdivided by a modern timber stud wall lined with plasterboard. This ran virtually the entire length of the building, creating two narrow rooms: 2a (Figure 19b) and 2c (Figure 20b), with an opening at the NNW end separating Room 2 from Room 3 (Figure 23a). A further subdivision at the end of 2a created a small store room, 2b (Figure 20a). The ceiling and walls within Room 2 consisted of modern plastered and painted surfaces with a mixture of strip lighting and suspended lights set into the ceiling. The flooring consisted of wooden floorboards, with some use of linoleum, some carpeted and bare areas.

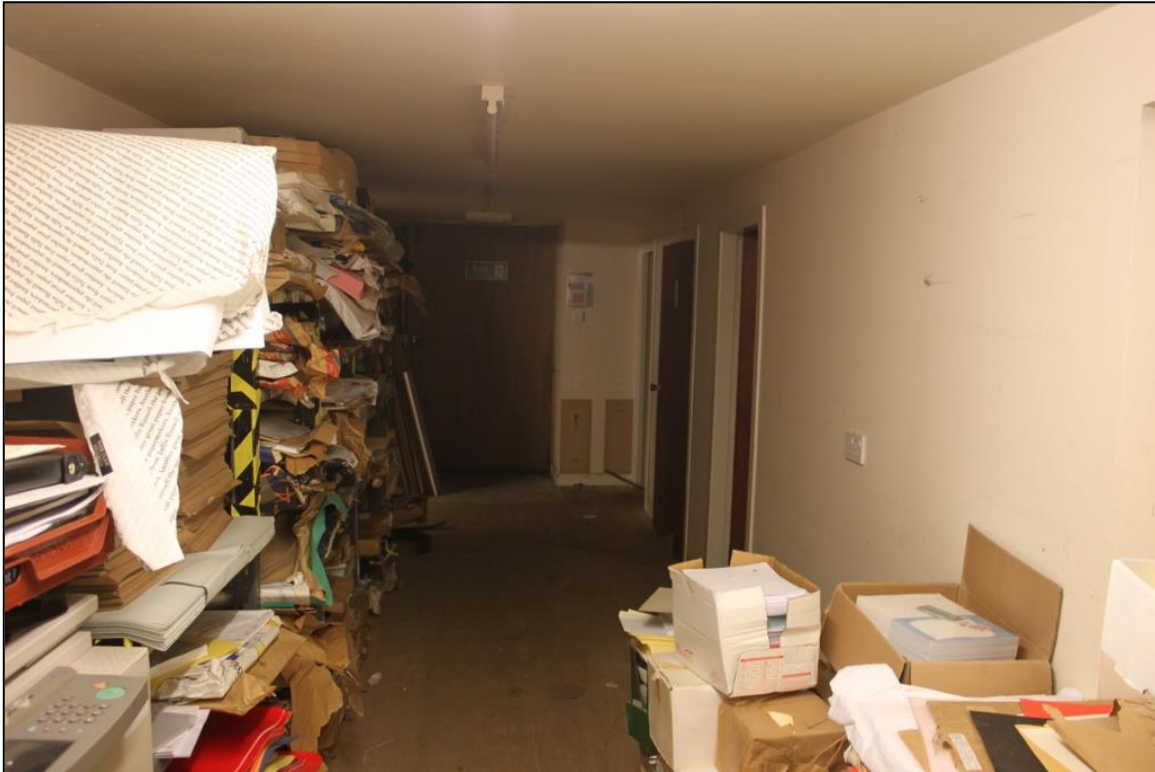
Figure 21a: View of Room 3a, Basement, 20 Swan St. From W

33. Room 3 was rectangular in plan and subdivided through the insertion of a modern plasterboard and timber stud wall along part of its length, creating one larger L-shaped room, 3a (Figure 21a) and three small rooms arranged in linear fashion against the external, WSW, wall, 3b-d (Figures 21b, 22b & 23a). These small rooms were furnished as toilets (3c and d) and a kitchen (3b). In the SSE wall was a set of modern wooden double doors. Two openings were located in the ENE wall for access into Room 2c. The ceiling and walls within Room 3 consisted of a modern plastered and painted surfaces with a mixture of strip lighting and suspended lights set into the ceiling. The flooring consisted of wooden floorboards covered variously by linoleum surfacing or carpeting, with some areas left uncovered.
