Culzean Castle Spine Wall Consolidation: Archaeological Mitigation

Data Structure Report

issued 31st March 2017

on behalf of National Trust for Scotland

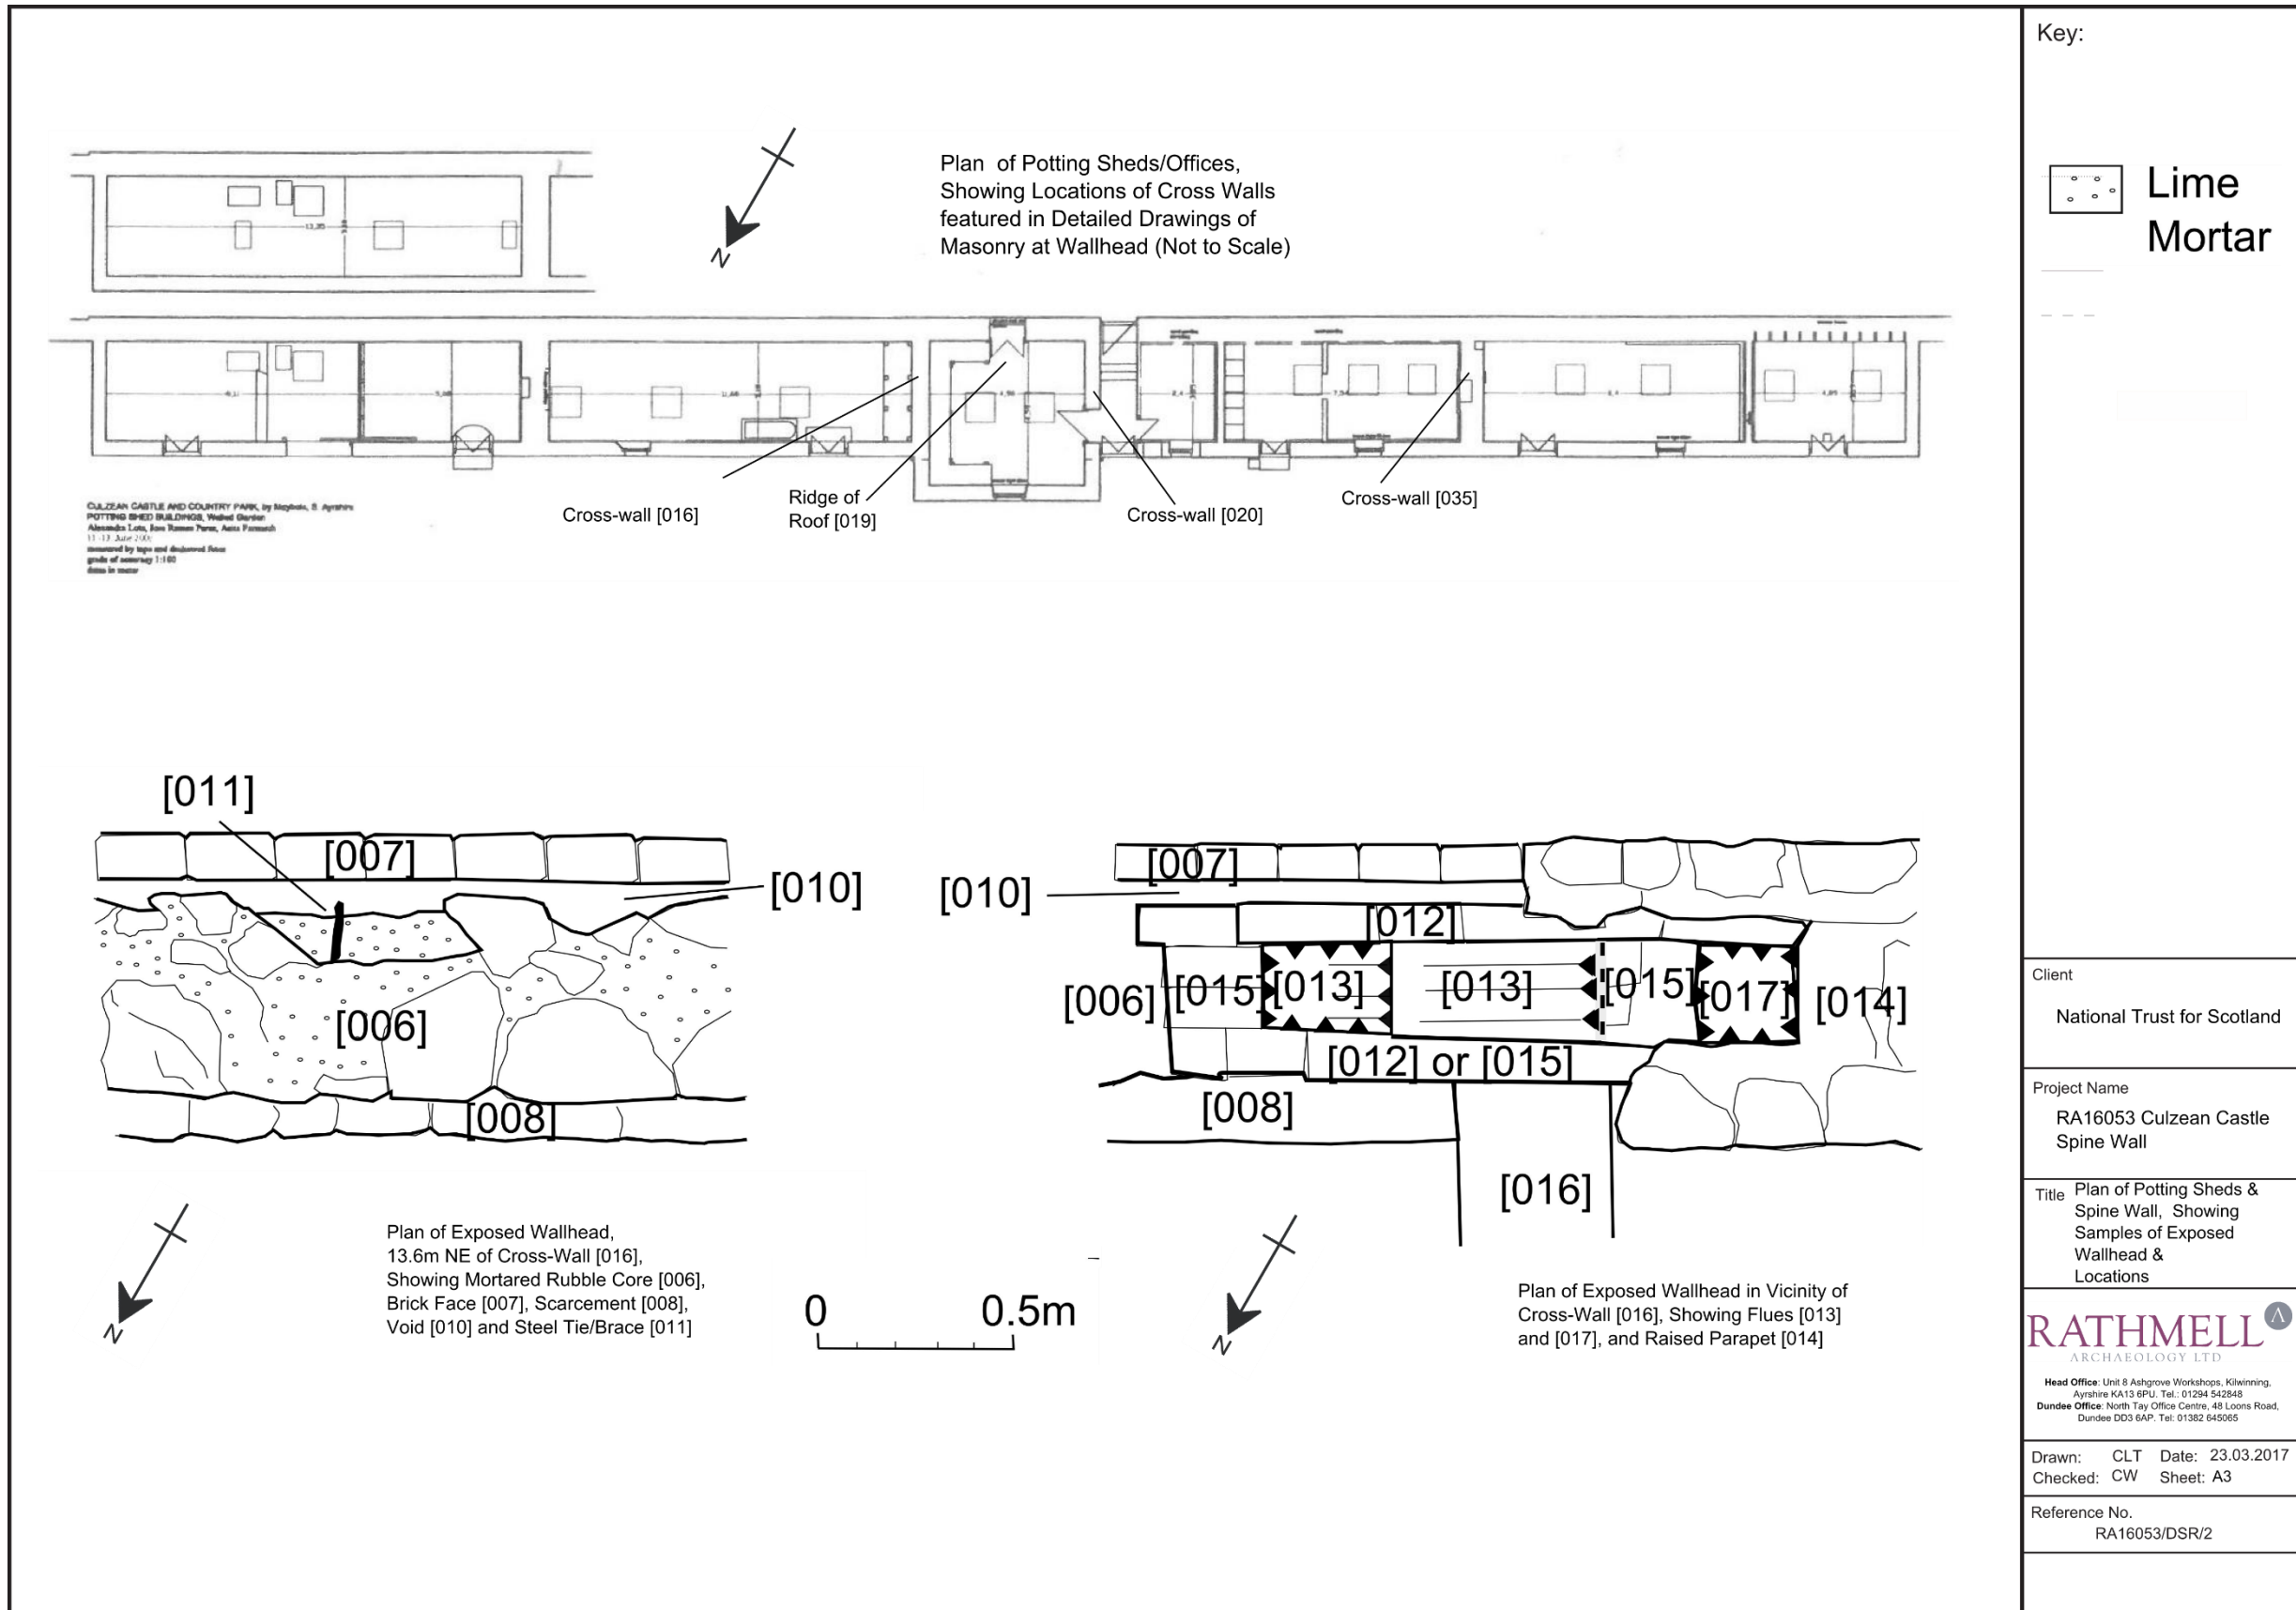
Figure 2: Plan of potting sheds and spine wall, showing samples of exposed wallhead and locations

17. The observations made during the two site visits are summarised in this section, with the accompanying drawings provided in Figure 2. These show the locations of structural elements such as cross walls as well as sample lengths of wallhead drawn in plan in order to demonstrate the character of the masonry in these locations. The wallhead is shown in section (outwith the extent of the raised centrepiece [014] in (Figure 3).

19. Beyond this point, the original masonry remained exposed, allowing unimpeded inspection of its character (Figure 4b). The locations of flues were noted, and sample lengths of the wallhead drawn on plan to provide more detailed records of the structure (see Figure 2).
