Haddo House & Country Park Ice House, Tarves: Archaeological Mitigation

Data Structure Report

issued 31st May 2017

on behalf of Landscape Services, Aberdeenshire Council

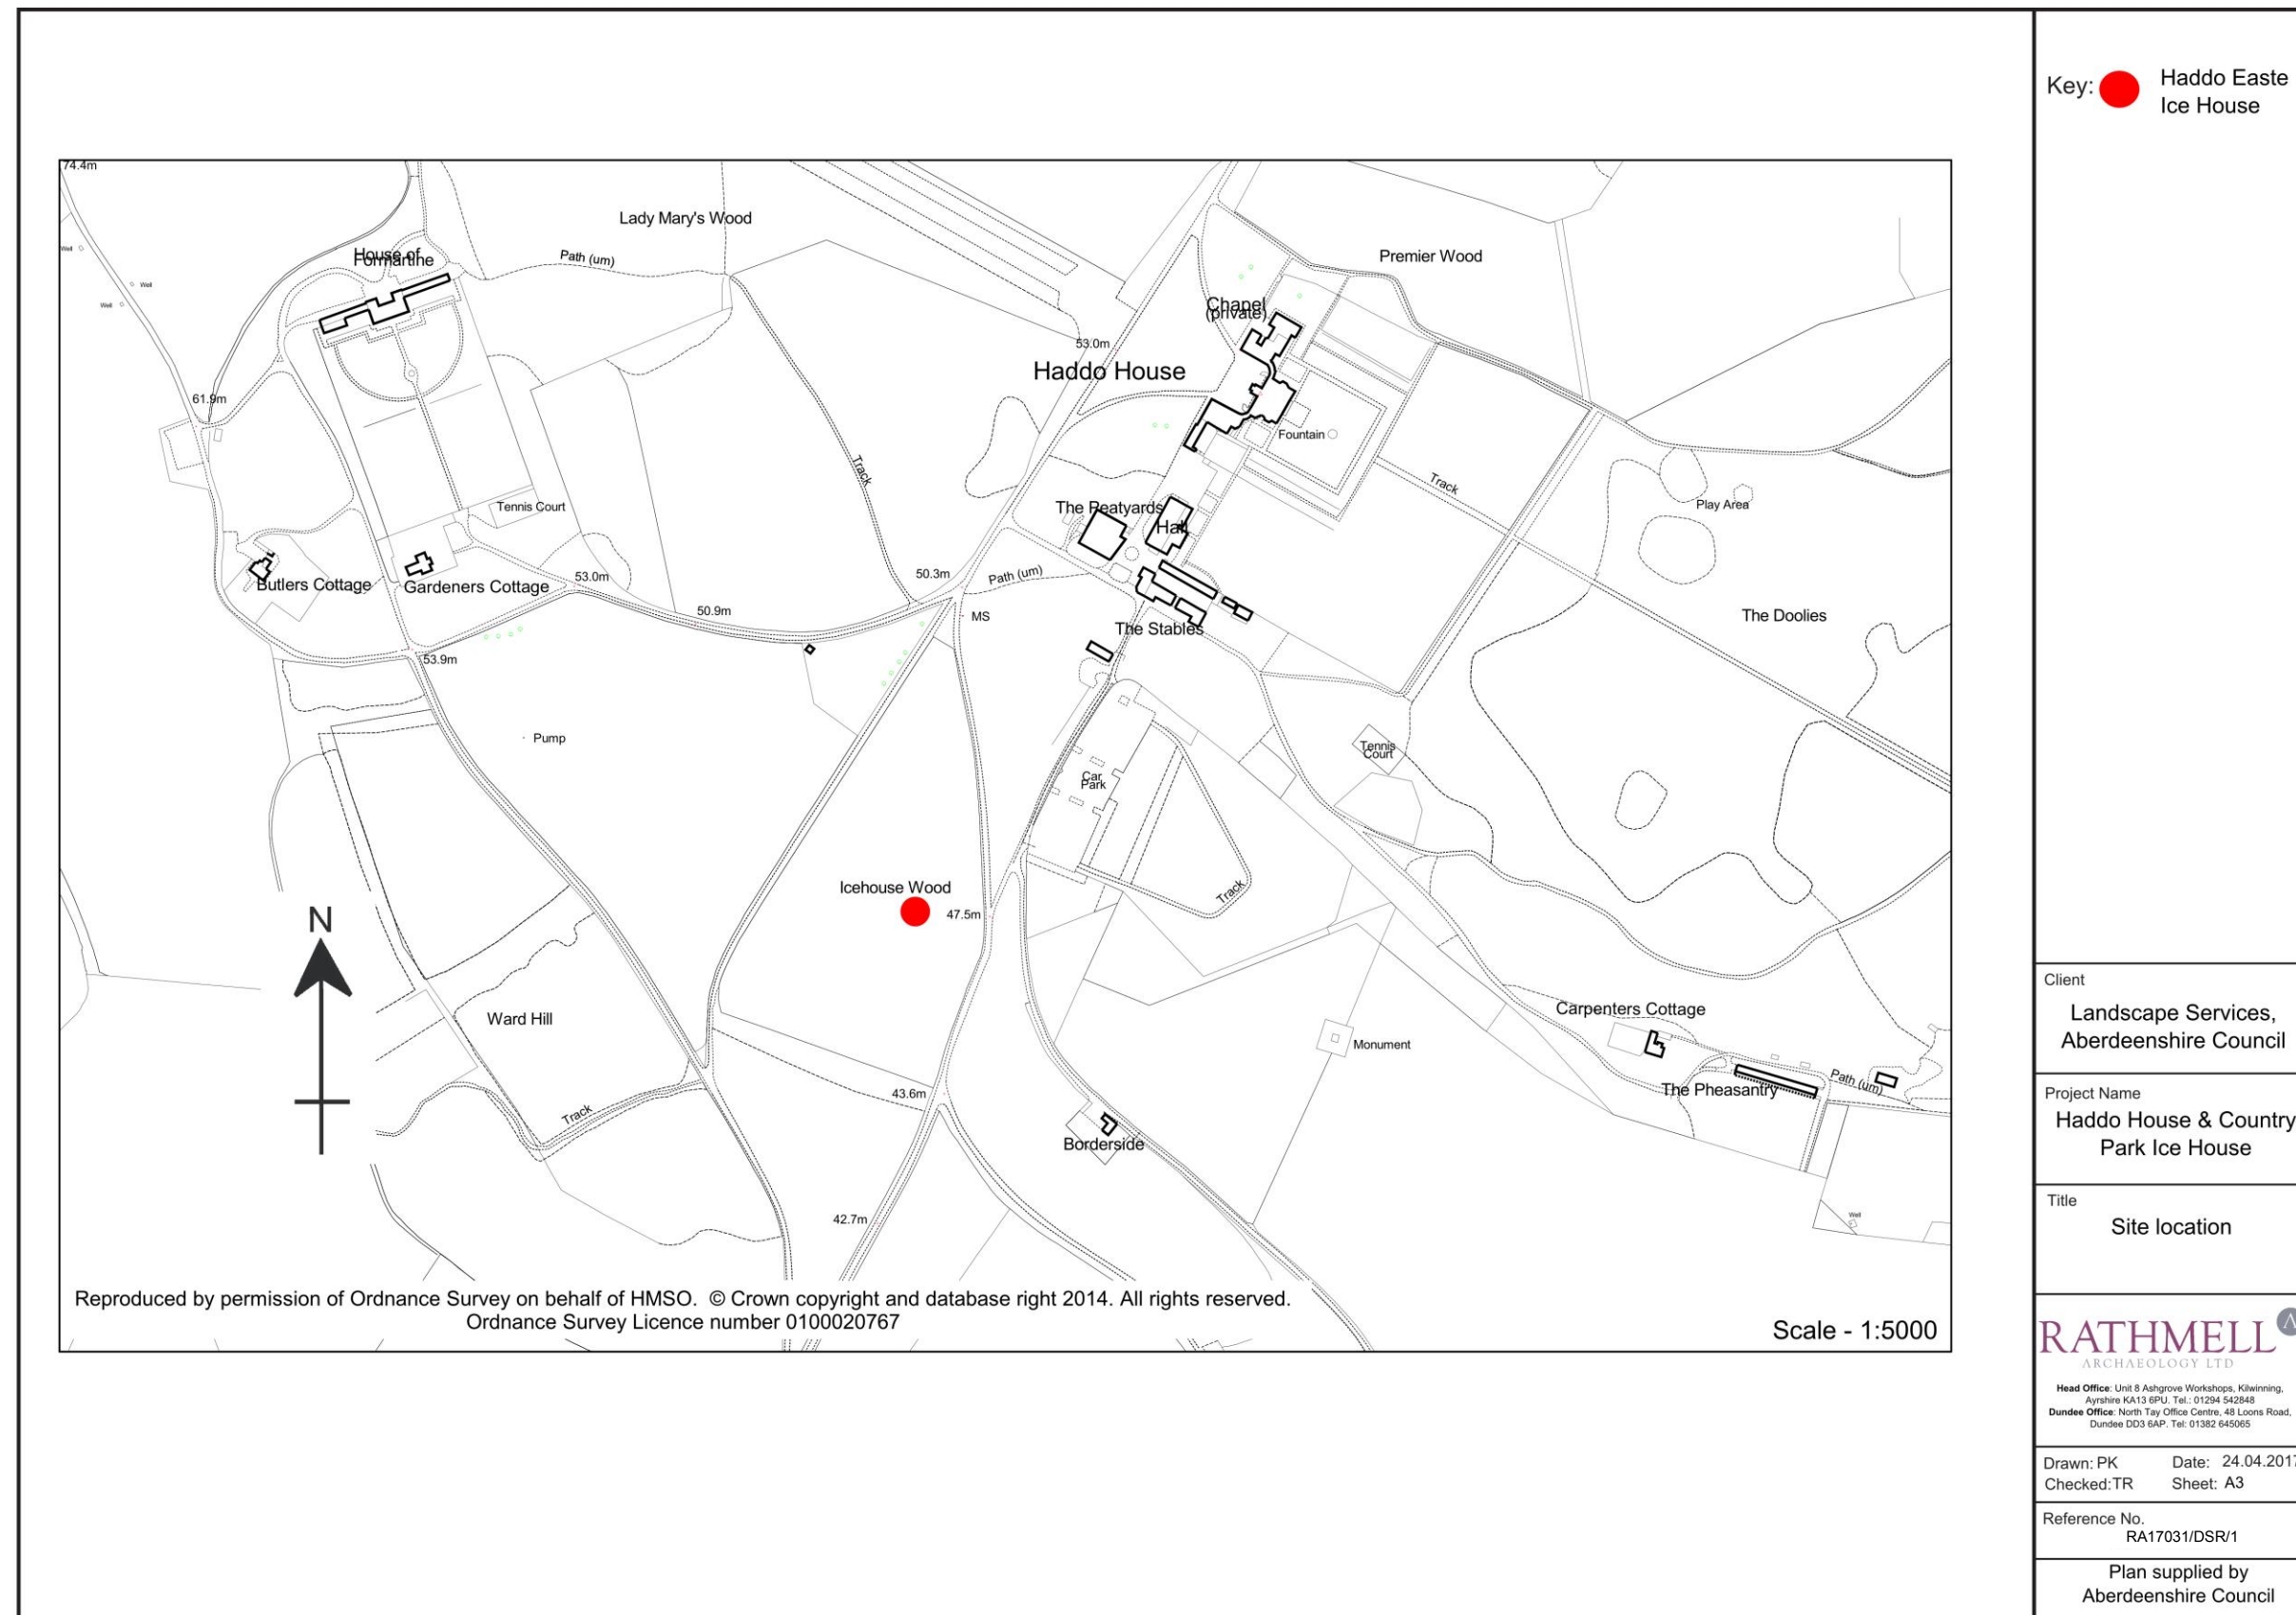
Figure 1: Site location of the Haddo Ice House

41. The Haddo Ice House is a Category C Listed Building (Listed Building ID: 16479, Canmore ID: 145999, HER ID: NJ83SE0076) located in an area of mature woodland approximately fifty metres southwest of the main Haddo Country Park car park (NGR NJ 86629 34434) (Figure 1).

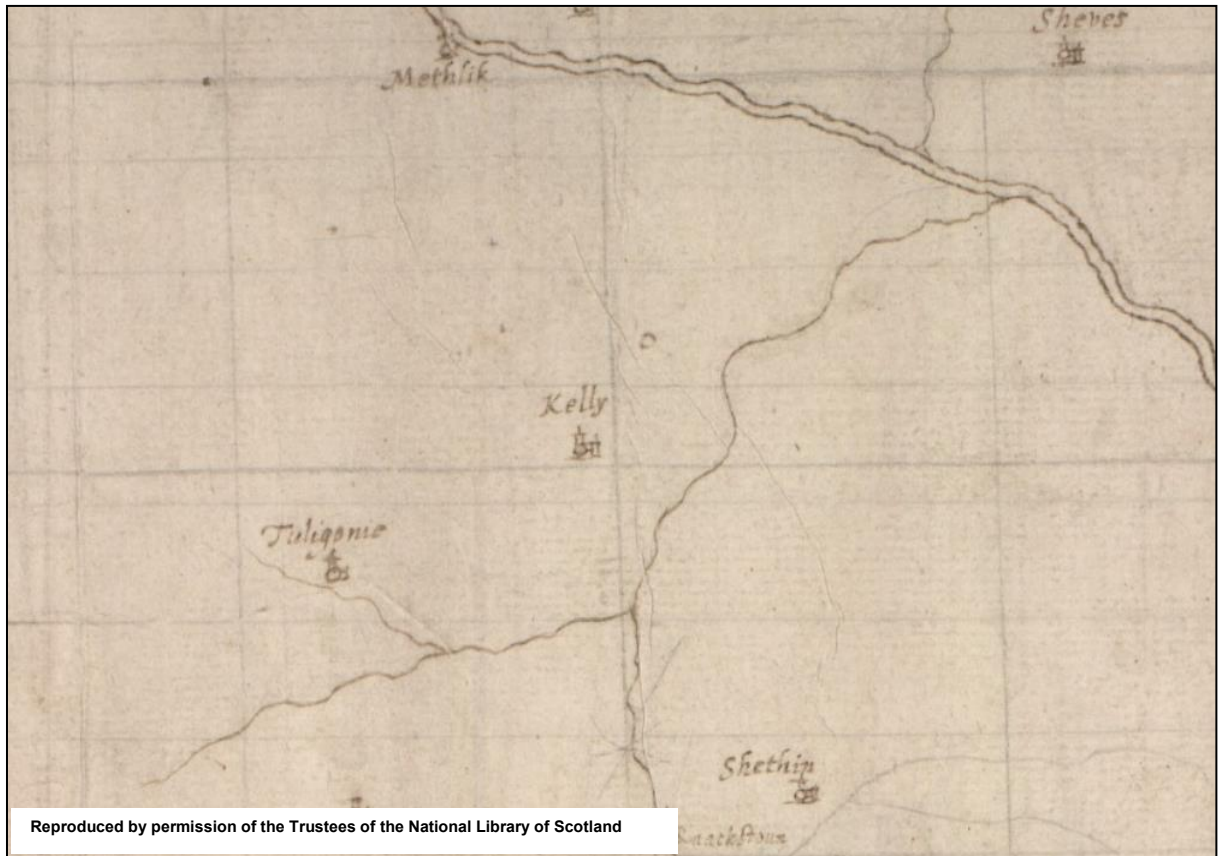
Figure 2a: Extract from Gordon's (1636-52) Formarten and part of Marr and Buquhan (right section)

27. Robert Gordon's (1636-52) (Figure 2a) *Formarten and part of Marr and Buquhan* provides the earliest depiction of the Kellie, spelt 'Kelly'. Apart from depicting the water course of the River Ytahn to the northeast and the present Kelly Burn to the southwest there is no detail on the immediate surrounding landscape to the castle.

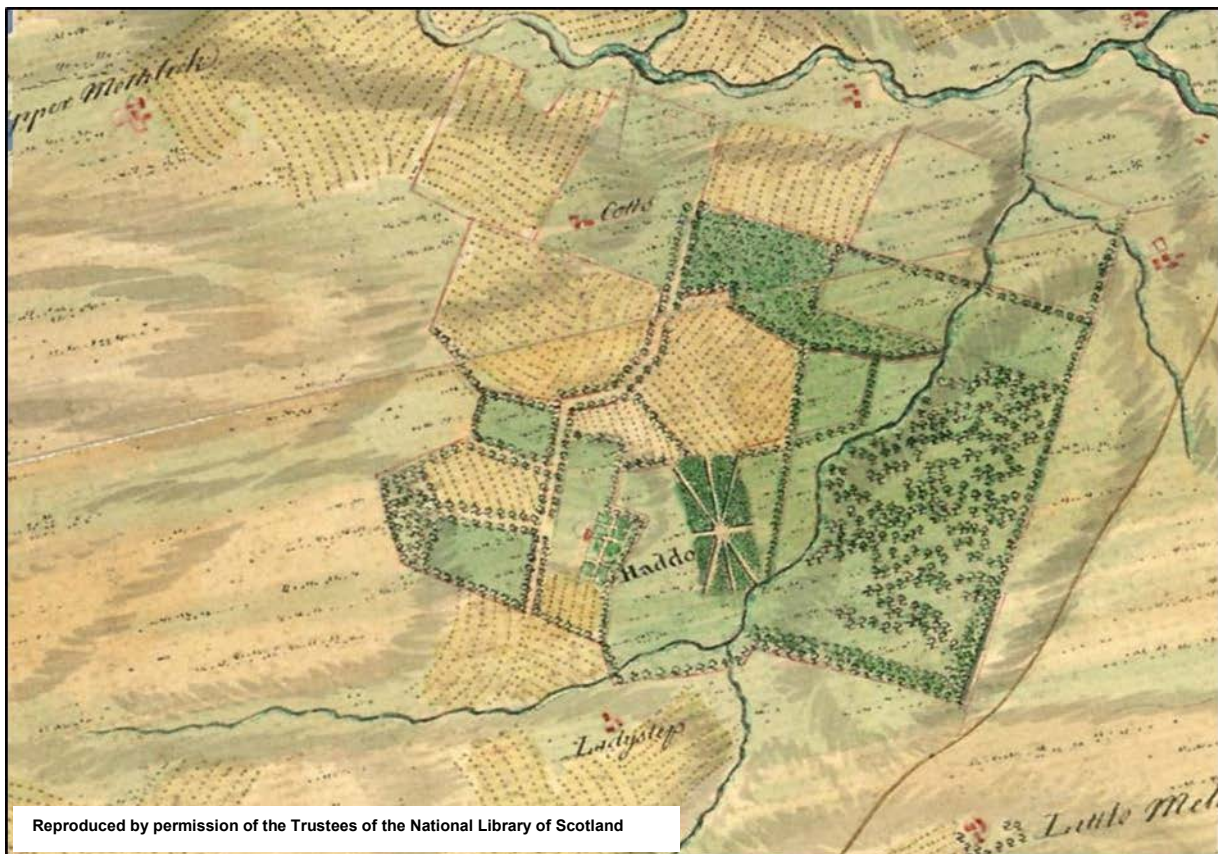
Figure 2b: Extract from Roy's (1747-52) Military Survey of Scotland

29. William Roy's (1747-52) (Figure 2b) *Military Survey of Scotland* is the first survey to provide a detailed depiction of the designed landscape of Haddo House, but it does not provide any detail on the form of the house itself. The House and gardens would have been in existence for over ten years by the time of Roy's survey. The area in which the ice house is located is depicted by Roy as land under cultivation.

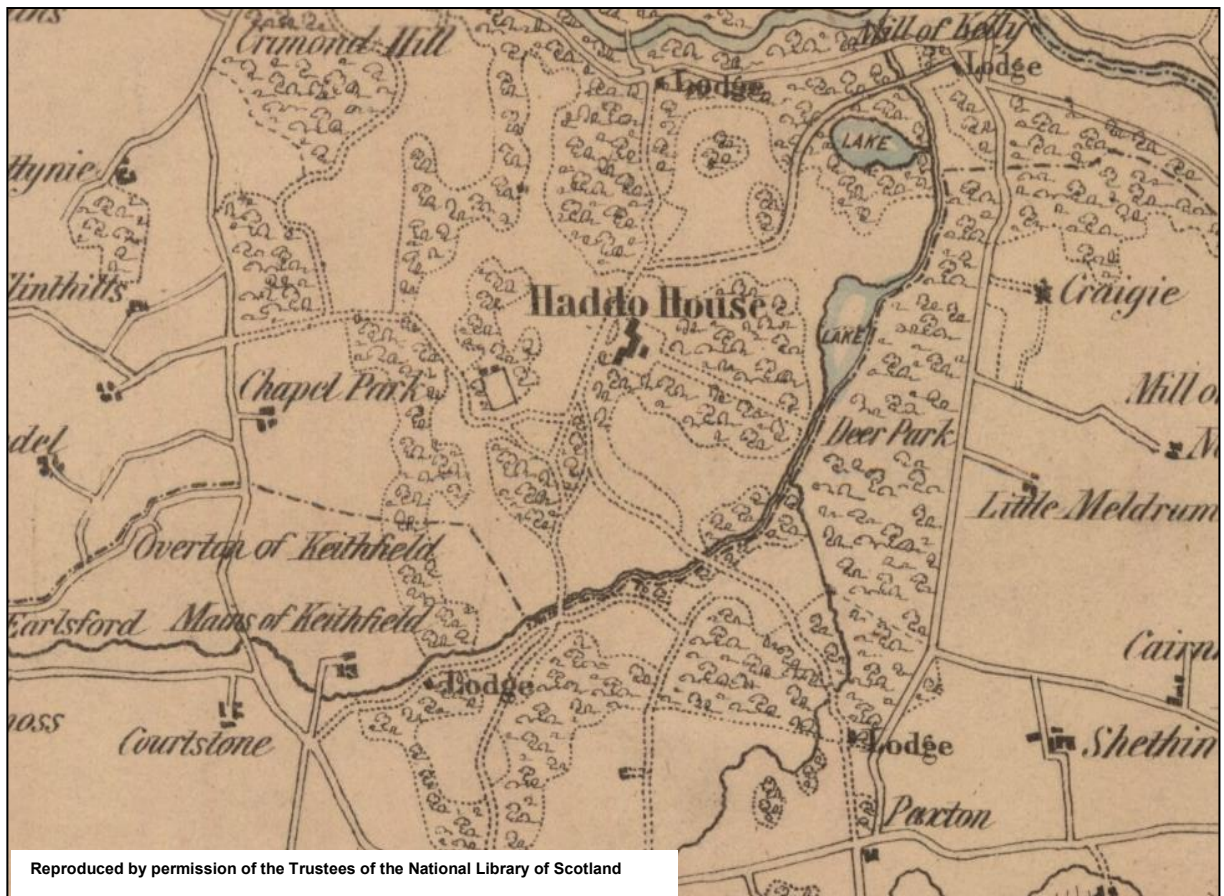
Figure 3a: Extract from Gibb's (1858) Map of the north eastern districts of Aberdeenshire

32. With Alexander Gibb's (1858) (Figure 3a) *Map of the north eastern districts of Aberdeenshire* more detail is provided. The roughly 'C-shaped' range of Haddo House is depicted with a separate structure located on the east side of the house. There is an

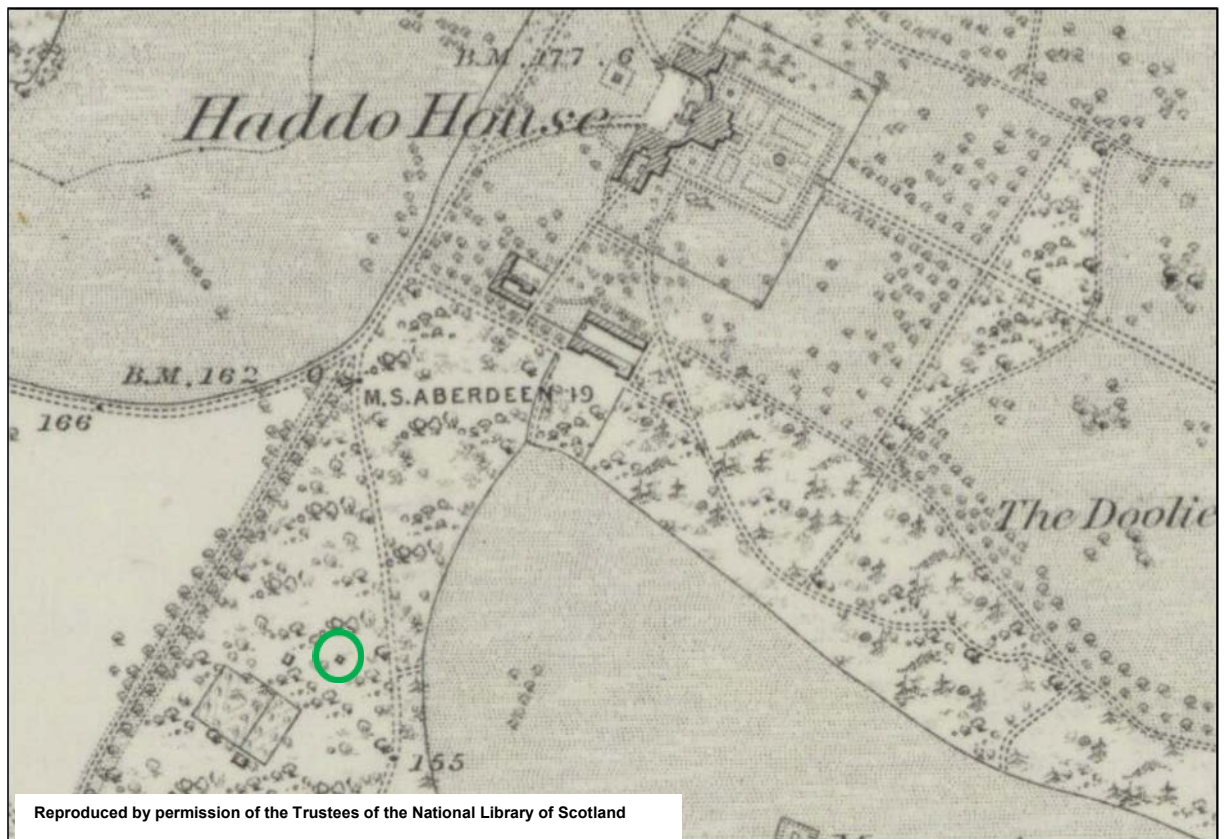
33. The 1st edition OS (1871) (Figure 3b) is the first to depict the location of the ice house as a small square building and to the west of a northwest-southeast aligned path/track. To the west of the ice house another small square building is depicted and to the southwest there is a rectangular enclosure divided in two with a rectangular building aligned northwest-southeast and located on in the southeast corner.
34. The 2nd edition 6-inch OS (1901) (not shown) depicts the ice house along with the enclosure that is labelled as a 'nursery'. The square building to the west of the ice house is no longer depicted and neither is the rectangular building on the southeast corner of the nursery.

Figure 3b: Extract from the 1st edition Ordnance Survey (1871) Aberdeenshire, Sheet XXXVII (includes: Fyvie; Meldrum; Methlick; Tarves). Green circle depicts Ice house

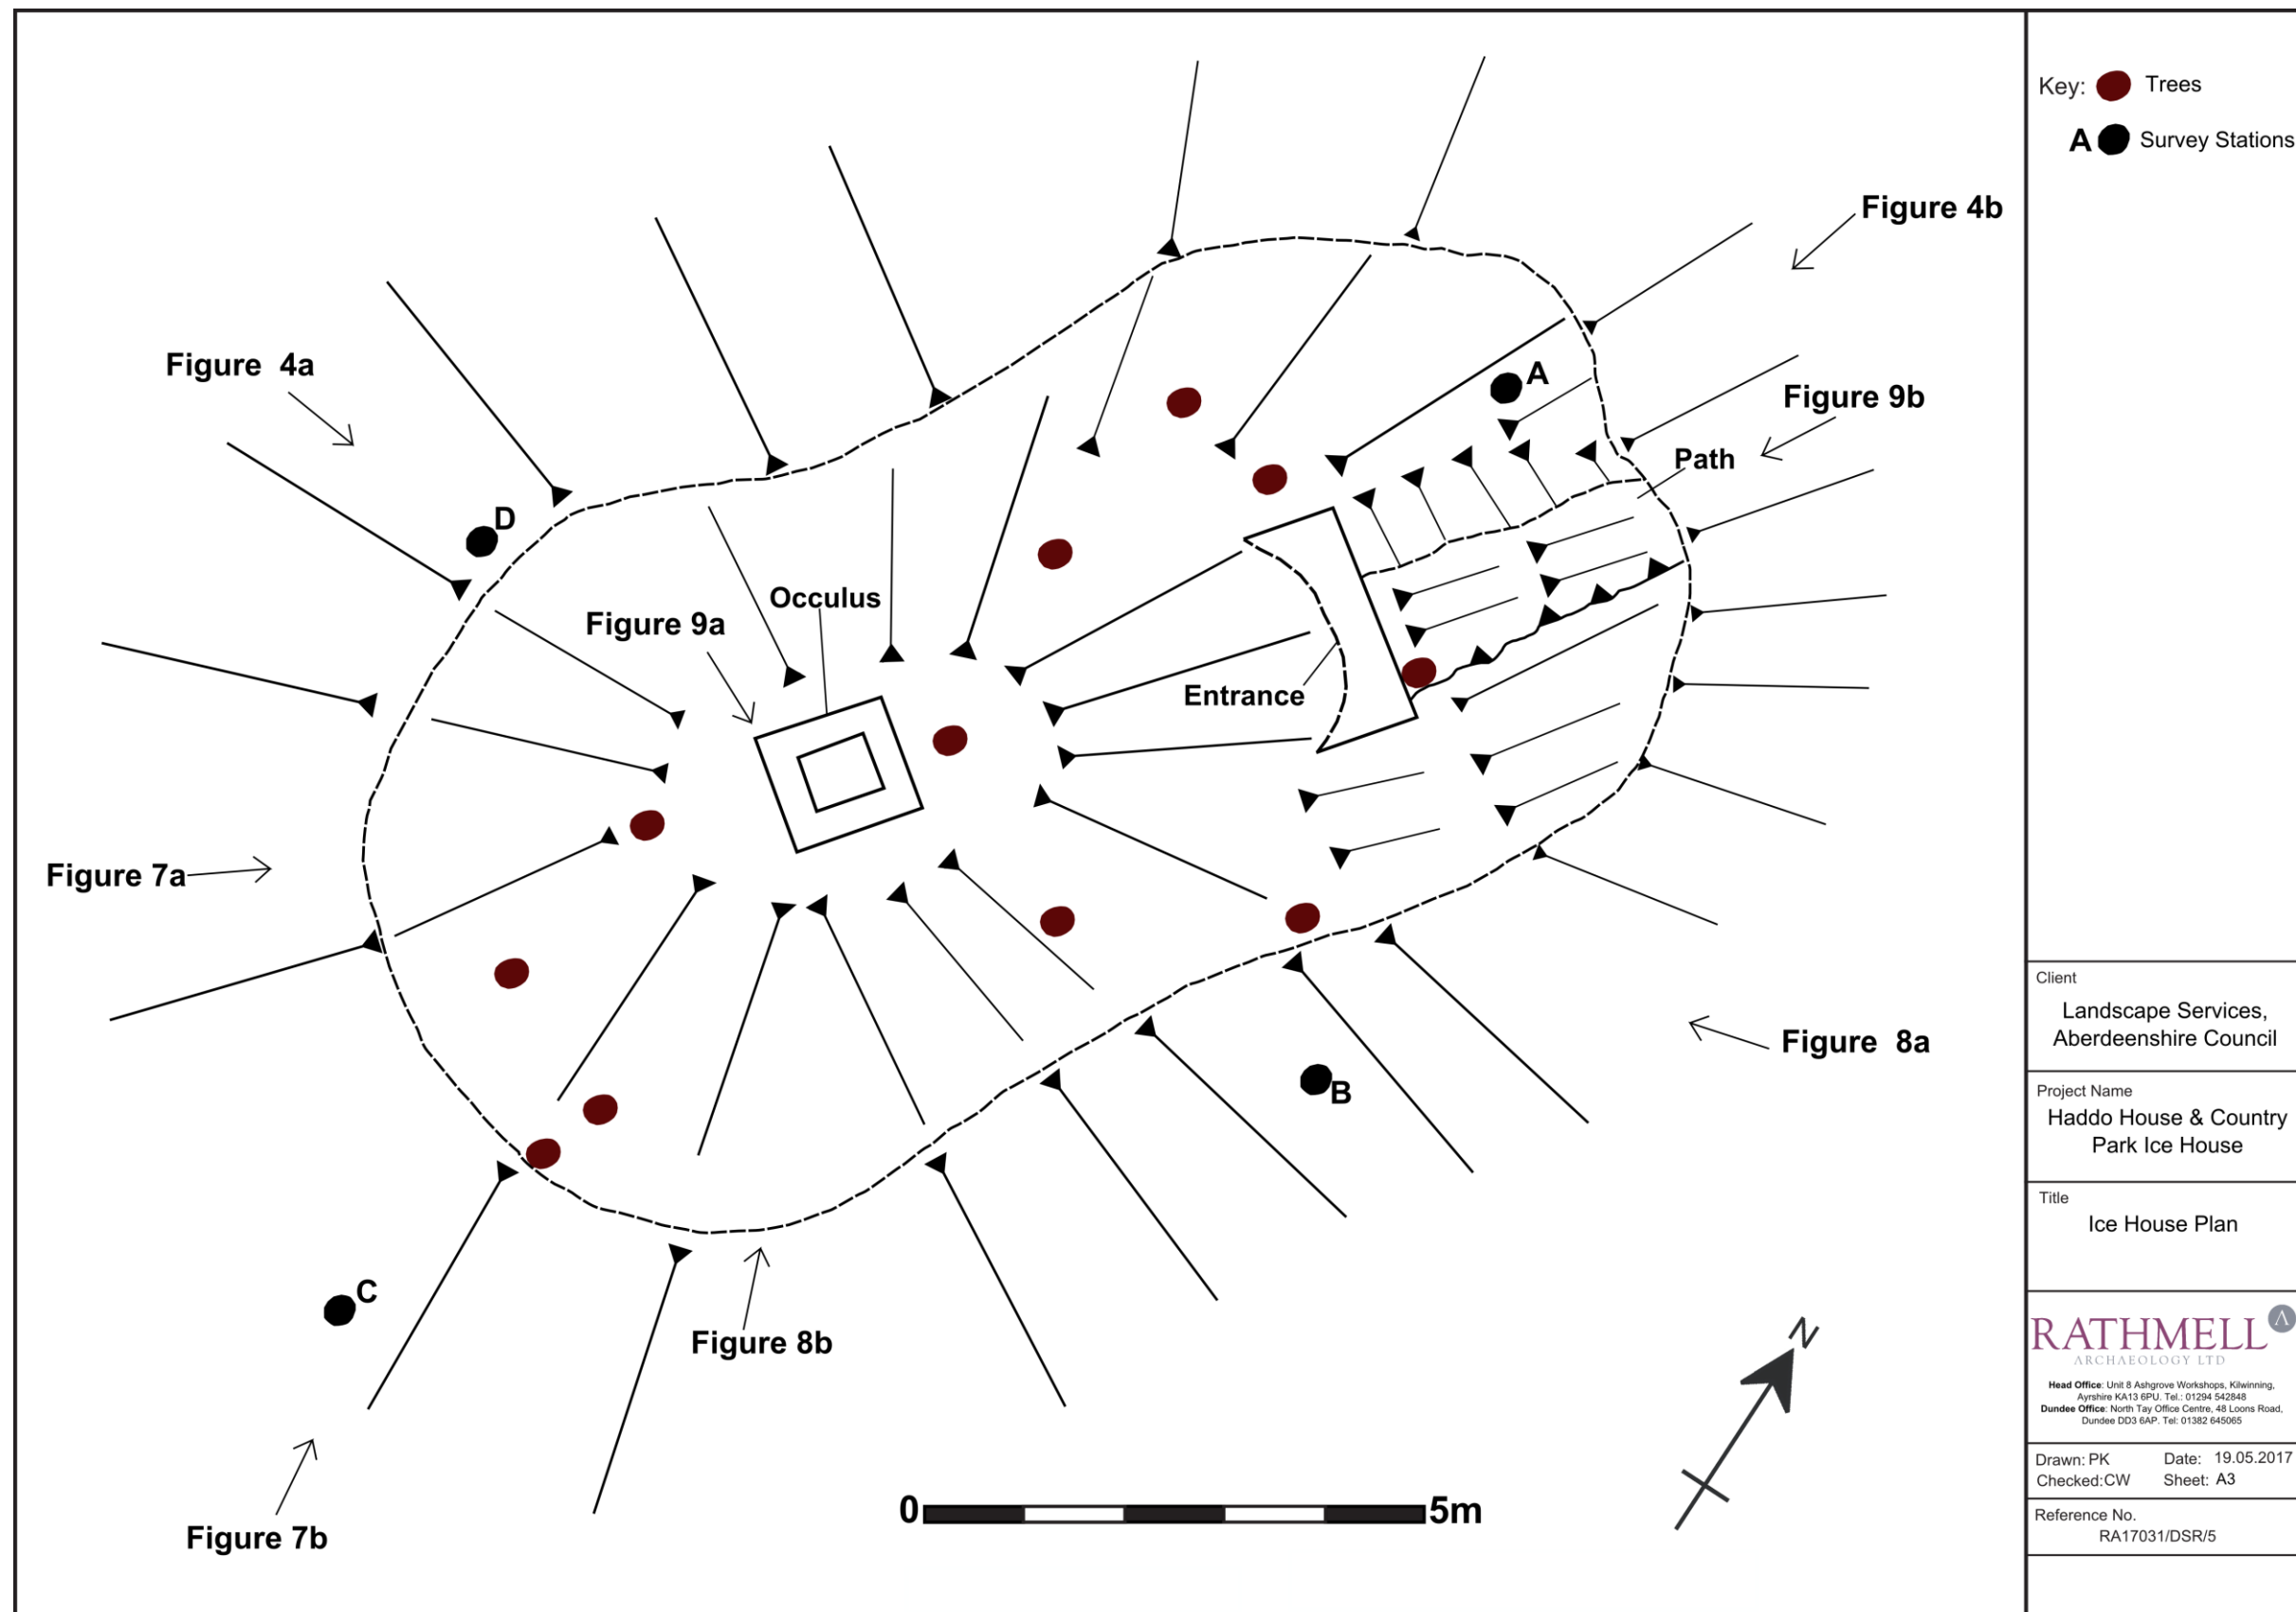
Figure 5: Plan of Haddo Ice House

42. The structure appears predominately as an uneven dome shape, situated on the woodland floor and located partly below ground level. It is roughly oval in plan with a northeast-southwest axis (Figure 4a & Figure 5). Access to the interior is through an entrance on the northeast side of the structure which is currently sealed off by a wooden fence panel (Figure 4b & Figure 6). A number of trees have grown up both around and over the structure (Figures 7a, 7b, 8a & 8b).

43. Due to the erosion that has taken place over the exterior of the dome it is difficult to be certain of its exact dimensions. However, it is possible to deduce these approximately: 12m northeast-southwest (length) by 7-7.5m northwest-southeast (width) (Figure 5). Within this extent there are eleven trees located across the dome.

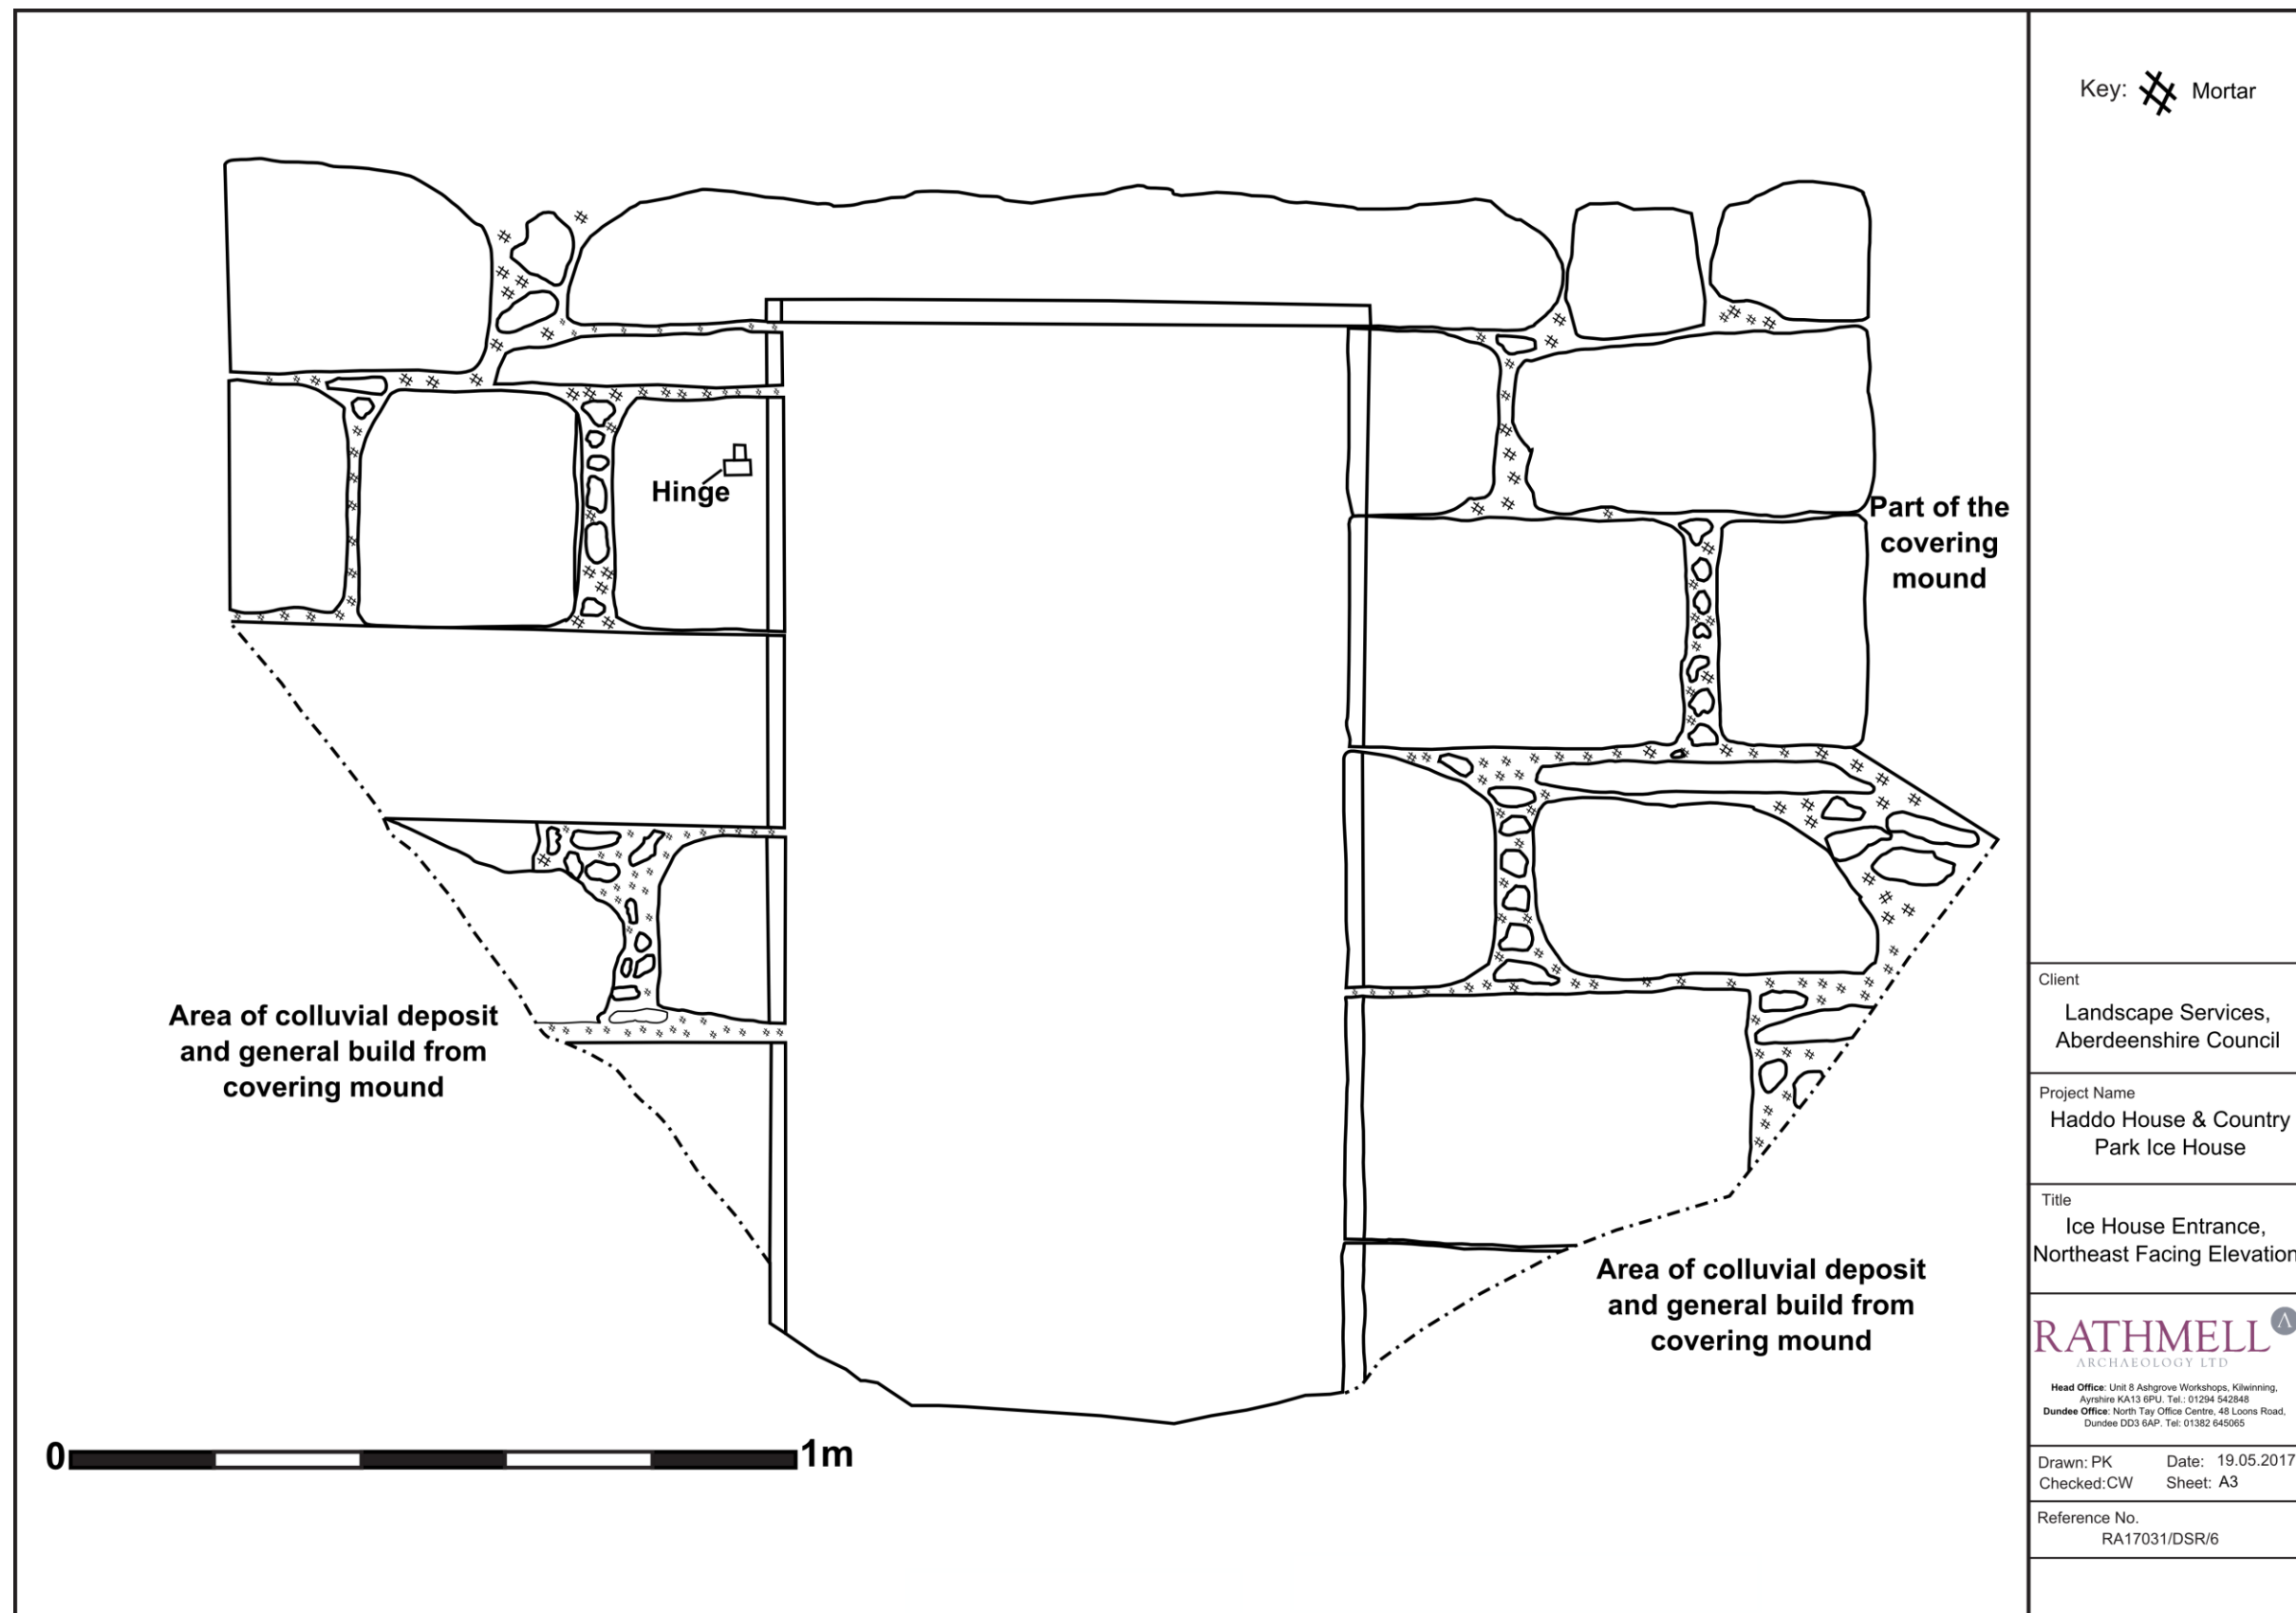
45. The main entrance to the ice house is on the northeast side of the building (Figure 6 & 9b) and is formed by roughly worked granite blocks with areas where smaller stones have been used to infill. The visible dimension of the northeast elevation have a maximum width of 2.25m and a height of 1.70m. The rectangular entrance/doorway has dimensions of 1.5m by 760mm in width and a depth of 617mm (Figure 6 & 9b). There is the presence of what would appear to be an original door hinge located on the upper east side of the entrance/doorway. This most likely was to hold an iron grille or gate.

Figure 6: Elevation of the main northeast access to the Ice House

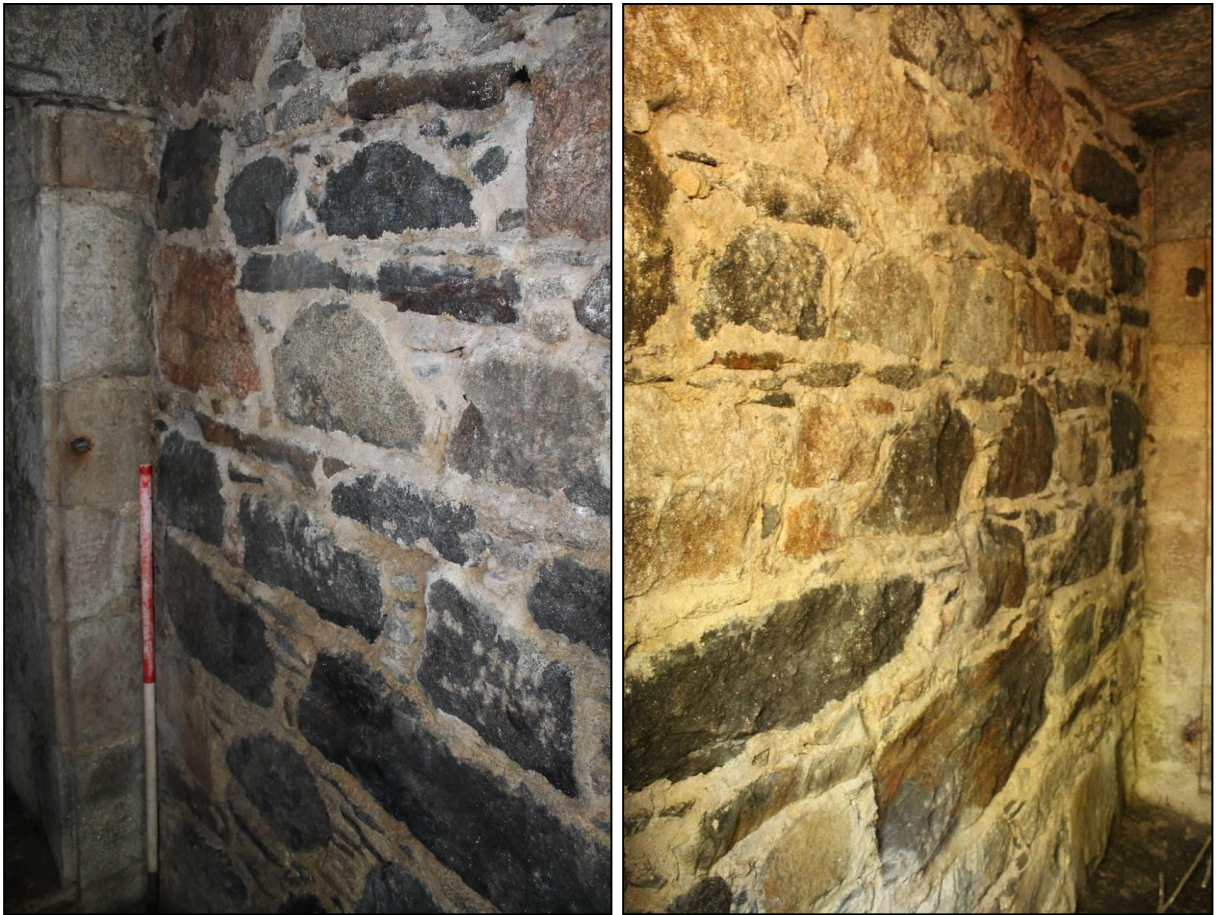
46. The entrance passageway leads from the exterior of the ice house to the main chamber with dimensions of 2.18m in length by 1.20m in width and 2.25m in high (Figure 13). Both side walls (Figures 10a) are coursed and constructed of roughly worked granite with the ceiling formed by six rectangular and roughly worked granite blocks (Figure 10b).

Figure 10a: West (left) and east (right) entrance passageway walls

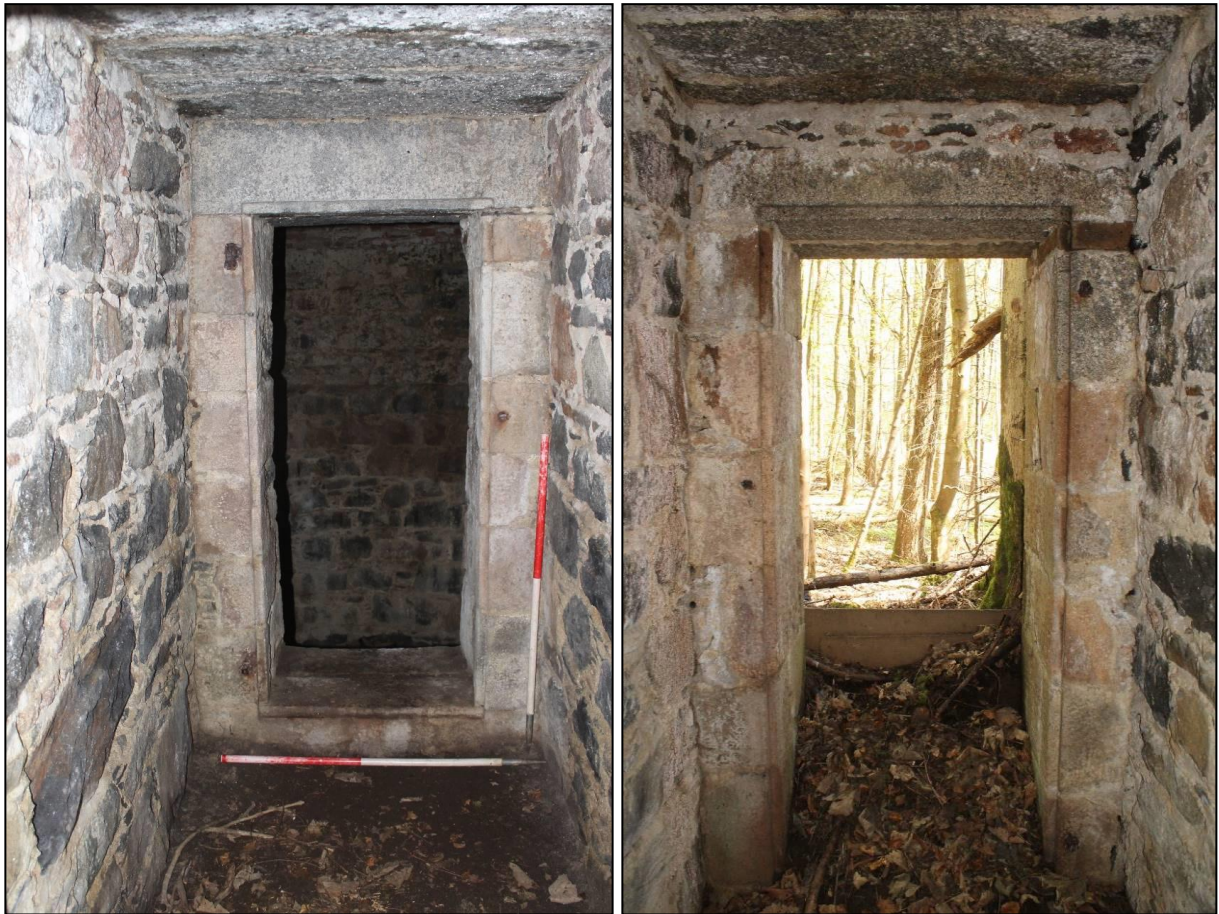
Figure 11a: Doorway (left) into the main circular chamber, doorway (right) to the exterior

47. There are two doorways at either end of the entrance passageway; one allowing access from the exterior and the other providing access to the main chamber (Figure 13). On both internal faces of the doorways within the entrance passageway, the original hinges are visible (Figure 11a). The rybats are of worked granite. The dimensions for the doorway into the main chamber are 1.76m high by 760mm in width and a depth of 650mm.

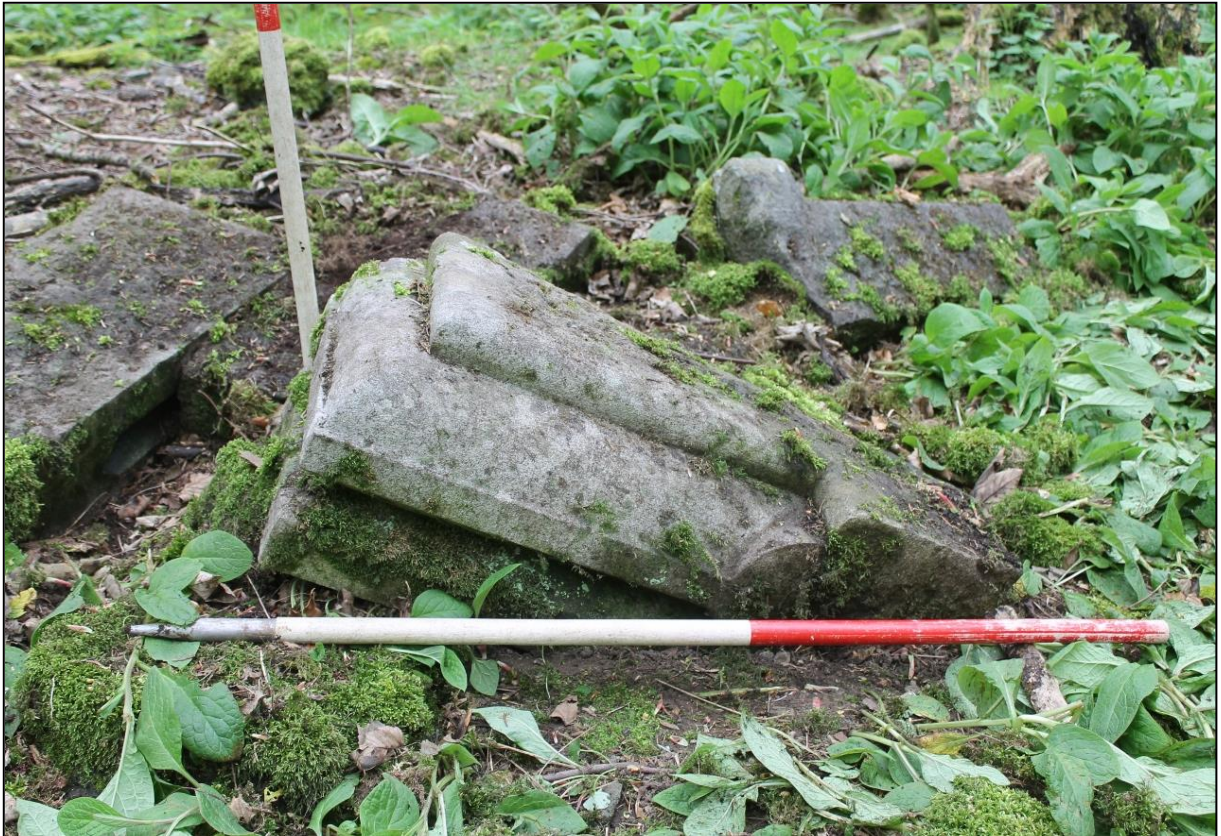
Figure 15a: Architectural stone identified near to the possible 'nursery'

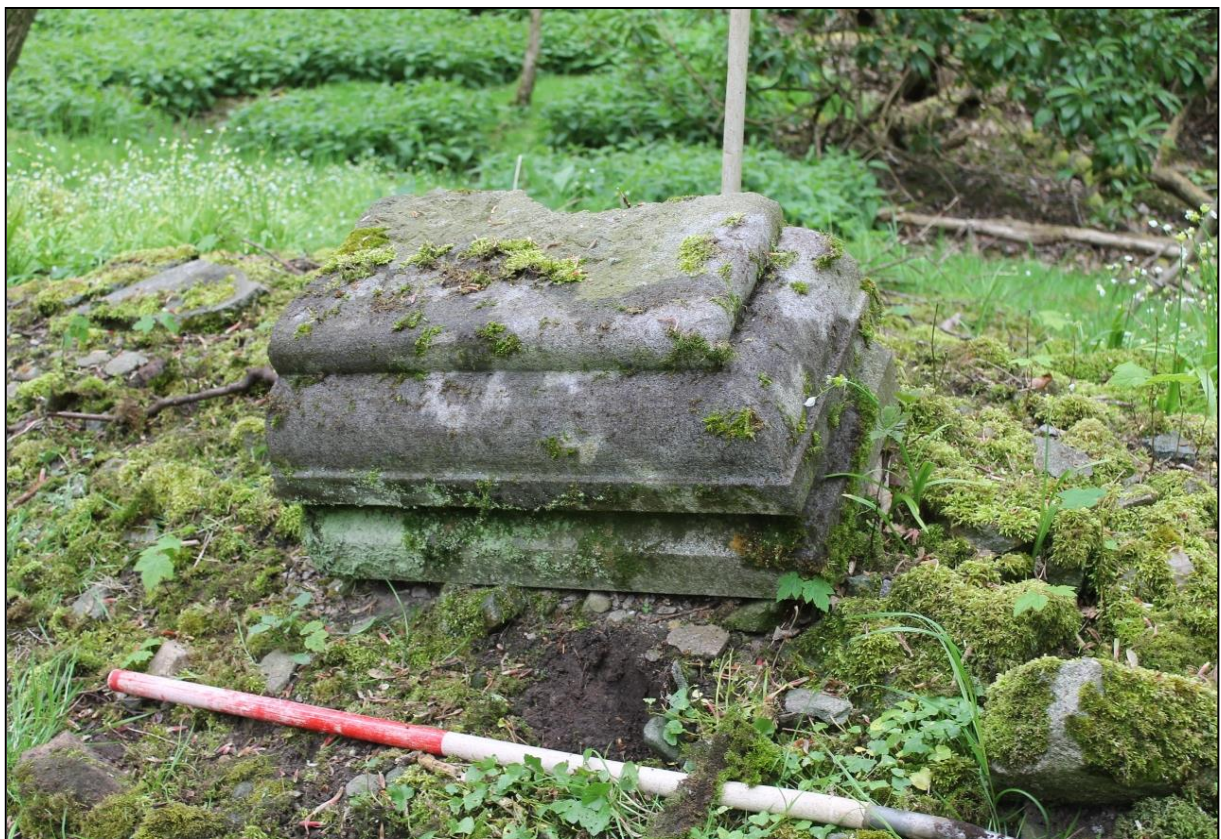
Figure 15b: Architectural stone identified near to the possible 'nursery'
