**Levensgrove Park, Dumbarton,
West Dunbartonshire:
Archaeological Mitigation**

Data Structure Report

on behalf of West Dunbartonshire Council

RATHMELL  
ARCHAEOLOGY LTD

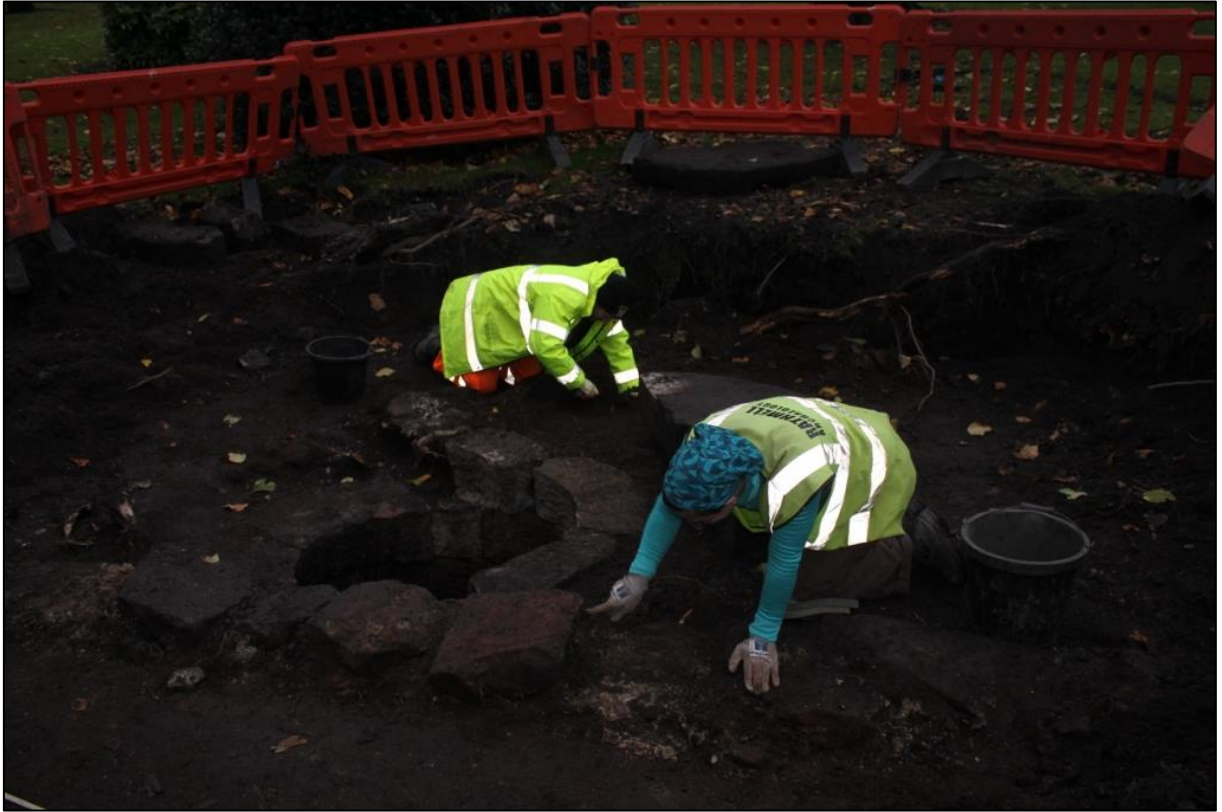
Figure 2a: View of the site during the site clean back. From the NE.

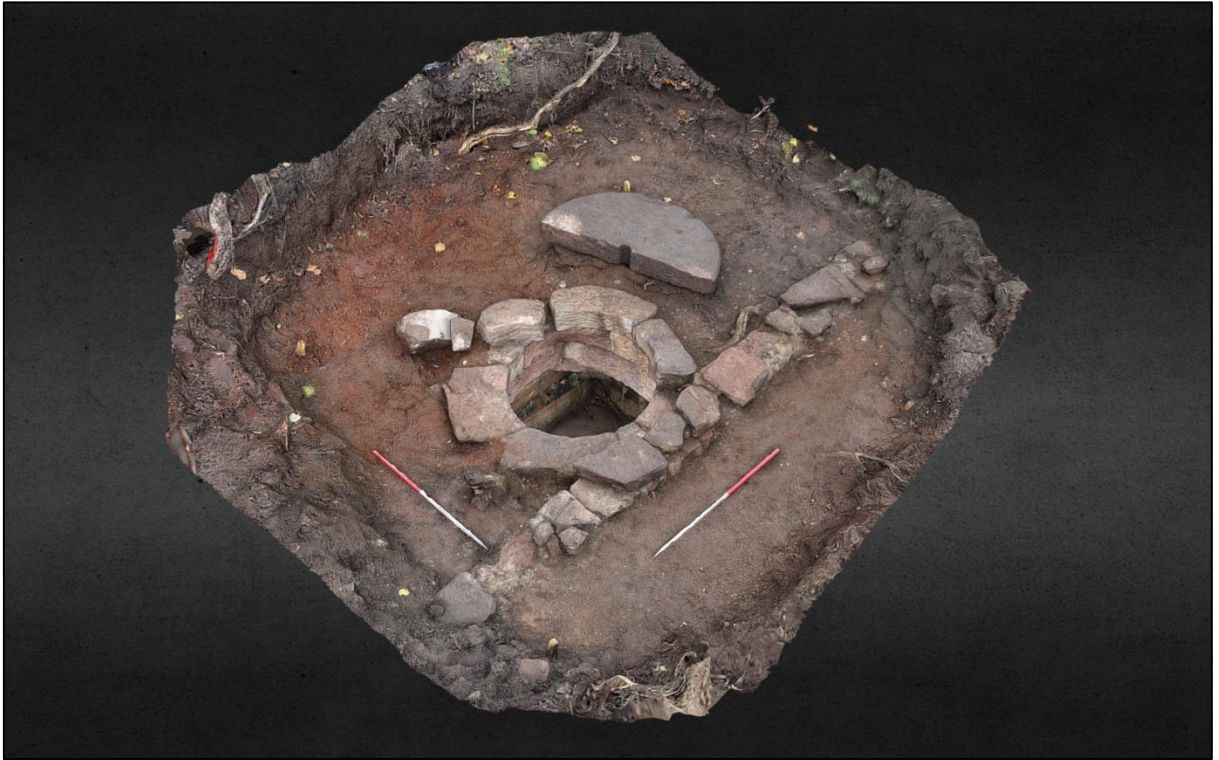
11. From examination of a 3D model of the excavated features on site (Figures 5a and 5b) it was observed that the wall shared the same orientation with the lower, subterranean chamber of the well [005]. It also had a similar orientation to Levensgrove Park's existing boundary wall on Woodyard Road located 8m to the southwest.

16. A 3D model of the well (Figures 5a and 5b) was constructed from photographs taken on site which allowed a better understanding of its internal construction and enabled the retrieval of the overall dimensions, which would have otherwise been impossible due to safety considerations. These dimensions were used to add to the site plan and profile of the well (Figures 1, 3 and 4). From this it was noted that the height from the well's opening to its base was 1.81m and that the circular upper part of the well was placed slightly off centre on its northeast to southwest axis (Figure 3). The inner part of the lower, square shaped, chamber measured 2.3m by 2.3m and had a height of 1.02m (Figures 3).

Figure 5a: View of the site 3D Model from the E.
