# Galloway Glens Landscape Partnership

## Can You Dig It?

Data Structure Report

1.2.g High Ground Wrecks and the Royal Observer Corps

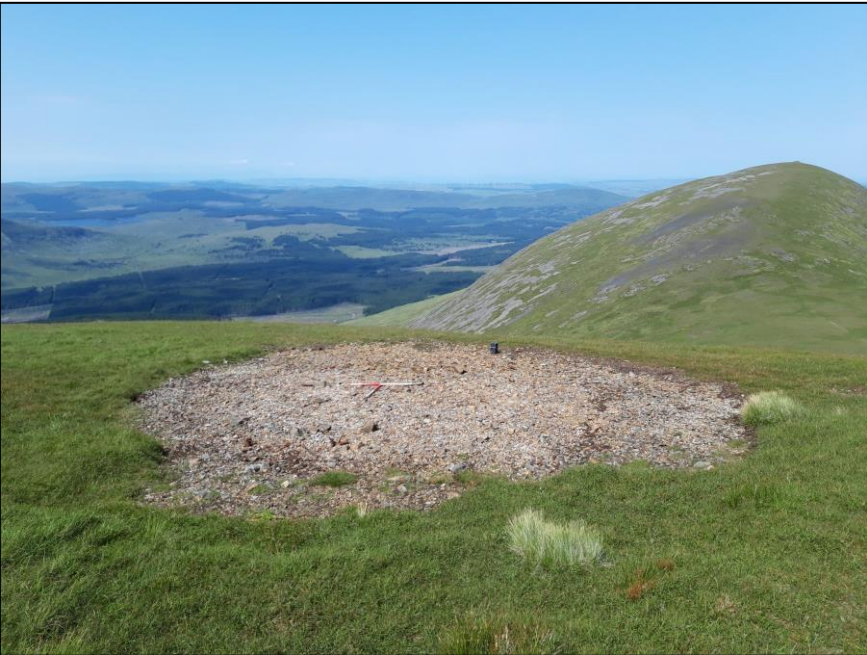
13. The site of the crash at **S3** remained visible as a sub-circular area of exposed bedrock (Figure 2a) measuring 8.8m east to west by 10.8m transversely. The exposed bedrock had been broken into small grey angular stones, which had an average size of 0.1m by 0.15m. The area also contained many fragments of charred aluminium, mostly pipes. A mainly intact battery was located at the northwest corner of the area (Figure 2b).

No	Site	HER Ref:	Description	NGR	Image from Site Inspection
S3	Crash Site: Avro Anson Mk.I	- MDG13043	<p><b>Research Design</b></p> <p>Documentary sources record that the site was cleared of all large wreckage following the crash. The site was recorded by the Peak District Air Accident Research Group. They reported that the site was visible as a burnt-out scar with small pieces of wreckage.</p> <p><b>Walkover Survey</b></p> <p>Wreck 3 was located as a sub-circular area of exposed bedrock measuring 8.8m east-west by 10.8m transversely. The exposed bedrock had an average size of 0.1m by 0.15m was grey in colour. It was broken into angular pieces. The area also contained many sections of aluminium, mainly as pipes. A battery was located at the northwest corner.</p>	NX 49695, 87180

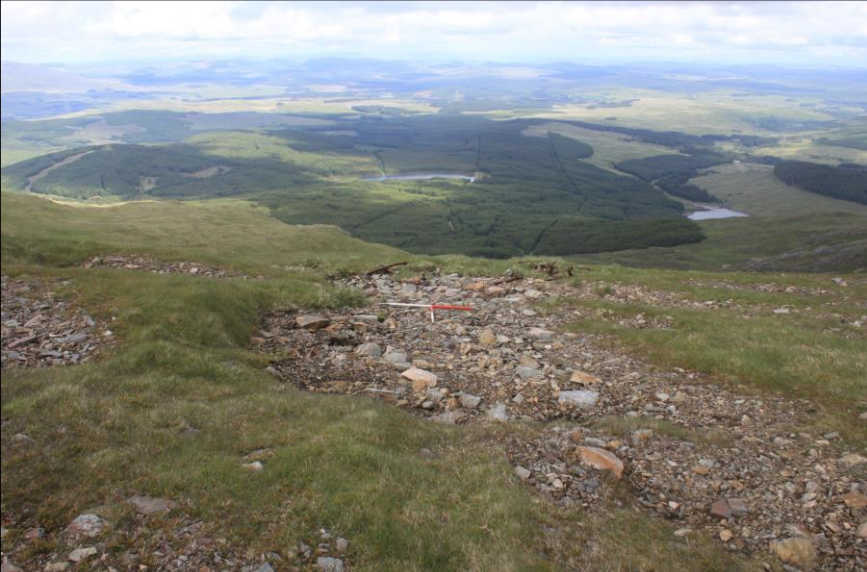
16. As with **S3**, the bedrock within each scar had been broken into smaller angular stones (Figure 3a). Several small metal fragments remained including pipes, screws, a possible tank, fuselage fragments and some timber fragments (Figure 3b).

S4	Crash Site: de Havilland Mosquito N.F. Mk.II	- MDG13046	<p><b>Research Design</b></p> <p>The site was visited by the Peak District Air Accident Research Group. They reported a scar at crash site with small fragments remains. Some larger remains of undercarriage were visible slightly downhill. Mosquito planes had a wooden frame, the bulk of the plane would have been destroyed on impact.</p> <p><b>Walkover Survey</b></p> <p>The wreck was located as a wide spread of bedrock “scars” over the hillside just under the lip of the hill at the “scar of folk”. Nine scars containing airplane debris were located, in addition to a number of small scars without material. The largest scar measured 7.6m by 11.8m and contained the fuselage and gears as well as metal and timber fragments. The other scars containing metal and timber fragments had an average size of between 2m x 0.5m and 3m x 1m. The scars were all sub-circular in form.</p>	NX 50474, 87032

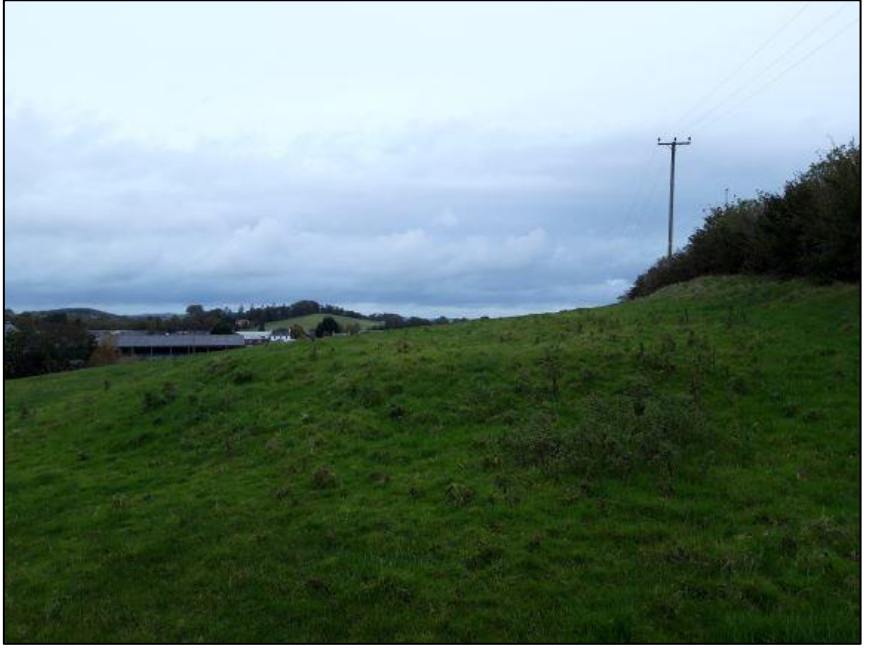
<p><b>S6</b></p>	<p>Castle Douglas - - ROC Post 33/C.1; 24/D.2; 22/E.3  WW2 post; Underground Post</p>	<p>- -</p>	<p><b>Research Design</b>  Opened August 1940. Equipped with flares to warn aircraft of high ground (Granite) in 1943. Later added an underground nuclear post in December 1961. Post closed in 1991. Underground post was probably demolished in 1991.  <b>Site Visit</b>  Underground post has been completely removed. Some faint traces of the disturbance from its demolition remain as an earthwork.</p>	<p><b>Underground post (site of):</b> NX 76804, 62300</p>

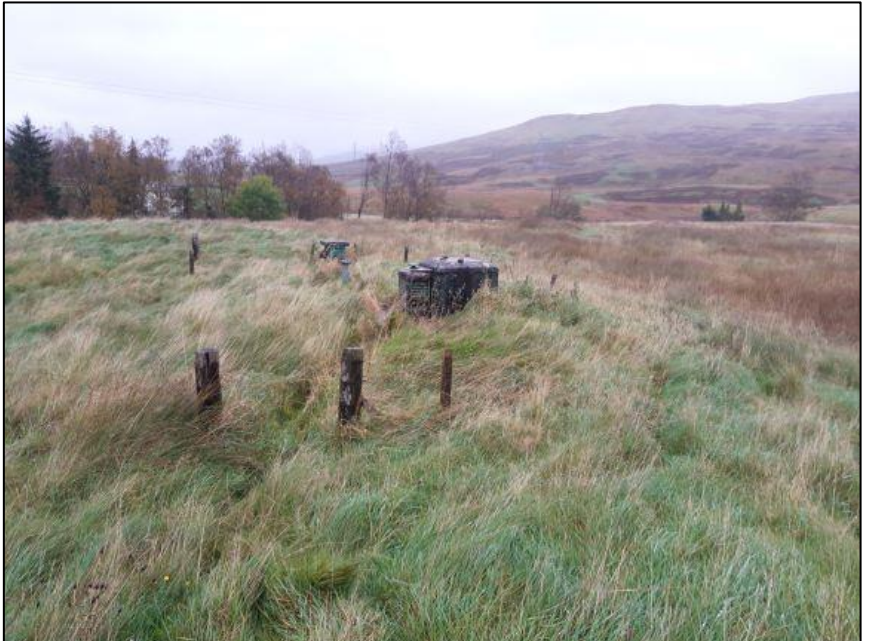
<p><b>S7</b></p>	<p>Carsphairn - - ROC Post 33/K.2; 25/H.2; 22/A.1  WW2 post, Underground Post</p>	<p>- -</p>	<p><b>Research Design</b>  Opened in August 1940. Nuclear bunker added in January 1962. Probably disbanded in 1991. Possible remains of WW2 post visible on low hill. Underground bunker visible within compound.  <b>Site Visit</b>  Surface remains of underground post still present and intact including ventilation shaft, access hatch and sampling/fixd survey meter probe – all made from concrete. Enclosing fence line still present. No access to interior of post as metal access hatch is padlocked. A circular black cover has been fitted to the side of the air vent which sits on its own.</p>	<p><b>Underground Post:</b> NX 56089, 93347</p>

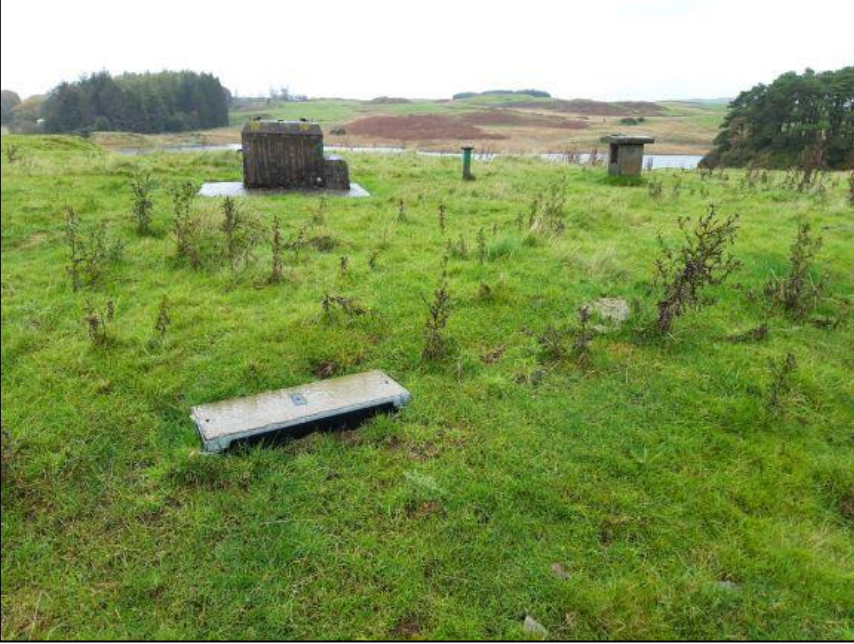
<p><b>S8</b></p>	<p>Dalry - ROC Post 33/B.1; 25/C.2; 22/A.2 - WW2 post, Orlit A, Underground Post</p>	<p>-</p>	<p><b>Research Design</b></p> <p>Opened in September 1940. Underground nuclear post added in January 1964. Probably disbanded in 1991. Orlit A and underground bunker still visible.</p> <p><b>Site Visit</b></p> <p>Surface remains of underground post still present including ventilation shaft, access hatch and sampling/fixing survey meter probe – all made from concrete. Phoneline running into the post's location also still present. Remains are all still intact apart from missing louvres on the air vents. No access to interior of bunker as metal access hatch is padlocked.</p> <p>Remains of Orlit Type A structure still standing. A small rectangular structure only single storey, it has a concrete floor with all walls made of reinforced concrete. It is divided into two halves – one side is unroofed with the remains of two concrete struts projecting from the floor. The other half is roofed with a flat concrete roof. The only internal feature remaining in this half is a wooden bench along the rear wall. There is only one doorway from the exterior leading into the roofed section, and a single internal doorway leading into the unroofed section. The structure is mostly intact apart from the front wall which has been separated from the structure and left leaning against it.</p>	<p><b>Underground Post:</b> NX 63249, 81400</p> <p><b>Orlit Type A:</b> NX 63033, 82001</p>	<p><b>Underground Post:</b></p>

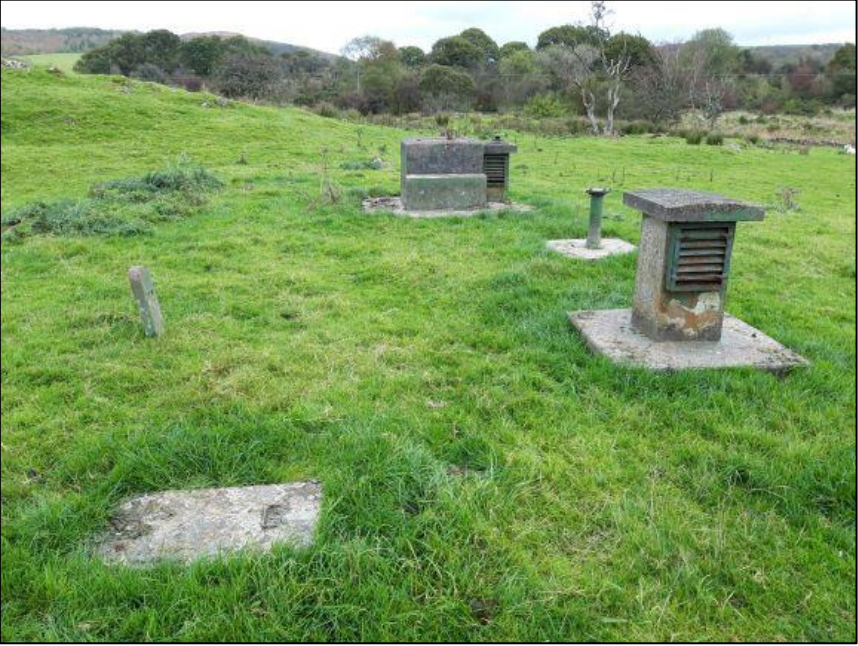
<p><b>S9</b></p>	<p>Parton ROC Post 33/B.3; 25/C.4; 22/A.3;  WW2 post, Nuclear Bunker</p>	<p>- MDG25531</p>	<p><b>Research Design</b> Opened October 1940. Equipped with “granite” 1943. Augmented “granite” 1944. Nuclear post established April 1960. Post probably disbanded in 1991. Concrete base of Orlit A visible on low hill near bunker.</p> <p><b>Site Visit</b> Concrete base of Orlit Type A still present but nothing else remains.  Surface remains of underground post still present and intact including air vent, access hatch and sampling/fixe survey meter probe – all made from concrete. The louvres on the ventilation shaft are still intact. No access to interior of post as metal access hatch is padlocked. A short, narrow upright pipe is visible protruding from the ground near to the meter probe is possibly the remains of a Bomb Power Indicator baffle plate.</p>	<p><b>Underground Post:</b> NX 68854, 70358  <b>Orlit Type A:</b> NX 68836, 70365</p>	<p><b>Underground Post:</b></p>

62. The condition of the surface features appears to be particularly good at **S9** with the concrete appearing mostly intact and a large portion of the green paint still visible.
