Drumcross Farm, Bishopton, Renfrewshire:
Historic Building Recording
Data Structure Report

by Louise Turner

issued 28th April 2010

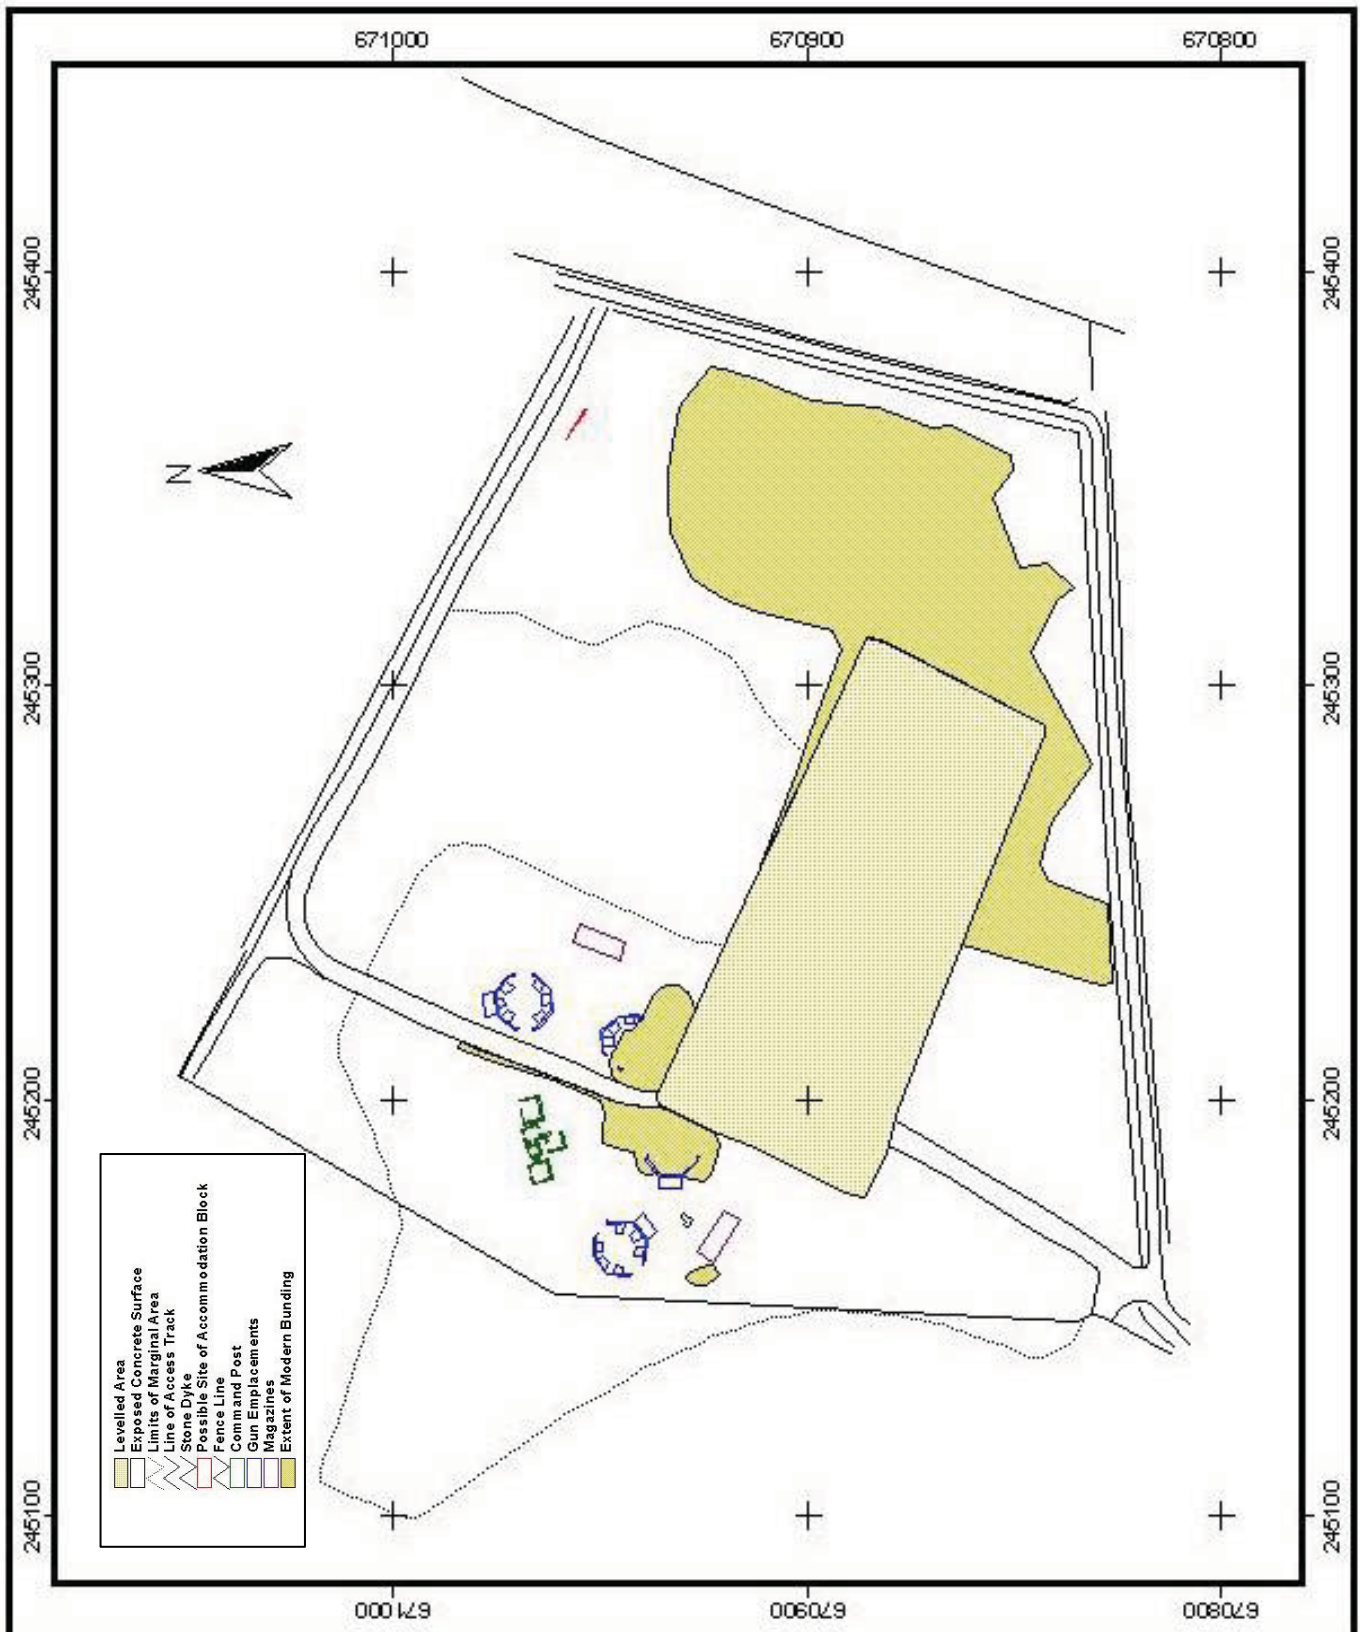
Figure 3: Plan of Site as surveyed

27. Figure 3 clearly shows that most of the original elements of the Gun Park still survive in some shape or form. The outlines of four Gun Pits are clearly visible, along with two Magazines, and the Command Post. A further two structures, visible on the aerial photographs, could not, however, be identified. No upstanding remains of the GL mat could, however be identified. Of the Domestic Site, there was only ephemeral evidence for one structure that once formed part of this service area.

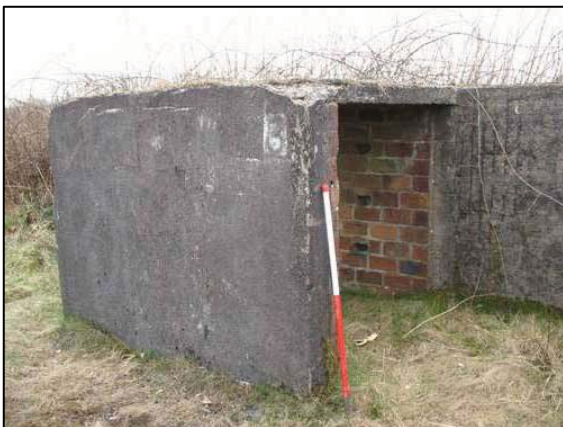
Figure 5e: Type 1 Ammunition Recess (Gun Pit 2)

34. Since Gun Pit 2 survived in best condition, it was decided to use this as the 'type-site' with which the rest of the battery could be compared. A close inspection of its six Ammunition Recesses demonstrated that these internal features represented two different forms. Four were of less substantial build, comprising a reinforced concrete slab resting on a concrete slab laid vertically, with an inner brick lining. The supporting wall thickness in these particular examples was 0.25m (Figure 5e) and they were located at those points in the gun pit located immediately adjacent to the opposing entrance gates.

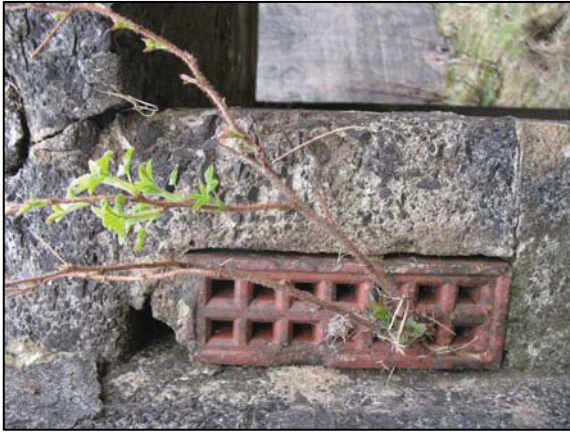
Figure 6a: Ventilated Brick inset into Type 2 Ammunition Recess (Gun Pit 2) - rotated

35. The central Ammunition Recesses were, however, more robust (Figure 5f). The supporting wall thickness here was 0.33m, with ventilated bricks set into the concrete at the upper and lower ends of each stanchion (Figure 6a). It is possible that these more robust structures functioned as shelters for the gun crew, one allowing on-site gun maintenance to take place (the 'limber gunner's shelter') the other for the on-site personnel (Brown et. al. 1996) though the presence of sockets within the brick lining of all six recesses (Figure 6b) suggests that they could all, if necessary, have had racking inserted for the storage of ammunition and fuzes.

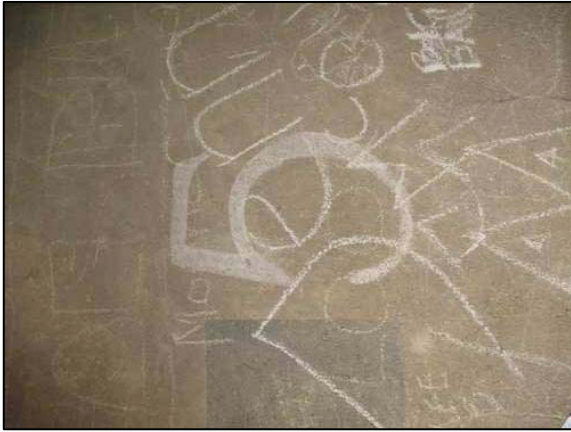
Figure 9a: Magazine 1 – Numbered Bay

51. The Magazine survived in good condition. The structure was built of concrete stanchions infilled with brick, and roofed with concrete, and was subdivided into five bays of roughly equal size (roughly 1.96m wide). A corridor measuring roughly 1.2m wide ran the length of the structure, allowing access to each bay (Figure 8f). Bays 1, 3 and 5 had a circular vent in the roof, and each bay had originally been numbered (Figure 9a). There were additional examples of potential original signage in places, but their details could not be established (Figure 9b).

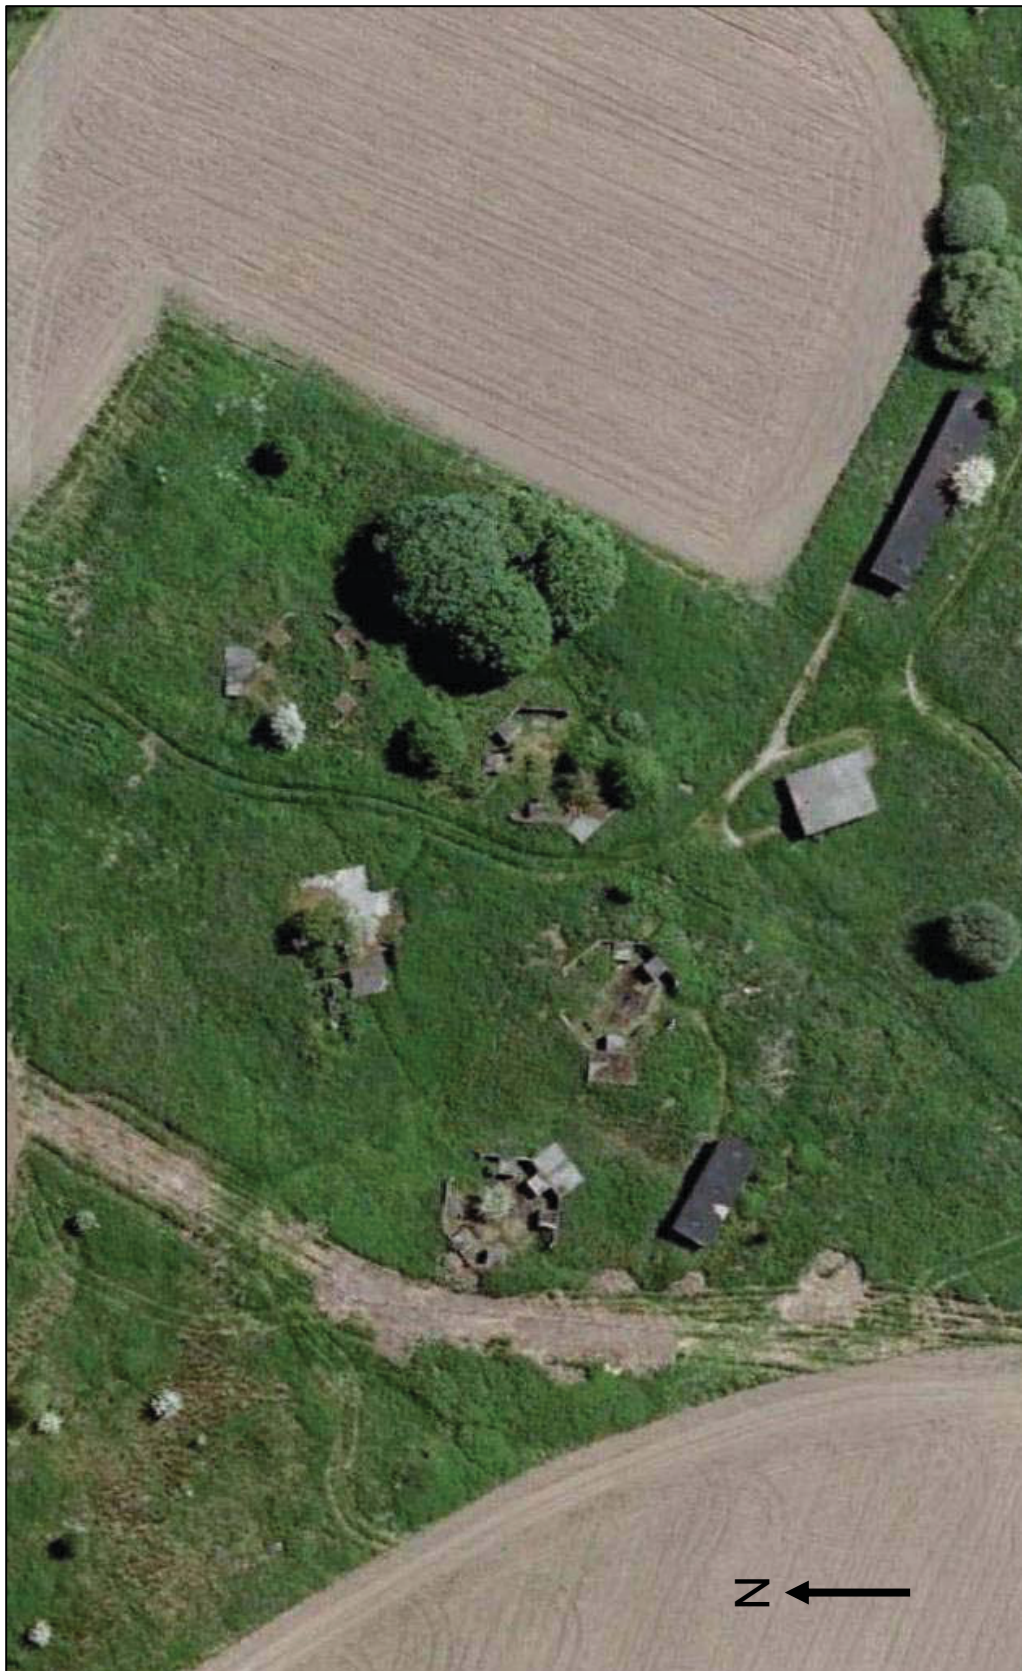
Figure 10: Aerial Photograph Showing Lost Structures to SW of Surviving Elements of Battery

56. Aerial photographic evidence from 2009 suggests that a further two structures once stood to the south-east of the surviving elements of the Gun Park (Figure 10). These bear no close analogy to the upstanding structures that still survive at the site, but comparison can be made with similar sites elsewhere. The smaller structure appears to have been the Gun Store where instruments and spare parts were housed (Brown *et. al.* 1996, 59), while the other appears to have been another, larger, magazine.

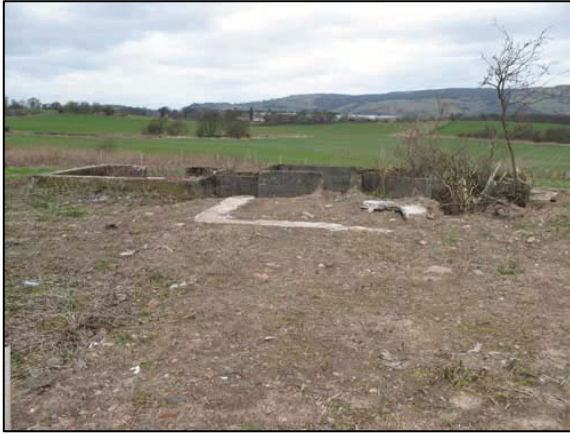
Figure 11a: Command Post, General View

58. The final element of the operations area was the Command Post. Located at the northern edge of the Gun Park, this structure was fundamental to its successful operation (Figures 11a & b). It would have housed the electronic equipment which received data from the radar and translated this into information for target plotting (Dobinson 1996, 125).

60. It is highly likely that the ruined command post identified at Drumcross represents an example of the DFW 55402, but since it survives only in incomplete condition, it is hard to equate the visible remains to the plan shown on Dobinson's plan.

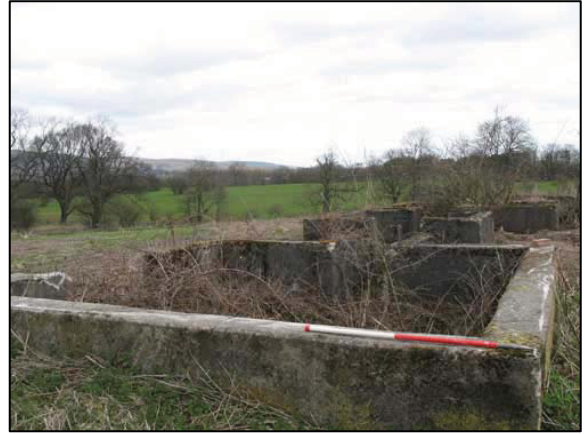
Figure 11b: Command Post – surviving upstanding elements

61. The main surviving element of this structure comprised three adjacent rectangular rooms, measuring (from northeast to southwest) approximately 3.5m by 4.2m, 4.5m by 2.9 m and 4.9m by 4.9m in extent. Each was linked to the next by a narrow corridor 0.75m wide. A concrete pillar or spigot remained upstanding within the central room (Figure 11c); with no clear means of establishing what the original layout of the structure would have been, it was impossible to interpret this feature further, though it may have been used to support the heightfinder or predictor.
