**NANQUIDNO VEAN**

**ST. JUST**

Archaeological Monitoring and Recording and Historic Building Recording

South West Archaeology Ltd. report no. 191007

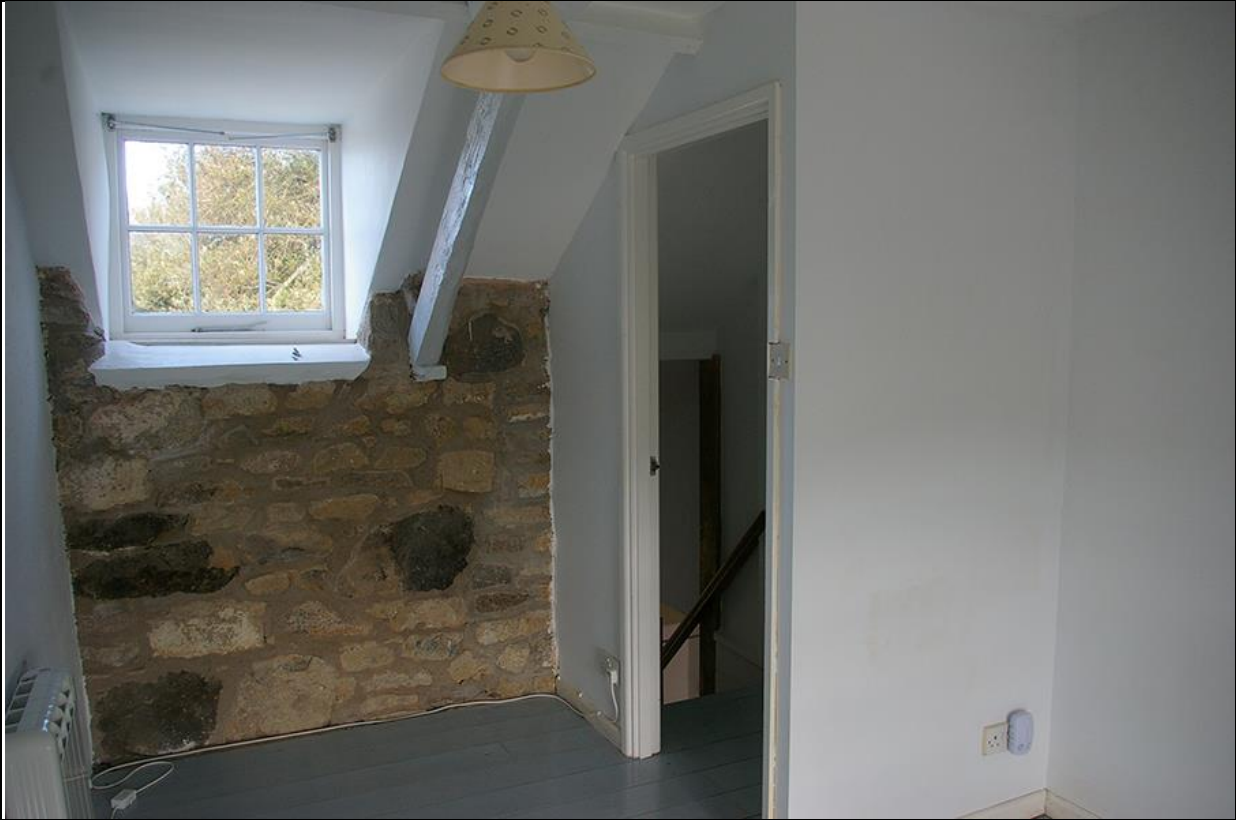
35. ROOM 8, WITH STONE WALL EXPOSED TO REAR, WITH RUSTIC A-FRAME TRUSS — MODERN PARTITIONS FORM R7, THE LANDING; FROM THE SOUTH-WEST.

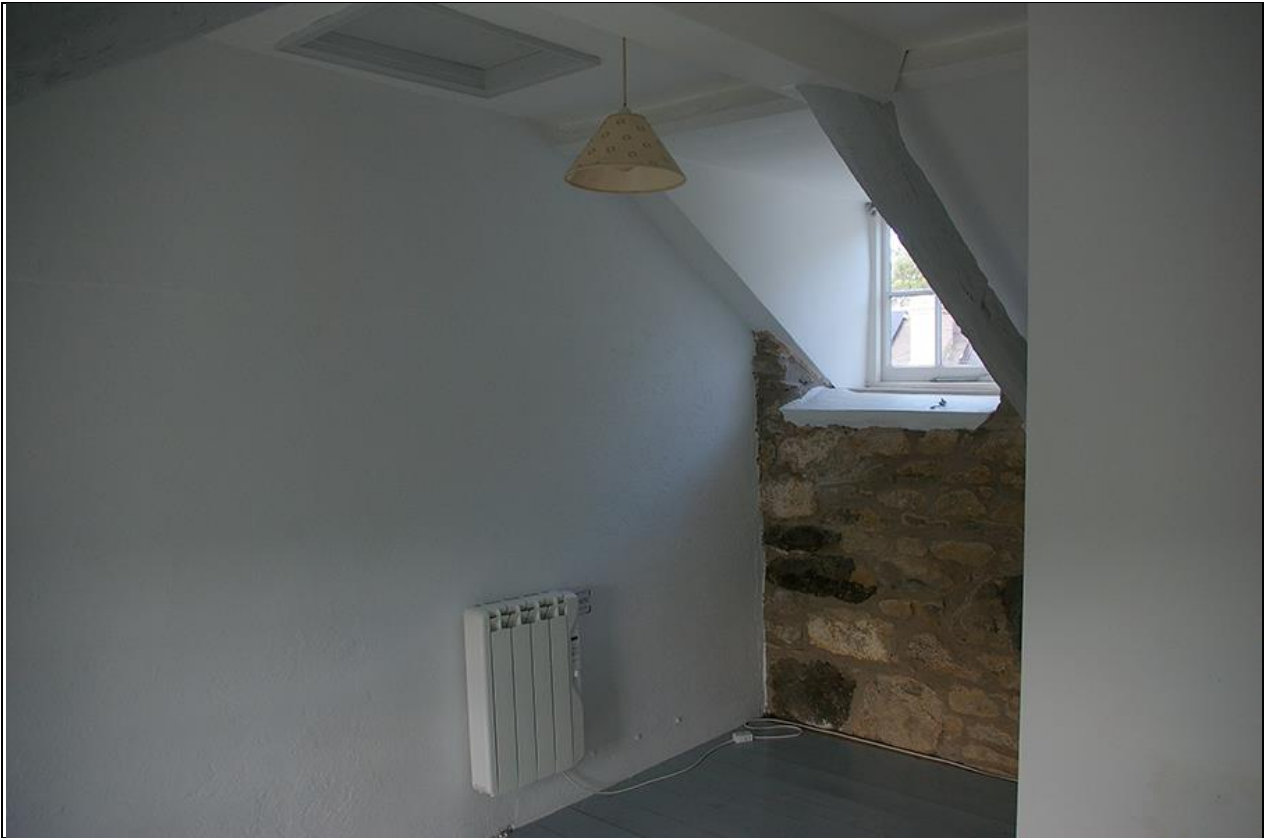
37. THE PLASTERED, RENOVATED END GABLE WALL – PROBABLY CONTAINING A BLOCKED FIREPLACE; FROM THE SOUTH-EAST.

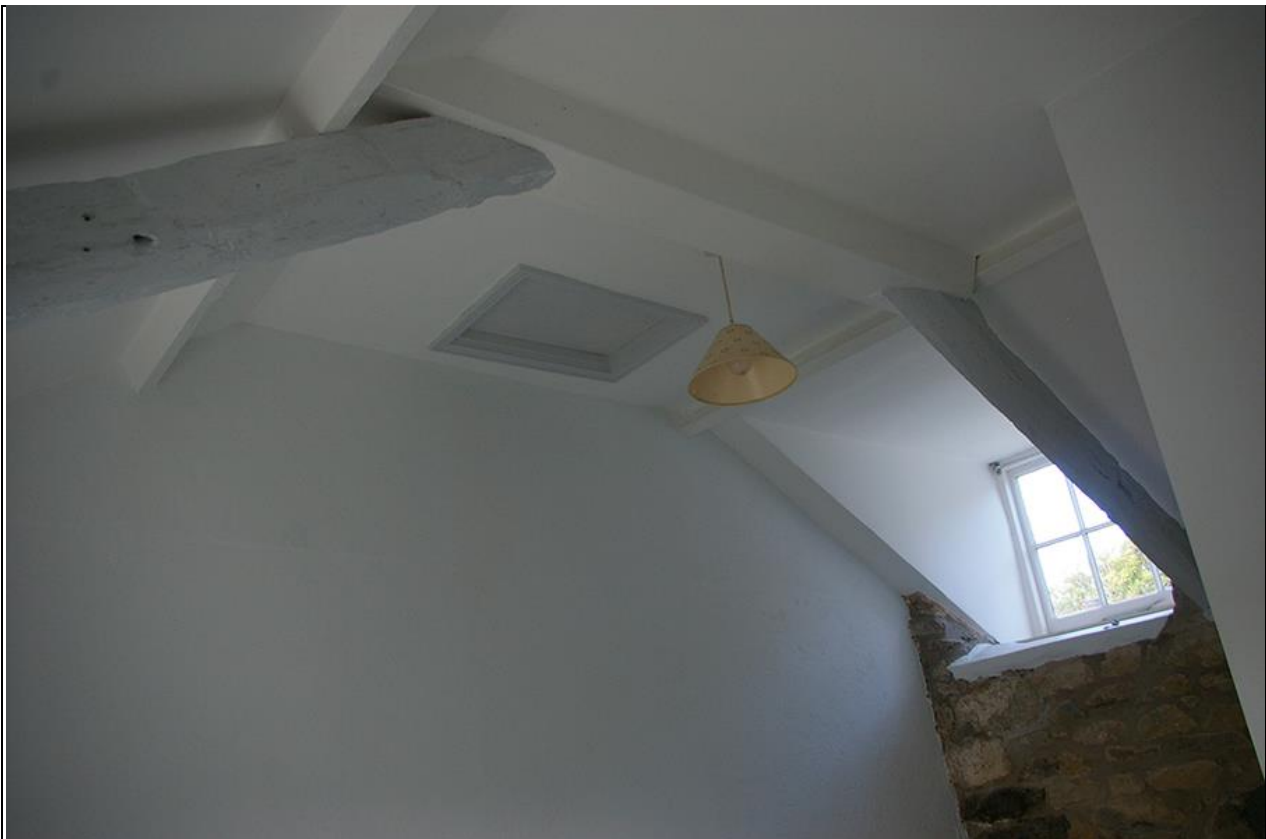
38. VIEW OF THE CEILINGS ON THE FIRST FLOOR – RAISED OVER THE RUSTIC TRUSSES ON A NEW ROOF STRUCTURE.

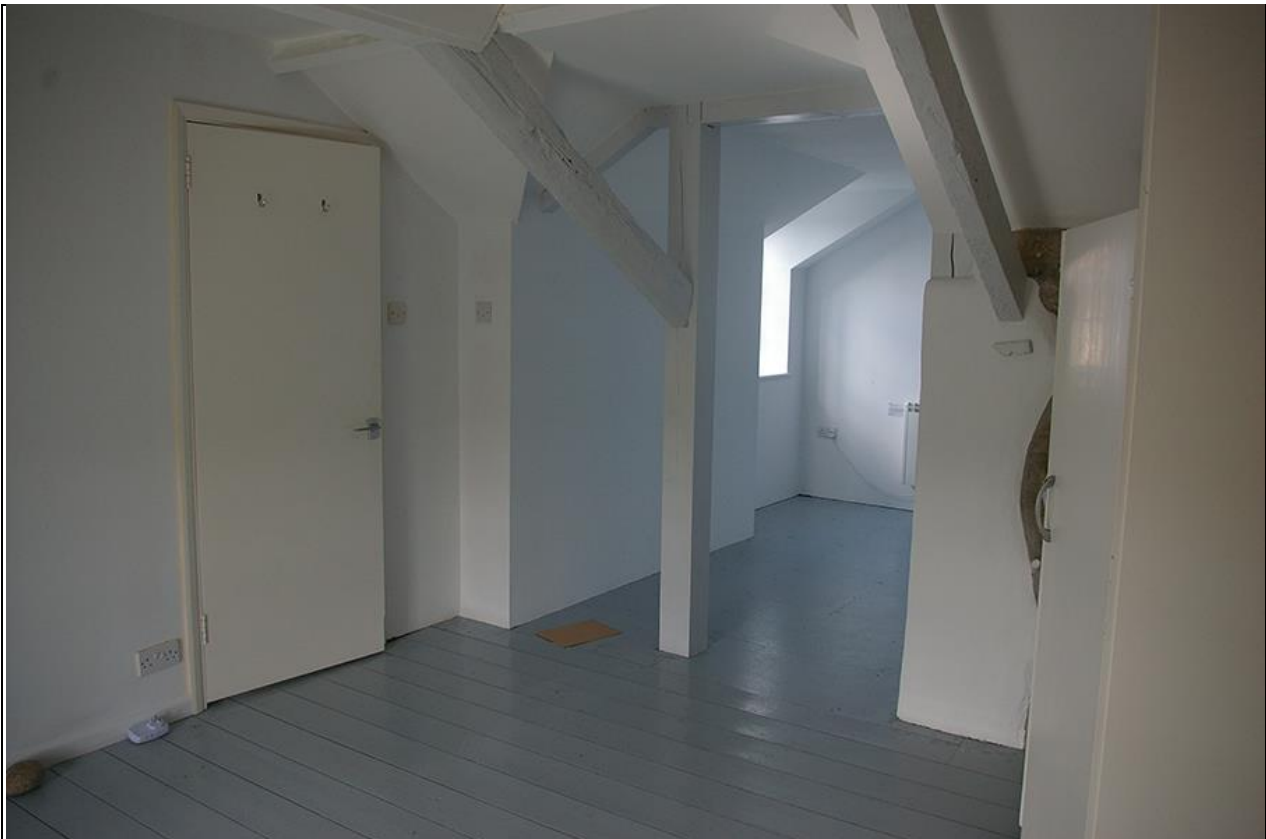
40. R9, WITH OPENING INTO R10, THE MODERN SPACE TO THE REAR; FROM THE SOUTH-EAST.

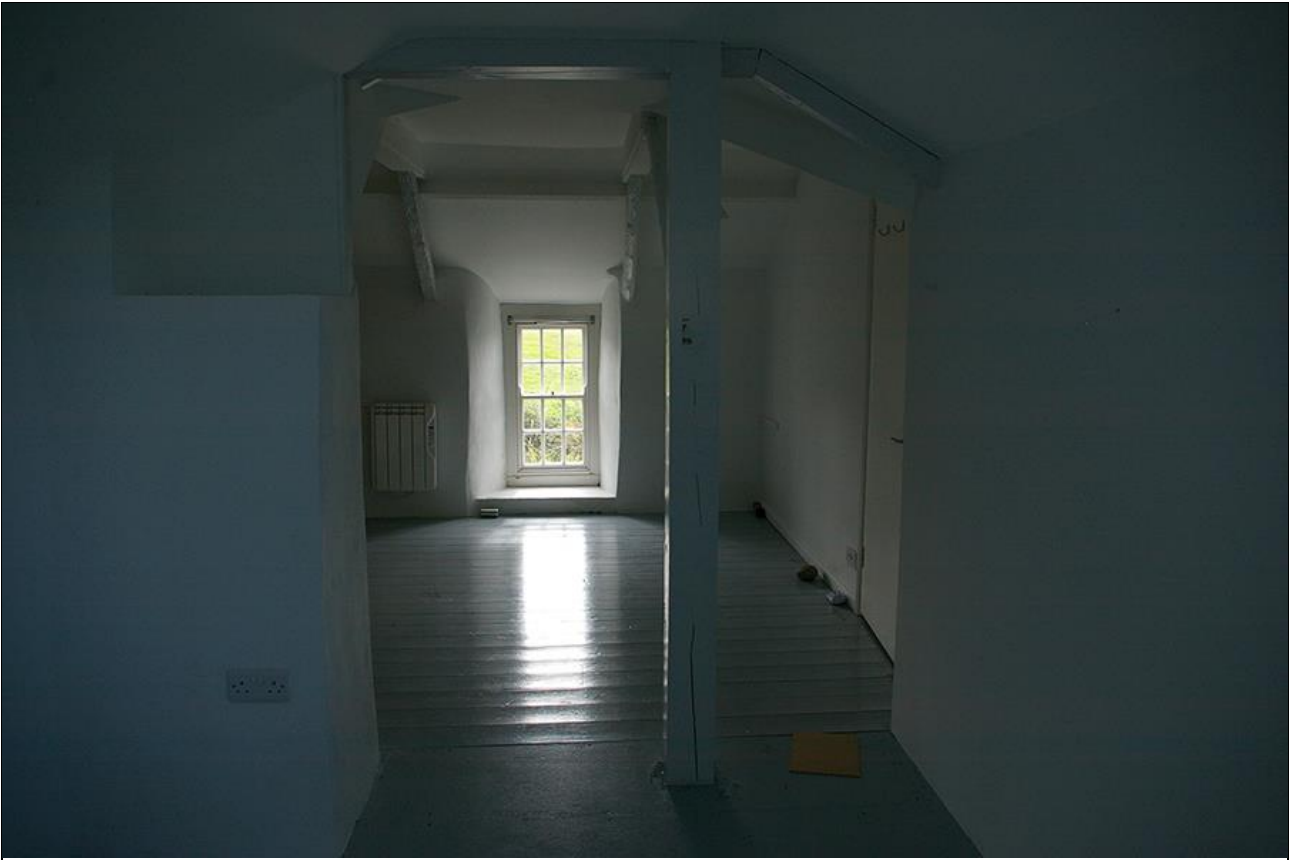
45. LOOKING THROUGH THE LARGE OPENING FORCED IN THE REAR WALL, FROM R10 TO R9; FROM THE NORTH.

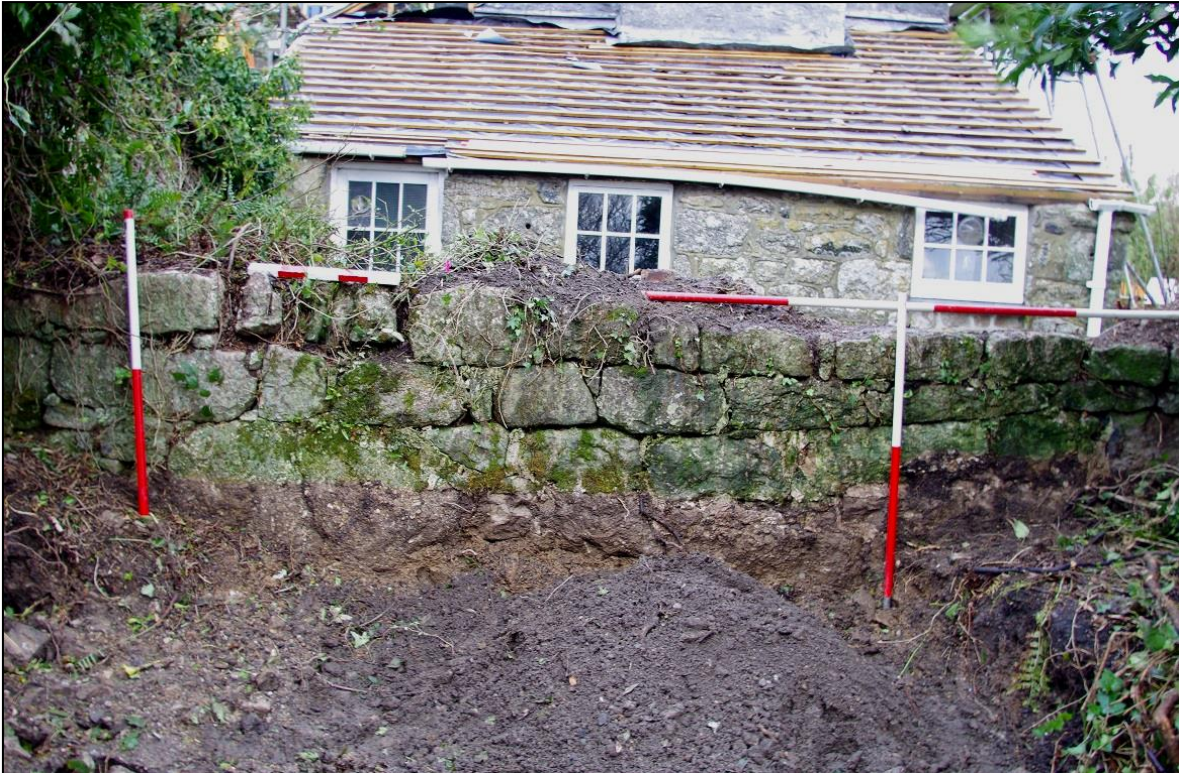
1. THE WEST WALL {041} OF THE RUIN, SHOWING THE WINDOW AND BLOCKED DOORWAY; FROM THE WEST (1M AND 2M SCALES).

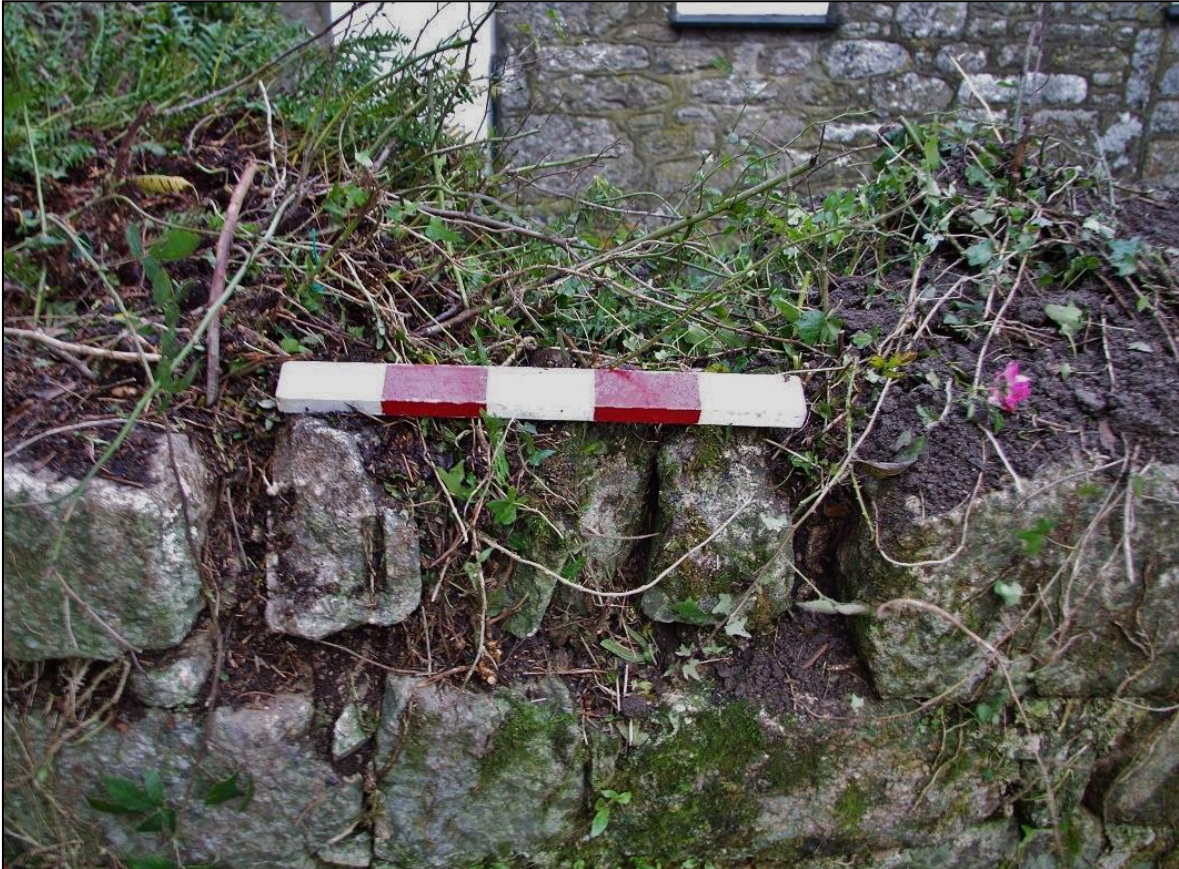
2. THE BLOCKED WINDOW {056} IN THE WEST WALL; FROM THE WEST (0.5M SCALE).

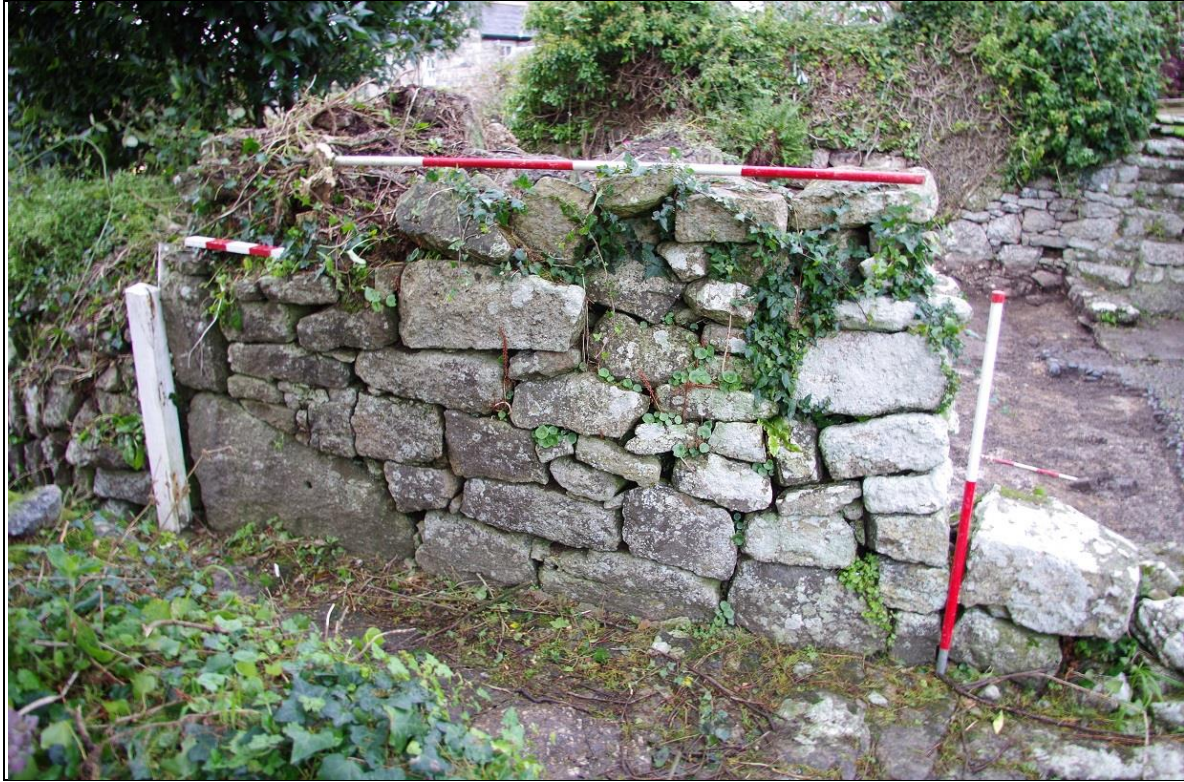
3. THE FRONT GARDEN WALL BANK {084}, DURING DEMOLITION; FROM THE SOUTH-EAST (2M, 1M AND 0.5M SCALES).

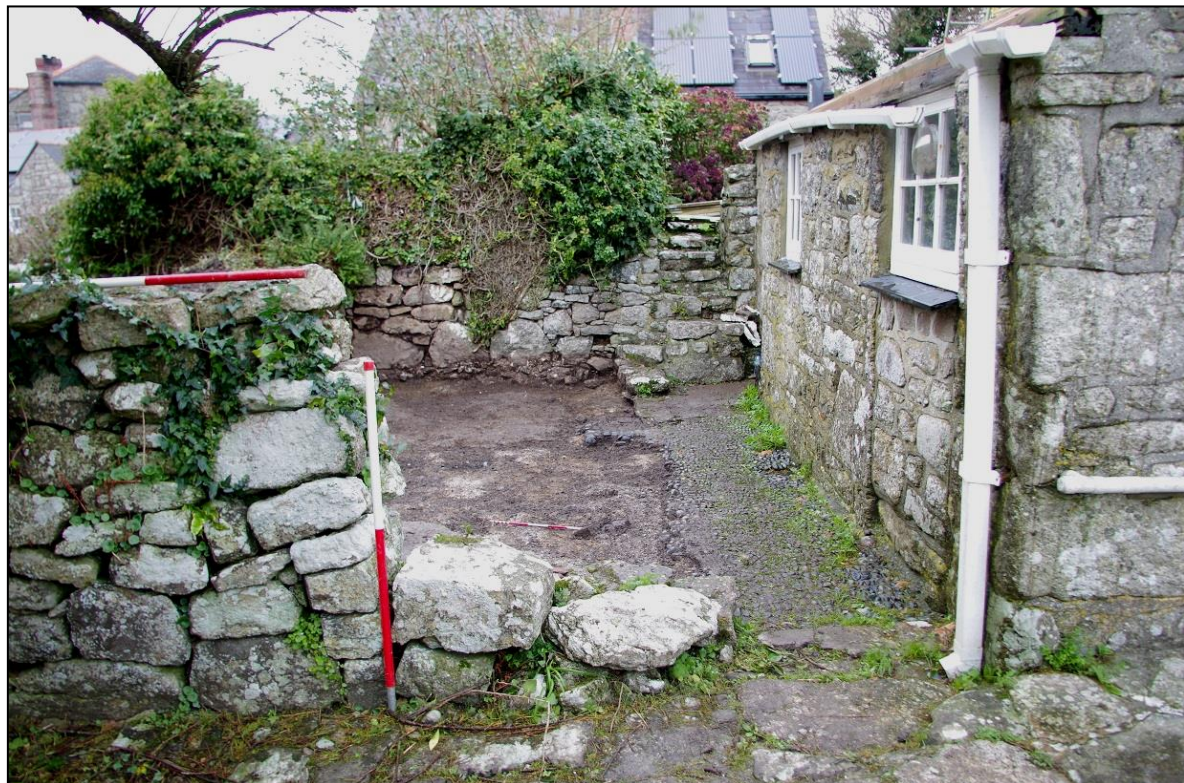
4. THE SHORT GARDEN WALL AND ORIGINAL DOOR AND PASSAGE TO THE RUIN; FROM THE SOUTH (1M AND 0.5M SCALES).

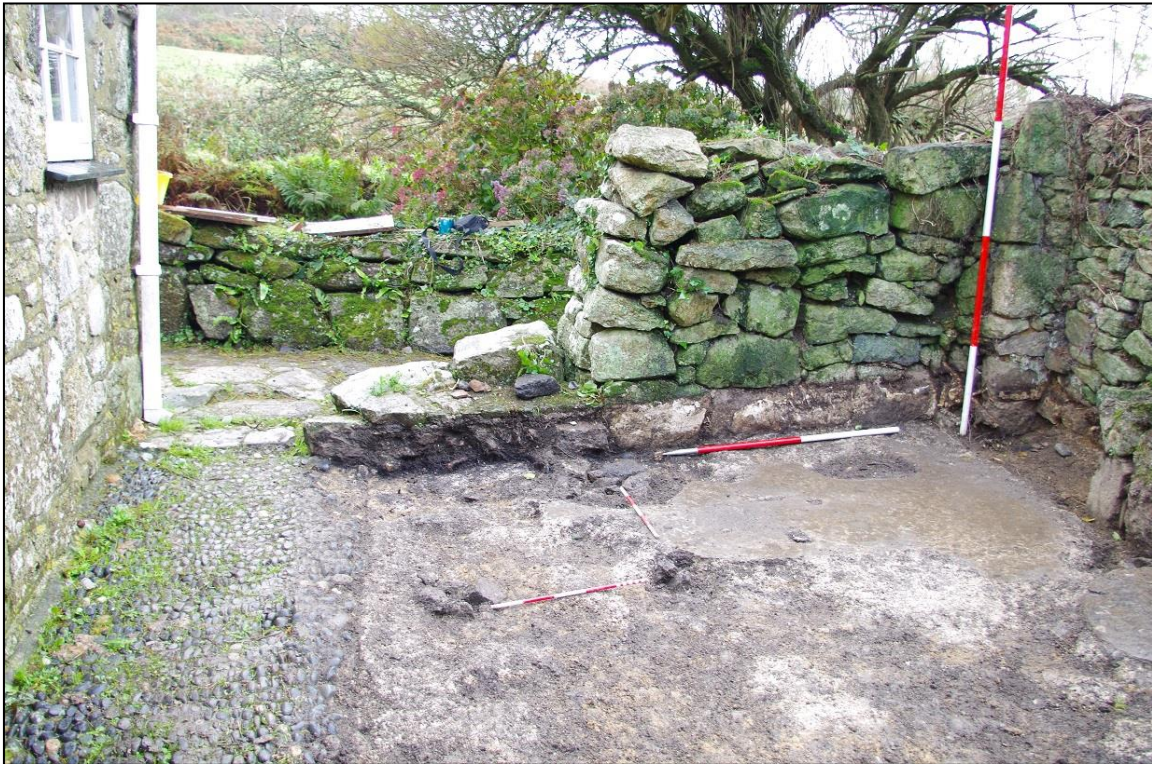
{048}	Structure	Ruined south wall surviving mainly as foundations, adjoining western gable wall of B1. Clay-bonded and cement re-pointed and patched, where it survives as one course to the west. Viewed during demolition of the ruin and B2.	Abuts B1 {085} on east side, granite paved path (091) to south, and by blocked doorway fill {086}; overlaid by lean-to {050}. Abuts {095}.	South wall is 0.66m thick x 3m to eaves line; east wall is 1.66m thick with chimney breast; 0.66m thick without it.	C19
{049}	Structure	Granite rubble wall foundations for narrower partition wall to R11 passage, clay bond.	Abutted from above by rebuilt walls of lean-to {050}, cut by threshold to south {}, abutted by contemporary threshold {}.	Originally c.4.20m long, only scattered stones or scar for wall survives – 0.10m-0.2m in places high.	C19
{050}	Structure	Mortared rubble west wall of lean-to and rebuilt rubble south wall, by which eastern half of ruin was re-roofed forming B2.	Abuts/overlies {049}, appears to overlie cobbles (003).	Originally c.4.20m long x 2m high x 0.50m thick; northern end rebuilt in 1980s, so now c.2.90m long.	Late C19-early C20?

5. THE REBUILT FRONT WALL OF THE RUIN; FROM THE NORTH, WITH OLDER SINGLE COURSE BELOW {048} (2M, 1M AND 0.5M SCALES).

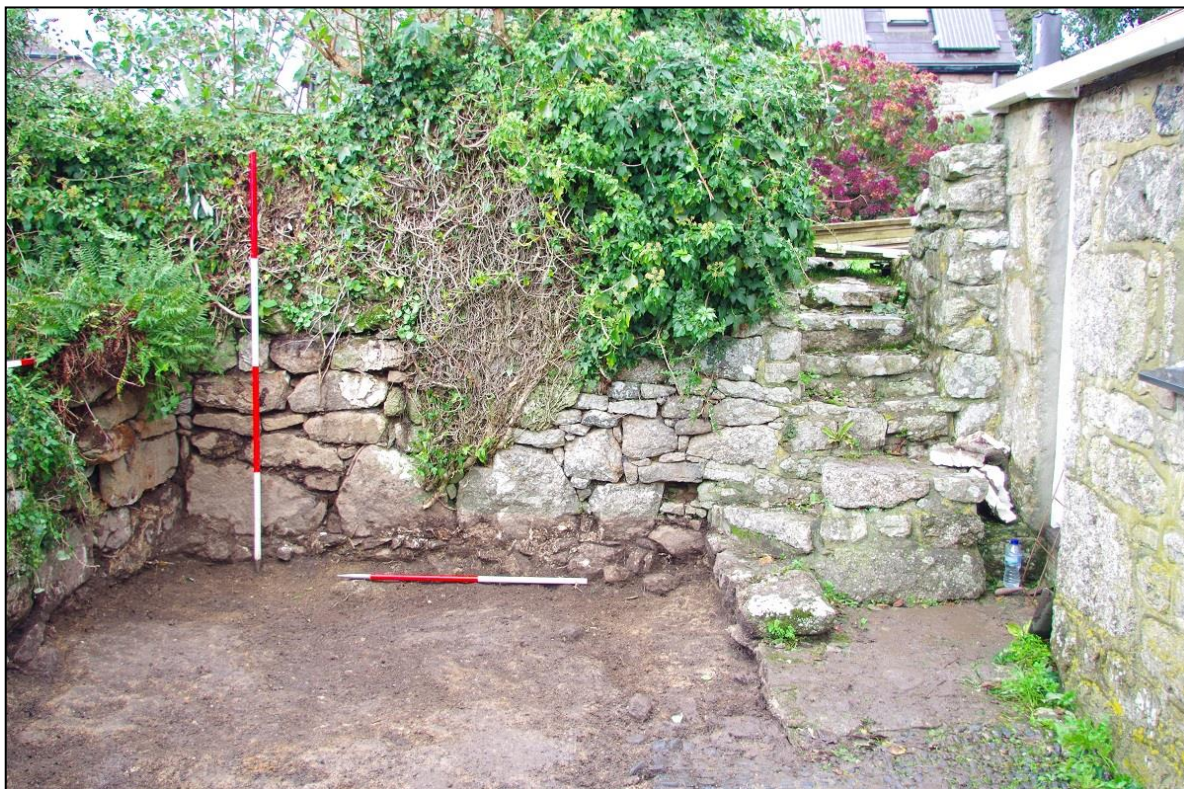
6. THE NORTH WALL OF THE BUILDING – ALTERED WITH STEPS CUT IN – POSSIBLY SET INTO A DOORWAY, WITH RAISED GARDEN LEVEL BEHIND; FROM THE SOUTH (1M AND 2M SCALES).

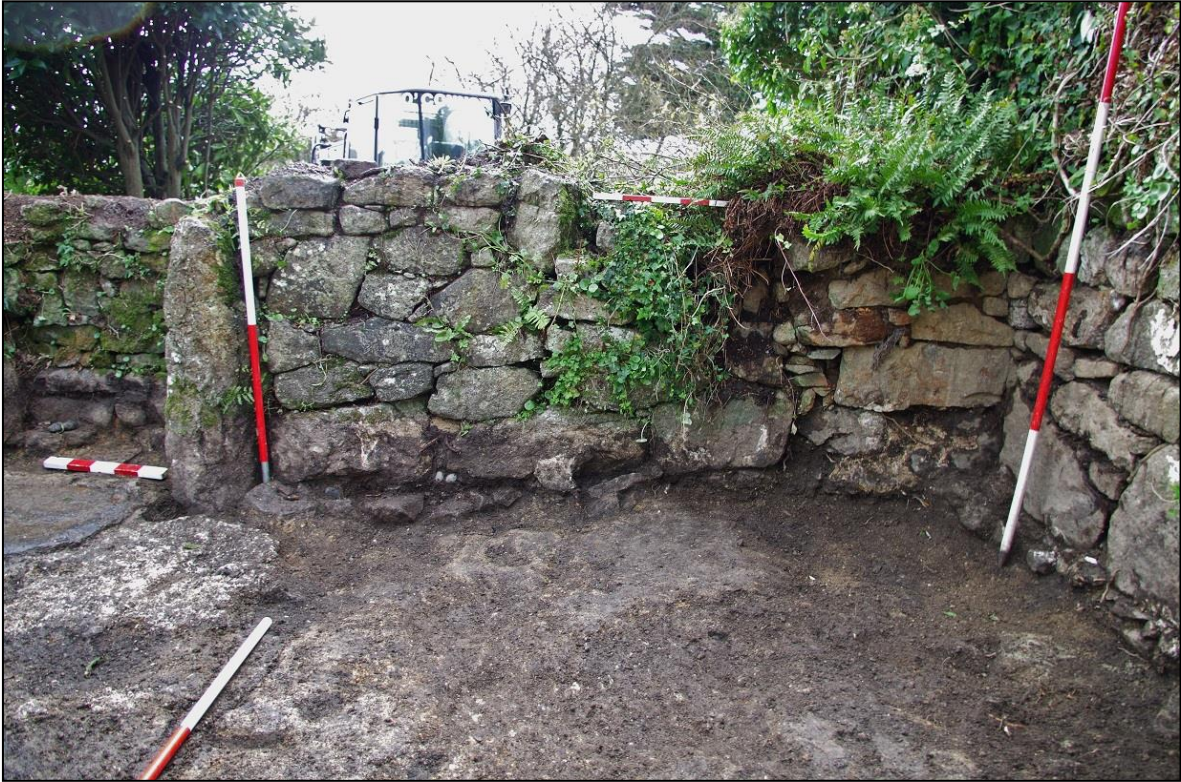
7. THE WEST WALL {041}, THE BLOCKED WINDOW 'NORTH' OF THE FIREPLACE; FROM THE EAST-NORTH-EAST (2M, 1M AND 0.5M SCALES).

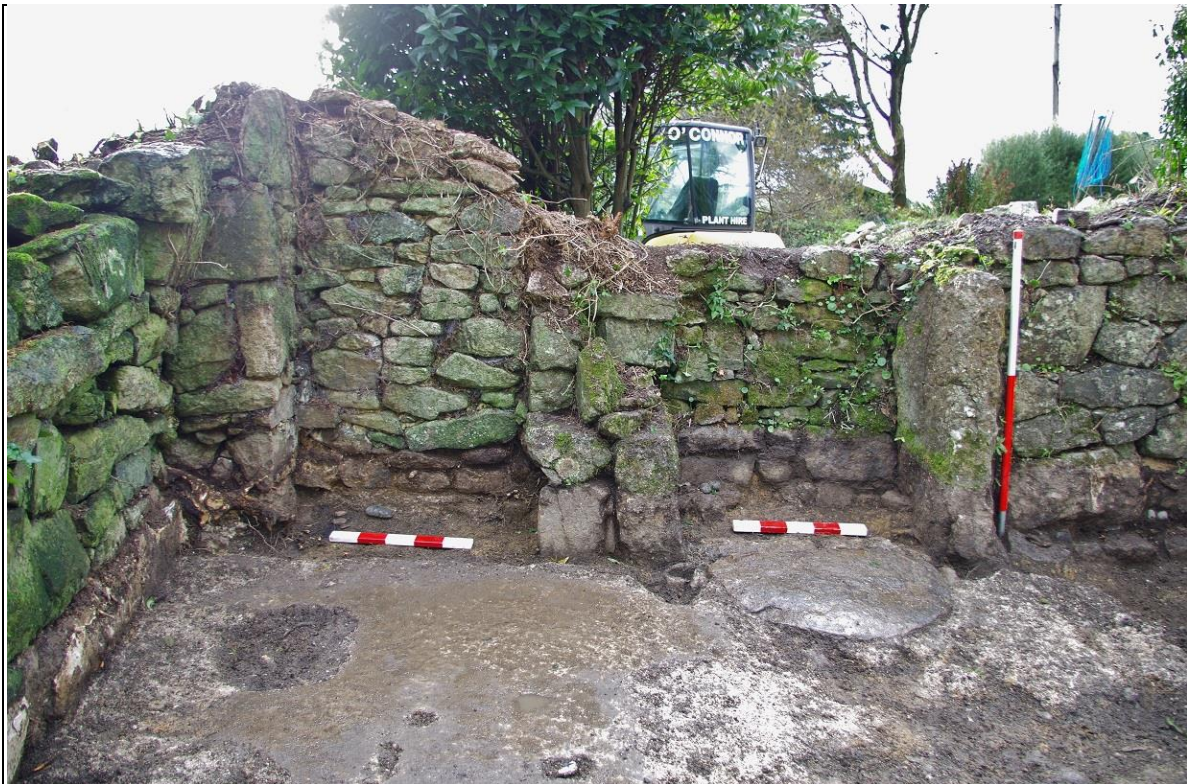
8. THE WEST WALL {041} OF THE RUIN, SHOWING THE BLOCKED DOOR, 'SOUTH' OF THE FIREPLACE AND THE FIREPLACE; FROM THE EAST (1M AND 0.5M SCALES).

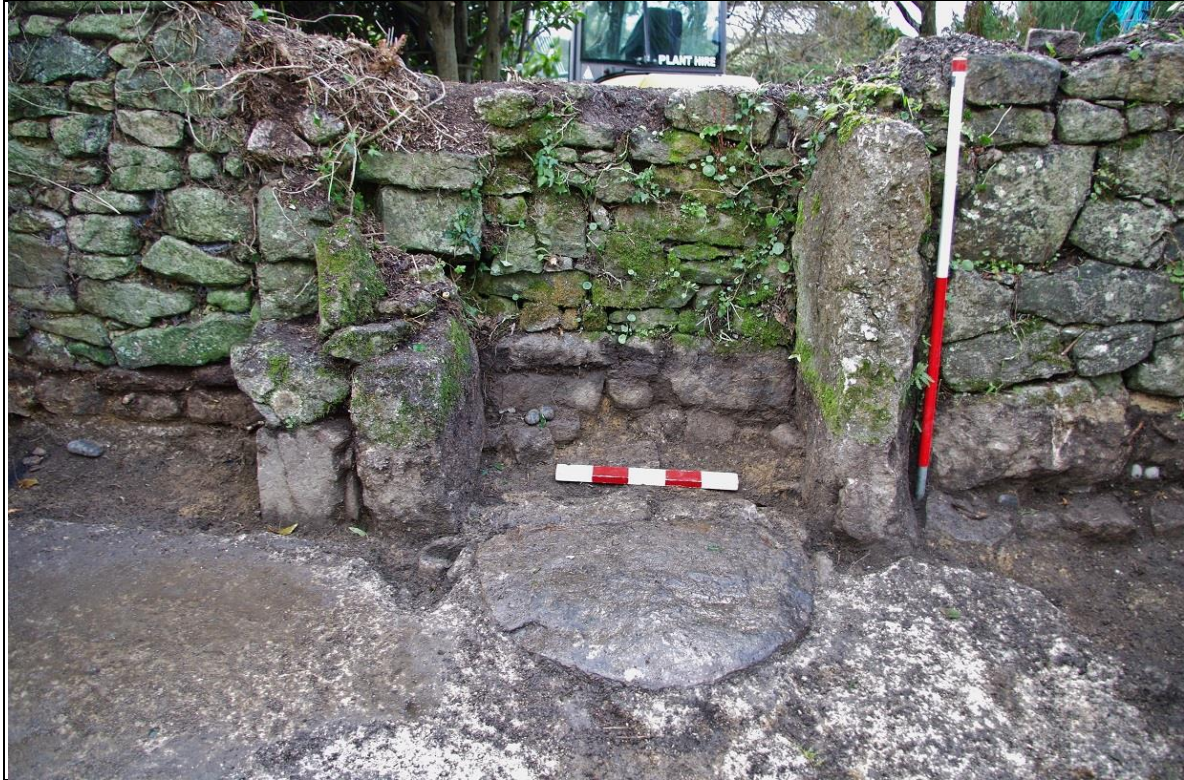
9. THE FIREPLACE {042} IN THE WEST WALL; FROM THE EAST (1M AND 0.5M SCALES).

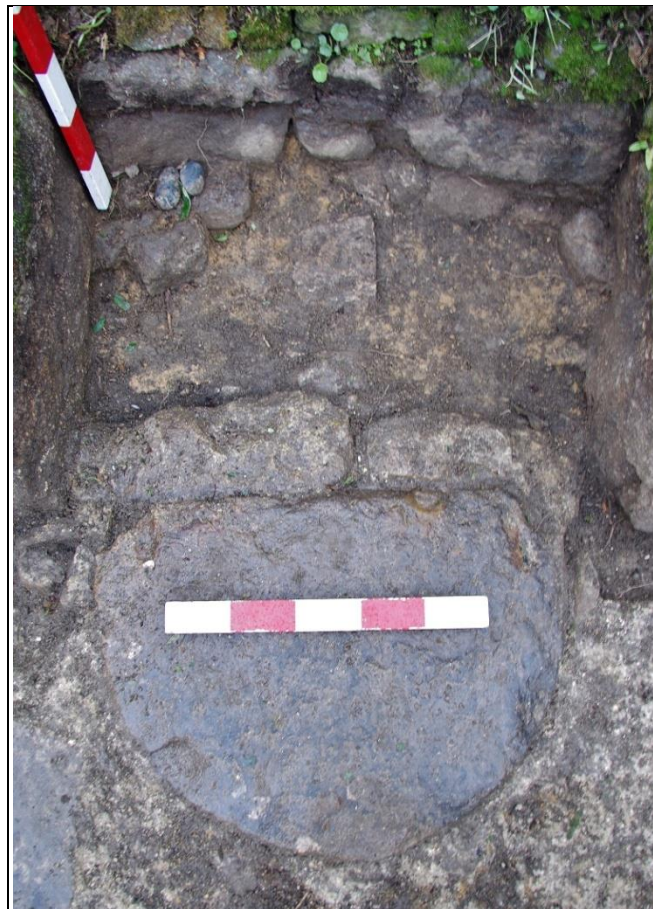
10. THE ROUNDED HEARTHSTONE {006} WHICH PROJECTS INTO THE ROOM, THE ROUGH PACKED STONework BEHIND (0.5M SCALES).

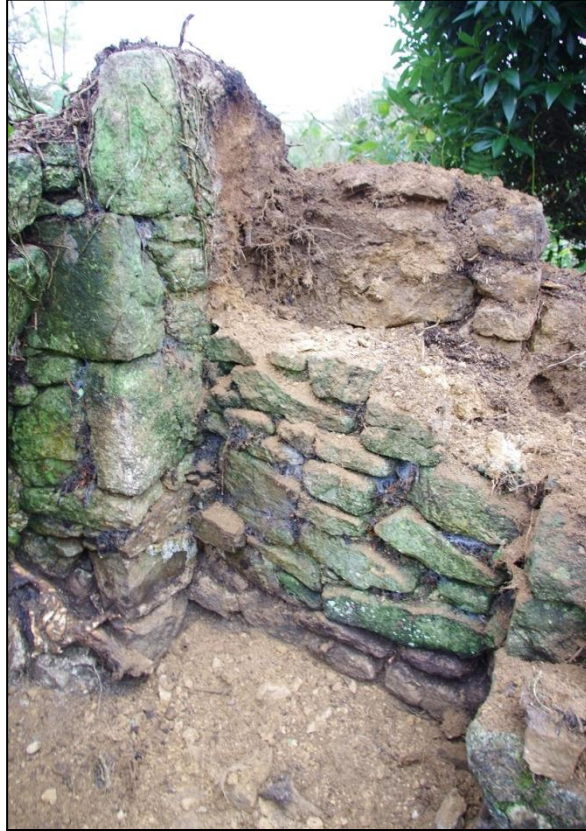
(021)	Fill	Dirty dark brown soil fill of post hole with burnt clay and ash.	Fill of [020], overlaid by (004).	0.25m x 0.33m x c.0.20m deep.	Late C19/early C20?
[022]	Cut/Structure	Doorway to the south of the west wall	Opening built into {041}, filled by (010)	0.87 wide x 0.83m thick x 1.05m high.	C19

11. THE BLOCKED DOORWAY {022} IN THE WEST WALL, ALTERED BY THE ADDITION OF THE FIREPLACE; FROM THE NORTH-EAST.

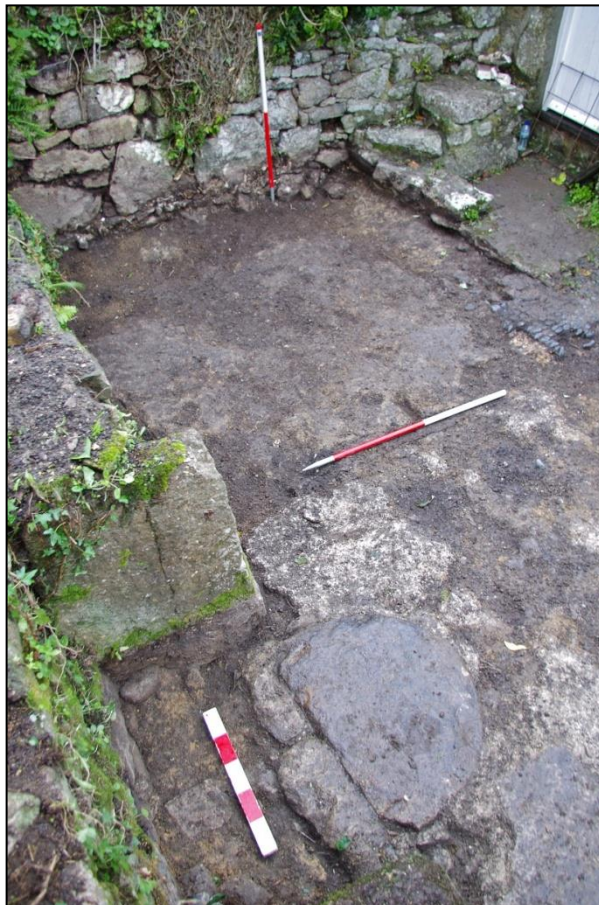
(005)	Layer	Yellowy orange-brown lime mortar floor in Room 13 of ruin, respecting plank partitions to south and probably to east, and older stone walls to north and west. Very decayed with no intact surface surviving, largely destroyed on northern edge. Occasional black pebbles on the western edge suggest that it replaced a cobbled floor as in the Room 11.	Overlies (063), overlain by (004), abuts {041} on north and west, {026} & {065} to south and {075} to east. Cut by [028] & [030], replaced pebble floor (055).	2.10m east-west x 2.34m north-south x 0.08m thick.	Mid-late C19
{006}	Structure	Partially surviving hearth structure of clay-bonded trapezoidal granite orthostats, inside fireplace in west wall of ruin. Largely lost in hearth area, but includes semi-circular dressed granite slab projecting into room. Latter is supported on two trig stones; at least one trig stone seen in hearth, set in yellow clay bedding material. Hearth slab of granite with large feldspars, very smooth and blackened on top; dressing scars on underside. Pair of indented wear marks with rust stains from wrought iron fire dogs set 0.60m apart at back edge of slab.	Abuts fireplace sides and back wall {041}, abutted by (008), (081) & (083), overlain by (004).	Total dimensions 0.90m wide x 1.16m front to back, x c.8-10cm deep. Hearth slab is 0.80m wide x 0.56m front to back x 8cm deep.	C19

(008)	Layer	Floor of dirty white mortar in Room 12 of ruin, respecting stone walls to west and south, and plank partitions to east and north. Some areas of intact surface survive in southern half, but it is largely eroded, parts of the north and east sides having gone entirely, leaving small patches overlying yellow clay bedding material (007). Occasional black pebbles on the southern and western edges suggest that it replaced a cobbled floor as in the Room 11.	Abuts (006), {041}, {064}, {065}; abutted by (009), cut by [012], [014], [016], [018], [020], [022], {024}, [037]; overlaid by (004).	2.80m east-west x 3m north-south x c.8cm thick.	Mid-late C19

12. VIEW ACROSS THE RUIN, SHOWING THE TWO LIME-PACKED FLOORS (008), (005); FROM THE SOUTH-WEST (1M AND 0.5M SCALES).

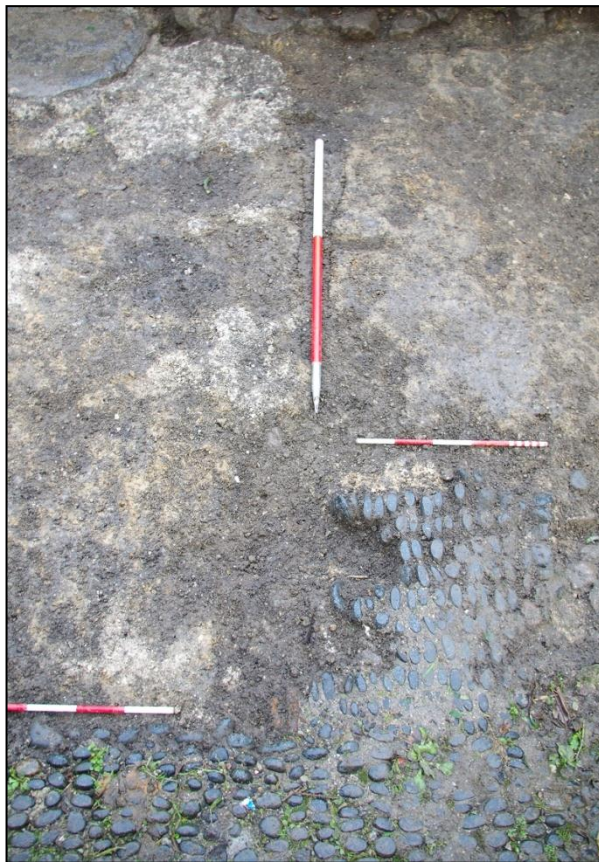
(023)	Fill	Dirty light brown silt, contains traces of timber partition {065} and wrought iron staple at east end.	Fill of [022], abutted by (008) & (032), abuts {064}.	0.64m x 0.19m x 0.10m deep.	Late C19/early C20
[024]	Cut, for a Structure	Long narrow slot, respected by mortar floors (005) and (008), perhaps void for decayed sill beam of east-west plank partition between R12 and Room 13 in ruin. Re-cut slightly on north side in R13, possibly to repair sill beam or replace planks.	Abutted by (005), (008) & (029); post void {026} adjoined and supported partition.	1.86m survives from original length of 2.25m, 7cm wide to east end; 20cm at west end. c.5cm deep.	Late C19

(025)	Fill	Very dark brown silt, derived from decay of sill beam {024}.	Fill of [024], cut by [030], abutted by (029).	1.86m long x 7cm wide to east end; 20cm at west end. c.5cm deep.	Late C19/early C20

14. THE SLOTS FOR THE PLANK PARTITIONS [ 024 ], [035 ], IN THE LIME-PACKED FLOORS (008), (005) BETWEEN THE FRONT AND BACK ROOMS, R12 AND R13; FROM THE EAST (1M AND 0.5M SCALES).

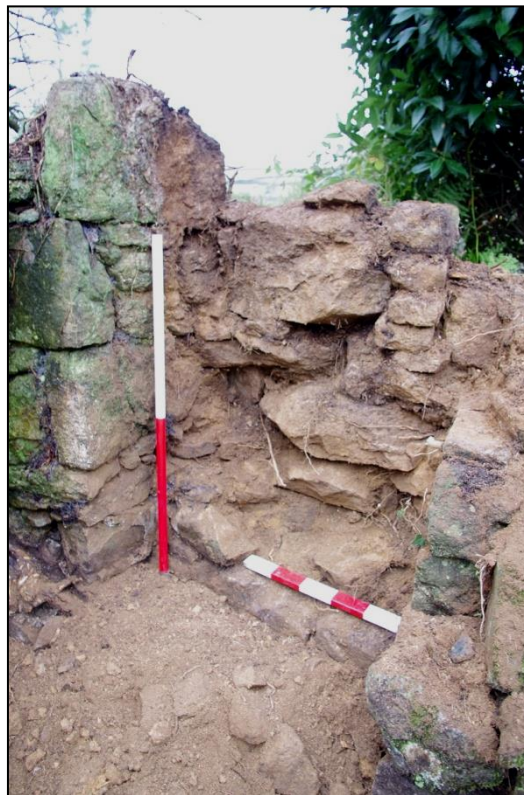
16. THE DOORWAY {022}, REMOVING THE BLOCKING (010); FROM THE NORTH-EAST (1M AND 0.5M SCALES).

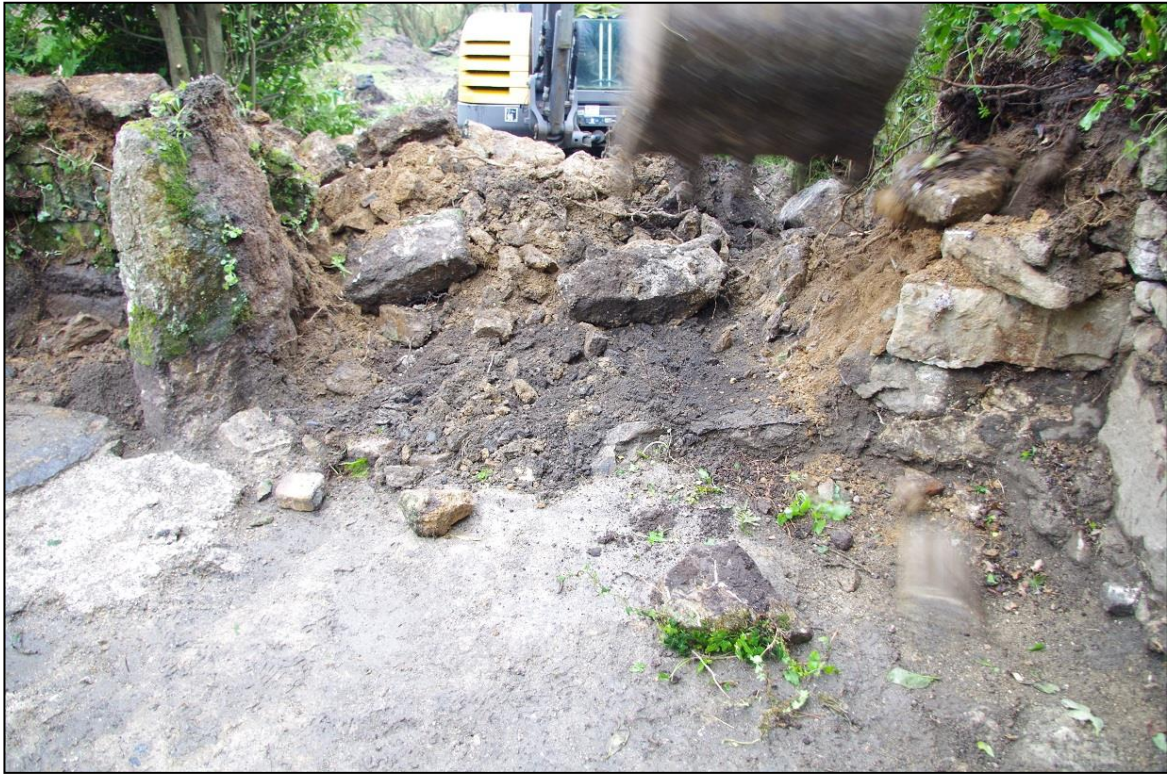
17. DEMOLISHING THE WEST WALL {041}, WORKING SHOT; FROM THE EAST-NORTH-EAST.

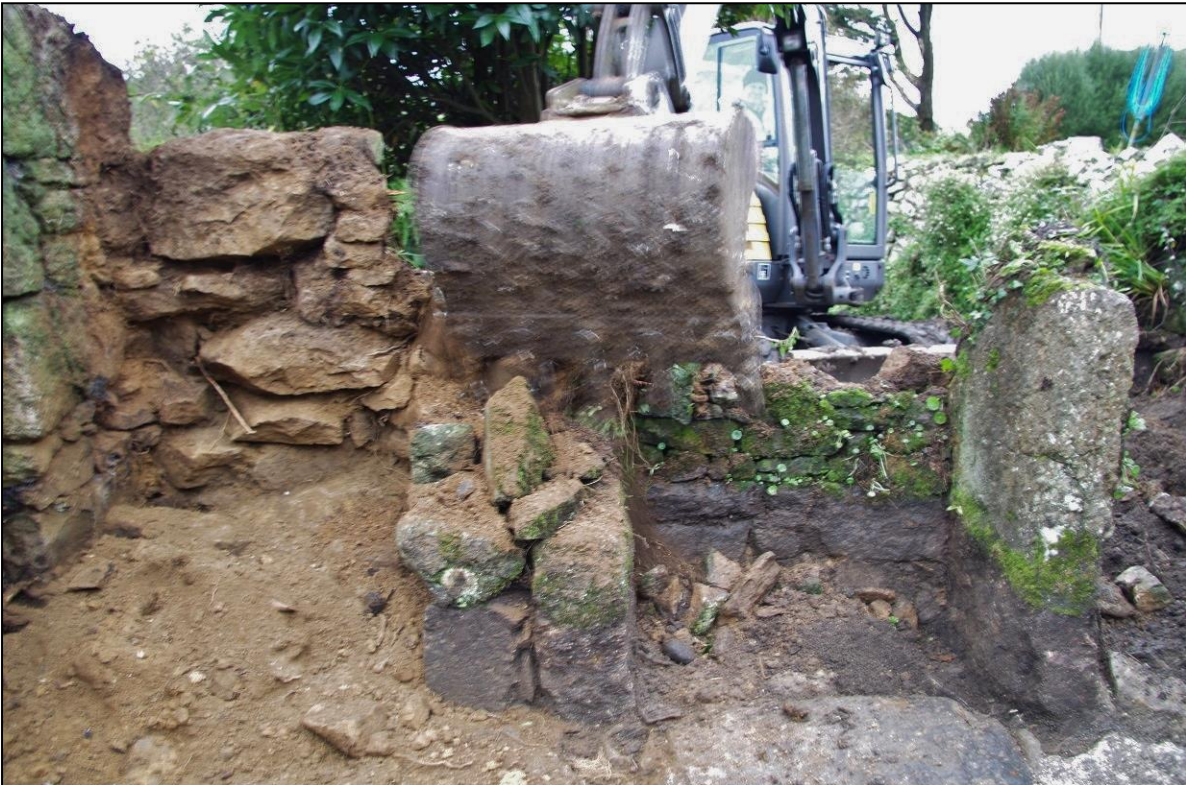
18. THE FIREPLACE {042} BEING DEMOLISHED, WORKING SHOT; FROM THE EAST.

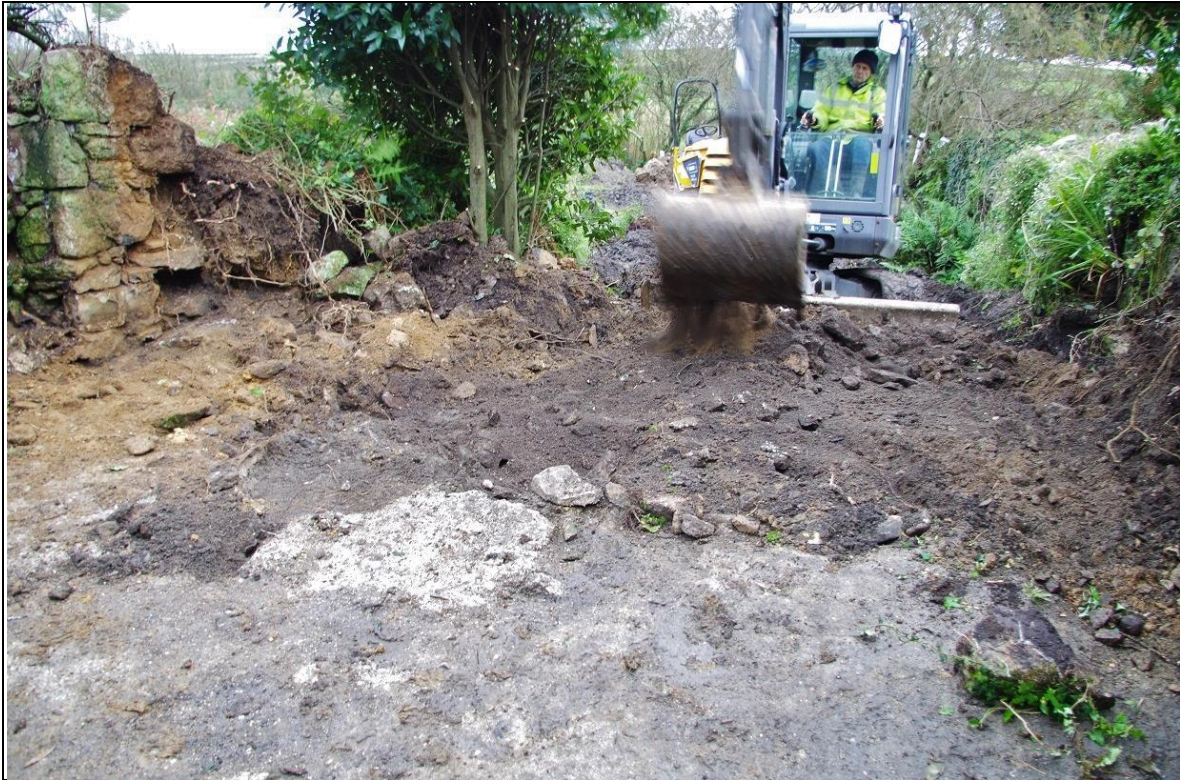
THE WEST WALL {041} OF THE RUIN BEING DEMOLISHED, WORKING SHOT; FROM THE EAST-NORTH-EAST.

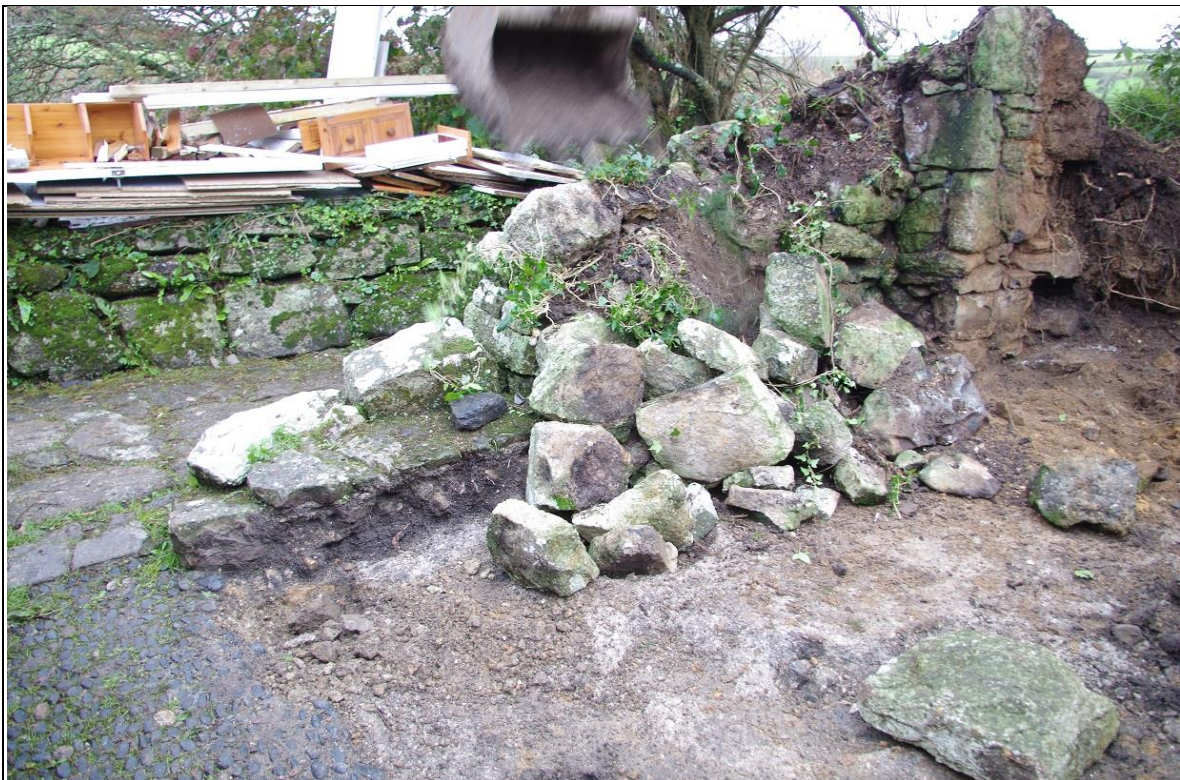
19. THE FRONT WALL {084} BEING DEMOLISHED – SHOWING TOPSOIL CORE; FROM THE NORTH-EAST.

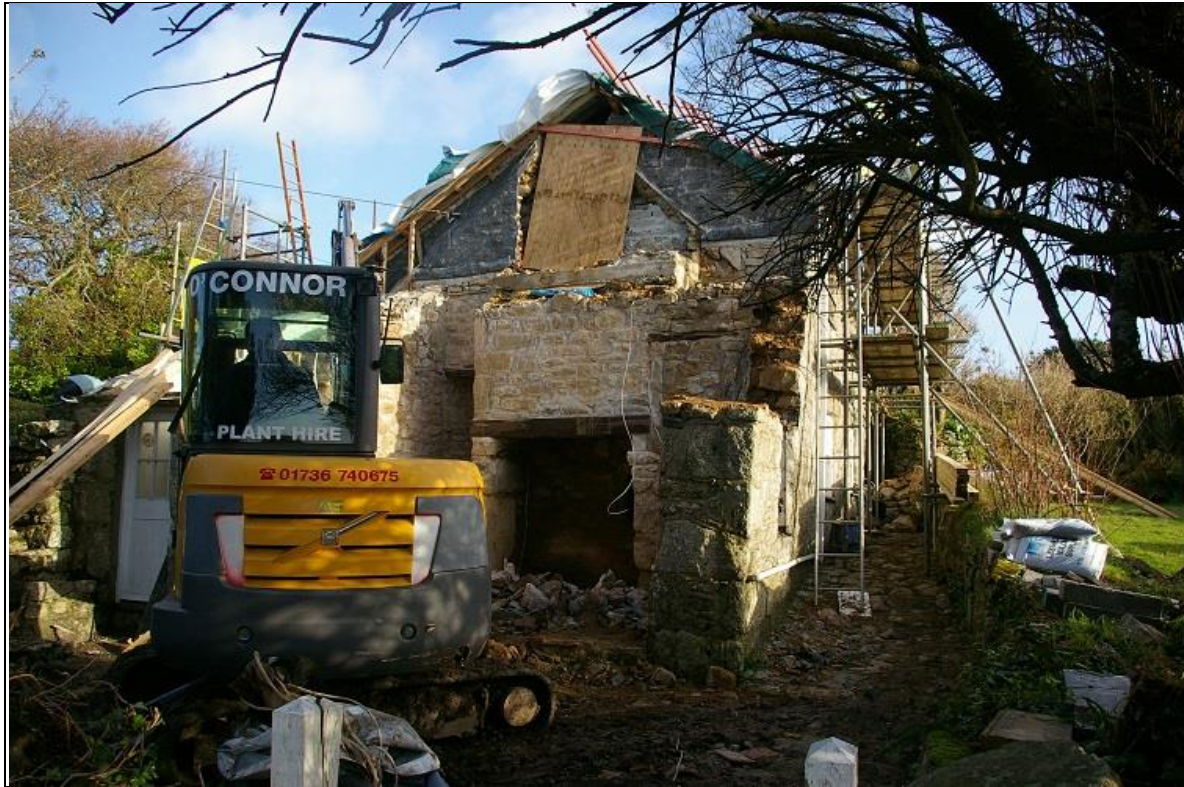
20. WORKING SHOT OF THE DEMOLITION OF B2, THE LEAN-TO; FROM THE WEST-SOUTH-WEST.
