**NANQUIDNO VEAN**

**ST. JUST**

Archaeological Monitoring and Recording and Historic Building Recording

South West Archaeology Ltd. report no. 191007

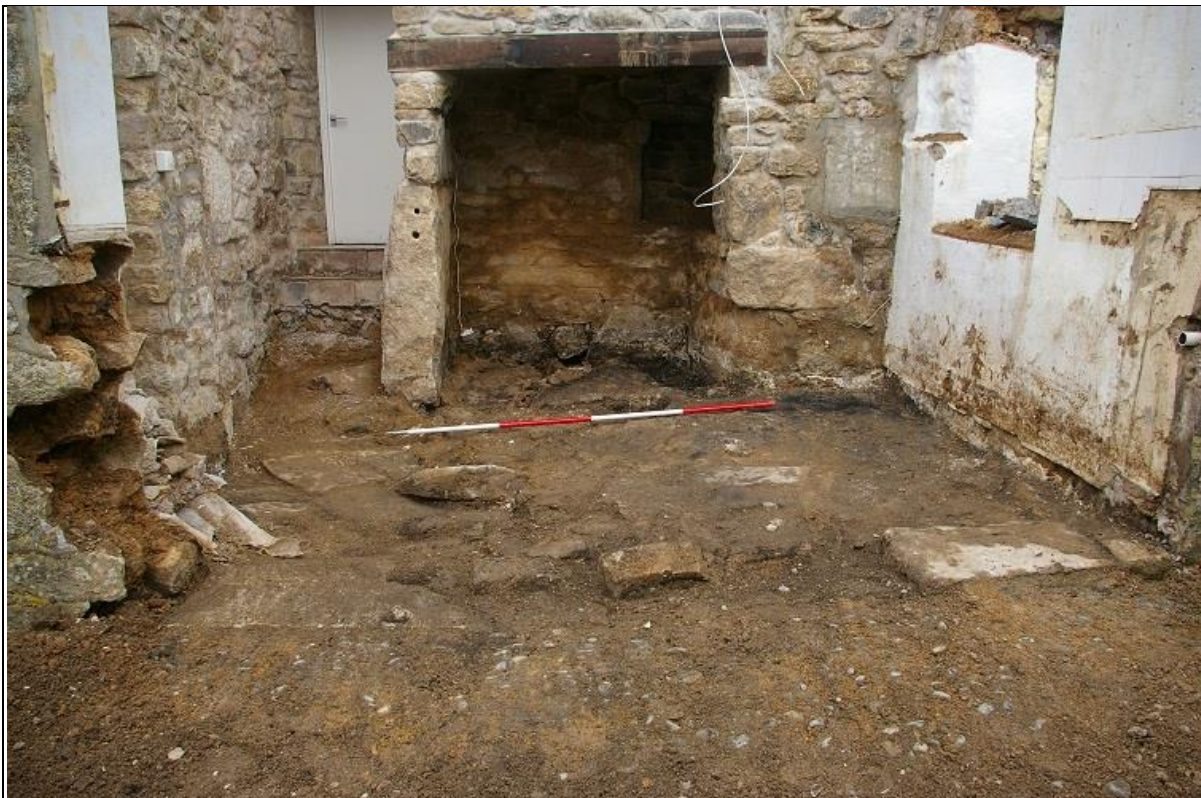
21. THE CLEARED HISTORIC REMAINS UNDER THE LEAN-TO — SHOWING TWO PHASES OF FLOORING (2M SCALE); FROM THE WEST.

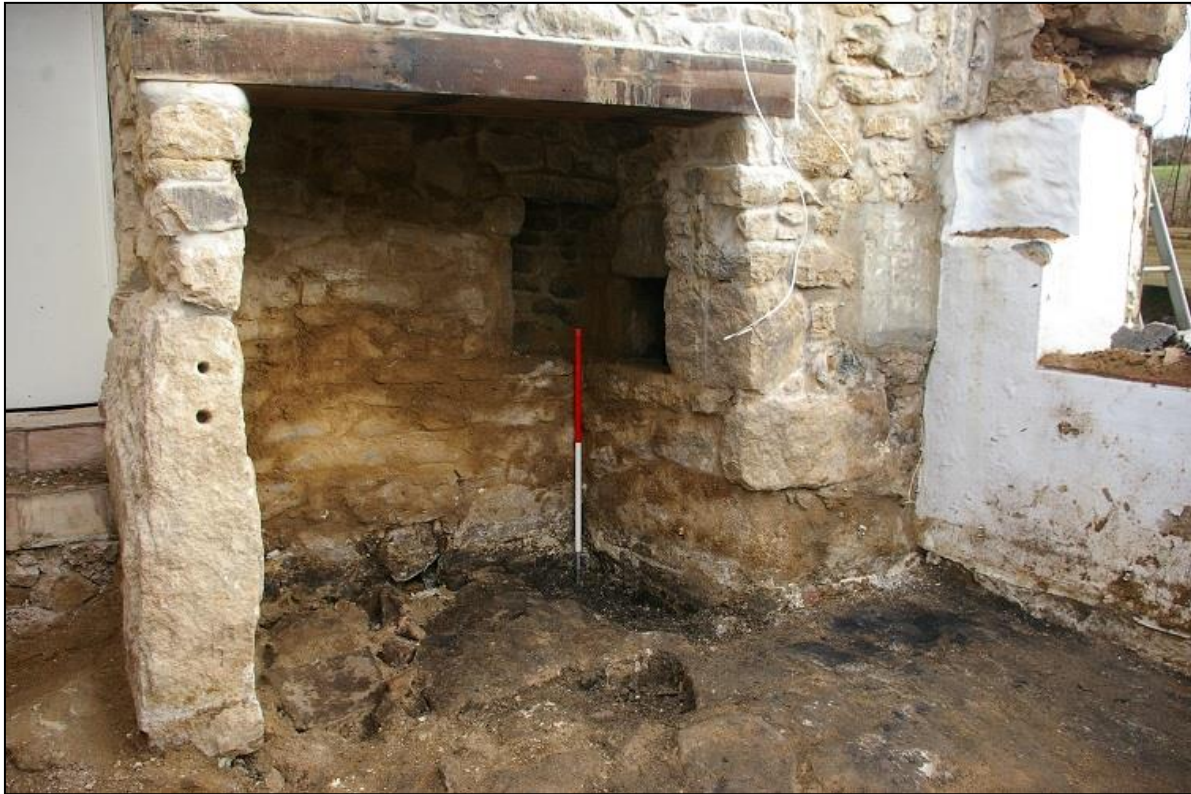
22. DETAILED VIEW OF THE FIREPLACE, WITH BREAD OVEN, BLOCKED KEEPING PLACE AND BLOCKED FIREPLACE AT FIRST FLOOR (1M SCALE); FROM THE NORTH-WEST.

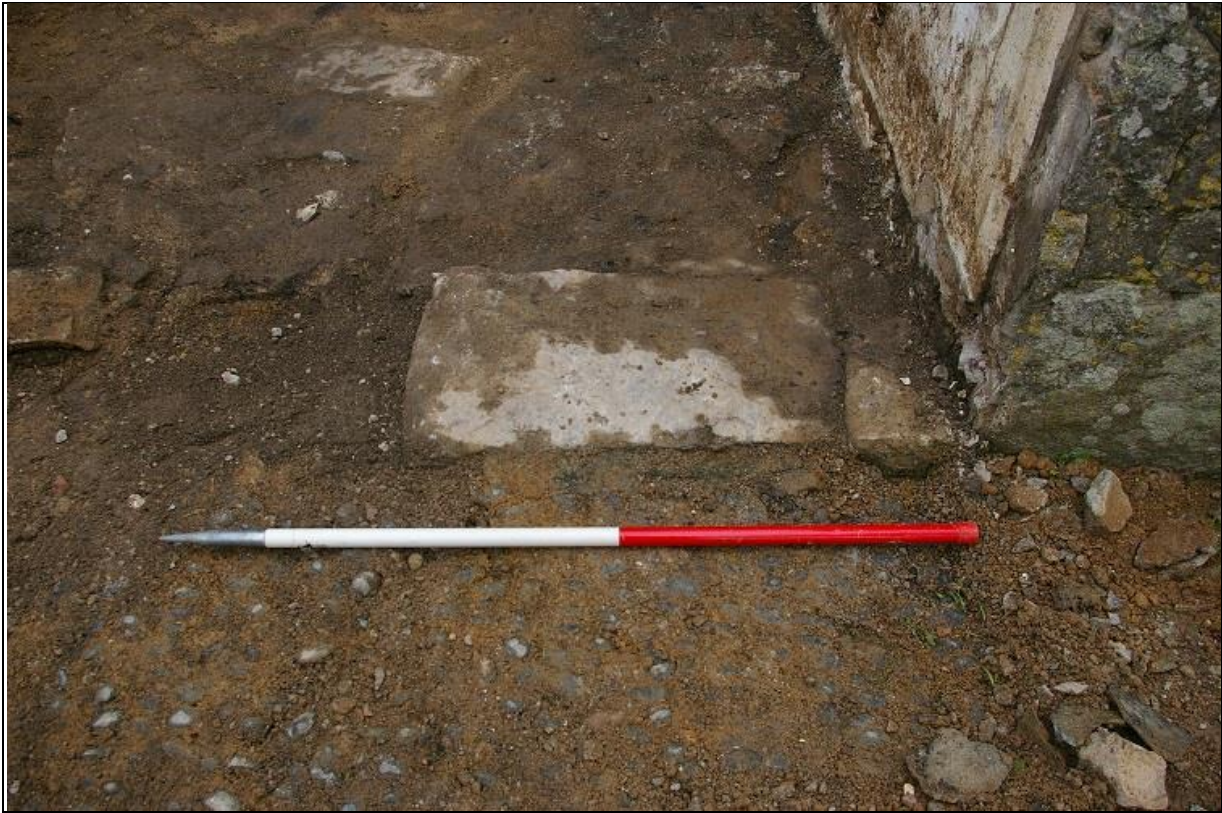
26. THE STONE THRESHOLD {051} OF THE BLOCKED DOORWAY IN THE WEST WALL OF B2, THE LEAN-TO EXTENSION, CUT INTO THE PASSAGE FLOOR; FROM THE WEST (1M SCALE).

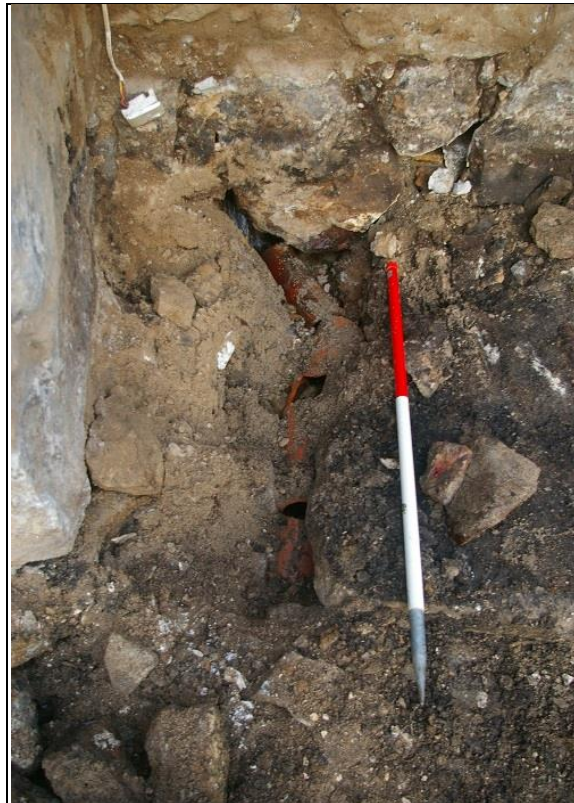
29. THE DRAIN WITH TERRACOTTA 19<sup>TH</sup> CENTURY PIPES INSERTED, WHICH HAS COLLAPSED DURING CLEARANCE; FROM THE WEST (1M SCALE).

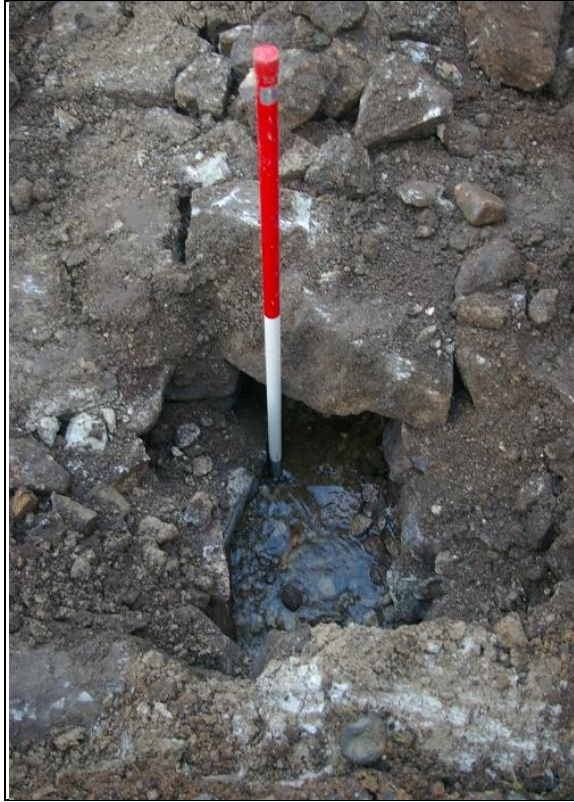
30. THE PROFILE OF THE DRAIN {076} WHICH RUNS UNDER THE HEARTH AND RUNS NORTH-WEST ACROSS R2, WITH HEAVY SLABS OVER THE DRAIN, THE BUILT STRUCTURE; FROM THE WEST-NORTH-WEST (1M SCALE).

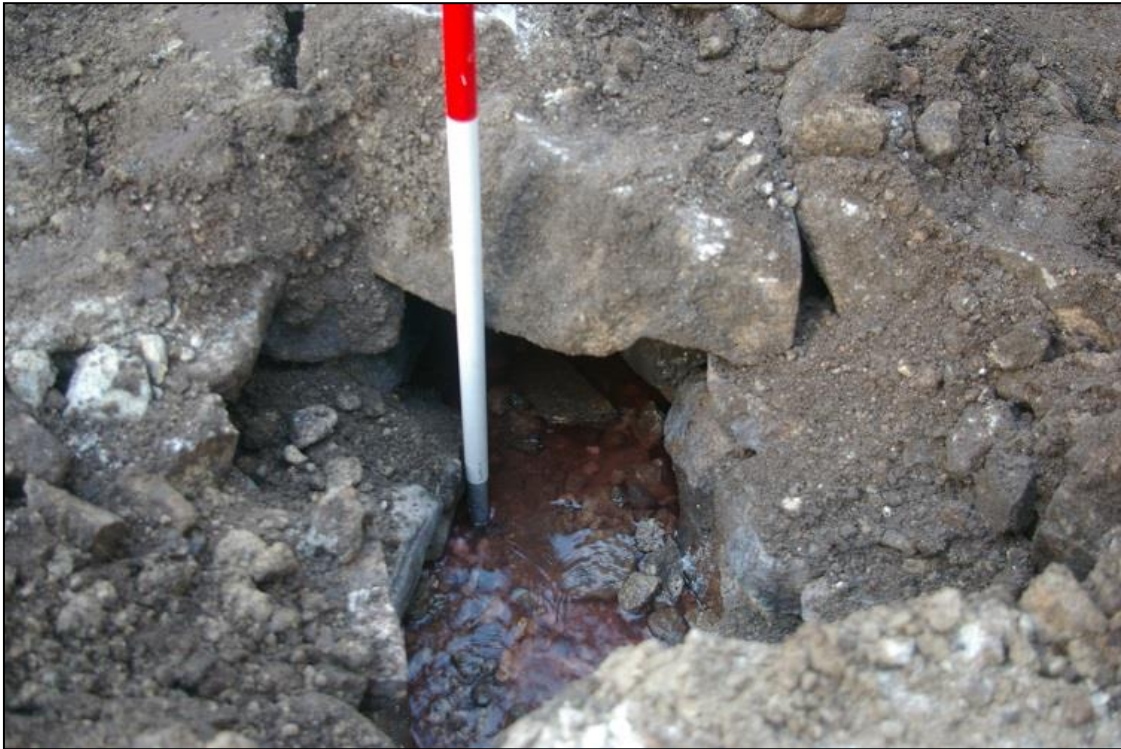
32. THE SECOND DRAIN {077} WHICH RUNS SOUTH-WEST AT A 45 DEGREE ANGLE FROM DRAIN {076}; FROM THE NORTH (1M SCALE).
