THE COMMUNITY CENTRE ST DAVID'S HILL EXETER

Results of Archaeological Monitoring
&
Historic Building Recording

Report No.: 120208
Date: 08.02.2012
Author: S. Walls
E. Wapshott

SWARCH project reference: ESD11
National Grid Reference: SX915928
OASIS reference: southwes1-108890
OS Map copying Licence No: 100044808
Planning application No: 10/1453/03 and 10/1523/07
City Archaeologist: Andy Pye
Project Director: Colin Humphreys
Monitoring & recording: Dr Samuel Walls
Building Recording: Emily Wapshott
Report: Dr Samuel Walls; Emily Wapshott
Report Editing: Deb Laing-Trengove
Graphics: Dr Samuel Walls

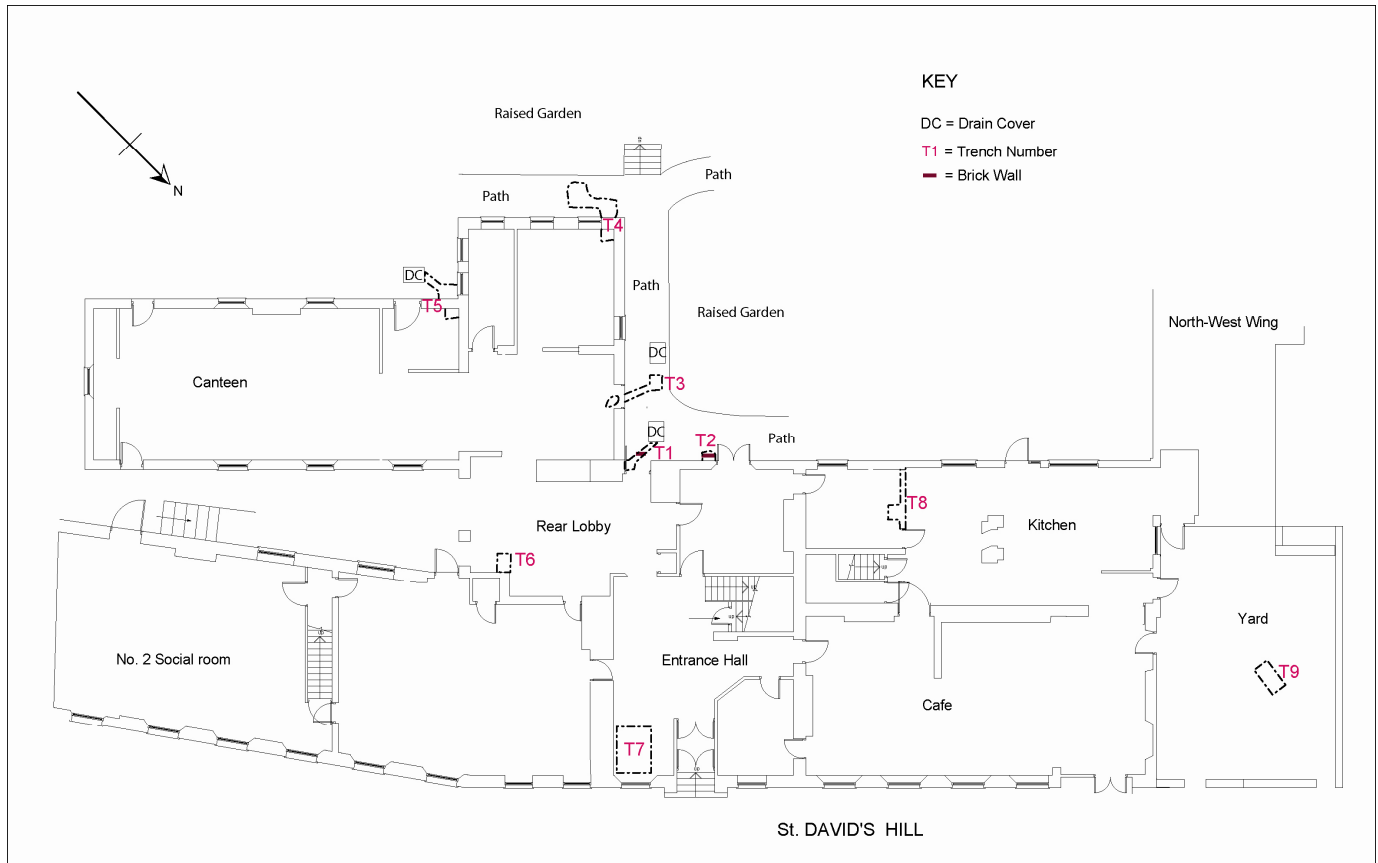
Figure 13: Location of the monitored trenches. (Not to scale)

The majority of the trenches were excavated in relation to services so the sizes of the observed areas were generally small and revealed little of archaeological note. For trench locations see Figure 13 below.
