The Walronds

Cullompton

A Revised Gazetteer

August 2014

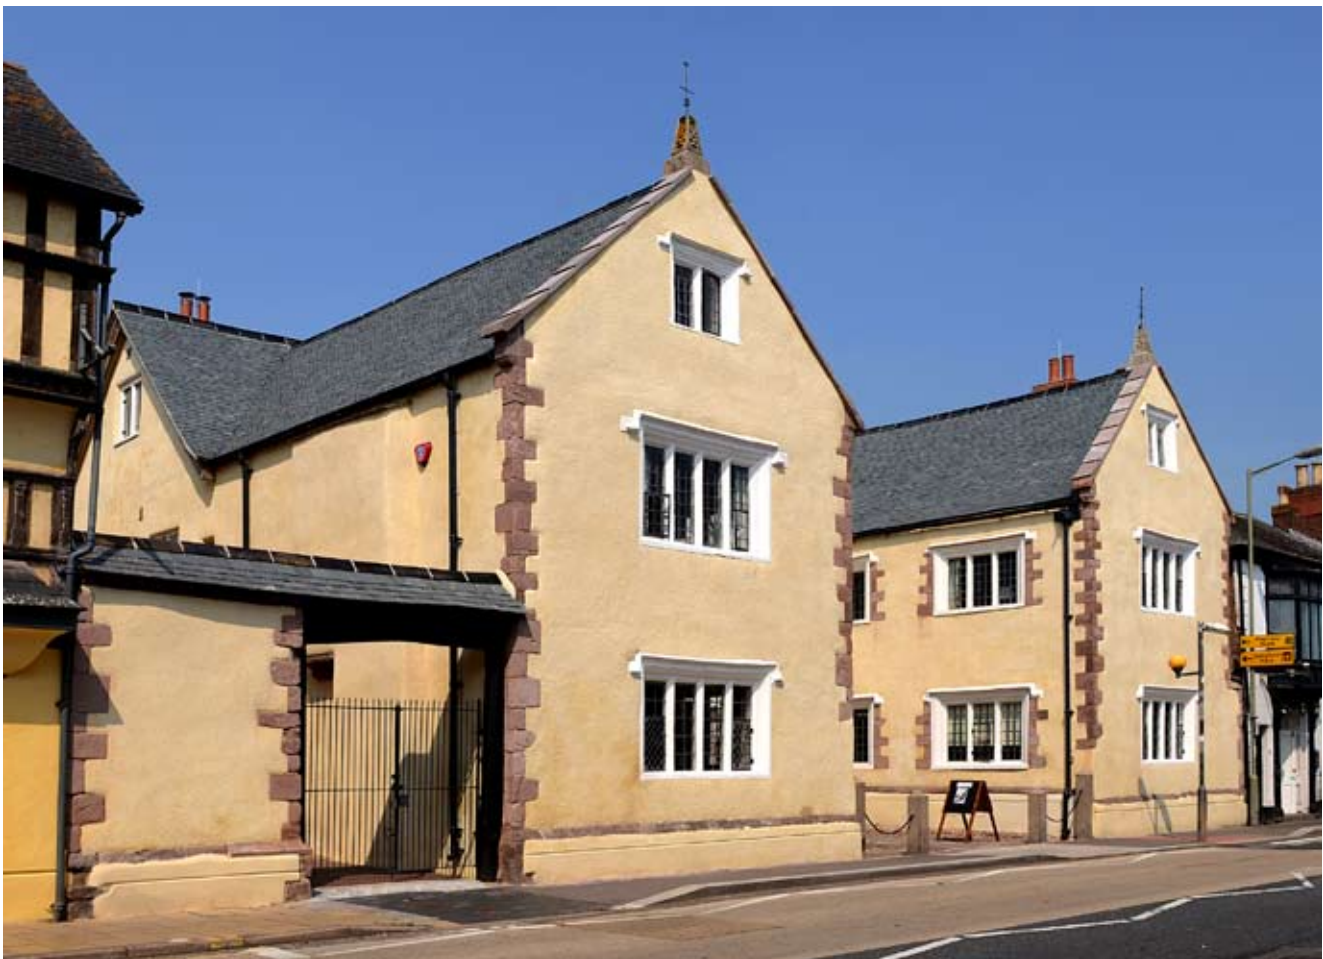
The front from the southeast, 24.07.2014.

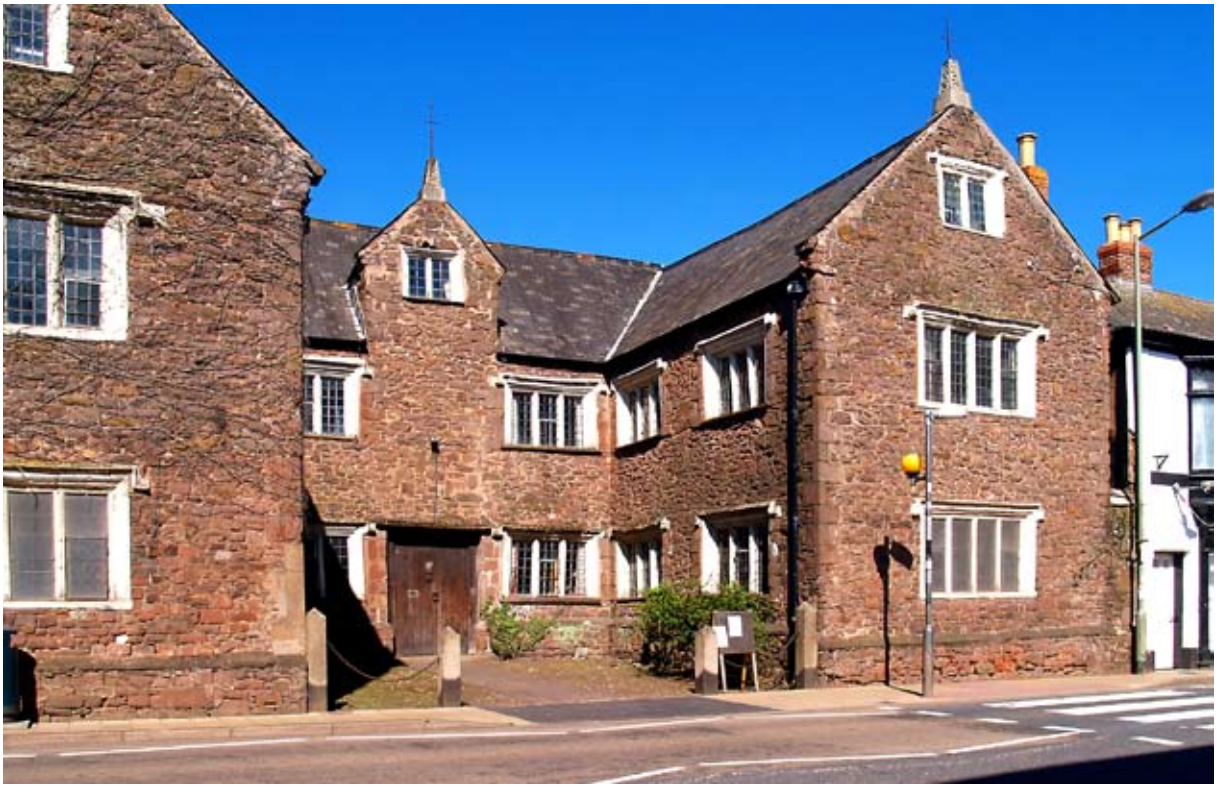
The front from the southeast, 02.06.2009.

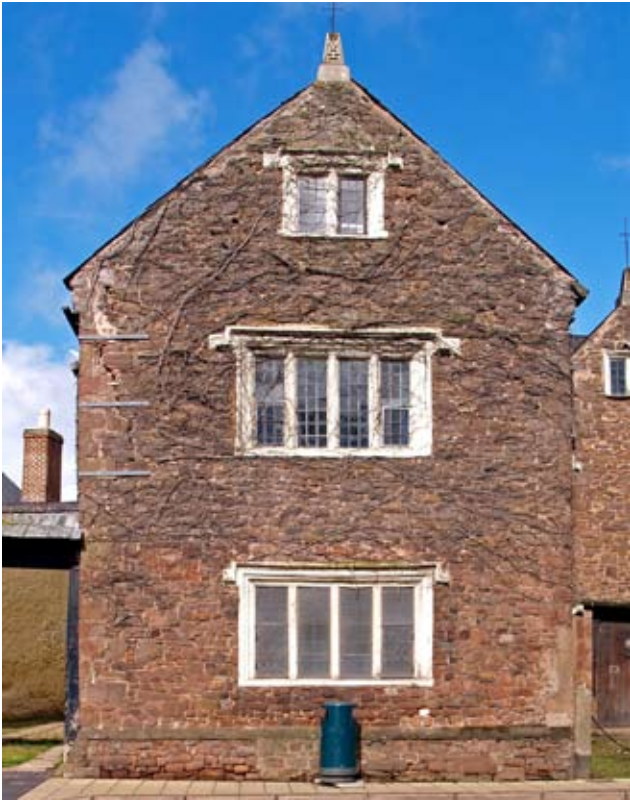
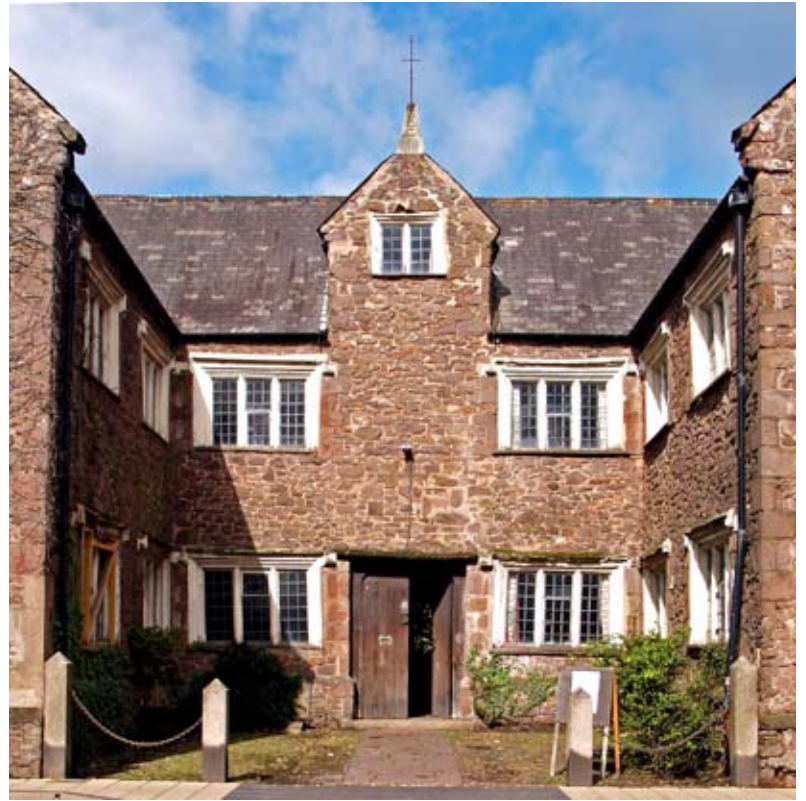
The front of the south wing and the forecourt, 03.07.2009.

The front of the south wing and the forecourt, 24.07.2014.

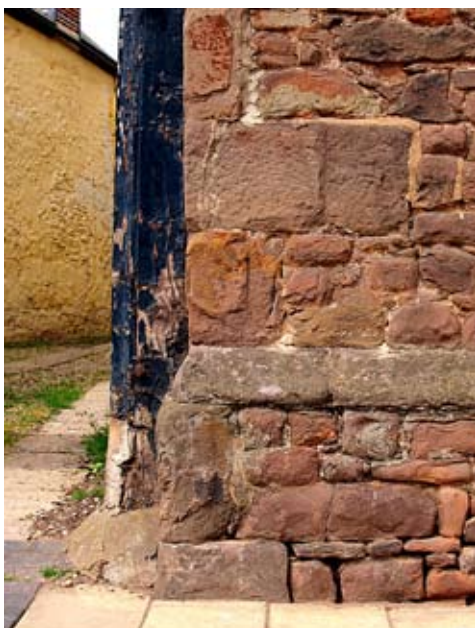
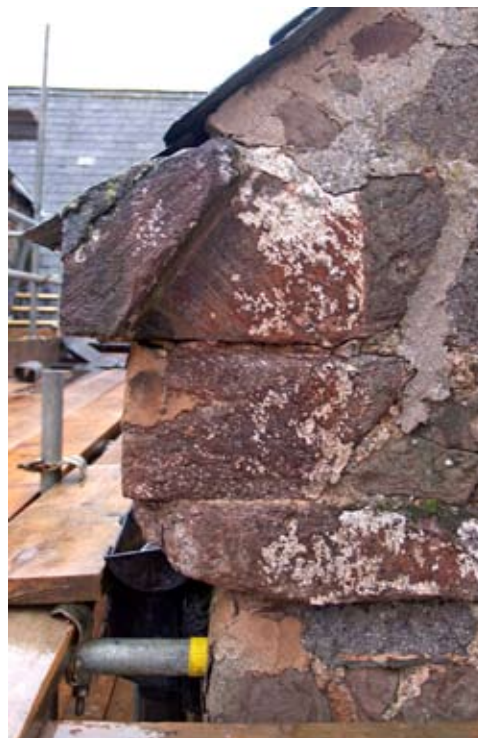
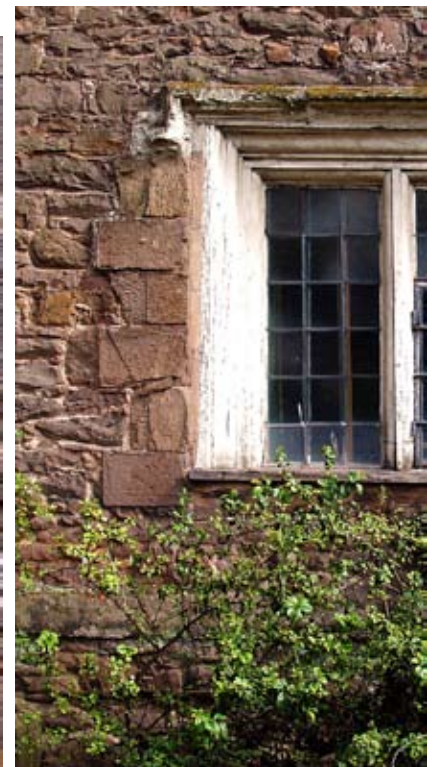
Details of the Thorverton stone dressings: From left to right, the plinth and lower quoins on the south corner of the south wing , 01.07.2009, the souther kneeler of the front gable of the north wing which retains traces of limewash, 04.12.2009, and the west side of the parlour window W.G. 06 on the north side of the forecourt, 03.07.2009.

these walls were again rendered in lime plaster leaving the proud surface of the dressed quoins, front window frames and the plinth exposed.

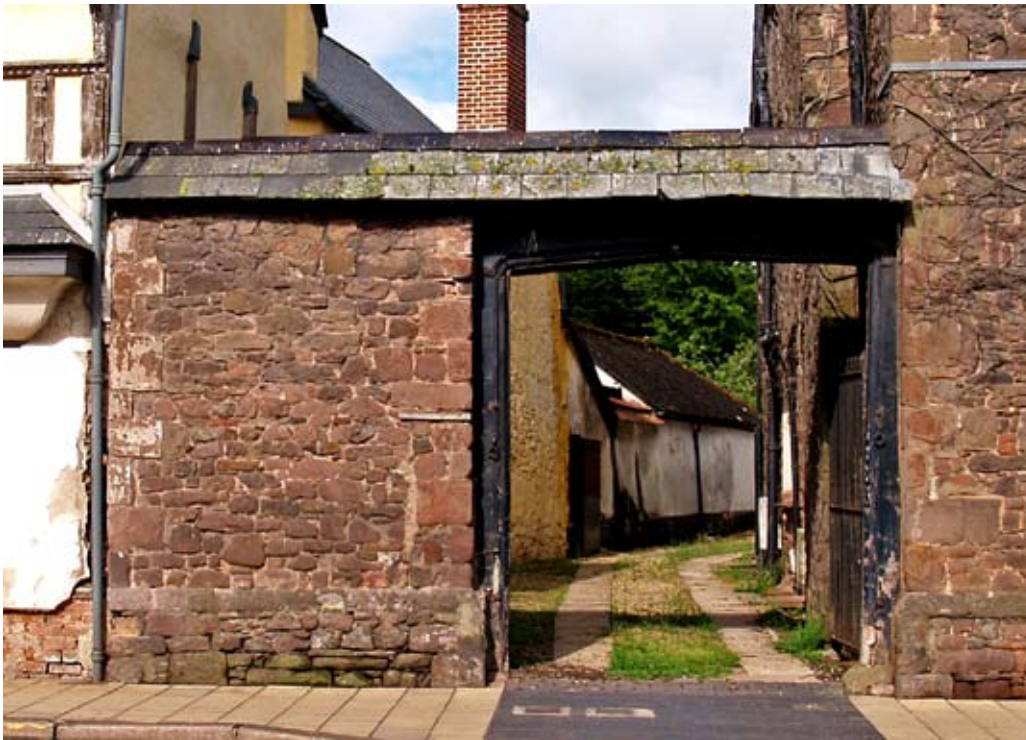
Carriageway c1605 opening and oak frame. A large Tudor arch with ogee-moulded surround. The feet are rather rotted and any stops have eroded. An undated but probably early 20th century photograph of the front from the southeast shows the arch containing panelled timber double doors (possibly 18th century in date) (Severn papers). Now mid 20th century iron gates.

The front of the gateway and boundary wall, 03.07.2009.

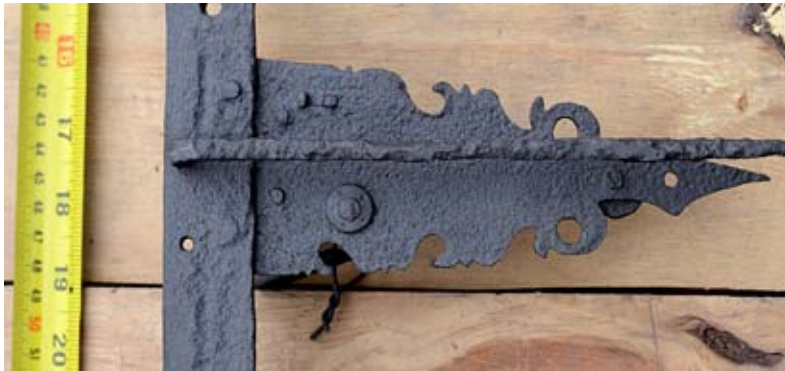
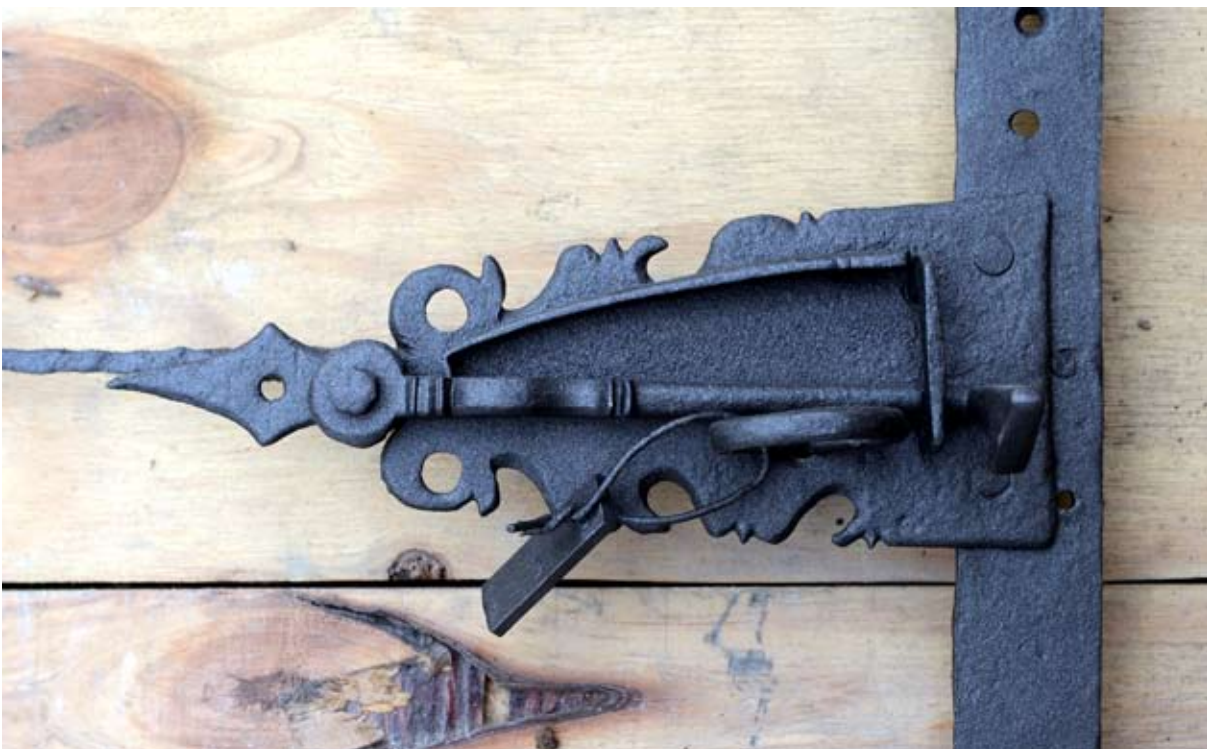
The central casement of the hall window G.W.05 is certainly ancient and might well date from c1605. The three photographs here show, from top to bottom, the inside of the casement, a detail of the outer backplate of the catch and the inside of the catch and backplate.

The photographs were taken during repair and conservation work at Brockweir, 20.05.2013.

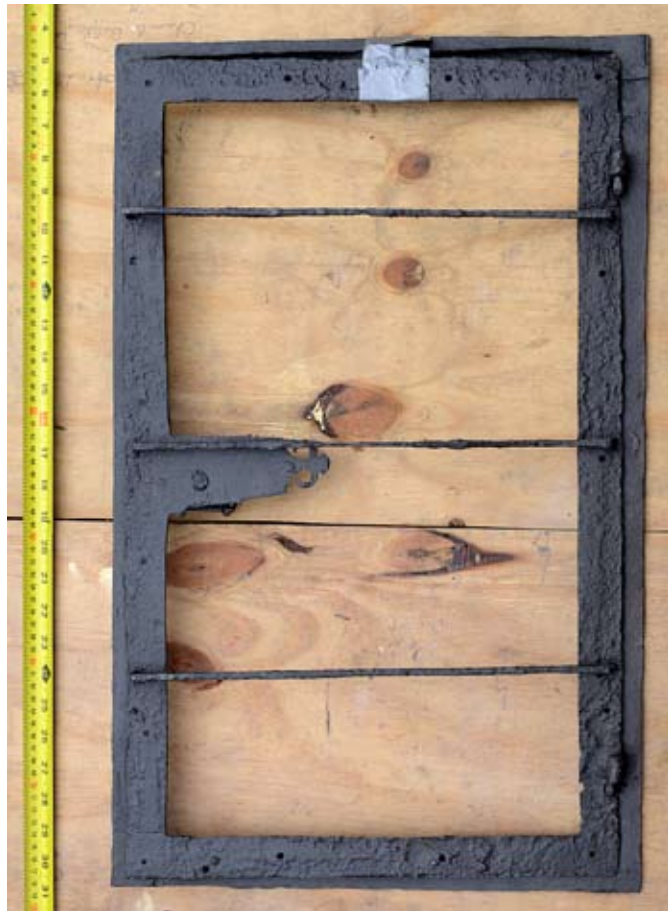
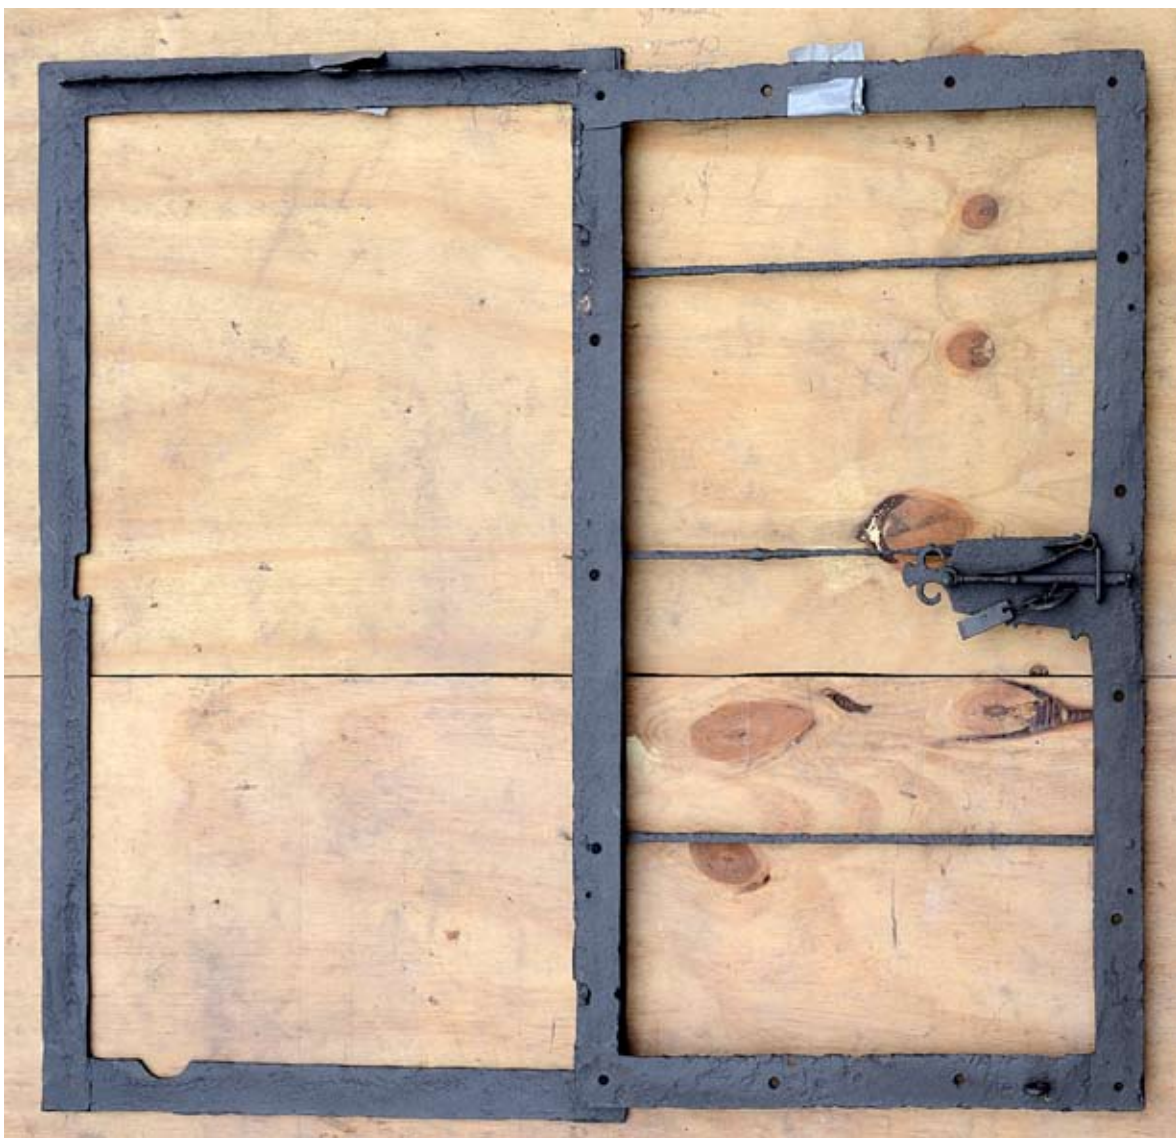
Detail of the backplate and catch of the northern casement of the east-facing first floor window W.F.08 from outside (above) and inside (below). Uniquely at the Walronds before 1890-91 the backplate is welded to the frame and maybe re-used from fragments recovered from the burnt out remains of the the 16th century house. The catch may date from c1605. The photographs were taken during repair and conservation work at Brockweir, 20.05.2013.

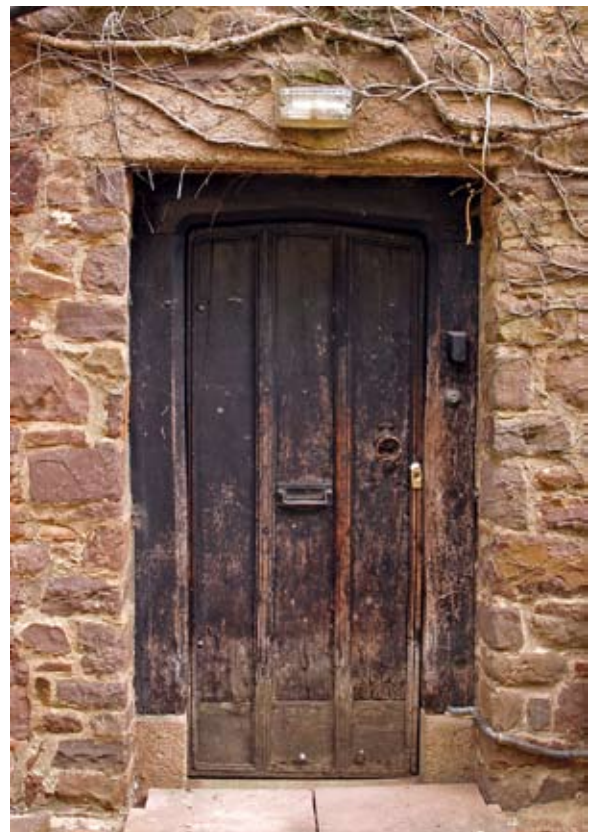
c1962 plain opening with concrete lintel, replacing Burrow opening of 1890-1. This contains a re-used 17th century oak frame with a Tudor arch head and chamfered surround to step stops. It contains a plank-and-ledge door of about the same date. It has a segmental arch head and tight ogee-moulded cover strips. The ledges are chamfered. It is held on 20th century strap hinges. Both frame and door have been lengthened to fit the opening.

Doorway D.G.01. was inserted 1890-1 when a passage was created inside, 01.07.2009.

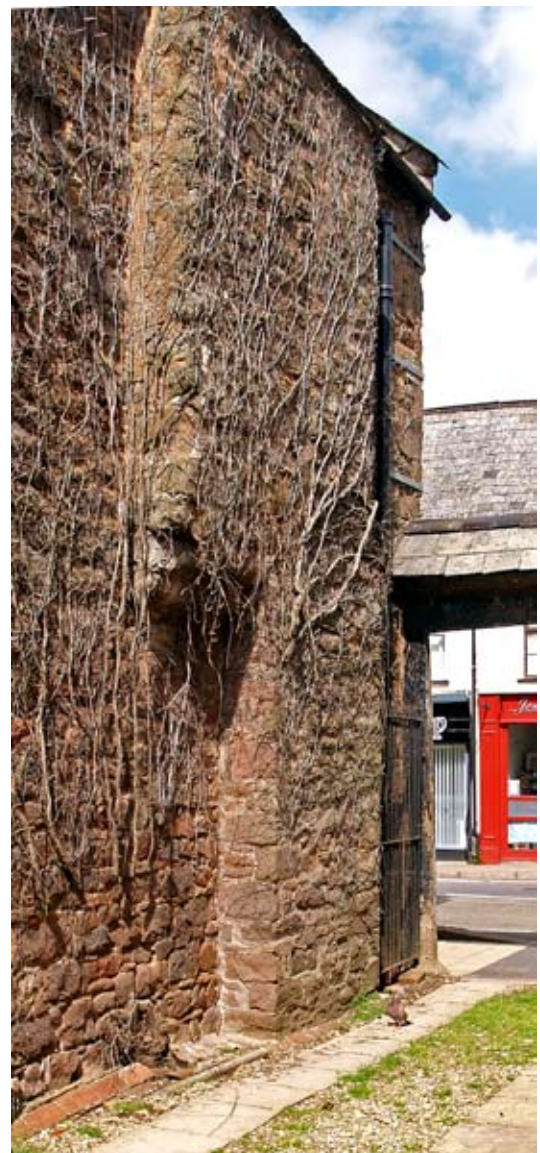
Chimneystack – kitchen. c1605 kitchen stack. Rubblestone with canted rear corner to rear service range and projecting oven housing below. Chimneyshaft rebuilt in brick 2012-13.

The two-phase chimneystack on the south side of the southern front wing, 09.06.2009.

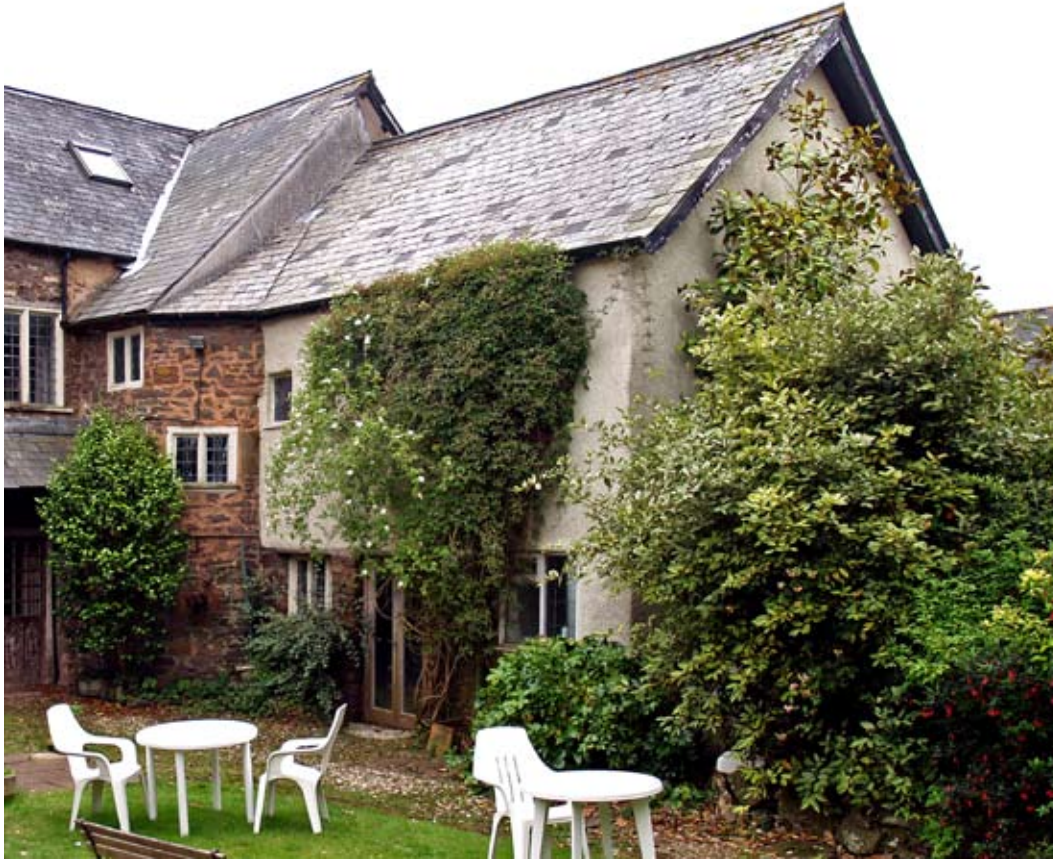
The lower level of the south wall showed extensive evidence of 1970 and 1989 work including brick repairs and alterations. A large patch of brick in the western gable is probably from the 1970 repairs.

The rear service block from the northwest on 09.06.2009 (above) and 12.03.2014 below.

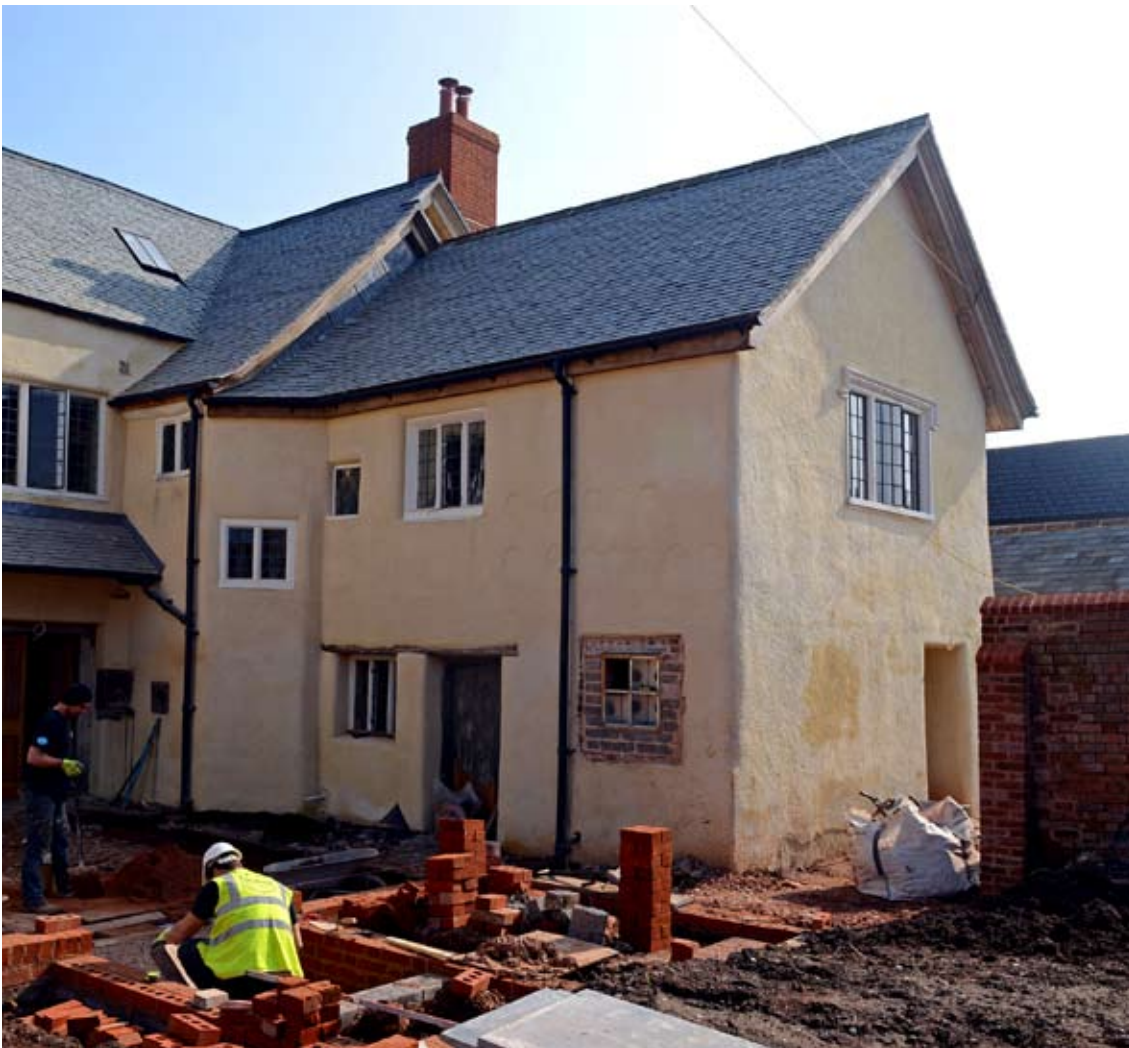
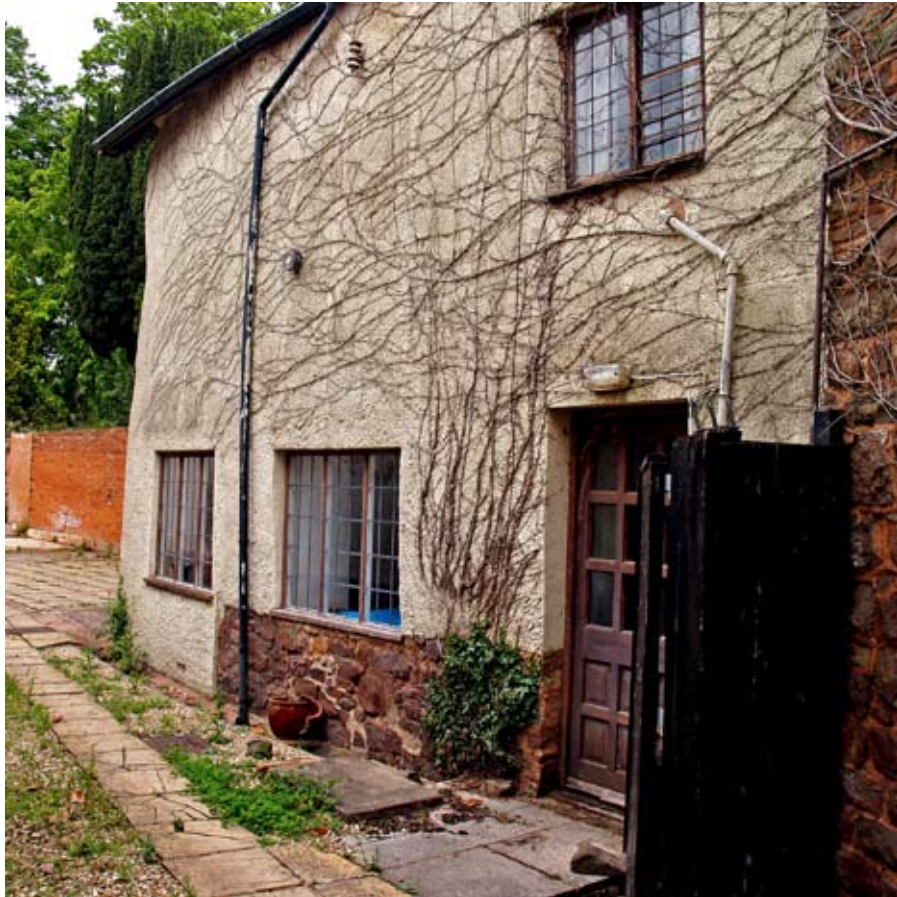
The south side of the rear service block on 09.06.2009 (above) and the north end on 12.03.2014 below.

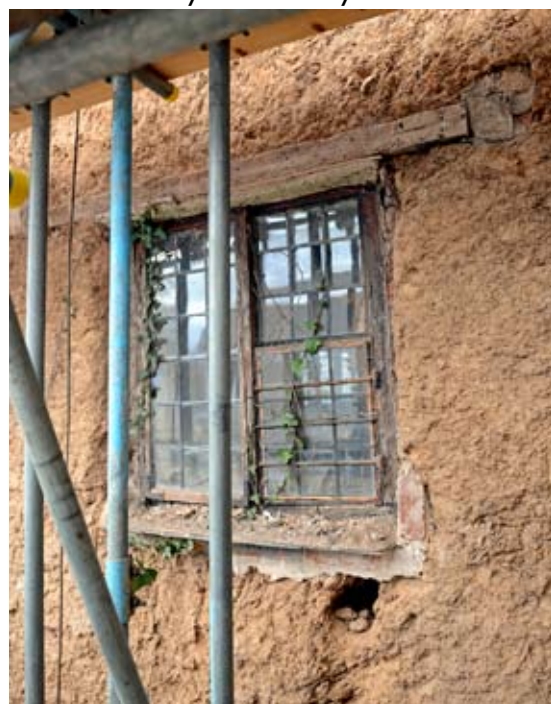
The first floor window, W.F. 20, on the south side on 29.10.12

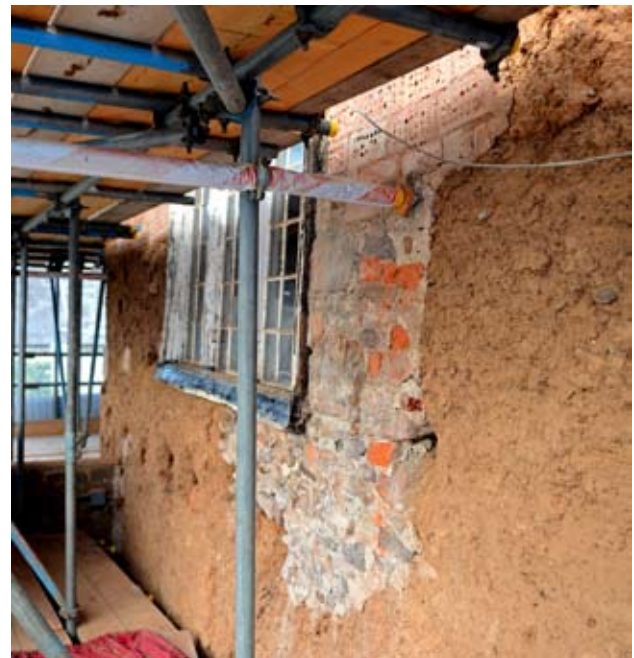
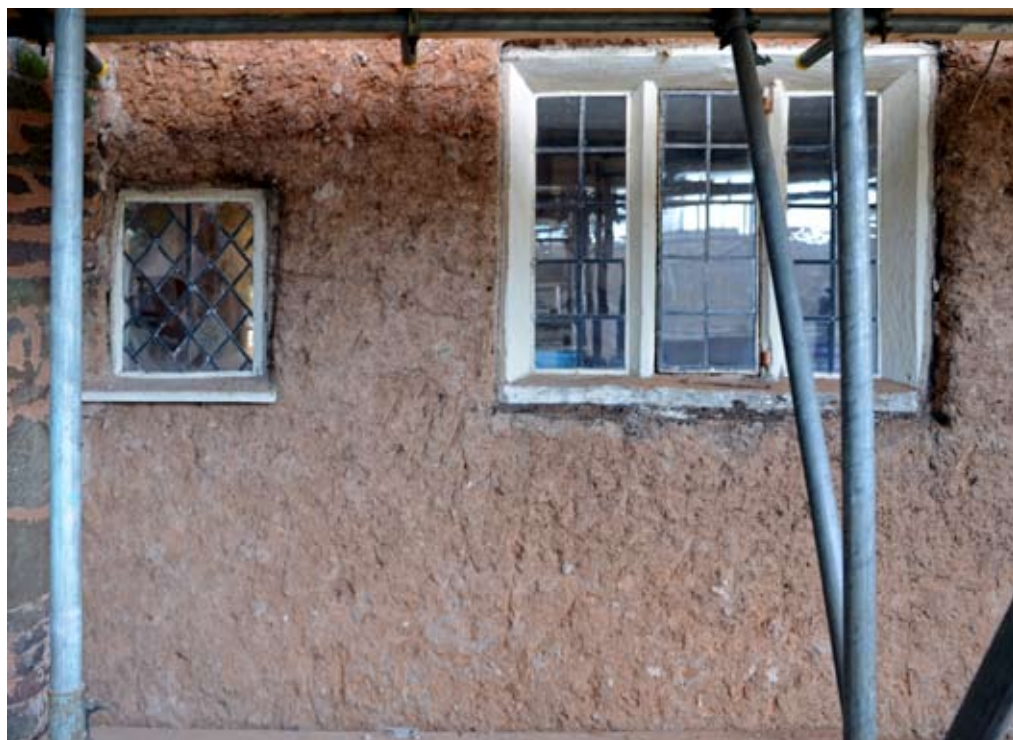
First, west, (W.F. 19) Replica in 17th century style. It is a large three-light timber window with cast-iron glazing bars looking like leaded glass. In 2012-13 the plaster render was removed to show that the northern side is cob and the southern side Burrow period masonry from 1890-1

The probably c1970 brick repair to the gable in the west end above the first floor window, W.F. 19, 29.10.12.

The first floor window, W.F. 19, in the west end with 1890-91 blocking to right (south), 29.10.12

The two first floor windows, W.F. 17 & 18, in the north wall, 29.10.12

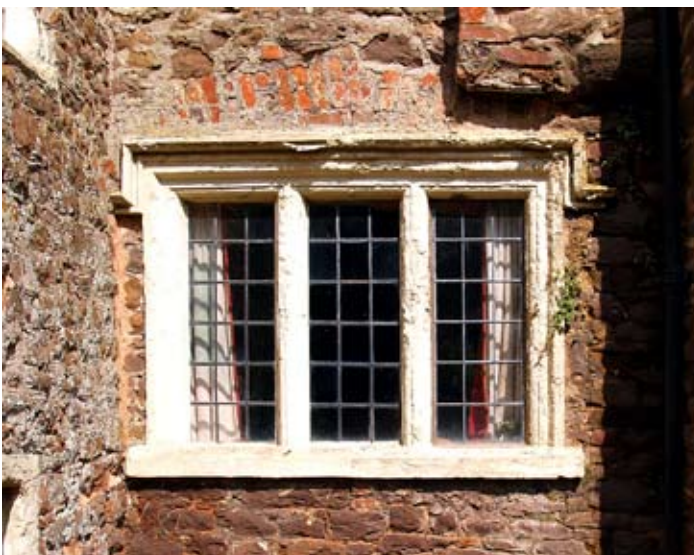
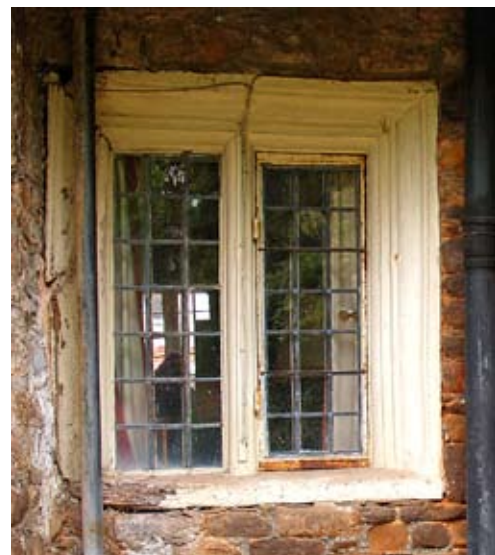
Ground, to hall, north, (W.G. 12) c1605. To the north of the chimney there is a three-light limestone hall window with ovolo-moulded mullions and chamfered frame – more like the main stairblock windows than the stone ones at the front of the house. It contains rectangular panes of leaded glass. The window has a brick relieving arch over (which has cut into the hall stack a little) suggesting that this window was repaired (maybe even altered) by Burrow.

Ground, to hall, south, (W.G. 13) c1605. To the left of the cross passage doorway and sharing the same pent roof, there is a two-light timber window with the same moulding as the windows to the front of the house.

The two west-facing windows lighting the hall, W.G. 12 to left and W.G. 13 to right, 09.06.2009

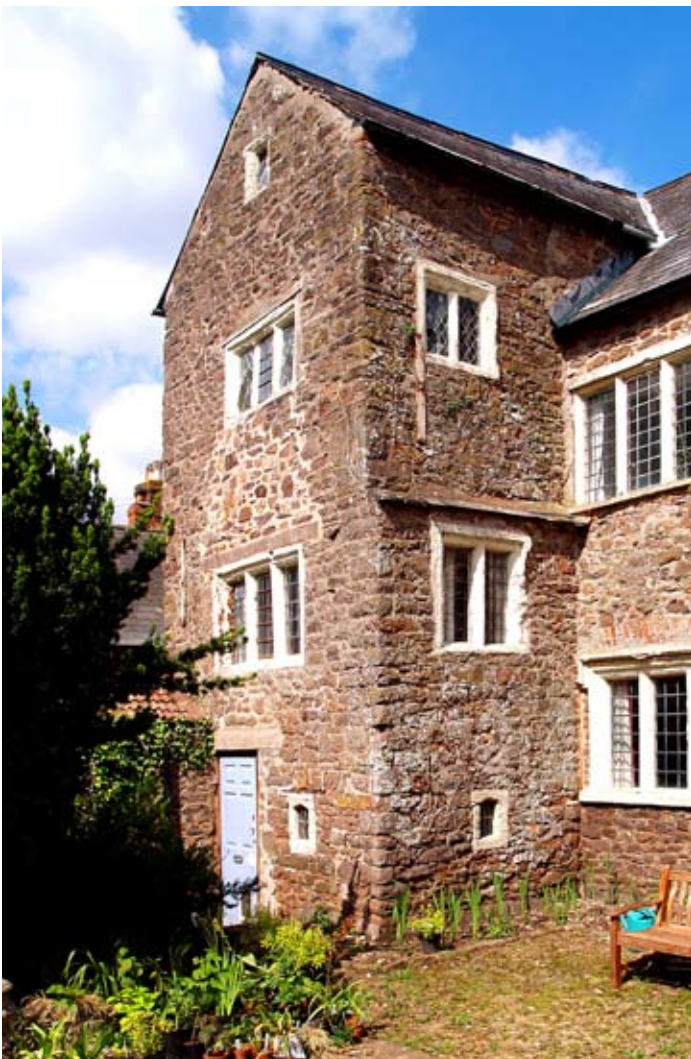
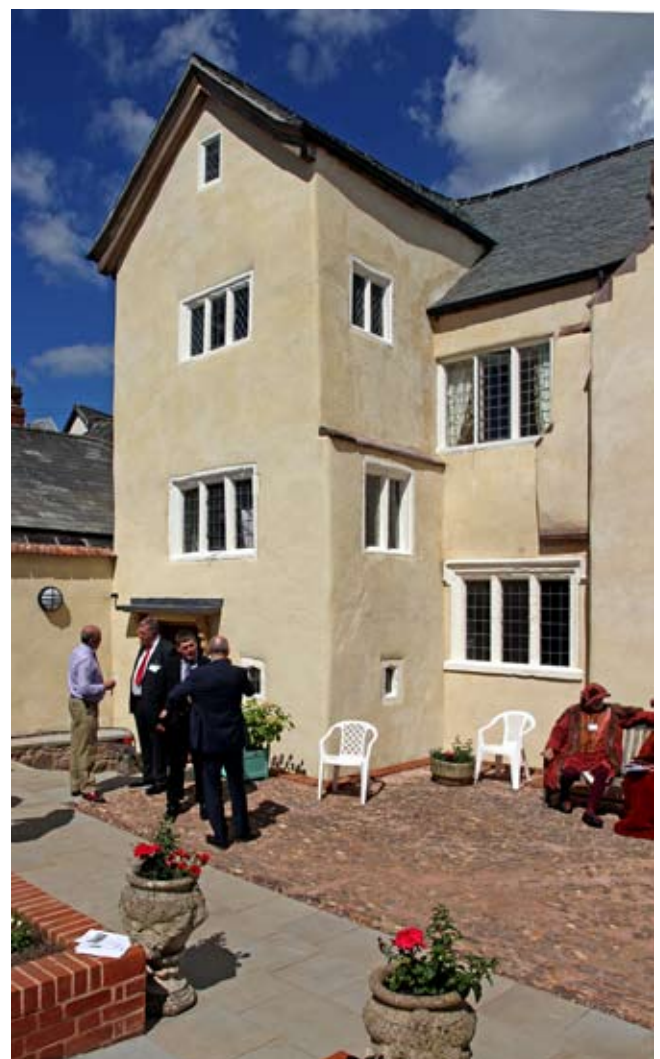
The main stairblock, 09.06.2009 to left and 18.06.2014 to right

The windows were in a poor state of repair in 2009. In 2012-13 the Beerstone frames were conservatively repaired along with the wrought-iron frames, glazing bars, casements and their leaded lights.

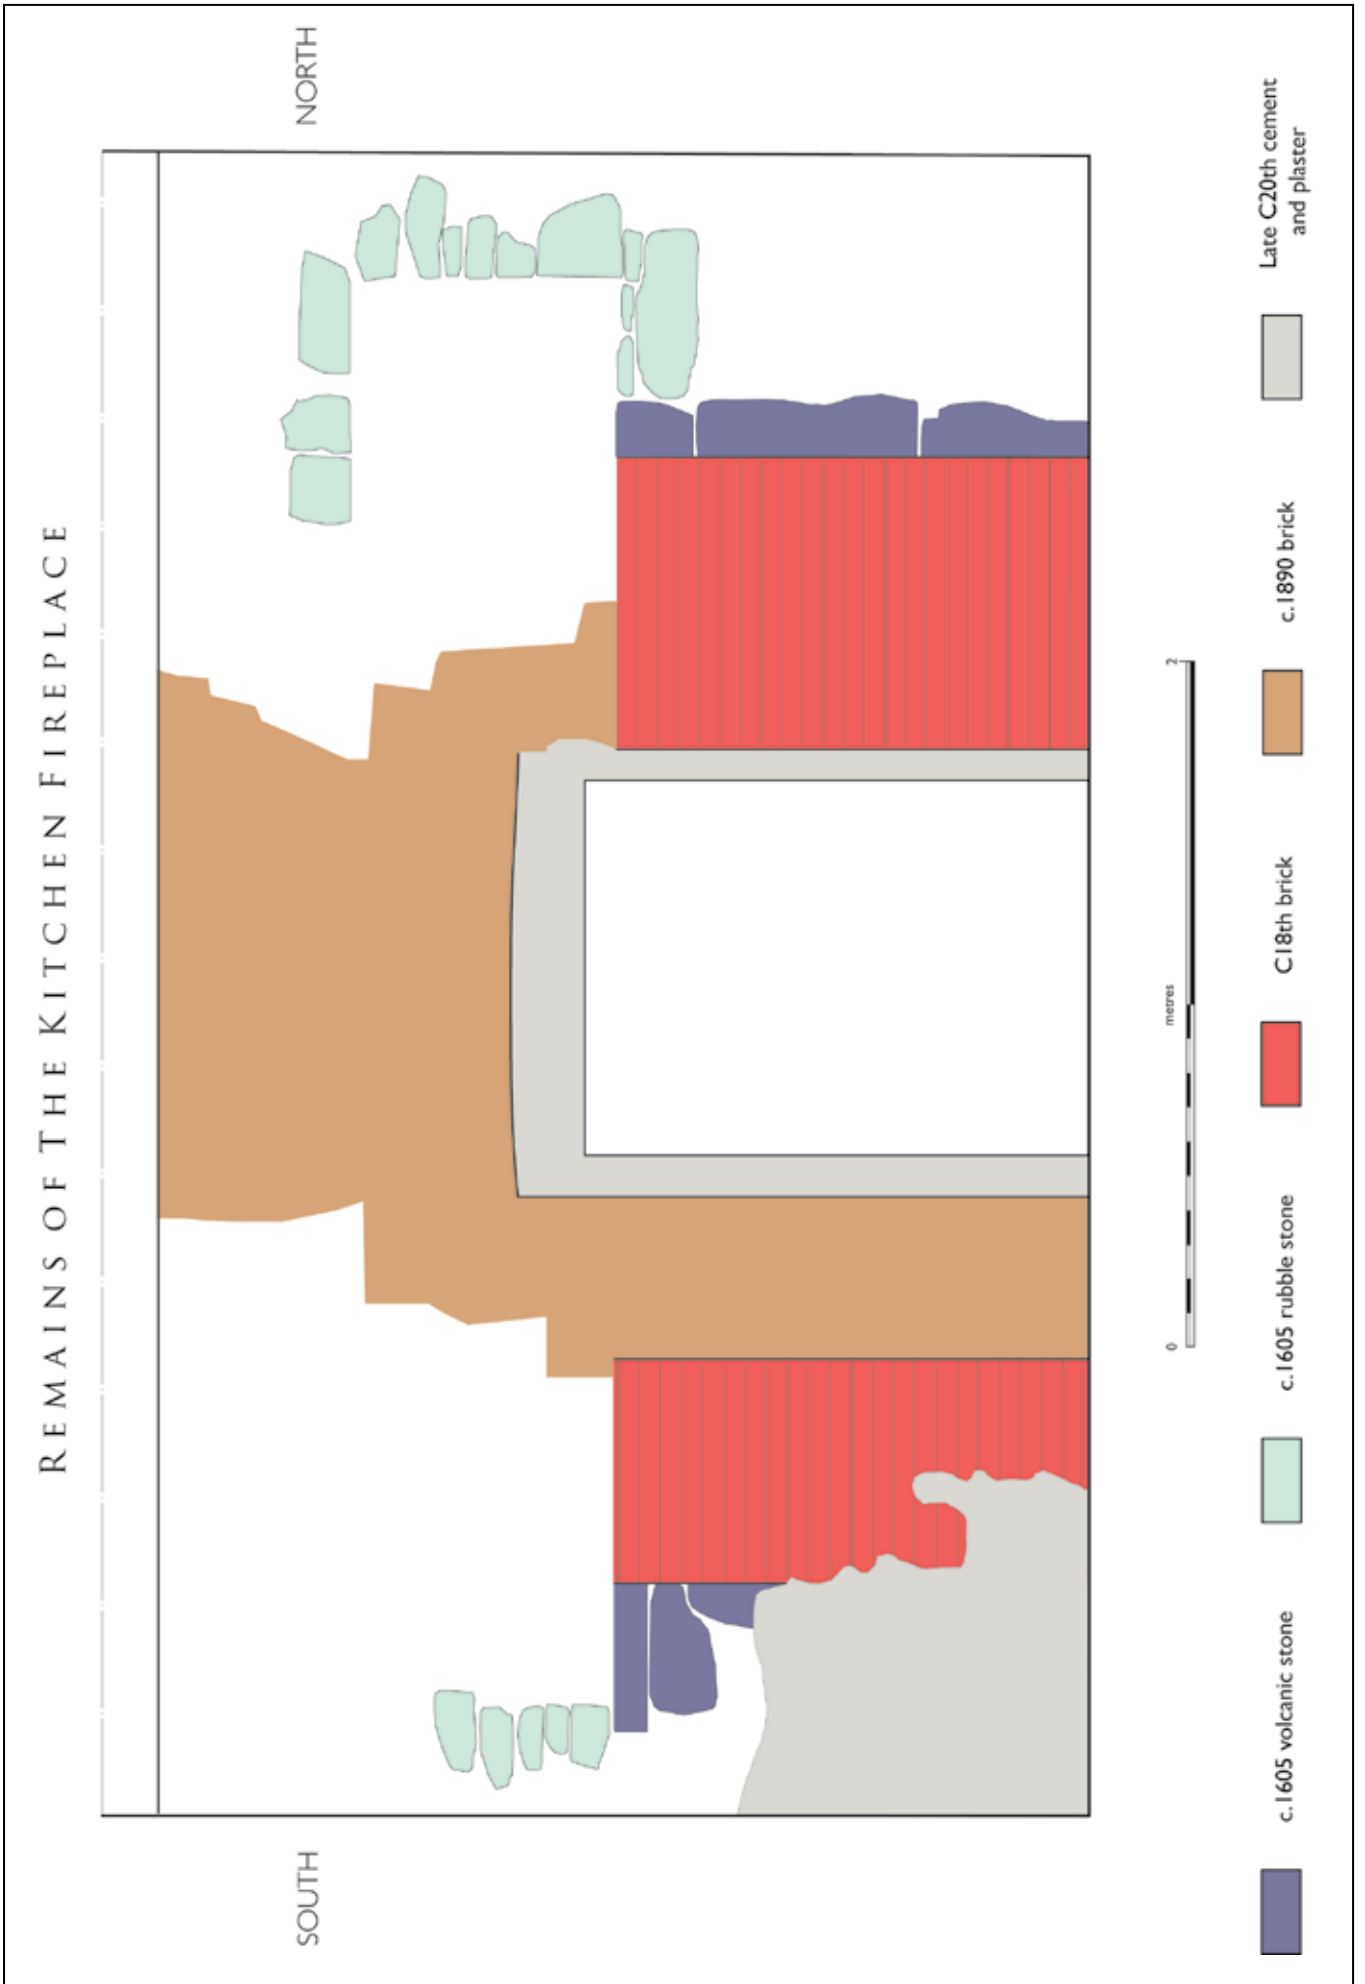
Record drawing and dating of the masonry of the sequence of fireplaces in the west wall.

In 2012-13 the 20th century plaster was stripped from the west wall revealing the earlier masonry beneath – see record drawing. Dressed jambs of Thorverton volcanic stone blocks revealed the enormous size of the c1605 kitchen fireplace – 3.25m wide. However these jambs survive only 1.37m high. This is surely too low for a workable kitchen fireplace unless it had a stone segmental arch head. Such a head might well have existed for such a wide fireplace since it would have been difficult to bridge the opening with a horizontal lintel of either stone or timber. Late medieval and later examples of such fireplaces survive in great numbers in higher status kitchens from Devon and indeed throughout northern Europe. What obfuscates the interpretation is an arrangement of stone rubble, particularly on the north side, which seems to hint at a horizontal lintel. The information is included because it appeared to be significant as it appears on the record drawing. Such a regular arrangement might be easier explained as 18th century cupboards either side of the then reduced fireplace, but the drawing is as recorded on 30.01.2013 in rather dark conditions. Later, probably in the first half of the 18th century, the fireplace was reduced to a width of 1.68m using hand-made brick. The jambs rise only as high as the c1605 ones. Again this is too low for a workable kitchen fireplace. In 1890-1 the fireplace was further narrowed in brick to 1.3m. This rose to a low segmental arch just shy of 1.5m high. This alteration was accompanied by a rebuild of the chimneybreast and the fireplace could accommodate a cast-iron Victorian range.

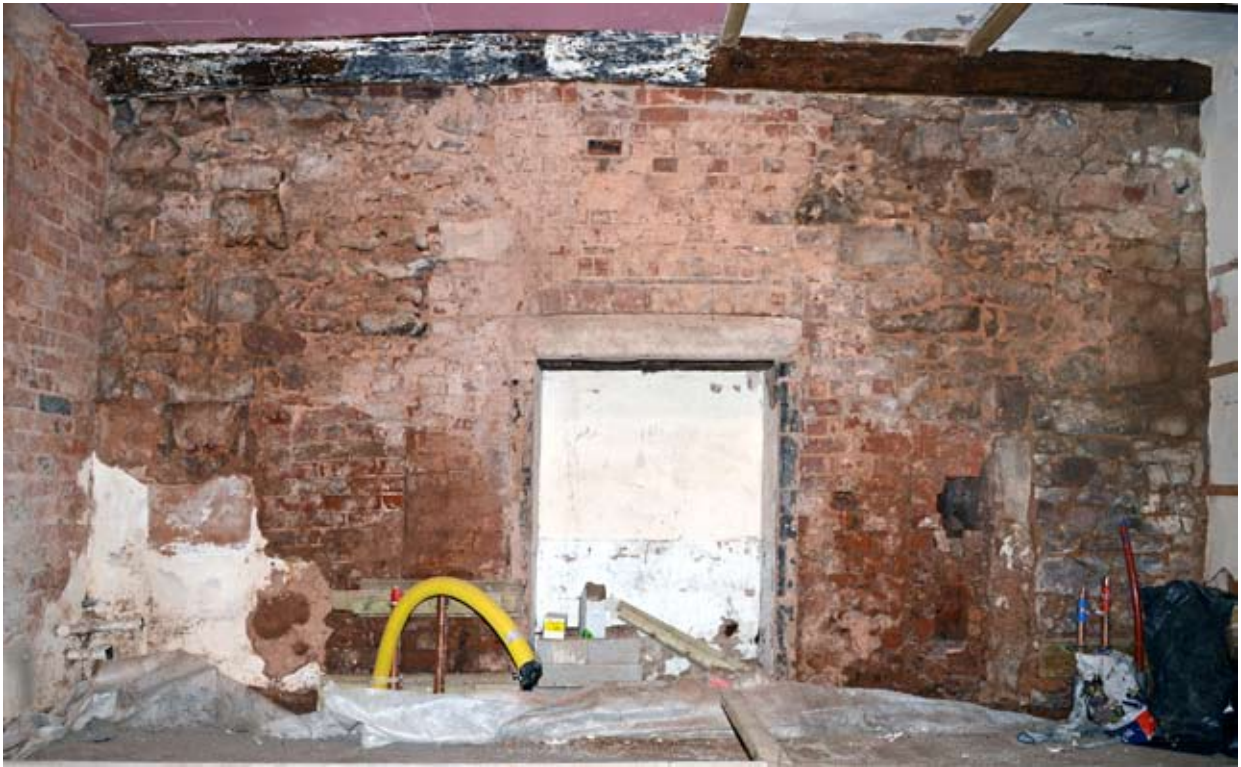
The west wall and remains of a sequence of kitchen fireplaces, 30.01.2013.

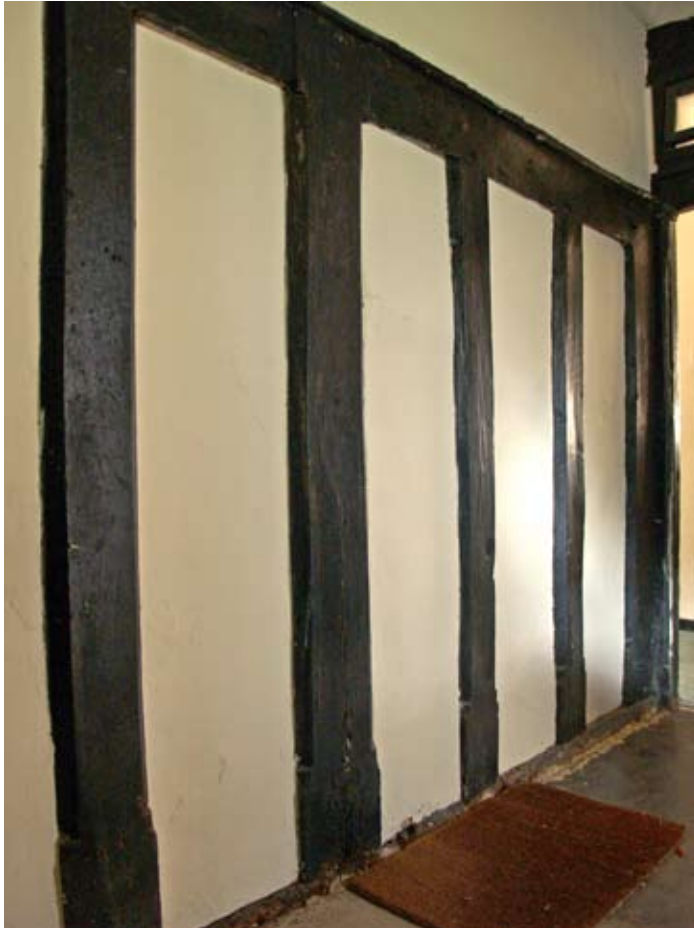
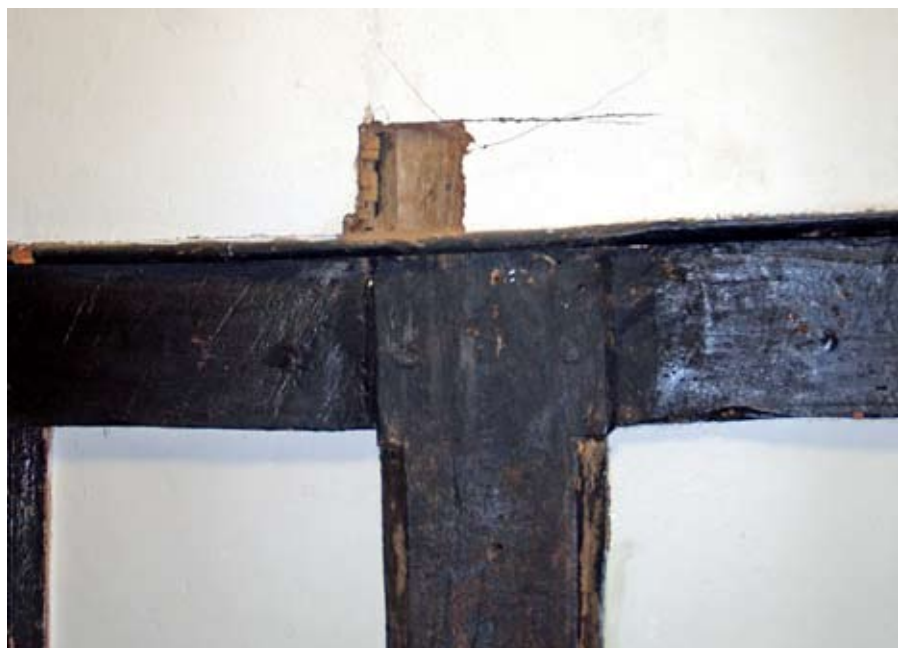
The wall is plastered above over a timber fillet. Keyhole opening up on 06.10.09 revealed that the upper part of the frame is covered with 1890-1 lath-and-plaster and that the king stud is chamfered above headbeam level. This suggests that the presented panelled lower tier continued up to the cornice (and might prove the cornice to be secondary). The upper level was not investigated further in 2012-13

The oak screen between the Kitchen Lobby and the Justice Room looking south, 09.06.2009.

Detail showing that the centre stud rises through the headbeam and is chamfered above. This suggests that the upper part was also panelled originally, 06.11.2009.
