The Walronds

Cullompton

A Revised Gazetteer

August 2014

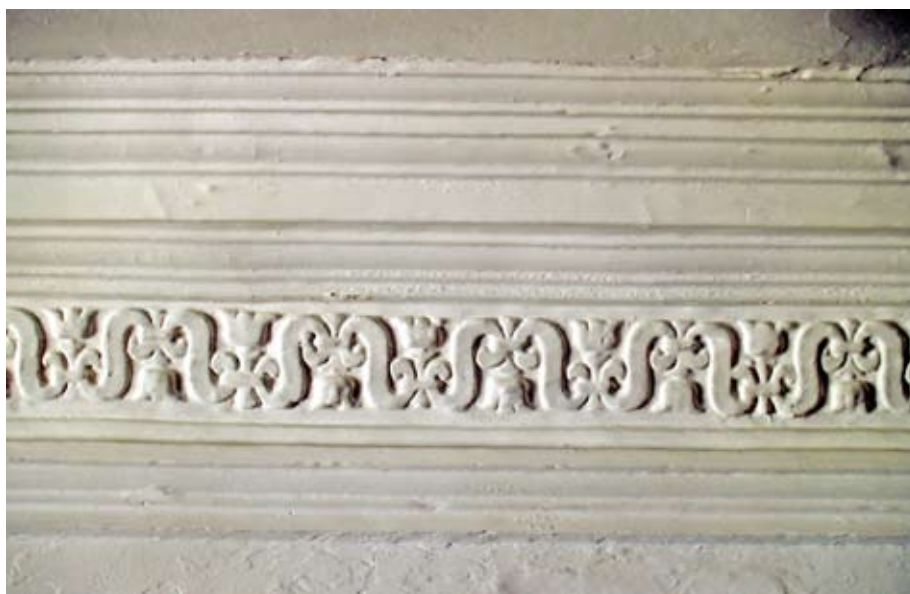
Cornice and frieze c1605. There is a hand-run plaster cornice running around the room which is basically a wide ovolo moulding with smaller multiple mouldings. It includes a cast frieze of stylised tulips, alternatively upside down. It is not complete. It is missing above the east window and the northwest window. Over the parlour door, and just below the cornice and frieze, there are two painted shields, from the Sydenham or Burrow periods. There are shadows of others at the same level under paint elsewhere, particularly noticeable on the north wall.

Detail of the plaster cornice, 02.06,2009

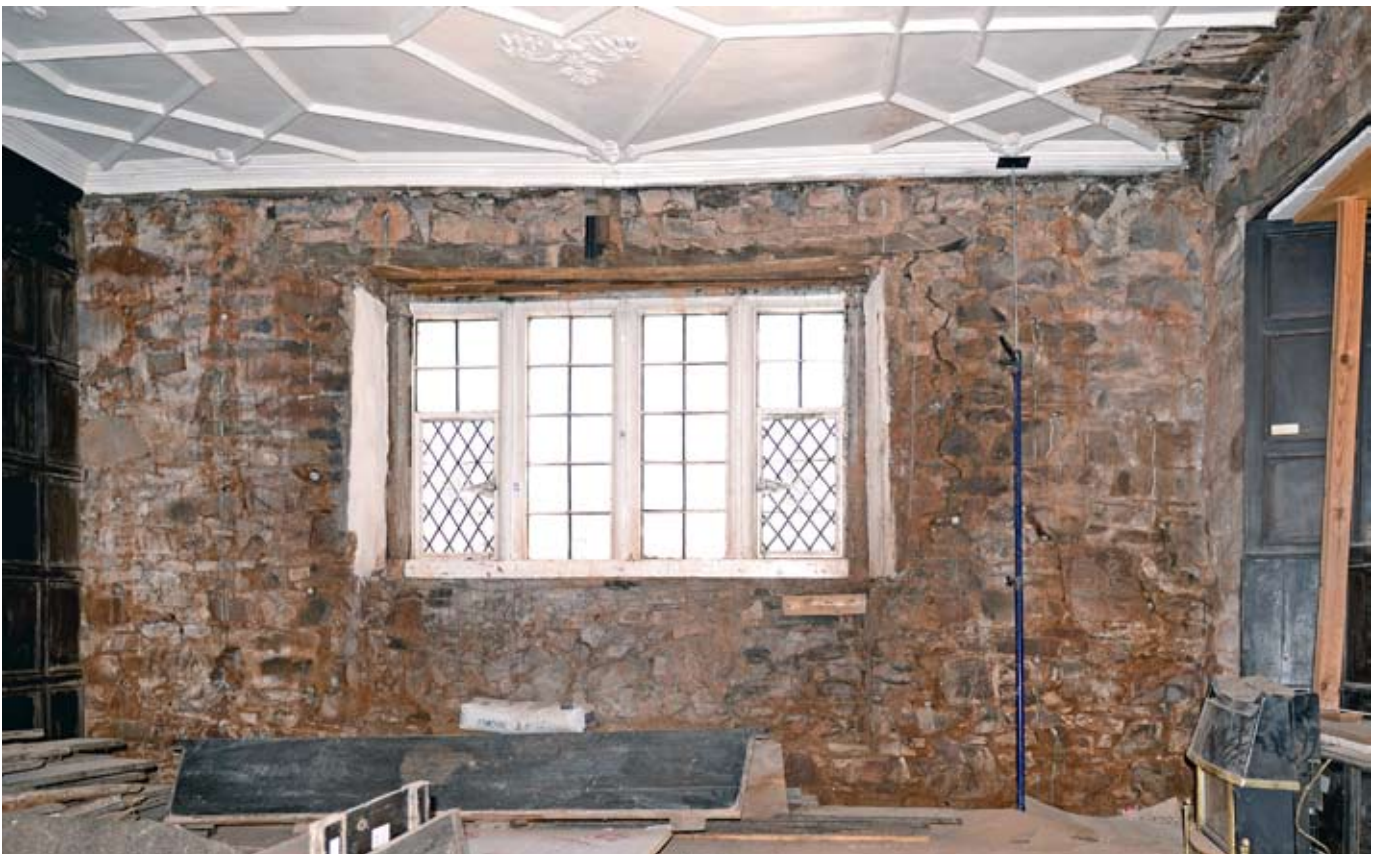
The east wall of the parlour with the panelling removed from the east wall. Examination the exposed masonry could have established whether the east window was a secondary insertion, as suggested above, or not. Unfortunately the evidence was as inconclusive as on the outside wall. What was clear is that the windowseat was certainly a secondary feature, 30.01.2013.

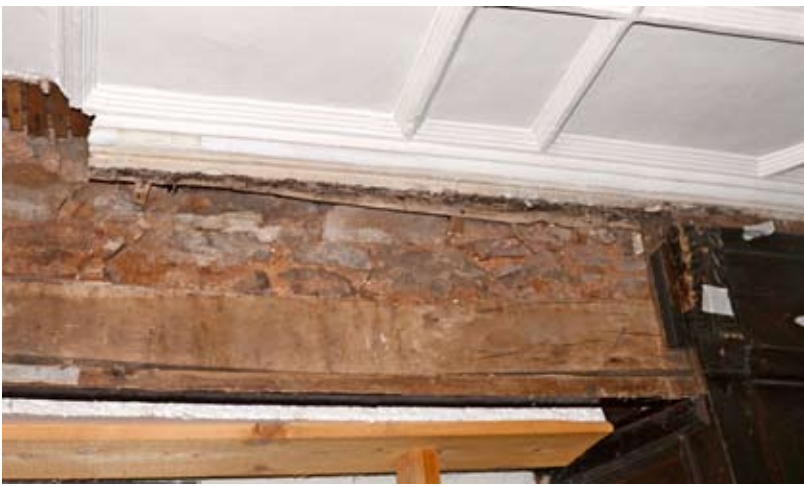
The ragged edge of the wall plaster at the east end of the south wall (over WG. 07) seems to indicate an original plastered wall which was cut out when the panelling was installed, 30.01.2013.

Wall plaster A small section of panelling was removed from the east end of the south wall on 06.10.09. This revealed a very short extent of vertical plaster descending from below the plaster cornice. This was lath and plaster onto studs which did not extend below the ragged (cut off) lower edge of the plaster. This suggests that at least the top part of the wall (maybe just for a frieze) was plastered before the present panelling was installed.

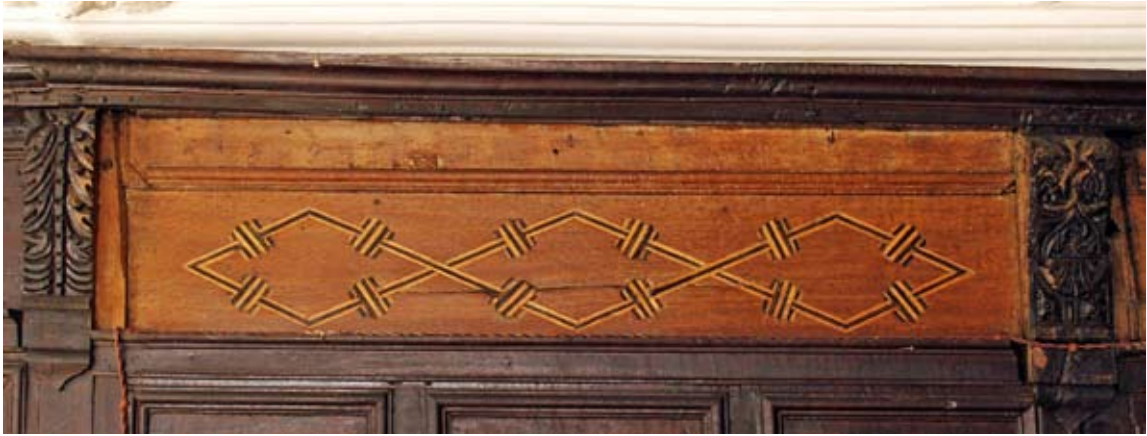
Detail of one of the marquetry inlay panels that was cleaned up in the late 20th century, 02.06.2009. It was varnished over in 2012-13.

In 2012-13 the exposed inlaid marquetry was painted over to match the rest of the overmantle.

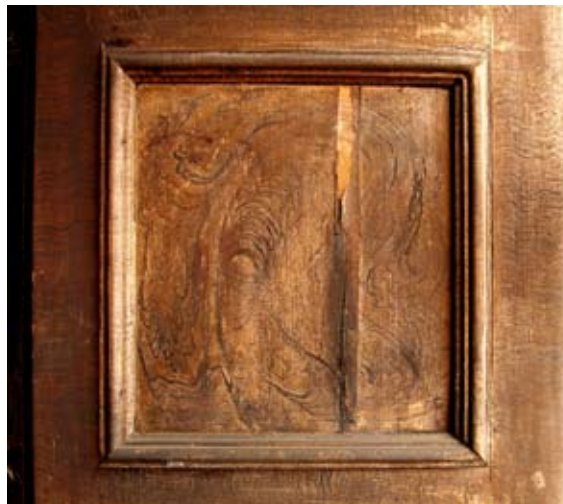
Shutters to the east window (W.G.08) The shutters are built of pine in the same style as the earliest oak wall panelling with the same proud moulding carved out of the solid. They probably date from the early 18th century and are hung on H-hinges with trefoil-shaped finials with butterfly hinges to the flaps. They were given a dark varnish finish, probably in 1890-91, but this covers a possibly late 17th century finish of walnut graining.

The grained walnut decoration shows through the Victorian varnish on one of the panels on the northern window shutter to the inserted east window, 01.07.2007.

It was varnished over in 2012-13

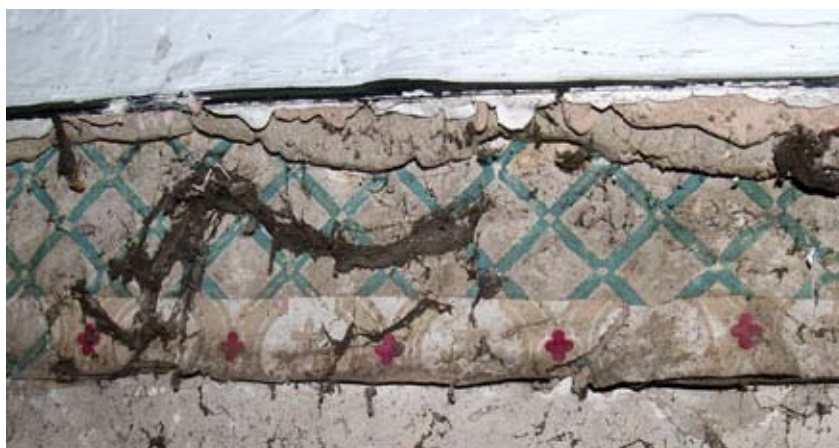
Wallpaper The same opening up exposed the bottom fringe of some Burrow-period wallpaper, the upper part covered in plaster. This is probably the wallpaper mentioned in the 1891 *Devon Herald* article: "Although the walls are uneven they have been made to look their best with old-fashioned patterned paper."

Fragment of Victorian wallpaper, 06.10.2009.

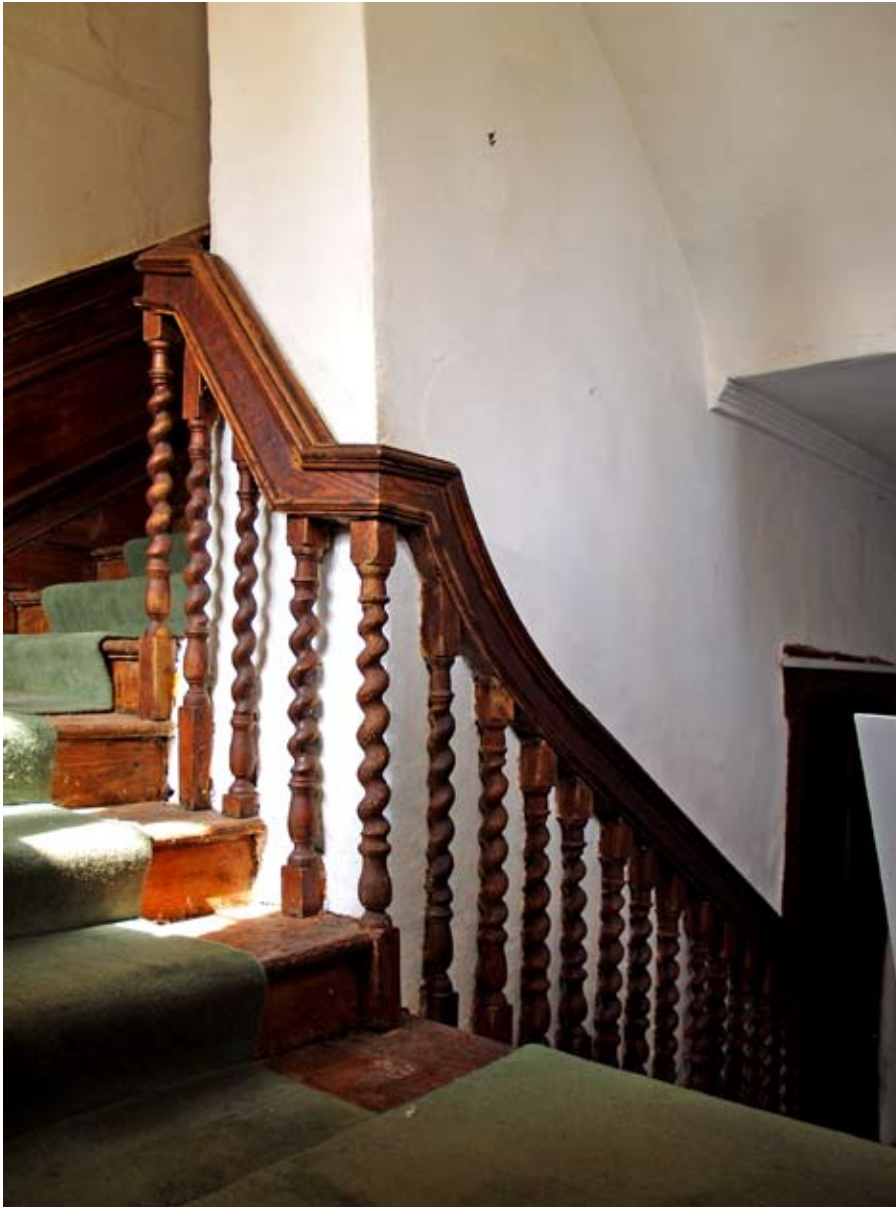
The first half landing of the early 18th century stair, 09.06.2009.

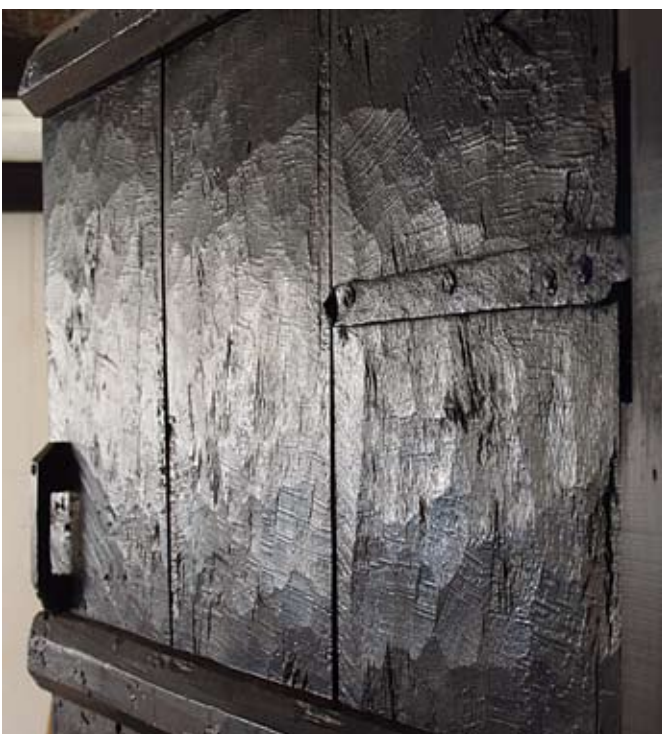
Detail of the back of G.D. 12D showing the adze marks, 09.06.2009.

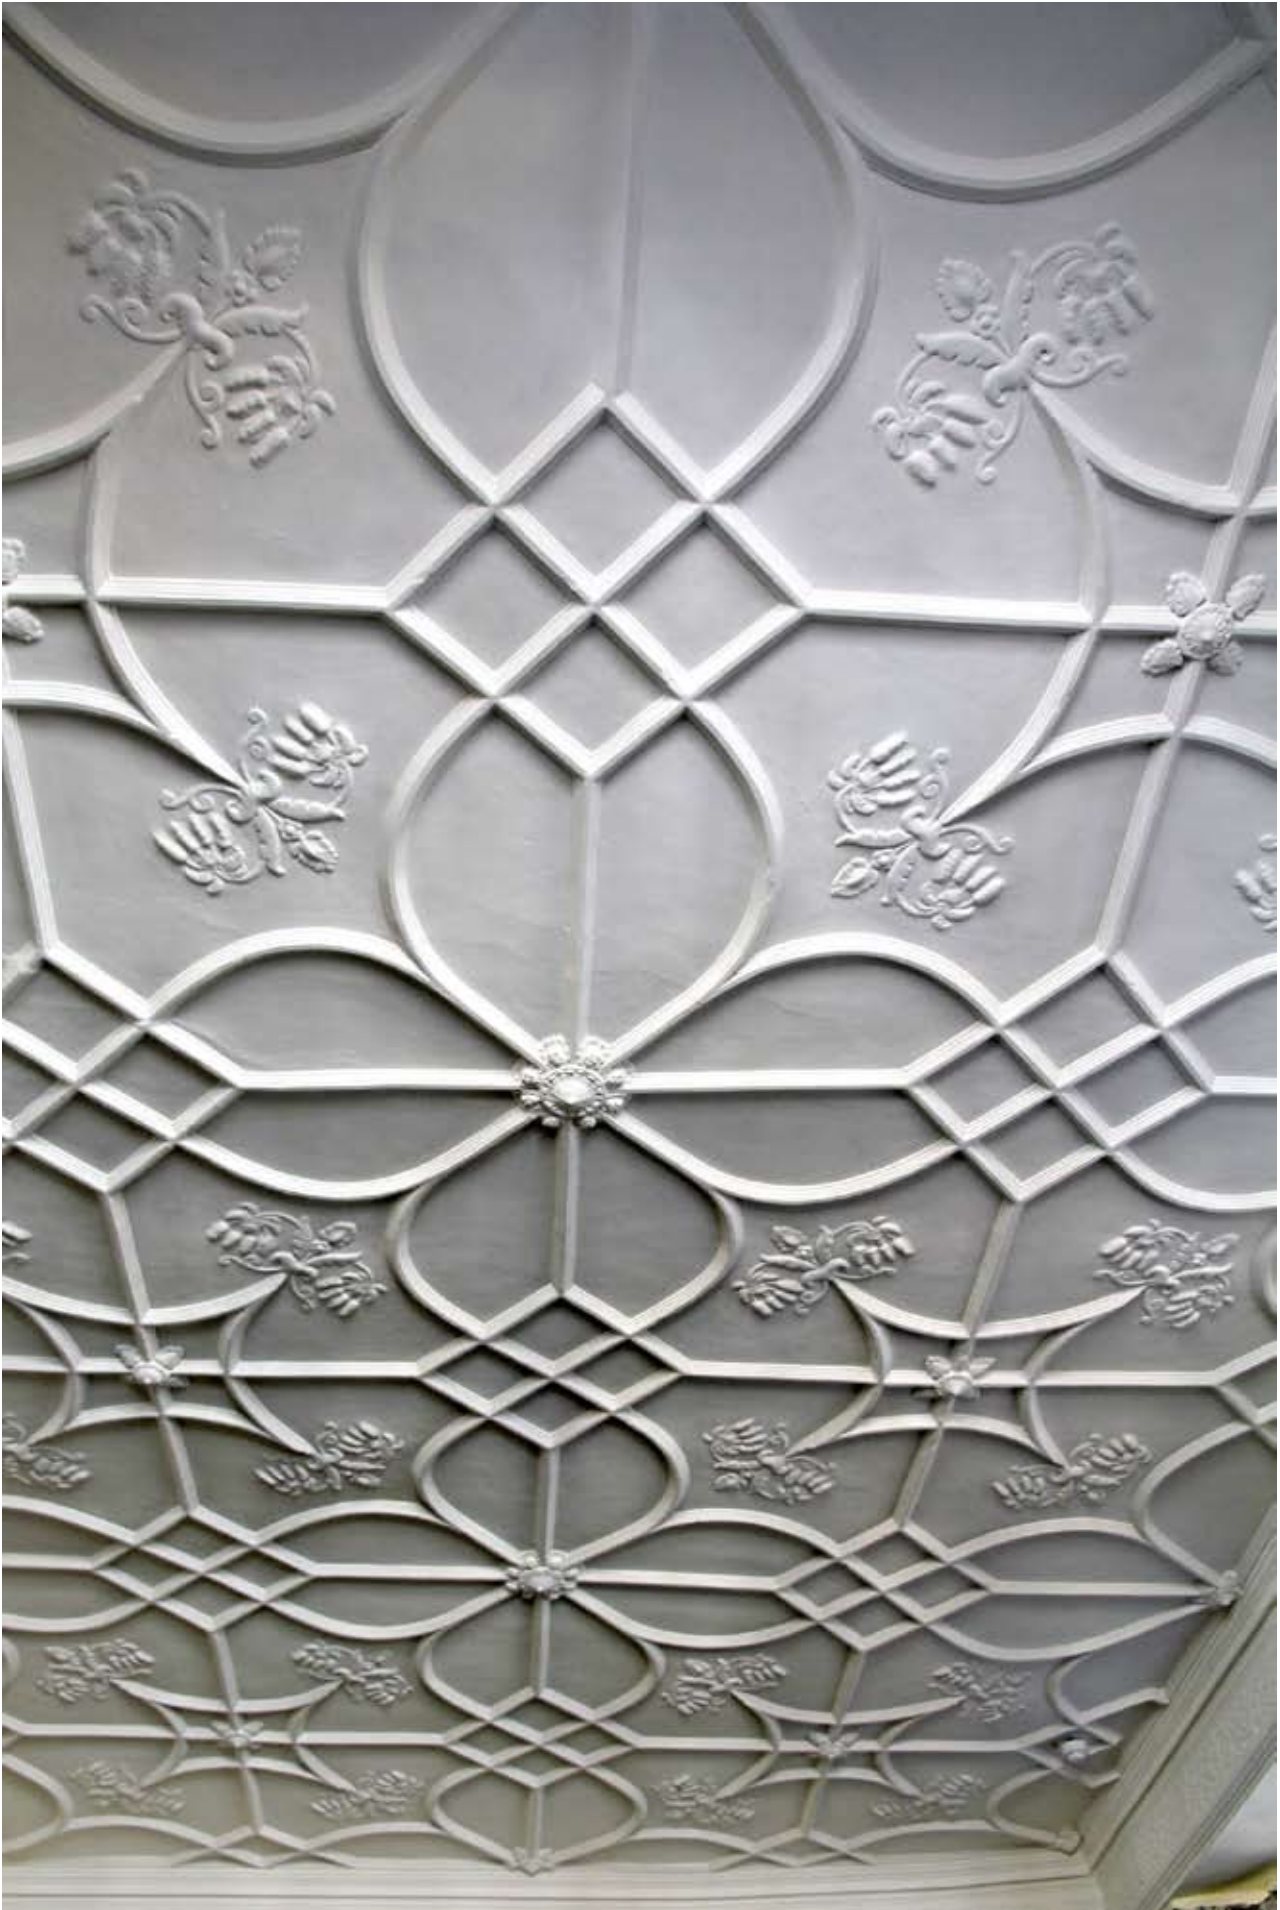
The ceiling of the Great Chamber, restored and cleaned, 18.06.2014.

c1605 ornamental plaster ceiling with an overall pattern of moulded single ribs intersecting to create a symmetrical geometric pattern of vesica and concave square panels. They radiate from principal bosses ringed with tiny female faces in the middle of daisies. It also features cast angle sprays in the form of hops with a central sprig of oak leaves, like those on the parlour and parlour chamber ceilings.

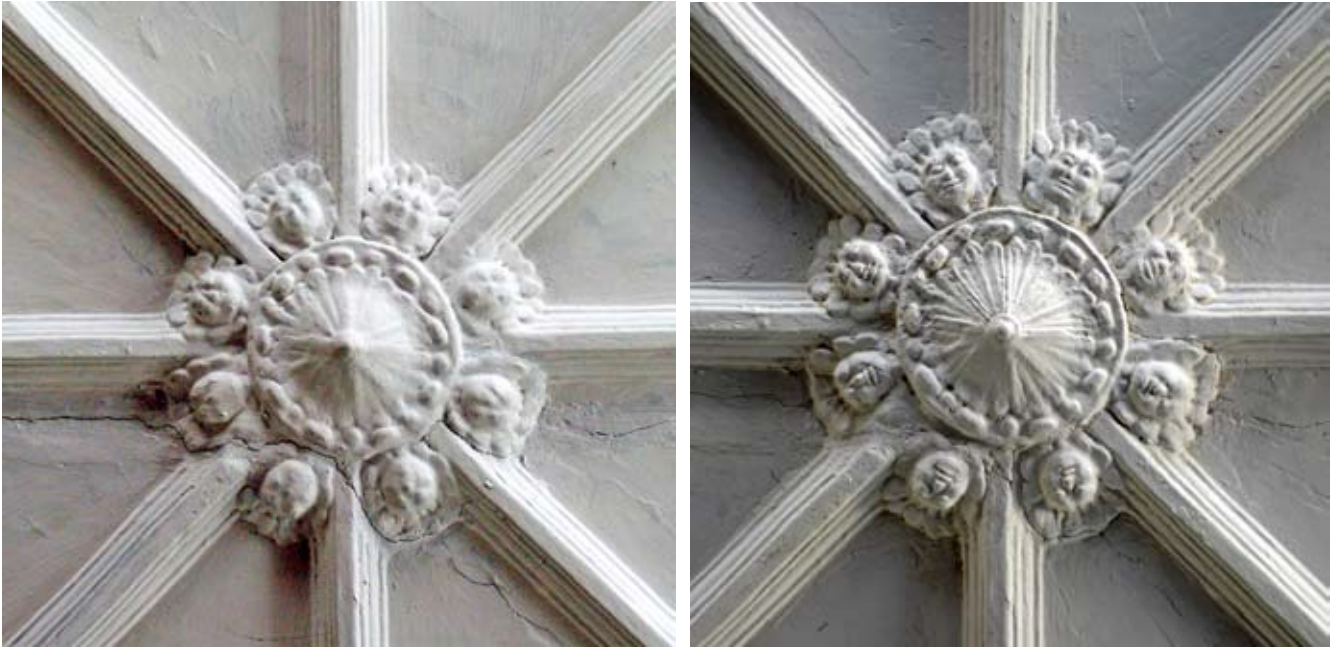
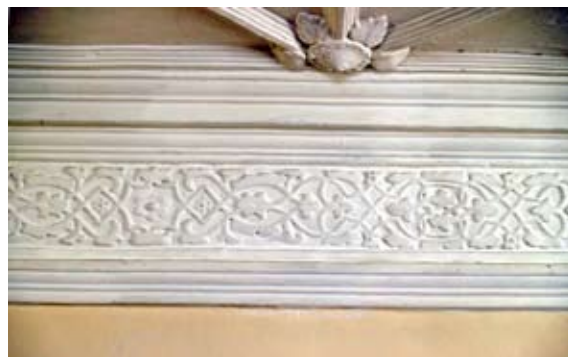
The small granny's bonnet boss before cleaning, 01.07.2009, and after, 12.03.2014 and (below) a section of the frieze from the west wall, 02.06.2009.

Summary of 2009 expert report: This frieze, which is similar in type, though larger and a little more elaborate than the others, has several old discontinuities along its length. (McNeilage Plaster Report, November 2009).

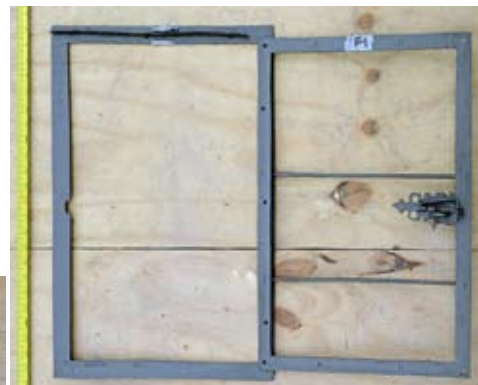
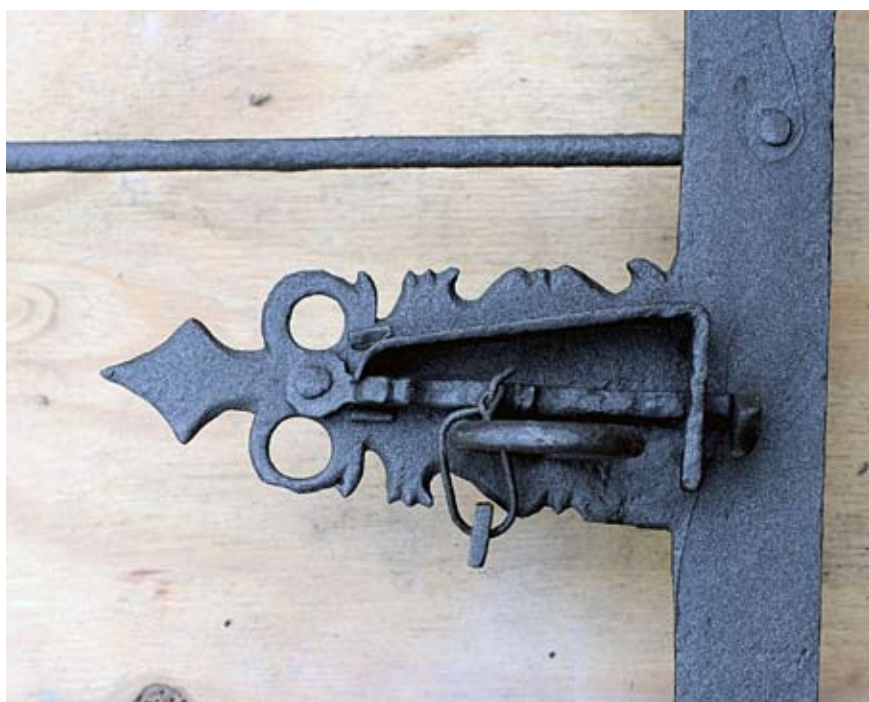
Summary of 2009 expert report: A stone four-light window with ferrous side-hung casements in the outer lights. The casements are 17th century in style, but different to those on the ground floor. The leadwork is 20th century, and some cylinder glass survives, but the remainder is 20th century sheet glass. Each light has two ferrous internal stanchions to which the panels are fixed with copper ties. (Holy Well Glass Condition Report, September 2009)

The northern casement of the east window (W.F. 01) and a detail of the catch. The surviving 17th century (probably c1605) catches of the first floor are a little plainer than those on the ground floor. Photographed during repairs at the Brockwier Glass workshop, 20.05.2013.

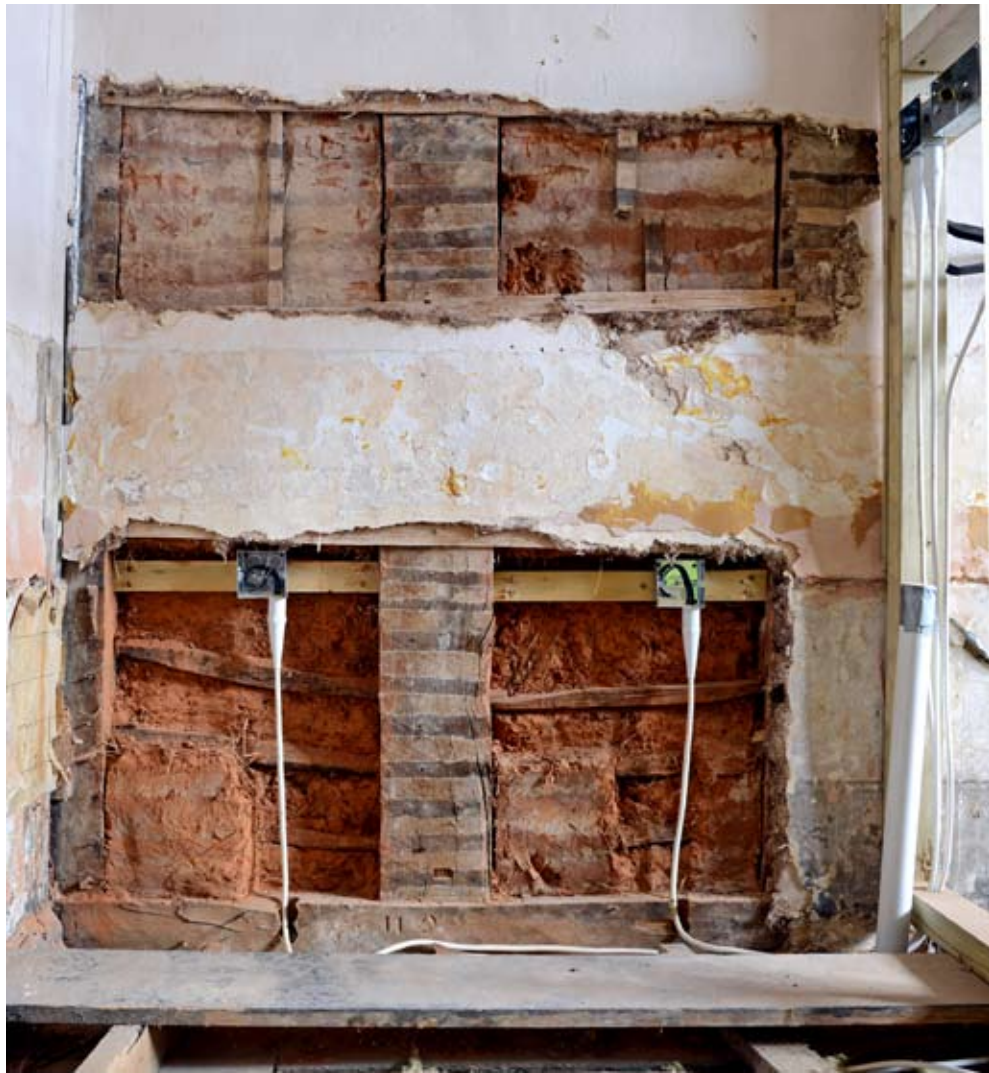
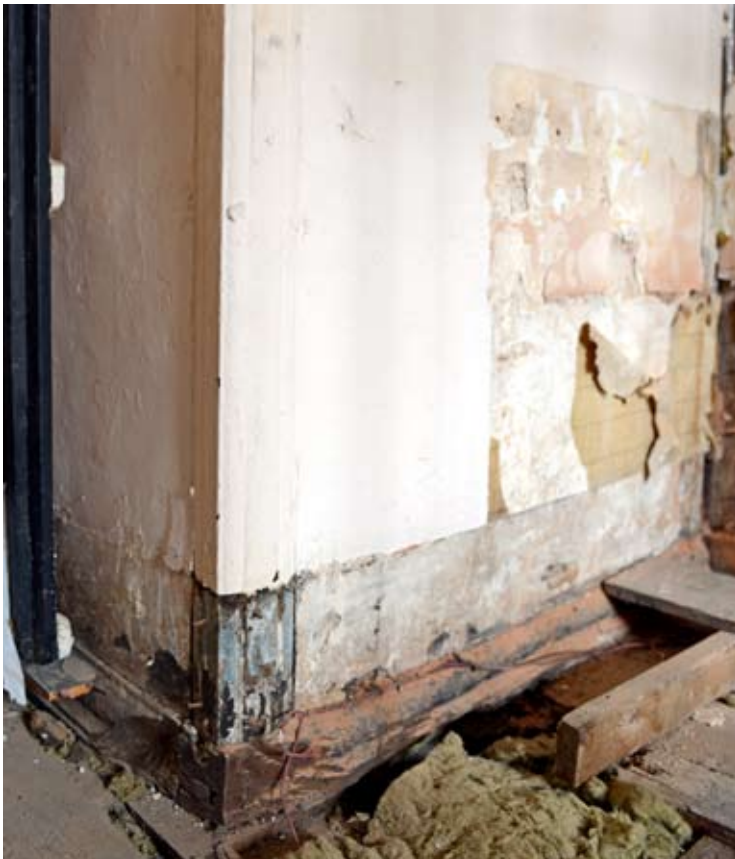
The east wall of the kitchen chamber backs onto the Great Chamber. It is close studded with rod-and-daub infill and clad with lath and plaster. Notice the chiselled assembly marks in the sill and the early 18th century painted black skirt to right, 18.06.2013.

The early 18th century painted black skirt continues round the base of the entry porch to the Great Chamber which projects into Room F. 02, 18.06.2013.

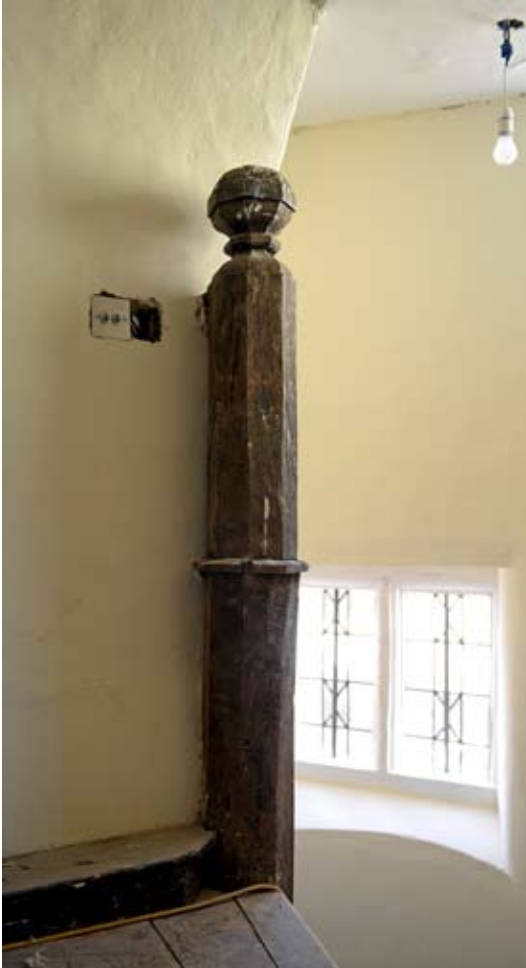
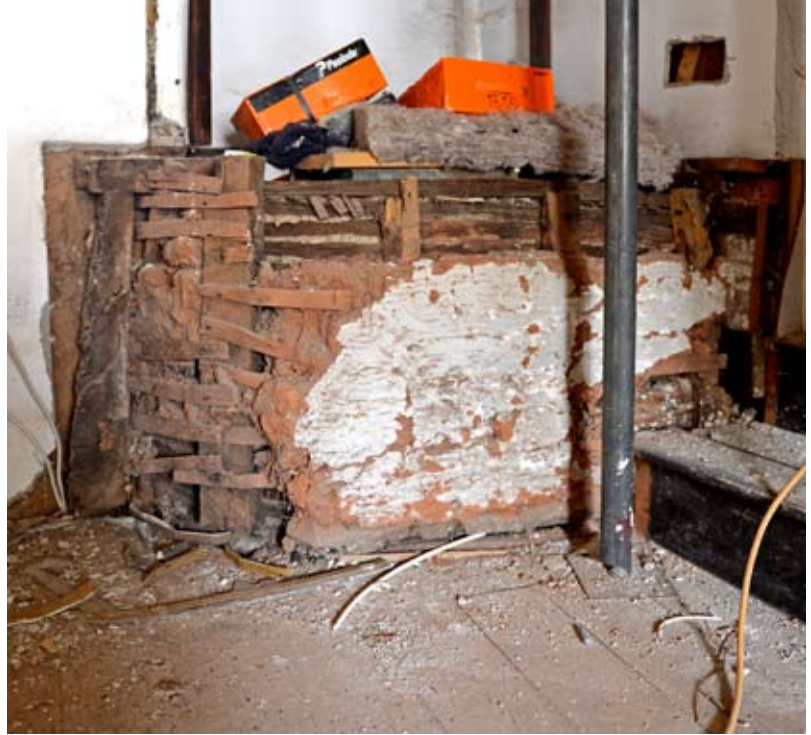
The newel post at the head of the service stair, 12.03.2014.

Not strictly this room. It is in fact the top of the newel stair rising in the northeast corner of the rear service block in Room F. 11. The photograph was taken during repairs and shows a rather crude frame making the curving wall. It is nogged and faced up with haired mud plaster finished with a skim of lime, 18.06.2013.

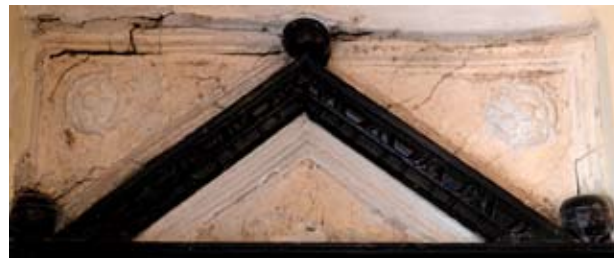
The head of the Mannerist arch to the porch entry to the Great Chamber from 02.06.2009 and the head during plaster repair on 12.03.2014

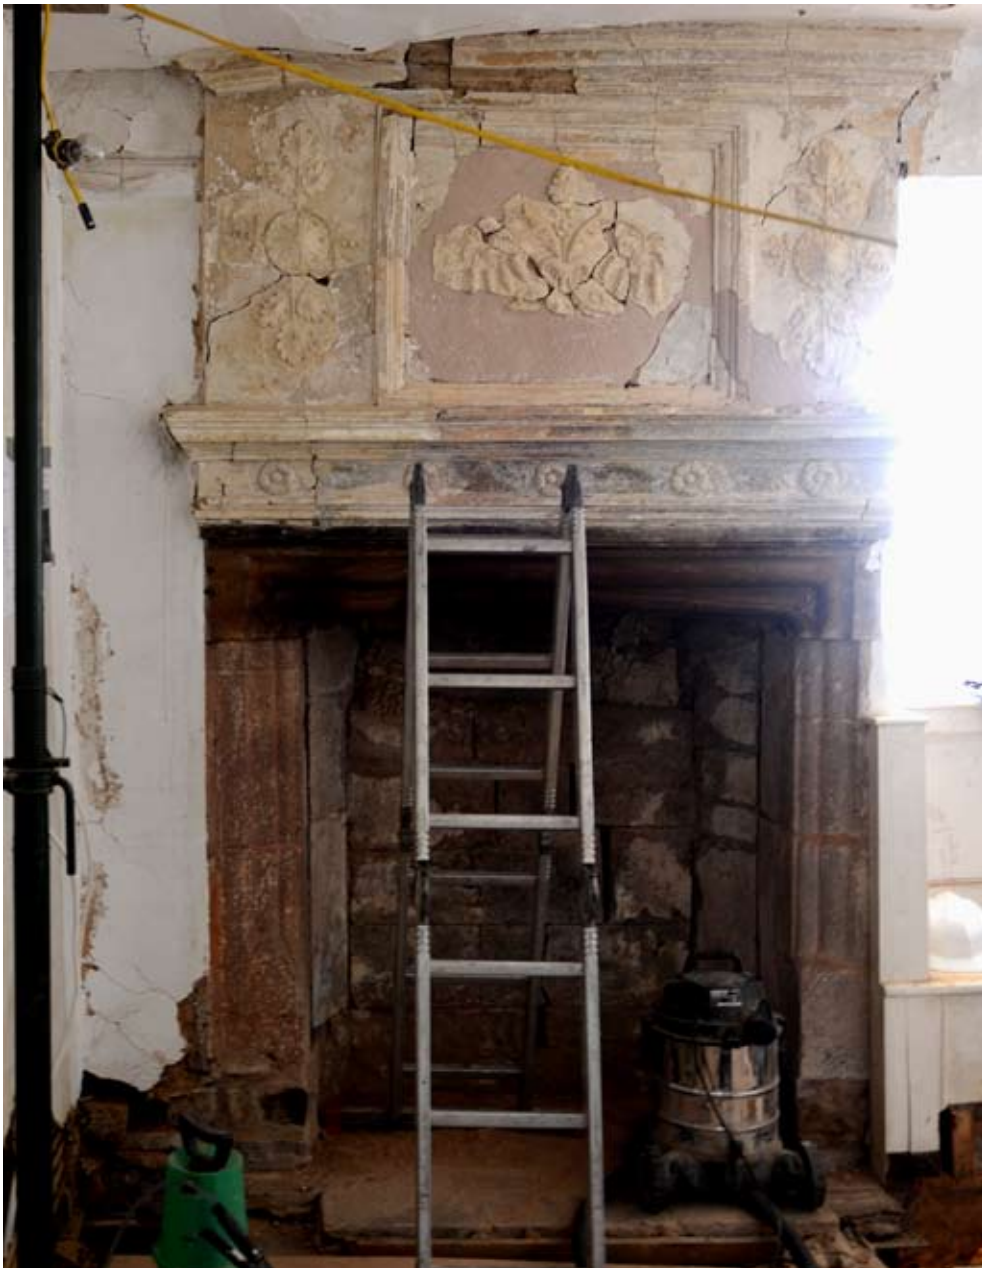
The fireplace and overmantle during repairs, 04.03.2013.

Overmantle c1605. Ornamental plasterwork in the same style, but less elaborate than those in the hall and Great Chamber using hand-run mouldings and cast motifs mostly from the ceiling plasterwork elsewhere in the house. It features a moulded square frame in the centre featuring the angle spray motif of hops and oak leaves. To either side of the plaque there are bosses with sprays of oak leaves radiating from them. The moulded base includes a frieze of carnation flowers and there is cornice of multiple mouldings up to the ceiling. When cleaned up for repair in 2013 it was found to have extensive repairs (probably in 1890-1) suggesting it was in a poor state then.

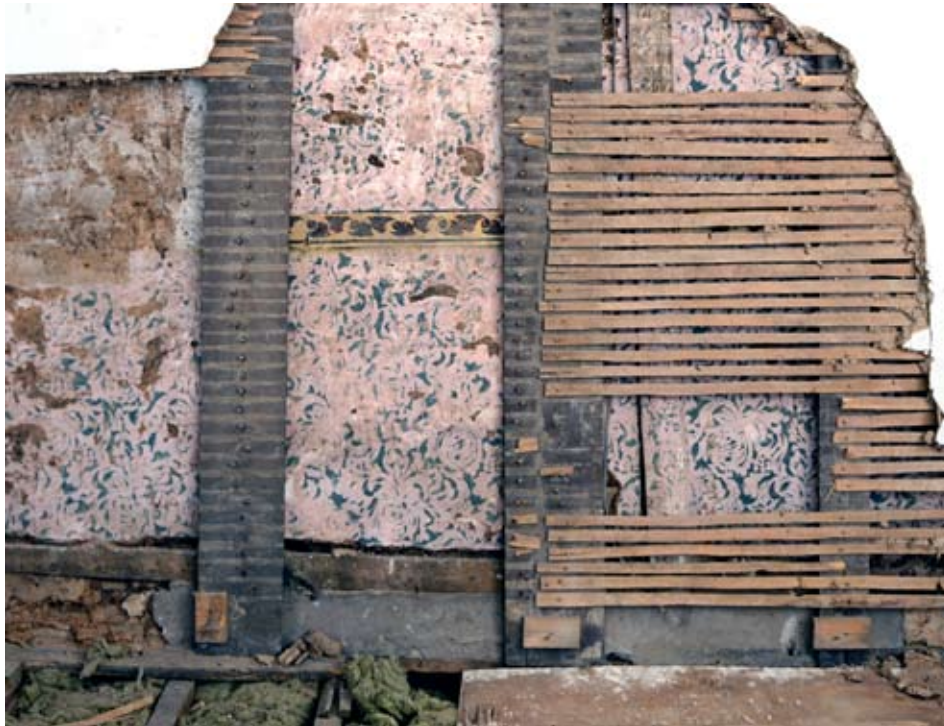
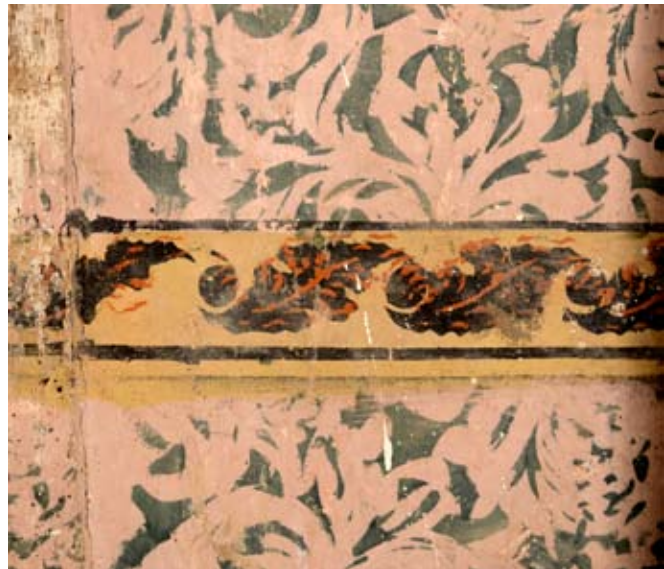
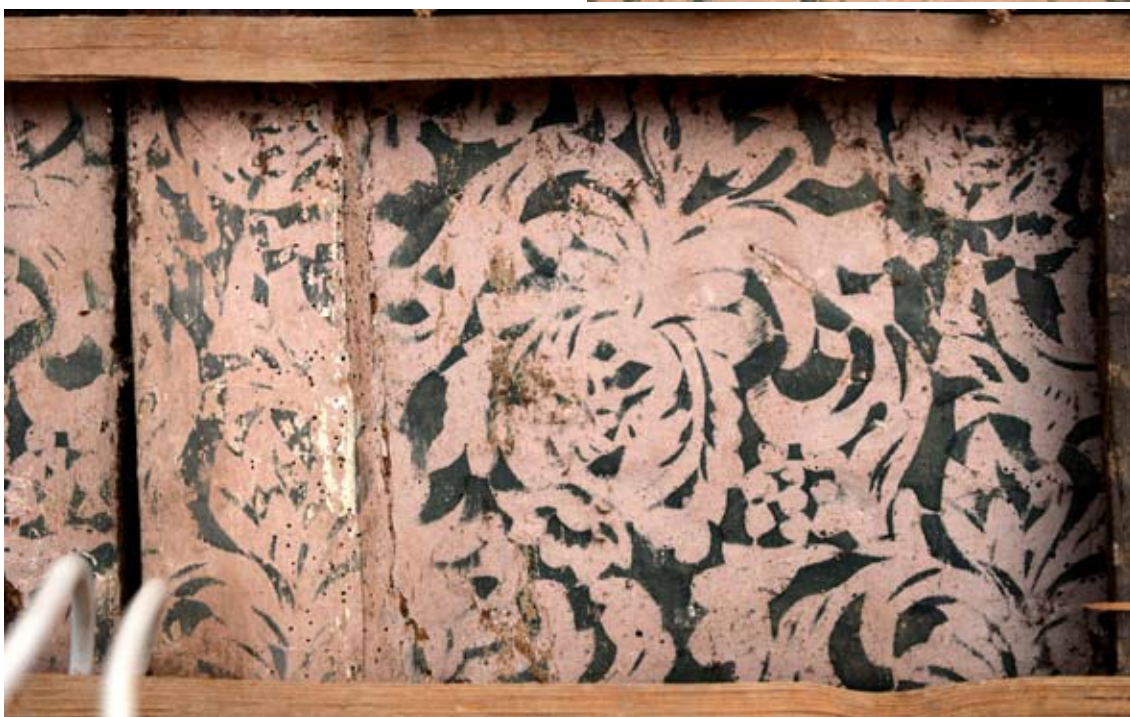
Stencil decoration In March 2013 some of the lath and plaster of the south wall was removed in order to upgrade the electric wiring in the room. This revealed part of an apparently overall scheme of stencilled decoration on the 18th century studwork wall behind.

*The stencil decoration on the south wall,
18.06.2013*

Detail of the dado strip, 12.03.2014.

Detail of the overall stencil pattern, 04.03.2013.

Conservation and presentation of the decorated wall was considered impractical for a holiday let bedroom, not to mention prohibitively expensive. Therefore the 1890-91 covering plaster was repaired leaving a hinged panel which can be opened to reveal a small section of the decoration including some of the dado strip.

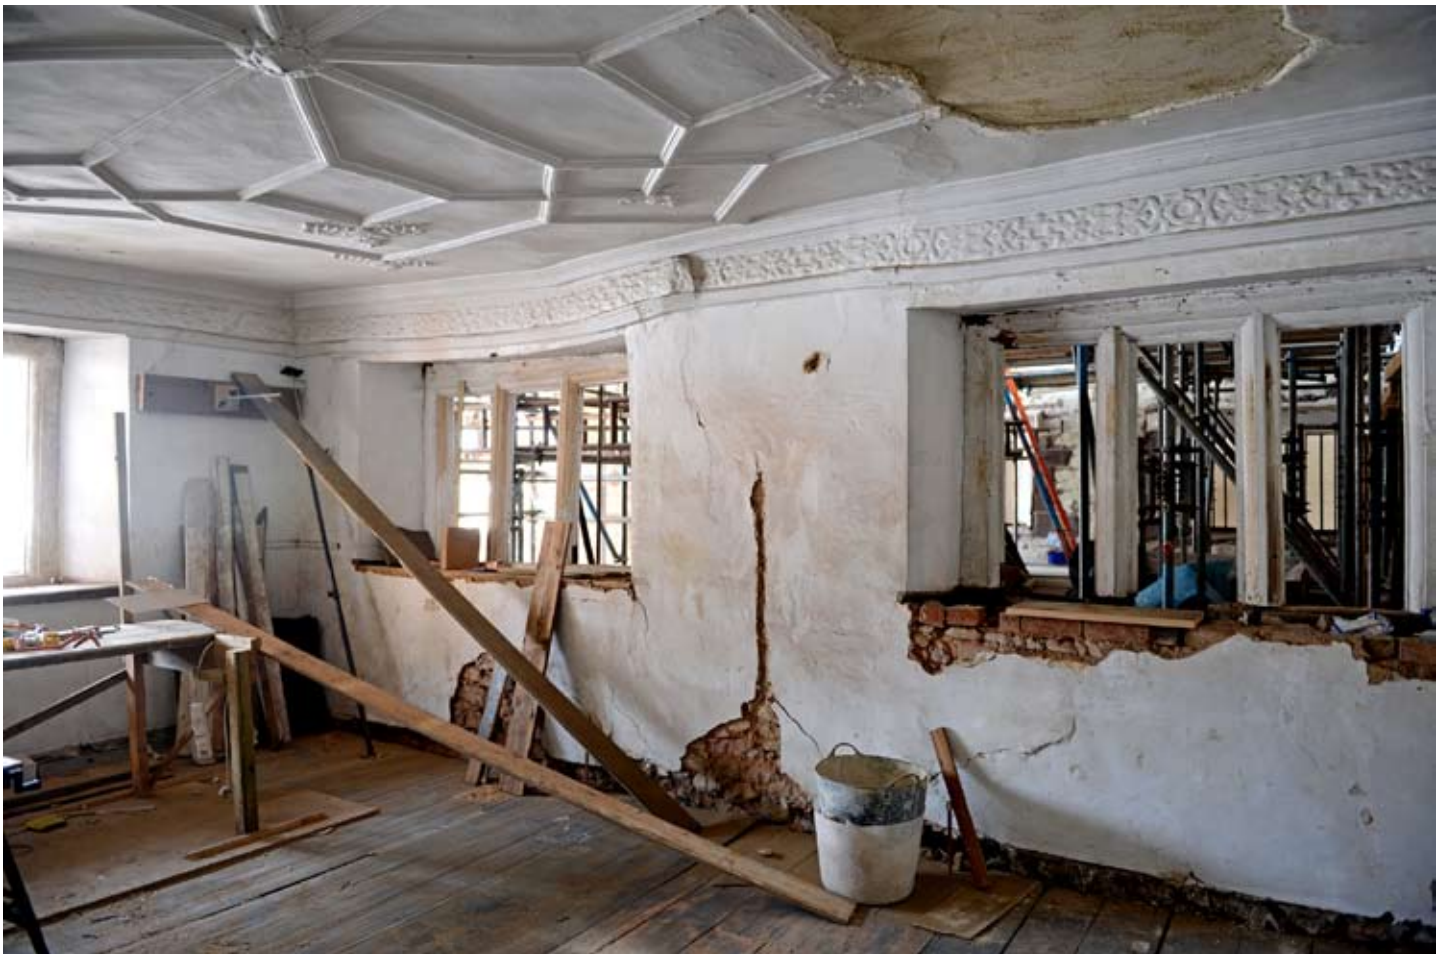
Summary of 2009 expert report: The frieze here is a series of cast units forming a geometric pattern; each unit is approx 18" long. Large areas appear to be replacement work – particularly along the north and west walls. A massive discontinuity in the southern side, in the centre of the wall must be related to structural movement in the wall itself. This area is cracked, potentially unstable and very unsightly. (McNeilage Plaster Report, November 2009).

The south wall during repairs, 18.06.2013.

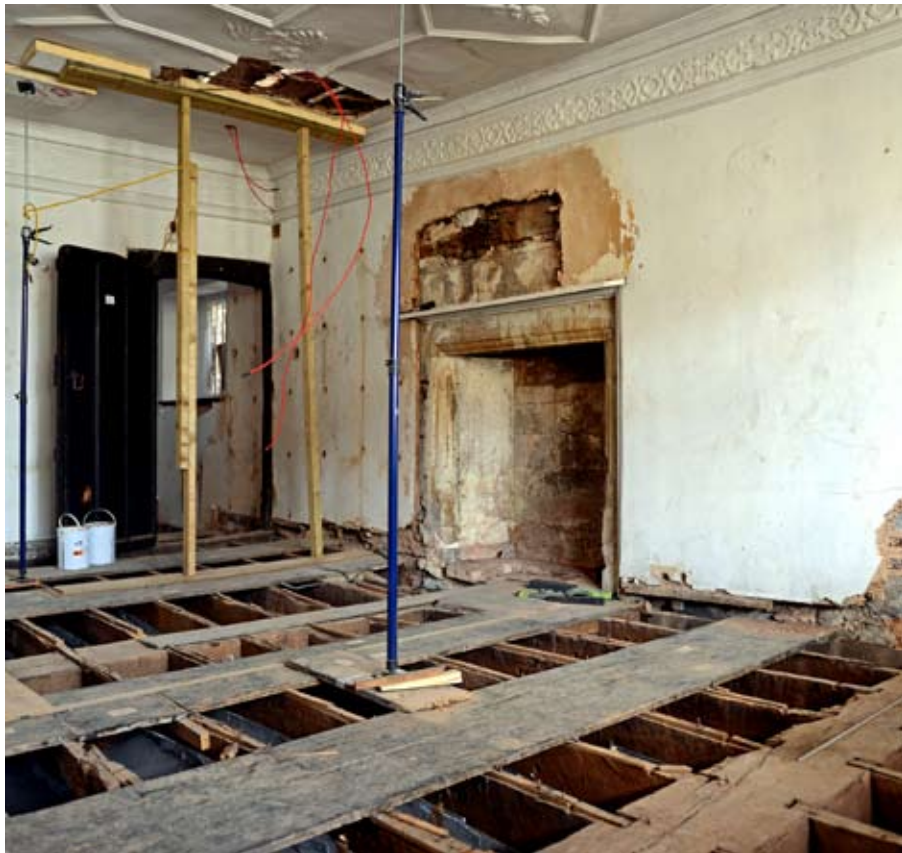
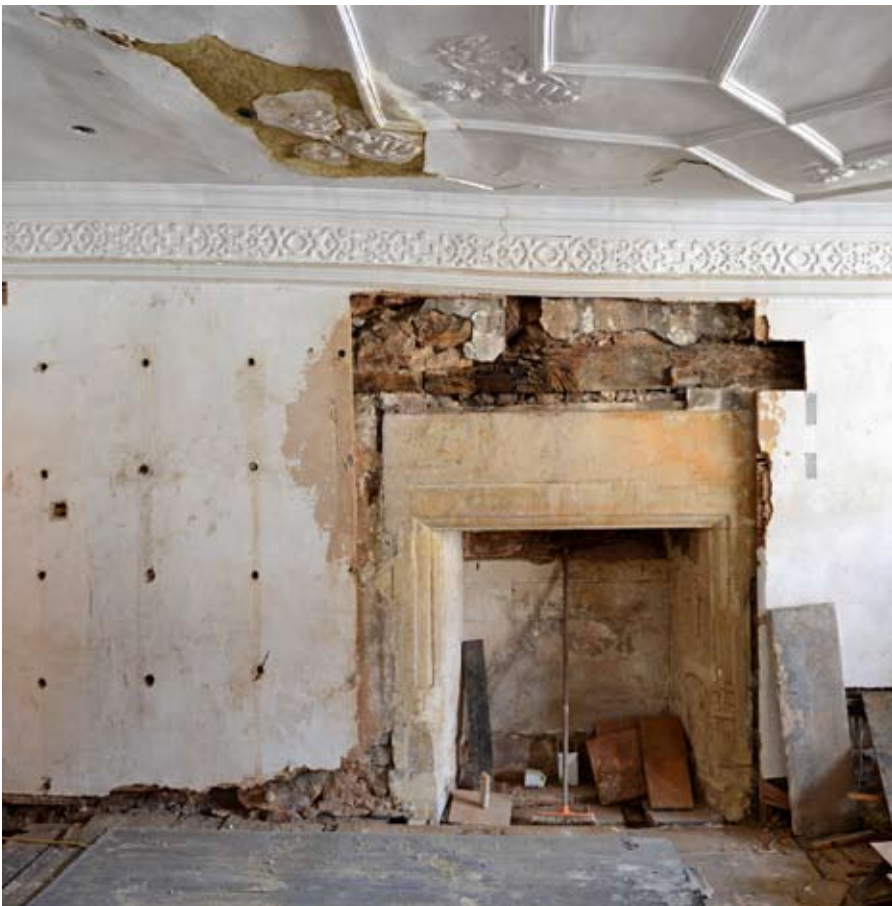
The northwest corner of the chamber with the floor joists exposed, 30.01.2013.

The fireplace and repair of the ceiling in progress, 18.06.2013.

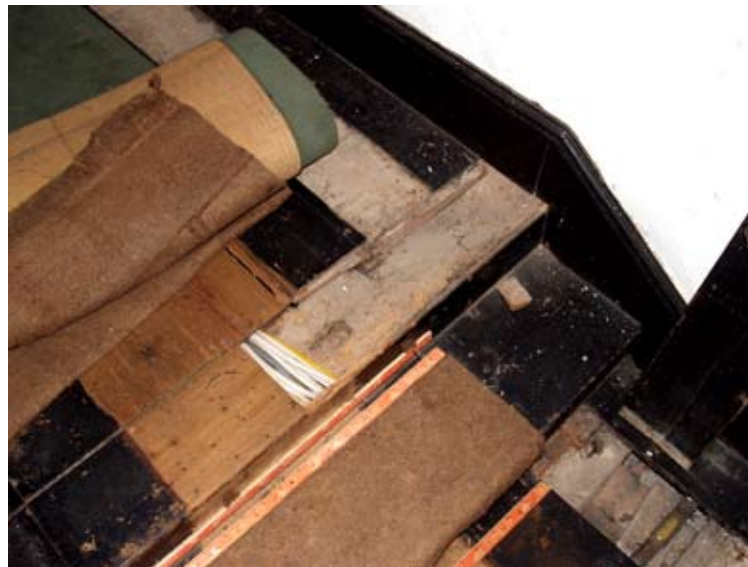
Evidence of 17th century framed partition. There are steps down as the first floor level descends from over the hall to the cross passage sections. On 06.10.09 the board over the top step was lifted to reveal an oak sill containing a couple of mortises for close-set studs. This represents the c1605 south wall of the full-width hall chamber. This part was demolished during the construction of the corridor.

The sill of the close-studded crosswall, 06.10.2009.

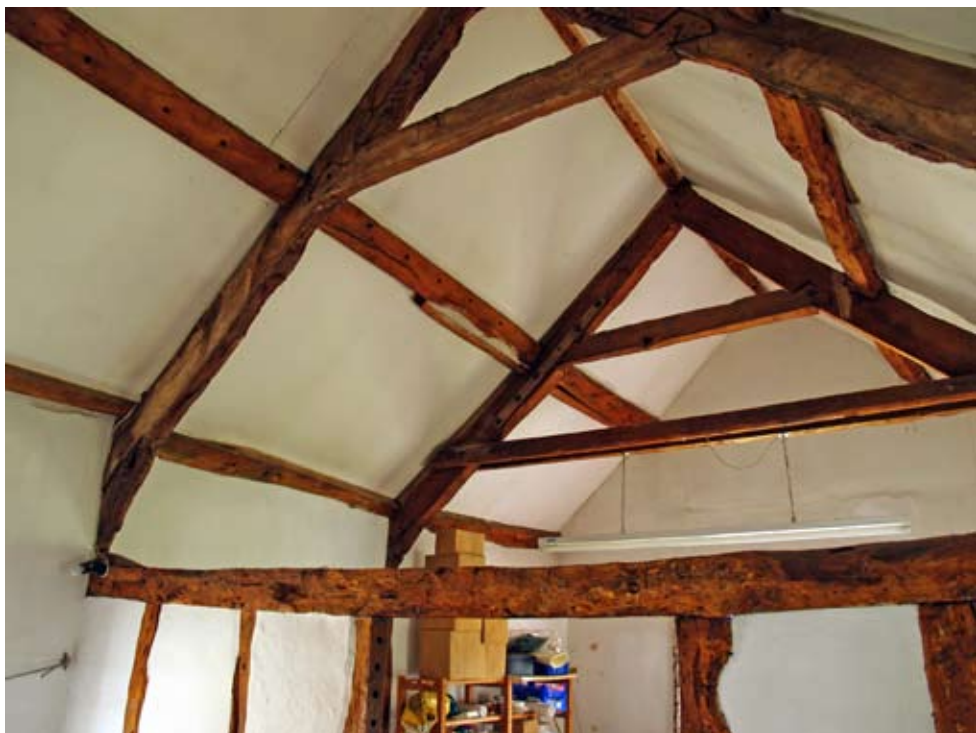
Framed partition. c1605 close-studded oak frame with pegged joints Infill of rod-and daub finished with a skim of lime plaster. One stud and two panels removed from the centre in 1970 to create doorway. The studs have holes down the insides for horizontal rods or battens which formed a ladder backing for the daub infill. The studs are numbered 1-7 in roman numerals. Number 4 has been removed.

The roof of the rear block from the east showing the top of the close-studded partition, 09.06.2009.

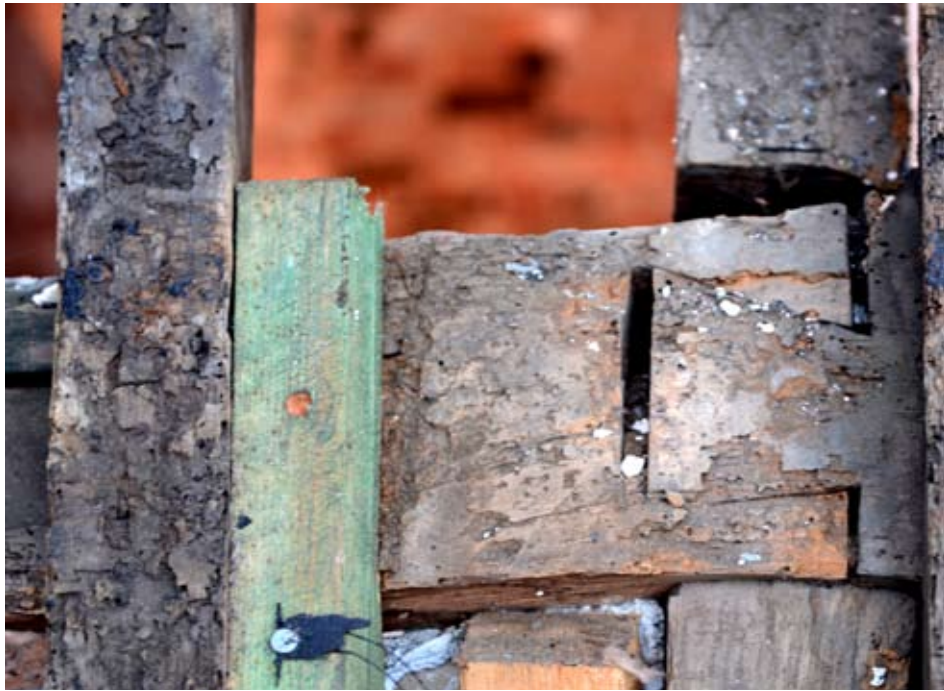
The joint between the two lengths of purlin on the back of the western truss on the north side, 16.11.2012.
