The Walronds

Cullompton

A Revised Gazetteer

August 2014

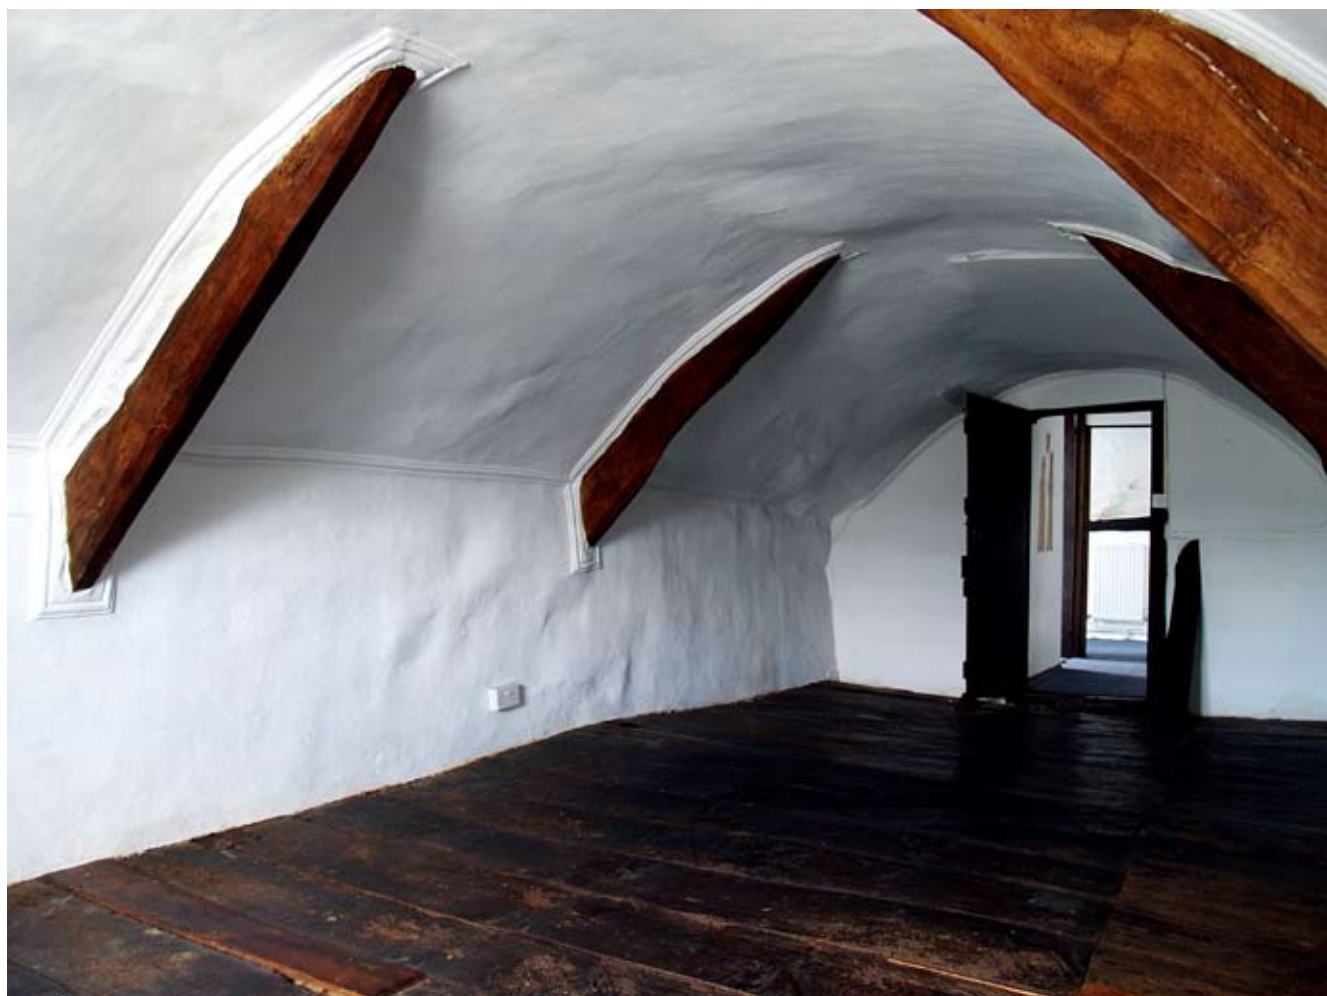
The attic chamber above the Great Chamber, known as the Nun's Dormitory, 09.06.2009.

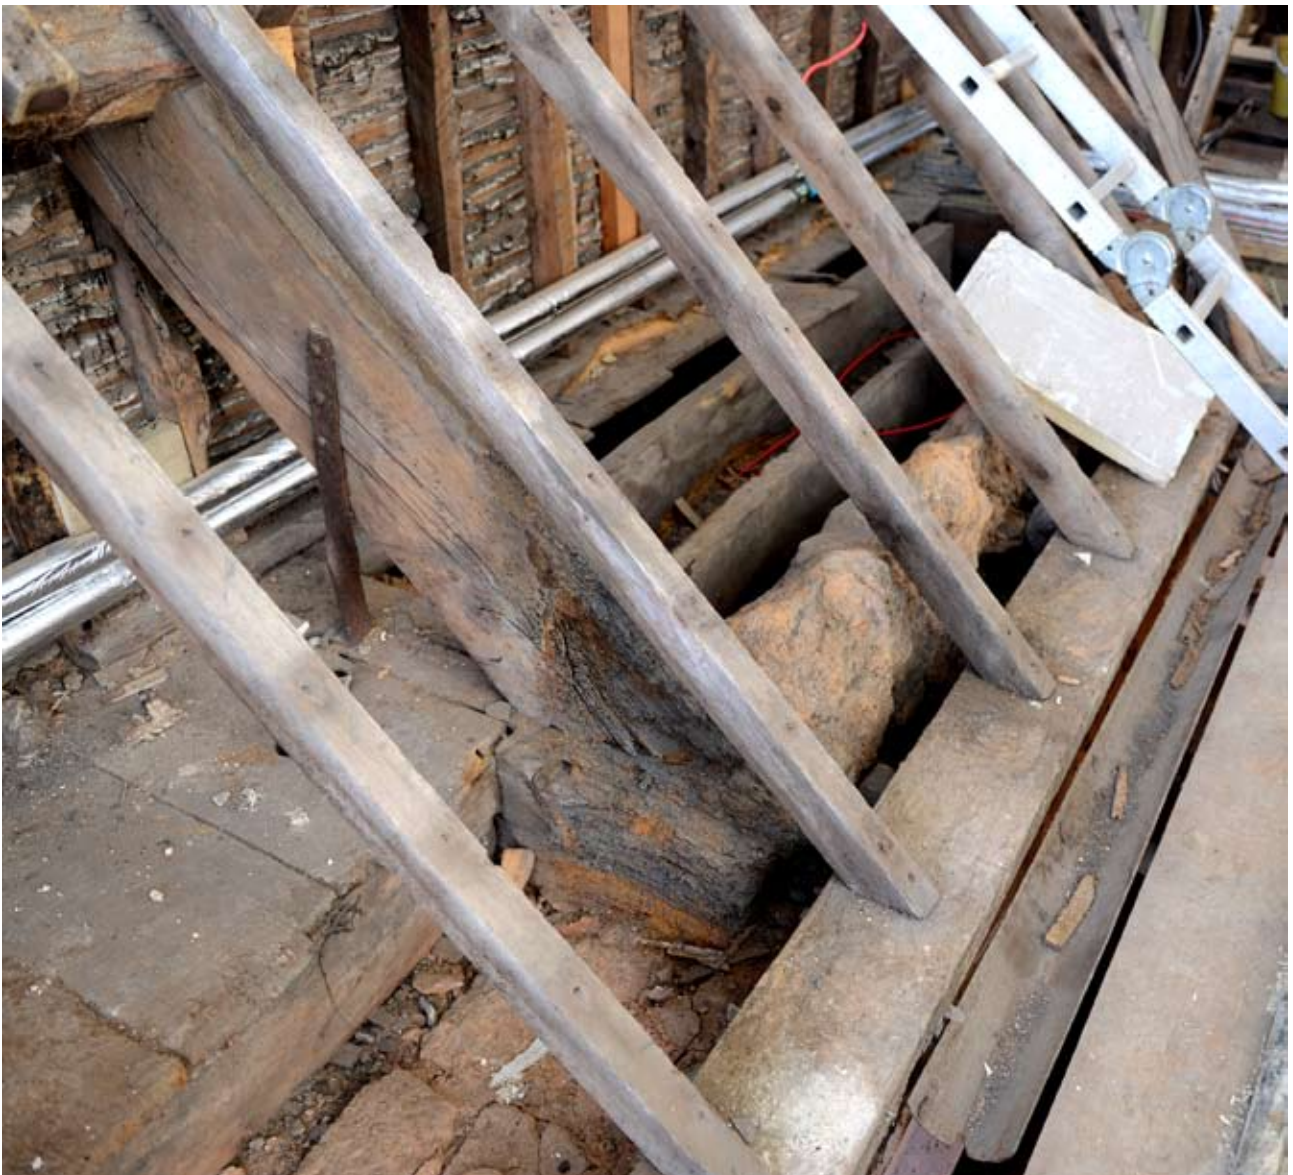
The southern pitch of the south wing roof looking east. The working common rafters are replacements from 1890-1 but the original were preserved between the purlins since the laths of the c1605 ceiling are nailed to them, 16.11.2012.

Detail of the north pitch of the south wing roof looking west at the base of the western truss. The common rafters and eaves plate date from 1890-1. Beyond the truss original cobbing up survives, 30.01.2013.

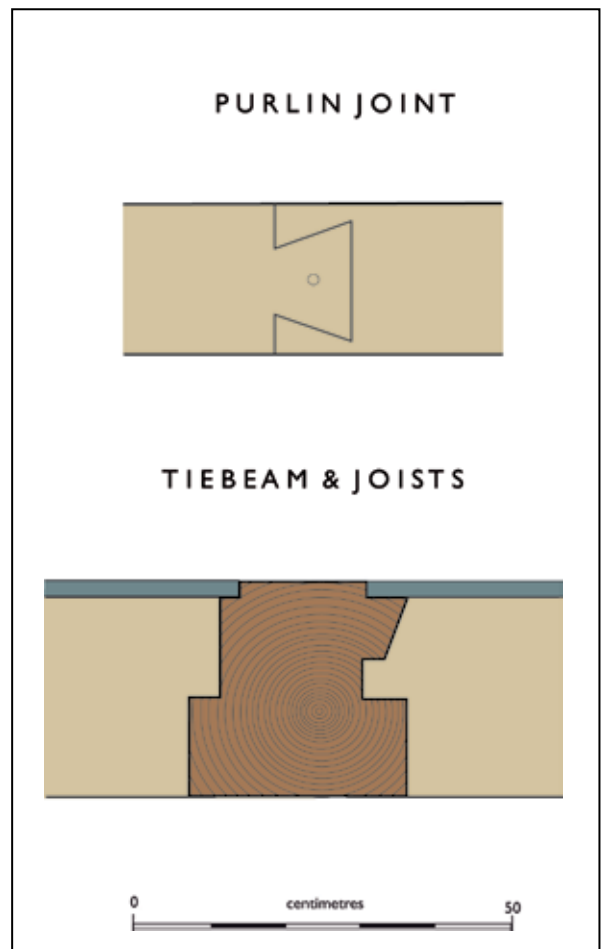
Recorded details of the tiebeam truss roof construction in the south wing.

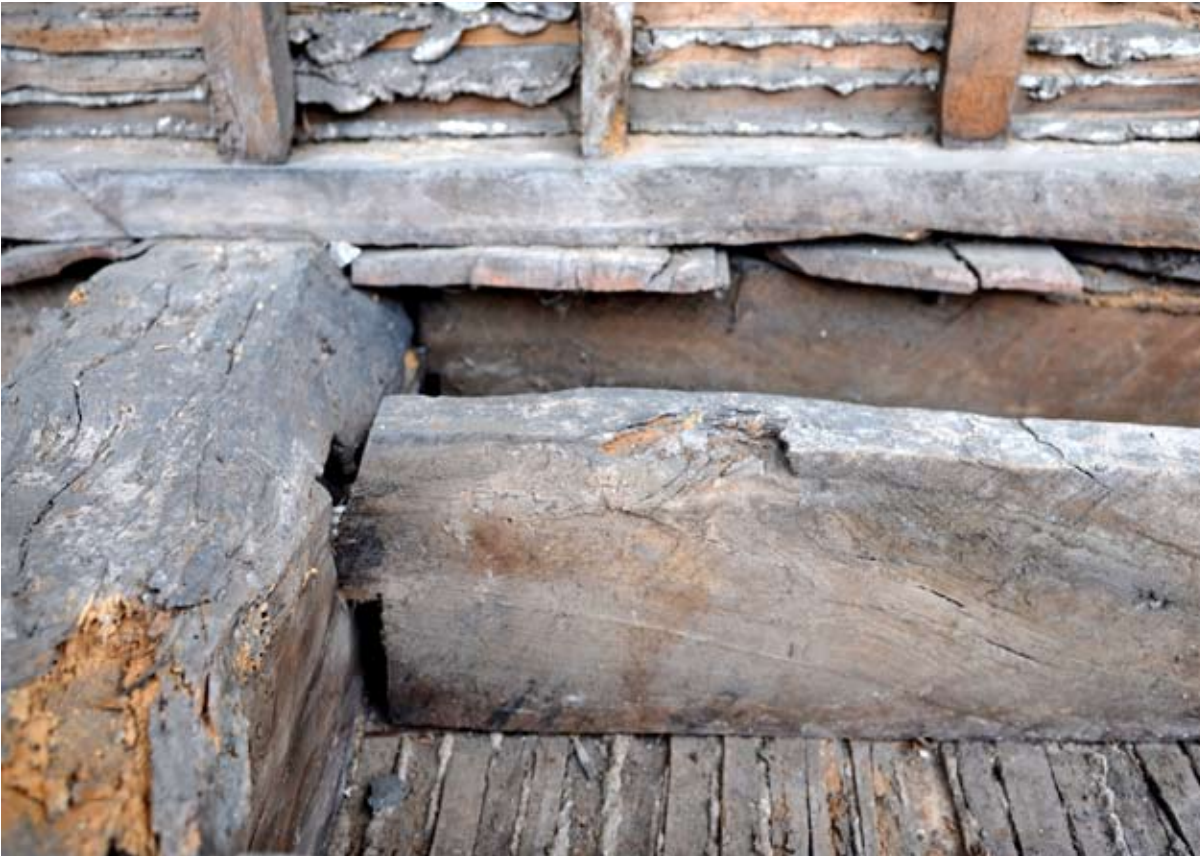
Plaster repairs showing the construction of the coved ceiling in the south wing, 30.01.2013.

Detail of the arrangement of the joists and floorboards in the east bay on the south side, 16.11.2012.

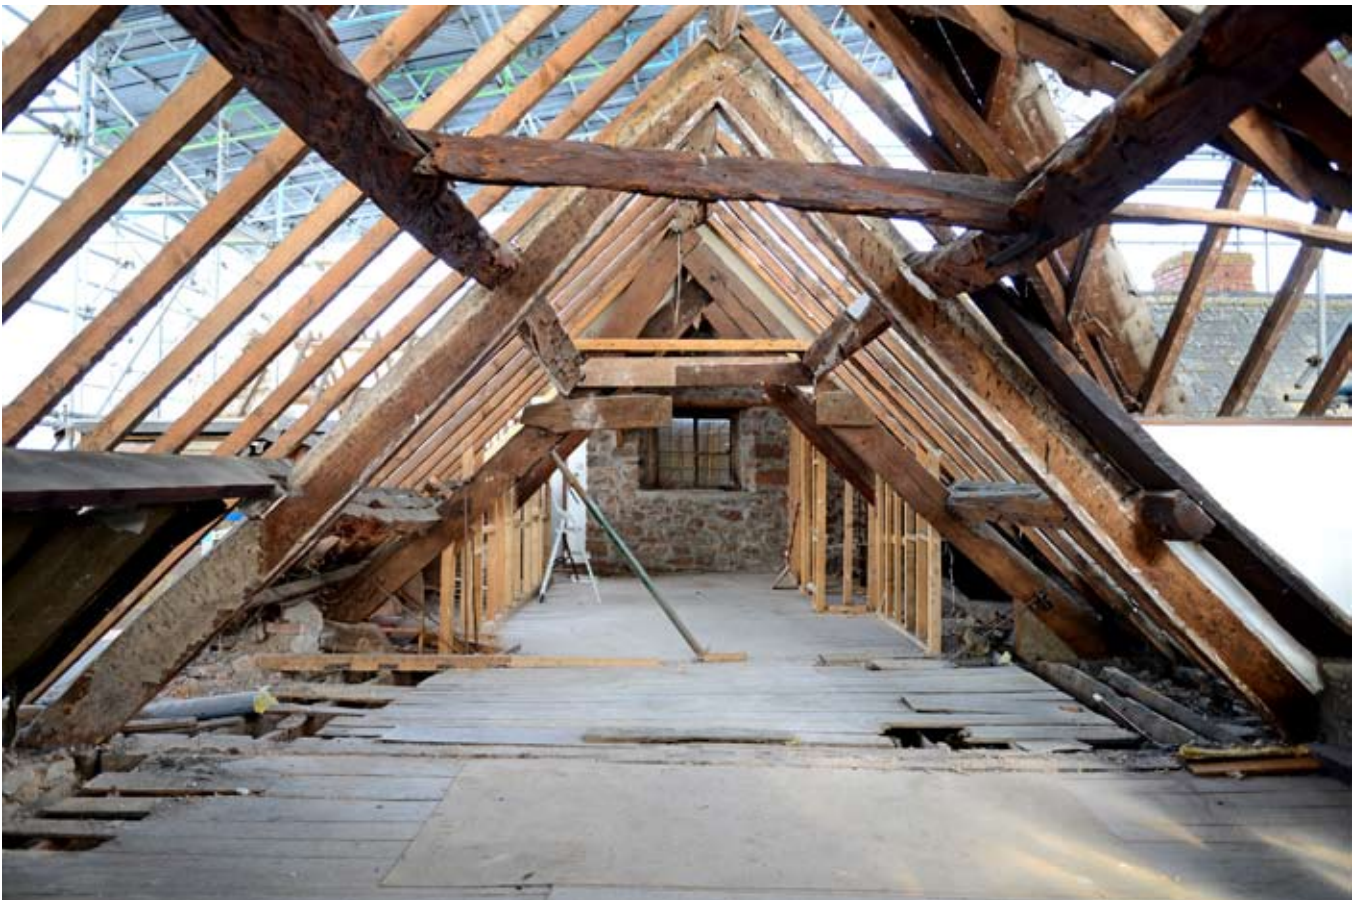
The main block roof looking north, 17.10.2012.

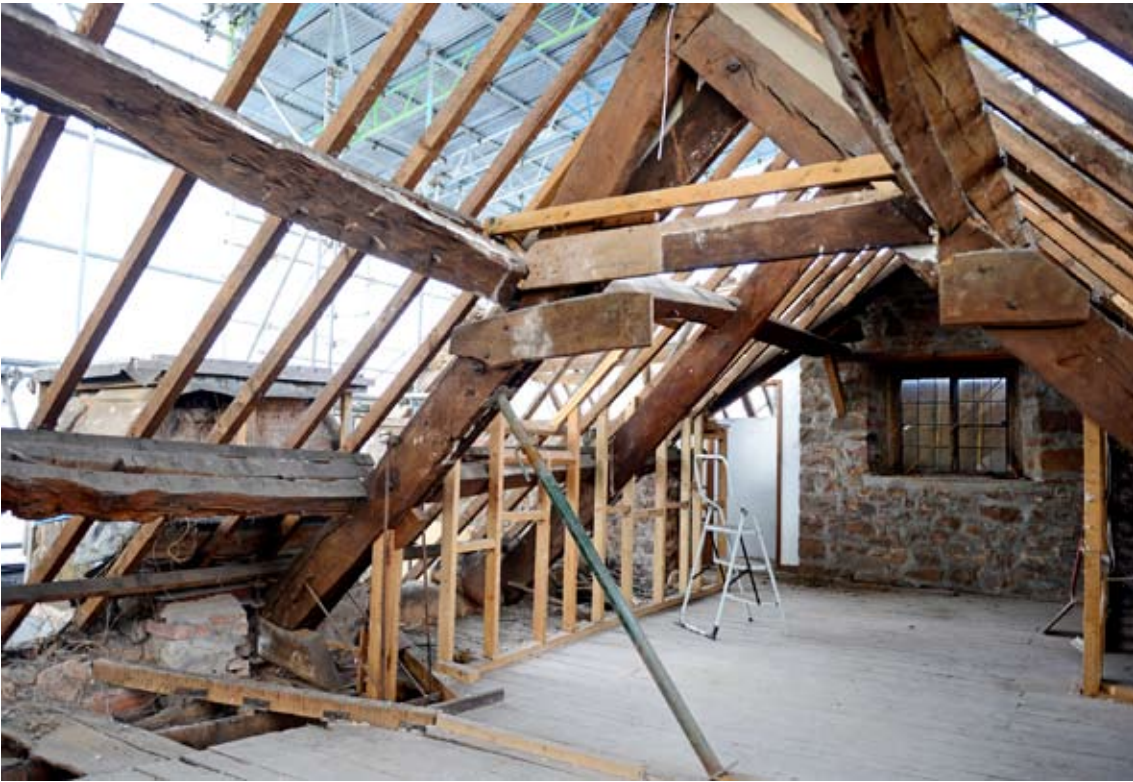
In 2012-13 it was possible to examine the roof structure in detail. The main trusses were largely intact although the one second in from the north end had undergone extensive repairs in 1890-1 on the west side where the tiebeam abutted the hall stack. As in the south wing and the rear service range the lengths of purlin met on the backs of the trusses with dovetail joints. c1605 cobbing up survived to south of the porch on the east side and north of the hall stack on the west side. The eaves plates were all 1890-1 replacements and the common rafters all dated from 1890-1.

The much-repaired truss set just north of centre, 17.10.2012.

Detail of the west end of the same trusses showing the repairs of 1890-1, 17.10.2012.

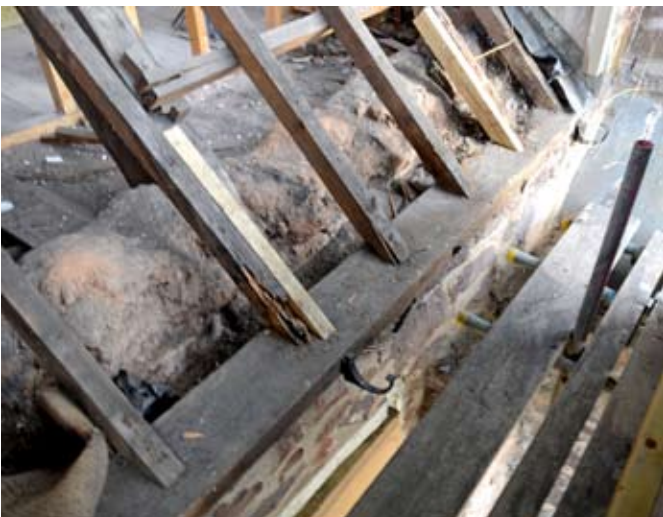
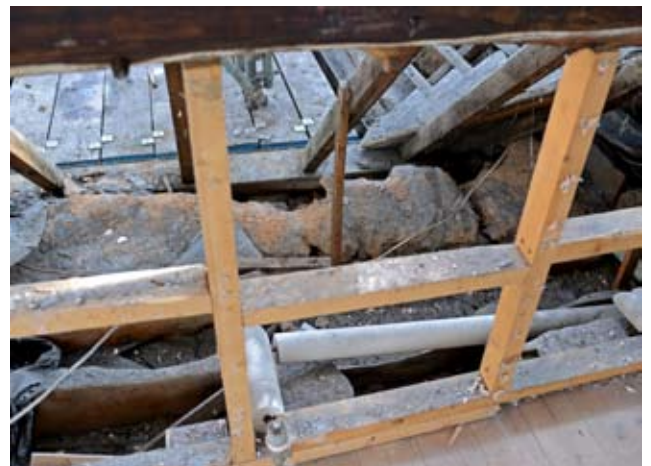
Original cobbling up on the west wall to north of the hall stack, 29.10.2012.

Original cobbling up on the east wall south of the middle gable, 17.10.2012

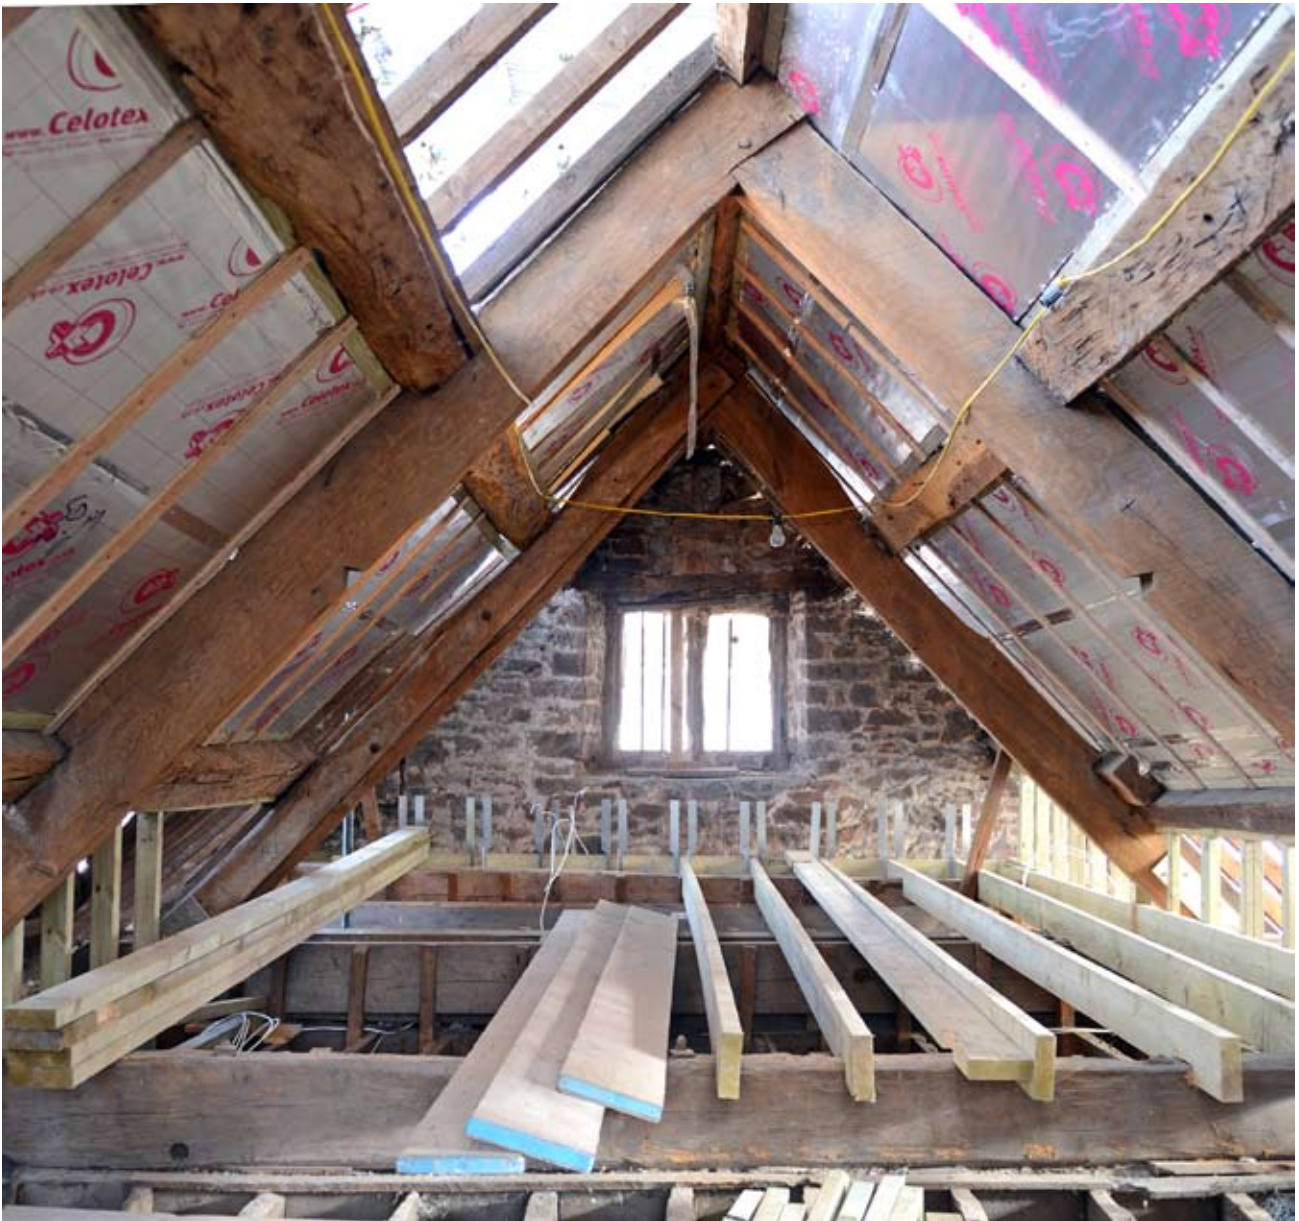
In 2012-13 it was possible to examine the roof structure in detail. The main trusses were largely intact, but braced by timbers introduced in 1890-1. As in the south wing, the main block and the rear service range the lengths of purlin met on the backs of the trusses with dovetail joints. No c1605 cobbling up survived. The eaves plates were all 1890-1 replacements and the common rafters all dated from 1890-1.

The north wing looking east, 30.01.2013.

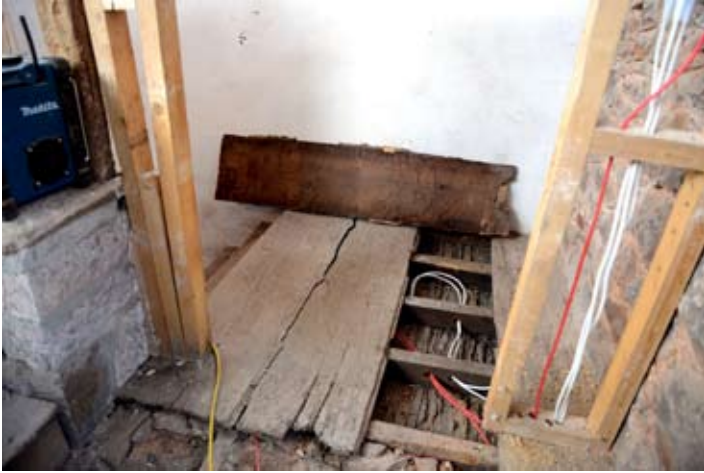
Old boards at the head of the main stair are half-edged together. They may well date from c1605, 30.01.2013.

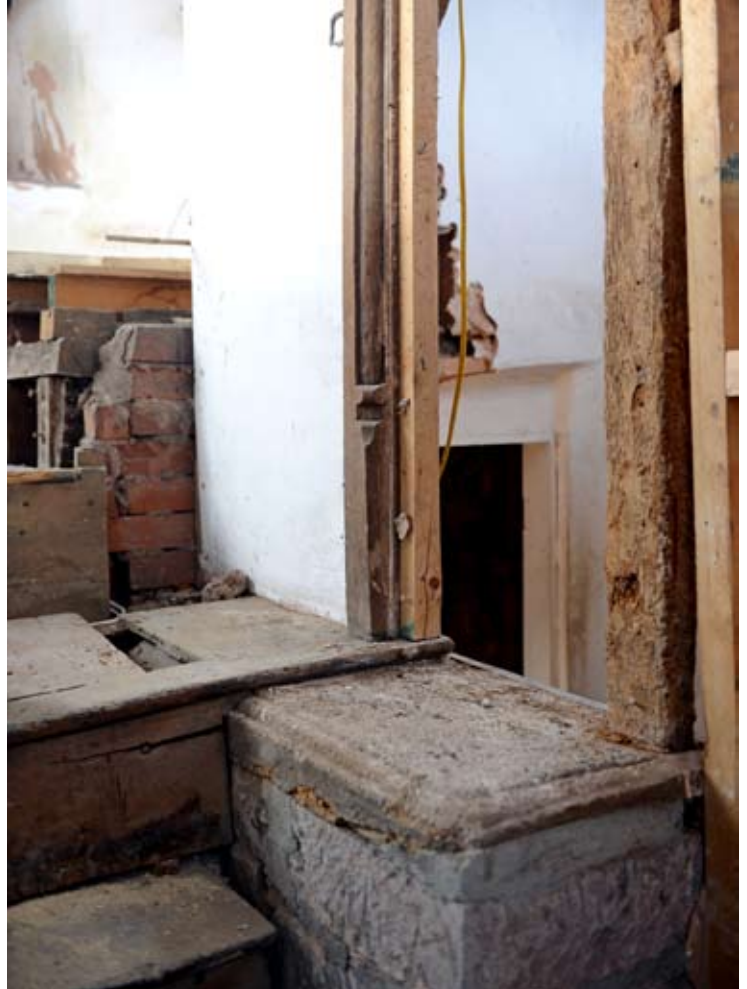
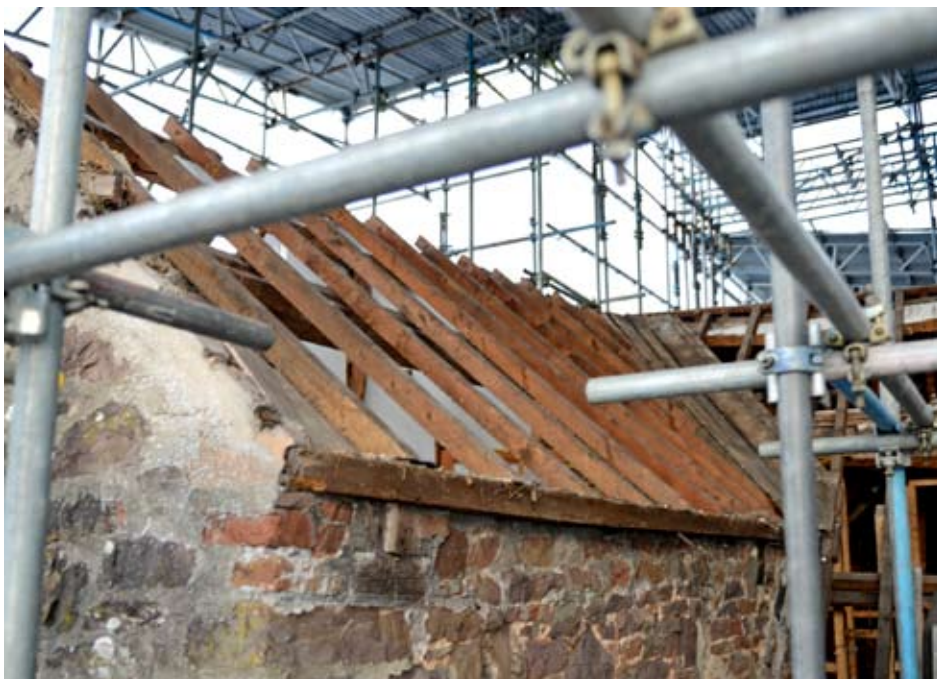
The moulded oak slab capping the stairwall and the surviving doorjamb to the tiny room over the main stair, 30.01.2013.

The stairblock from the southwest shows extensive repairs from 1890-1, 29.10.2012.
