HOAR OAK COTTAGE LYNTON & LYNMOUTH DEVON

Results of Historic Building Recording
&
Archaeological Monitoring

Report No.: 130815
Date: 15.08.2013
Authors: Dr B Morris
T Green

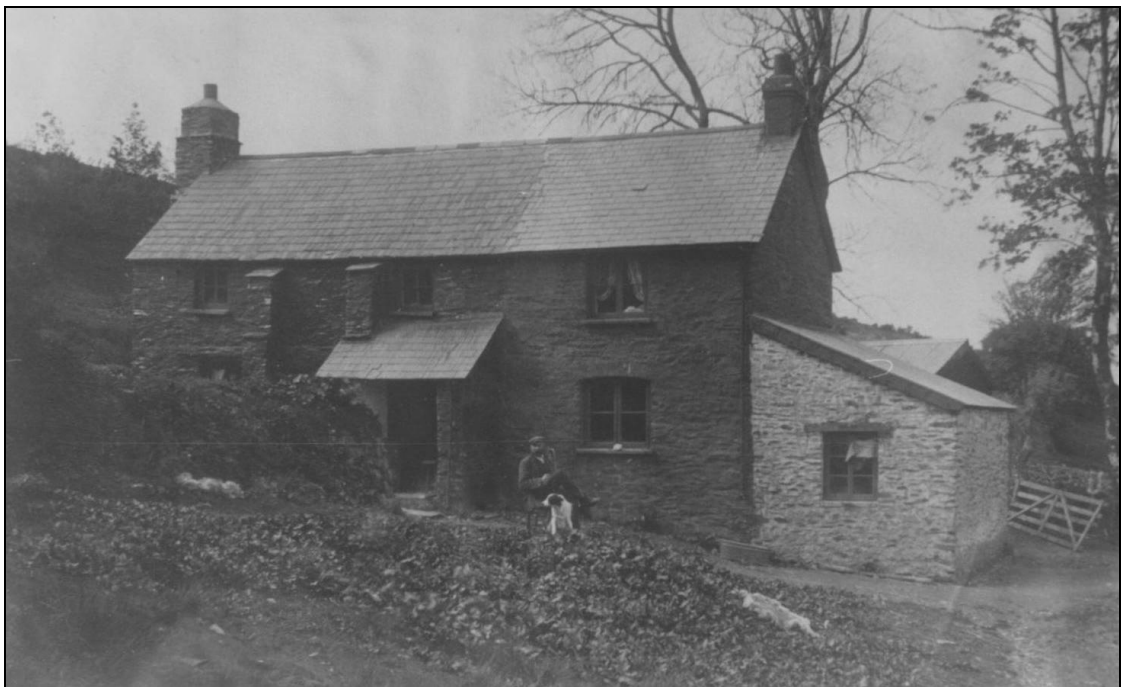
Figure 3: Hoar Oak Cottage, probably in the early 20th century, viewed from the south-east. The new slate roof on the 19th century extension (Room 2) can clearly be distinguished (FoHOC).

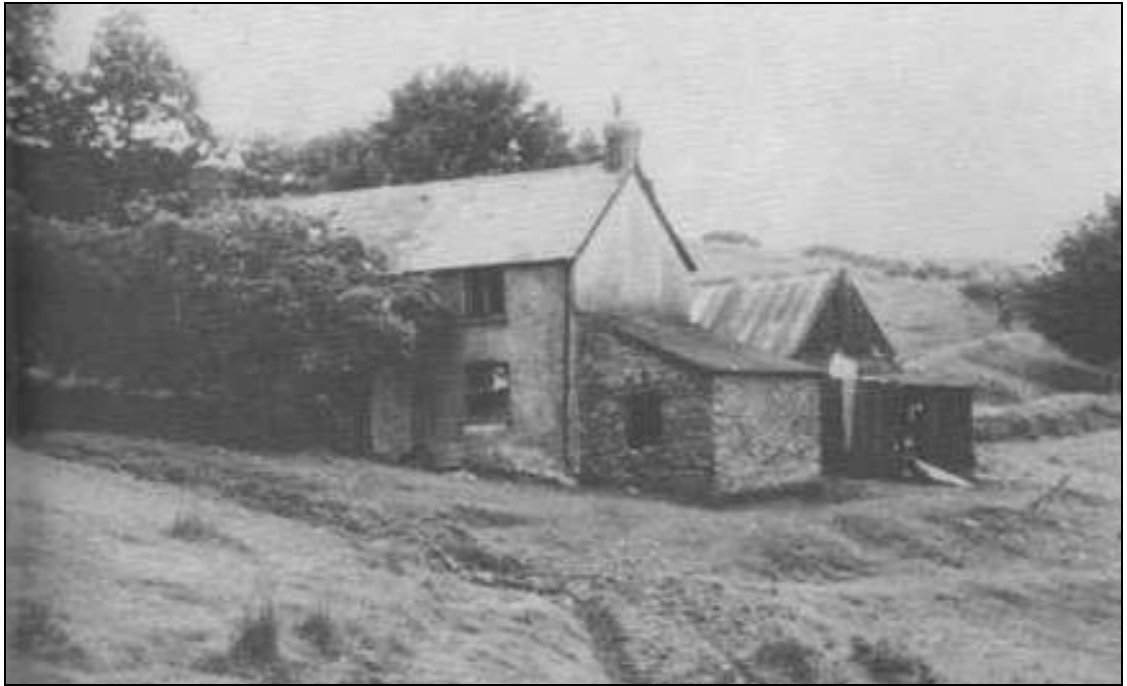
Figure 4: The cottage, viewed from the south-east. The trees have grown up around it, and the lean-to (Room 3) has weathered in (FoHOC).

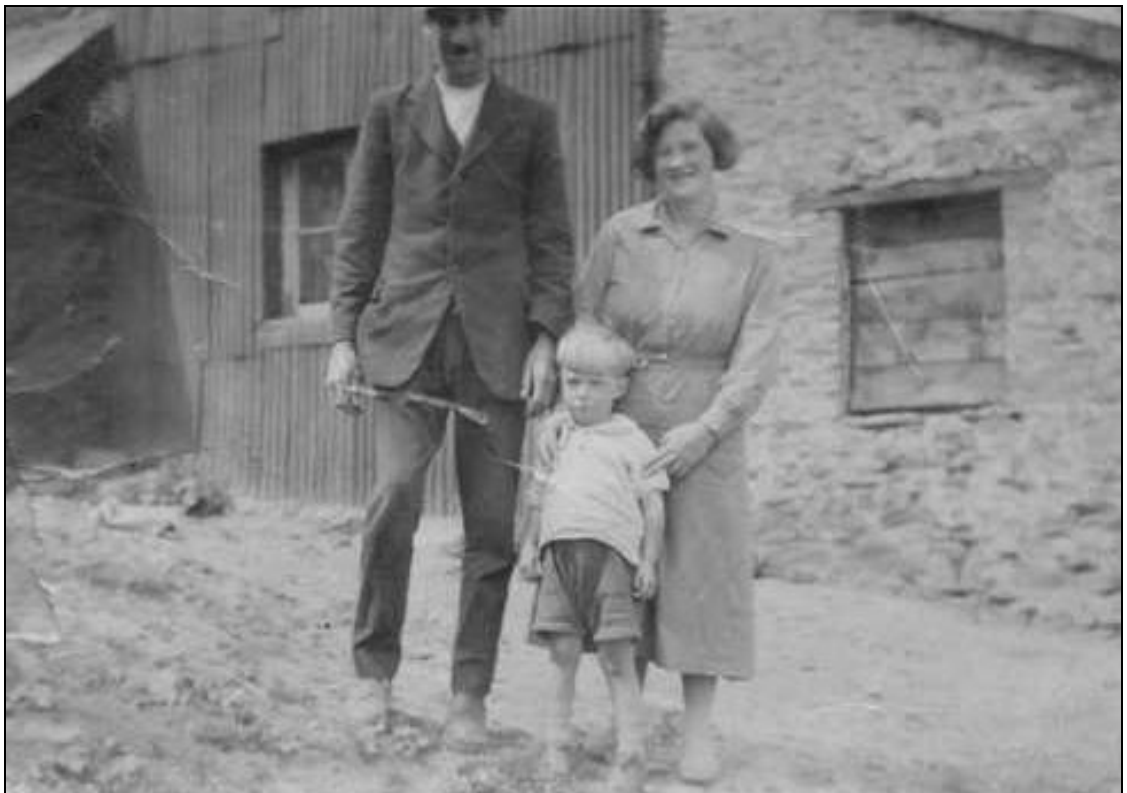
Figure 5: The same view of the cottage from the mid 1930s, but showing the exterior of Room 3 clad in corrugated iron (FoHOC, showing Bill, Dorothy and Denise Little).
