# COOMBE FARM BRIXTON DEVON

Results of Historic Building Recording  
& Dendrochronological Analysis

Report No.: 140227  
Date: 27.02.14  
Authors: B. Morris  
C. Humphreys  
E. Wapshott

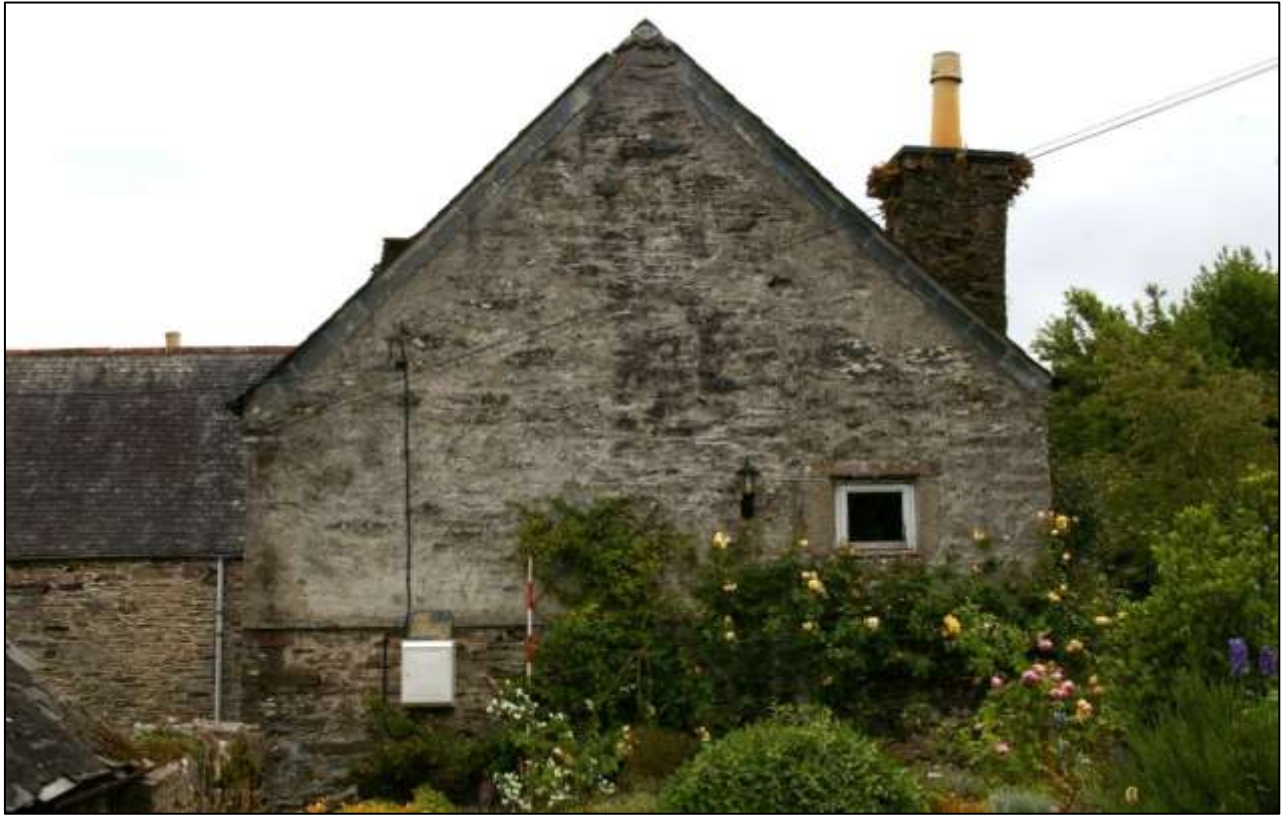
This elevation has three openings: two blocked windows and one open one. On the ground floor (and partly buried) is a blocked window with chamfered granite surround and central mullion. On the first floor and

directly above the other one is a similar window with chamfered granite surround, lacking the central mullion and with a simple 19<sup>th</sup> century wooden window frame inserted. On the second floor is a blocked window, visible only from the interior. All three windows are very similar in terms of size and style.

Figure 57: West-facing elevation of the 15<sup>th</sup> century block; viewed from the west, looking east (scale 2m).

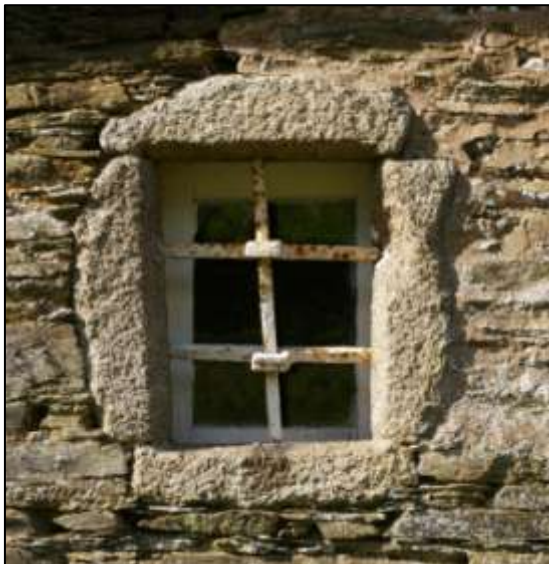
Figure 59: The single surviving original window in the southern elevation. Note the chisel marks on the knuckles of the *ferramenta*.

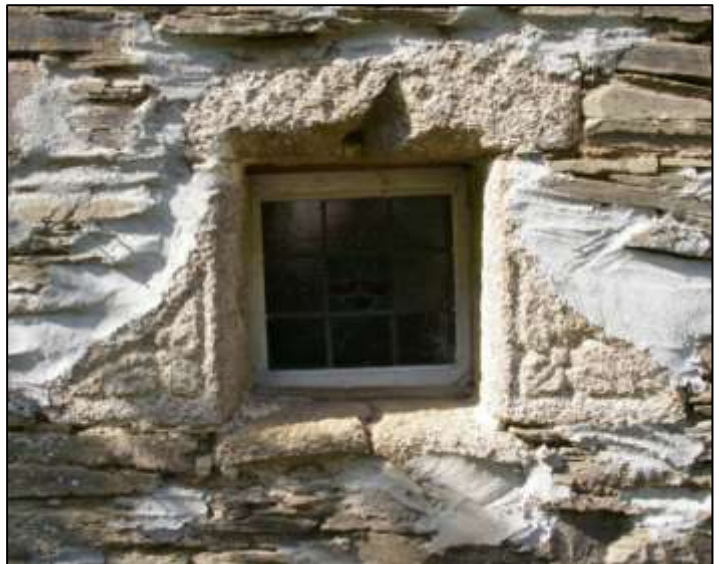
Figure 60: The lower window in the southern elevation, showing the decorative clusped mouldings and floral motif.

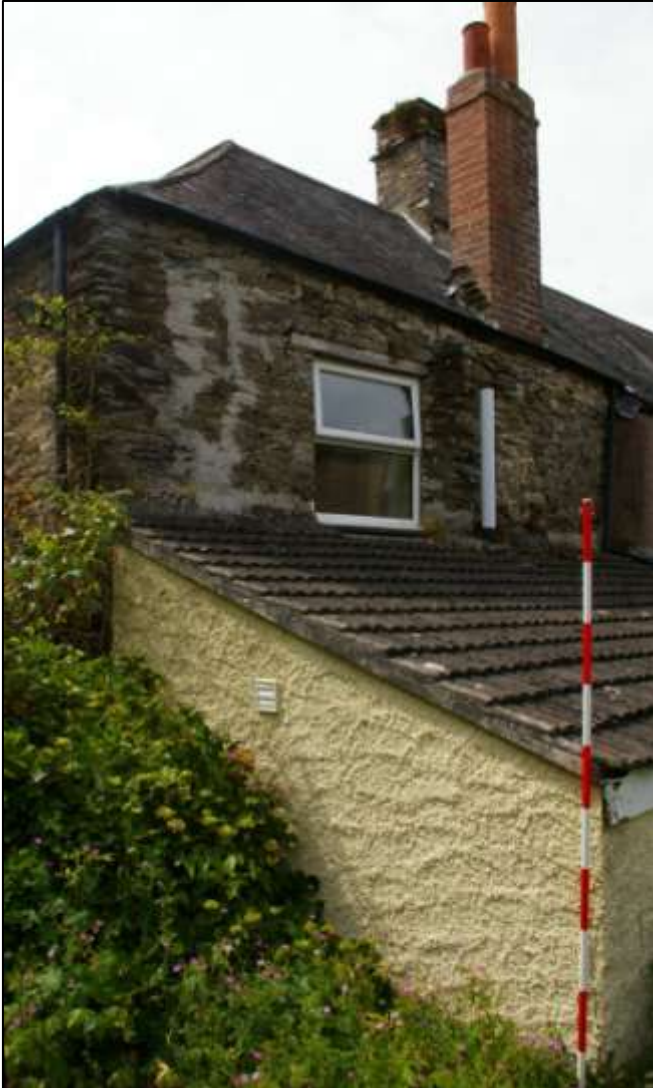
Figure 61: The eastern end of the 15<sup>th</sup> century block; viewed from the south-east, looking north-west (scale 2m).

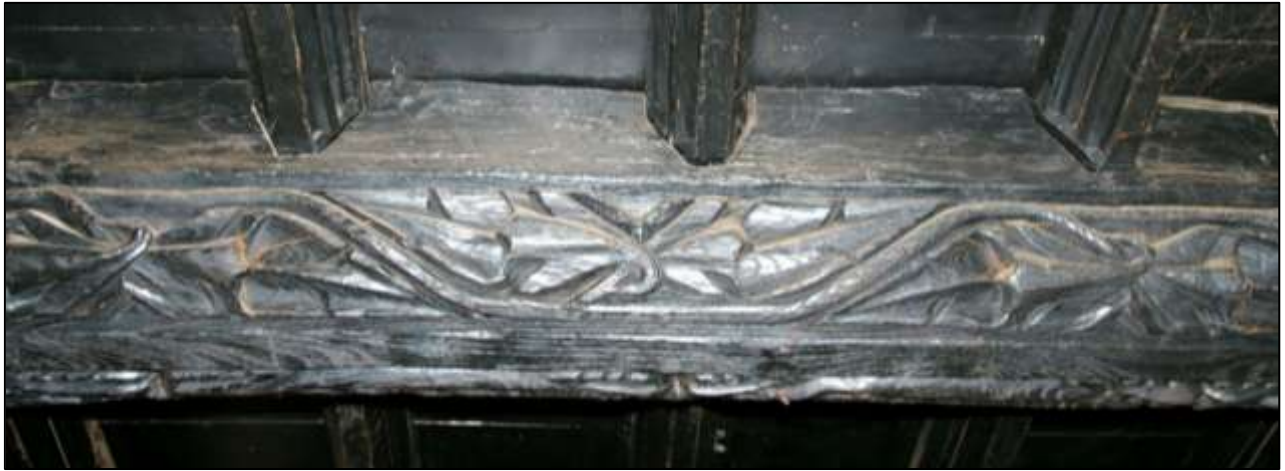
Figure 64: The west face of the western beam, Style 1a.

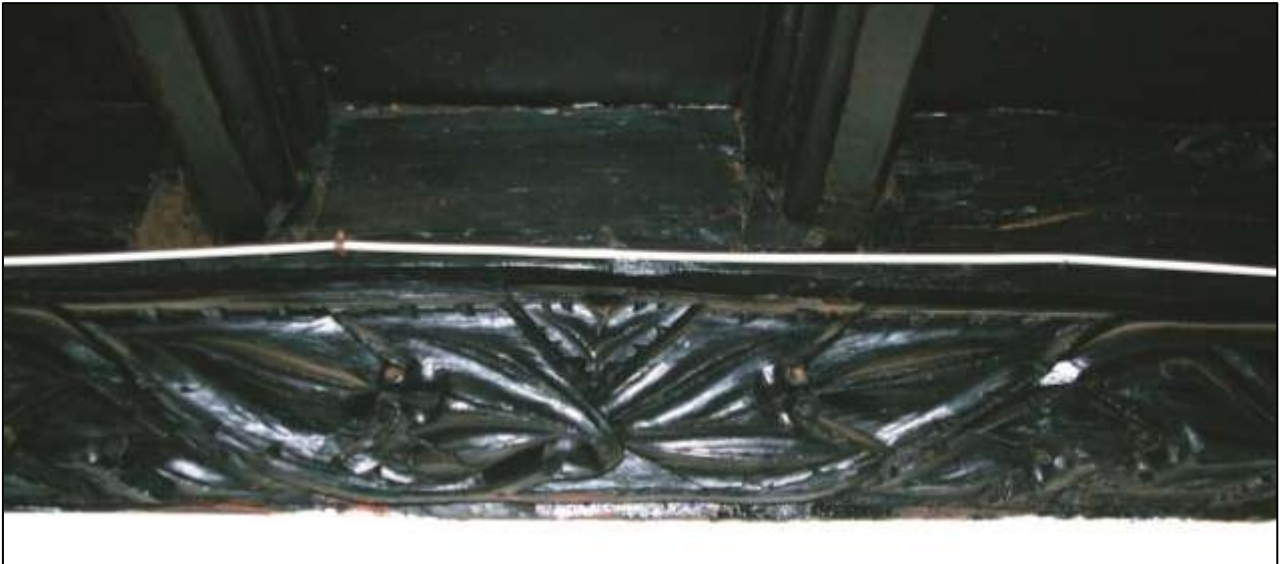
Figure 67: Eastern wallplate, Style 4. Note the holes at the joints of the leaves, and the ill-fitting joists.

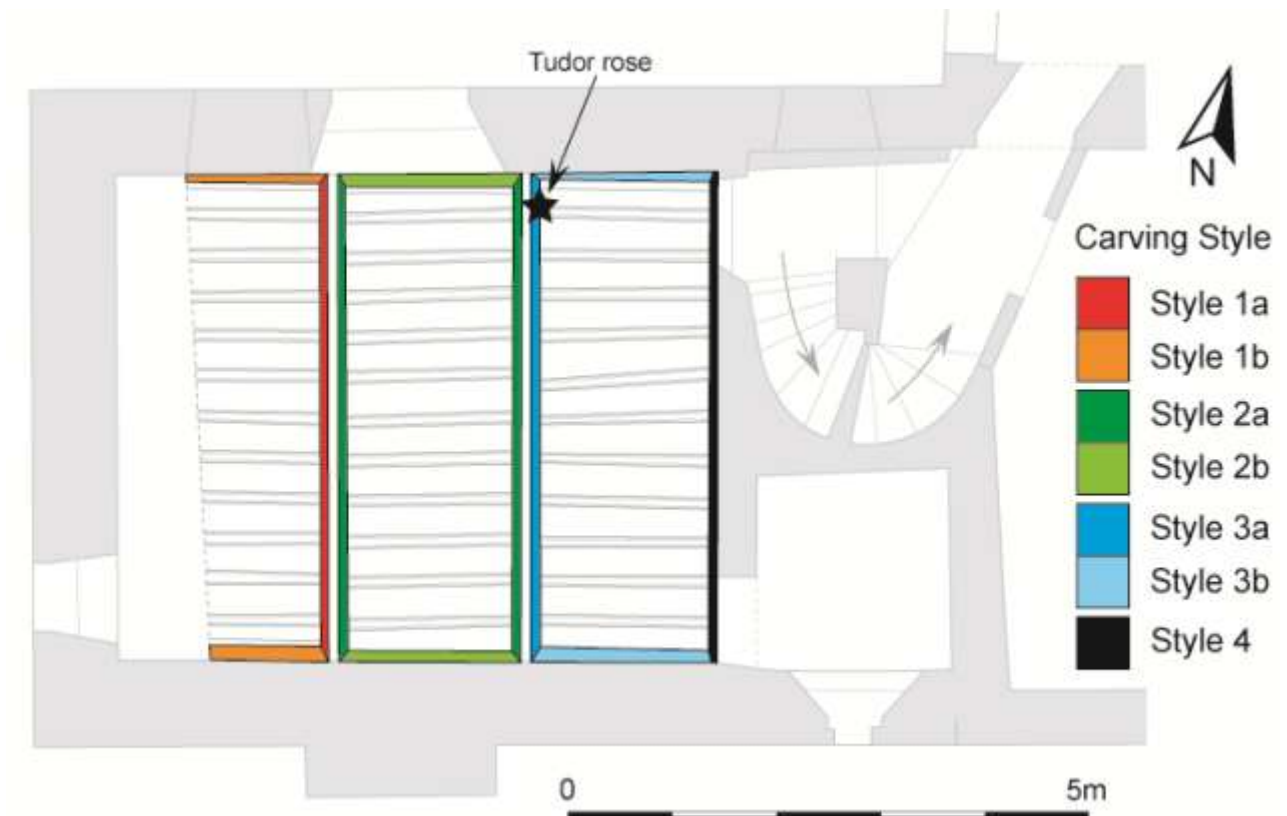
*Ceiling:* Elaborately carved oak beams and wall-plates support deeply carved joists, cavetto over ovolo moulding. The wall plate to the west is concealed behind the false wall. The pattern of carving on the beams and wall plates is coherent, but overall does not seem to fit very well, implying all elements bar the eastern wallplate have been inserted into this structure at a later date. In addition, one of the central beams is supported by an upright. There are four different patterns of scrolling vine leaves and/or linen scrolls, with an additional three minor variations (see Figure 64 - Figure 67). The western 'panel' of carving has a repeating motif of a pair of leaves separated by a curving vine (Style 1a and 1b). The central 'panel' has a horizontal vine around which a linen scroll is wound, with paired leaves either side of the vine 'inside' the linen scroll (Style 2). The eastern 'panel' is similar to the western 'panel', but less well executed (Style 3a and 3b). At the northern end of the central beam, a tiny Tudor-type rose is incorporated into the pattern, this is directly opposite and visible from the door into R3. The variation in Styles 1 and 3 concern the small triangular area between the paired leaves. In Style 1b, this space contains a small set of paired leaves; in Style 1a it is a simple 'V' pattern. In Style 3a, that space again contains paired leaves (or the Tudor-type rose), whereas Style 3b has the simple 'V' pattern, and overall the carving is larger and less well executed. The eastern wallplate in the room is similar, but the execution is much better (Style 4). Again, there is the repeating pattern of paired leaves around a curving vine, but this time the leaves incorporate four small peg holes (c.8-10mm diameter) per 'down' leaf, two peg holes per 'up' leaf, probably for further decoration. The story goes that these holes held 'acorns', but they were removed at some point in the past and taken to a monastery in northern France (MacBean *pers. comm.*). Whereas the joists are fitted into bespoke sockets in the central beams, the Style 4 wallplate has central rectangular sockets adapted to take the current joists. This, together with its overall quality, would suggest this wallplate is rather earlier in date than the other parts of this ceiling. Beams, joists and ceiling painted black.

Figure 68: Diagram of the carved beams and joists, projected against the first-floor plan and showing the layout of the various different Styles.

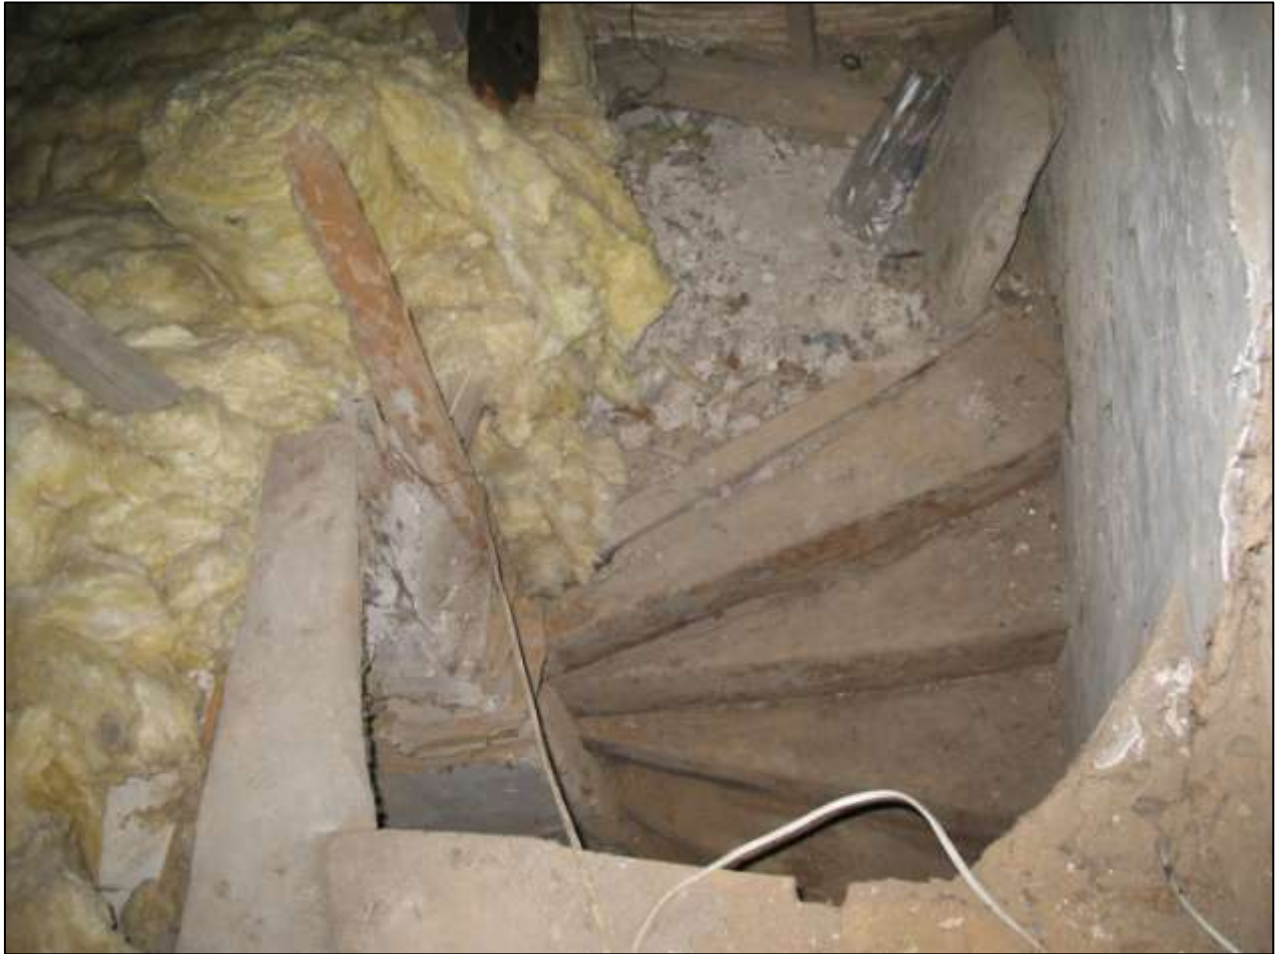
*Interpretation:* R14/15 probably open to the roofspace, perhaps with an integral stack or possibly a smoke hood on the west gable. Truss D probably blocked in by panelling, with stair inserted later. The fact that the stairwell appears to have been reduced in height might suggest the roof height has been dropped.

Figure 72: The top of the stairwell; viewed from the west. Note the stairs appear to continue up to the left.

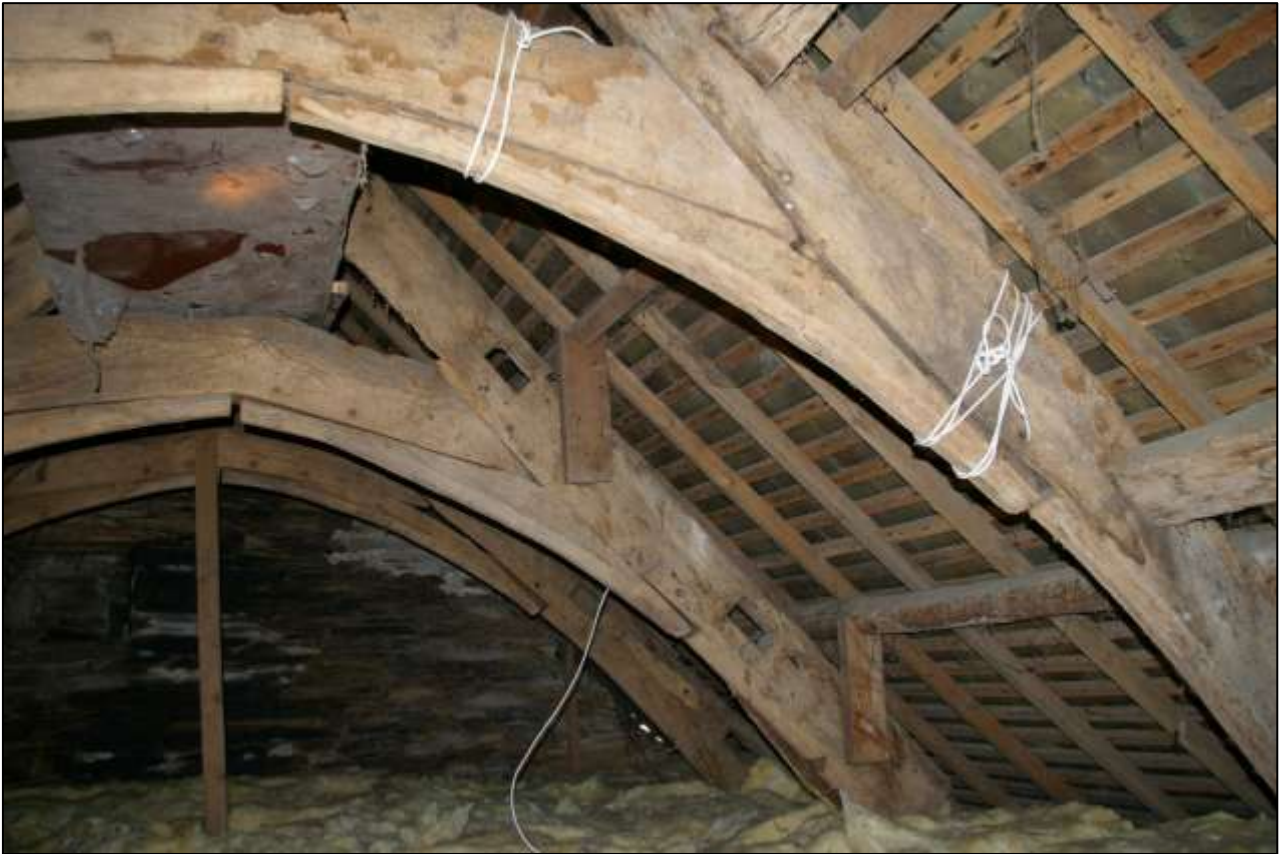
*Roof Structure:* Four 15<sup>th</sup> century trusses with through-and-through purlins but no windbraces. Six of the original 16 purlins survive, with 1-5 squared treenails in each. Three arch-braced trusses (A-C) with simple chamfers to the west, Truss D adjacent to the stairwell has a collar and wall-height tie-beam but no arch-braces. There is a square socket for a ridge pole (now missing) at the apex of each truss. The three trusses have separate upper arch-braces inset into the principal rafter; instead of a lower arch-brace the lower part of the principal rafter is chamfered. Simple mortise-and-tenon joints held by treenails. Each of the four trusses bear carpenters marks on the eastern side. The northern half of the upper face of the tie beam for Truss D has a line of five shallow rectangular sockets cut into the upper surface, probably for panelling. They cross the tie beam diagonally, perhaps to avoid the wall of the stairwell. The 15<sup>th</sup> century structure now carries recent pine purlins and rafters for the current slate roof.

Figure 73: Detail of the roof structure in R 26; viewed from the east, looking west.

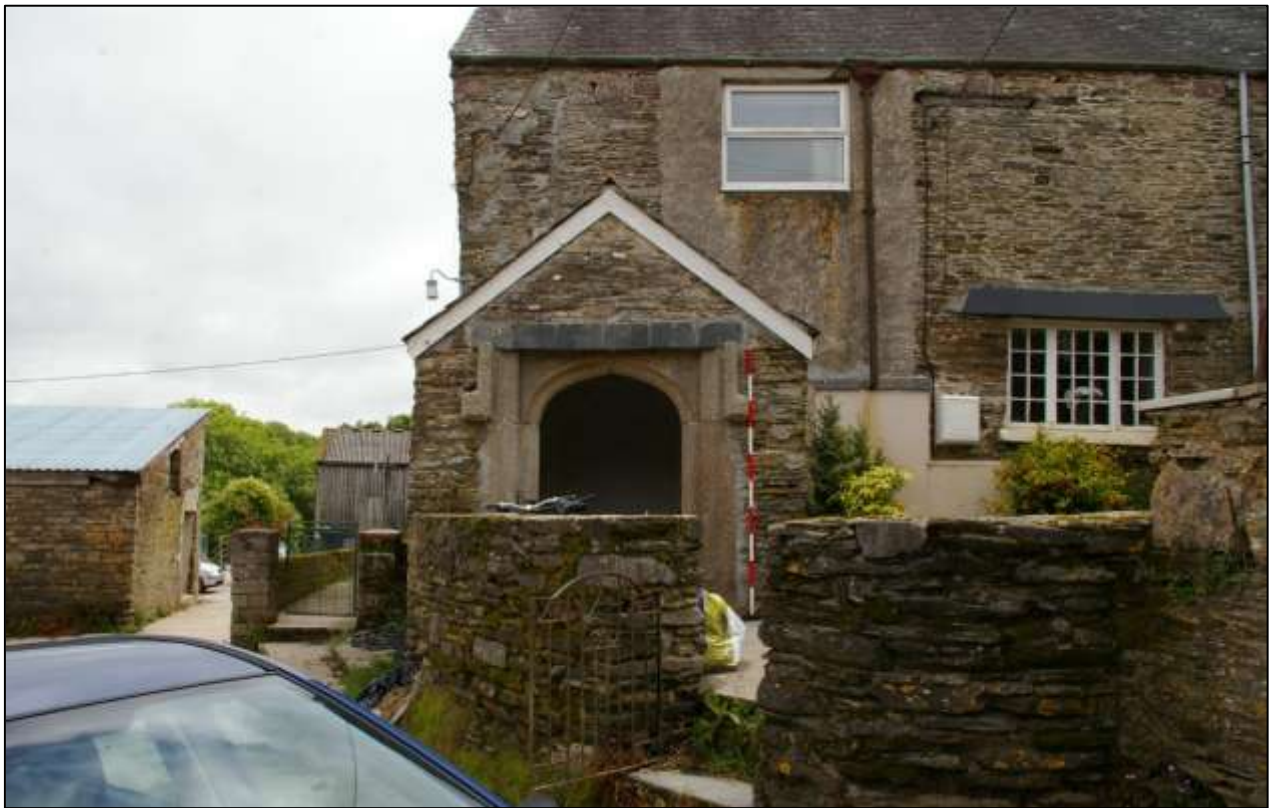
At the northern end of the wall there is a clear vertical break in build, and the corner lacks good quoins. There is a vertical panel of grey cement render, perhaps concealing an opening for a two-storey window or the scar from a lost/moved two-storey porch. The visible ground-floor wall is markedly wider than the first-storey wall, and its stonework is comprised of larger and better dressed rubble slate-stones. This implies the upper part of the wall has collapsed in the past and been rebuilt, but before the roof was raised. There are exposed timbers in this part of the elevation, perhaps part of the original wallplate. The section of wall abutting the 15<sup>th</sup> century block has been rebuilt in the later 20<sup>th</sup> century.

Figure 74: The west-facing elevation of the 17<sup>th</sup> century block (scale 2m).

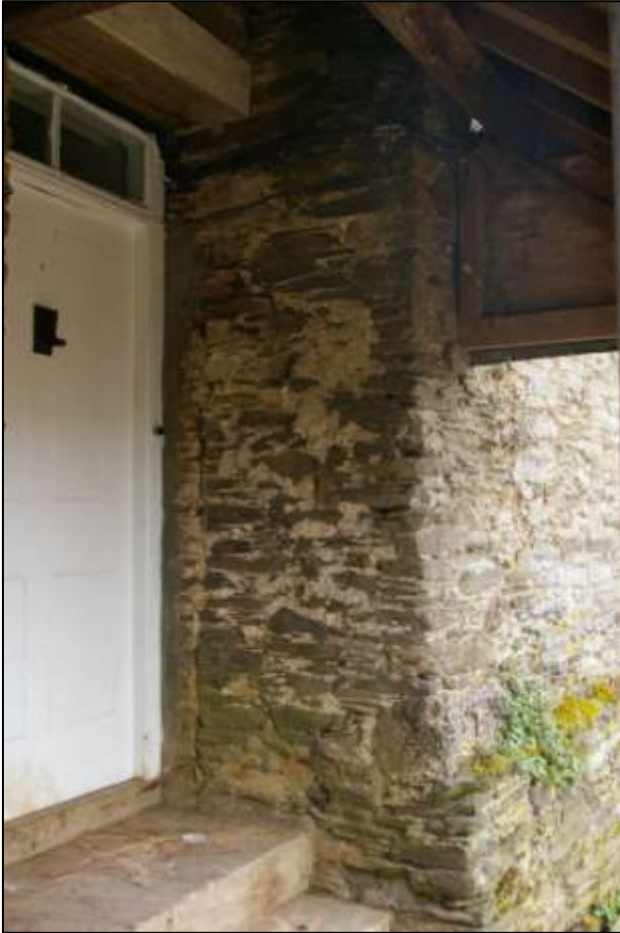
Figure 78: The north-east corner of the northern gable of the 17<sup>th</sup> century block, showing the vertical change of build.

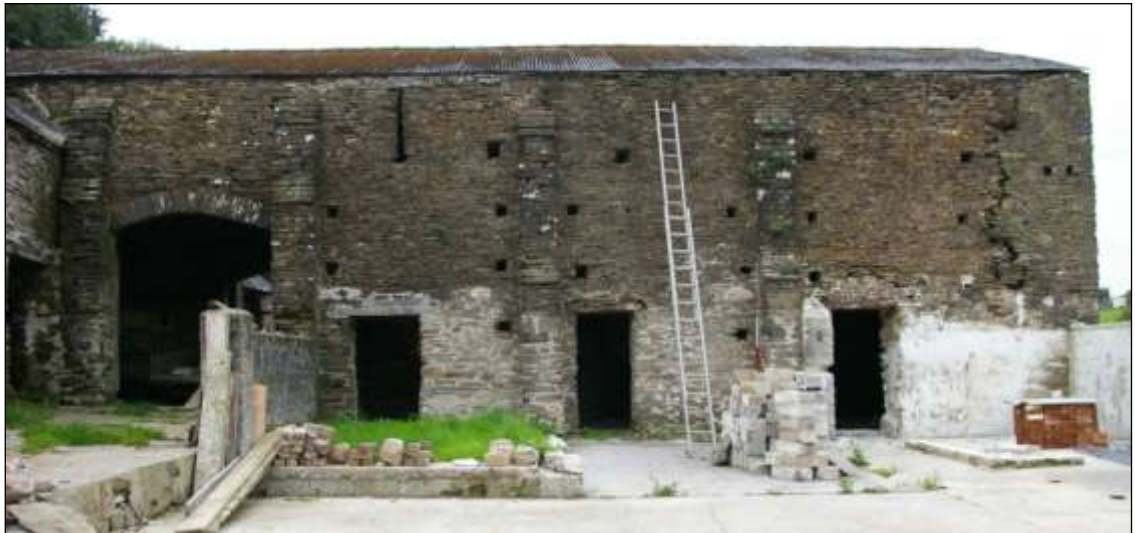
Figure 86: East Elevation of the Great Barn, viewed from the east (scale 2m).

There is a projecting string course at wall-plate height (also found on the west elevation), although this survives only within the Stables. The elevation has a number of put-log holes arranged in parallel lines along the length of the barn, either side of the buttresses. At the north end there are two small pigeon holes at the same height of those on the north elevation. The elevation is partly rendered and white-washed at the north end, where modern concrete block buildings, including a dairy, have been removed. There is a large vertical structural crack at the north end of the elevation, where the north gable was rebuilt.

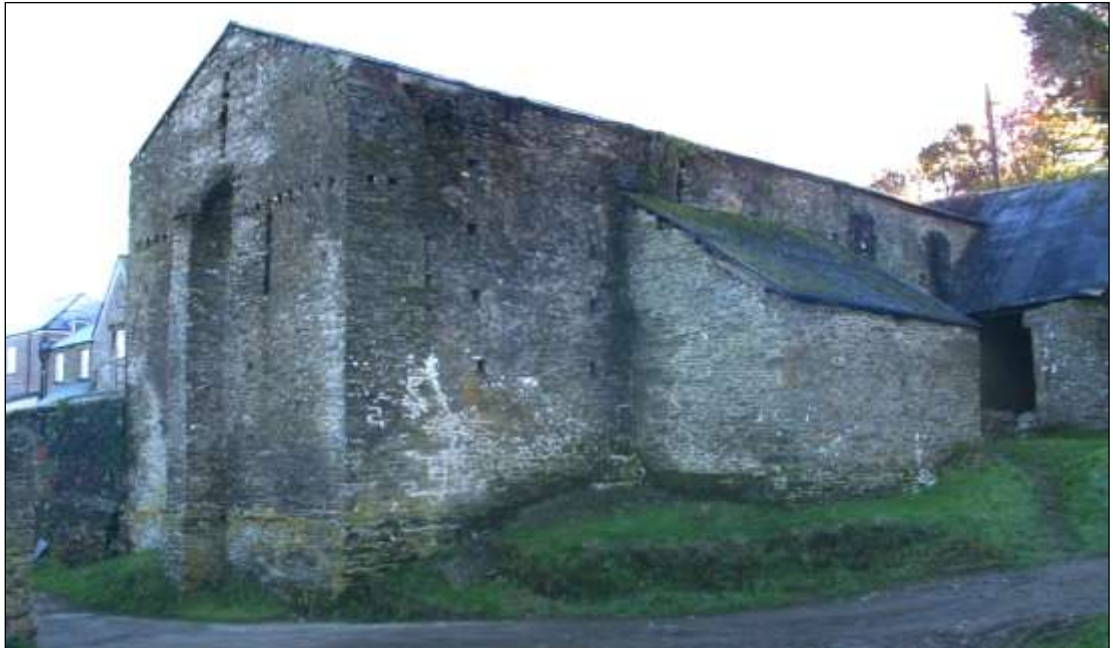
The gable-end elevation of the Great Barn, facing north (see Figure 89), fronts onto the modern driveway to the main farmyard and valley to the north. A rubble slate-stone elevation, stepped out at the base, under a corrugated asbestos roof, abutted by the farmyard wall to the east. Ground levels have been reduced to expose the rougher foundations of the gable at the north-west corner. With three slit air-vent openings, in a triangular arrangement, with a single row of 16 pigeon holes running above the bottom two openings. A large central buttress running out beneath the central upper opening, this is also stepped at its base. There is only one small possible put-log hole to the right of the main buttress. The obvious vertical structural cracks at the northern end of east and west elevations, the difference in stonework, the presence of pigeon holes, and the markedly different style of buttress indicate this elevation has been rebuilt. The rebuild of the northern gable indicates the Great Barn has either been extended (from 10 bays to 10.5 bays), or was reduced (from 12 bays to 10.5 bays). It is possible the vertical cracks on the west elevation belong to a second set of threshing doors in a much larger structure, but given the fall of the land this seems unlikely.

Figure 89: North and west elevations of the Great Barn, viewed from the north-west.

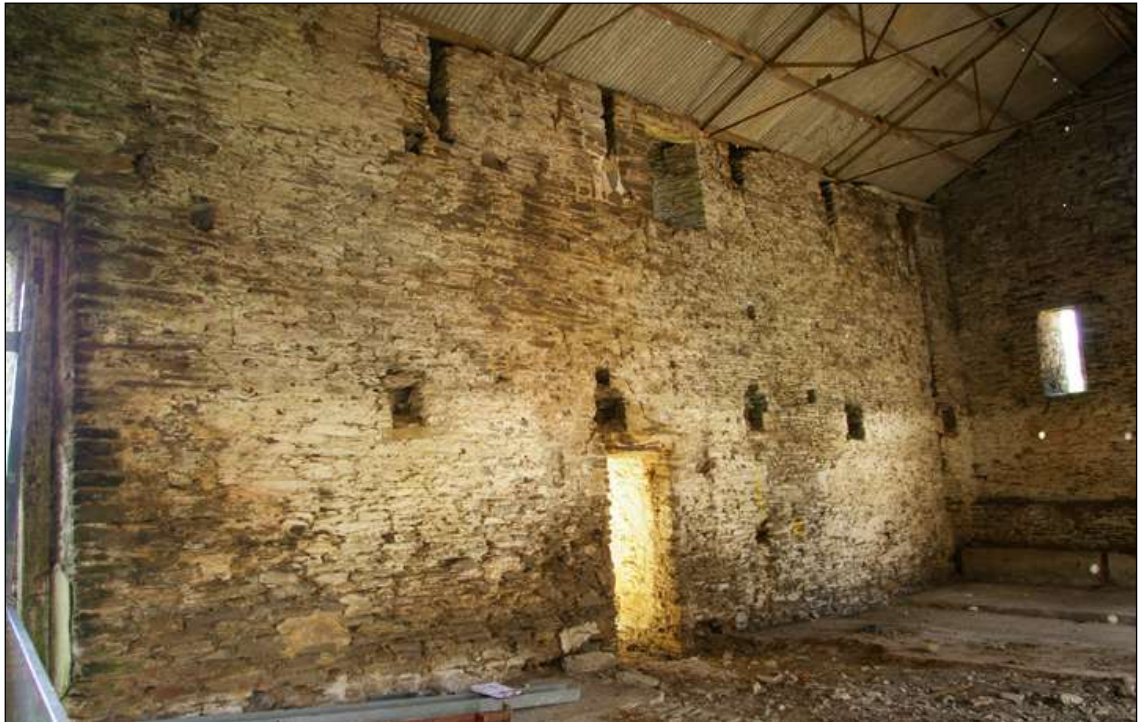
The interior of the Great Barn forms a single open space 22.5m long by 6m wide (see Figure 92). The roof structure is modern, with steel bolted struts and trusses and corrugated asbestos sheeting. The internal floor surface slopes down from south (where bedrock is exposed) to north (where the internal floor level is c.1.5m above exterior levels). The northern wall steps in c.0.2m at c.1.2m above the floor, and there is a small blocked opening in the middle of the wall just below the step. There are large vertical structural cracks

between the east and west walls and the northern gable. The floors to the north of the threshing doors are concrete over rough cobbling and to the south they are earthen over bedrock.

Figure 92: The interior of the Great Barn, the north end of the west wall, viewed from the south-east.

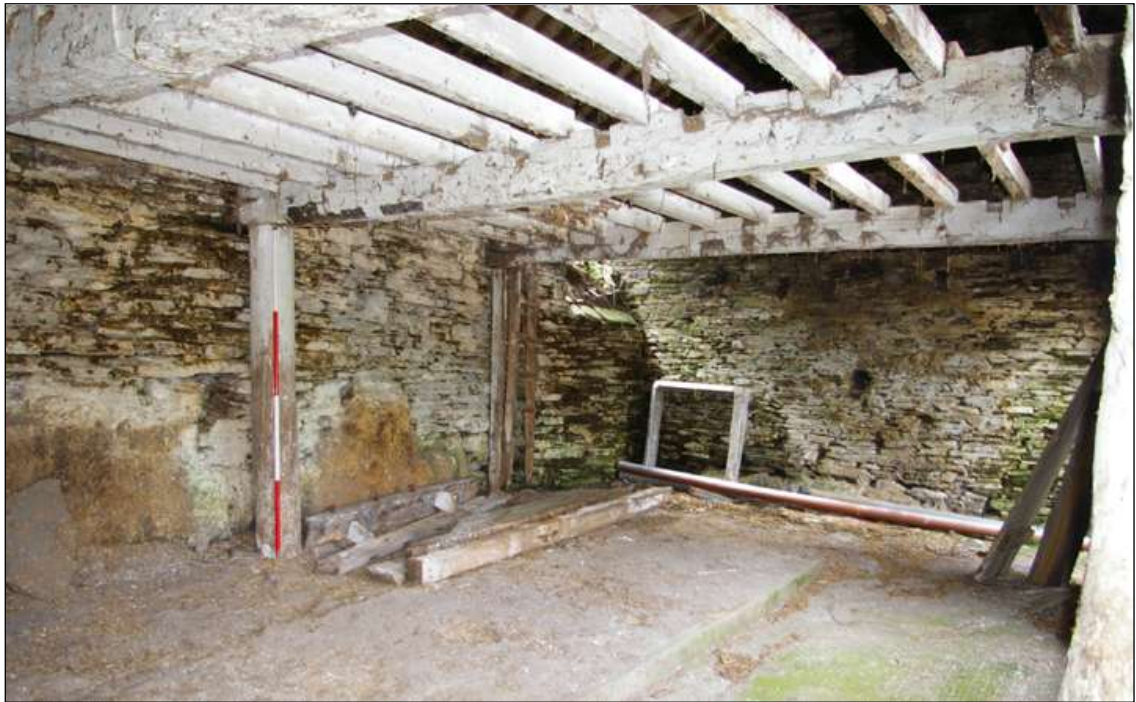
Internally, the Stables form a single space with hay loft over (see Figure 99). The floor is of concrete, with cobbles and/or bedrock showing through where the concrete has failed. The step in the floor indicates stalls for eight cattle originally lined the northern wall, with a manure passage to the north. Scarring on the floor indicates the presence of a feed passage along the north wall. The walls and ceiling of the ground floor are white-washed, and the lower part of the north wall is plastered, suggesting this building has been used as a cowhouse/dairy in the past.

Figure 99: The ground floor interior of the Stables, viewed from the north-east (scale 2m).

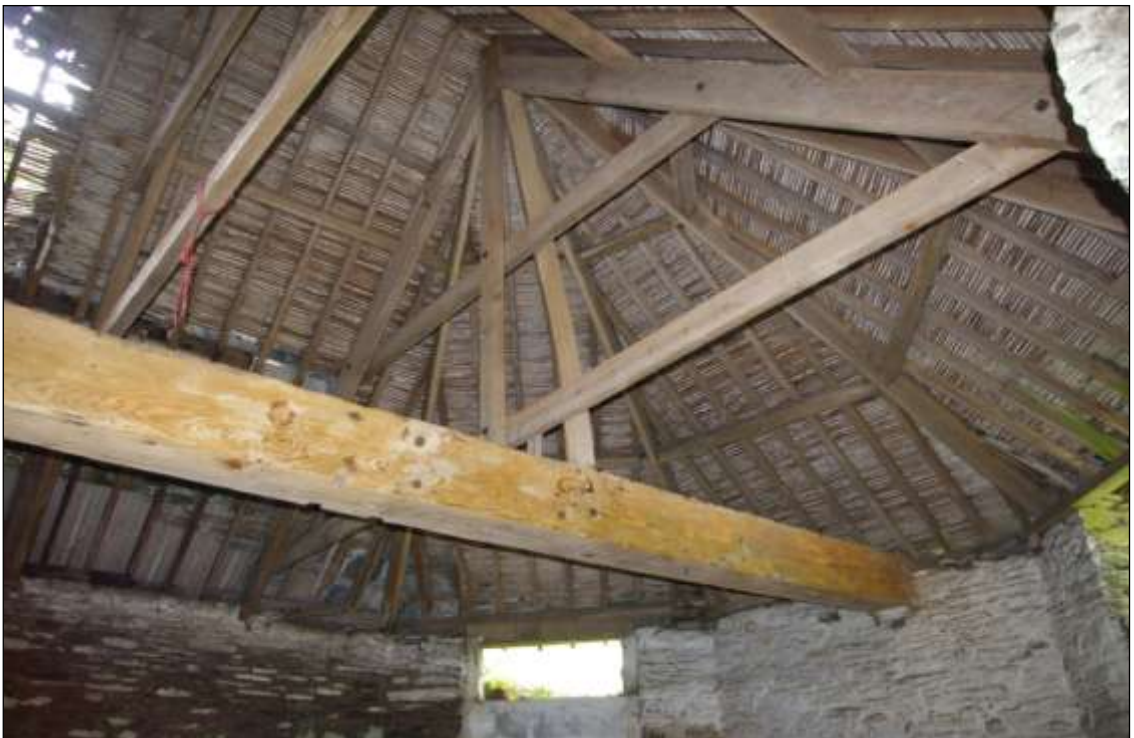
Figure 101: The interior of the Horse Engine House, viewed from the north-east.

This beam also bears the scars of many pintles/bolts and sockets, indicating its main function would have been related to the horse engine that would have sat in this room. None of the original machinery survives, although the blocked opening adjacent to the main beam suggests shafting originally went through the wall into the Great Barn at this point, later diverted or superseded by the forced opening with the brick pillar and

pintles (see above) to the south. There is an irregular oval patch of damage on wall of the Great Barn where the horse would have passed when driving the horse engine, and there are numerous sockets and blocked sockets in this wall.

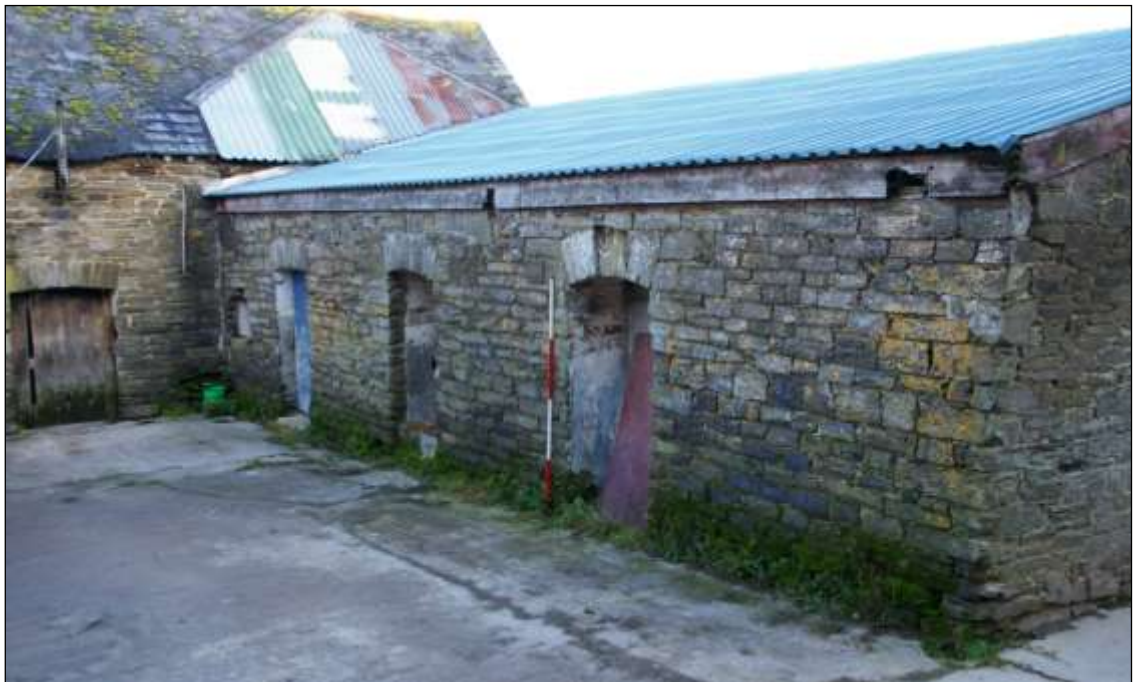
The presentation side of the Milking Parlour faces west onto the farmyard, and features dressed coursed stone walls with three symmetrical doorways with dressed stone segmental arches and stone reveals (Figure 102 and Figure 106). Note that this is the only building on the property to feature such well-dressed stone, and may therefore come from a demolished medieval building. This elevation has been reduced in height following the collapse of the roof. The two doorways to the south have been blocked with concrete blocks, although the blocking is set back flush with the interior face of the wall, revealing white-washed uppers and part-rendered lower walls to the depth of the door splay. A small window opening has been forced through the elevation at the north end immediately adjacent to the south wall of the Shippon. This opening has ragged edges and missing stones and has been partially rendered and cemented.

Figure 102: West elevation of Milking Parlour, viewed from the south-west (scale 2m).

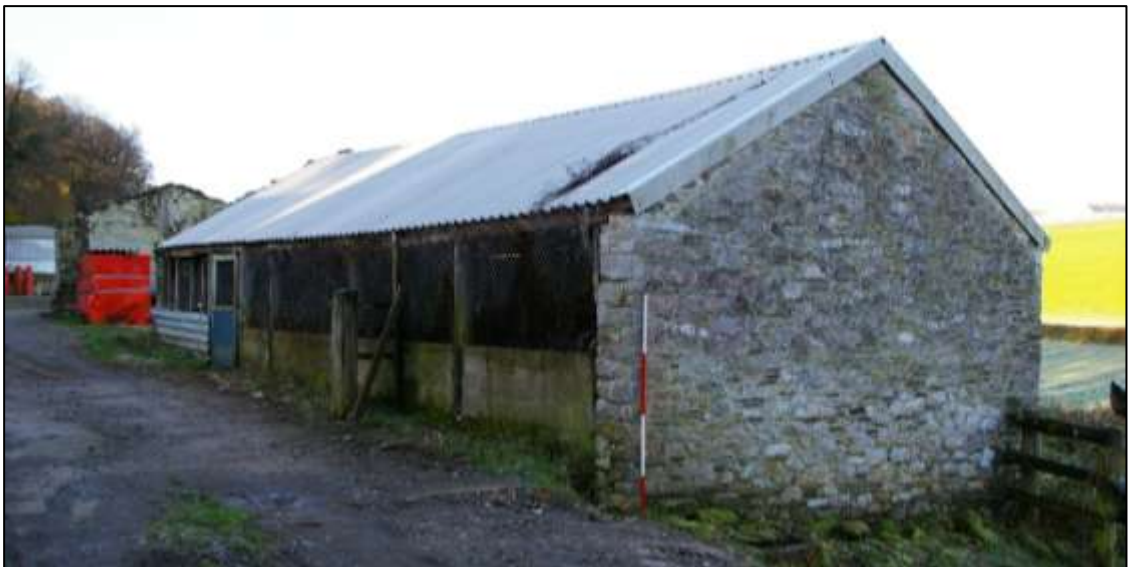
Figure 108: The eastern Cartshed; viewed from the south-east, looking north-west (scale 2m).

The eastern Cartshed is built of roughly-coursed limestone stone rubble, with a pitched roof of corrugated box-section plastic-coated tin sheeting. The roof is supported by simple bolted trusses; the open front is supported by a line of telegraph pole sections partially infilled with concrete blocks. A building is shown at this location in c.1770, but the stonework is tied into that of the western Cartshed, and in build and style matches that of the Studio, implying it was rebuilt in the 20<sup>th</sup> century.

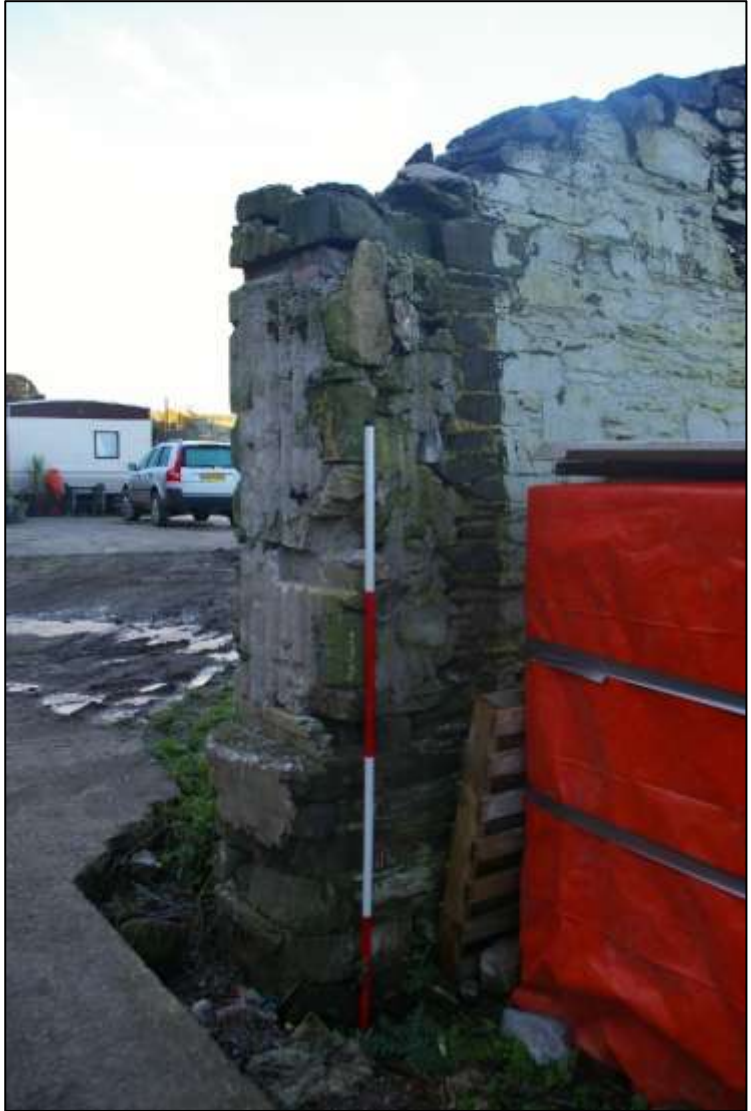
Two abutting open-fronted buildings located on the north-western side of the farmyard. The western Cartshed is of roughly-coursed slate rubble-stone construction, with an asymmetric pitched roof (reduced to match the roof of the eastern Cartshed), now missing. The open ends of the gable walls were rounded, although only traces remain; a number of the stones are not 'set on bed' but are laid 'on edge', making them more susceptible to weathering. This building has a concrete floor. There are no obvious openings or details in the east and north wall, but there appears to be a small blocked opening in the western gable. This structure was built between 1842 and 1862.

Figure 109: The western cartshed: the rounded end of the west gable (scale 2m).
