BEASLEY WEIR DULVERTON EXMOOR NATIONAL PARK WEST SOMERSET

Results of Historic Building Recording

Report No.: 150202
Date: 02.02.15
Author: B Morris

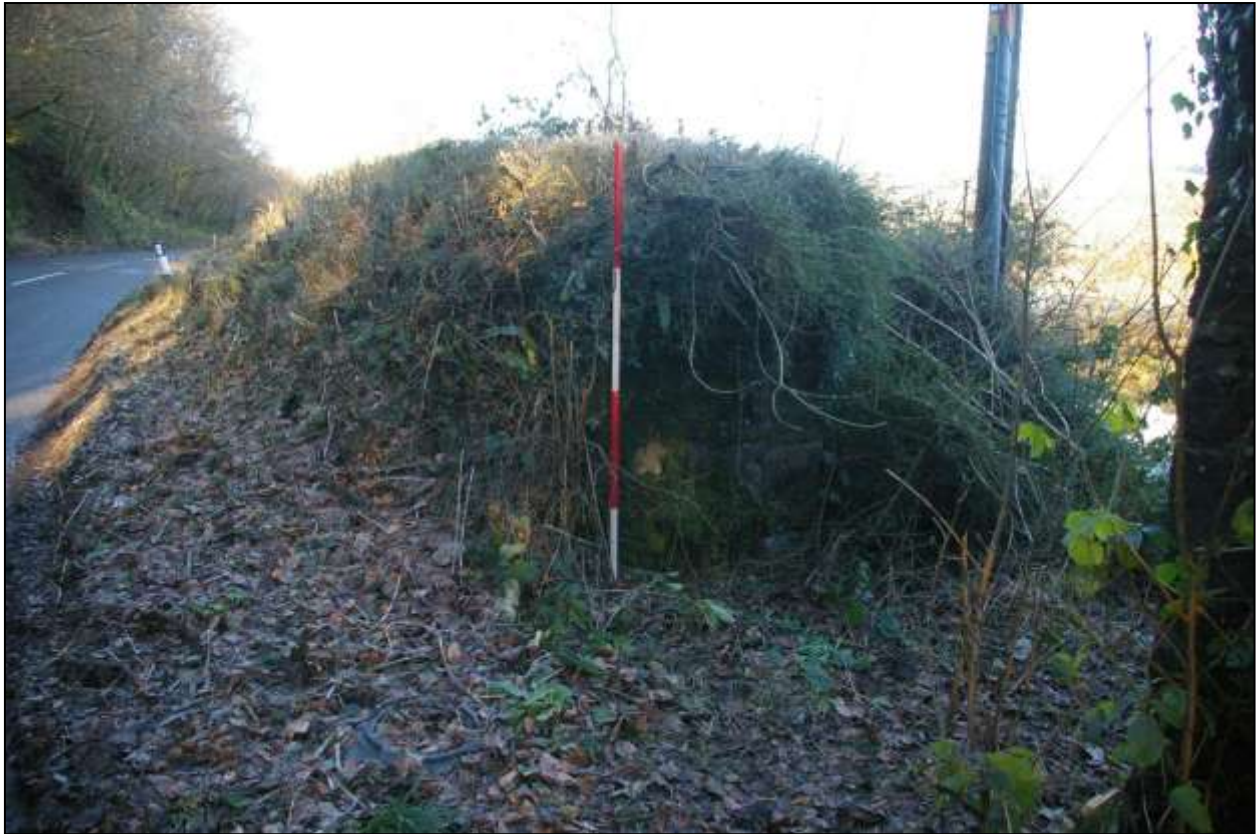
Figure 22: Roadside hedgebank and stub of wall; viewed from the south (scale 2m).

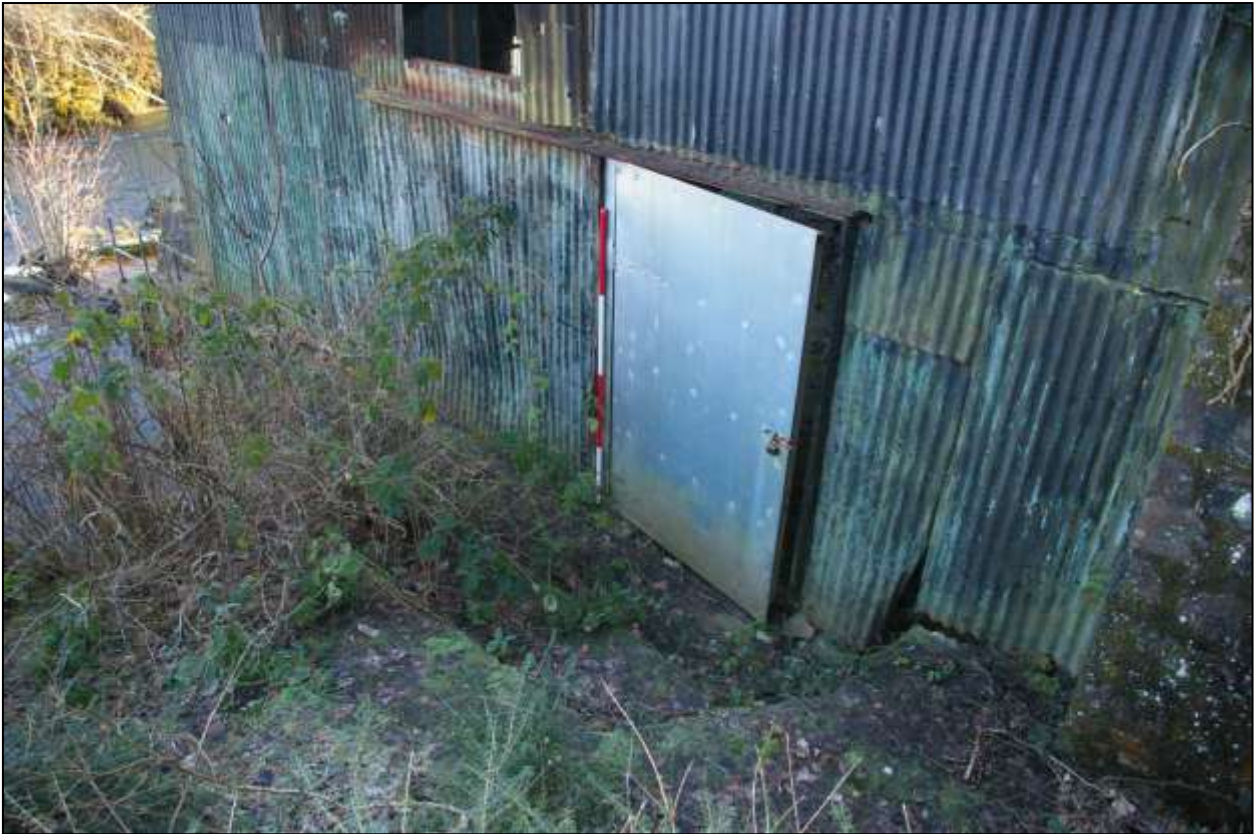
Figure 28: As above, detail of the new door and external steps (scale 2m).

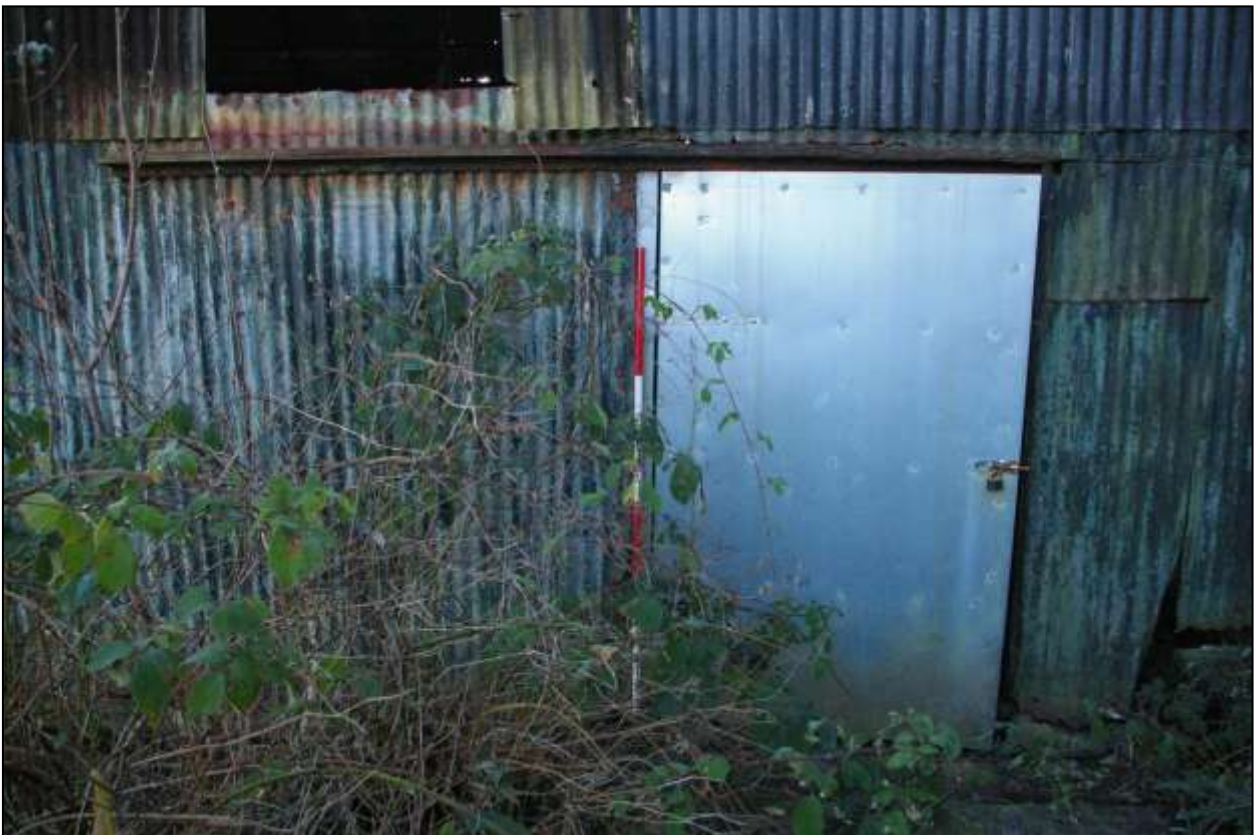
Figure 29: Detail of the door and rails in the north elevation; viewed from the north (scale 2m).

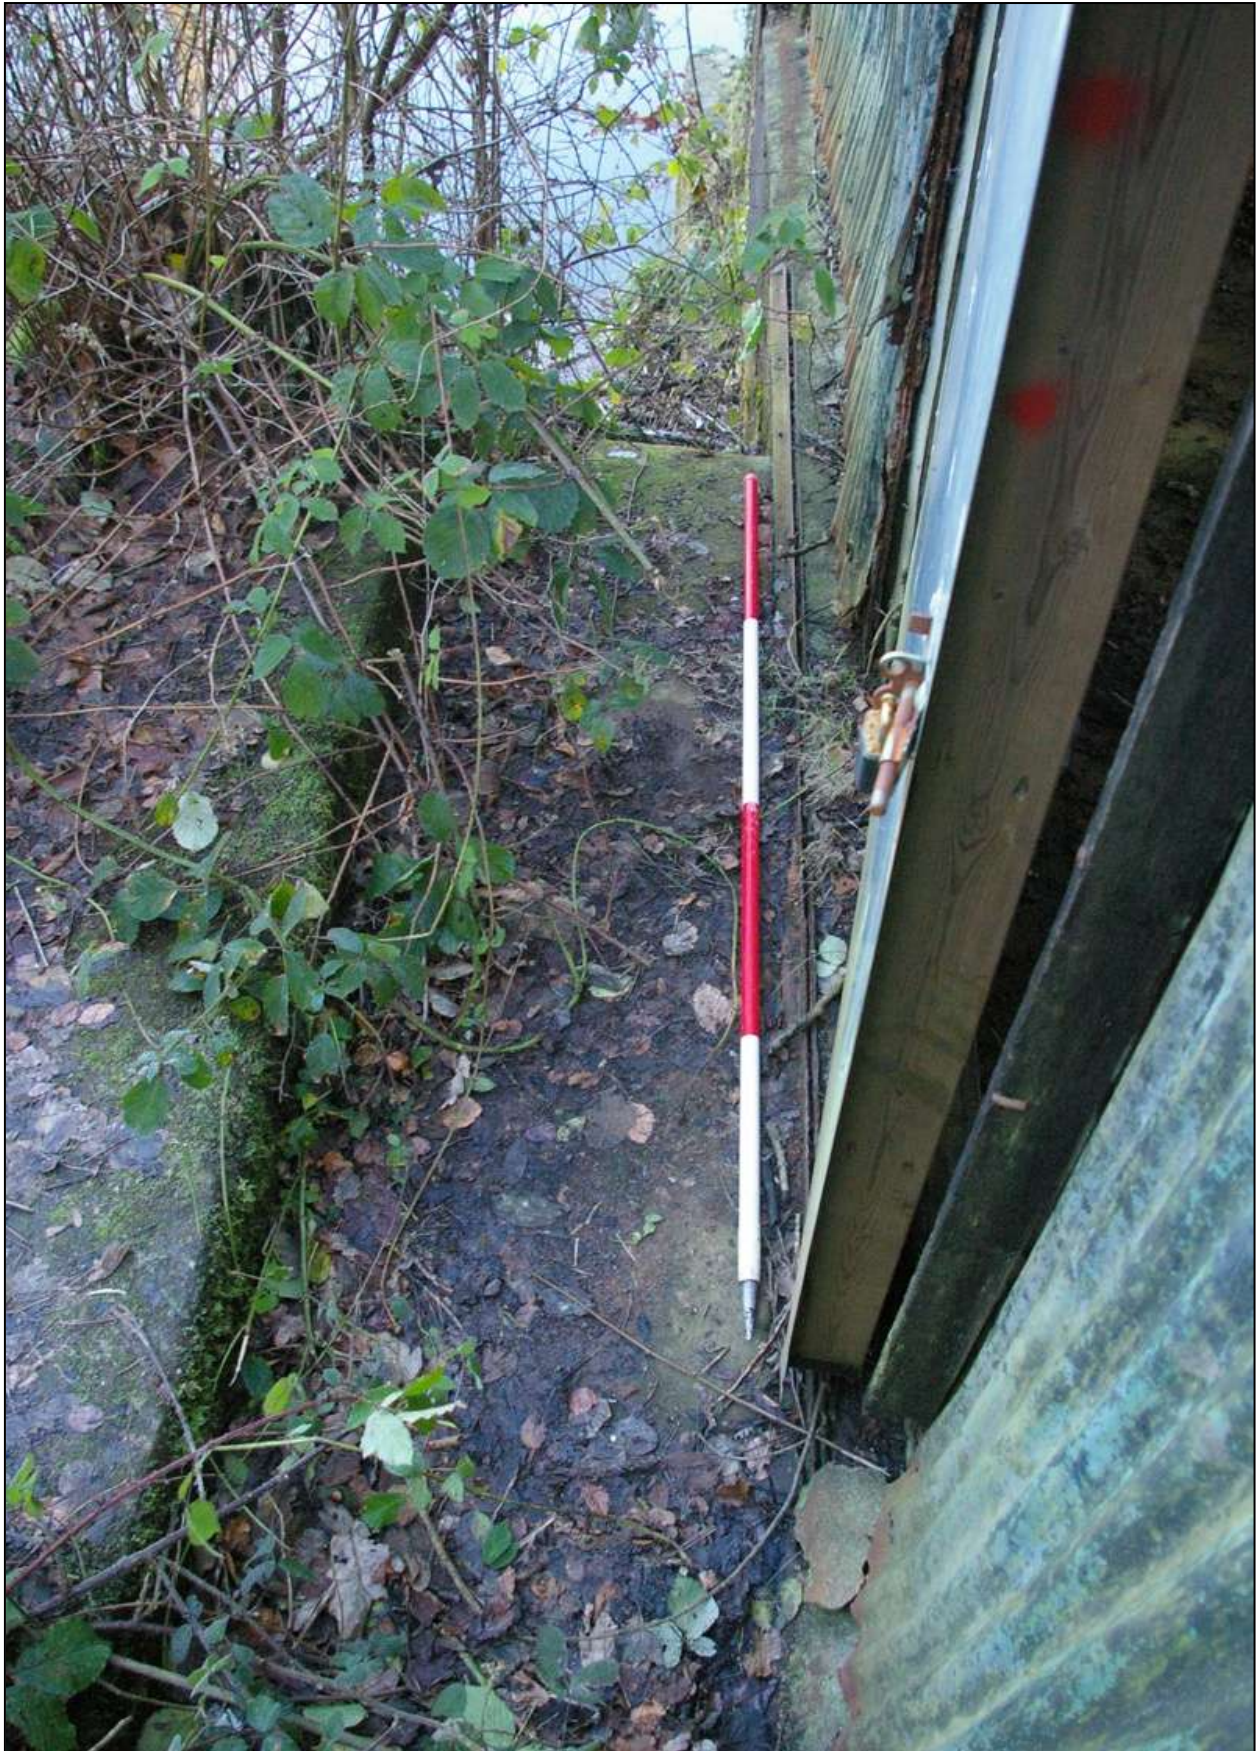
Figure 30: Detail of the lower door rail; viewed from the west (scale 2m).

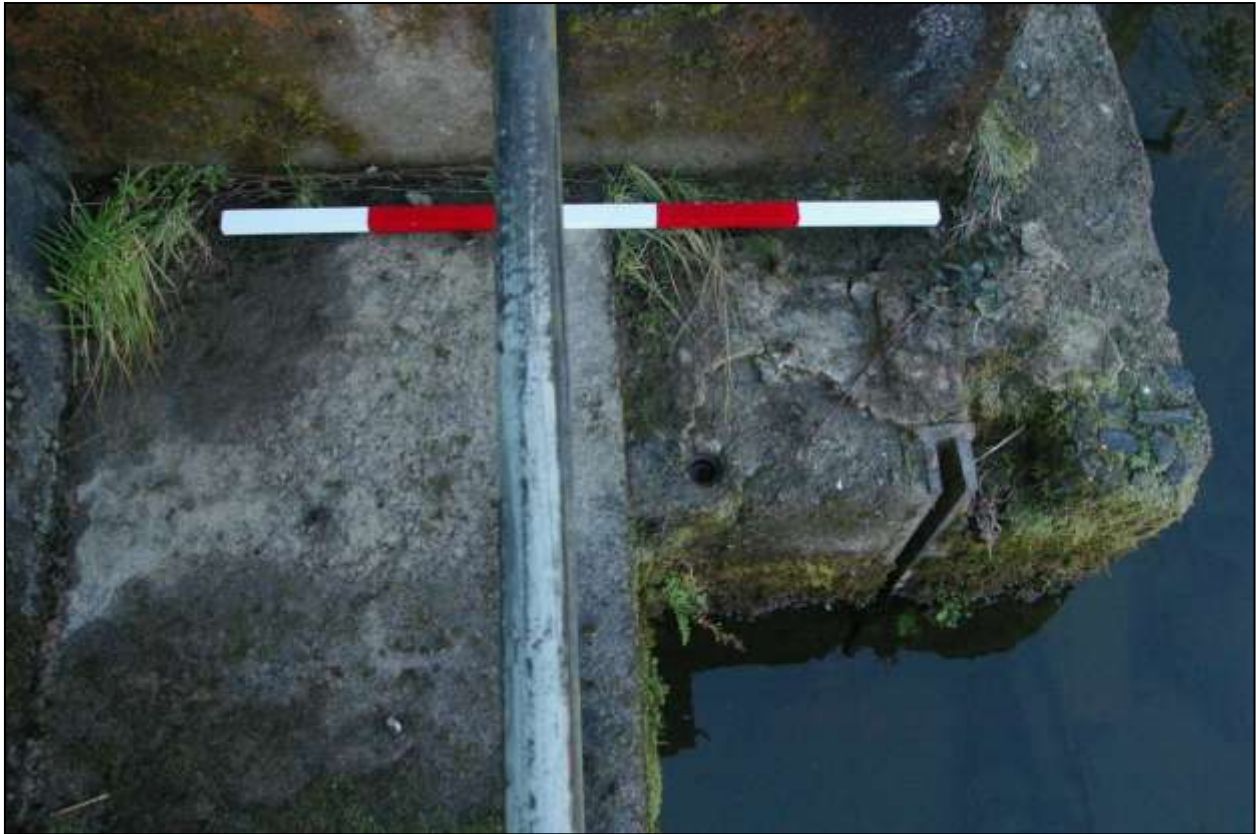
Figure 34: As above, from above, showing the sluice gate and associated pintles; viewed from the east (scale 1m).

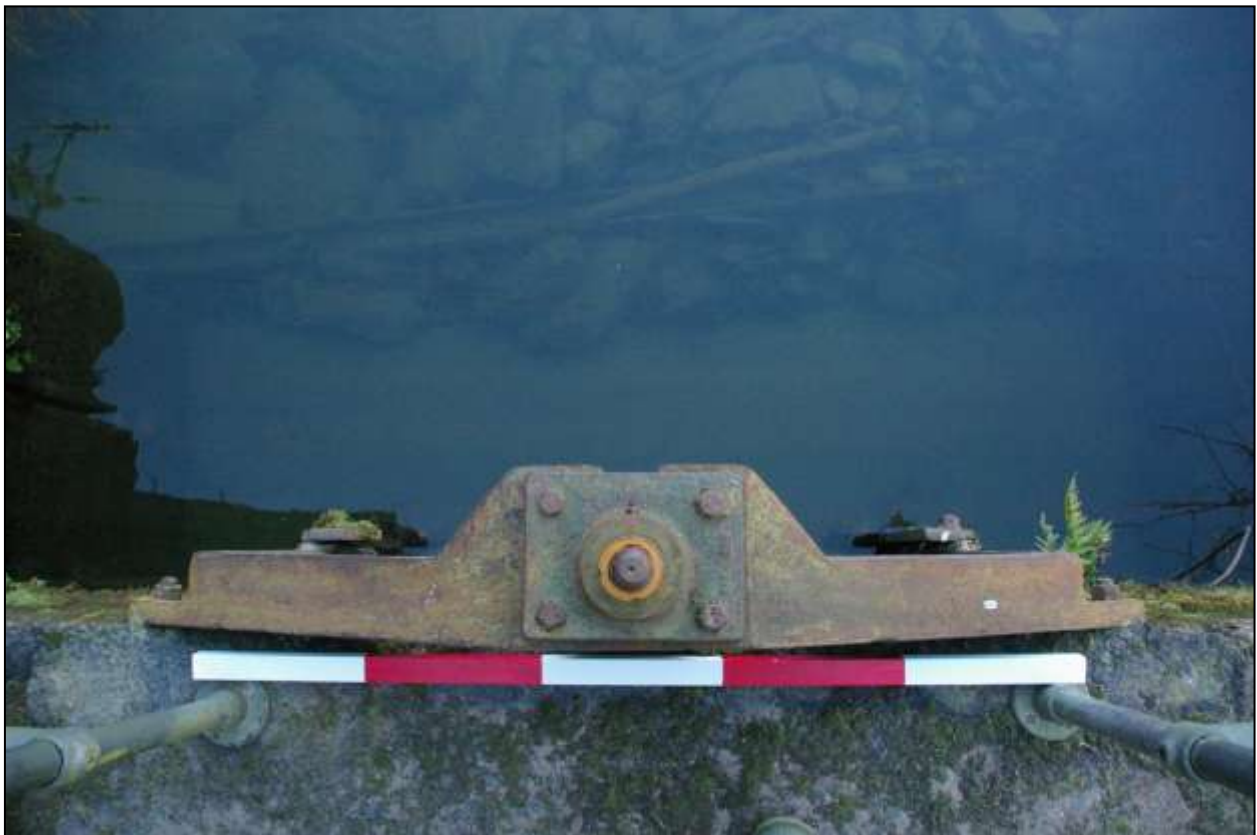
Figure 35: The current sluice gate, viewed from above (scale 1m).

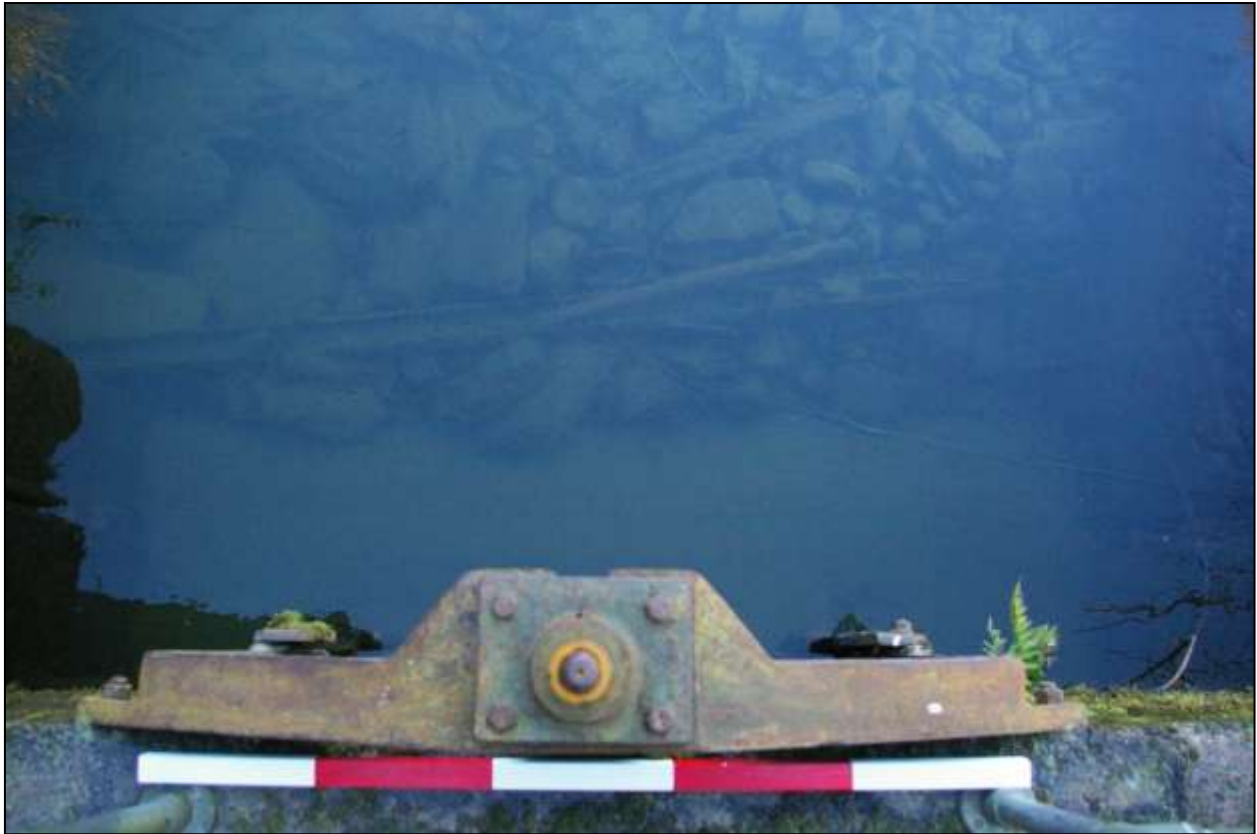
Figure 36: As above, showing an iron girder in the streambed; viewed from the south (scale 1m).

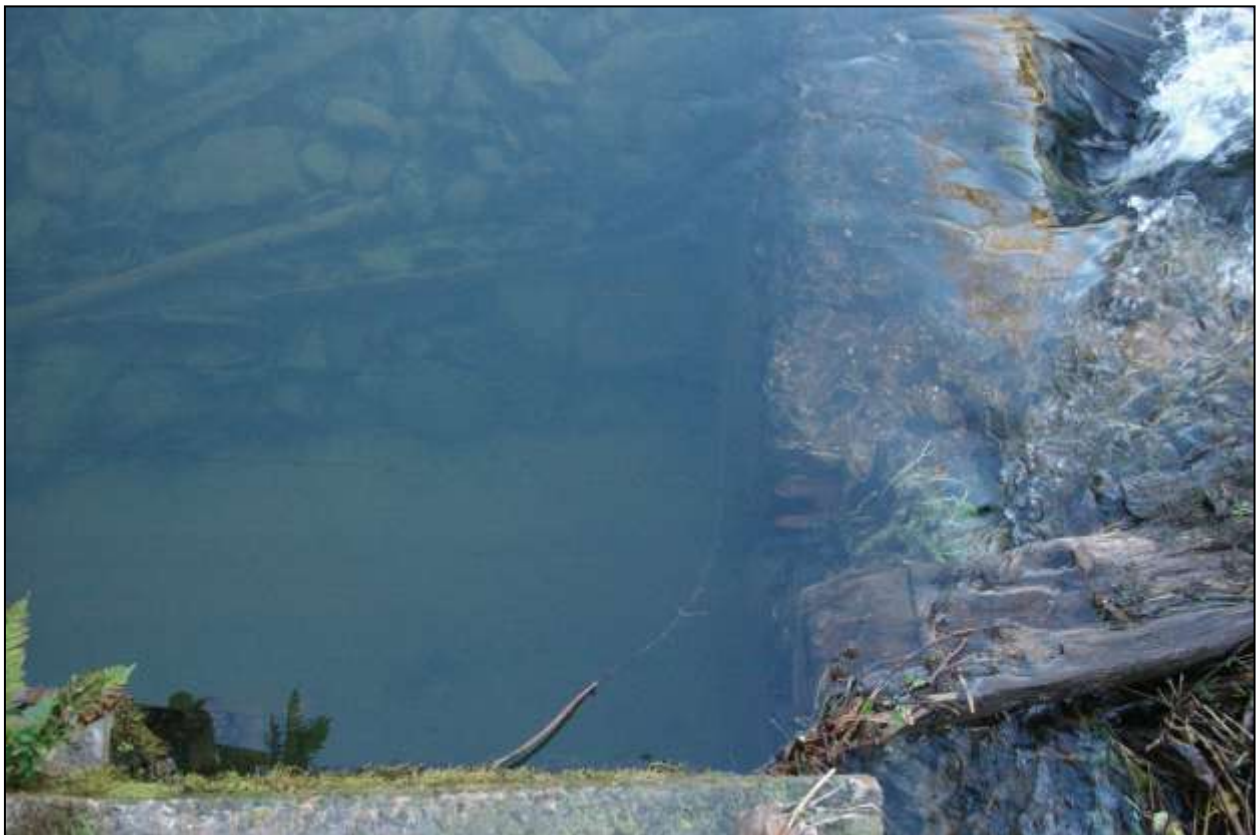
Figure 37: The eastern side of the former sluice gate; viewed from the south (no scale).

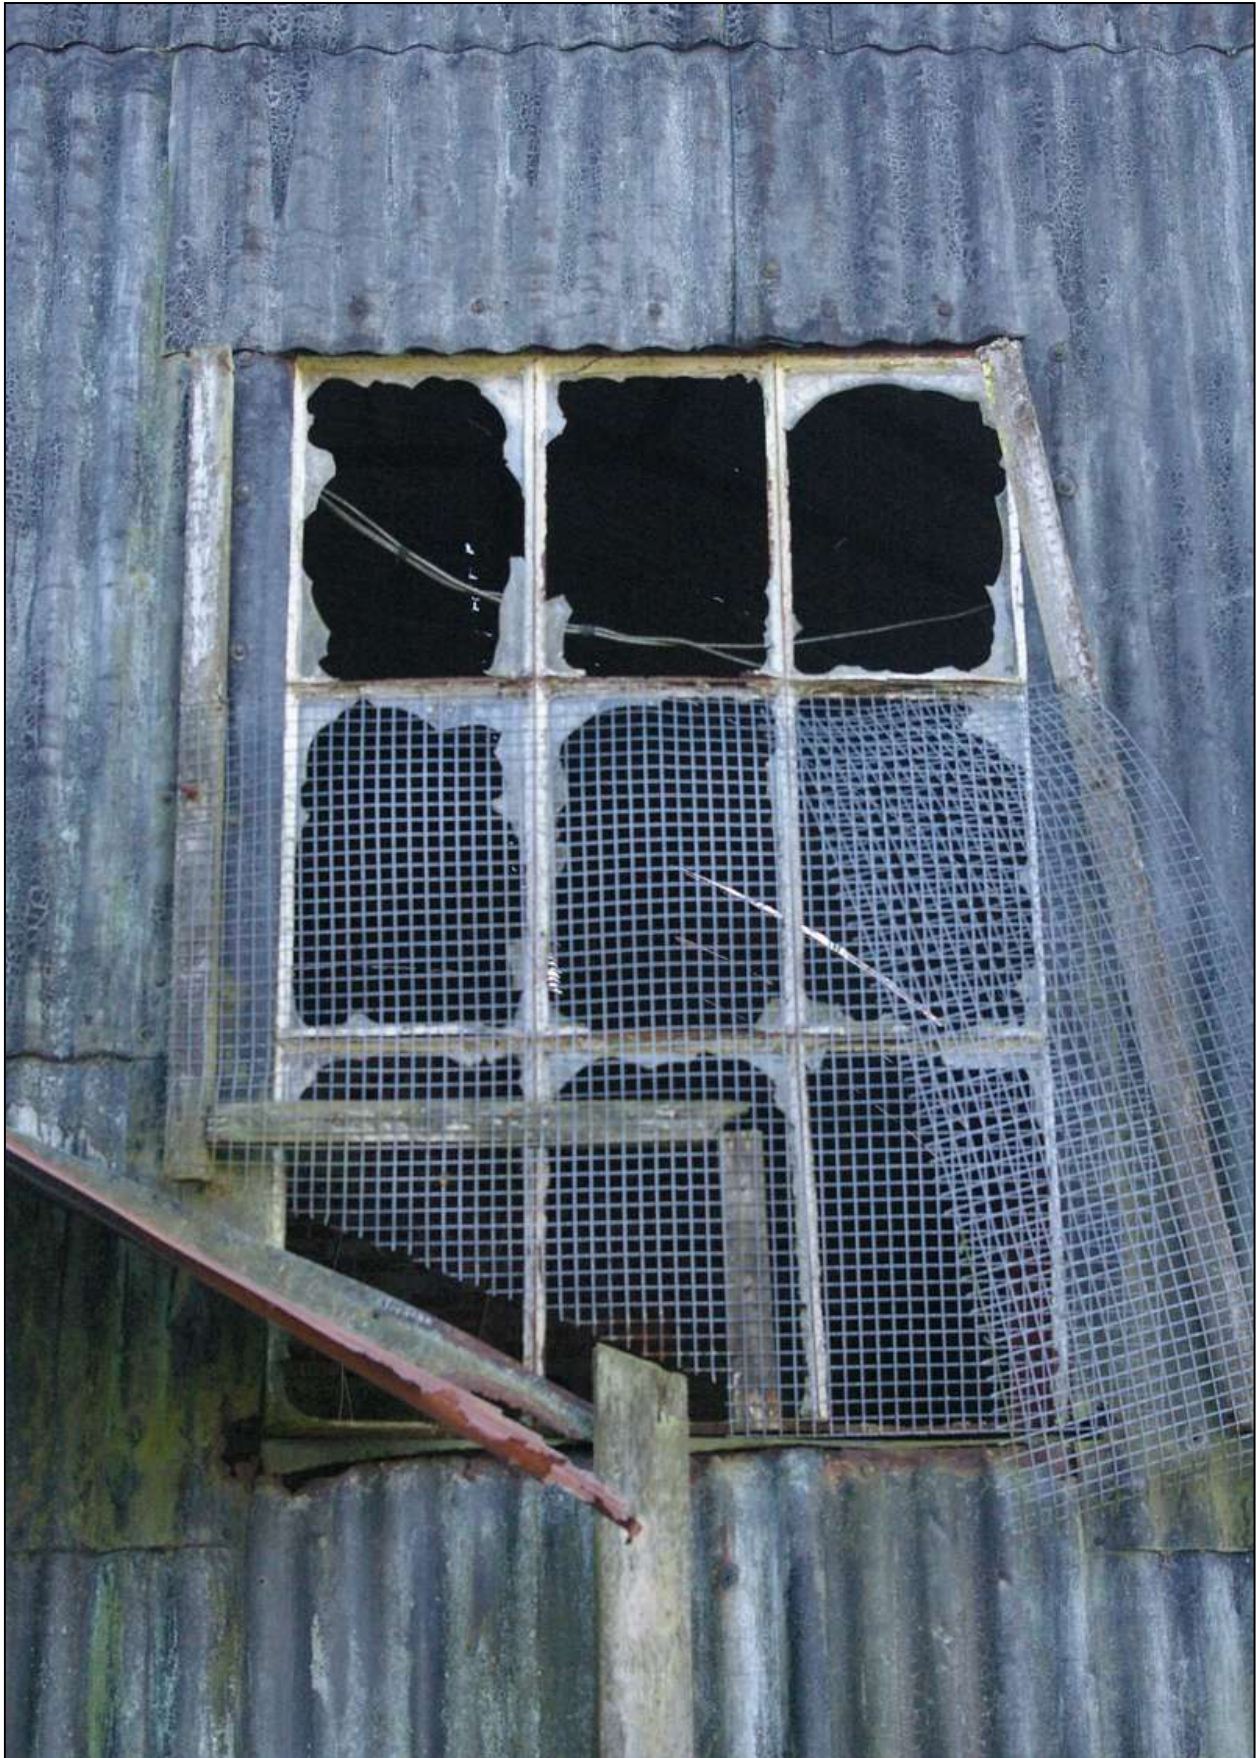
Figure 44: Detail of the window in the east elevation; viewed from the east (no scale).

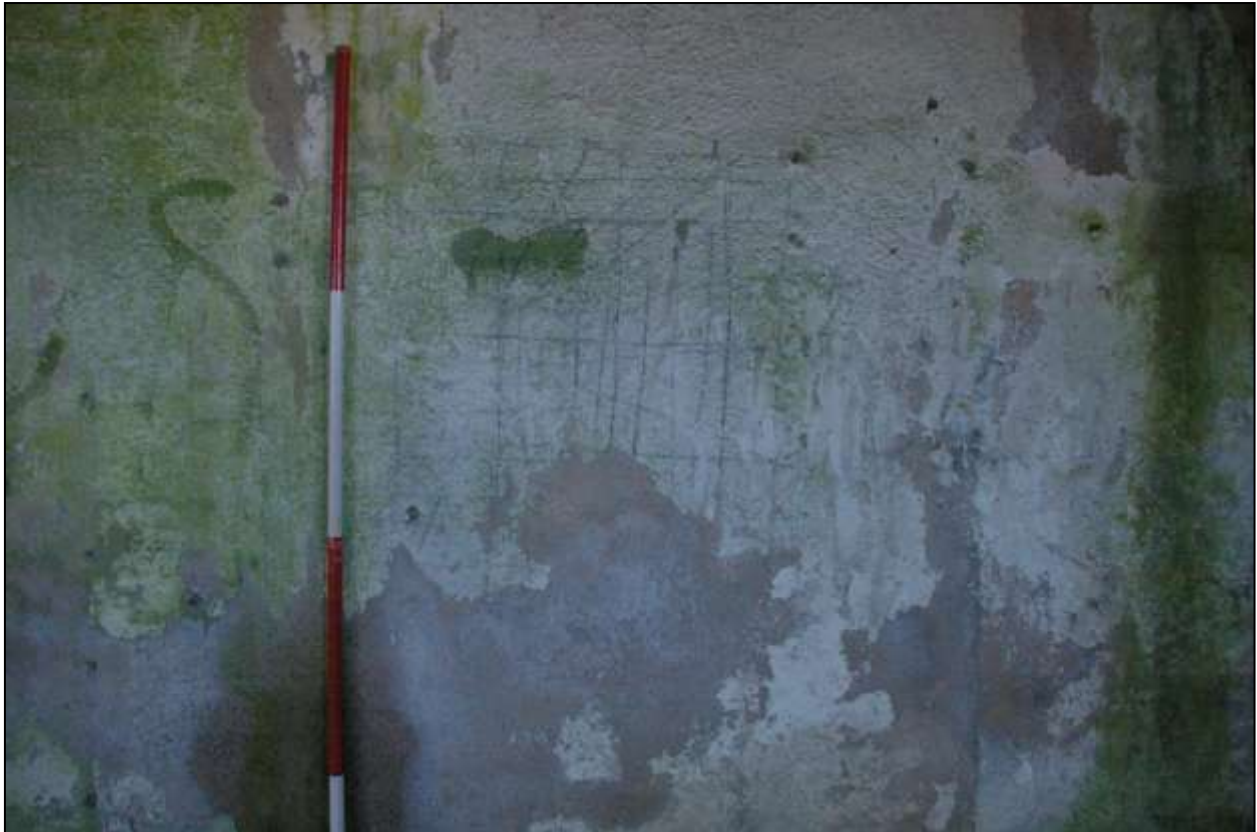
Figure 117: Scars on the west wall of B1, viewed from the east (scale 2m).
