TANTONS HOTEL, RIVERSIDE FLATS AND HAMPTON TERRACE, BIDEFORD DEVON

Results of a Historic Building Assessment

Report No.: 141101
Date: 01.09.2014
Author: C. Humphreys
E. Wapshott
J. Bampton

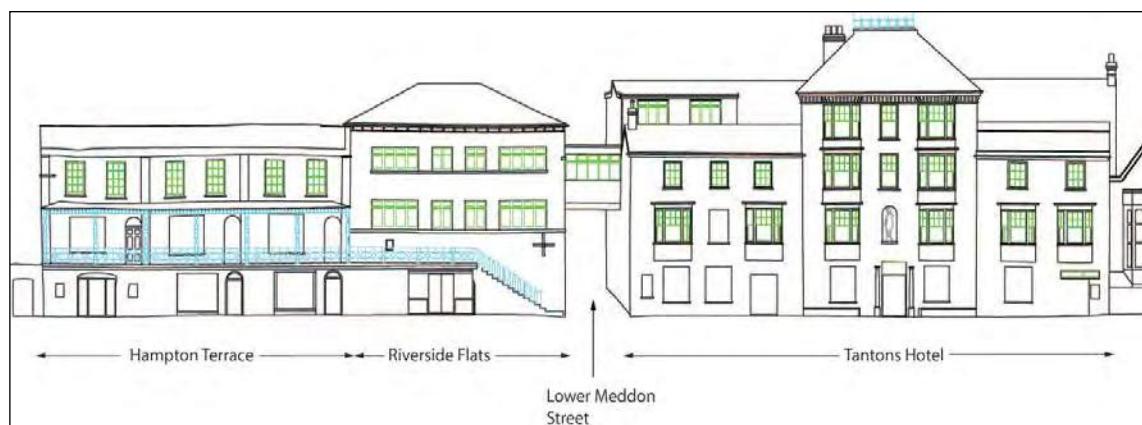
Figure 2: east elevation of Tantons Hotel

A decorative niche in the central range holds a figure head from a ship thought to be taken as the deposit paid by an impoverished ship's captain for repairs to his sailing ship when Bideford was one of England's busiest ports. The wing to the north has a raised plinth above the elevation, with attached metal 'hotel' signage.

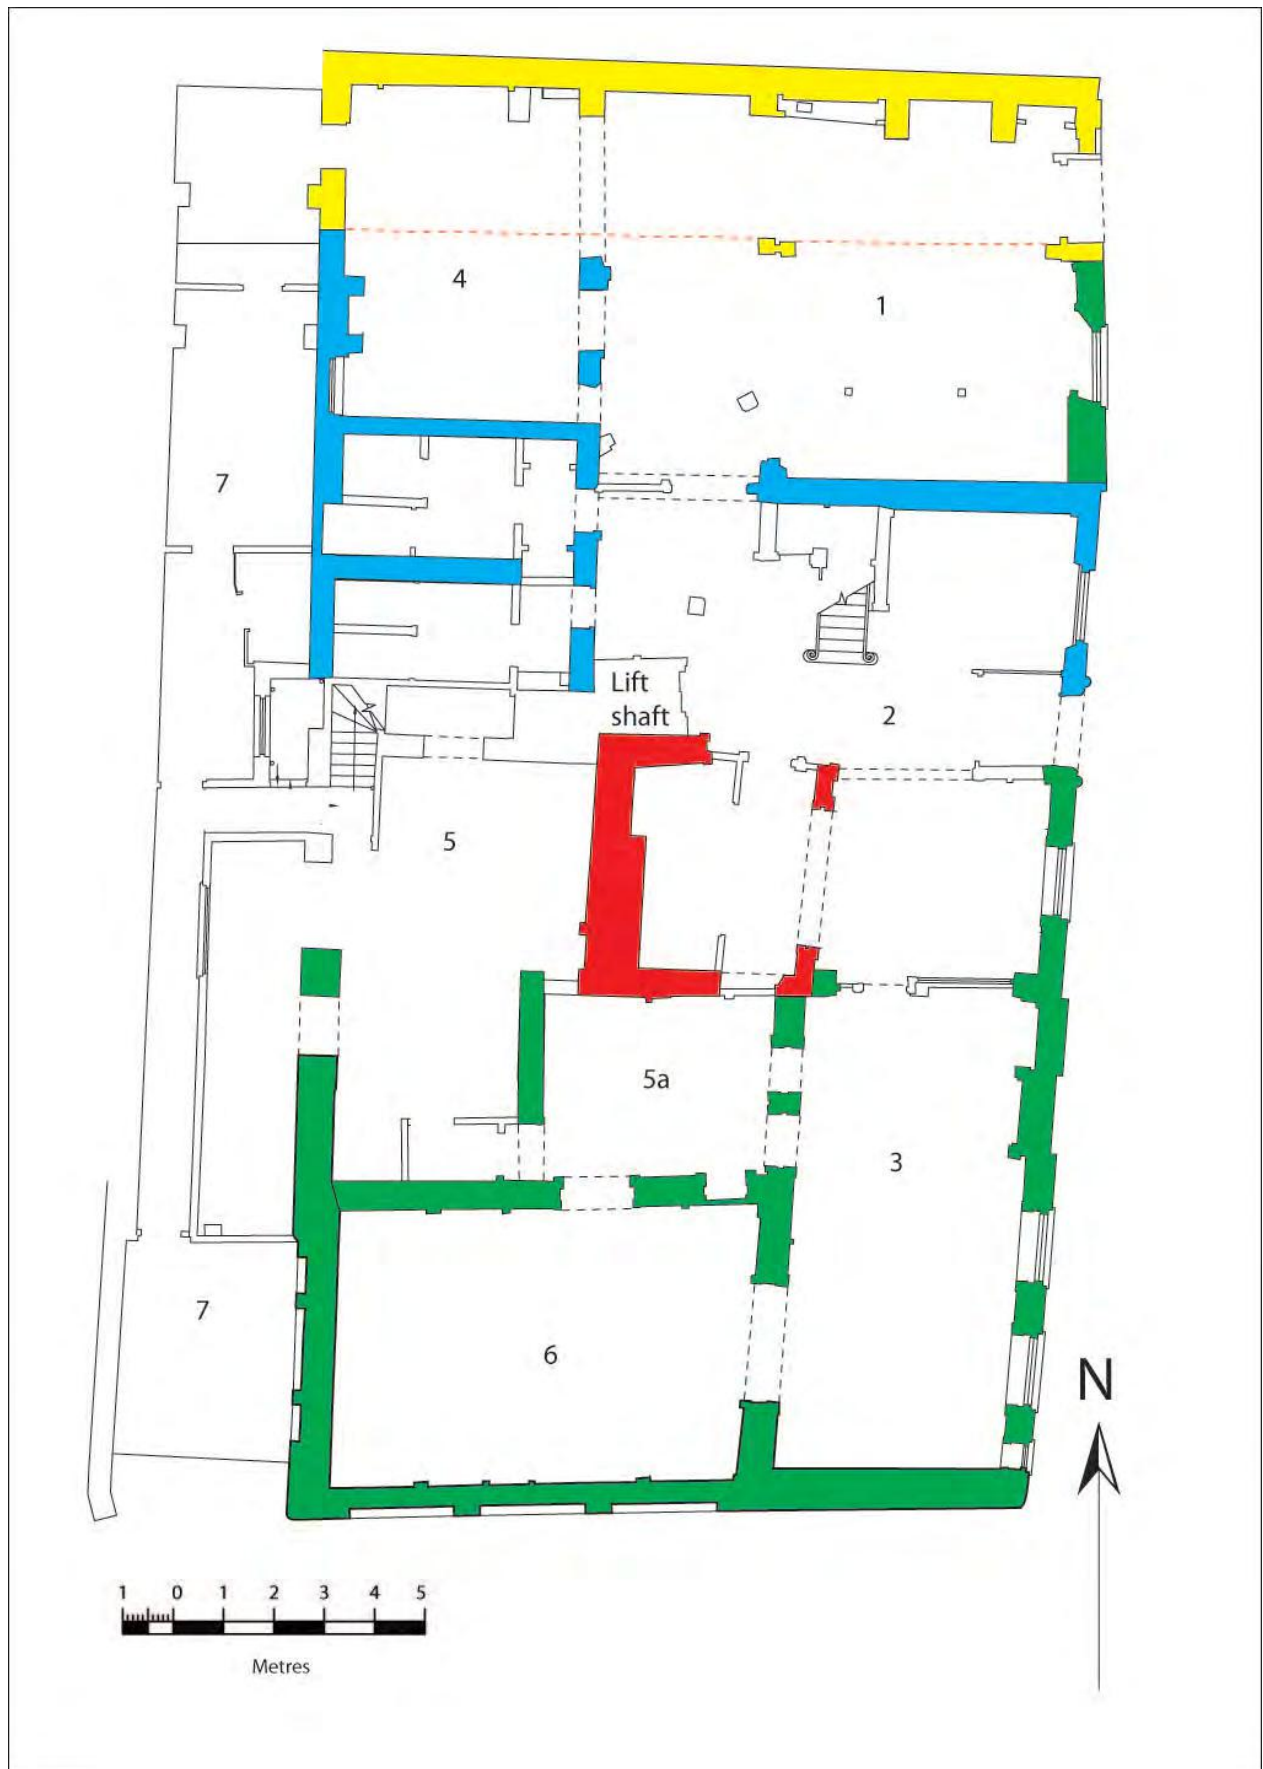
Figure 6: Ground floor phase plan of The Tanton Hotel.

Establishing the development of this building with any degree of accuracy has not been possible. Figure 6 below (based on the John Wood map of 1842) is an indication of how the building may have developed as an amalgamation of earlier structures however the different elements cannot be accurately dated. Plans of the other floors have been included to allow for the layout of the rooms to be understood, however as these cannot be accurately dated, they have not been coloured to reflect phases.

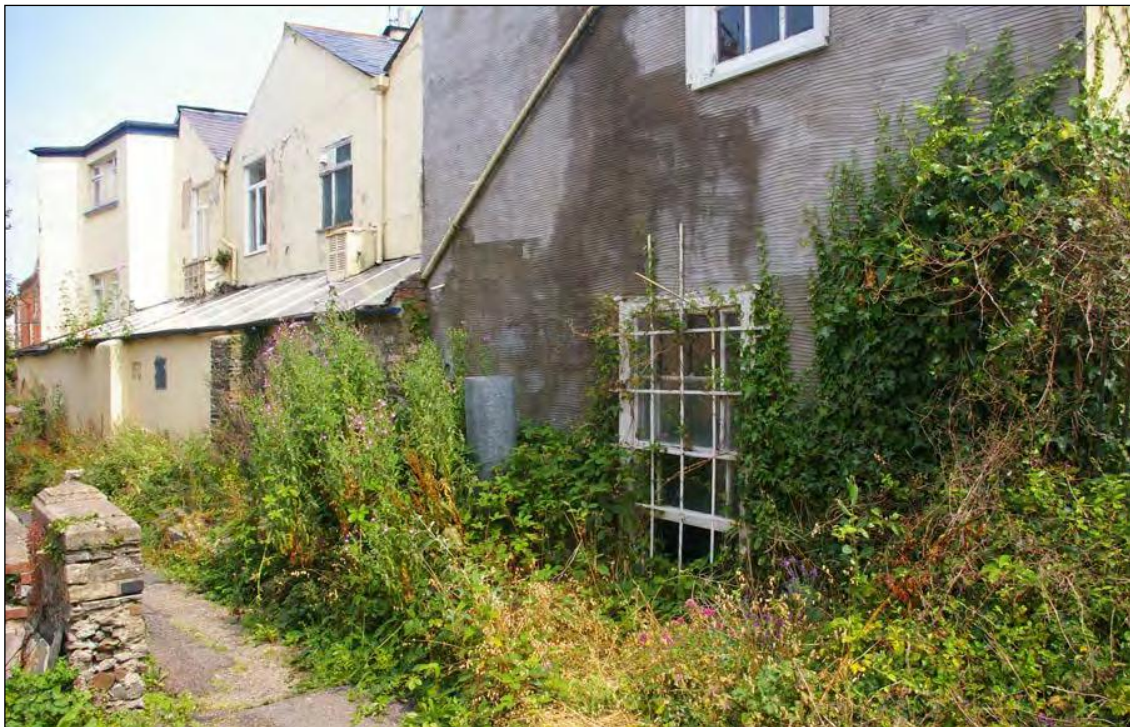
Figure 16: South end, west side of Hampton Terrace; viewed from the south-west.

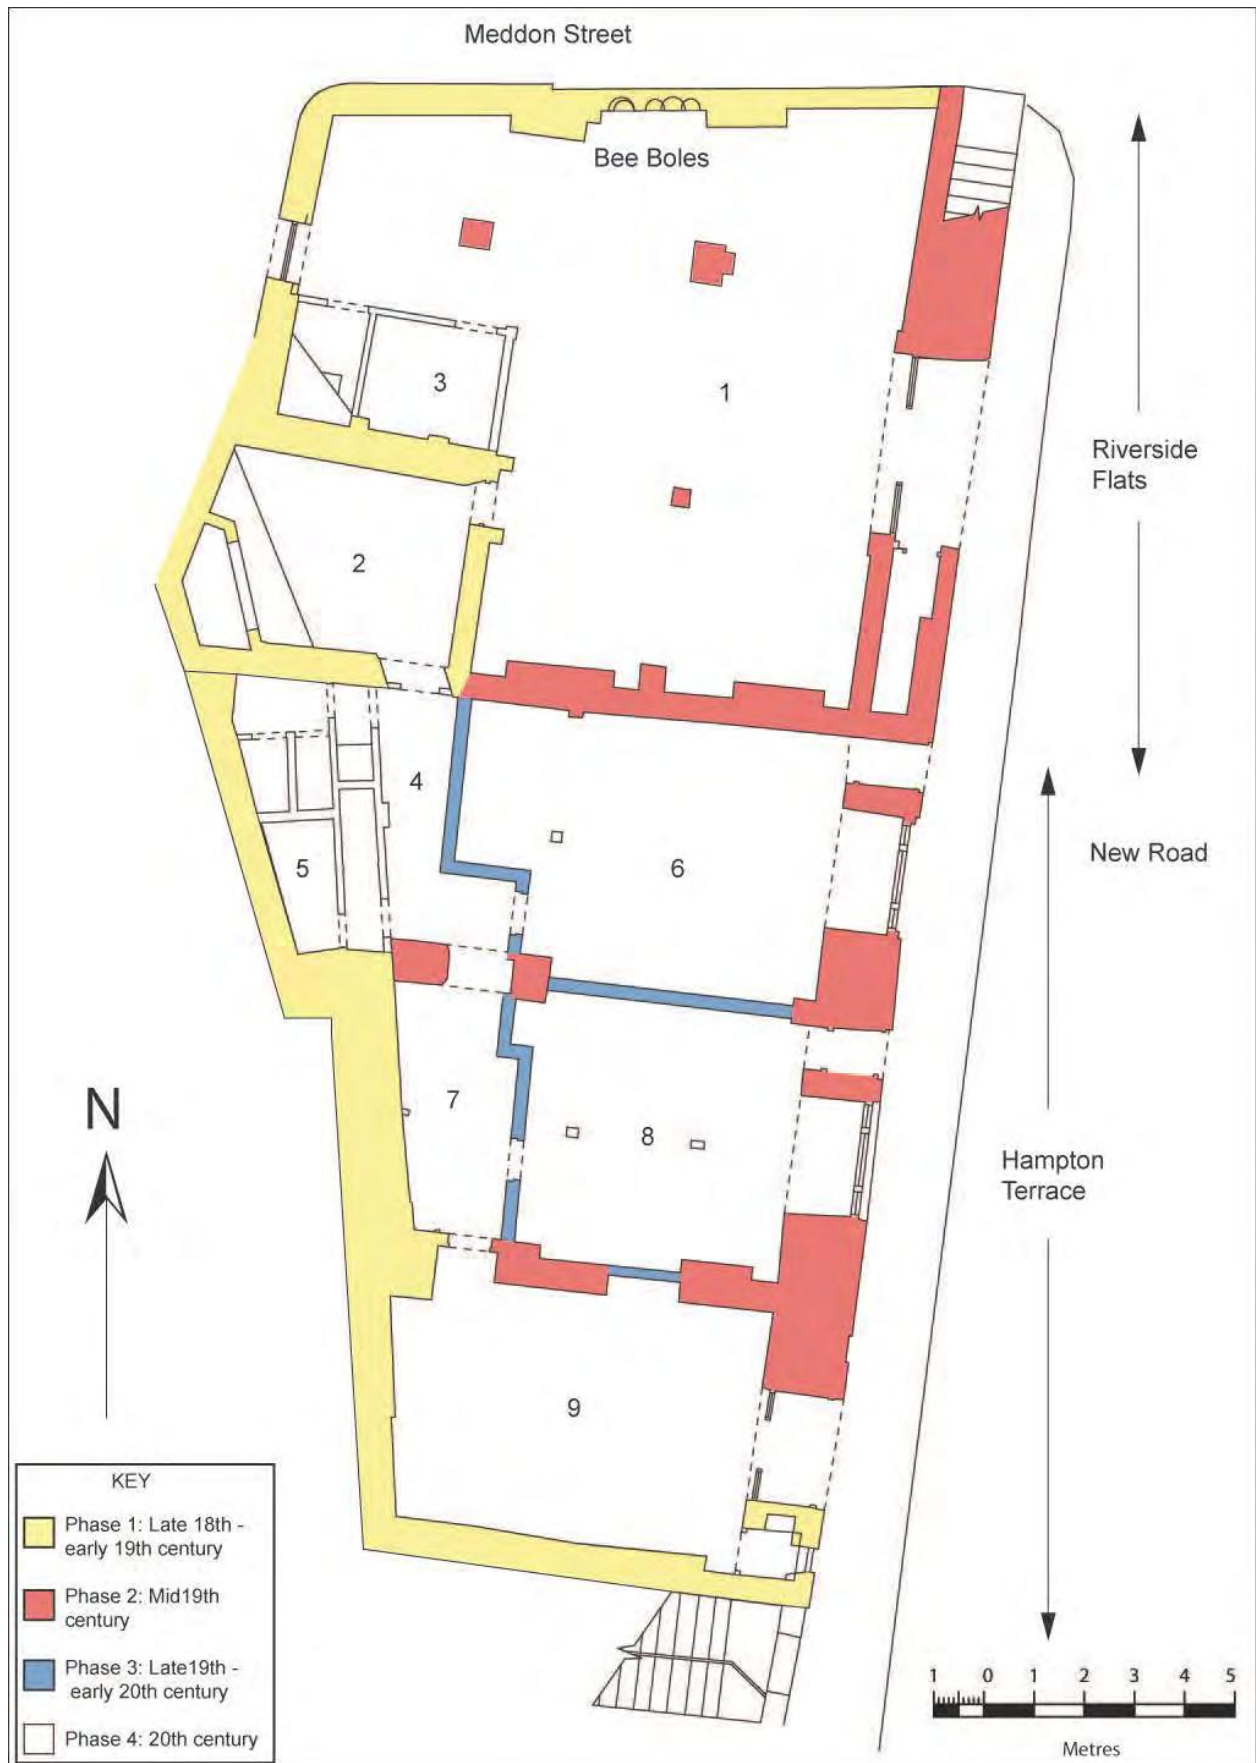
Figure 20: Ground floor phase plan of Riverside Flats and Hampton Terrace.

The ground floor (Figure 20) is split into the three separate units, respecting the division of the three town houses above. All of the units have been extensively modernised in the 20th and 21st centuries and are boarded out with plasterboard, obscuring much of the detail. The unit to the north has a cast iron pillar, supporting the main central ceiling beam; the central unit has two timber posts also supporting the main central ceiling beam. Both the central and north unit have alcoves, set back to the north side of the open space, with a door to the south side, leading west to a space to the rear. The area to the rear of both the north and central units has been completely modernised to form toilets, with no historic fabric exposed for study. The unit to the south is set back further into the

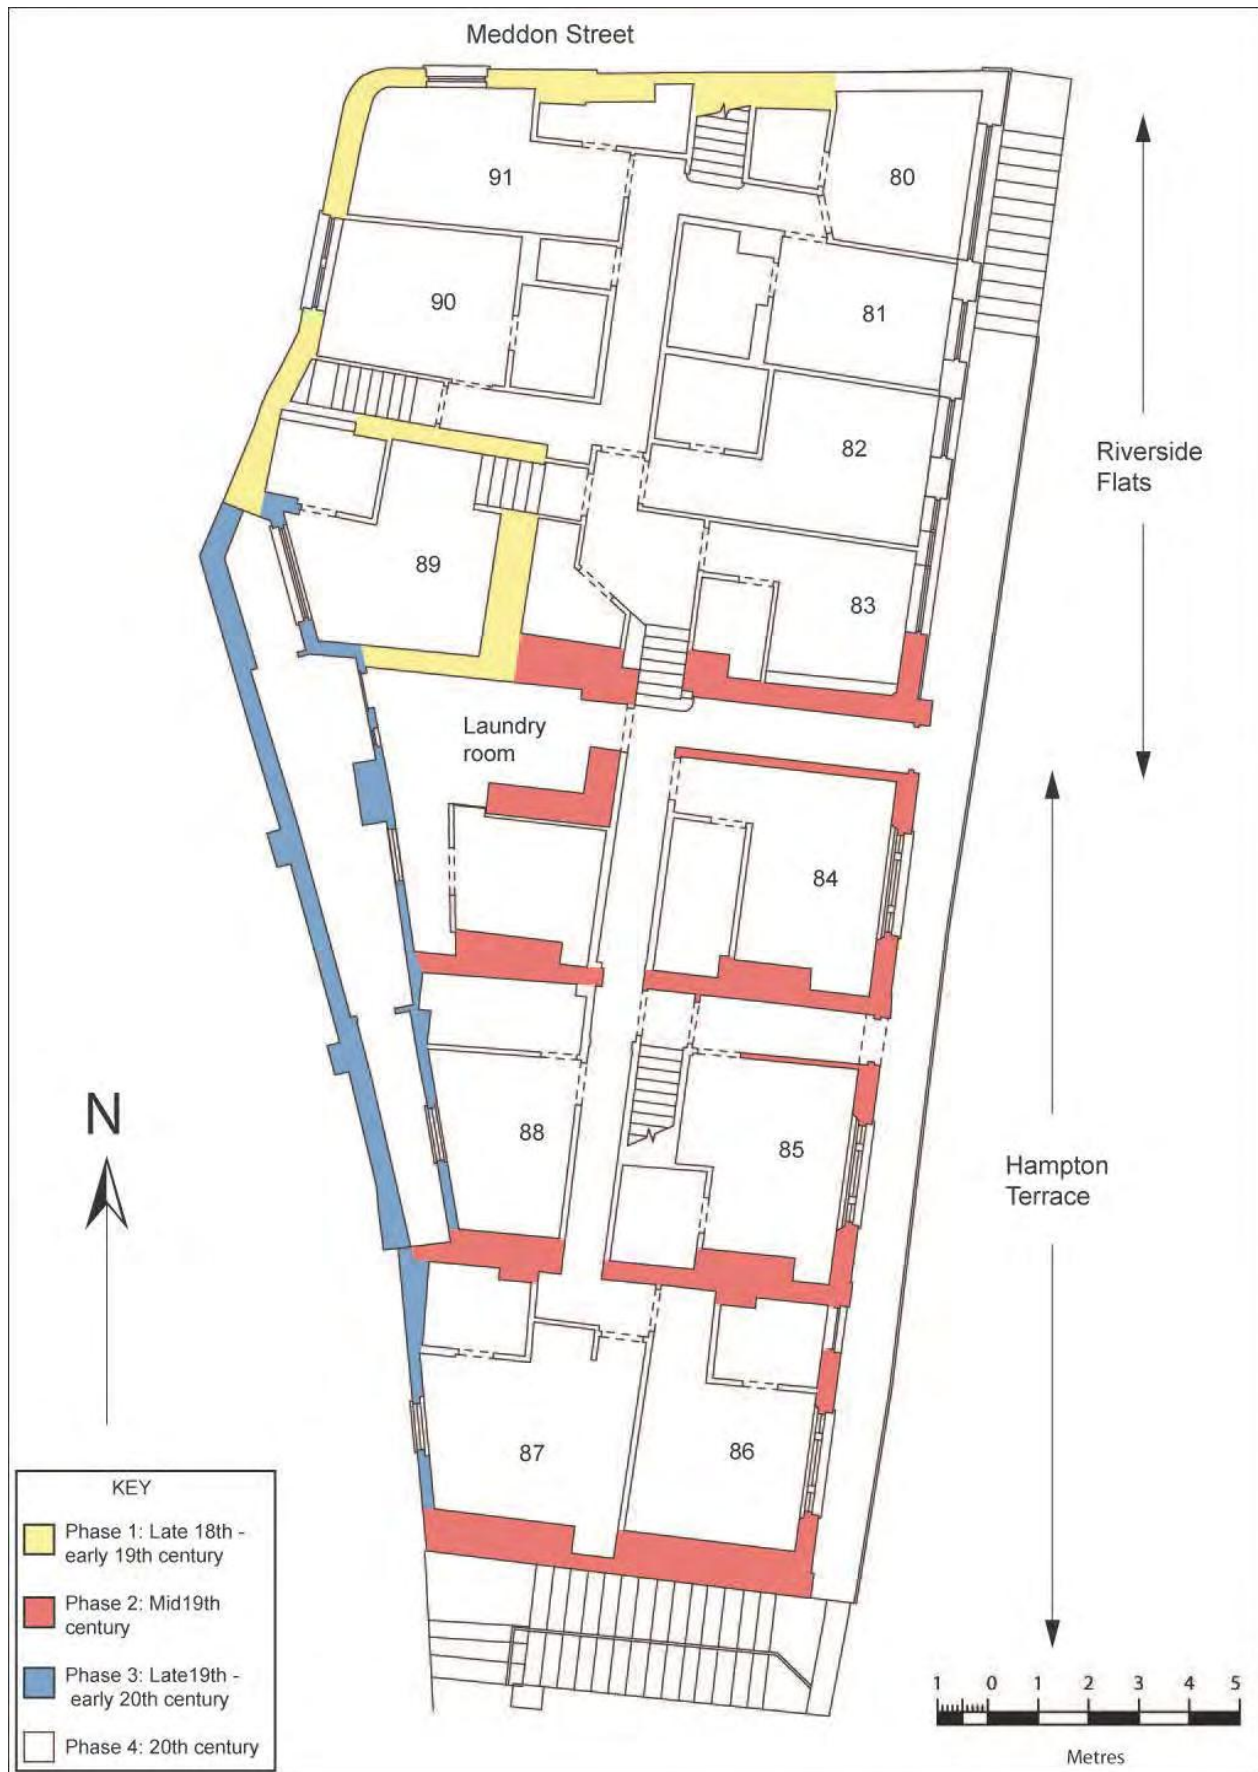
Figure 21: First floor phase plan of Riverside Flats and Hampton Terrace.

The basic plan of the building on the first and second floor (Figures 21 and 22) is a spine corridor, serving rooms to the west and east, looking over the street or quayside respectively. The majority of the doors have been refitted with modern fire doors and small en-suite bathrooms or shower rooms have been inserted into the rooms with plasterboard partitions. The walls are predominantly plasterboard partitions, either of the mid 20th century remodelling or a later 20th century phase. No significant historic features were viewed within the first and second floors. There are some sections of thick stone wall which may relate to the surviving historic structures evident on the ground floor. These can be seen in rooms 89 and 62, but they have been built over by the 20th century building and are boxed-in. These sections of surviving stone wall may merit further investigation (Figures 5 and 6 for room locations).

The historic plan of the three townhouses remains preserved within the modern layout, to a certain extent (Figures 21 and 22). Each house had an identical symmetrical layout of four rooms set around a central stair; all four rooms in each house were heated. On the first floor, narrow hallways to the north side of each house, serve the front door, with access off to a large front reception room, with the stair to the centre and a smaller domestic room/kitchen to the rear. On the second floor there were two rooms, set either side of the central stair. A table of surviving features, as noted, room by room is included as an appendix (Appendix 2).
