BRICK HOUSE ST. NEWLYN EAST CORNWALL

Results of a Historic Building Assessment

South West Archaeology Ltd. report no. 160506

By N. Boyd & E. Wapshott
Report Version DRAFT01
29 April 2016

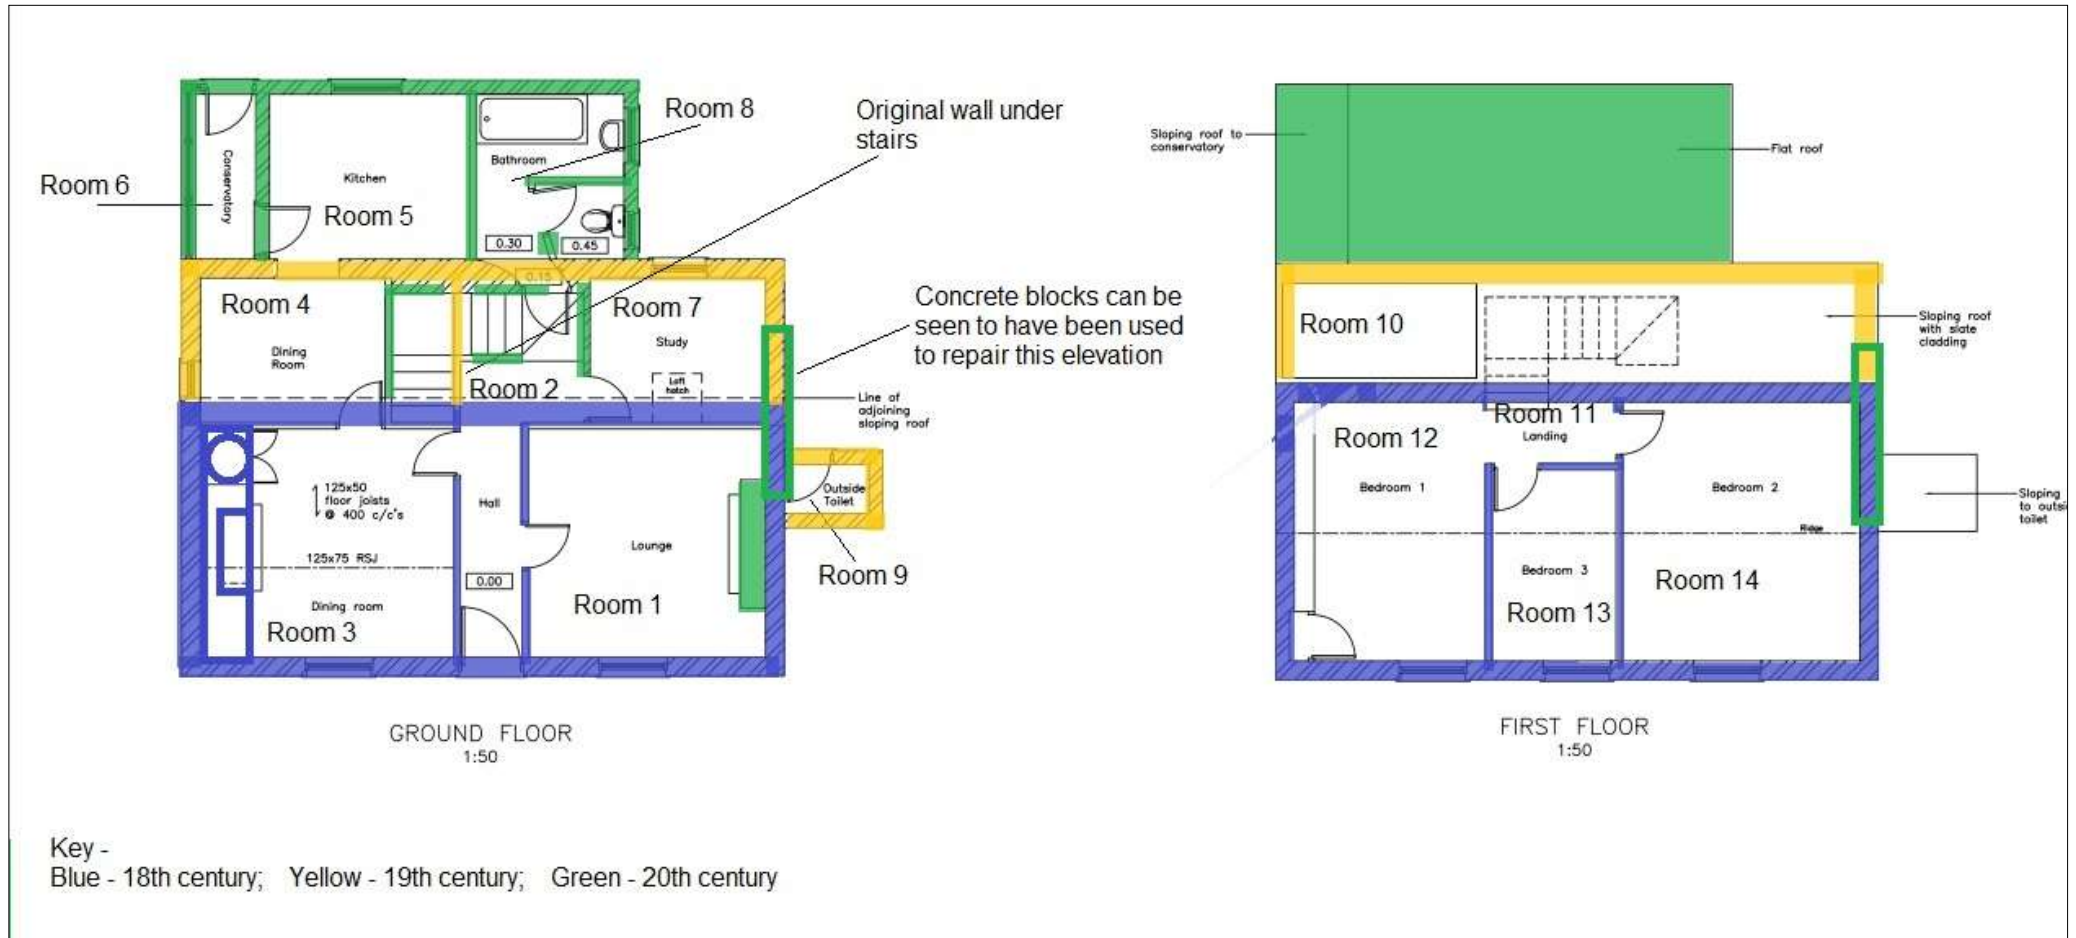
Figure 5: Phased plan showing room numbers.

Concrete blocks can be seen in the west elevation of the main farmhouse which is heavily rendered and there may have been some strengthening works or repairs needed here. The upper part of both chimney stacks and the southern part of the west gable were completely rebuilt at this stage. The first floor within the farmhouse was also replaced, steel RSJs inserted to brace the building. This suggests that at some point in the 20th century the building may have fallen into disrepair, requiring more intensive renovations.

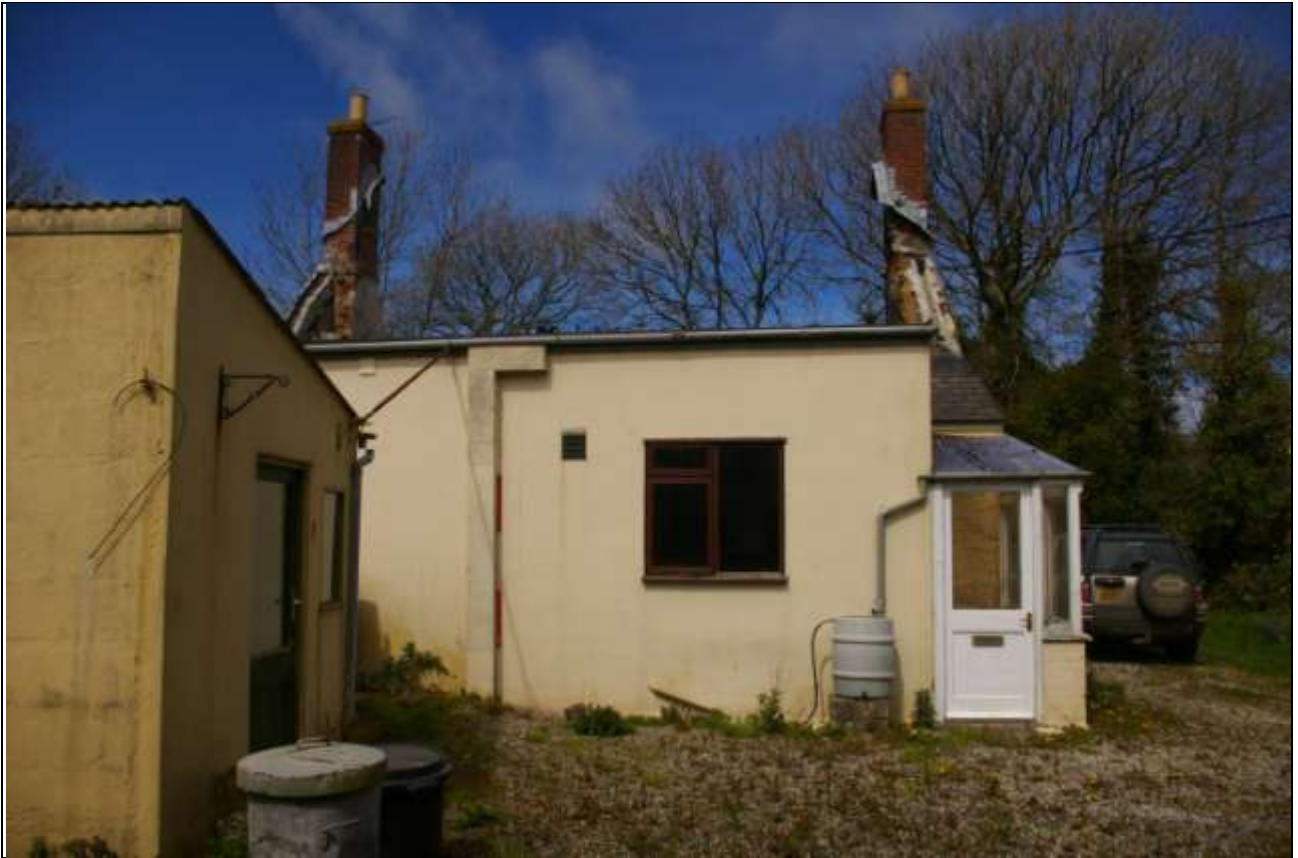
The rear of the house, with modern extension and part glazed lobby; from the south (2m scale).

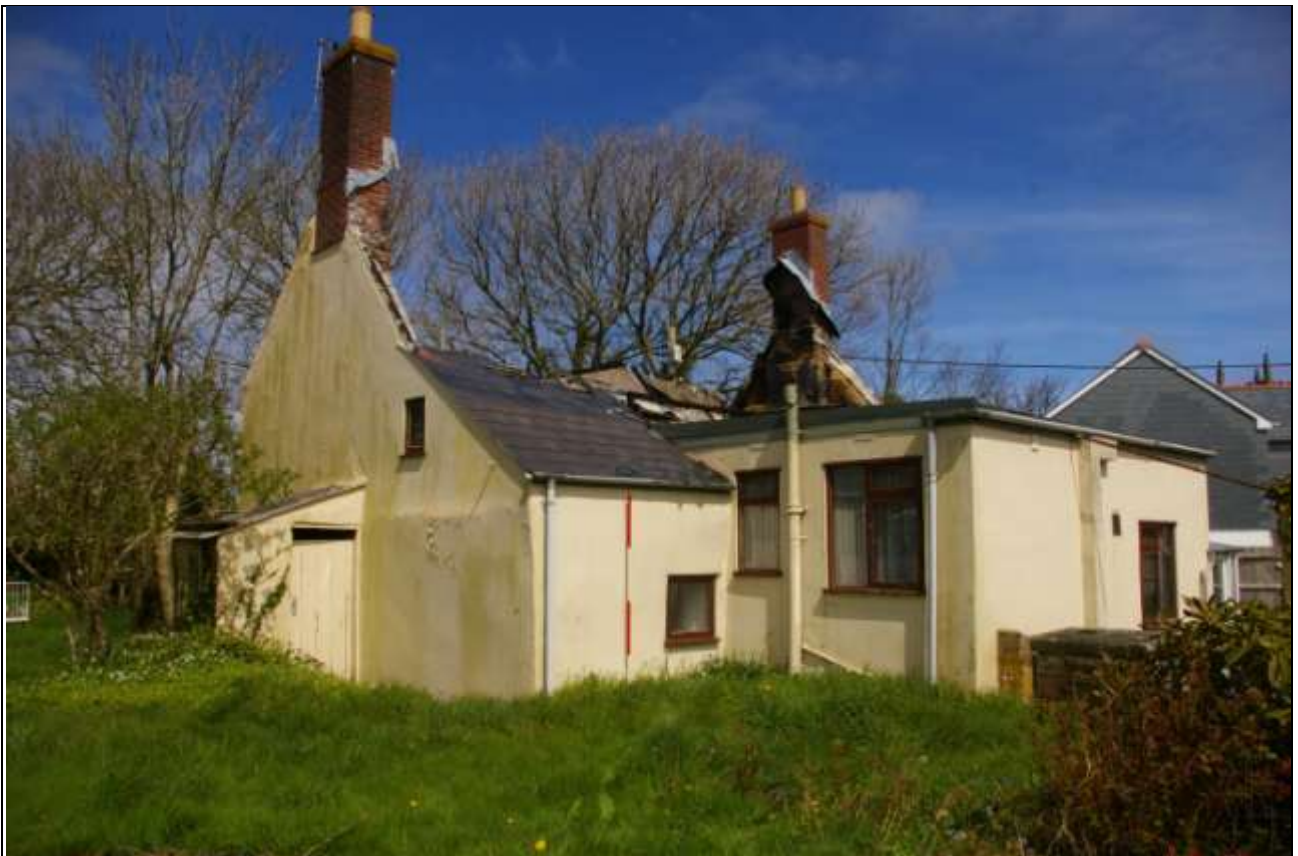
The rear of the farmhouse, showing the two phases of extension; from the south-west (2m scale).

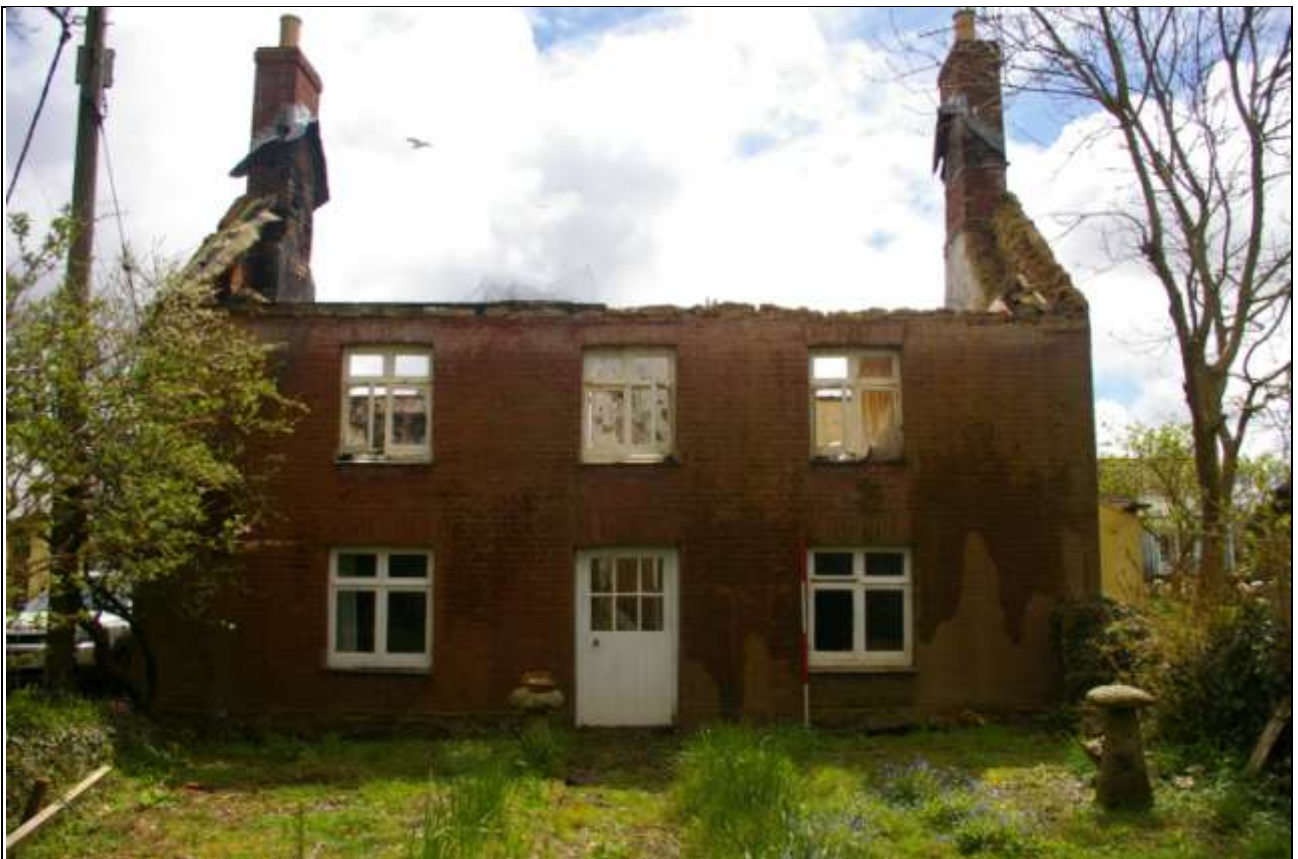
The main farmhouse is of brick on a stone rubble foundation plinth, with gable end stacks. The principal elevation is to the north, of three window range, with a central, ground floor doorway. It is of Flemish bond brickwork and each opening has a shallow segmental relieving arch; of typical 18th century symmetrical appearance. The gable ends are blind, with in-wall stacks and rebuilt upper brick shafts. Both gable end elevations are built in English bond brickwork, the east gable painted, the west gable rendered and painted. The rear of the main farmhouse is obscured by a 19th century extension but is also of English bond brickwork. The former thatch roof and timber roof structure were lost in a recent fire.

The north elevation of the farmhouse; from the north, north-west (2m scale).

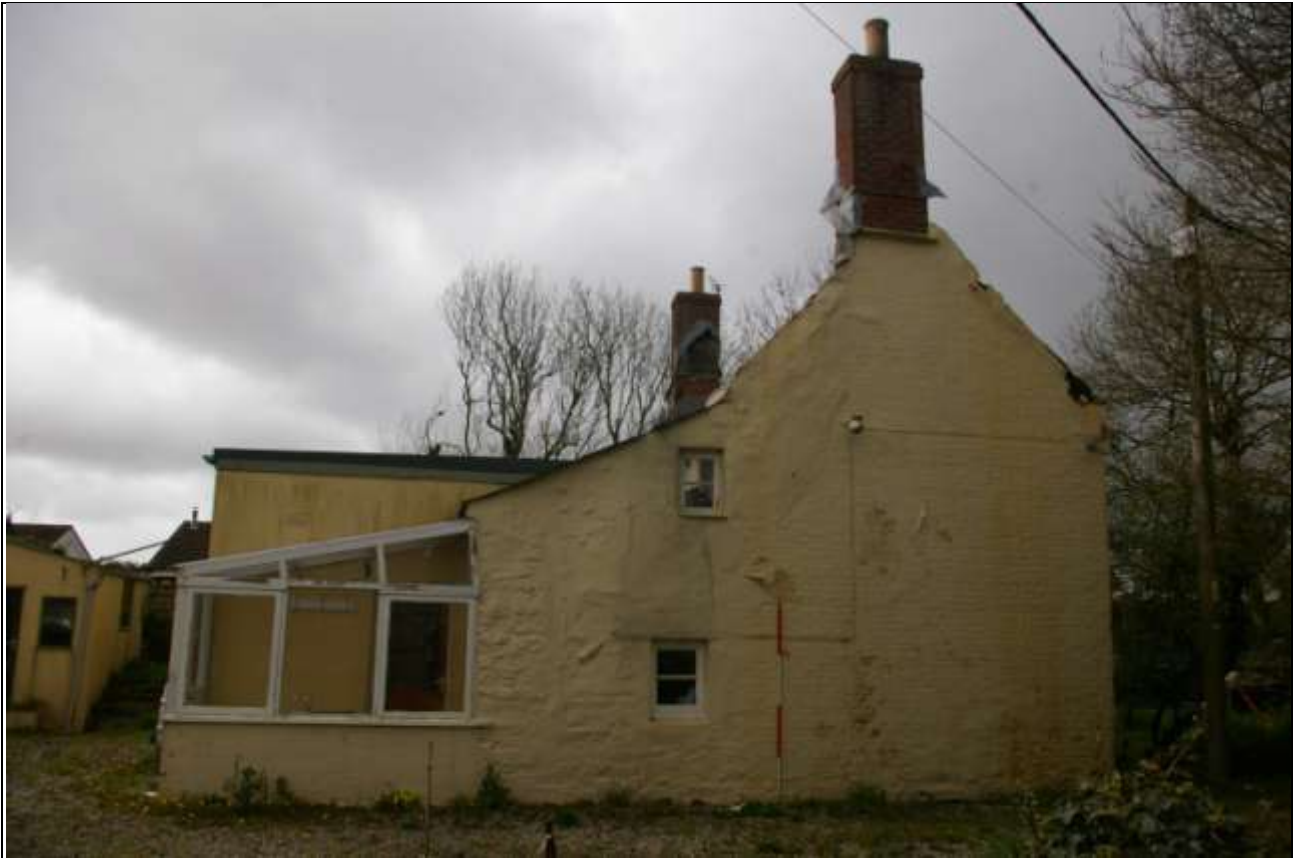
The east elevation of the farmhouse; from the east, south-east (2m scale).

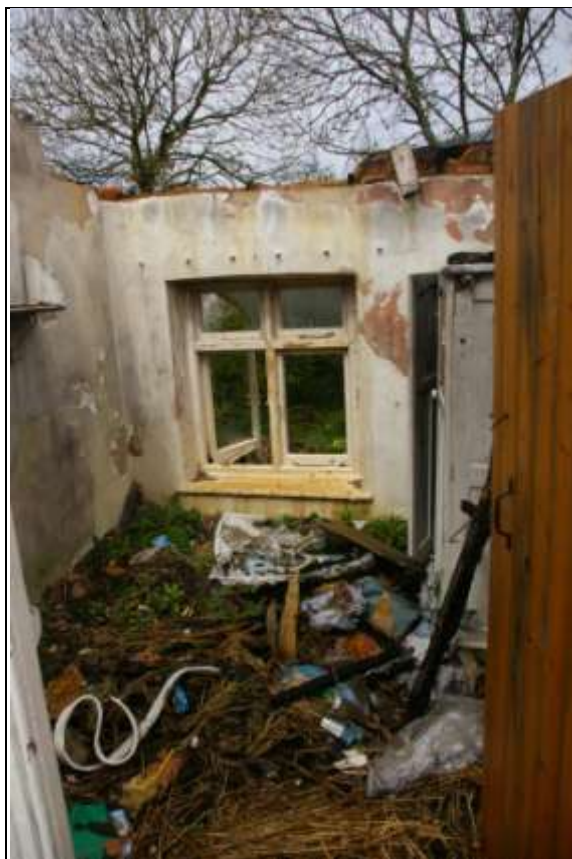
Floor:		20 th century, floorboards or boarded, was carpeted, damaged by fire and water
Ceiling:		Lost to fire.
Opening – Window:	1	Mid 20 th century casement window, with chunky timber frame and chunky transom mullion between two opening casements, with two small hopper casements above.
Opening – Door:	1	18 th century moulded door frame to room 11, 20 th century plank door with iron thumb latch
Significant Details:		Modern alcove area with shelves to the south of the chimney stack, concrete blocks seen in the wall where it has been rebuilt here, is this a larger repair? There is a narrow cupboard to the north of the chimney stack, as seen in room 12; the door has been replaced with a modern boarded door.

Room 13, mid 20th century window, modern plank door in moulded original door frame; from the south, south-east.

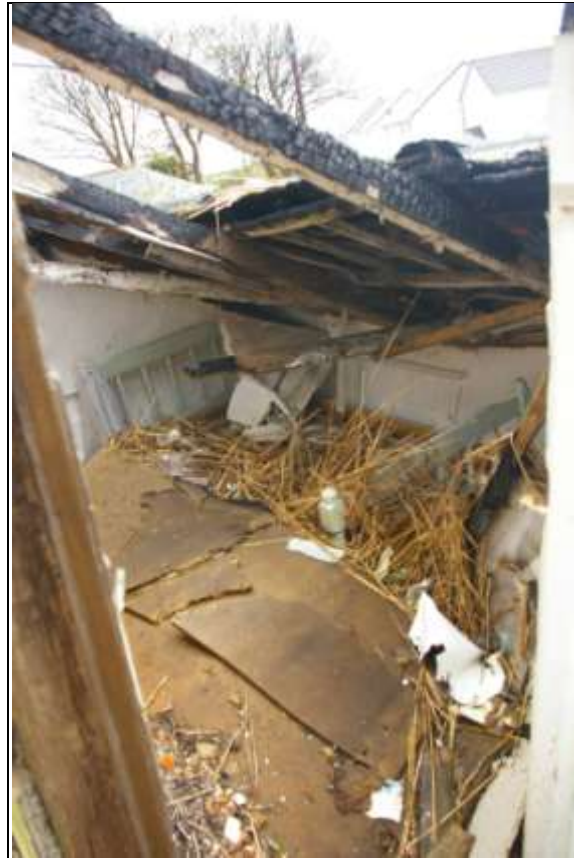
Significant Details:		The porcelain toilet has survived in here from the early 20 th century
Interior – Room 10		
Description		
Function:		Small loft over service rooms, now a bedroom
Walls:		Plastered and painted, some plasterboard, now damaged from fire and water
Floor:		Floorboards - 19 th century pine
Ceiling:		The ceiling was partly plasterboarded and partly plastered, mostly lost to the fire and water damage.
Opening – Doors:	1	Deep set two panelled door, reused here from elsewhere, in wide moulded frame,

The small loft-style bedroom, Room 10, showing part of the surviving 19th century roof structure; from the west, north-west.

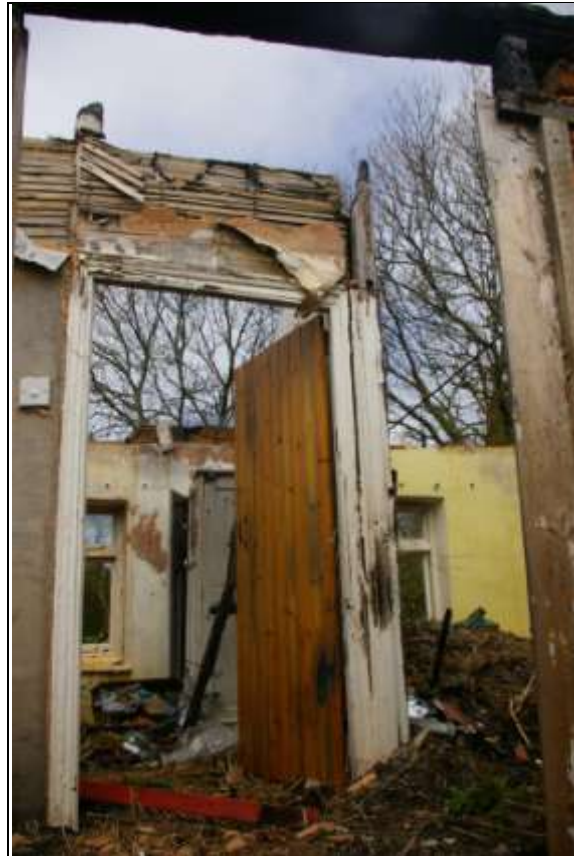
The landing, with the surviving lathe and plaster walls of Room 13 and original moulded door frame; from the south.

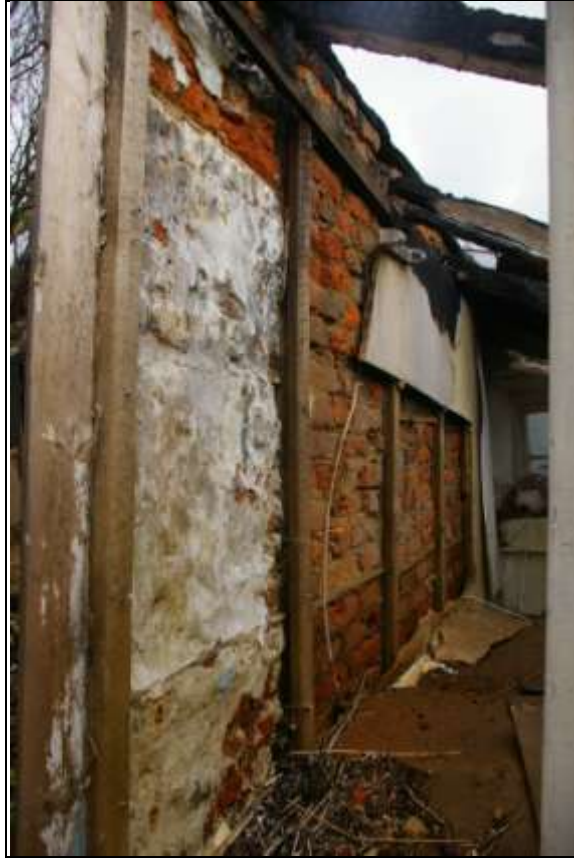
The brick rear wall of the house, with timber noggin and later surface mounted timber framing, visible within Room 10; from the west, south-west.

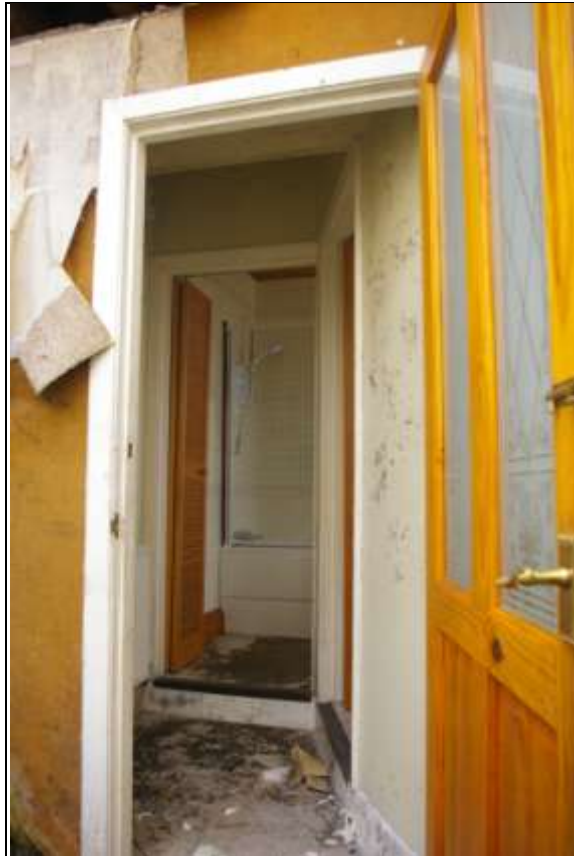
The house was further extended, providing a modern kitchen, bathroom and toilet. This is of concrete block and brick, single storey, rendered to the exterior with a flat bitumen roof.

The modern extension to the rear of the house, a modern bathroom and separate toilet (Room 8); from the north, north-west.

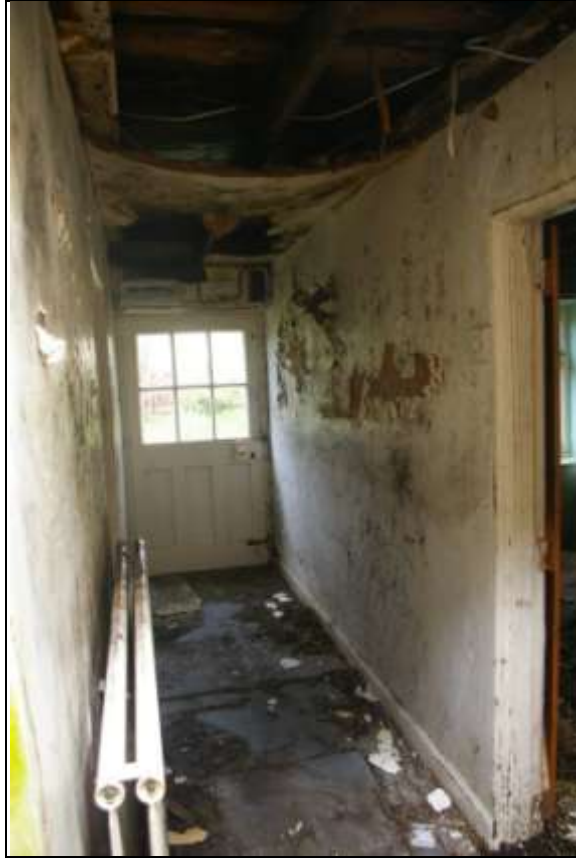
View down the hallway to the front door, Room 2; from the south, south-west.

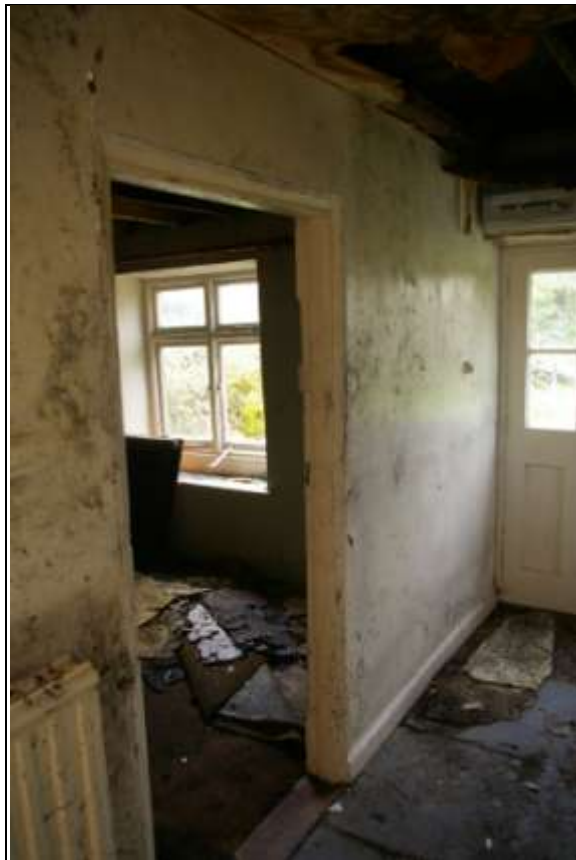
View of the original lathe and plaster partition wall to Room 1 and the moulded door frame, the door is modern, with mid 20th century replacement window beyond; from the south-east.

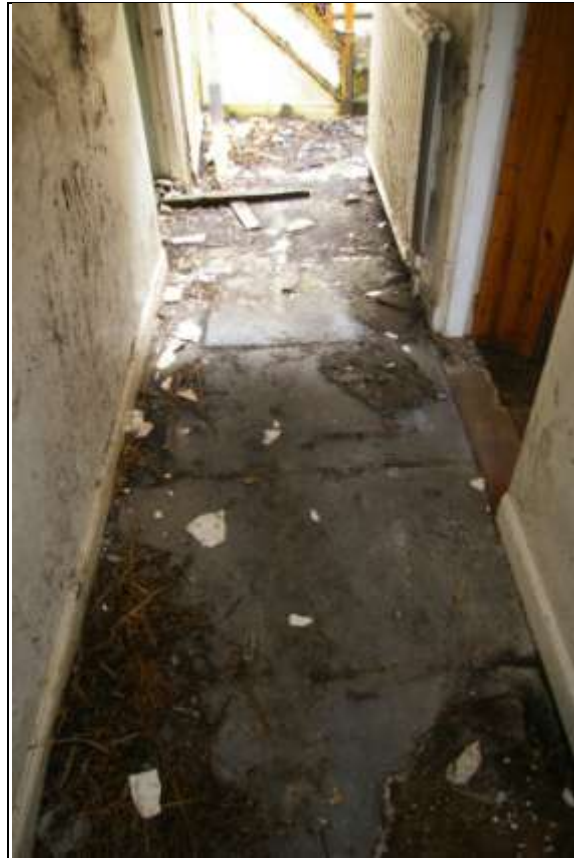
Floor:		Original 18 th century slate slab floor. Possibly reset when concrete floors were installed in the two main rooms.
Ceiling:		Plasterboard ceiling was damaged by fire and water and has collapsed. There are some surviving wider and irregular ceiling joists beneath, with wide floorboards laid directly on top in Room 13. Ceiling may be 19 th century and may even be 18 th century in date.
Opening – Doors:		Early to mid 20 th century front door, in 19 th century style, boarded to the base with glazed panels above, ledged to rear, with iron lock and brass handles. 18 th century moulded door frames to rooms 1 and 3. 20 th century door frame to room 7 and modern Victorian style door to room 8.
Significant Details:		20 th century Victorian style staircase has been inserted to rear and the space has been pushed through into 19 th century service extension, altering the layout. The stair rises over an earlier 19 th century partition.

The original slate floor in the hallway, Room 2; from the north.

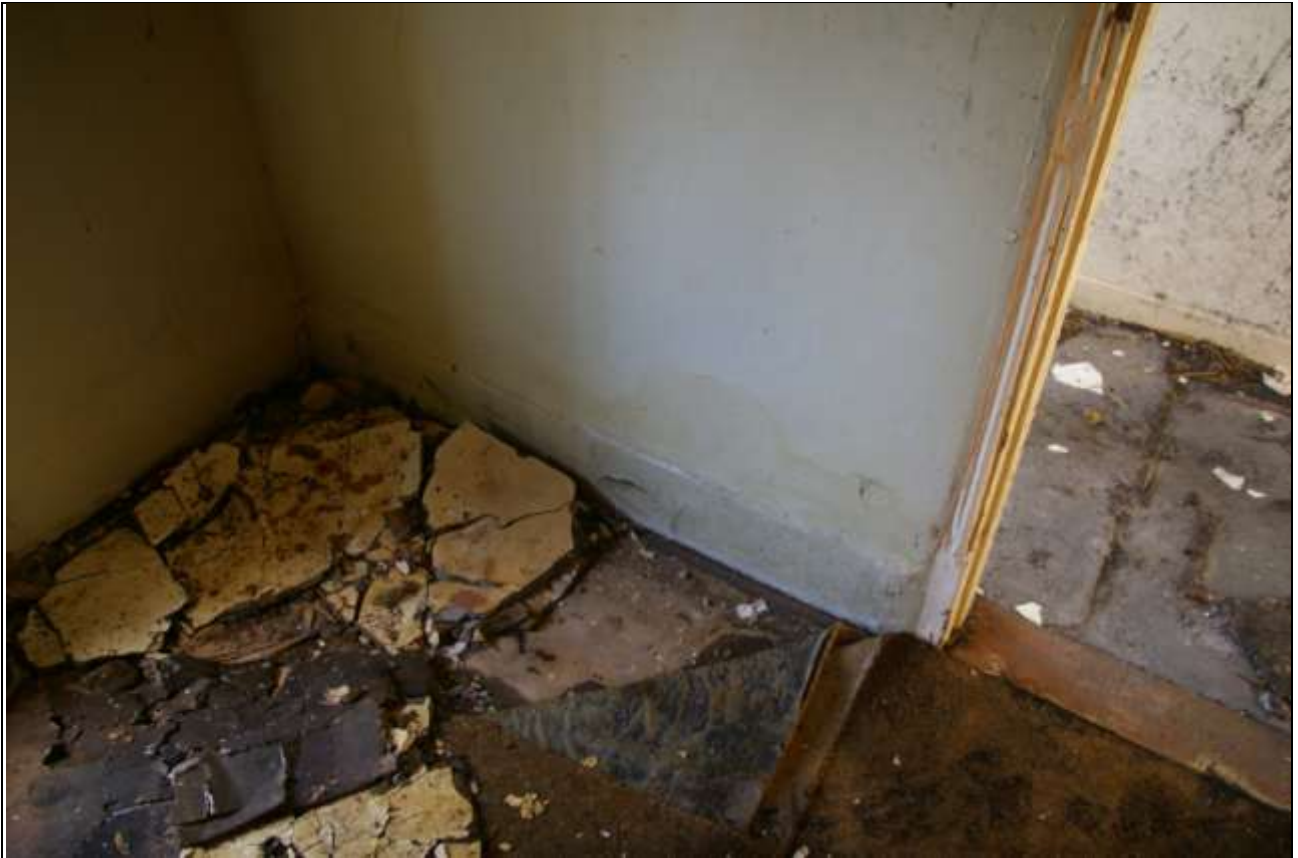
Interior – Room 1		Description
Function:		Living Room/Parlour (Lounge)– one of the two original rooms in the main range.
Walls:		Plastered and painted, the plaster in the north-east corner and on the partition wall to the hall (room 2) may be surviving lime plaster. There is a section of surviving deep 18 th century lime plastered skirting to the north-east corner. The rest of the skirting boards are of 20 th century date.
Floor:		Concrete, replaced in the 20 th century.
Ceiling:		Steel RSJ and modern narrow joists, all replaced in the 20 th century, plasterboard ceiling has now collapsed due to water and fire damage.
Opening – Doors:	1	18 th century moulded door frame, 20 th century plank door, with iron thumb latch.
Opening – Windows:	1	Mid 20 th century casement window, with chunky timber frame and chunky transom mullion between two opening casements, with two small hopper casements above.
Significant Details:		The fireplace and stack project shallowly into the room and the fireplace is modern slate effect. There are two shallow arched alcoves either side of the fireplace, now set with modern shelves and cupboards. It is not clear to what extent the stack and wall here may have been repaired and rebuilt during the 20 th century renovations which replaced the first floor.

Section of surviving original deep plain plaster skirting, the only section found in the house, in the north-east corner of Room 1, along the partition wall; from the south-west.

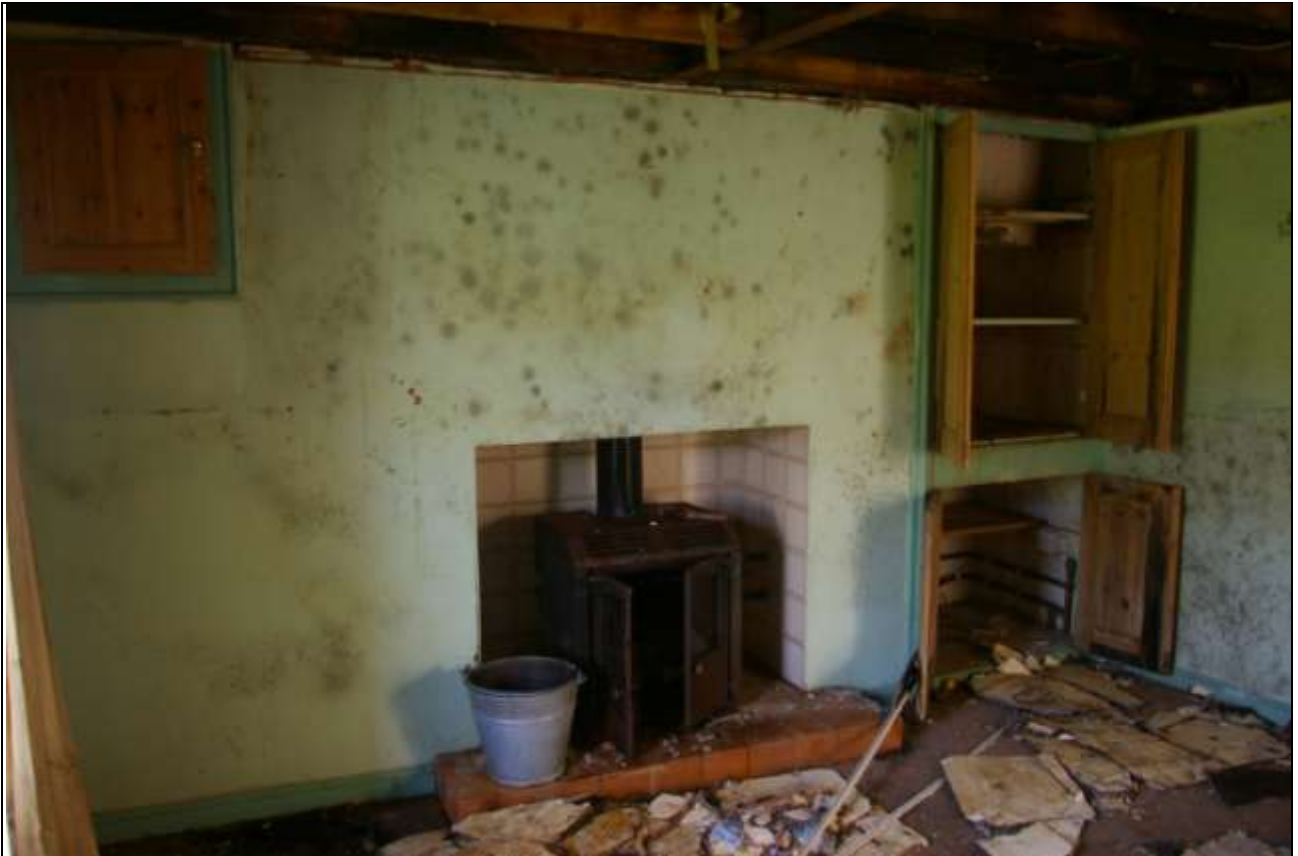
Interior – Room 3		Description
Function:		Former Kitchen, Second Living Room (Dining Room)
Walls:		Plastered and painted. All skirting is narrow, of 20 th century date, various styles of plain or moulded.
Floor:		20 th century concrete replacement floor.
Ceiling:		Steel RSJ and modern narrow joists, all replaced in the 20 th century, plasterboard ceiling has now collapsed due to water and fire damage.
Opening – Doors:	2	18 th century moulded door frame to room 2 and 19 th century door frame to room 4, moulded on the side facing this room. 20 th century plank door to room 2. 19 th century plank and boarded door, ledged to rear, on blacksmiths hinges with brass door knob.
Opening – Windows:	1	Mid 20 th century casement window, with chunky timber frame and chunky transom mullion between two opening casements, with two small hopper casements above.
Significant Details:		The chimney stack has been overhauled in the 20 th century, the fireplace has been partially blocked and reduced in size, now fitted with a stove, on a projecting tile hearth. There is one small cupboard to the north of the stack, set near the ceiling, in a moulded beaded frame, but with a newly replaced panelled door. There is a large cupboard, with moulded surround and modern panelled doors set into the large alcove south of the stack; this opening appears to have once been an oven, with ragged scars in the brickwork from a removed structure within the cupboard space.

Room 3, with the altered original fireplace, now with stove, with small original beaded cupboard to the north and large 19th century cupboard to the south, occupying position of former oven; from the north-west.

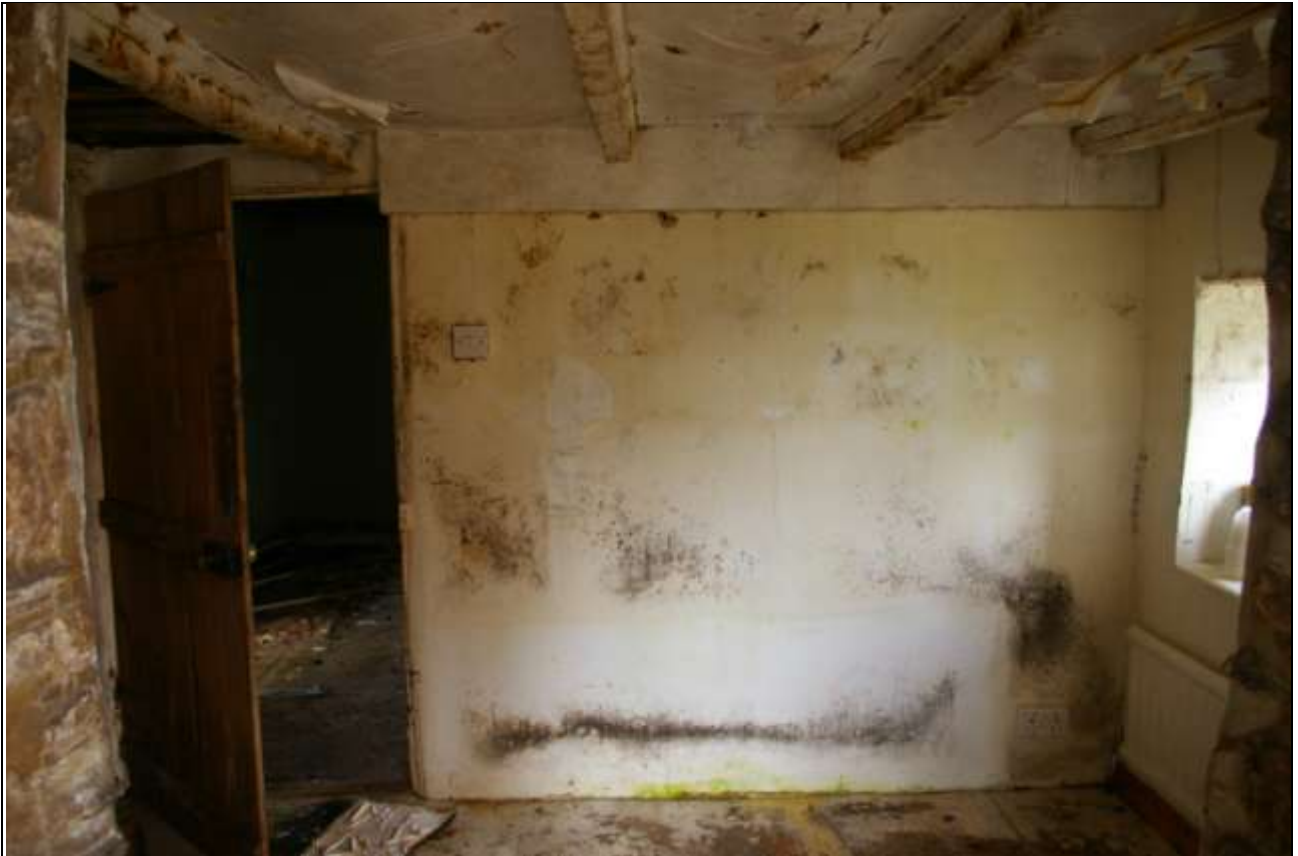
Interior – Room 4		Description
Function:		Room in service lean-to, now a dining/breakfast room.
Walls:		Plastered and painted. 20 th century narrow skirting boards.
Floor:		Concrete floor, several layers of lino or tiles, water and fire damaged.
Ceiling:		False beams, set onto narrow joists, beaded, with floor boards above laid directly on their backs (room 10), plasterboard was fitted between the joists but has been lost to fire and water damage. Ceiling is probably 19 th century in structure.
Opening – Doors:	2	19 th century door frame to room 3, 19 th century door, plank boarded with ledging bars to rear and brass door knobs. 19 th century plank door with ledging bars to rear and small iron latch to cupboard; the cupboard is modern so this has been reset here from elsewhere.
Opening – Windows:	1	One small, two pane opening casement in a chunky pegged frame, with heavy iron catch and latch - which look blacksmith made - and heavy hinges.

Room 4, with low ceiling, small narrow joists, possibly original, with plasterboard between. The door frame suggesting a change in status between the main range and 19th century extension; from the south.

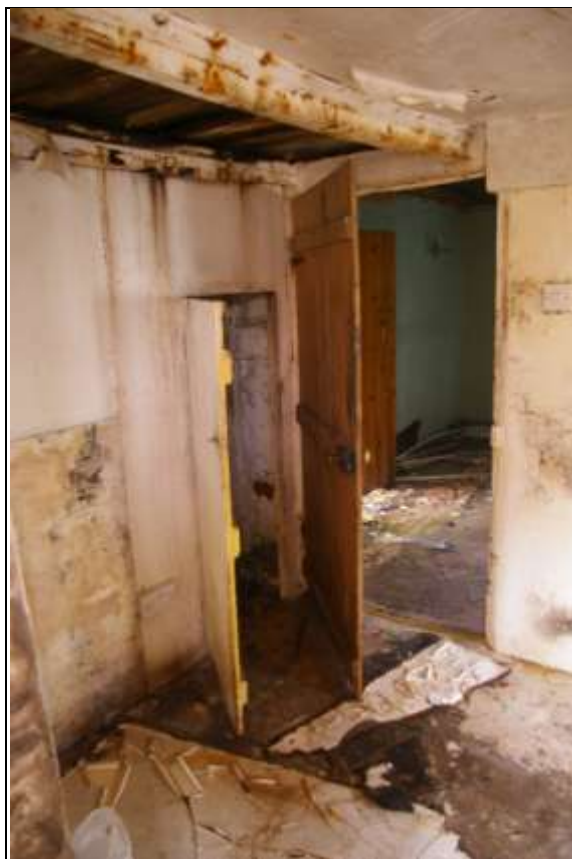
The door to Room 3 and modern cupboard under the stairs in Room 4, the wall under the stairs is of brick and timber framing and is of 19th century date, probably the original division of the space; from the south-east.

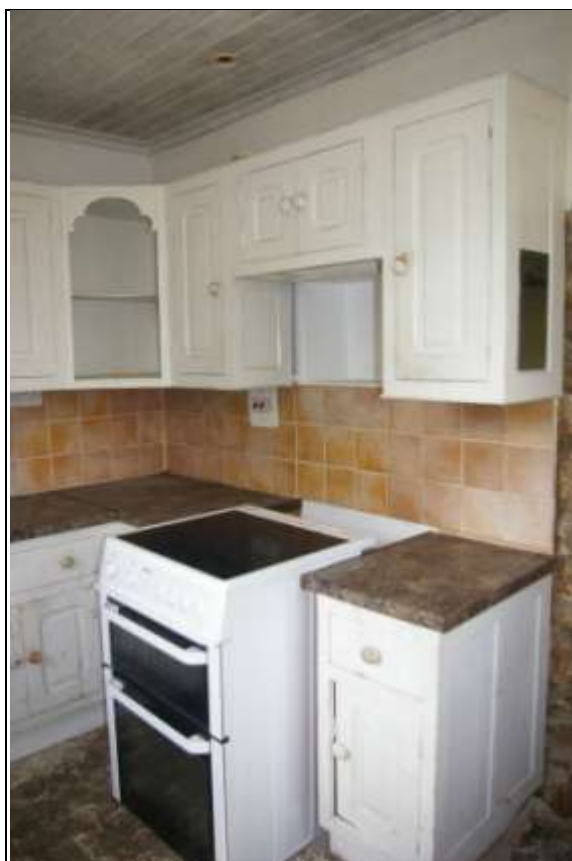
Significant Details:		The door frame to room 3 is plain on this side, moulded to room 3, indicating the change in status between the main range and the service lean-to.
Interior – Room 5		Description
Function:		Modern Kitchen
Walls:		Plastered and plasterboard, painted. Fitted kitchen cupboards and base units line the walls.
Floor:		Concrete, covered with several layers of lino. Water and fire damaged

The modern kitchen (Room 5); from the south-east.

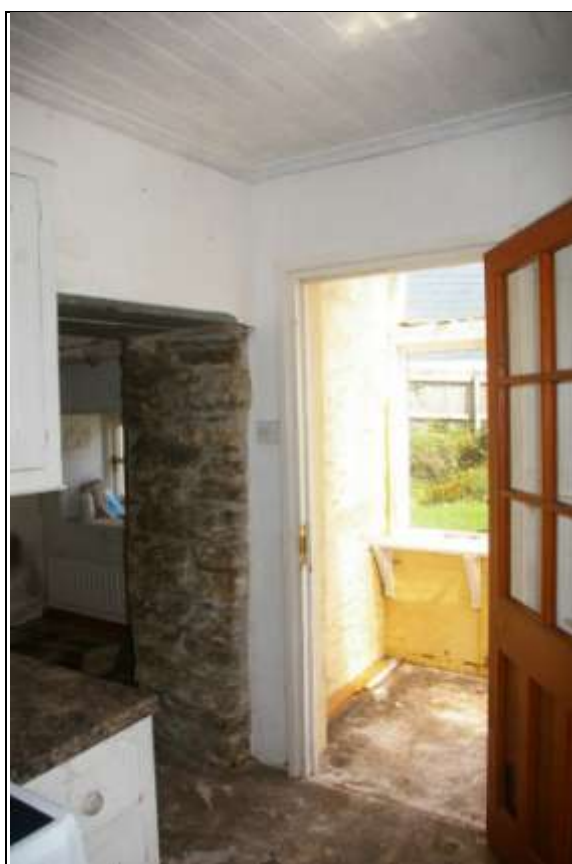
The rear wall of the 19th century extension, from within Room 5, showing the forced opening to Room 4 and also Room 6, the part glazed lobby/conservatory; from the south-west.

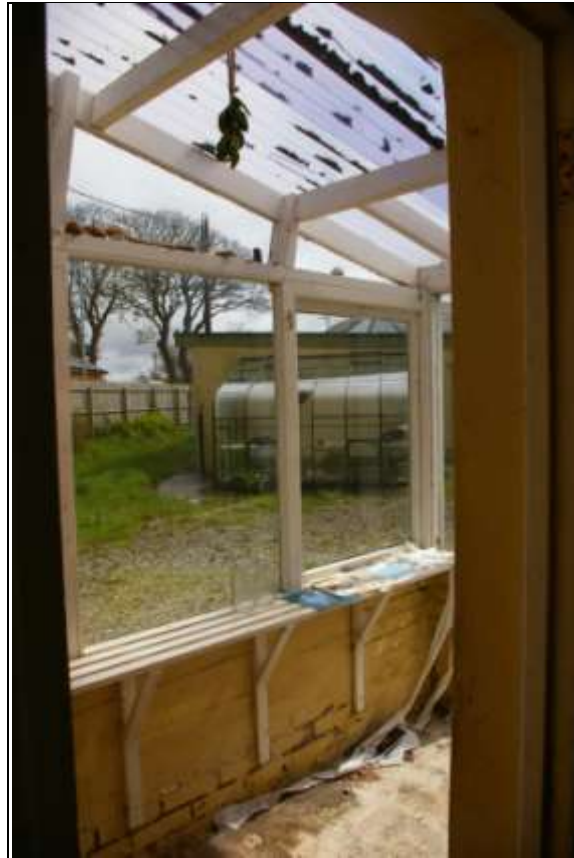
The part glazed lobby/conservatory, Room 6; from the north-west.

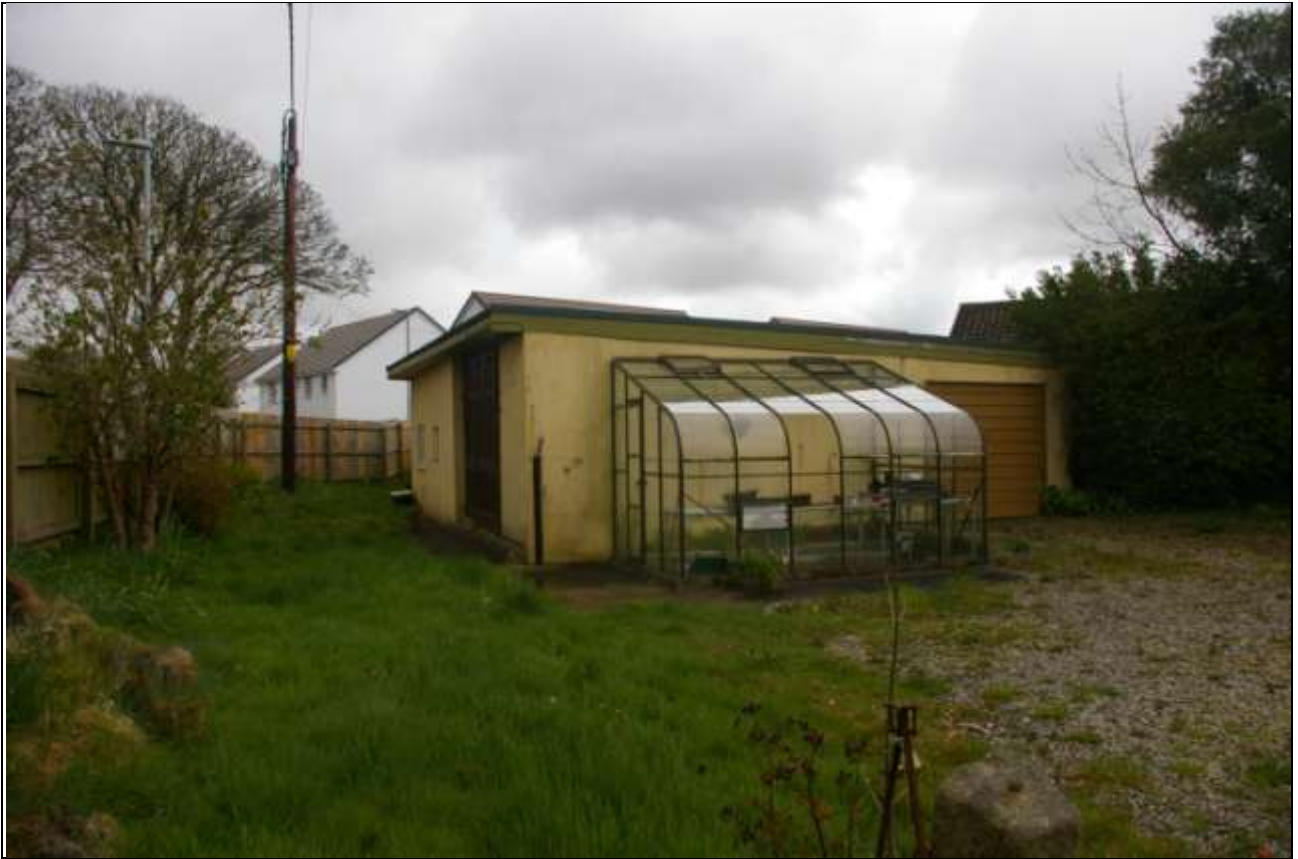
View of the garage and workshop which may contain elements of an earlier outbuilding within its structure. This large building occupies the south-east corner of the plot, behind the house; from the north, north-west.

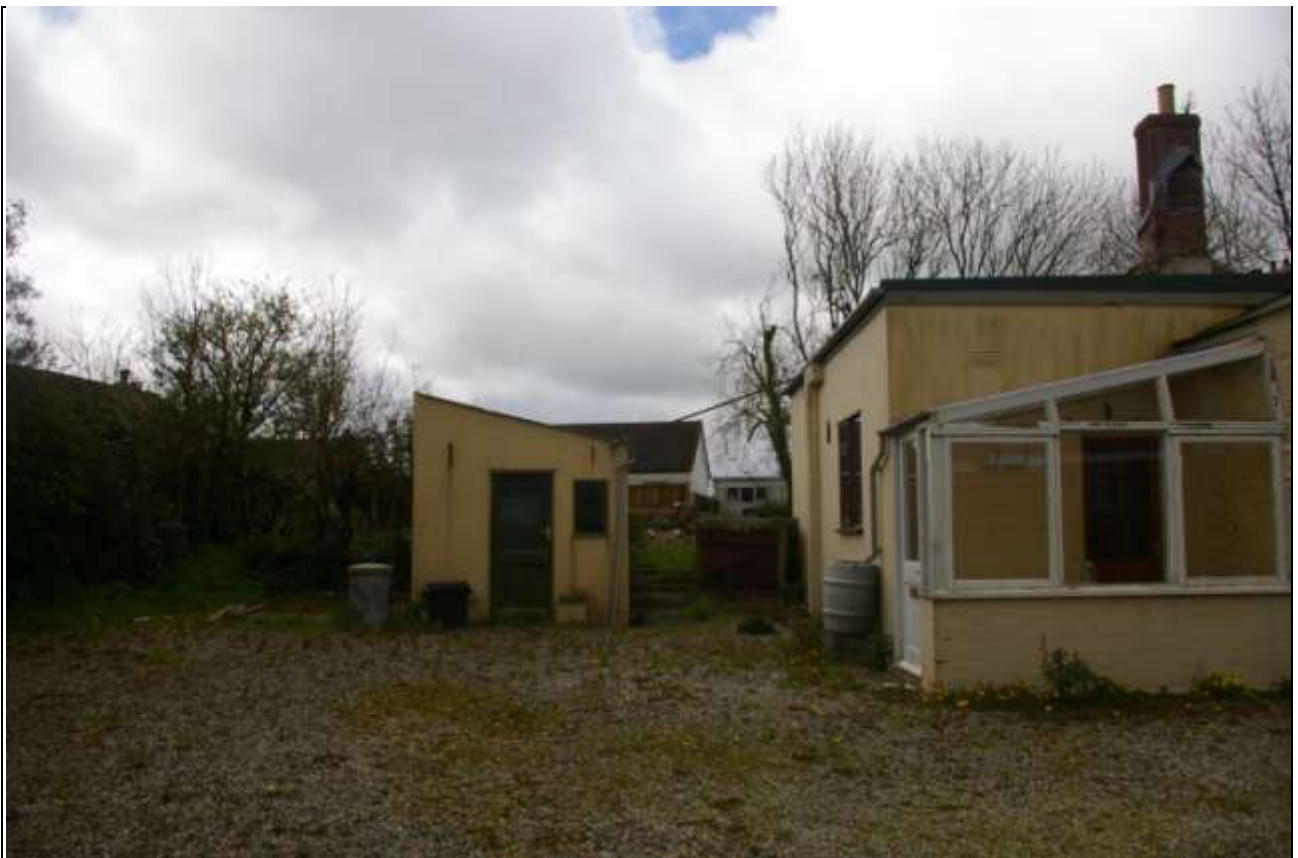
The early to mid 20th century laundry and utility behind the house, near the well house; from the east.
