# CLEEVE FARM BARN IVYBRIDGE SOUTH HAMS DEVON

Historic Building Recording

South West Archaeology Ltd. report no. 170613

By E. Wapshott & N. Boyd  
Report Version 02  
13<sup>th</sup> June 2017

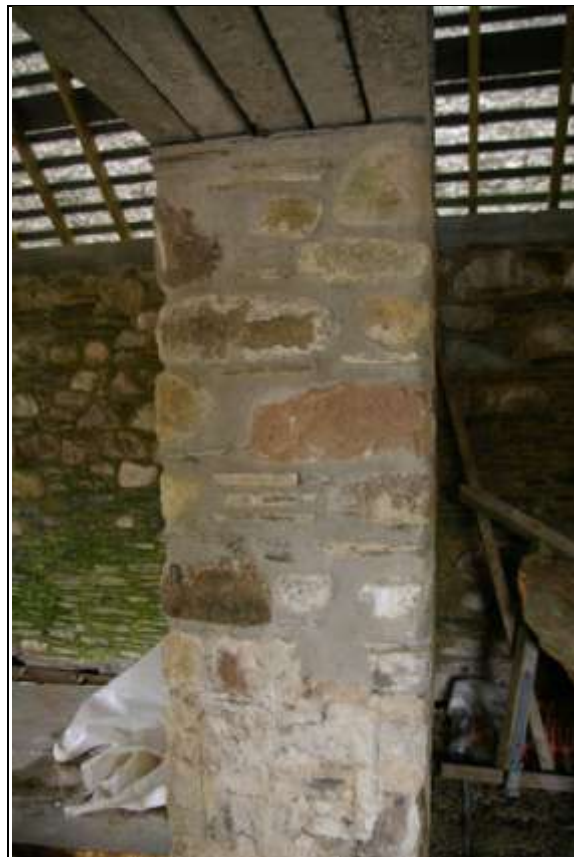
FIGURE 19: THE HEAVY PARTITION WALL IN BARN A, WITH CONCRETE LINTELS INSERTED; FROM THE EAST.

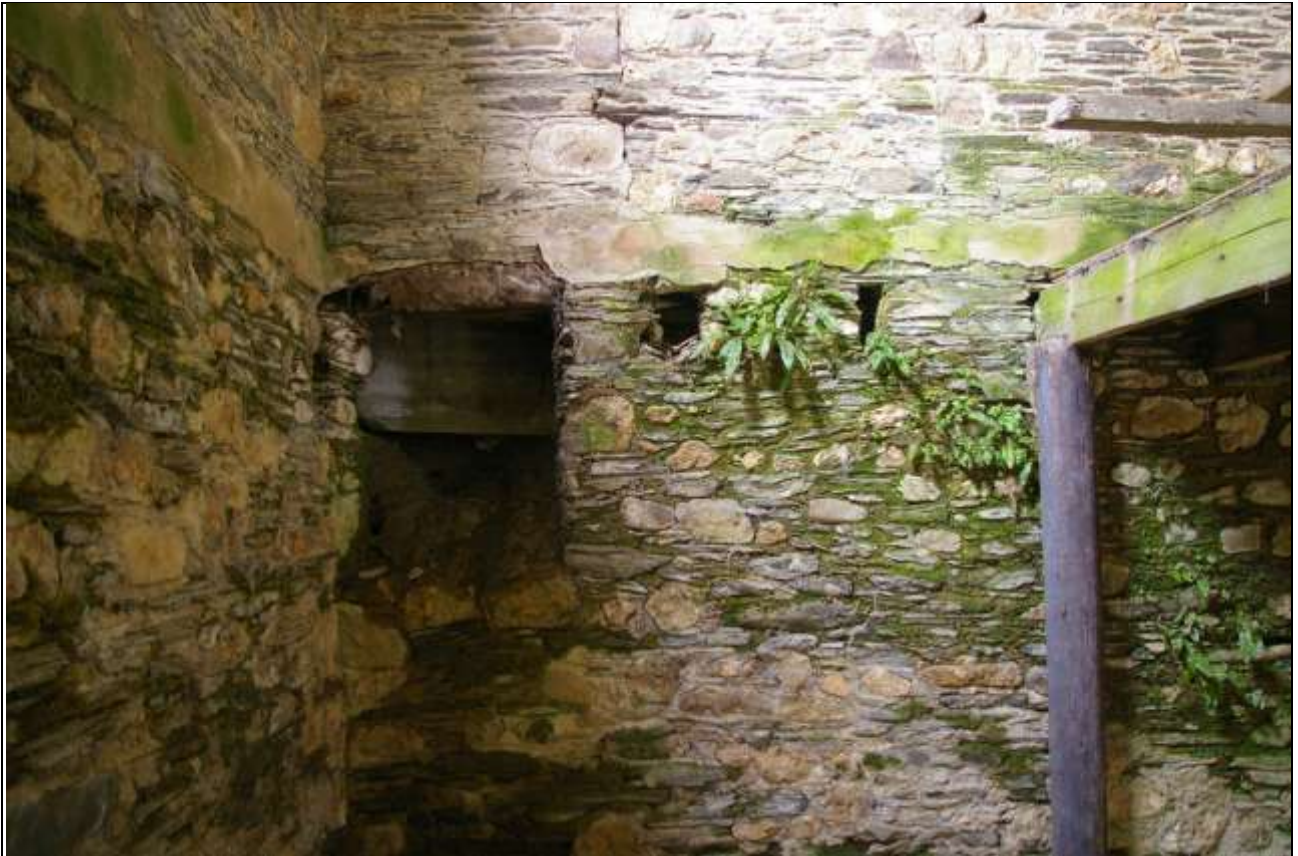
FIGURE 41: THE FORCED OPENING IN THE NORTH-WEST CORNER OF BARN B; FROM THE SOUTH.

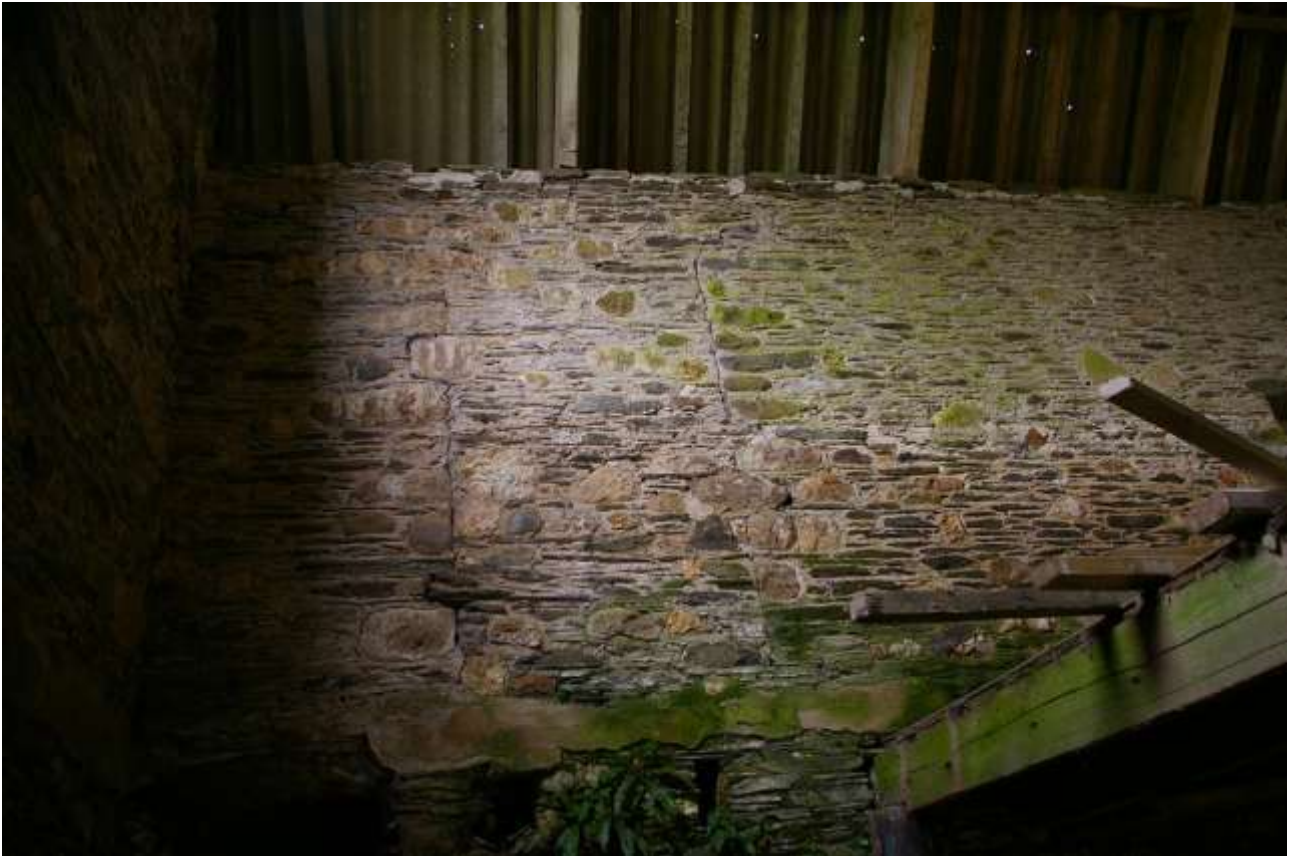
FIGURE 42: THE FIRST FLOOR BLOCKED DOORWAY IN THE NORTH WALL OF BARN B; FROM THE SOUTH.

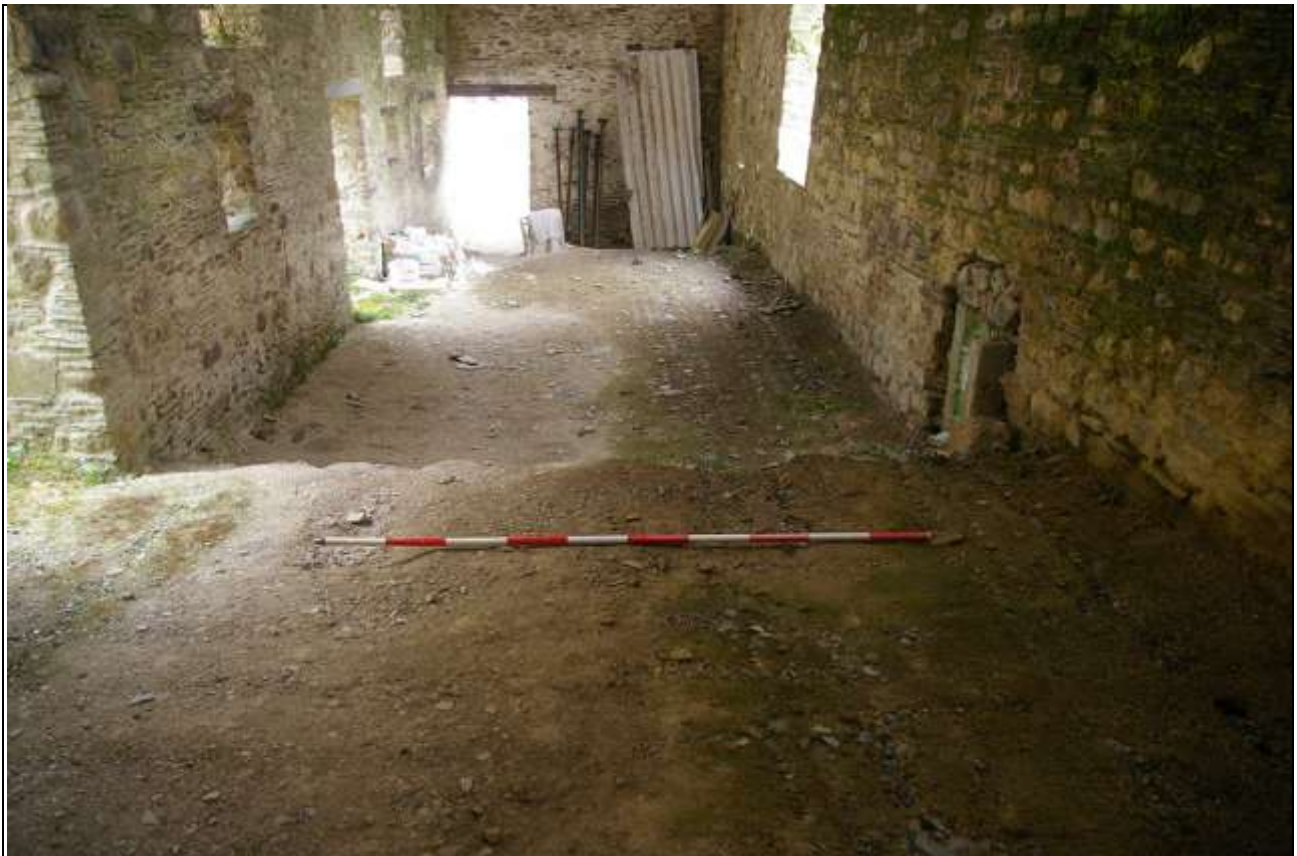
FIGURE 58: LEFT: VIEW FROM BARN A, DOWN THE SURVIVING SLOPING SECTION OF COBBLED YARD, ALONG THE NORTH WALL OF BARN C; FROM THE WEST. RIGHT: THE OPENING TO THE SOUTH COMPARTMENT, BARN A, THE FEED CHANNEL, WITH ALL FITTINGS REMOVED AND HISTORIC LINTEL REMOVED; FROM THE NORTH.

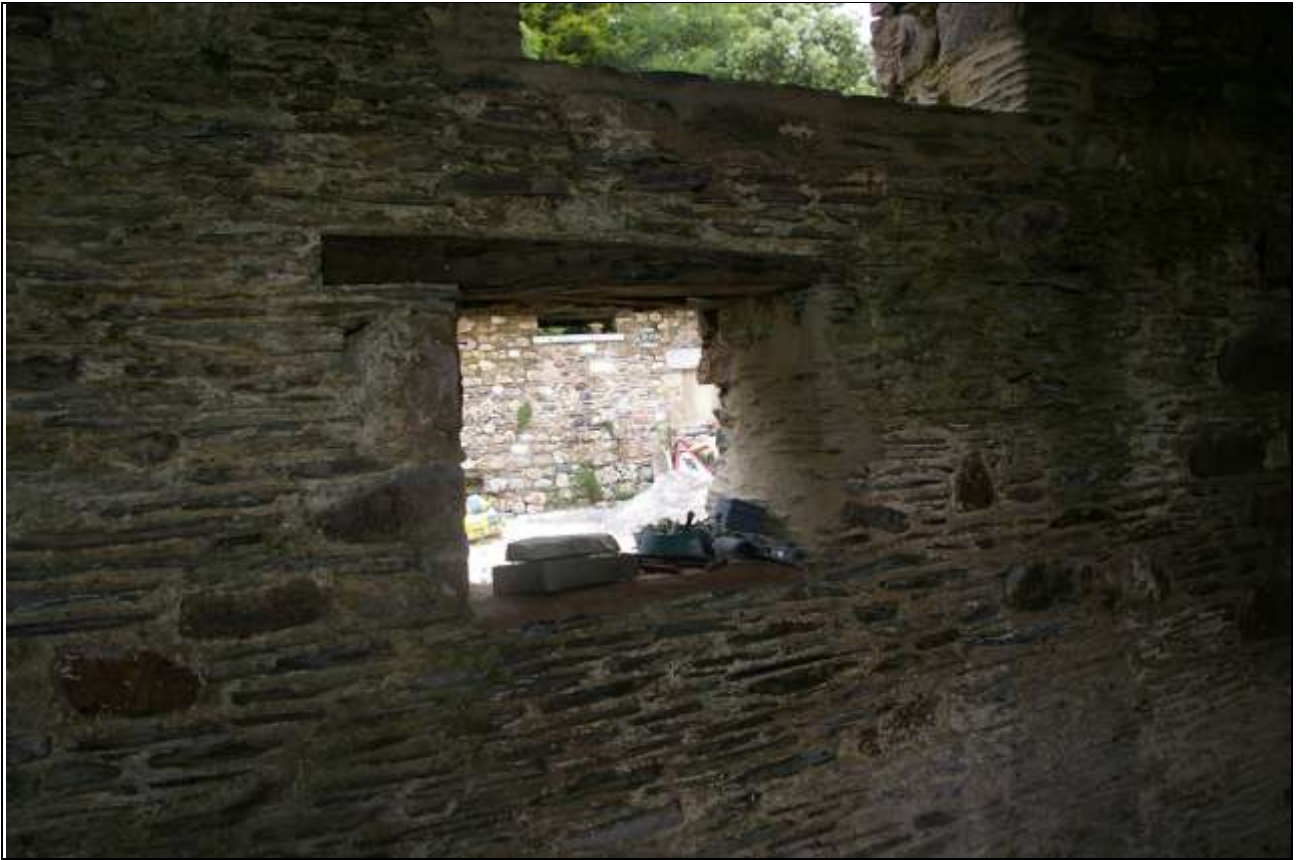
FIGURE 63: A FORCED OPENING IN THE SOUTH WALL OF BARN C, WESTERN END; FROM THE NORTH-NORTH-EAST.
