# SESSLAND FARM SOUTH TAWTON CREDITON DEVON

Desk-Based Assessment & Historic Building Recording

South West Archaeology Ltd. report no. 180104

04<sup>th</sup> January 2018

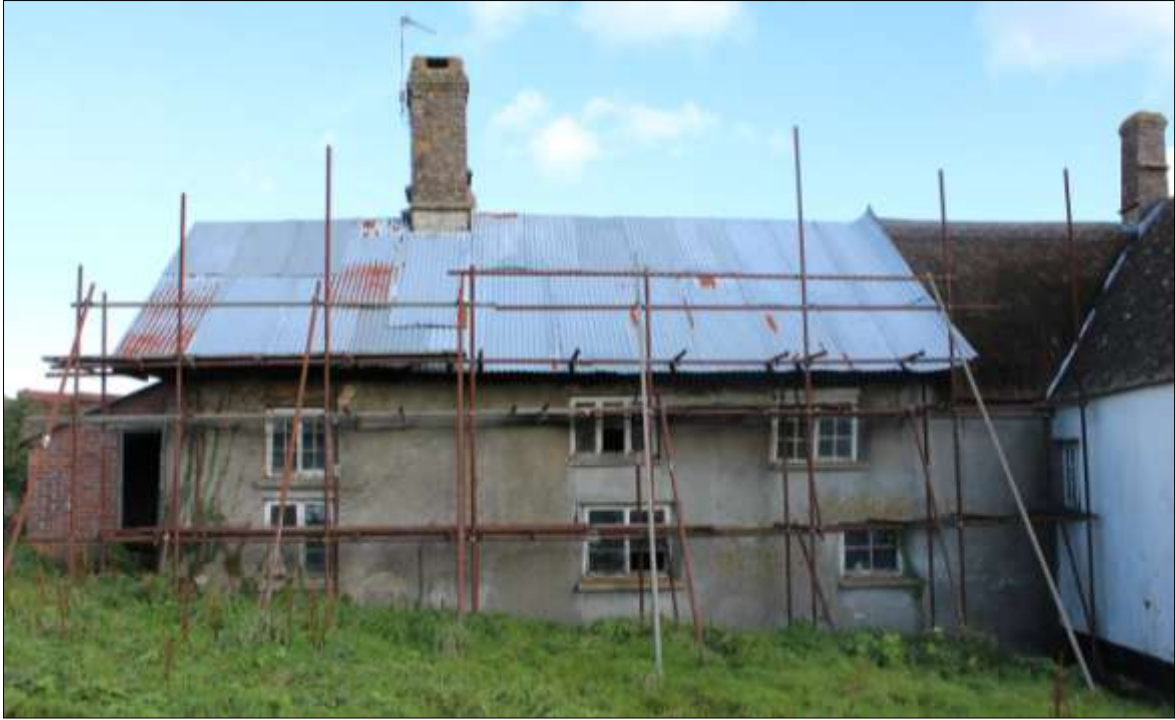
FIGURE 8: SOUTH ELEVATION, VIEWED FROM THE SOUTH.

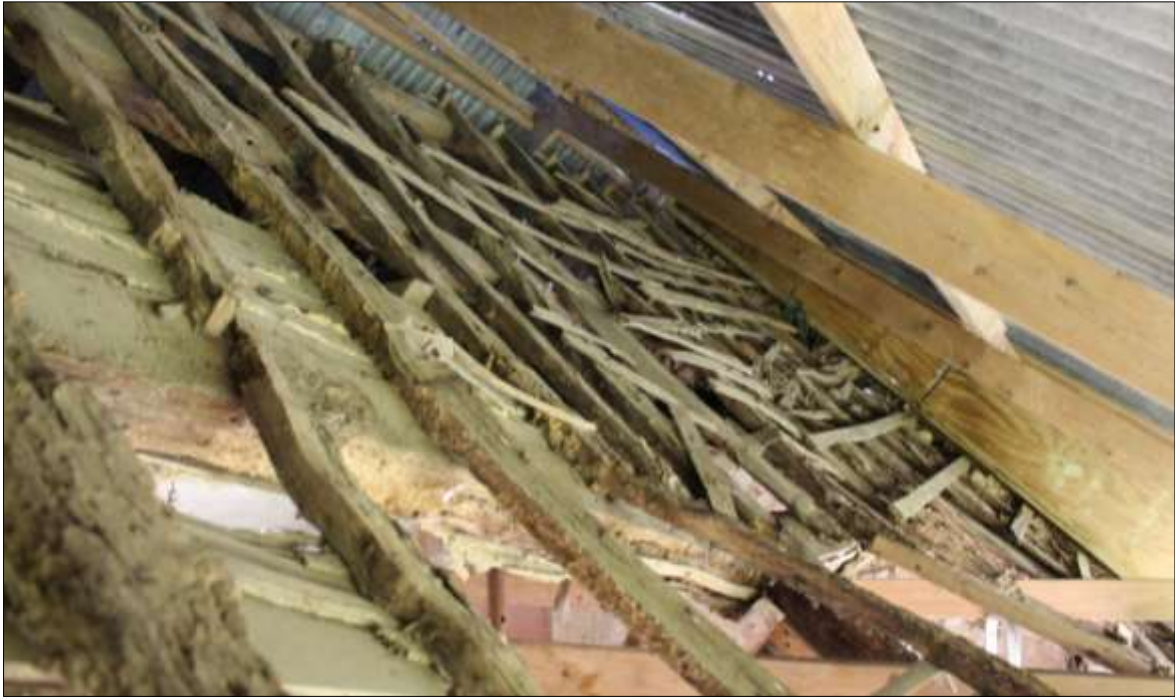
FIGURE 12: THE ROOF STRUCTURE ON THE SOUTH PITCH, VIEWED FROM THE WEST. NOTE THE PEGGED RAFTERS AND BATTENS.

The building is currently protected by scaffolding and a corrugated sheet roof. The historic roof covering was thatch, but it was not maintained and water was allowed to enter the structure. The thatch has now largely been removed, but remnants survive within and between the structural timbers. The ingress on water also caused the timber roof structure to fail, causing it to drop and push the walls out. The exposed roofline scar on the chimney stack indicates the pitch was originally steeper. The roof structure consists of one full truss (T1), set centrally over the main room, with a single truss blade (T2) to the south side of the chimney stack. There are no trusses west of the stack, merely heavy-set purlins, and the purlins rest directly on the east gable wall. The single complete roof truss has been considerably altered and is reset in this position, having been jacked up on crude uprights set in the walls. It has wide, heavy, typically 17<sup>th</sup> century blades with through sockets for purlins. The three surviving truss blades are all of a similar style and form and appear contiguous with the two pairs of heavy scantling on-side butt purlins to each pitch. The quality of these timbers, their form and scantling weight would typically be associated with a much finer roof. In style and date they appear to be contemporary with the stone stack (c.1600). The roof on both sides of the stack features a heavy, roughly-shaped overlapping diamond ridgepole, with wide and irregular split rafters that are pegged above the ridge. The battens are also split laths and pegged to the purlins. The crude and rustic/agricultural character for the rafters is at odds with the surviving truss blades.

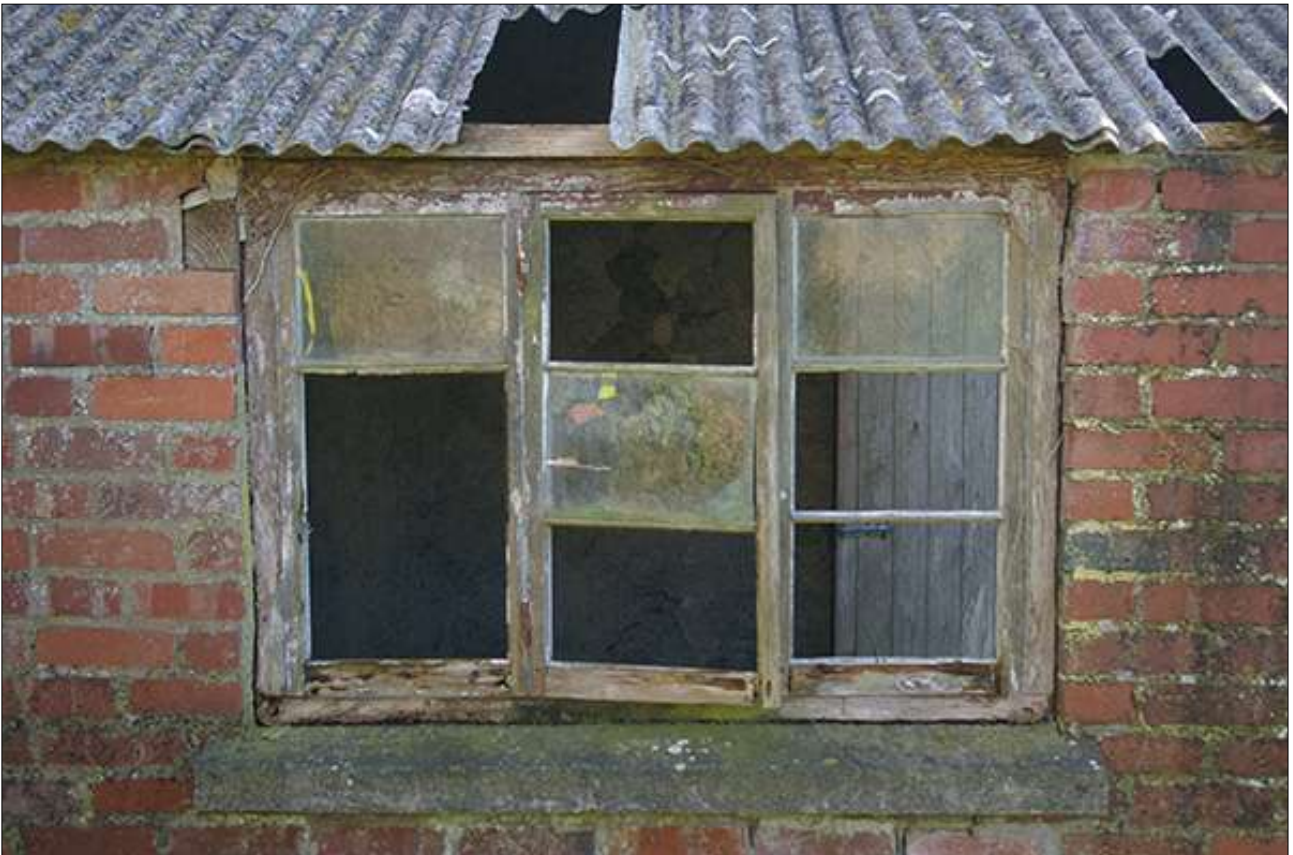
REUSED 19<sup>TH</sup> CENTURY CASEMENT WINDOW IN R6; VIEWED FROM THE NORTH-WEST.

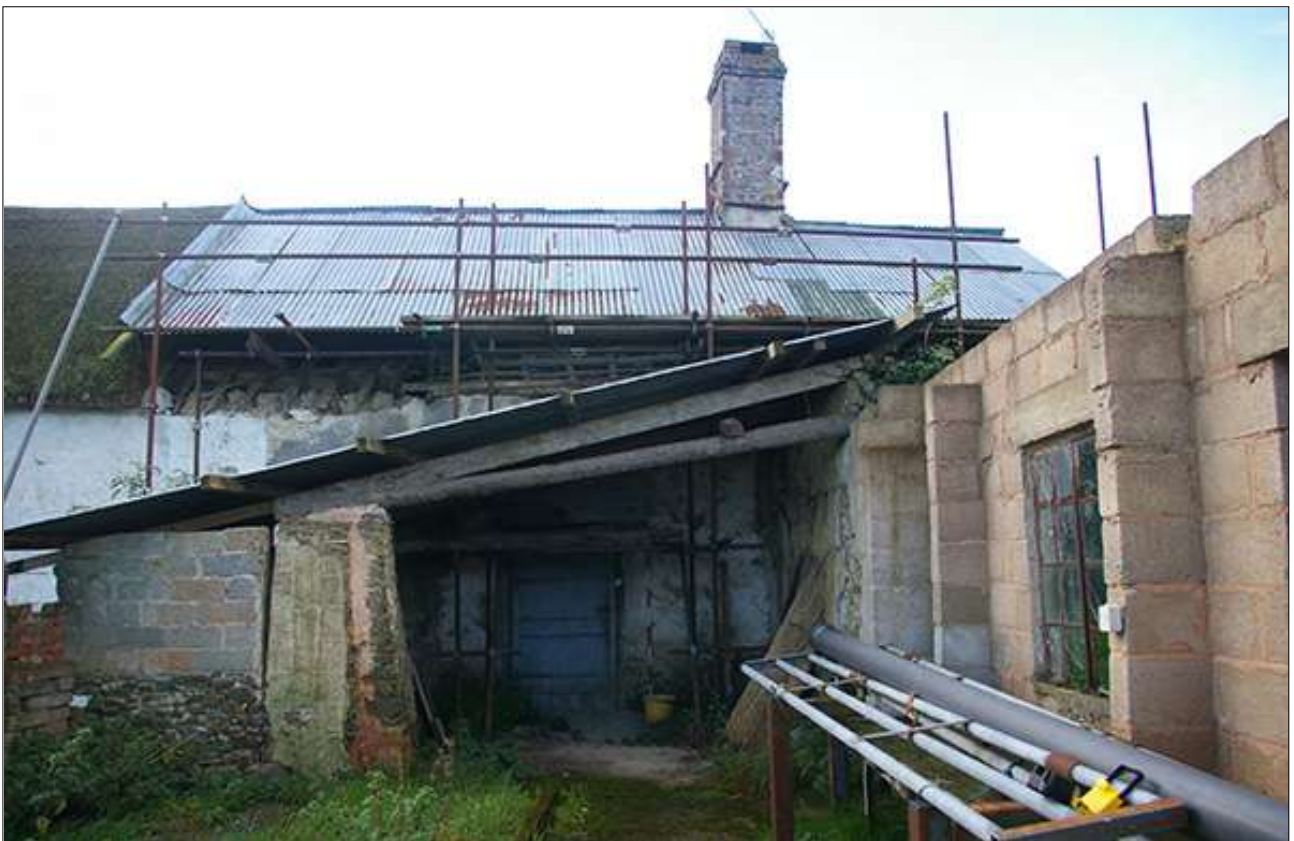
THE NORTH-EAST ELEVATION, EASTERN END, WHERE IT ABUTS THE LOST LINHAY. VIEWED FROM THE NORTH-EAST (SCALE 2M).

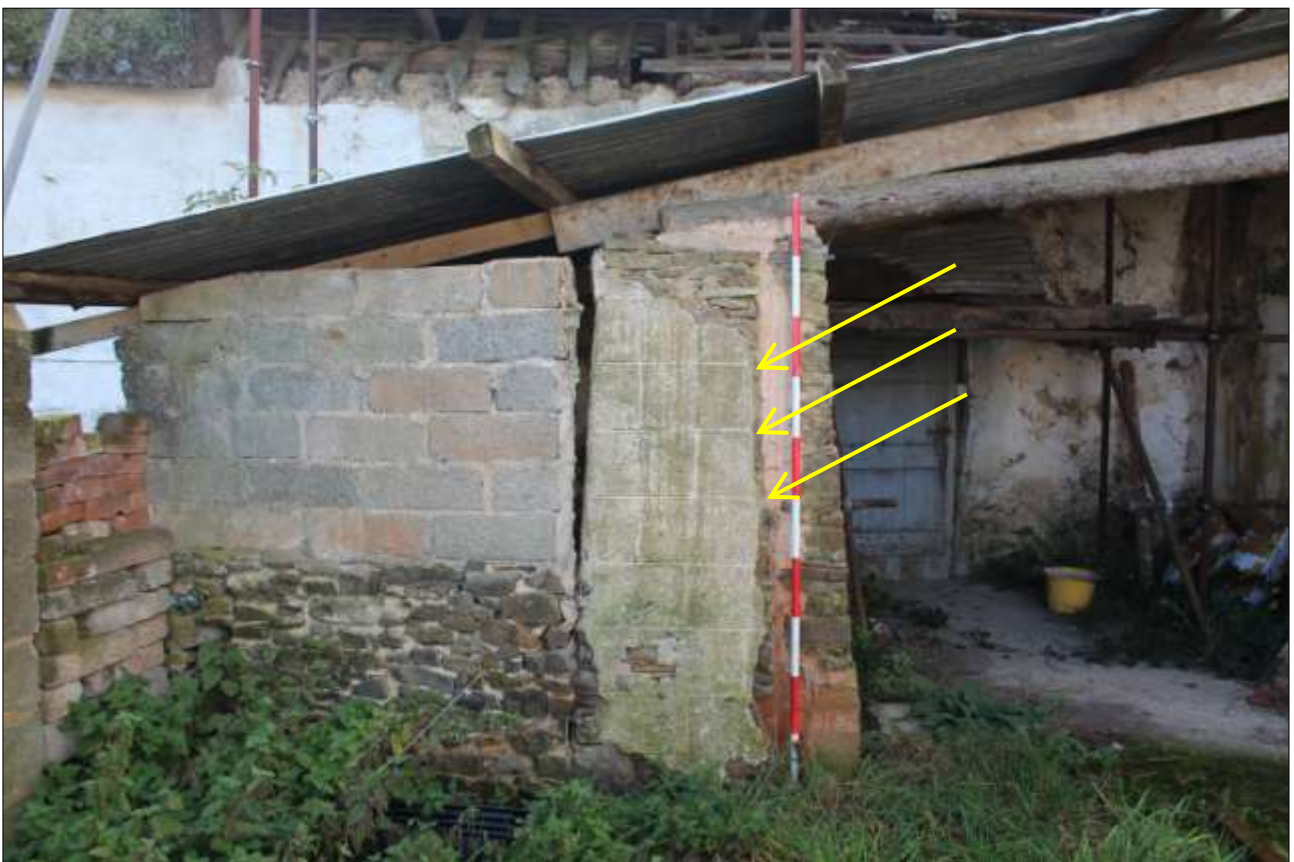
Openings – Doors:	1	Door to R1, described with that room.
Significant Details:		The pier and its ashlar detailing are significant elements of the former Linhay.

PART OF THE WALL OF THE FORMER LINHAY; VIEWED FROM THE NORTH-EAST (SCALE 2M). NOTE THE ASHLAR DETAILING ON THE PIER (INDICATED)

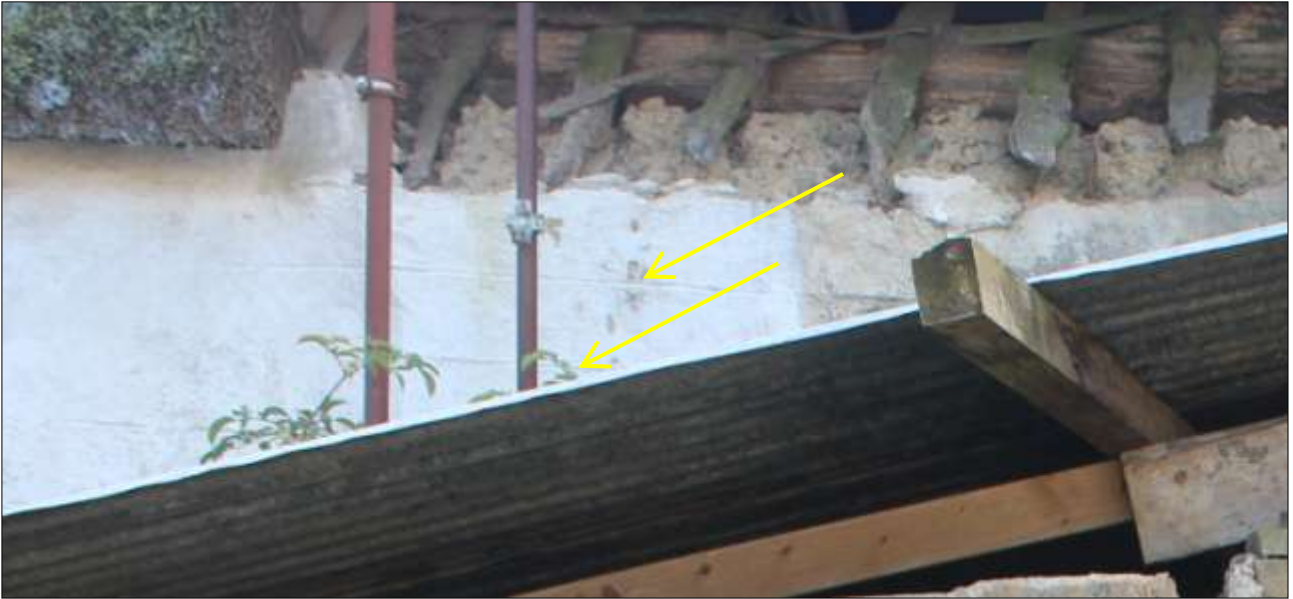
ASHLAR DETAILING ON THE NORTH-EAST WALL (INDICATED).

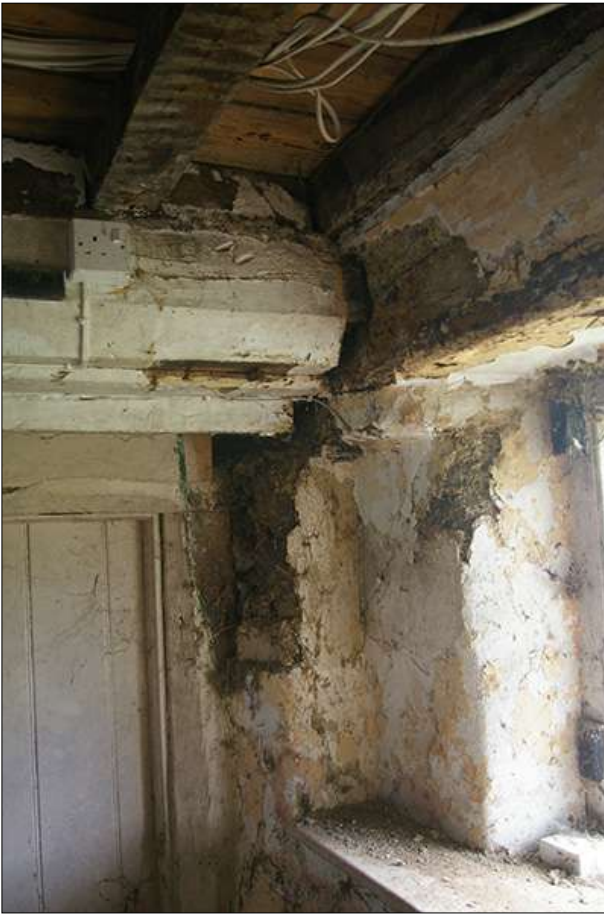
SOUTH ANGLE OF R1, SHOWING THE BEAM SOCKETED INTO THE WINDOW LINTEL; VIEWED FROM THE WEST.

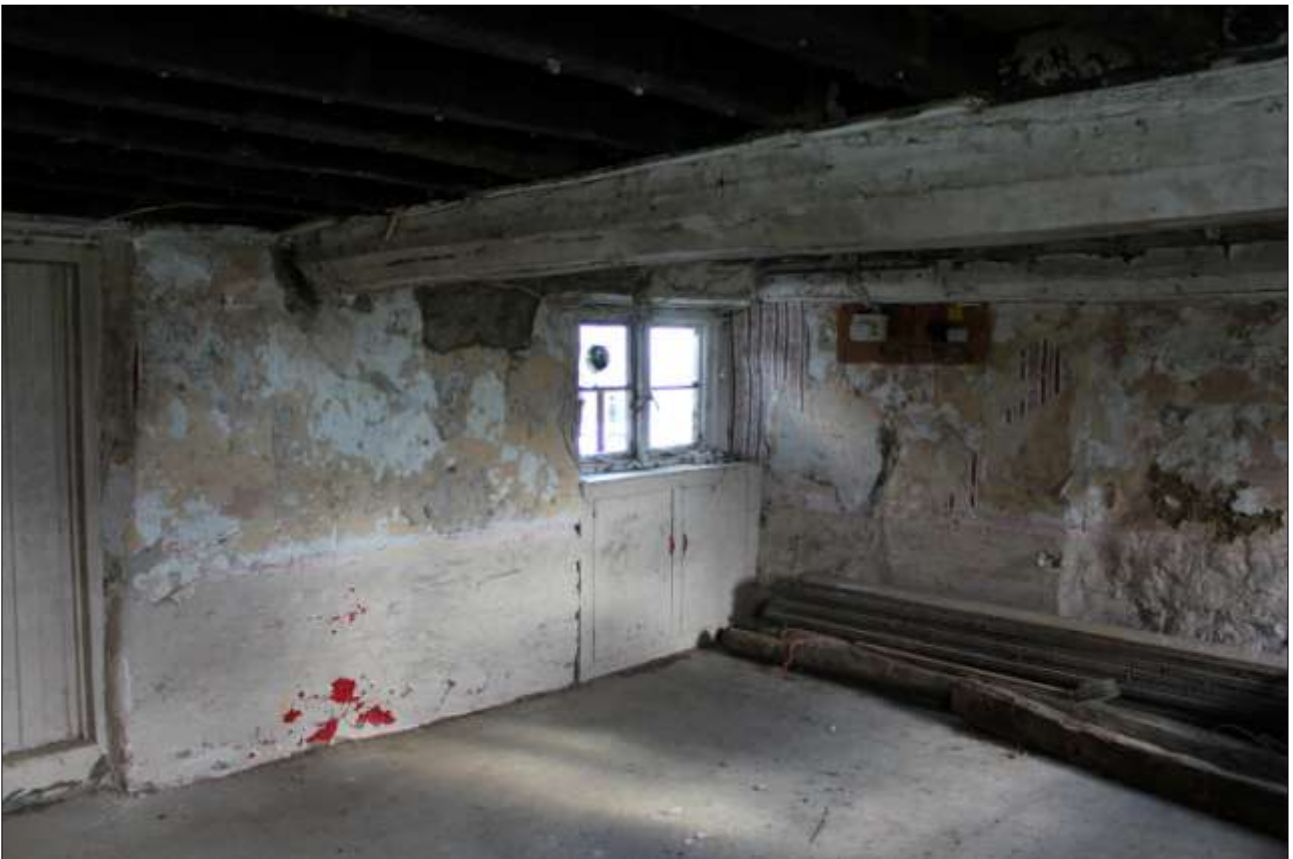
R1, NORTH-EAST WALL; VIEWED FROM THE WEST.

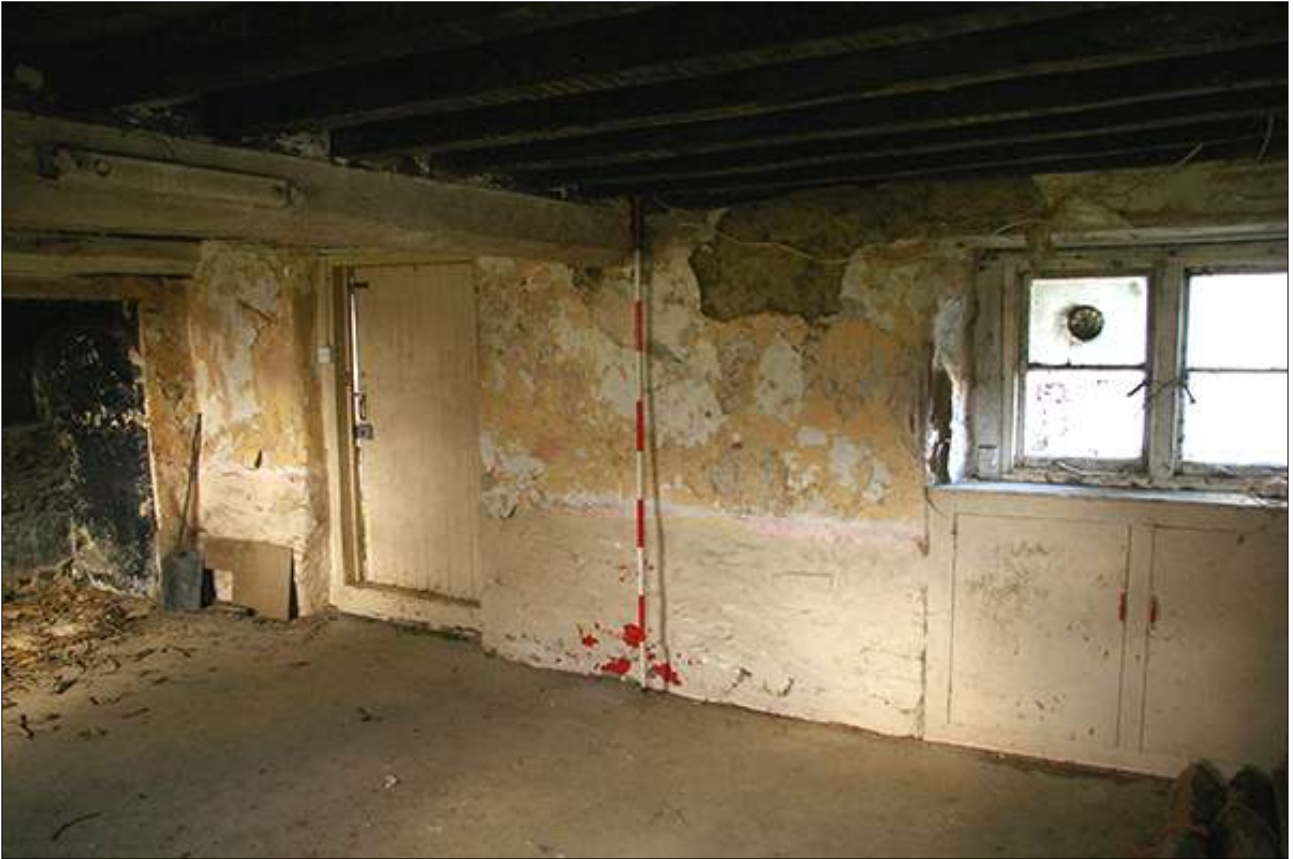
R1, NORTH-EAST WALL; VIEWED FROM THE SOUTH (SCALE 2M).

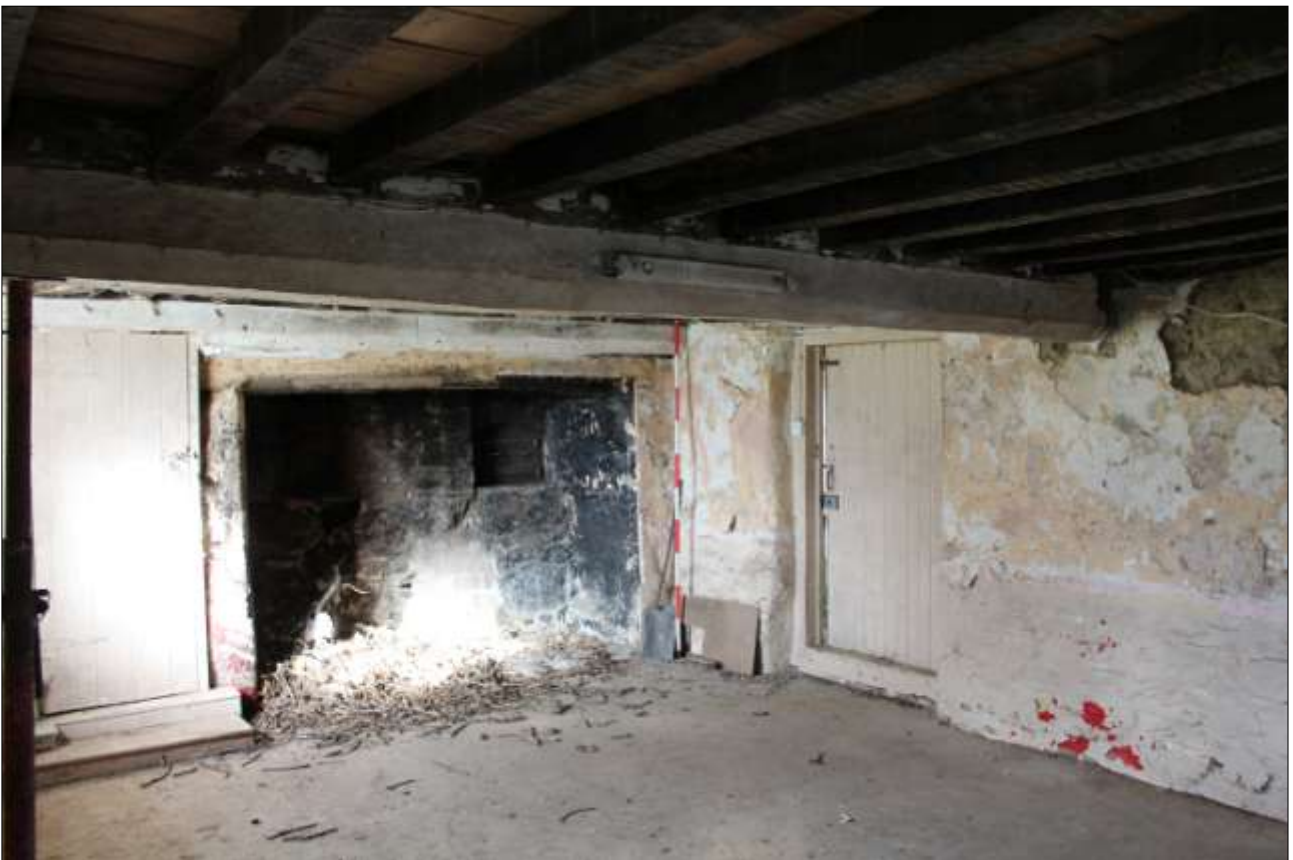
R1, NORTH-EAST AND NORTH-WEST WALLS; VIEWED FROM THE SOUTH-EAST (SCALE 2M).

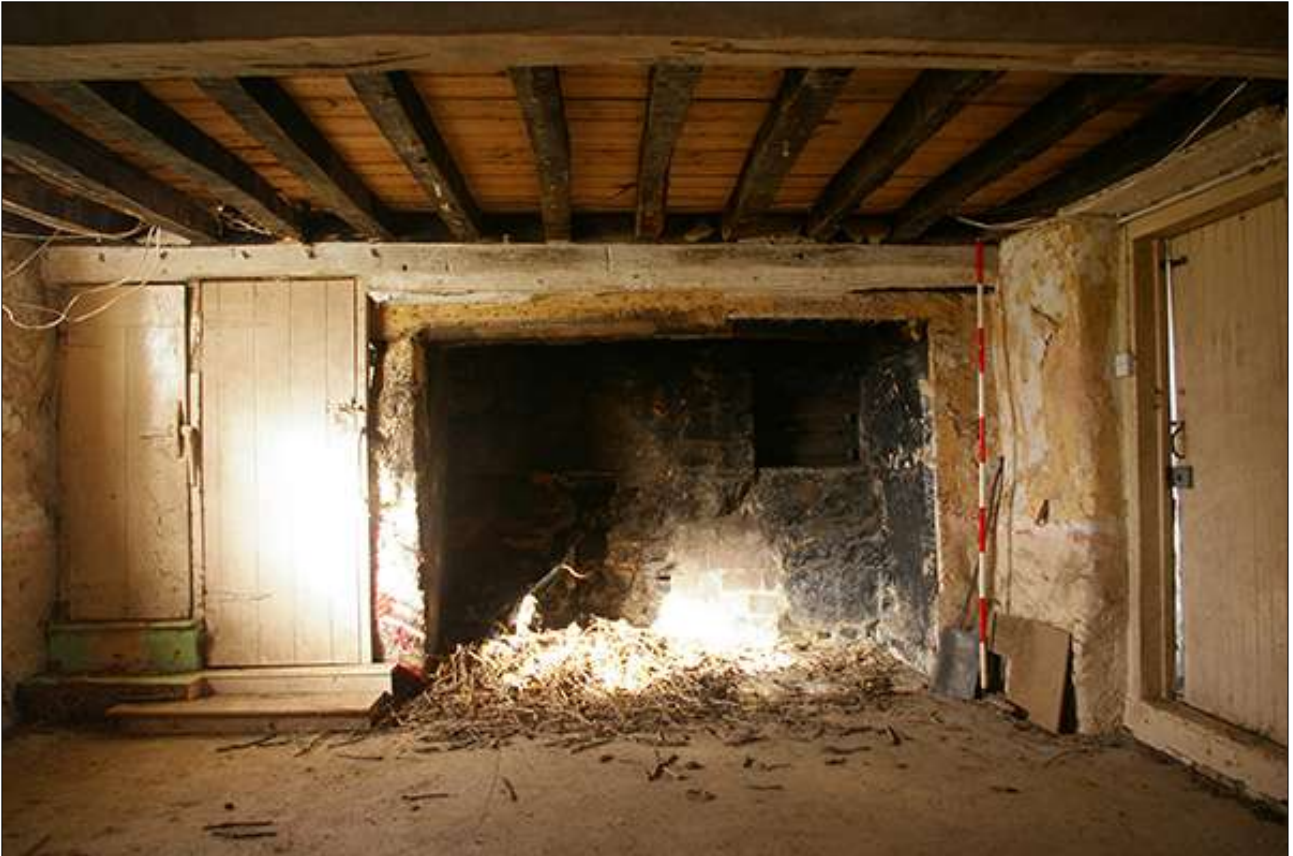
Significant Details:		Large open hearth to the north-west wall, with heavy chamfered timber bressumer beam, with cut stop to west side. Hacked for plaster in later times, this would have been exposed. Sockets cut for upright sets. The ceiling beam is cut around this bressumer beam. Massive granite orthostat upright, cut with narrow chamfers. Stone rubble to the rear, patched with looser rubble, cob and brickwork, when a range has been recently removed. Possible blocked oven or smoking bay etc to west side (where passage to R2 forced through), very disturbed. Contemporary opening for bake oven to rear of hearth on the northern side, with tall tapering arched opening, now infilled with stone with a low brick arch to a 19 <sup>th</sup> century bread oven with iron frame and door. The rest of the oven was removed and the

R1, NORTH-WEST WALL; VIEWED FROM THE SOUTH-EAST (SCALE 2M). THE WIDE HEARTH IS IMMEDIATELY APPARENT, WITH DOORS THROUGH TO R2 AND R3 TO THE LEFT.

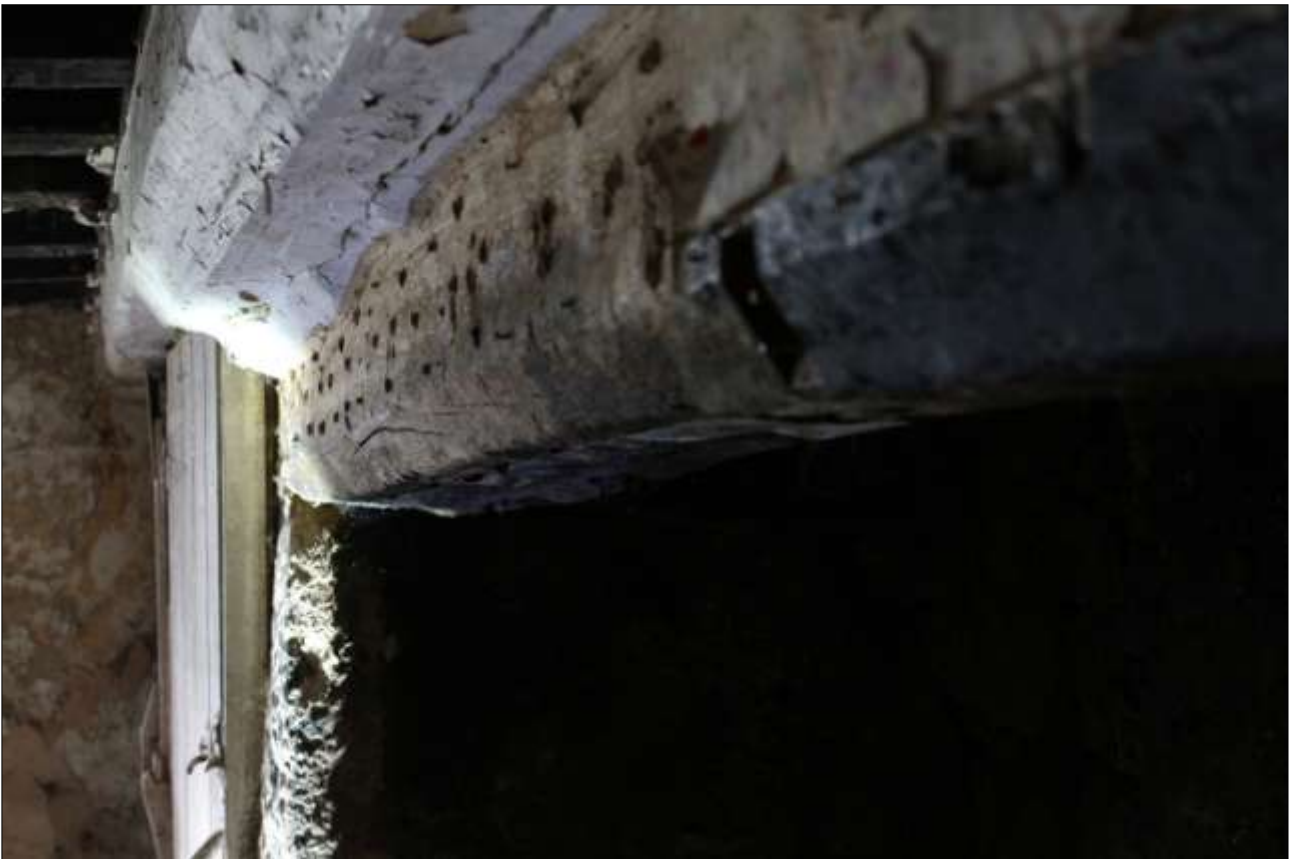
R1, DETAIL OF THE CHAMFER ON THE LINTEL AND GRANITE ORTHOSTAT; VIEWED FROM THE NORTH-EAST.

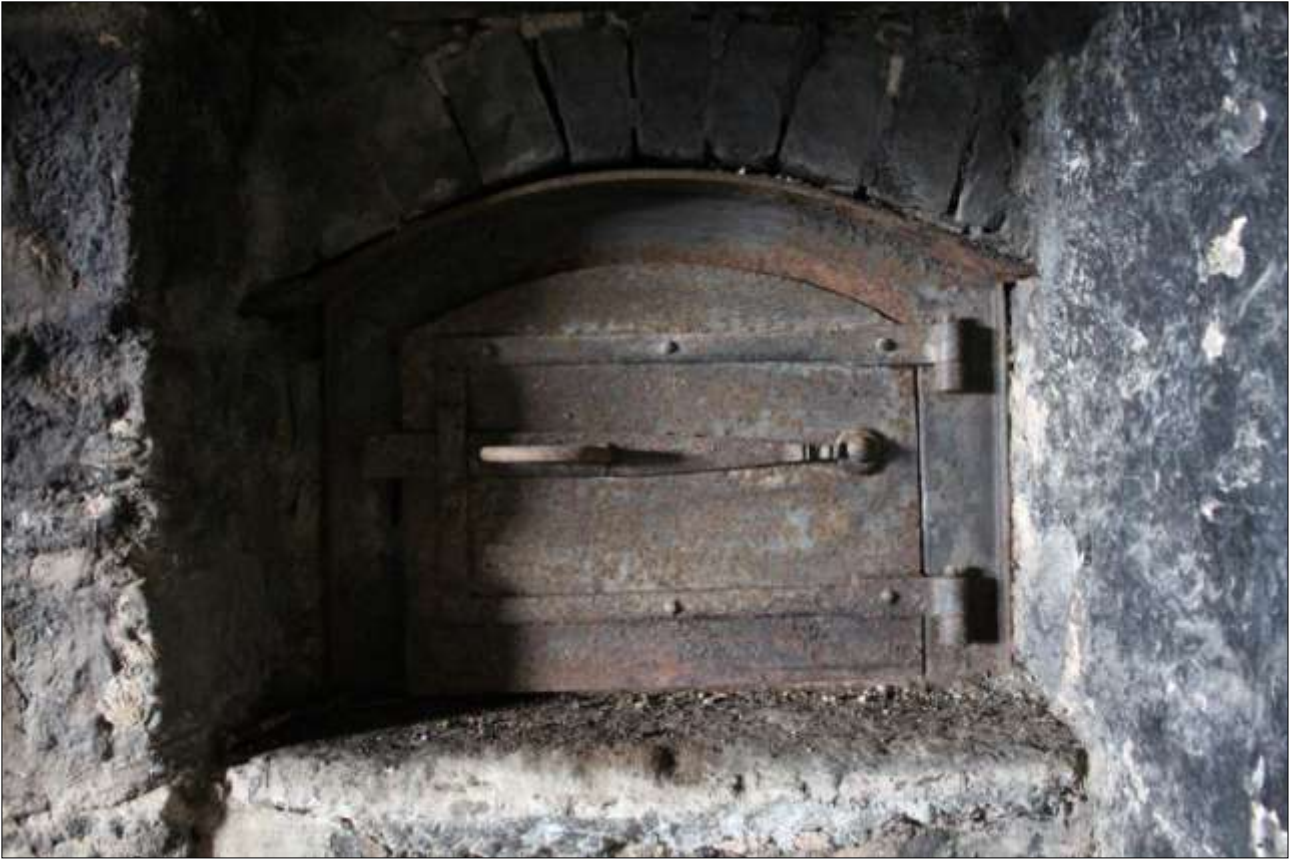
R1, THE 19<sup>TH</sup> CENTURY CAST IRON DOOR TO THE FORMER BREAD OVEN; VIEWED FROM THE SOUTH-EAST.

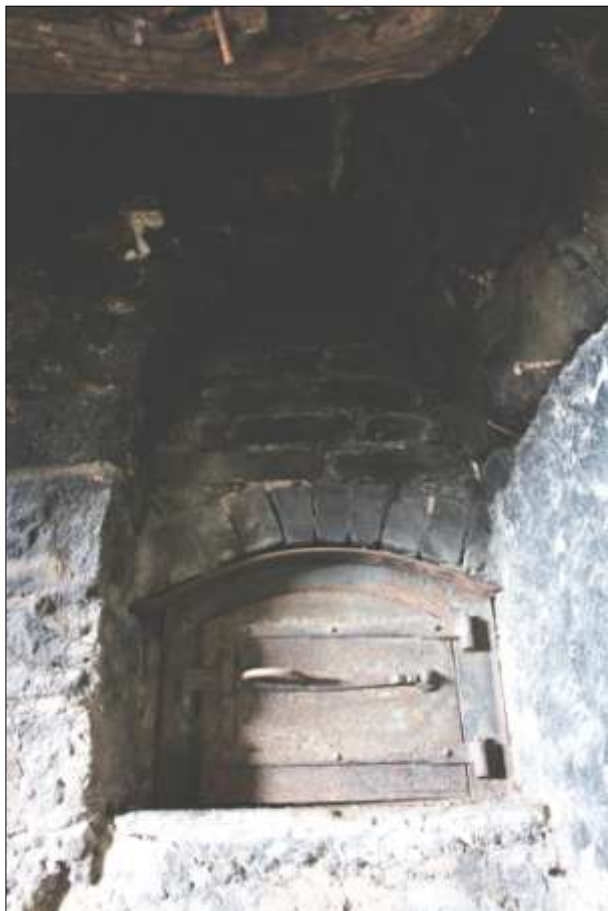
opening blocked when the toilet was inserted in R2. The stack is open and rises, tapering to the square dressed stone shaft. Two small square sockets above head height to north and south for axial beam. Stone slab hearth, damaged and cracked. There is a blocked doorway in the north side of the south-east wall. All joists are hacked and marked with nail rust, where a lath-and-plaster ceiling has been removed.
Fittings:		Some iron hooks on the beams and to the fireplace there is a cut section and iron fittings, possibly for a spit or similar.
<b>Room 2a (R2)</b>		
Function:		Small addition, store room, converted to kitchen in the early 20 <sup>th</sup> century.
Walls:		Cob walls on a stone plinth, lime plastered walls over cob plaster. Painted various colours and partly tiled to ½ height to the north end, in small square 20 <sup>th</sup> century ceramic kitchen wall tiles. Wall to R2b is a 20 <sup>th</sup> century partition of lath-and-plaster. Some narrow low skirting boards survive in places.

R1, THE C.1600 ARCHED OPENING TO THE FORMER BAKE OVEN; VIEWED FROM THE SOUTH-EAST.

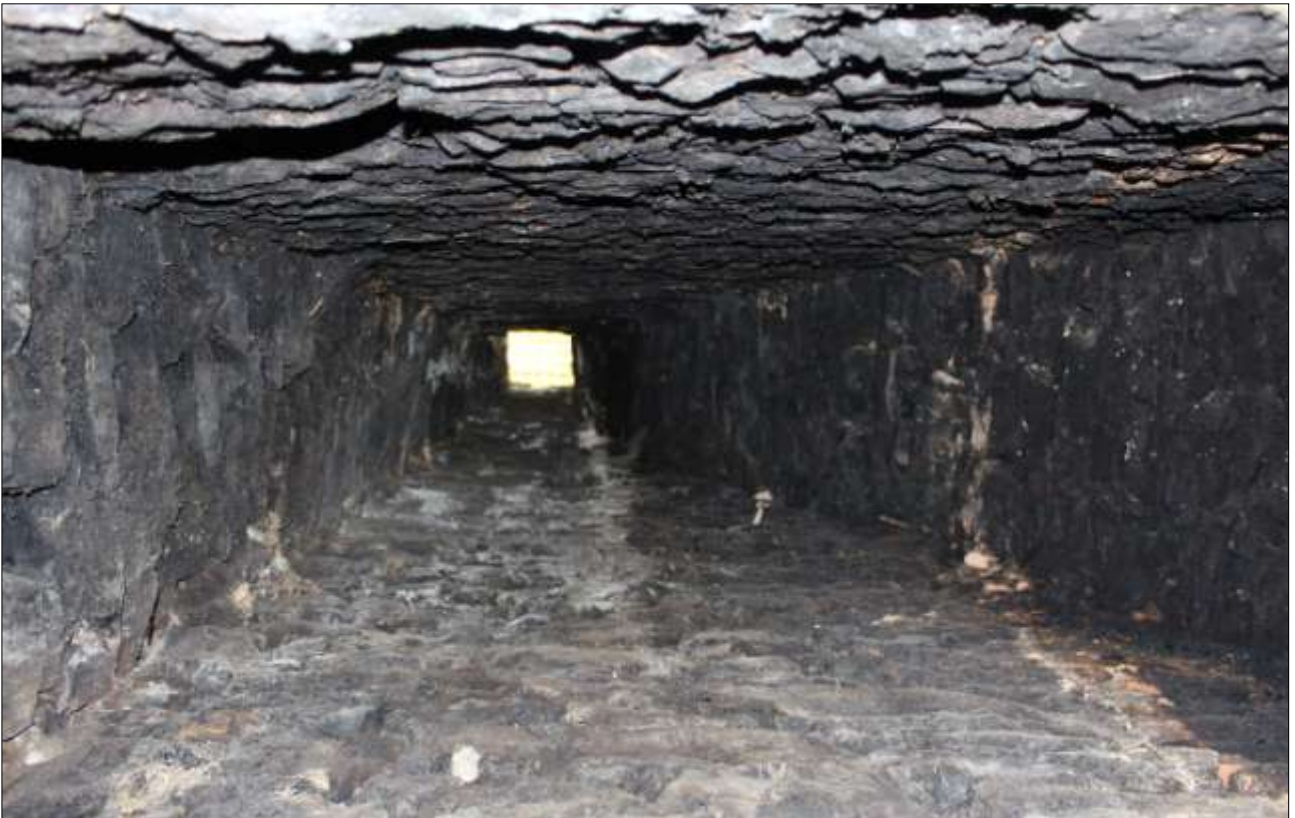
R1, VIEW UP THE CHIMNEY.

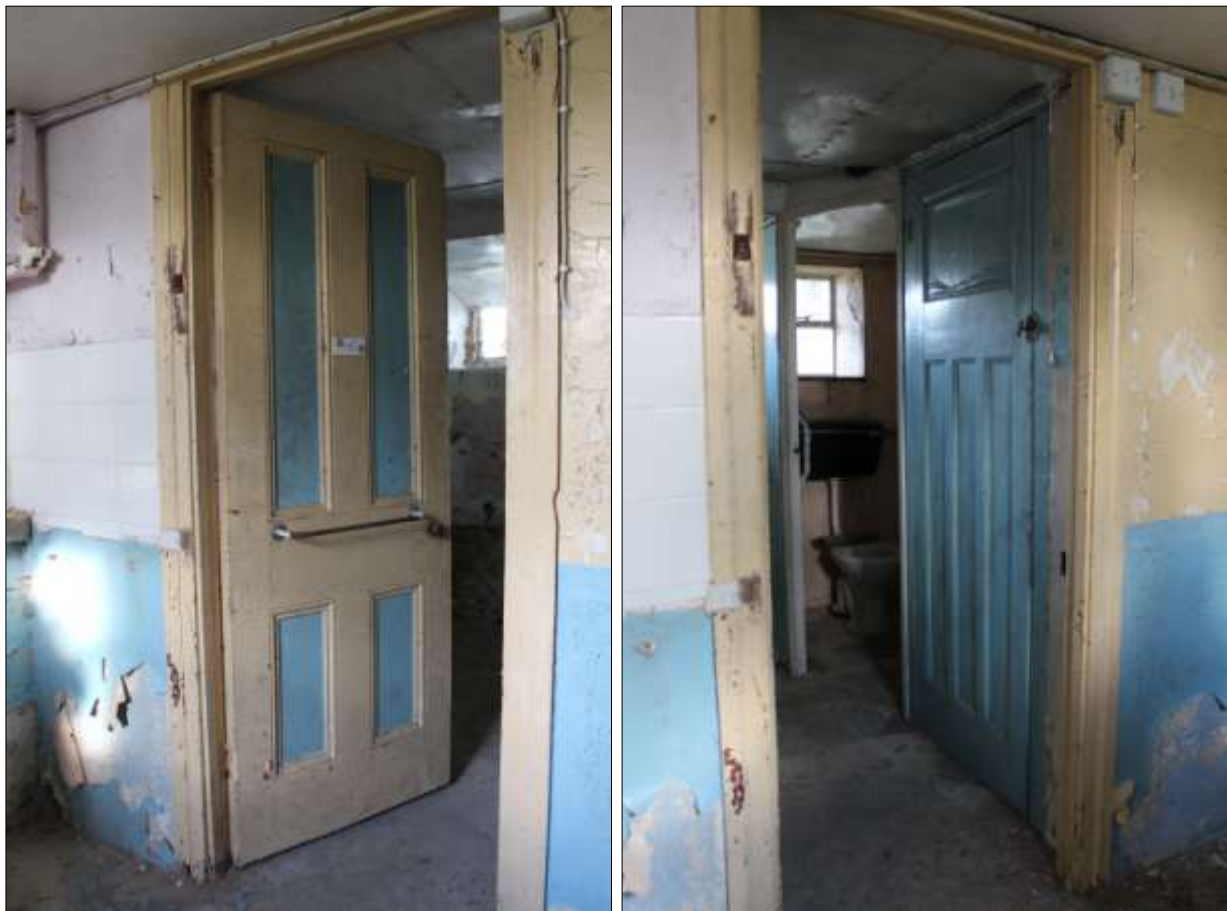
R2, THE INTERNAL PARTITIONS AND DOORS; VIEWED FROM THE SOUTH.

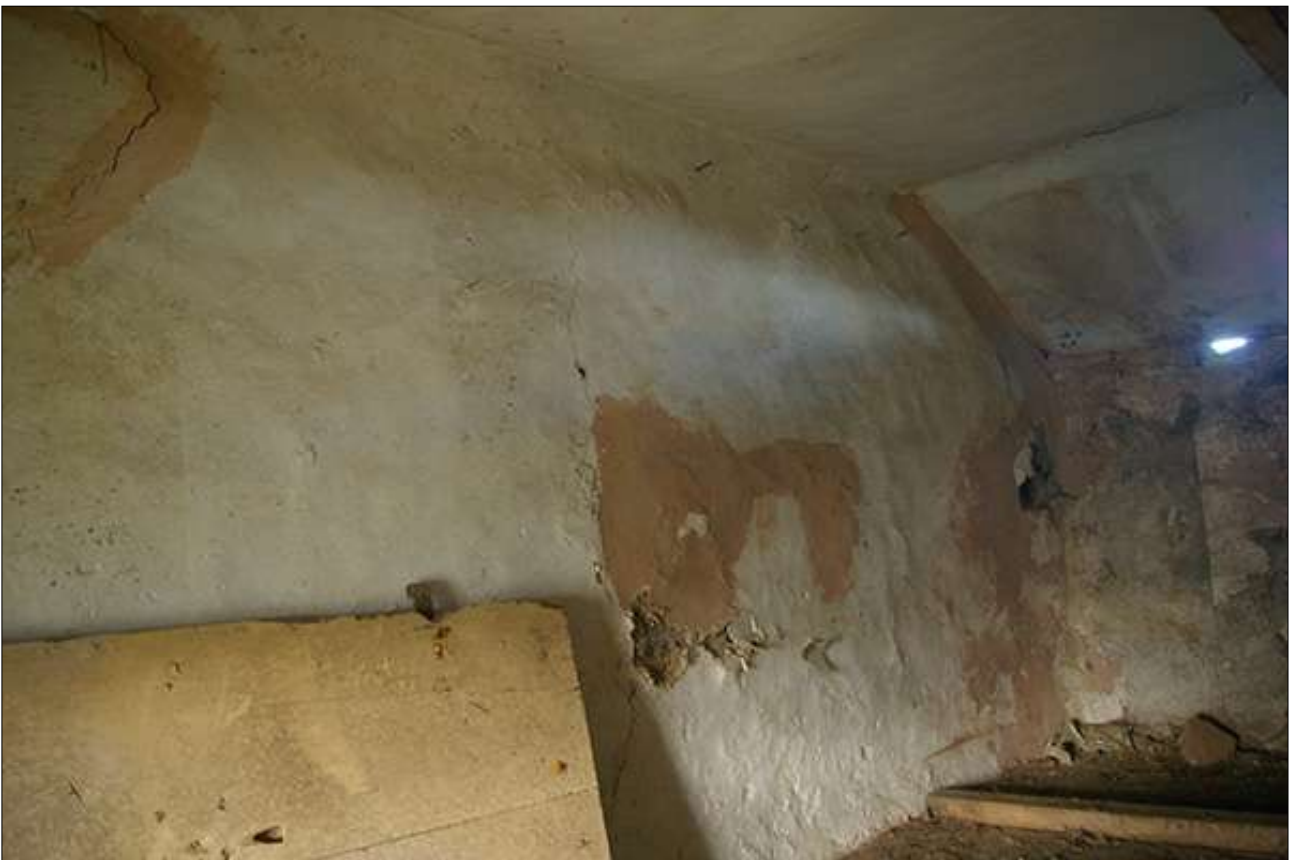
R5, THE NORTH-WEST GABLE; VIEWED FROM THE SOUTH.

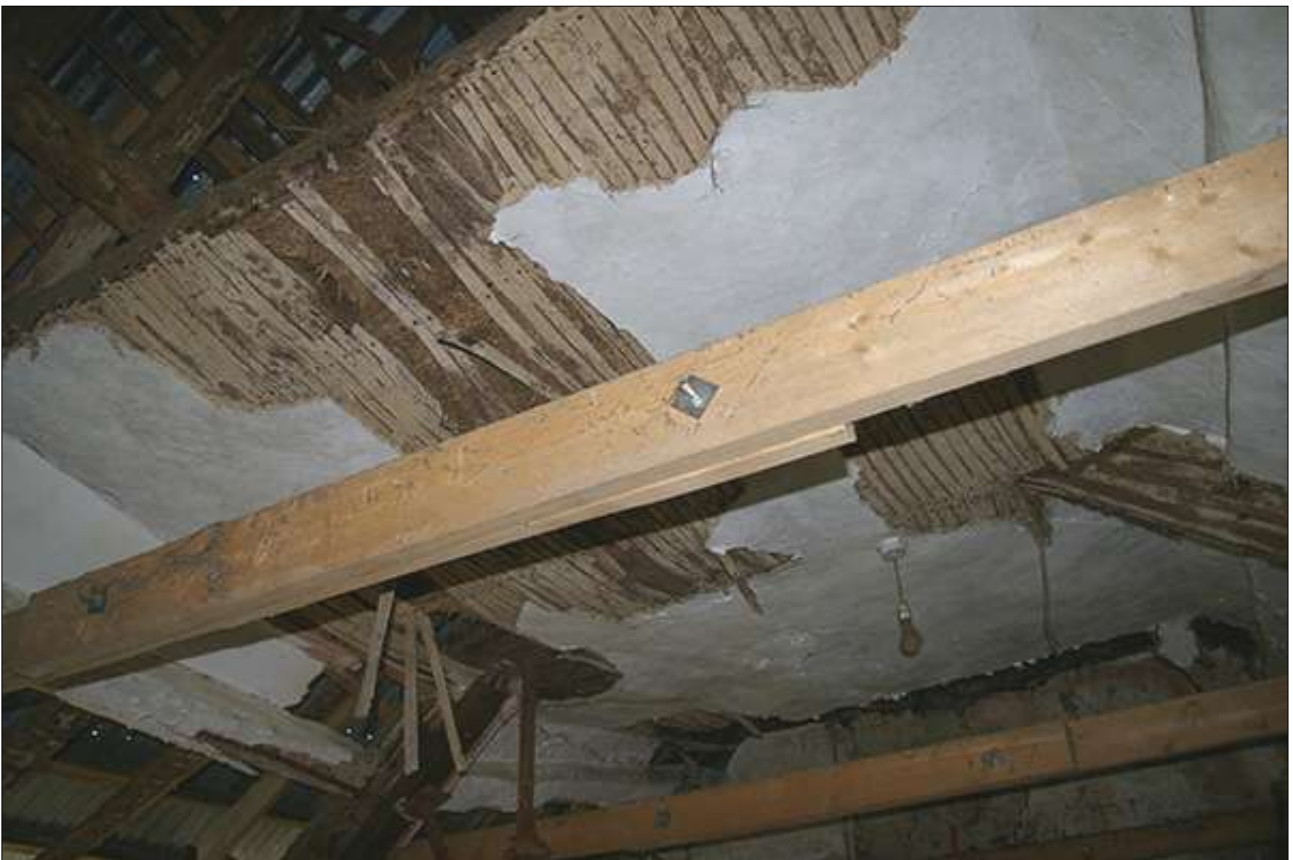
Floor:		Relatively-modern boarded floor where water ingress had damaged the floorboards.
Ceiling:		Lath-and-plaster ceiling encloses sloping eaves and boxes out the ridge, as well as covering the heavy purlins. This is carried on lightweight joists between the main trusses.
Roof Structure:		One complete truss of heavy plain truss blades and reset collar. Evidence for two sets of earlier lower lap-jointed and knotted collars with pegged joints. Current collar is bolted, and dates the lath-and-plaster ceiling. The roof has been raised, the truss blades having been jacked up on crude heavy posts sat in the walls. Two sets per pitch of very heavy purlins, on side set, recut into truss blades, butt purlins, other sockets visible. One truss blade survives to the west side of the stack, bracing the purlins of the roof. Split wide battens of very agricultural character carried historic thatch (now missing), pegged to the thin rafters, which in turn are pegged to the purlins. This is a later 16 <sup>th</sup> or early 17 <sup>th</sup> century roof structure, jacked up to provide more headroom when the open space was ceiled, during a heavy remodelling of this building. Later altered in the 18 <sup>th</sup> and 19 <sup>th</sup> century, when the roof structure was ceiled in.

R4, VIEW OF THE INSERTED LATH-AND -PLASTER CEILING; VIEWED FROM THE EAST.

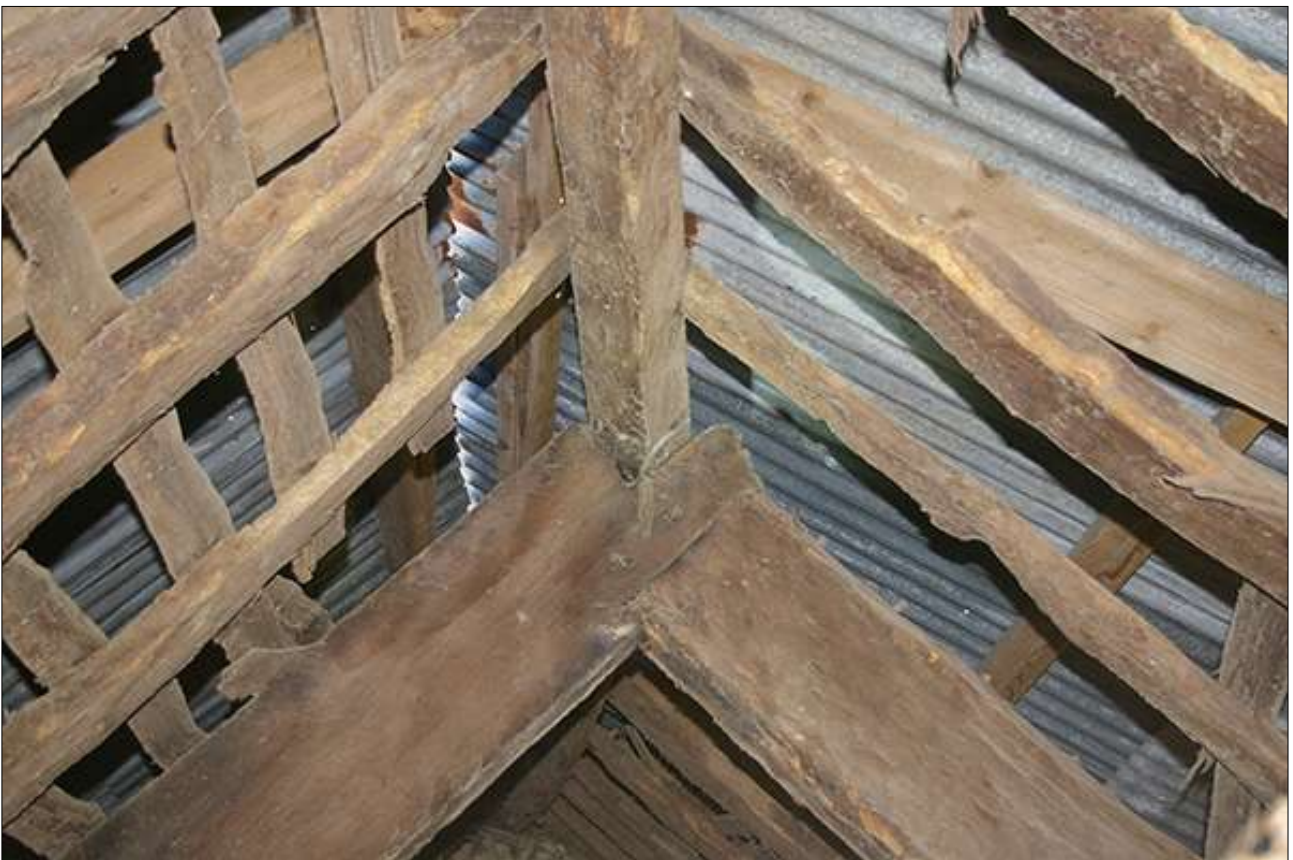
R4, THE RIDGEPOLE AND PEGGED RAFTERS; VIEWED FROM BELOW AND TO THE EAST.

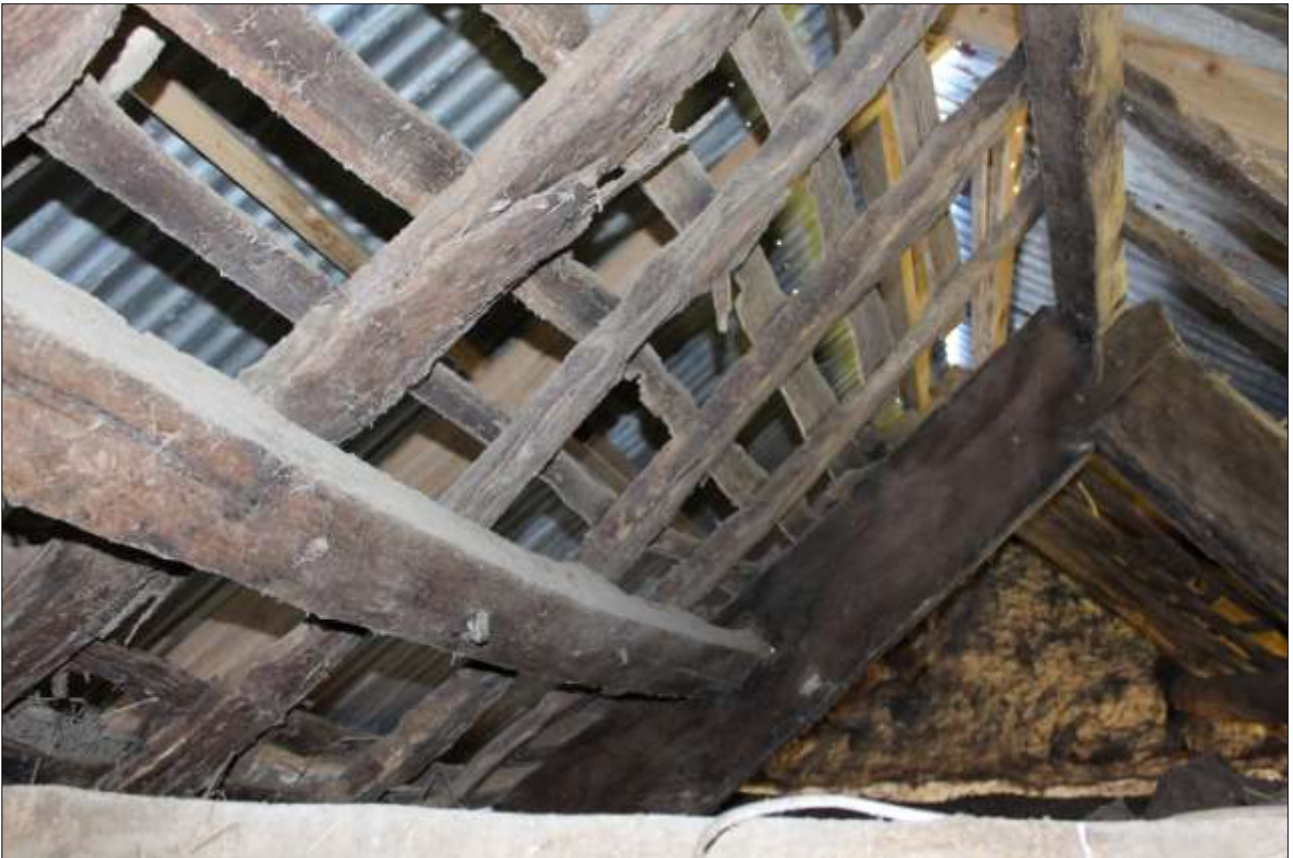
R4, DETAIL OF THE APEX OF TRUSS #1; VIEWED FROM THE NORTH-WEST.

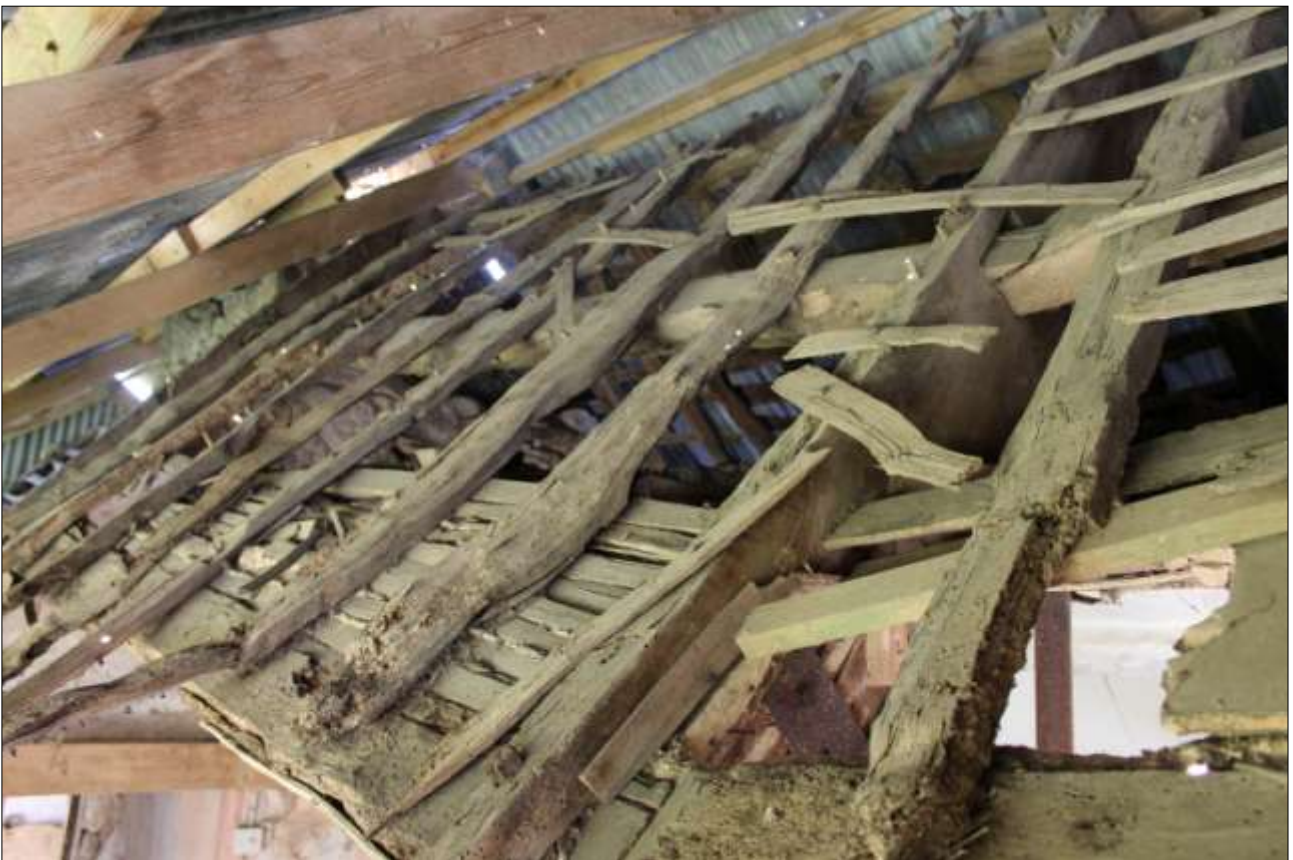
R4, DETAIL OF THE PEGGED PURLIN ON THE UPPER NORTH-EAST PITCH; VIEWED FROM THE NORTH-WEST.
