# SESSLAND FARM SOUTH TAWTON CREDITON DEVON

Desk-Based Assessment & Historic Building Recording

South West Archaeology Ltd. report no. 180104

04<sup>th</sup> January 2018

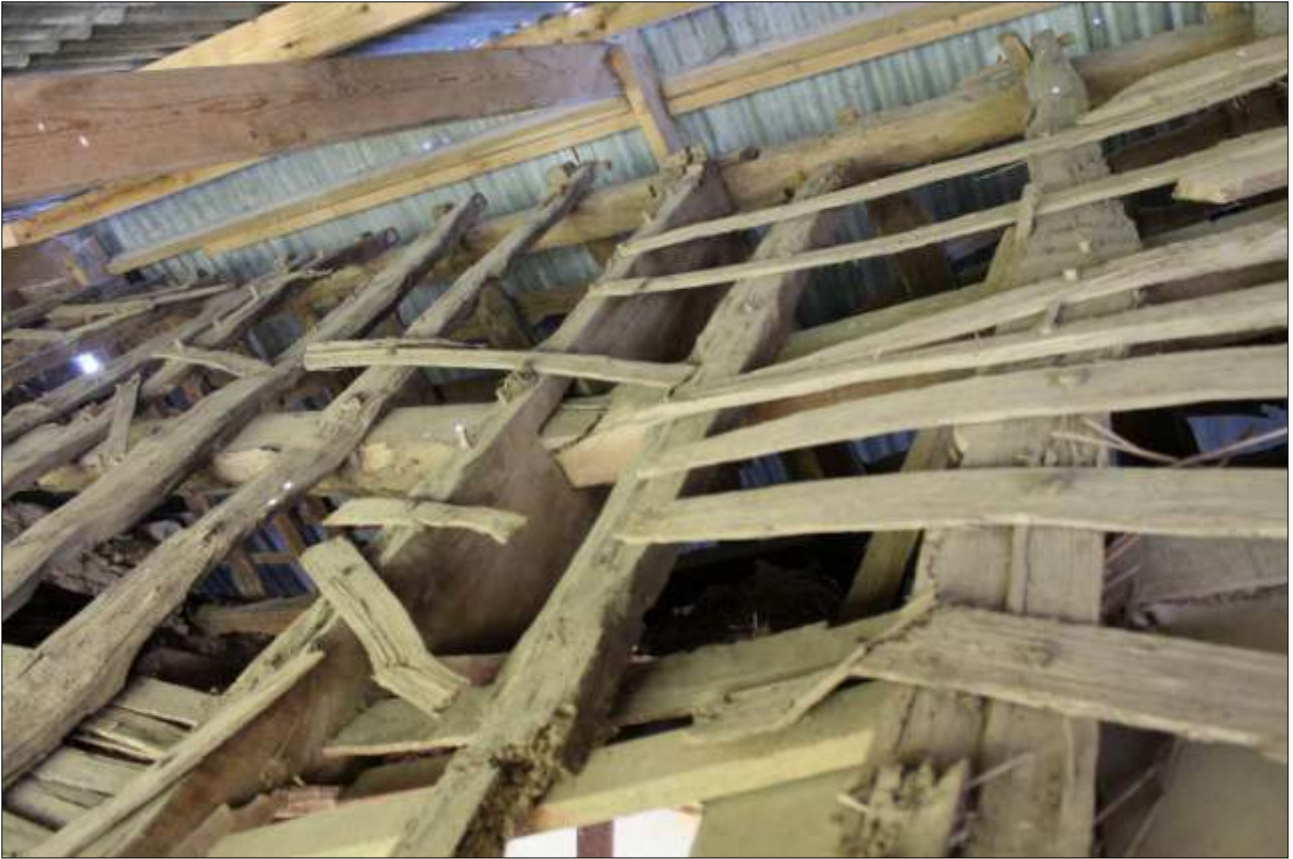
R4, THE SOUTH-WEST PITCH FROM ABOVE, SHOWING THE RAFTERS PEGGED TO THE TRUSS BLADE AND PURLINS, AND THE BATTENS PEGGED TO THE RAFTERS; VIEWED FROM THE SSE.

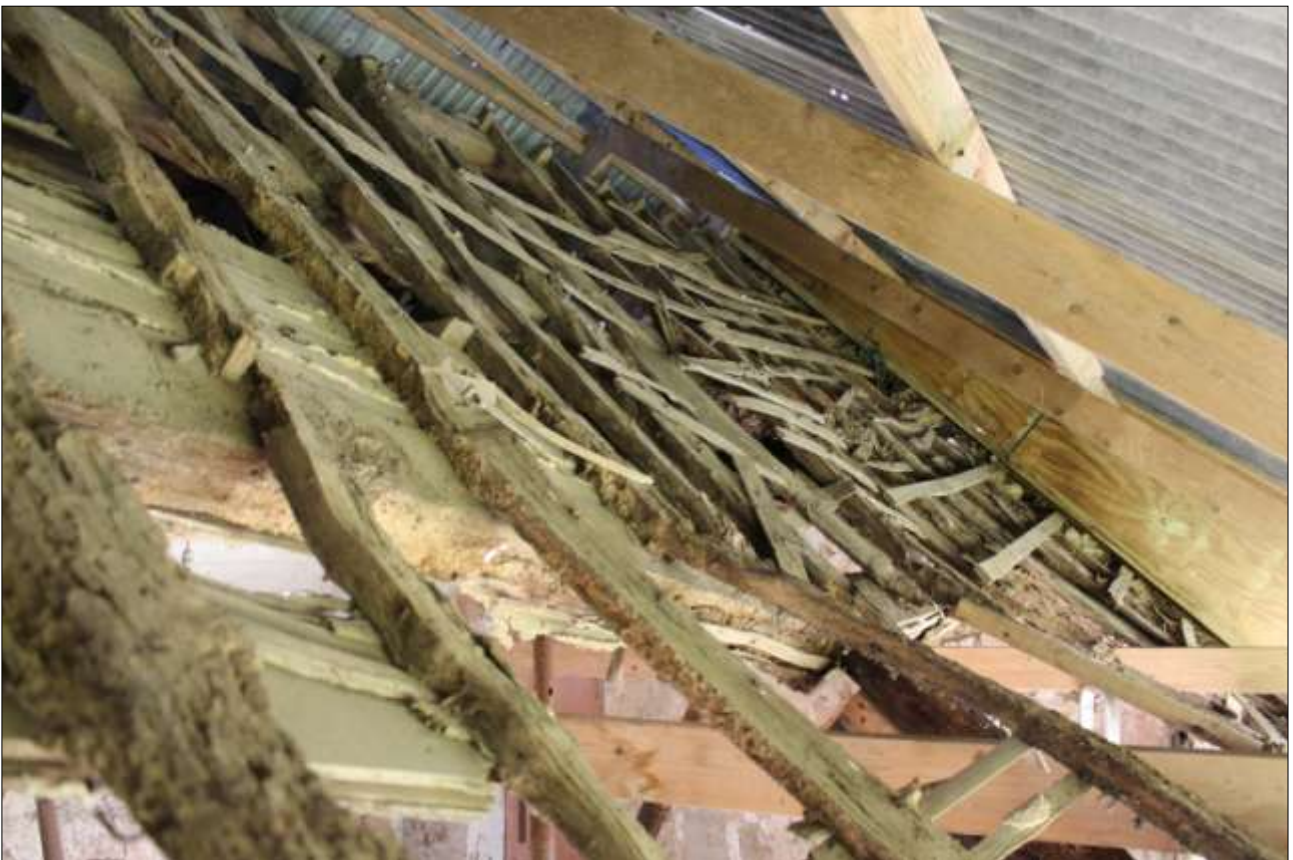
R4, AS ABOVE, SHOWING THE LAPPED PURLINS MEETING AT THE TRUSS BLADE; VIEWED FROM THE SOUTH.

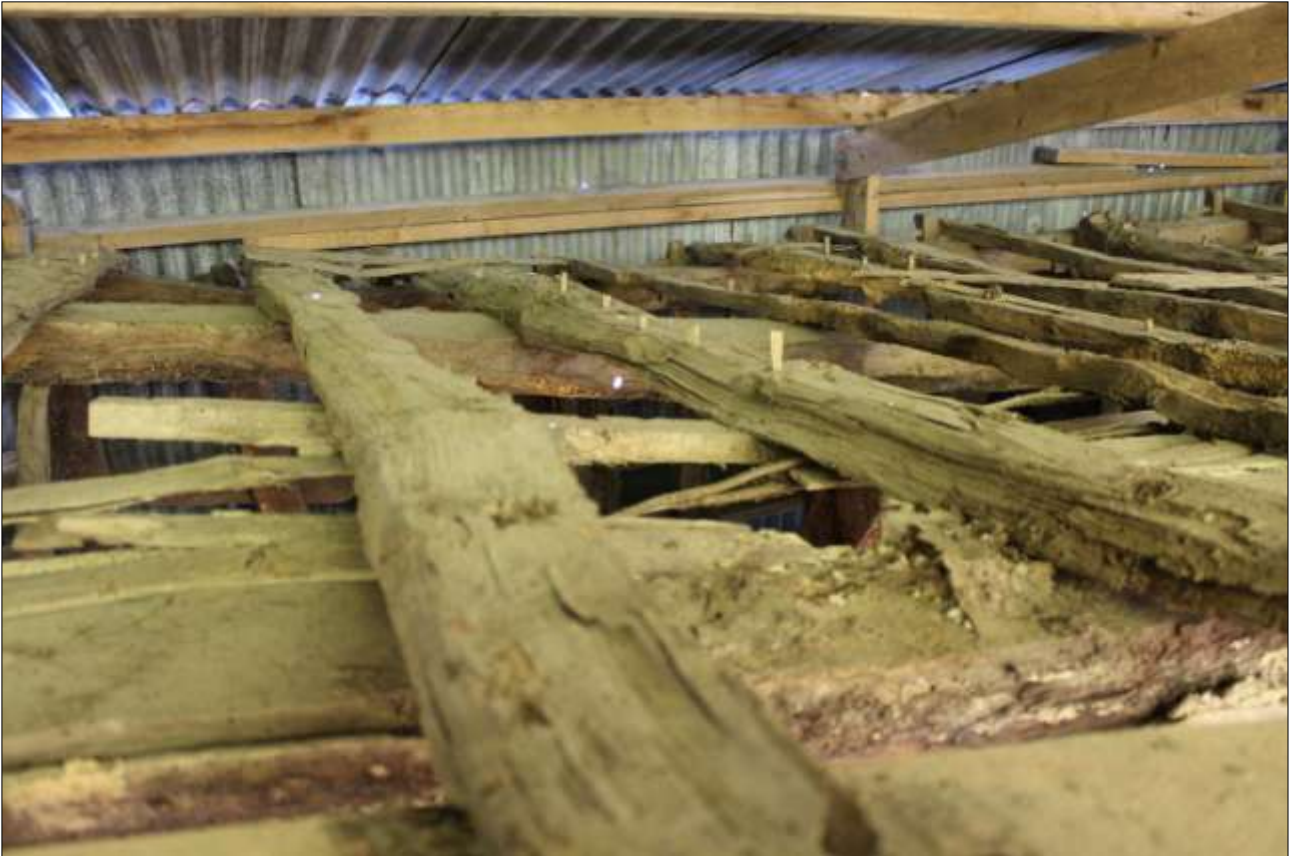
R4, THE SOUTH-WEST PITCH FROM ABOVE, SHOWING THE RAFTERS PEGGED TO THE TRUSS BLADE AND PURLINS, AND THE BATTENS PEGGED TO THE RAFTERS; VIEWED FROM THE SSW.

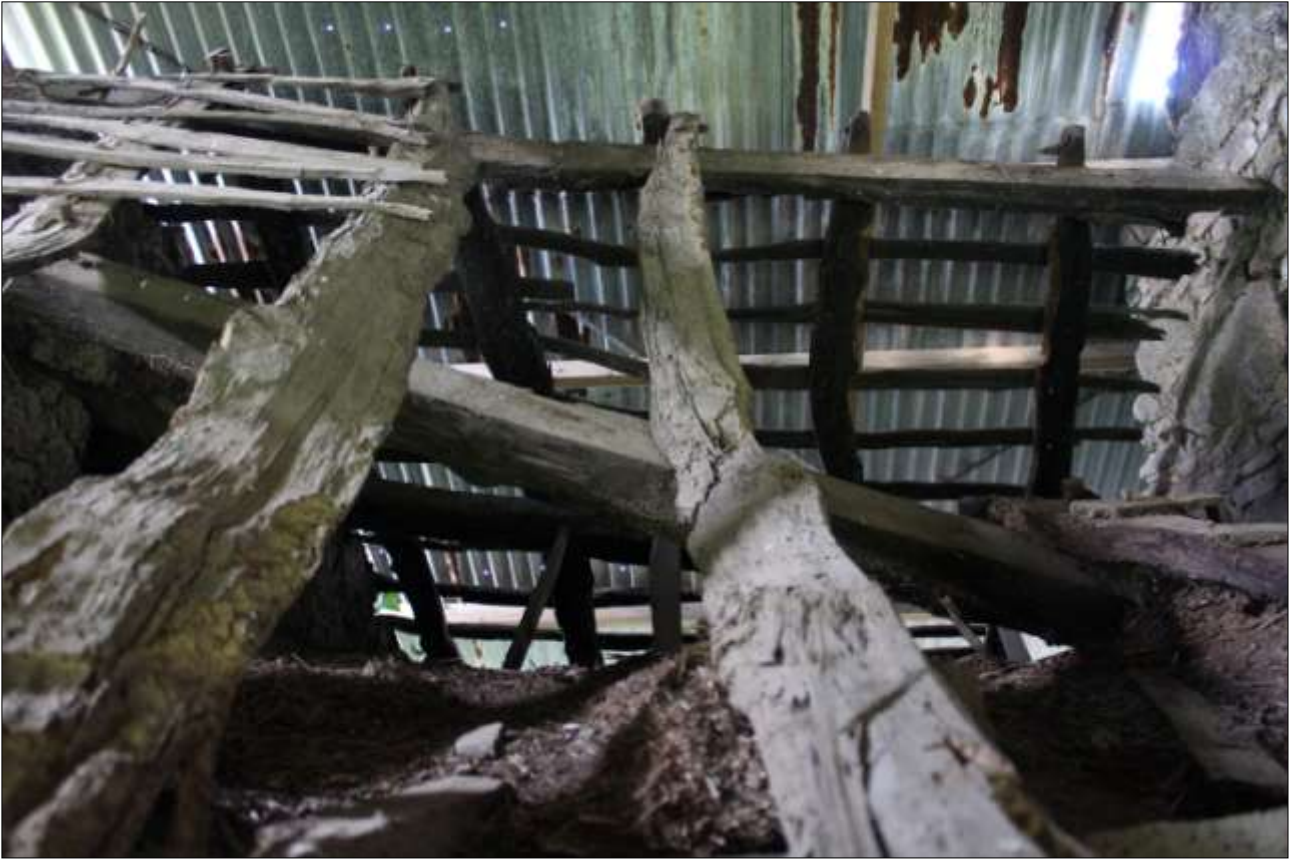
R4, DETAIL OF THE RAFTERS PEGGED OVER THE RIDGEPOLE (INDICATED); VIEWED FROM THE SOUTH.
