# THE LOWER DRY CHARLESTOWN St AUSTELL CORNWALL

Results of a Desk-Based Appraisal, Historic Building Assessment &  
Heritage Statement

South West Archaeology Ltd. report no. 170906

By B. Morris  
Report Version: 02  
29<sup>th</sup> September 2017

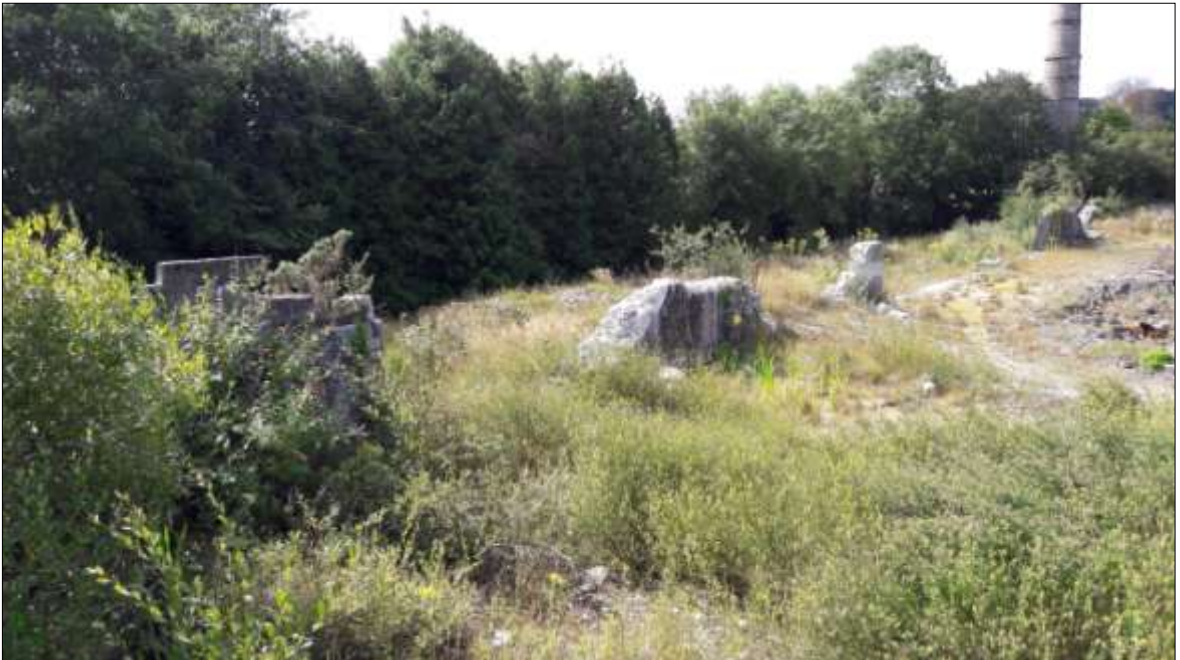
FIGURE 12: THE REMAINS OF THE WEST WALL OF THE SETTLING TANKS, VIEWED FROM THE SOUTH-EAST.

Most of the internal tank walls have now been lost; c.50% of the west wall of B1 has gone, although the southern part adjacent to B2-3 survives substantially intact. The internal walls are more complete towards the northern end of the site; the only surviving fragment of 1945x55 wall survives attached to the east gable of B2. The north and east walls of the tanks survive intact. The breach in the south wall has been widened to the east; this breach was c.6m wide, but the wall does not now survive to full height for a further c.8m. Most of the china clay has been removed

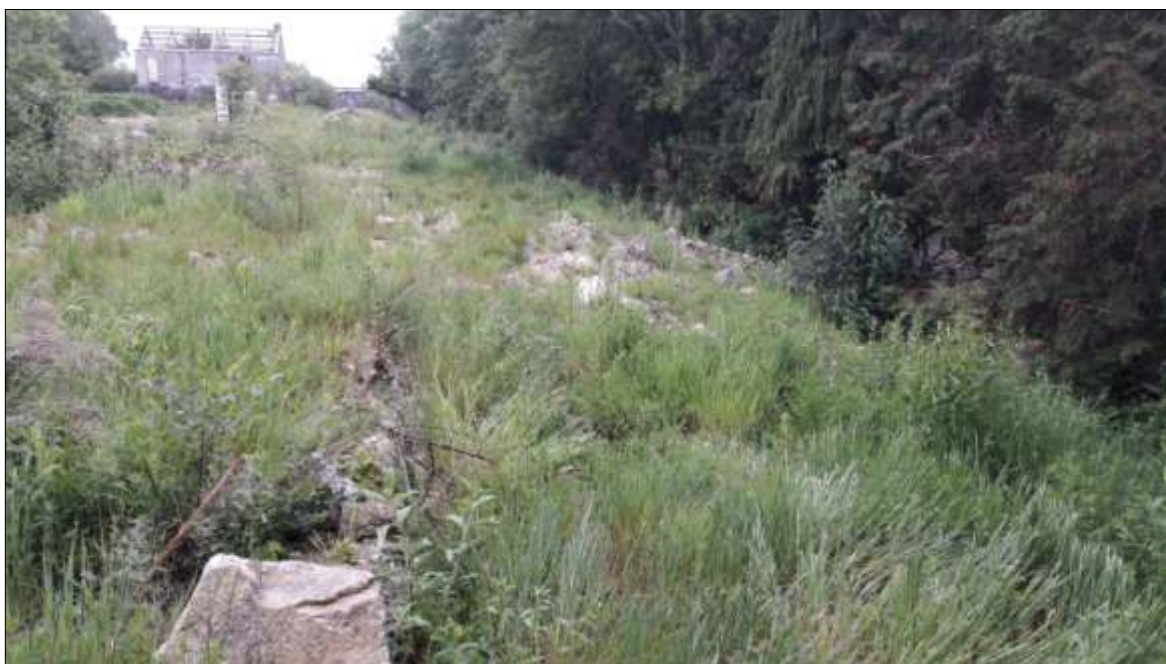
FIGURE 19: THE INFILLED COMPARTMENTS OF THE LINHAY, VIEWED FROM THE NNW.

C2-4 have been infilled with china clay and are somewhat overgrown, with no visible features. To the northern end of C1 some sort of timber and steel structure is visible attached to the north

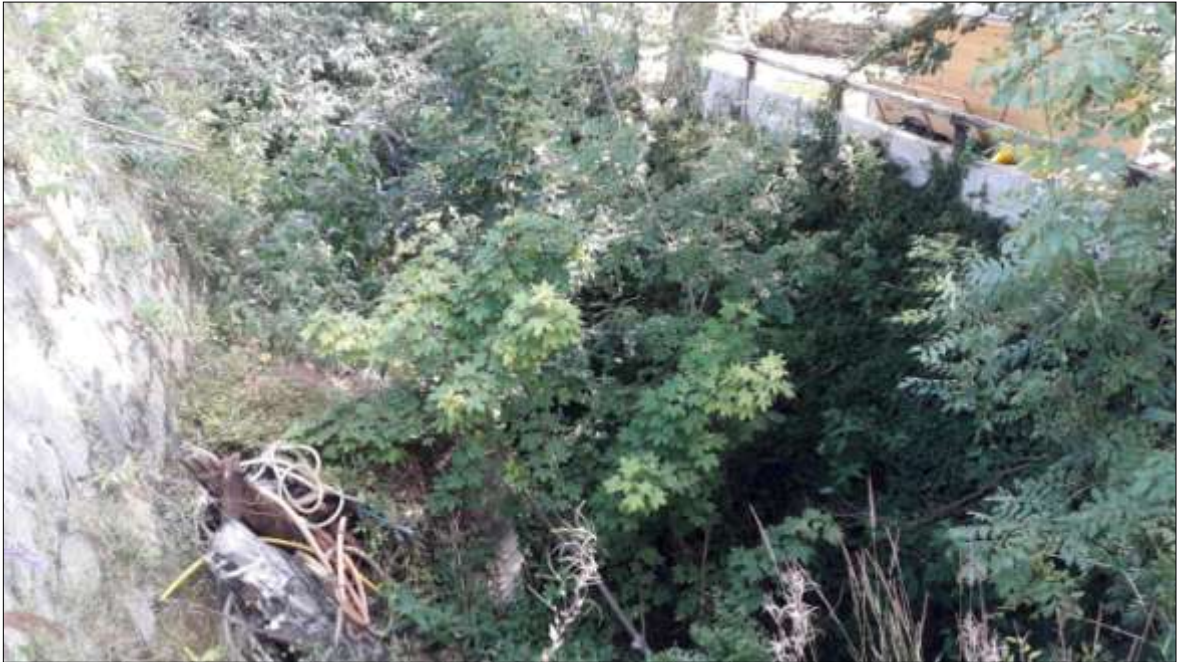
gable end. C5 is largely free of china clay but is still heavily overgrown and contains a fair amount of dumped rubbish. The gaps between the iron pillars in the west wall have been infilled in concrete block. The narrow opening between the compartments has been infilled in stone rubble.

FIGURE 20: C5, SHOWING THE DEPTH OF THE FEATURE, AND THE RUBBISH/UNDERGROWTH; VIEWED FROM THE NORTH.

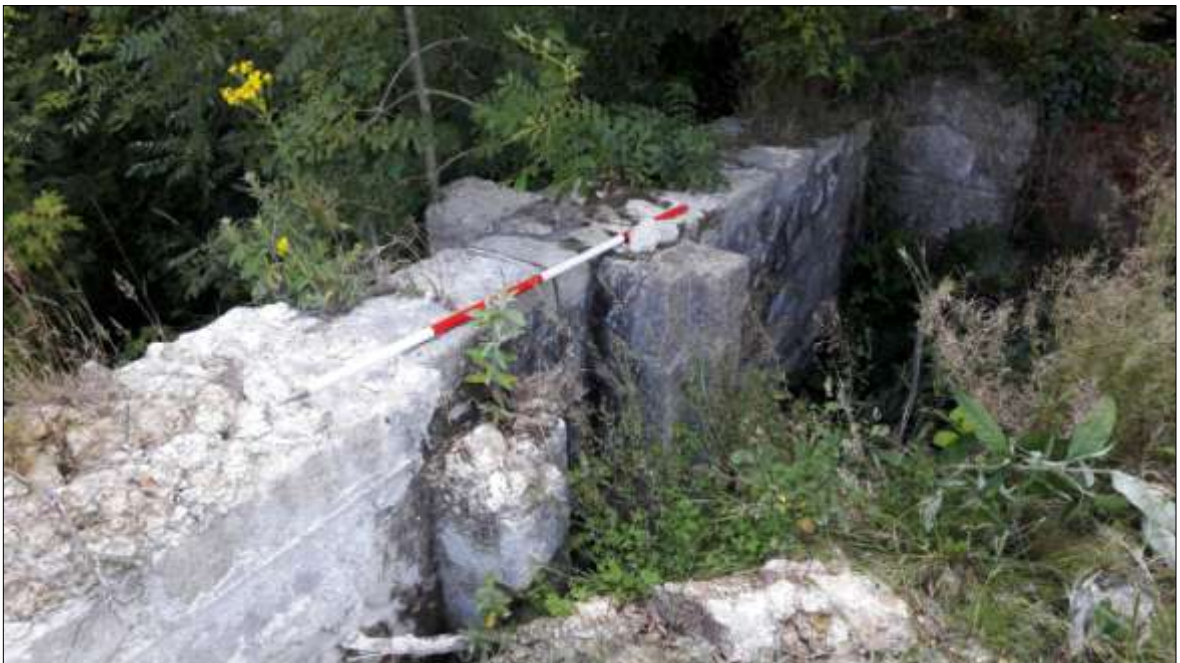
FIGURE 21: THE WALL SEPARATING C4 AND C5, SHOWING THE POSSIBLE OPENING WITH REINFORCED PROJECTING REVEALS; VIEWED FROM THE NORTH-EAST (SCALE 2M).

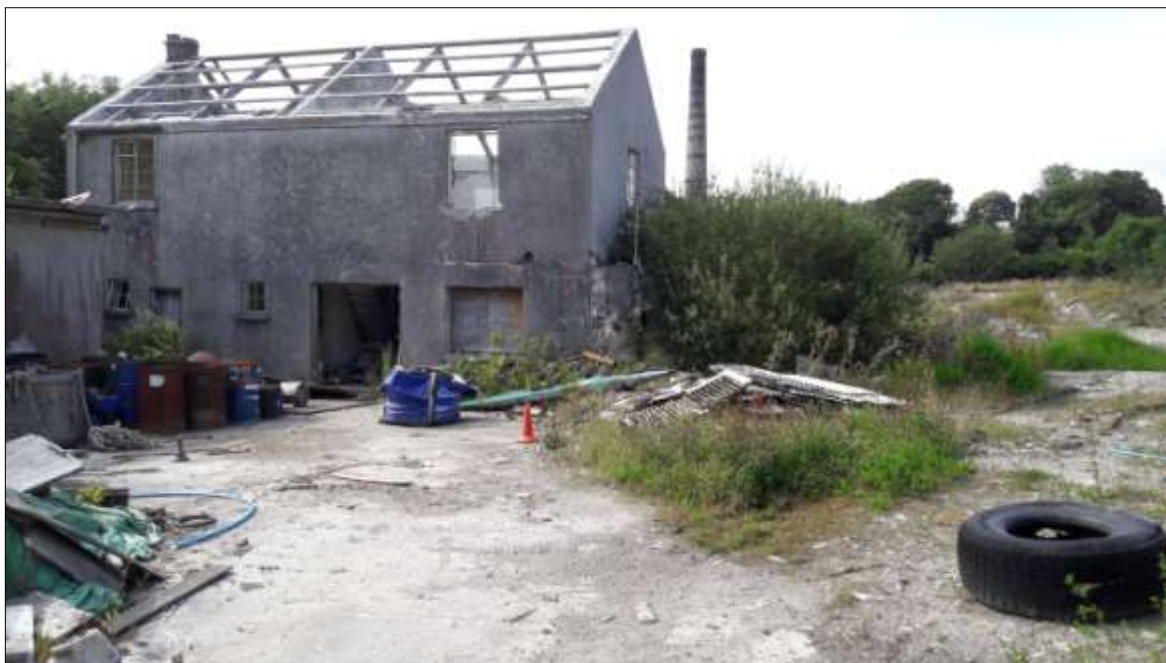
The floors are of concrete (shuttered concrete to first floor). The corrugated asbestos roof has been removed to reveal the simple pine trusses, half-lapped and bolted at the apex, with simple bolted tie beams. The window and door frames are timber, but the window casements are of galvanised steel. This structure can readily be divided into two separate halves by function: staff welfare to the west, and the pump house to the east.

FIGURE 24: B2, VIEWED FROM THE SOUTH-EAST.

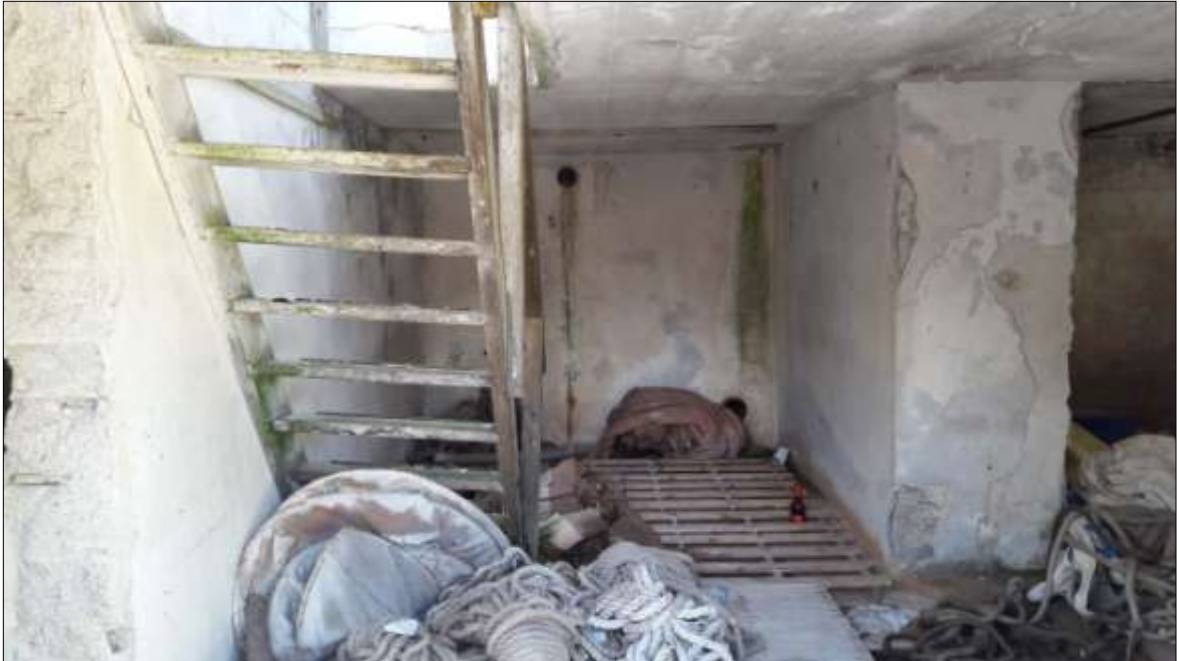
Almost all the fixtures and fitting have now been lost. The stumps of iron pipes, or scars in the walls or floor, are all that remain of its former use. An opening has been forced at ground floor

level into the shuttered-concrete chamber, and doorways forced through to the staff welfare on both the ground and first floor.

FIGURE 28: THE GROUND-FLOOR INTERIOR OF THE PUMP HOUSE, VIEWED FROM THE SOUTH.

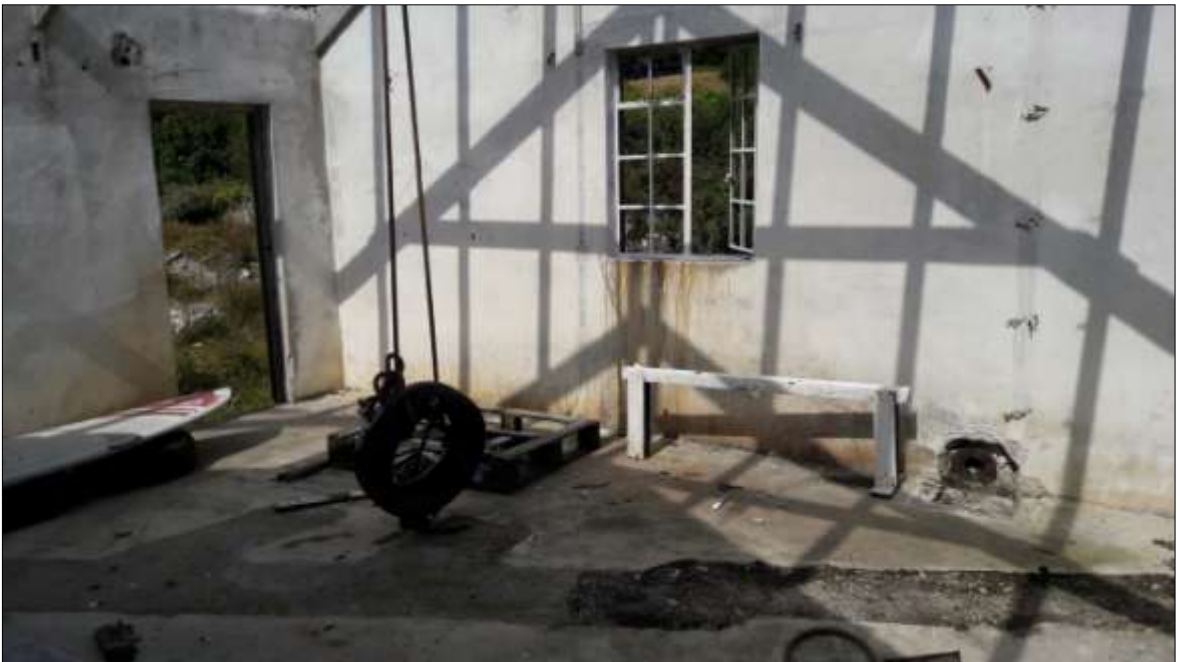
FIGURE 29: THE FIRST-FLOOR INTERIOR OF THE PUMP HOUSE, VIEWED FROM THE SOUTH-WEST.

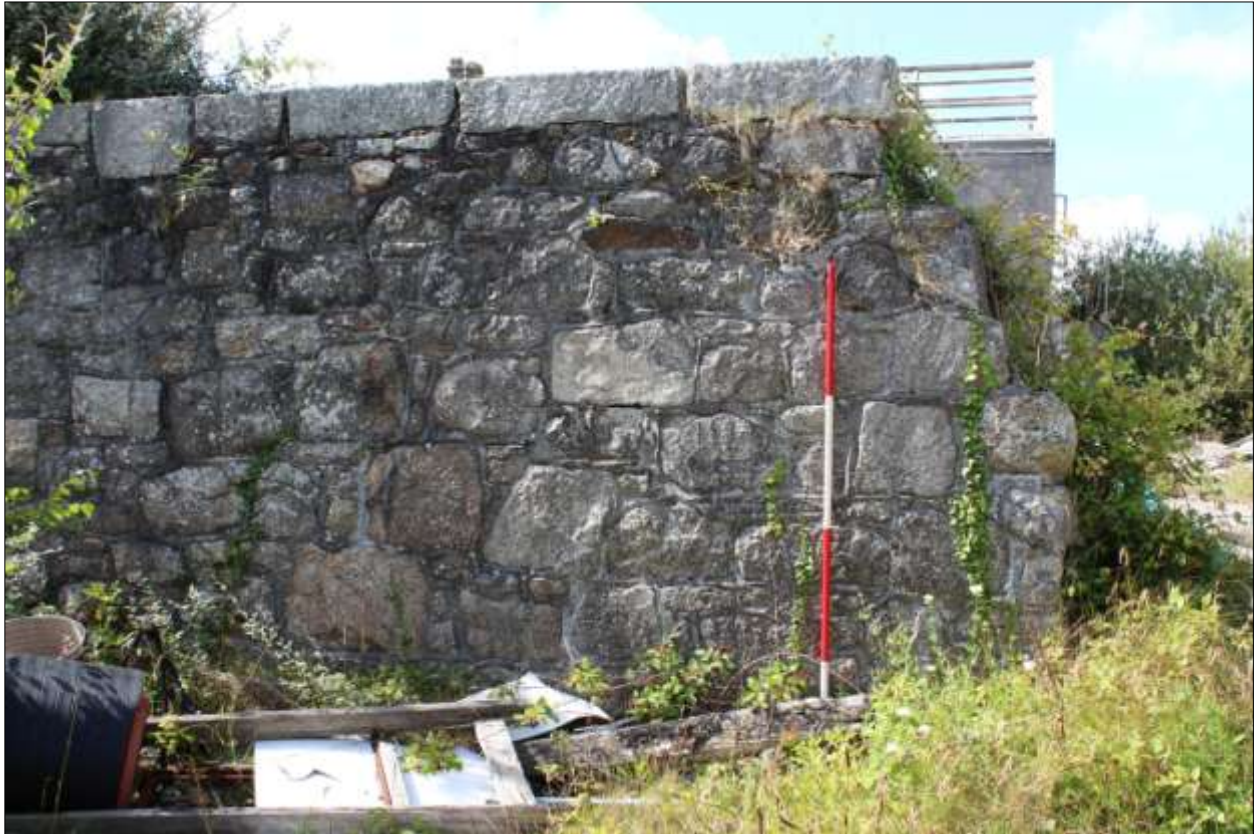
The south wall of T8, next to the breach; viewed from the south (scale 2m).

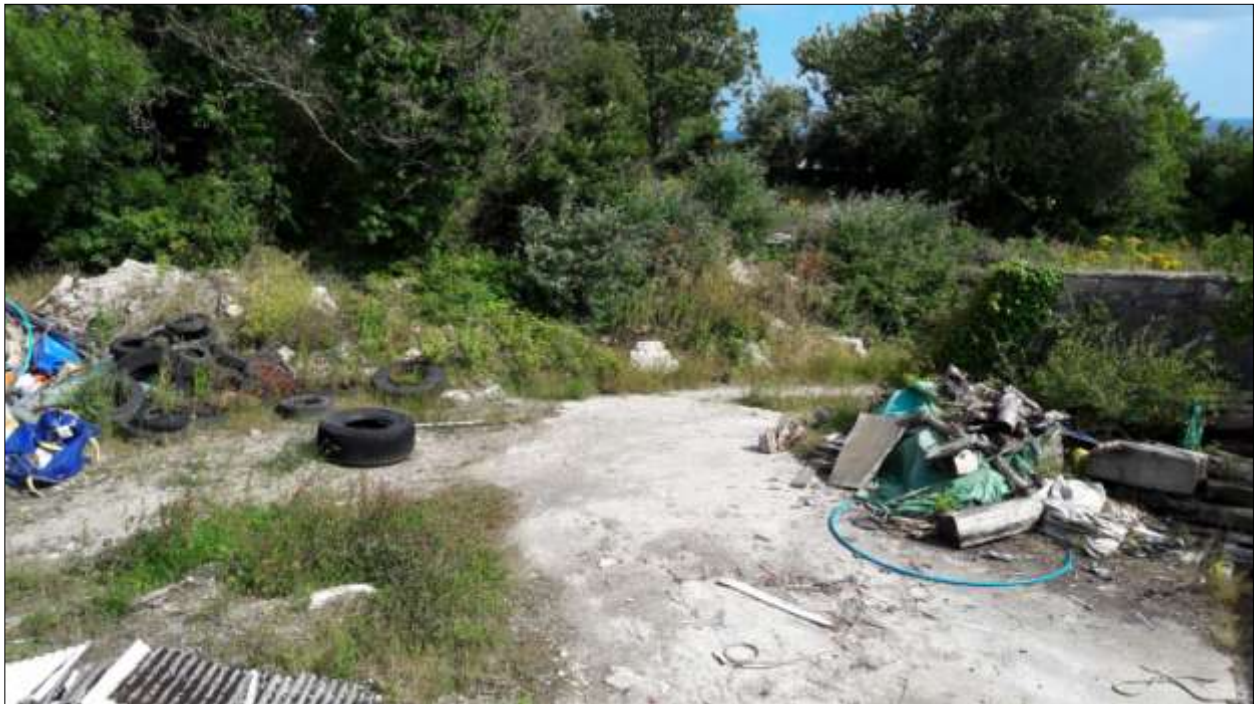
The lower part of T8, showing the breach in the wall; viewed from the north-west.

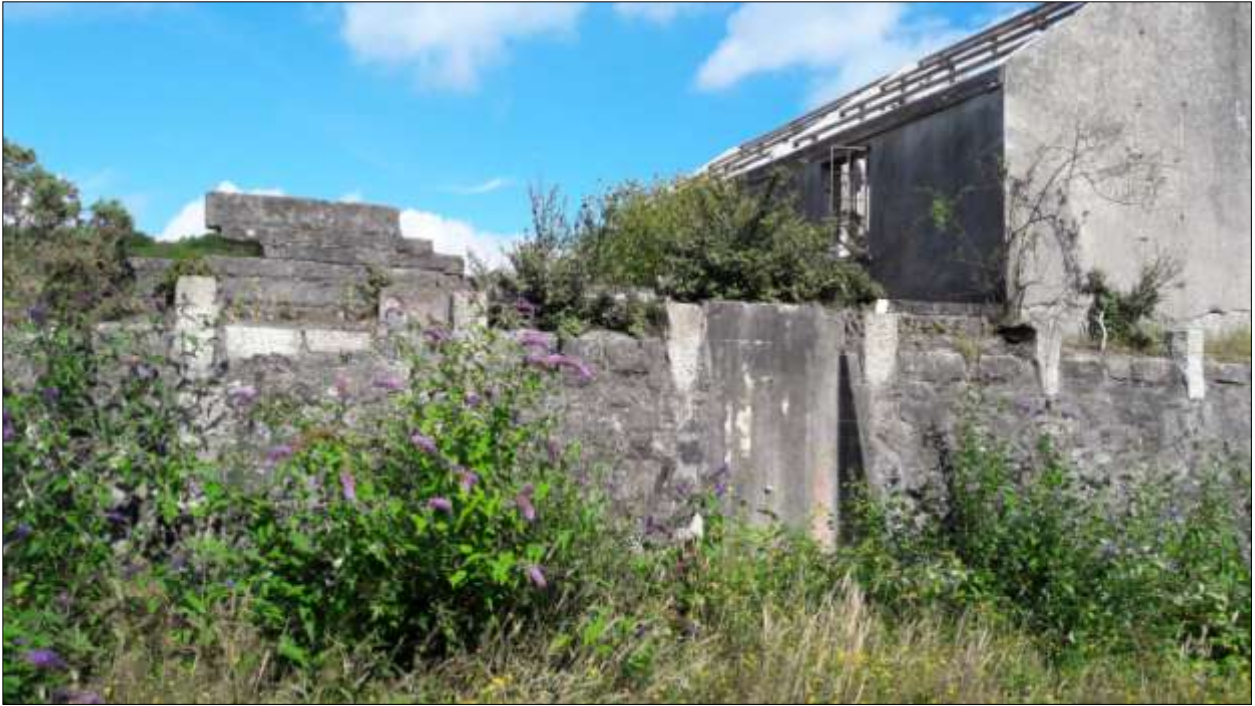
The west wall of T7, with B2 and the blocked sluice gate; viewed from the west. Note the projecting granite blocks along the wall top to carry the timber wallplate, and the extra blockwork to the left; the latter is presumably part of the building shown here on the 1969 OS map.

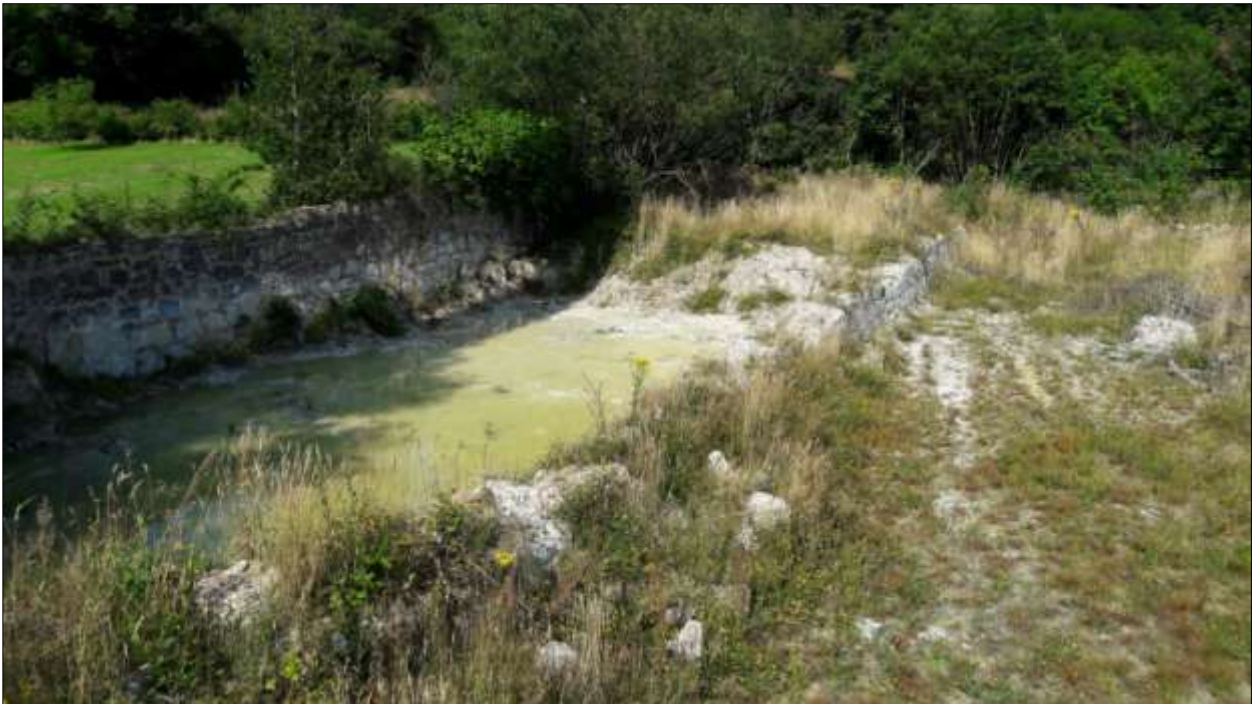
T1, viewed from the WSW. Note the *in situ* china clay deposits.

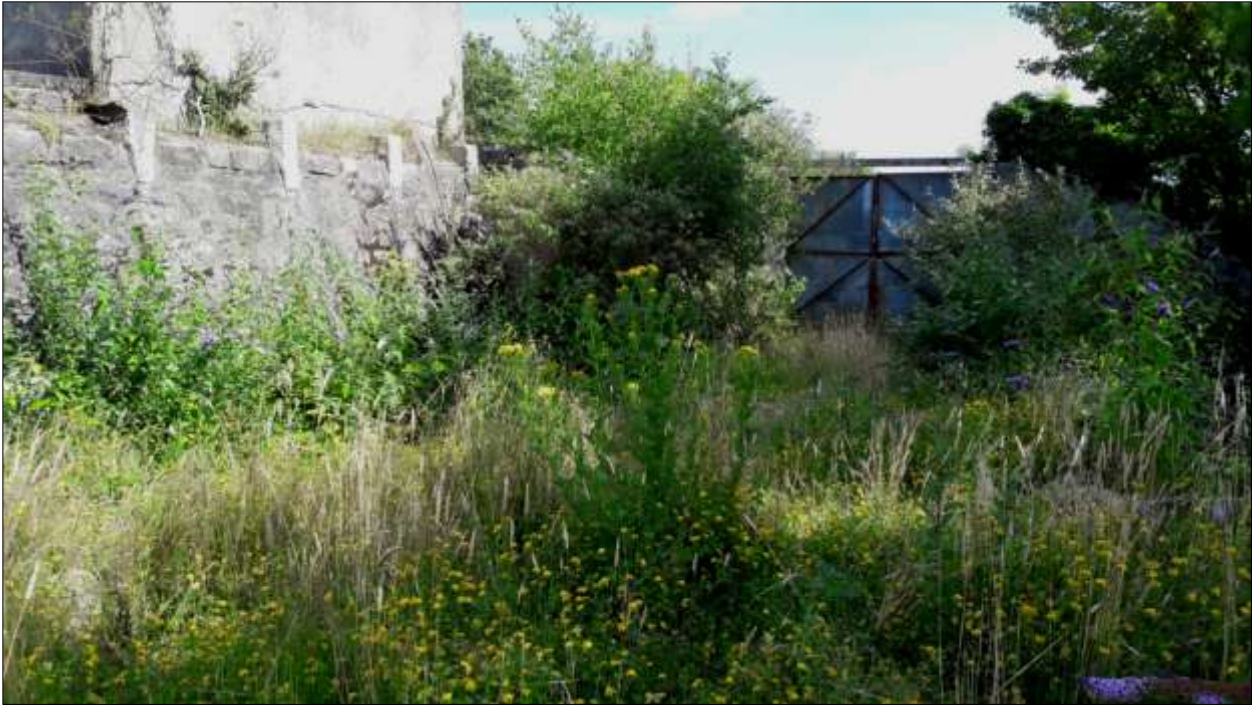
The southern end of the drying floor, viewed from the NNW.

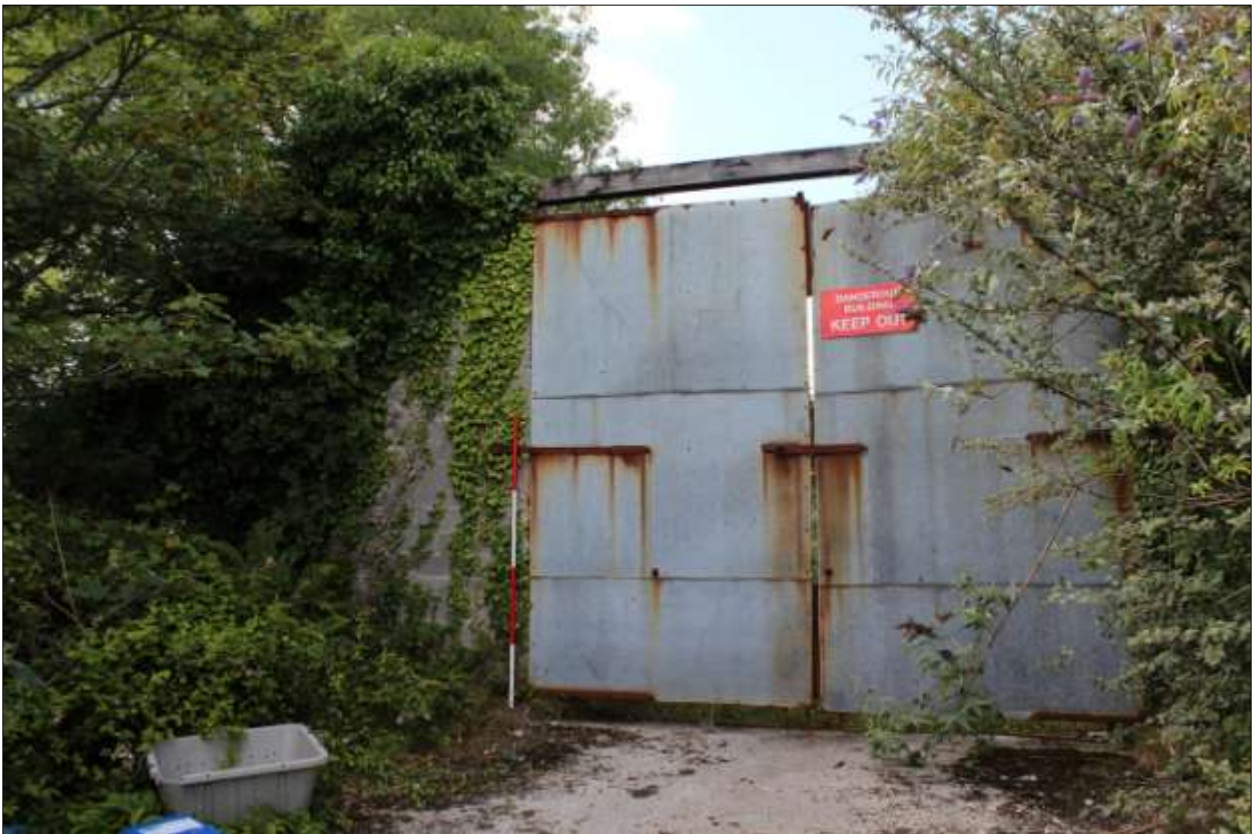
The south doors of the drying floor; viewed from the south (scale 2m).

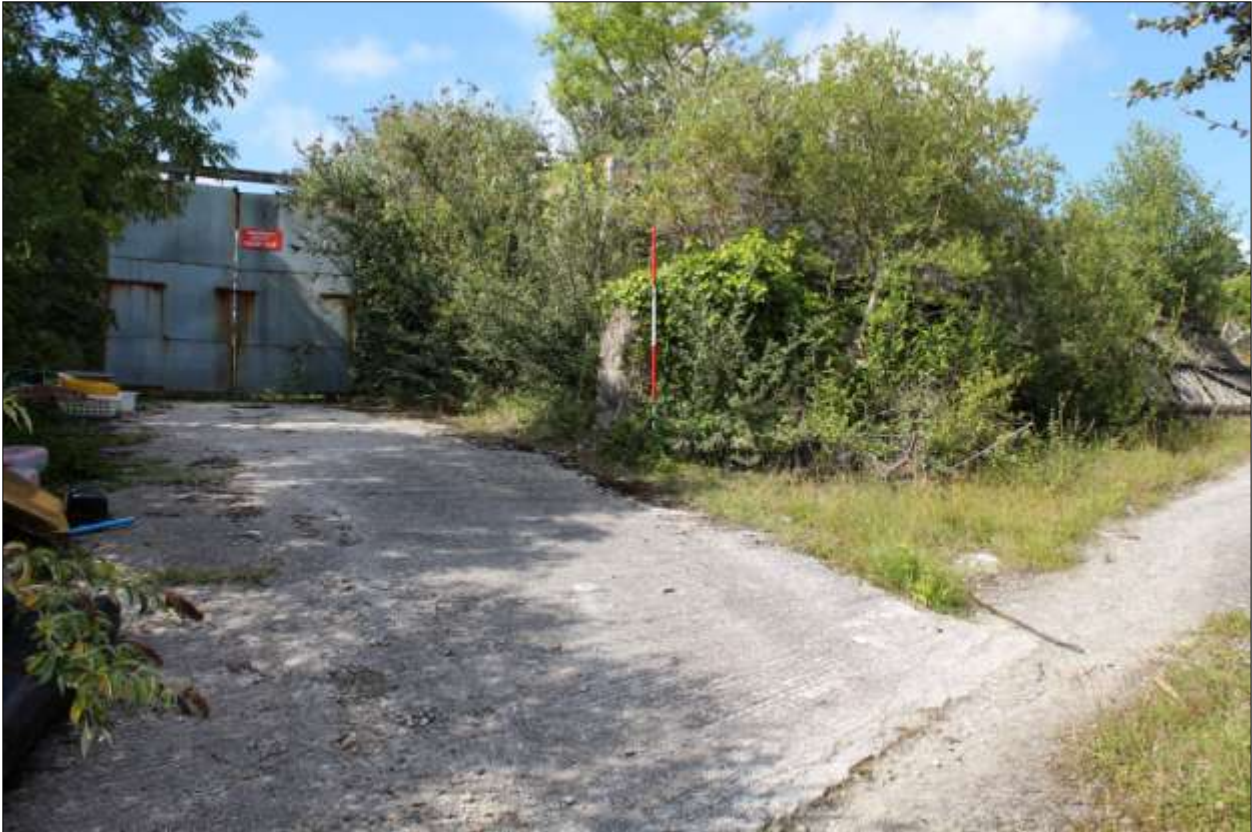
The concrete ramp leading up to the steel doors; viewed from the south (scale 2m).

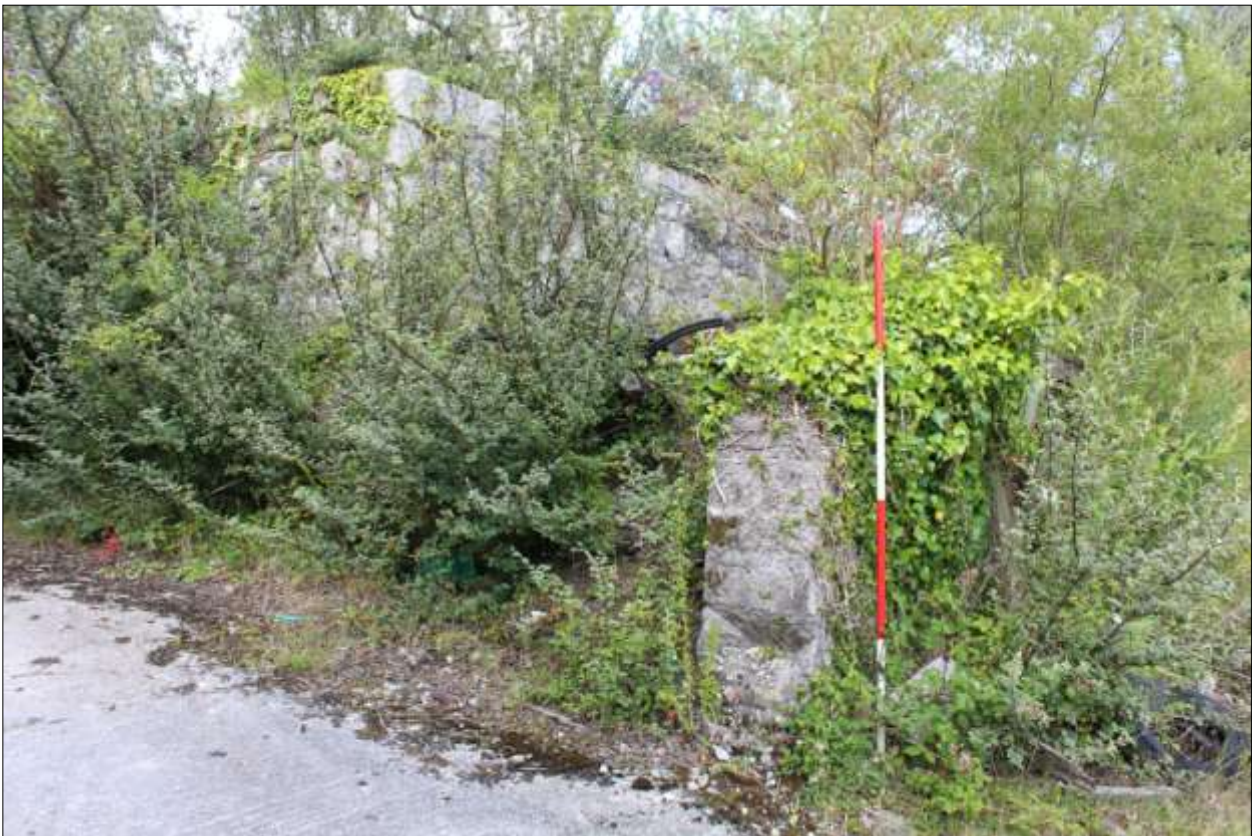
The truncated ramp adjacent to the south wall of T8; viewed from the west (scale 2m).

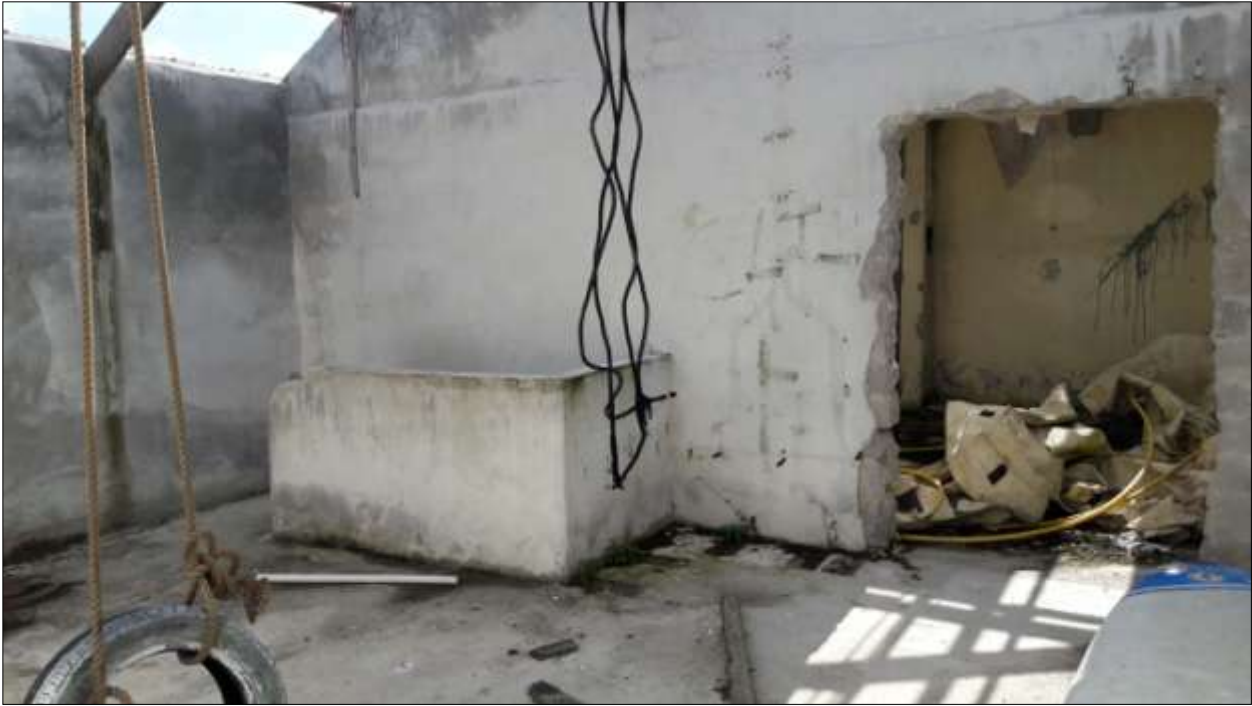
B2, the first floor interior of the pump house showing the breach to the staff welfare; viewed from the north-east.

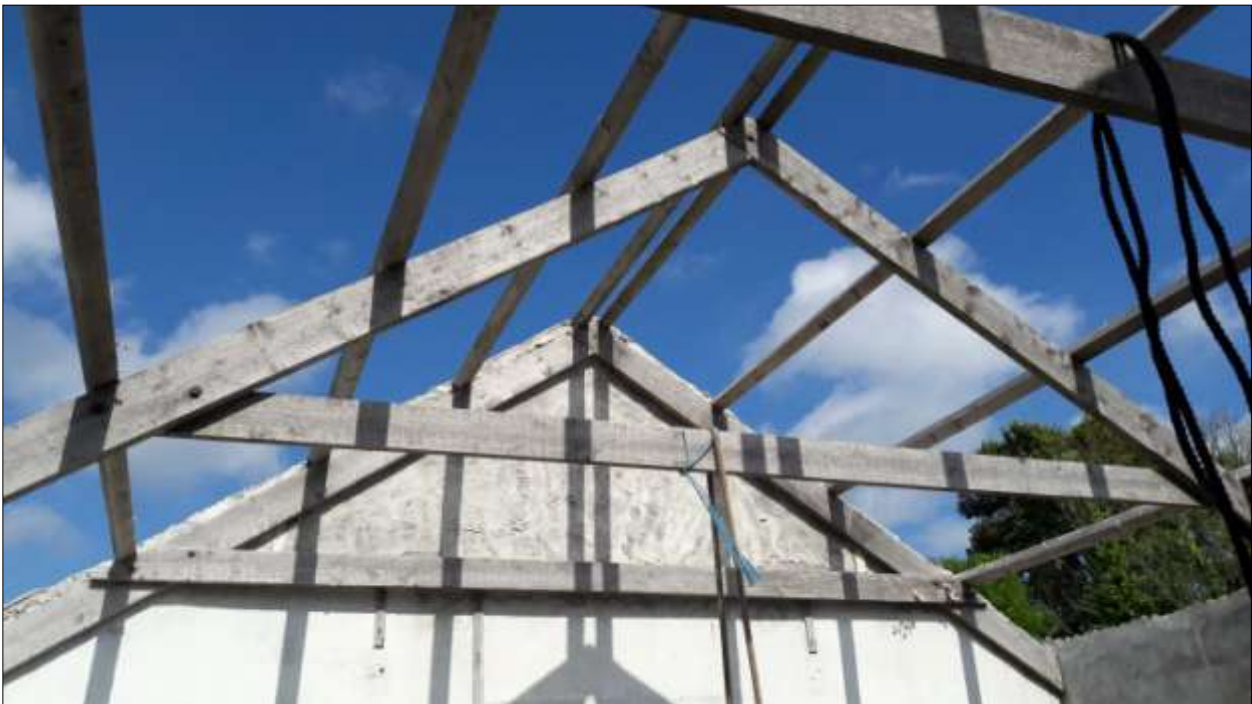
The exposed roof structure in B2, viewed from the west.

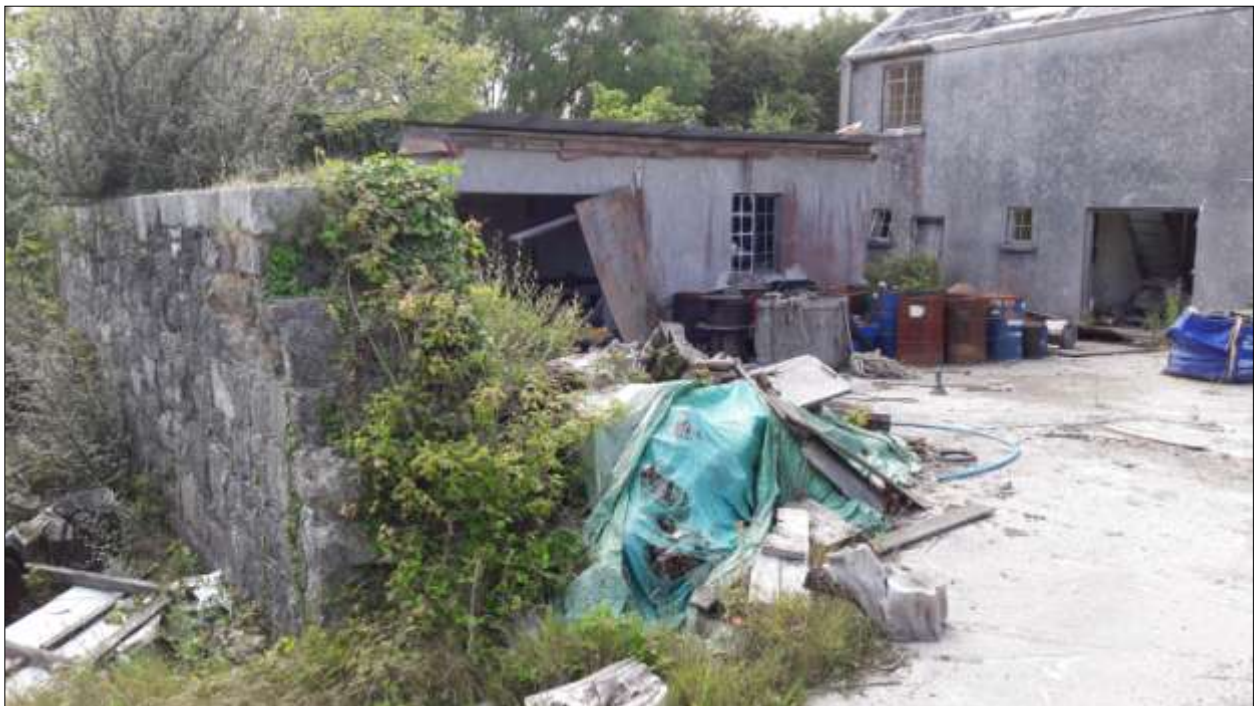
The breach in the south wall of T8, showing the yard with B3 and B2; viewed from the east.
