**YOUNGCOTT BARN
MILTON ABBOT
WEST DEVON
DEVON**

Historic Building Recording

South West Archaeology Ltd. report no. 170913

By N. Boyd & E. Wapshott
Report Version FINAL
13th September 2017

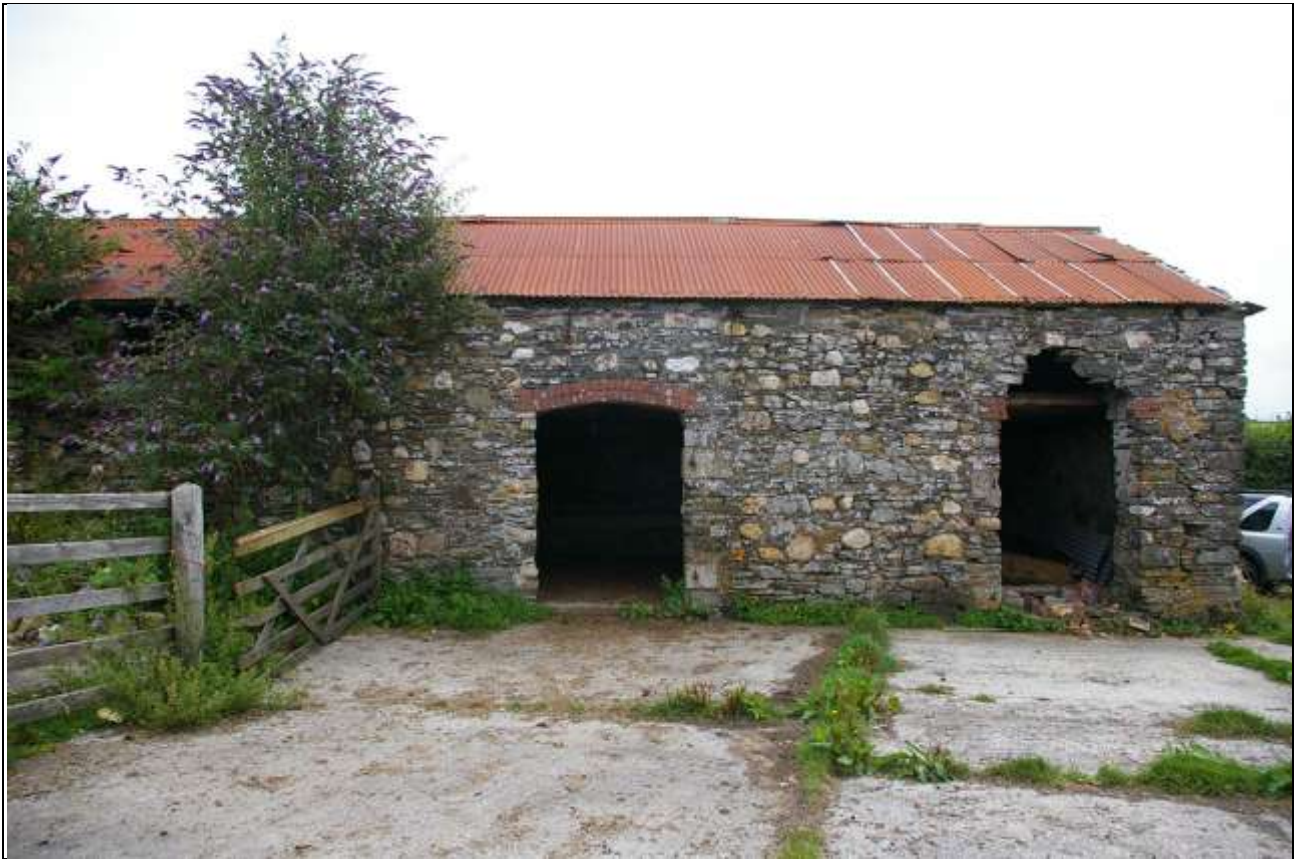
Barn 2 has undergone adaptation, a large doorway in the east elevation was blocked when the troughs were built and the two openings in the west elevation, former stable doors, were enlarged and heightened, with brick arches inserted. It appears that the south gable has received a substantial reconstruction or repair, sitting at an oblique angle to the rest of the structure. Barn 2 shares a common roof with Barn 1, the whole replaced in the early to mid-20th century, probably pre-1945. The roofline of the south gable end of Barn 2 has been altered, as Barn 1, the height reduced, leaving the tops of the wall ragged. The interior of the barn has been wholly worked over in the 20th century, with a narrow boarded loft carried on iron girders, rubble built troughs and modern hayricks occupying the east wall and the floor concreted over, raising its height, forming a step up from the yard.

The west elevation of Barn 2, with pair of stables doors facing the yard; from the west.

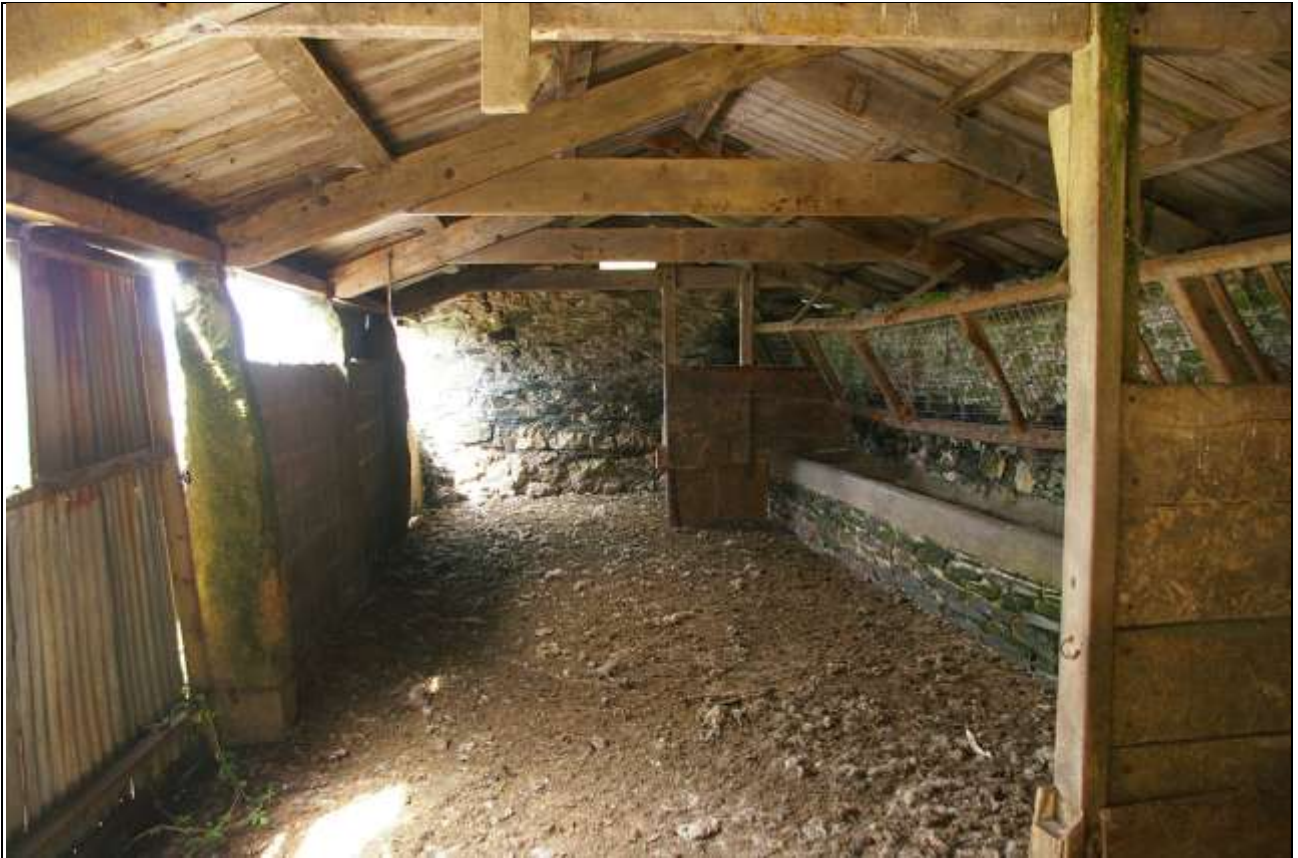
The interior of Barn 3; from the east.

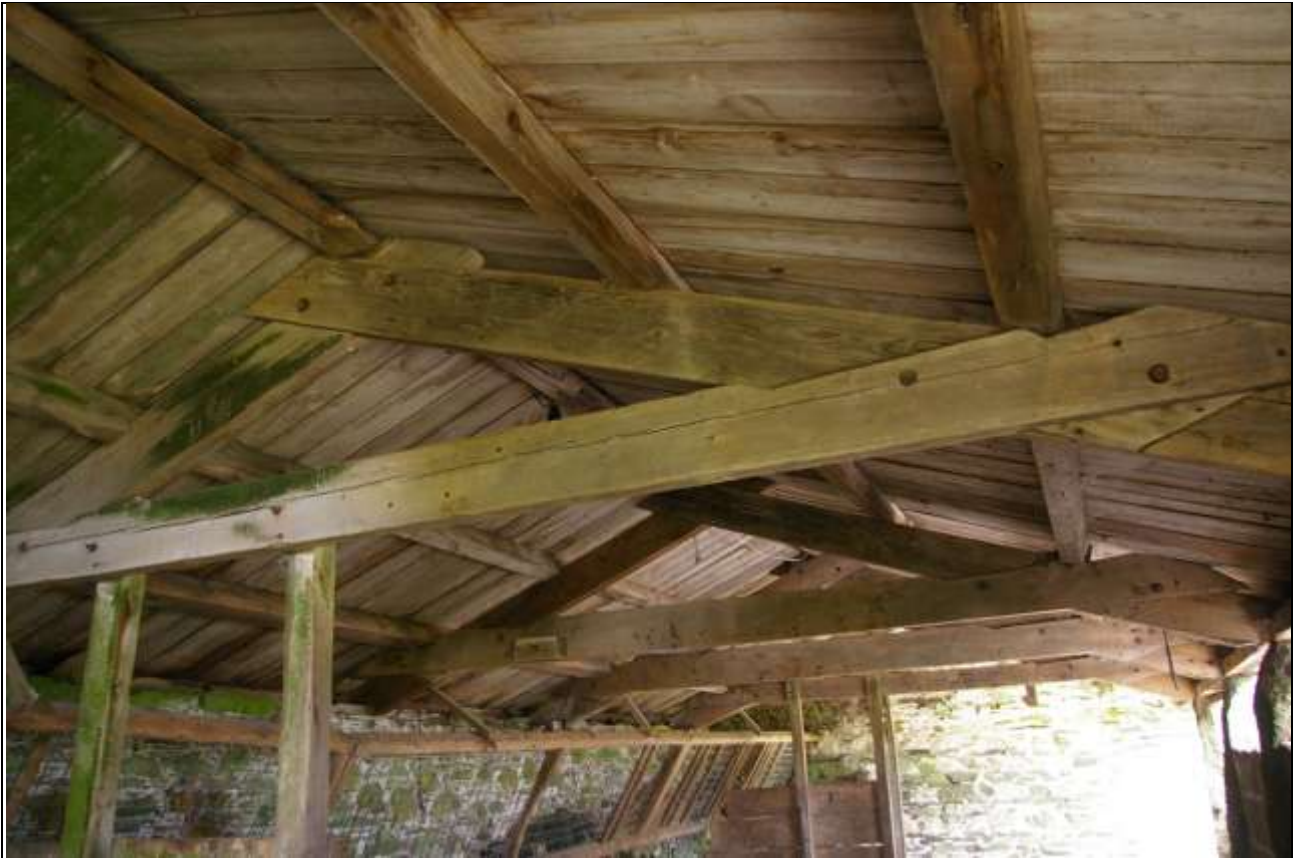
The roof structure in Barn 3; from the south-west corner.

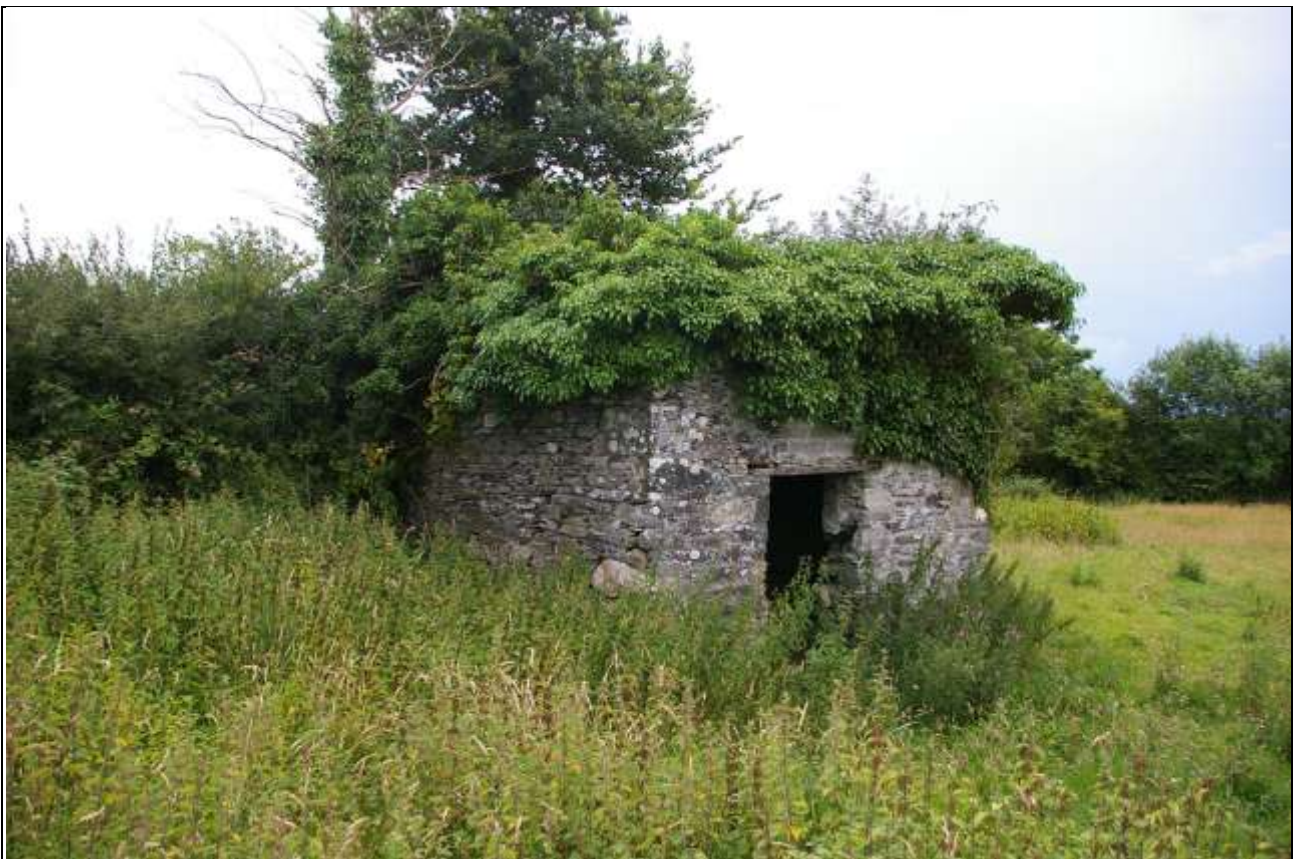
Roof Covering:		Roofless ruin.
Significant Details:		Long narrow timber ties at approx 1.5m high within the stonework, some large iron nails. These ties may be intended for holding/bracing fittings.
Relationships:		The north elevation is cohesive with the surviving parts of the east and west elevations.
Outbuilding Elevation SOUTH		Description
Fabric Description:		The stone building has been truncated at the south elevation, loosely infilled with concrete blocks, with an integral concrete block built trough.
Relationships:		The concrete blocks infill between the historic elevations.
Outbuilding Elevation WEST		Description
Fabric Description:		Regularised rubble stonework, semi-coursed mixed shale and slate, with quartz stones. Heavy slatestone roughly dressed quoins, with some large quartz boulders.
Roof Covering:		Roofless ruin.
Opening – Doors:	1	Wide but quite low doorway in the centre of the surviving section of wall. Slatestone quoins, with some granite and quartz. Heavy timber lintel. Exterior mounted iron pintles, no door or frame survives.

The north and west elevations of the outbuilding in the field; from the north-west.

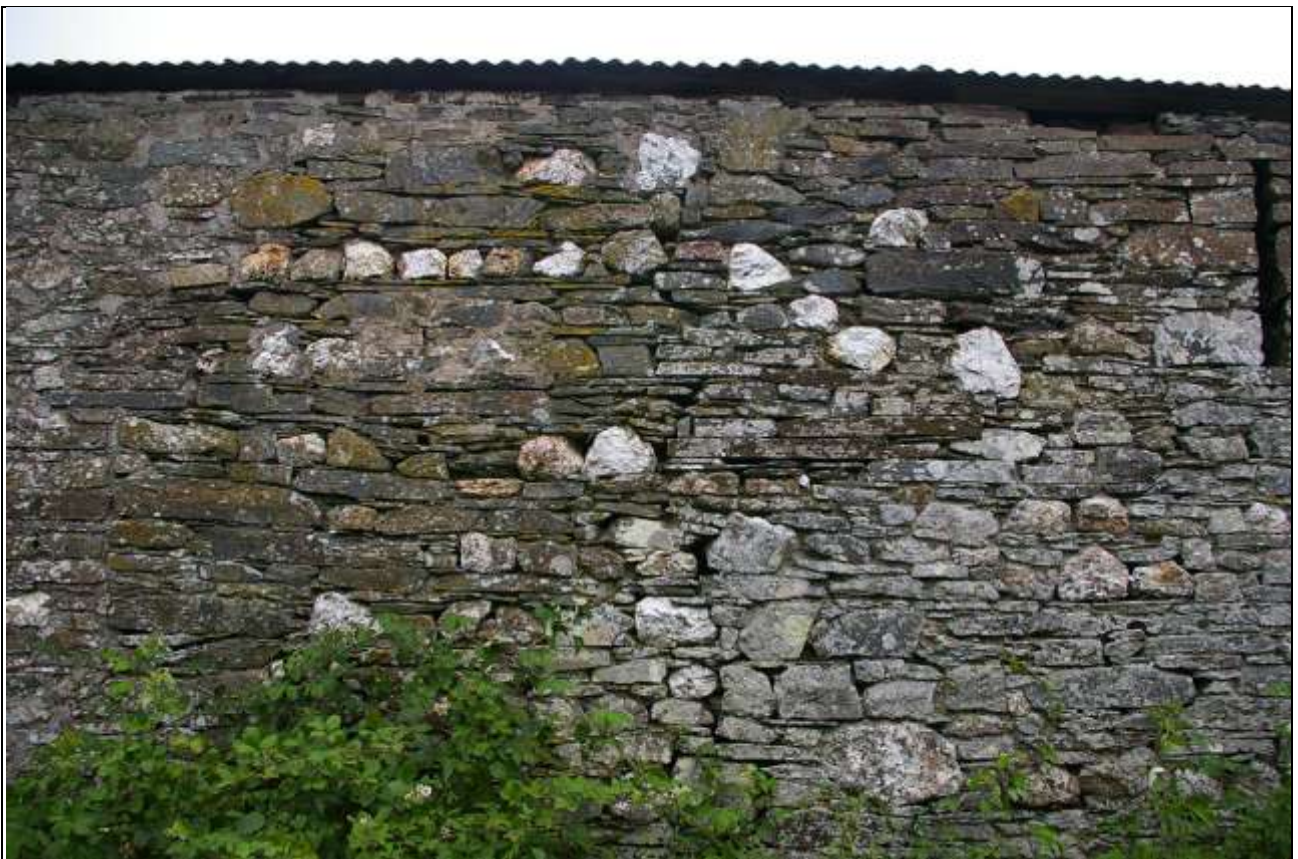
The better section of stonework in the east elevation of Barn 2; from the east

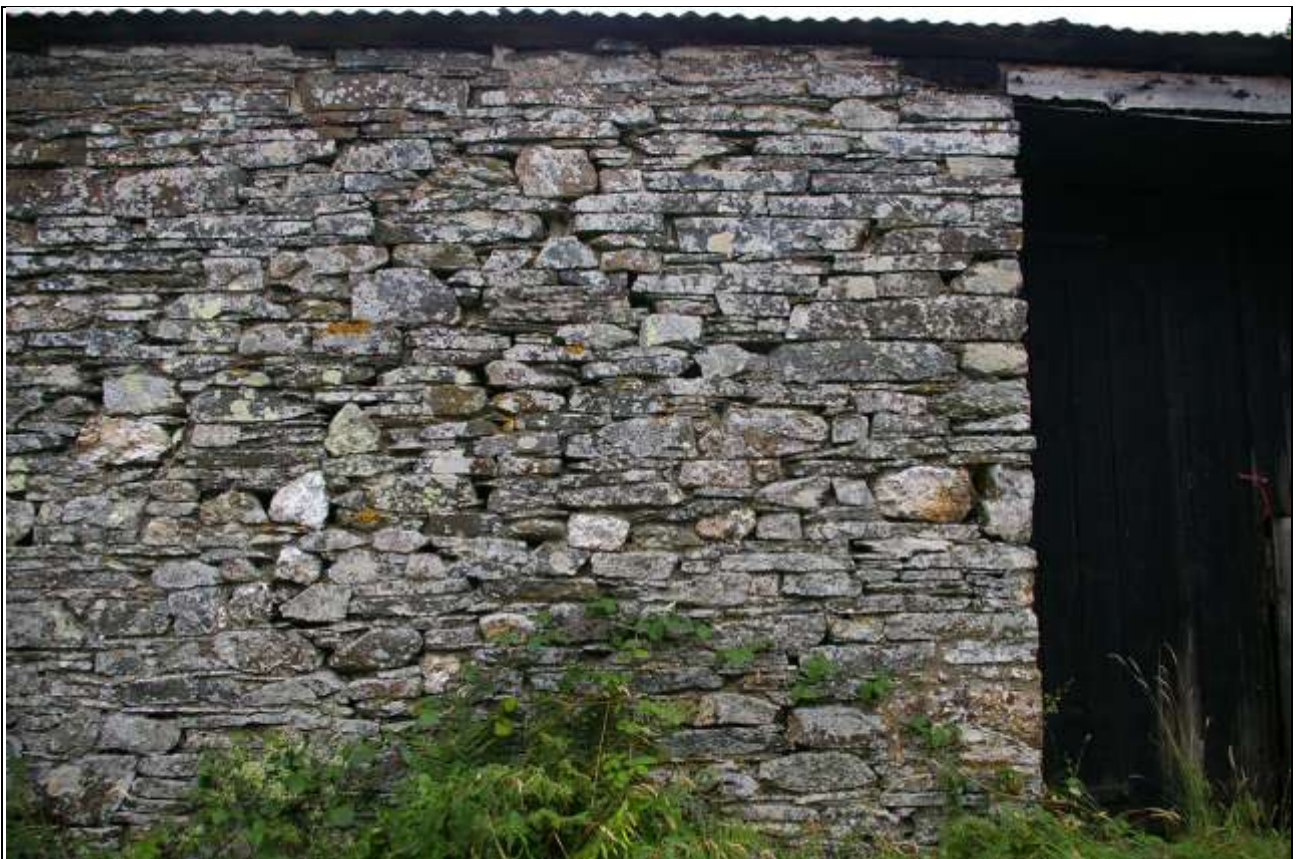
The stonework just south of the threshing door in the east elevation of Barn 1, with less quartz and a lack of formal courses; from the east.

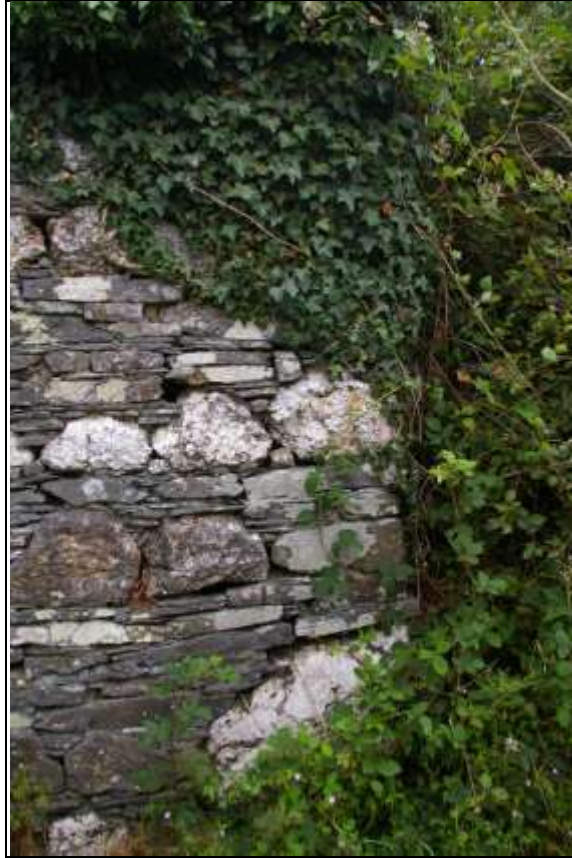
The heavy quoins to the north-east corner of Barn 1; from the east-south-east.

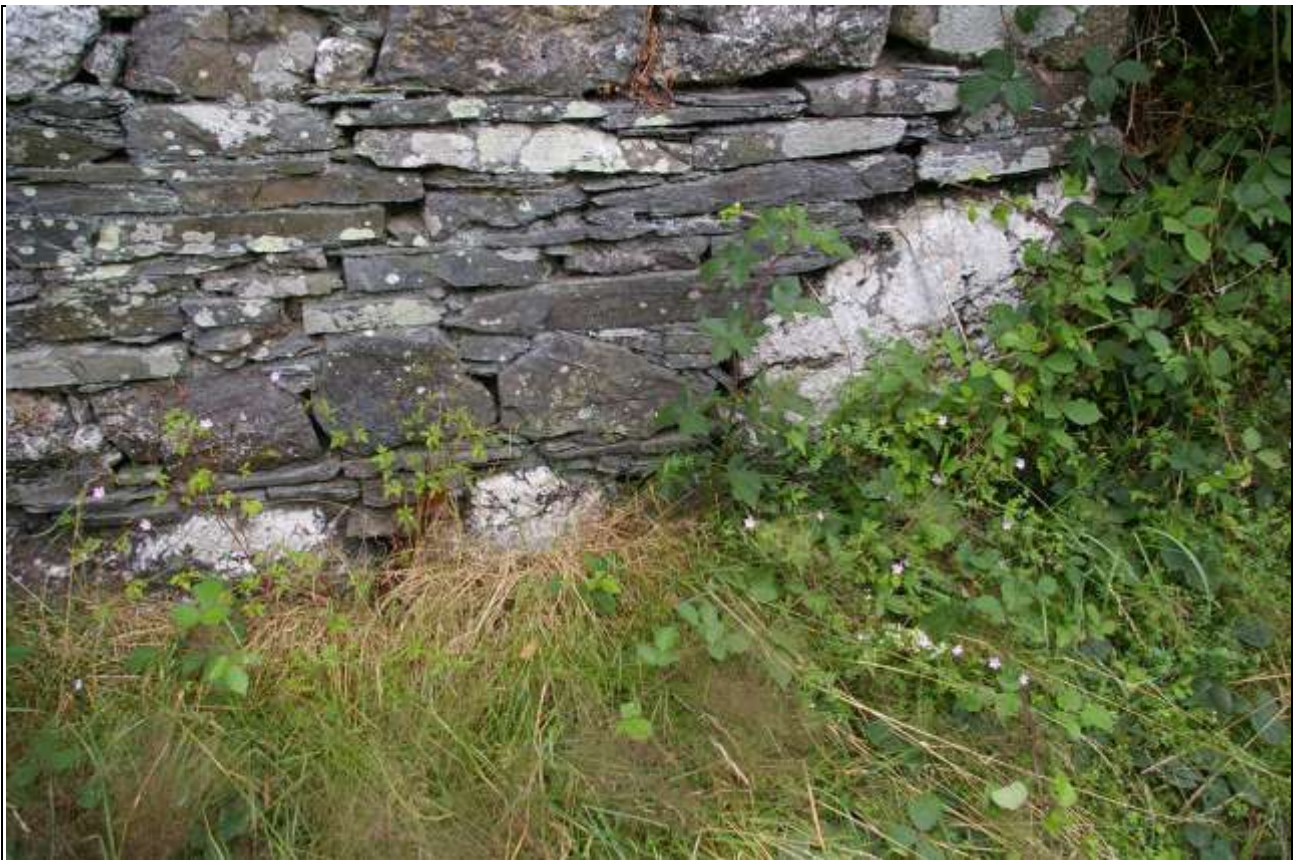
The massive quartz boulders upon which Barn 1 is built, seen in the east elevation; from the south-east.

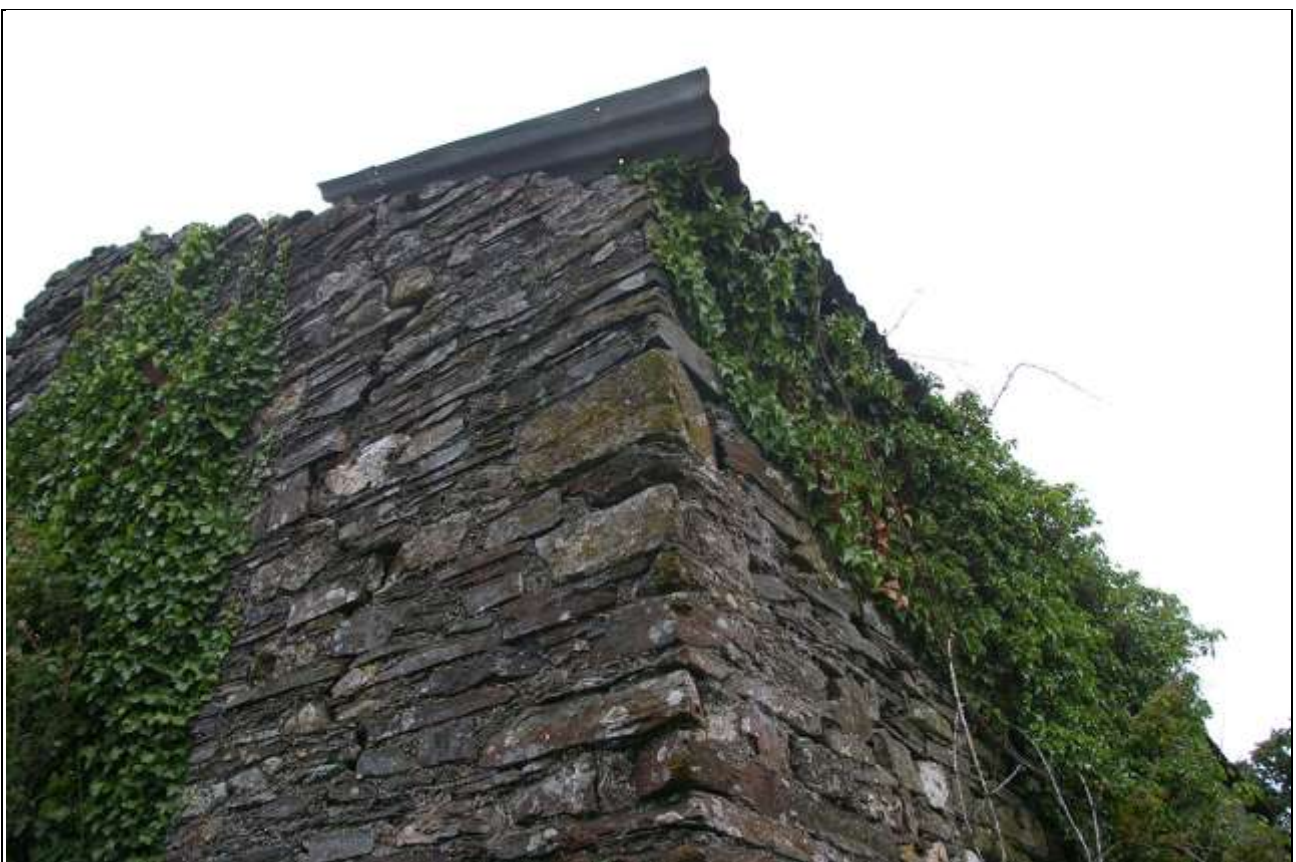
The slatestone quoins in the south-east corner of Barn 2, with two small dressed and faced formal grey limestone type blocks used in the quoins from elsewhere, one which may have been carved; from the south-east.

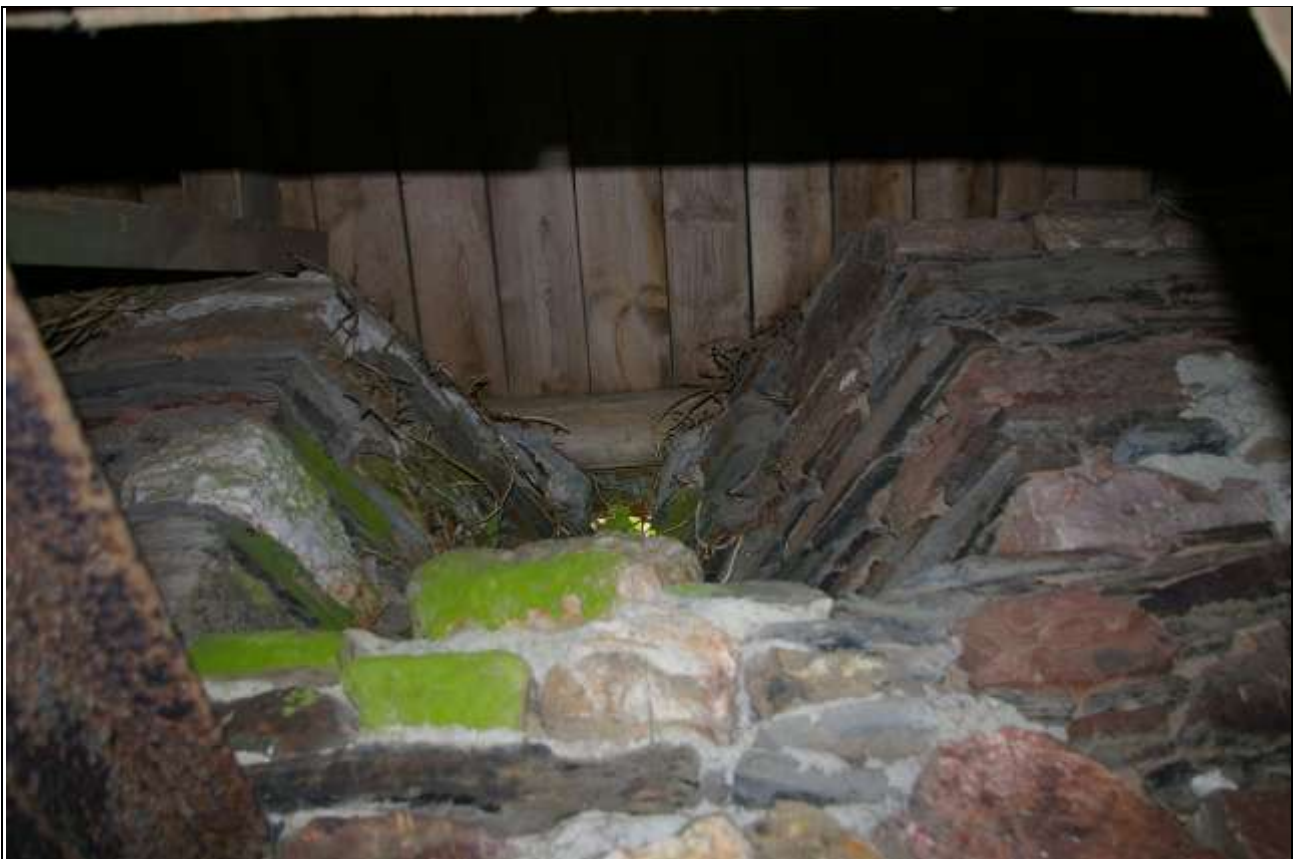
The slit air vent in the east elevation of Barn 2; from the west (below).

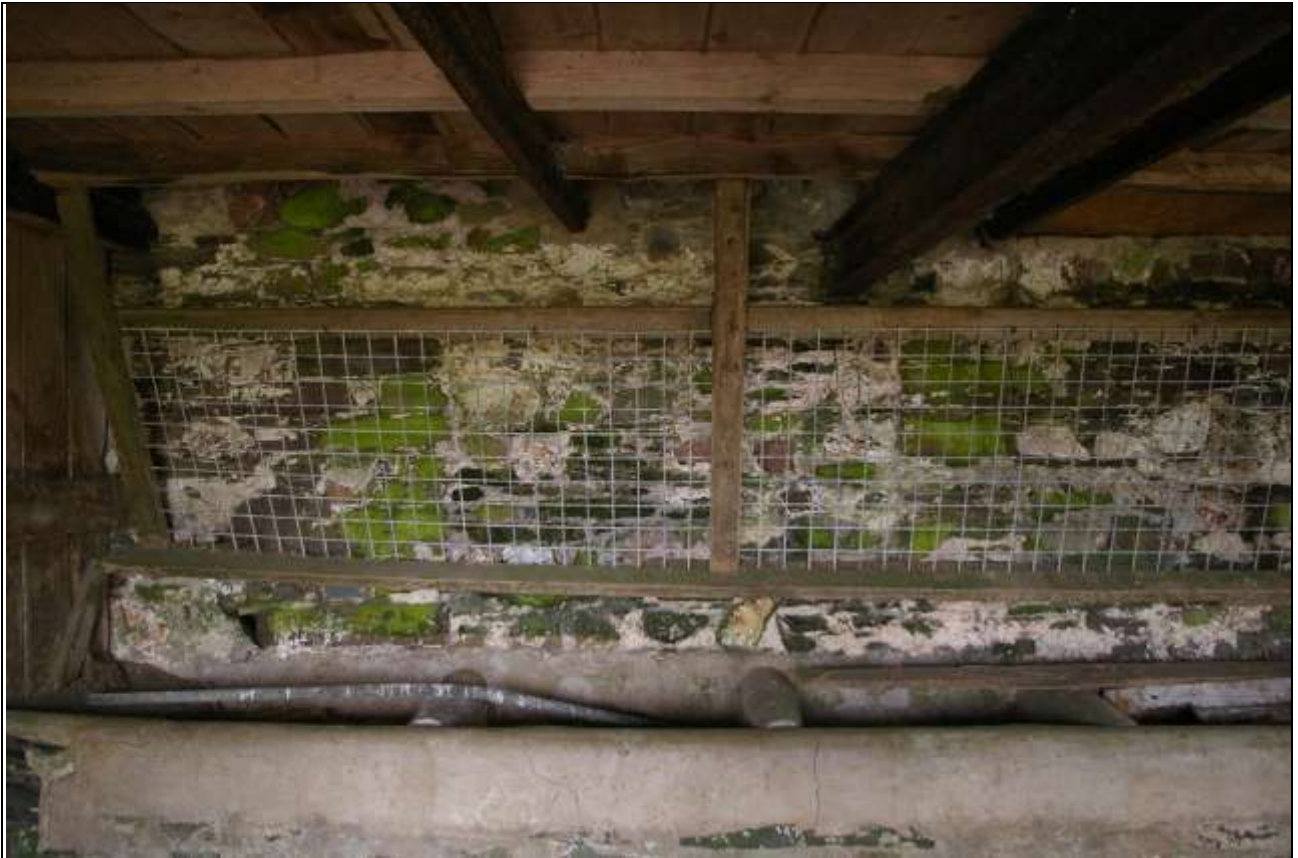
The interior face of the east elevation of Barn 2, with blocked doorway defined by former quoins; from the west.

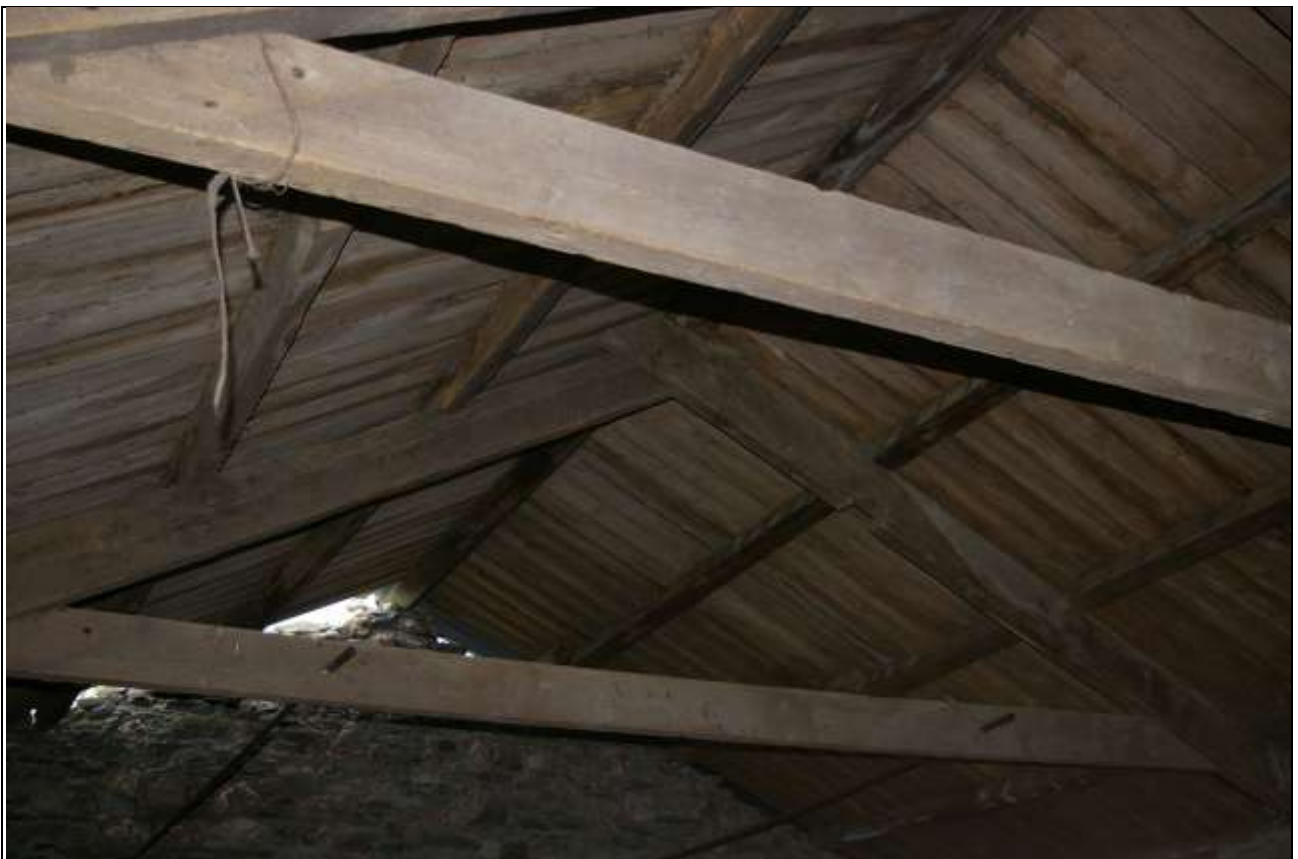
The roof structure over Barn 2; from the north-east.

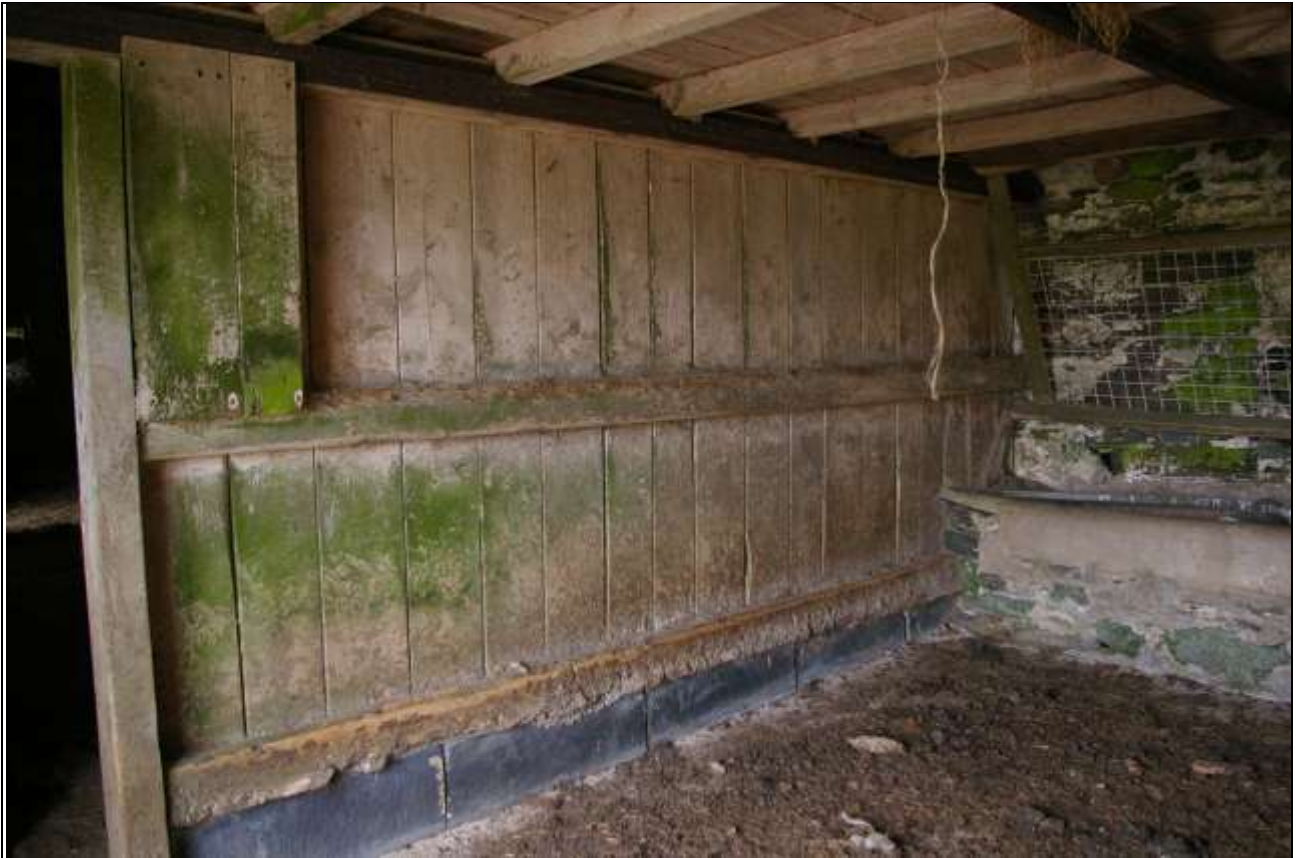
The timber partition between Barn 1 and Barn 2, viewed from within Barn 2; from the west-south-west.

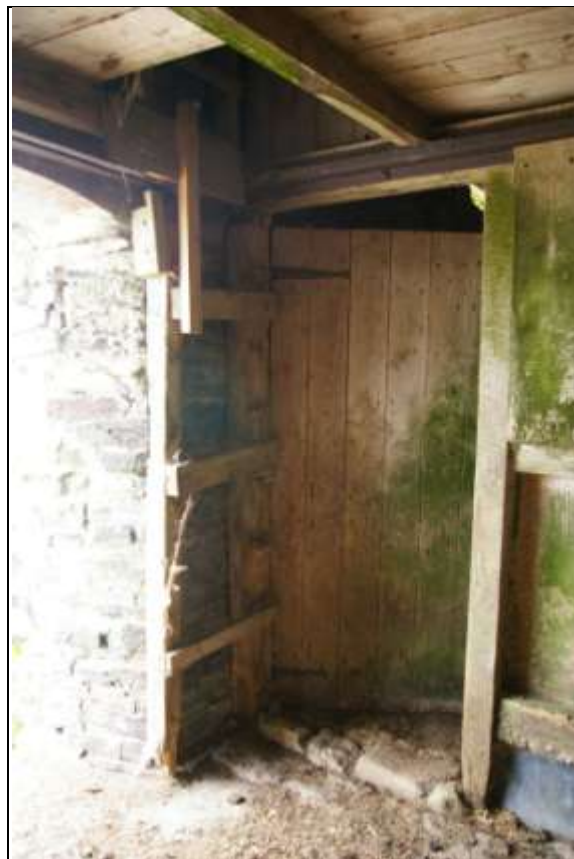
Significant Details:		There is a heavy timber ladder, accessing the current loft which is braced to the partition wall, but has been significantly repaired in recent times, having lost several of its chunky timber rungs.
B2 Elevation SOUTH		Description
Fabric Description:		Tall gable end wall.

The doorway in the partition wall and ladder to the loft in Barn 2; from the south-east.

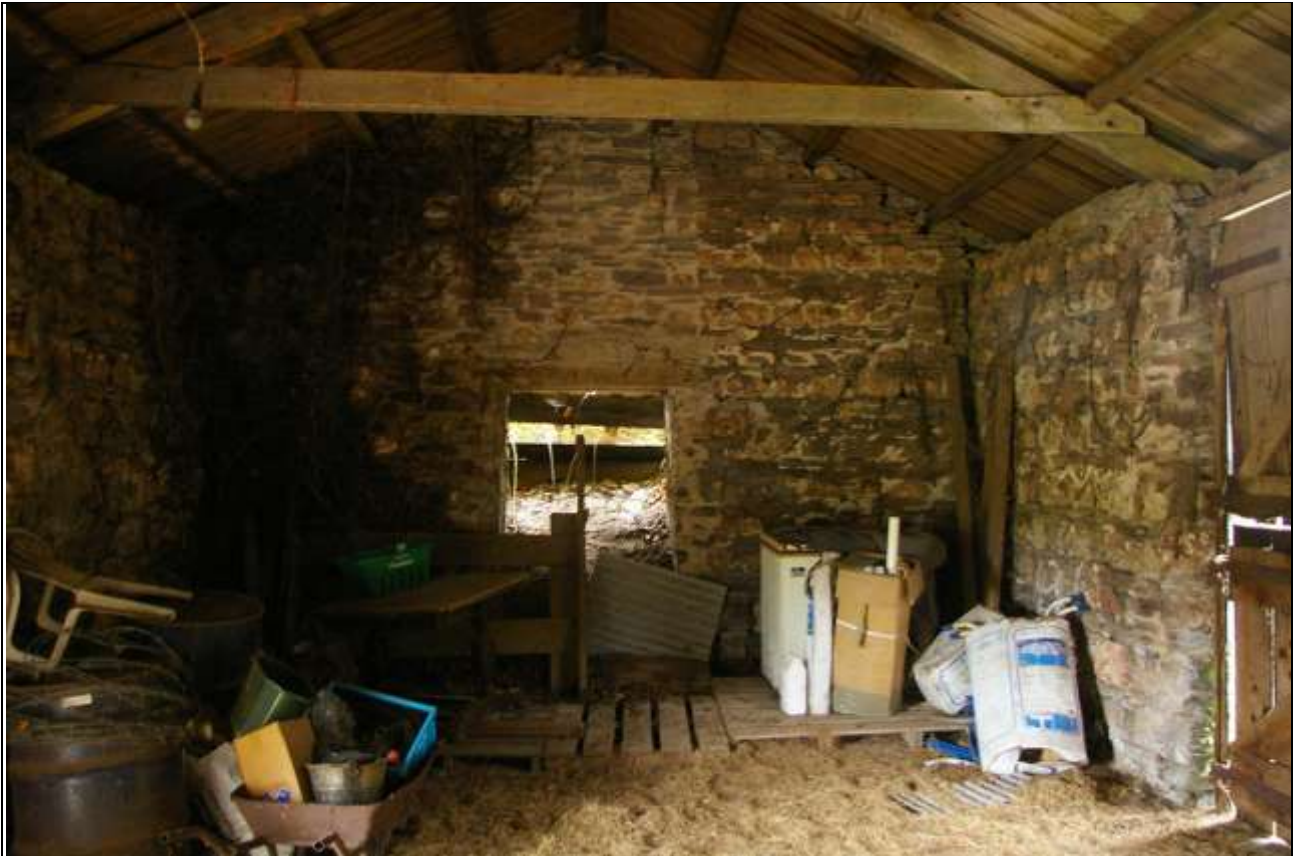
The better quality formally coursed slate slab and quartz stonework to the north end of Barn 1; from the south.

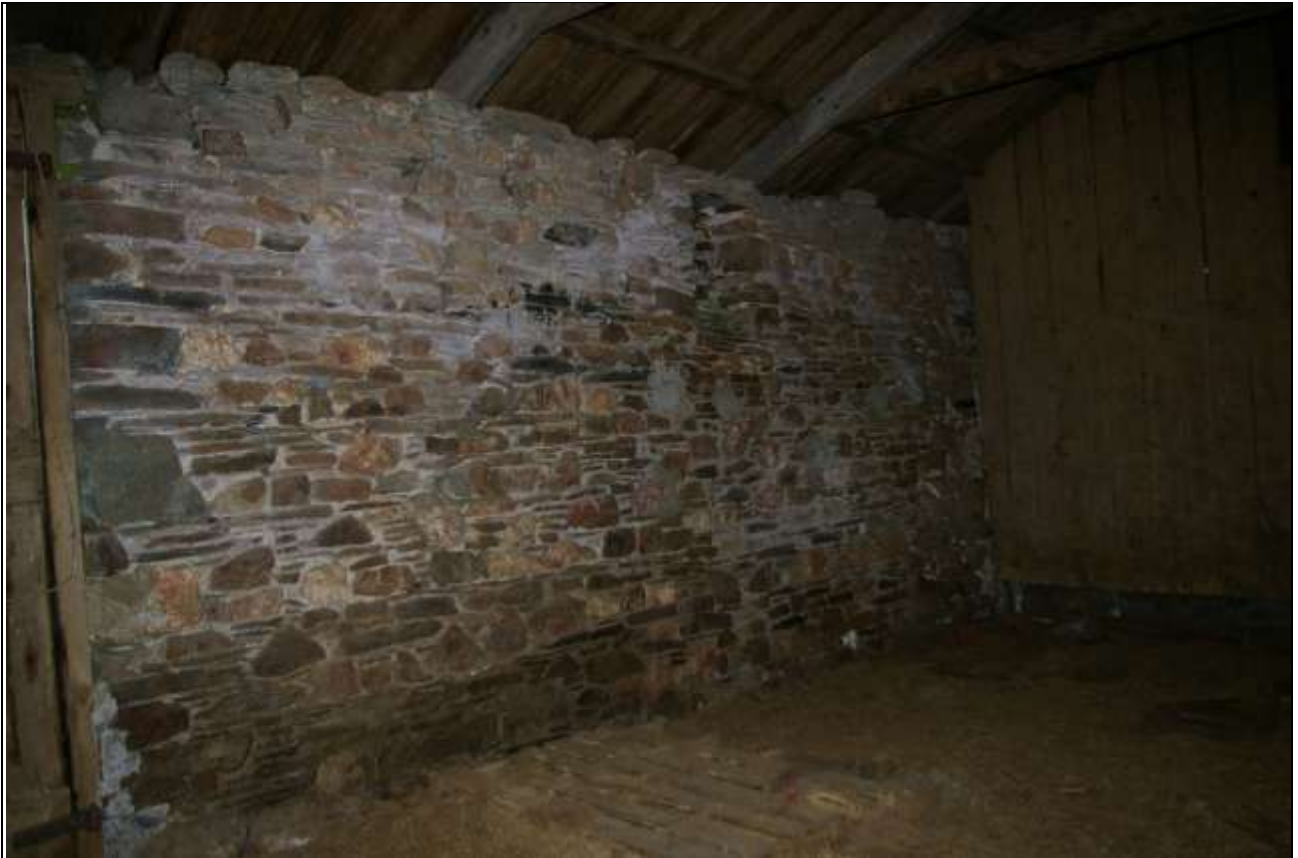
The inner face of the east wall of Barn 1, of similar quality to that to the north end; from the north-west corner.

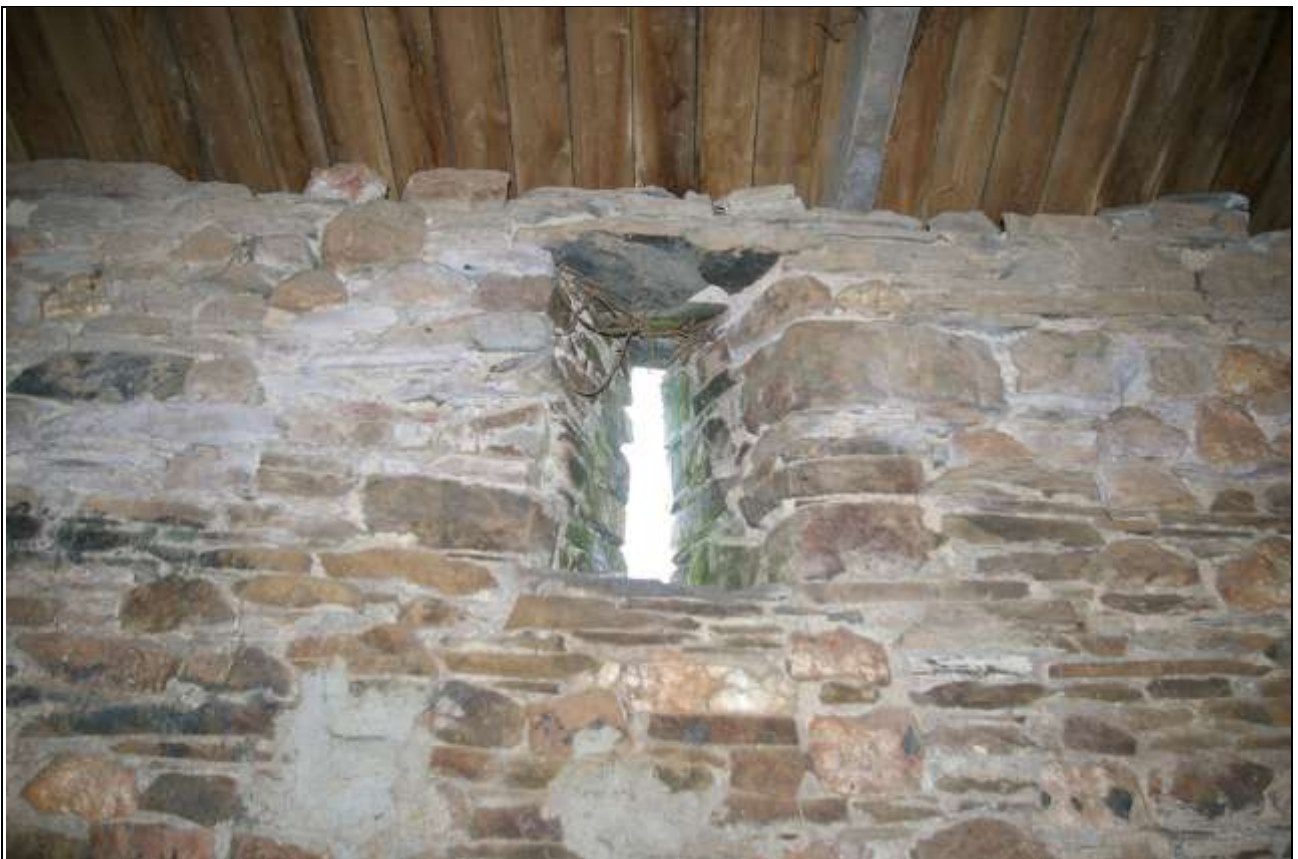
The interior face of the slit air vent in the east wall of Barn 1; from the west.

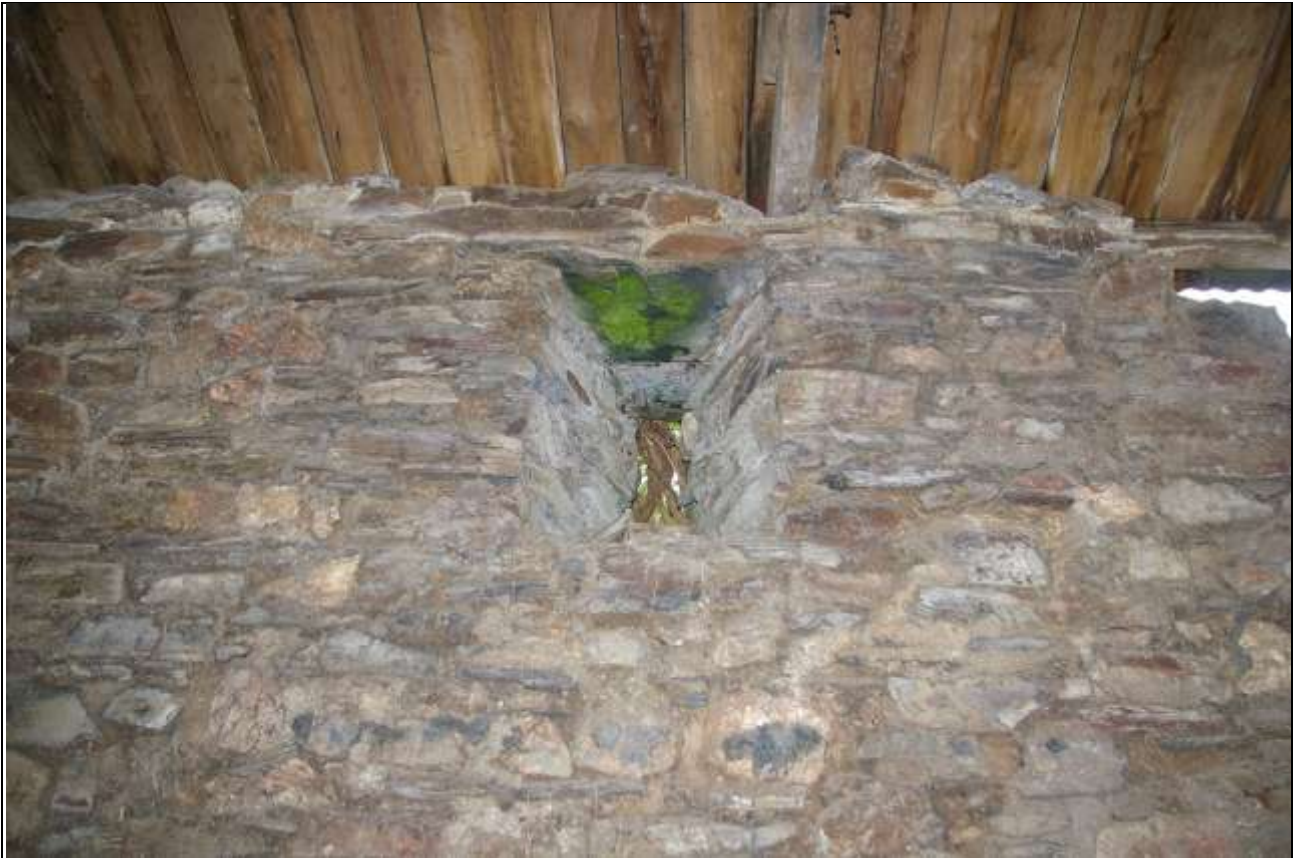
The interior face of the slit air vent in the west wall of Barn 1; from the east.

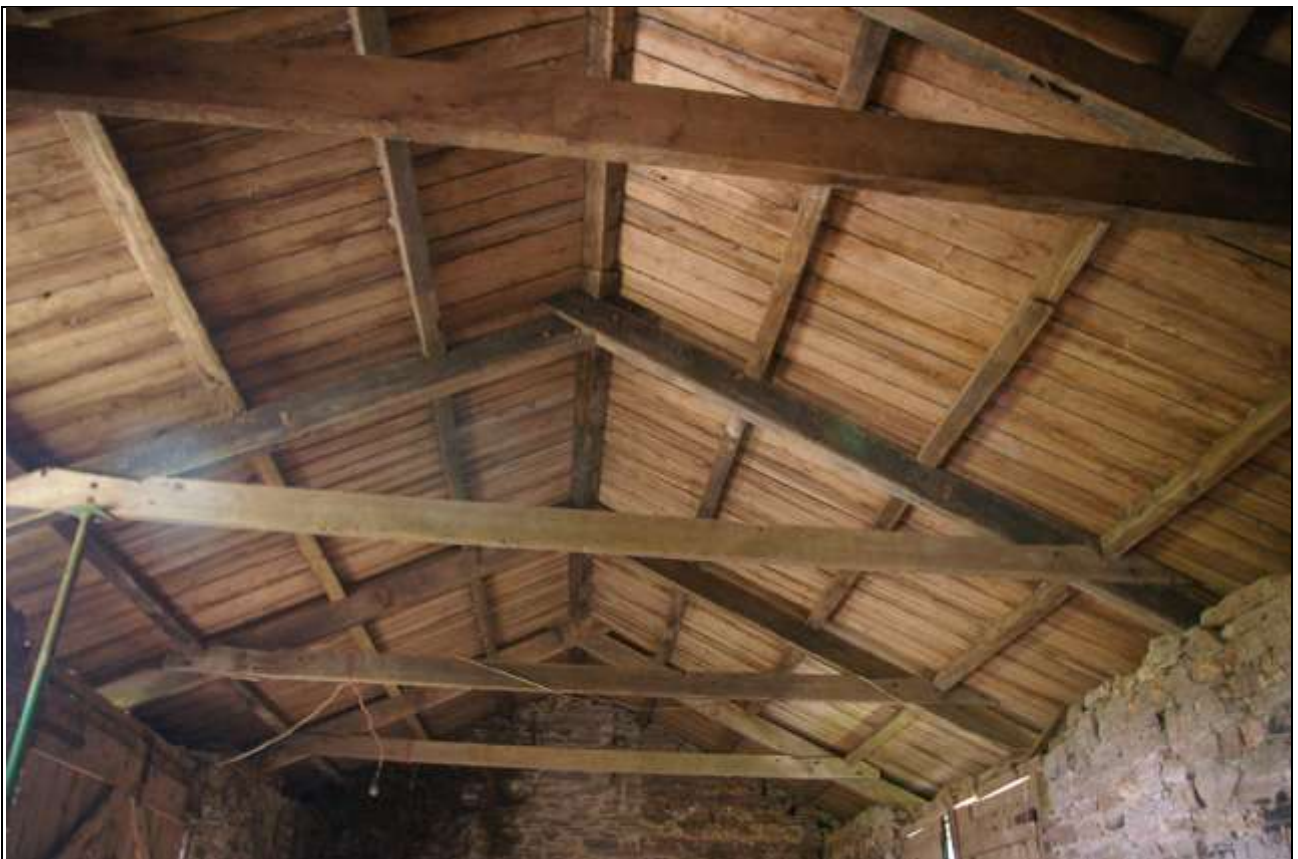
The roof structure in Barn 1; from the south.

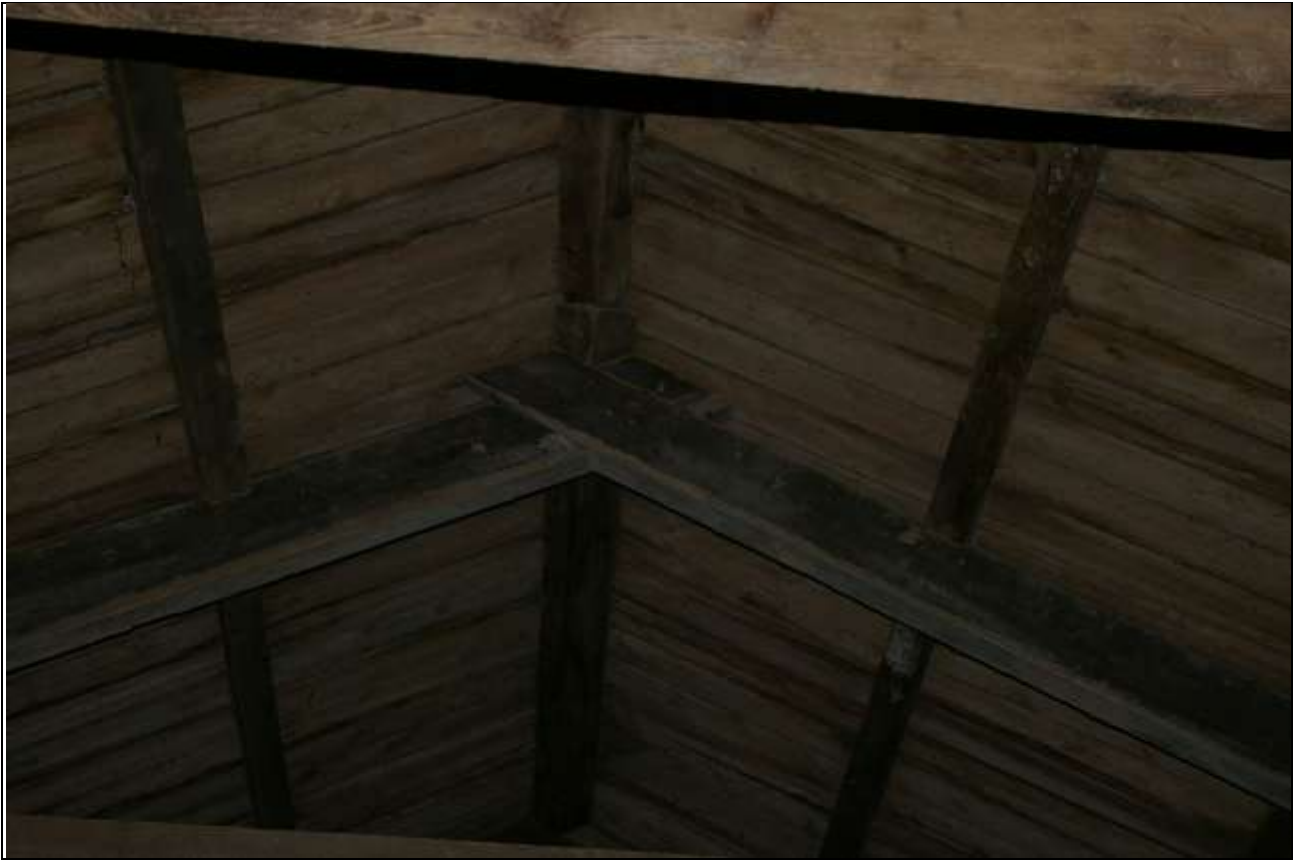
View of the ridge in Barn 1; from the south.
