**YOUNGCOTT BARN
MILTON ABBOT
WEST DEVON
DEVON**

Historic Building Recording

South West Archaeology Ltd. report no. 170913

By N. Boyd & E. Wapshott
Report Version FINAL
13th September 2017

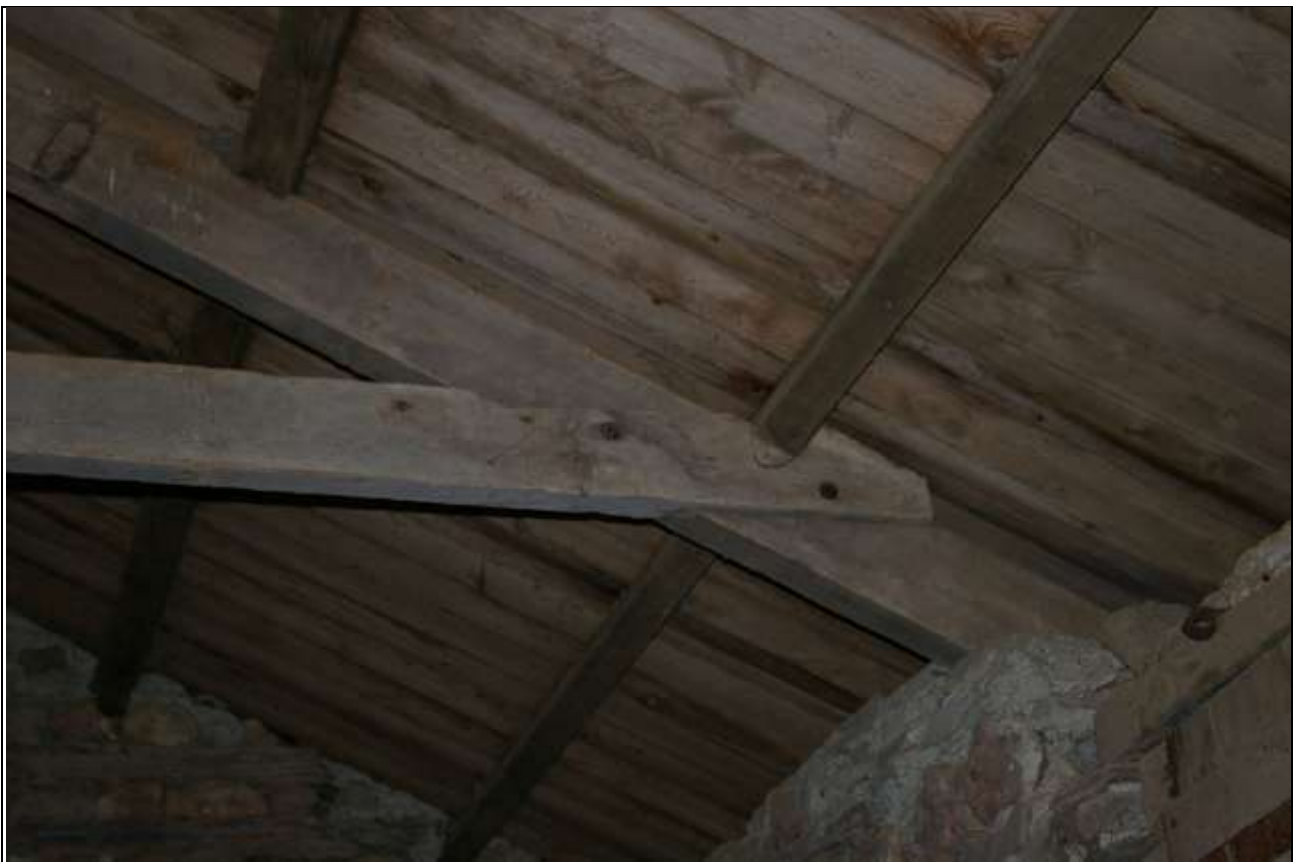
The notched lap joint to the collars, in Barn 1; from the south-west.

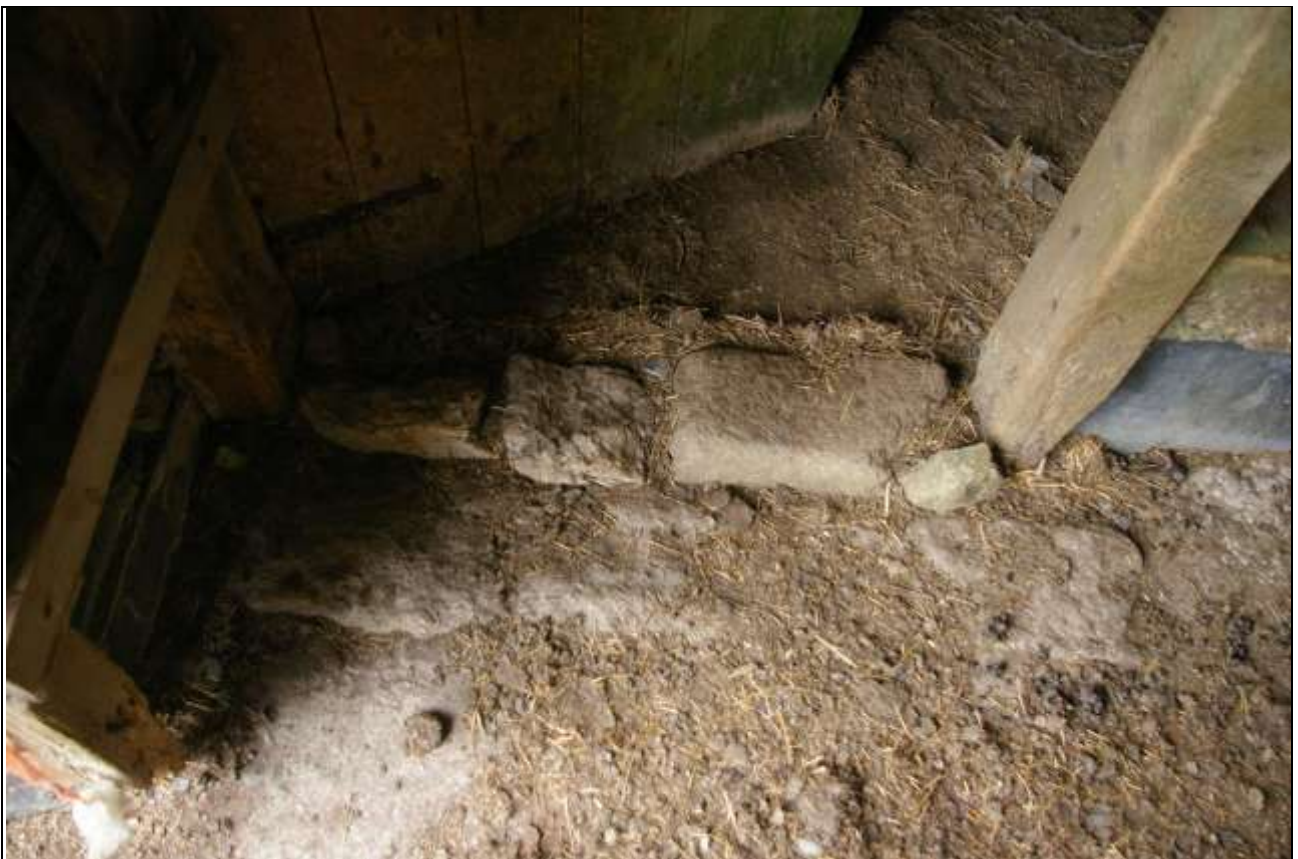
The granite block threshold of the doorway in the partition wall between Barn 1 and Barn 2; from the south.
