MAYOR'S AVENUE TRAVIS PERKINS

DARTMOUTH

Desk-Based Assessment & Historic Building Recording

South West Archaeology Ltd. report no. 181127

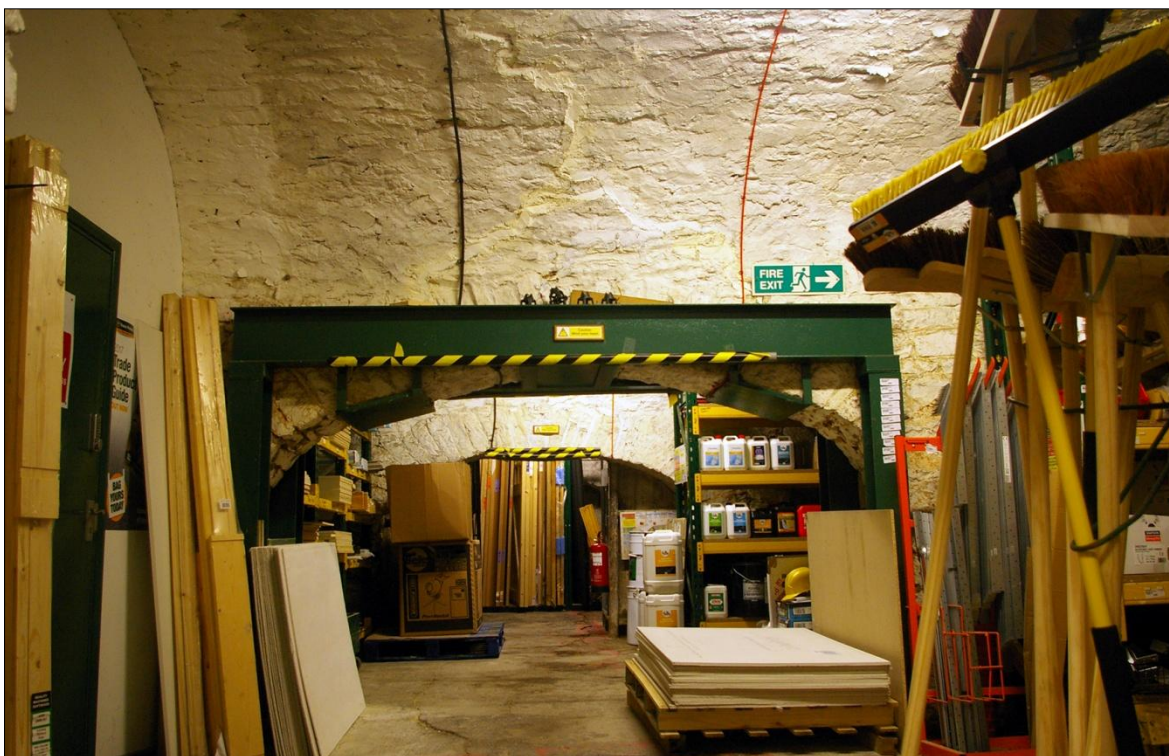
FIGURE 20: THE VAULTS ON THE GROUND-FLOOR LEVEL OF B1, LOOKING THROUGH ARCHWAY D4 TO D7, IN VAULTS V3-V5; VIEWED FROM THE SOUTH.

From the internal walls spring round-arched vaults of narrow mortared slatestone; these have deformed over time and now appear as flattened arches, with the western end of V1 supported by a brick pier. The northernmost vault (V6) is divided by narrow concrete-block walls into toilets, shower room and additional storage/welfare. This vault features a wide blocked forced opening in the north wall (BO23), probably a double-doorway matching the one above on the first floor. The entire east wall of B1 has been rebuilt at an angle to the original structure, with narrow (0.5m) mortared walls of stone rubble; this wall leans out to the east, opening large (up to 50mm) gaps between it and the roof of the vaults. V1 is currently accessed by a forced door (D1) with reset chamfered architrave (lintel re-set upside down) in the south wall from B6. V3 is accessed by a widened opening (D5) in the east wall from B2. Four of the other vaults (V1, V2, V4 and V6) have slightly-offset doorways in the east wall, but these are now blocked. When B1 was built each vault was accessed via a doorway in the west wall. These doorways are all now blocked, but feature heavy curved timber lintels and shaped quoins, with iron pintles, loops catches, spikes and sockets indicating secure door fittings. The small arched window above each door is set into the apex of the vault and was designed to throw light into the chamber; each deeply-splayed window sports *ferramenta* (chunky iron bar with saddlebar). When the bus depot was redeveloped, these blocked openings were revealed (see Figure 23). There are two similar windows in the north wall of V6, though the *ferramenta* have been lost.

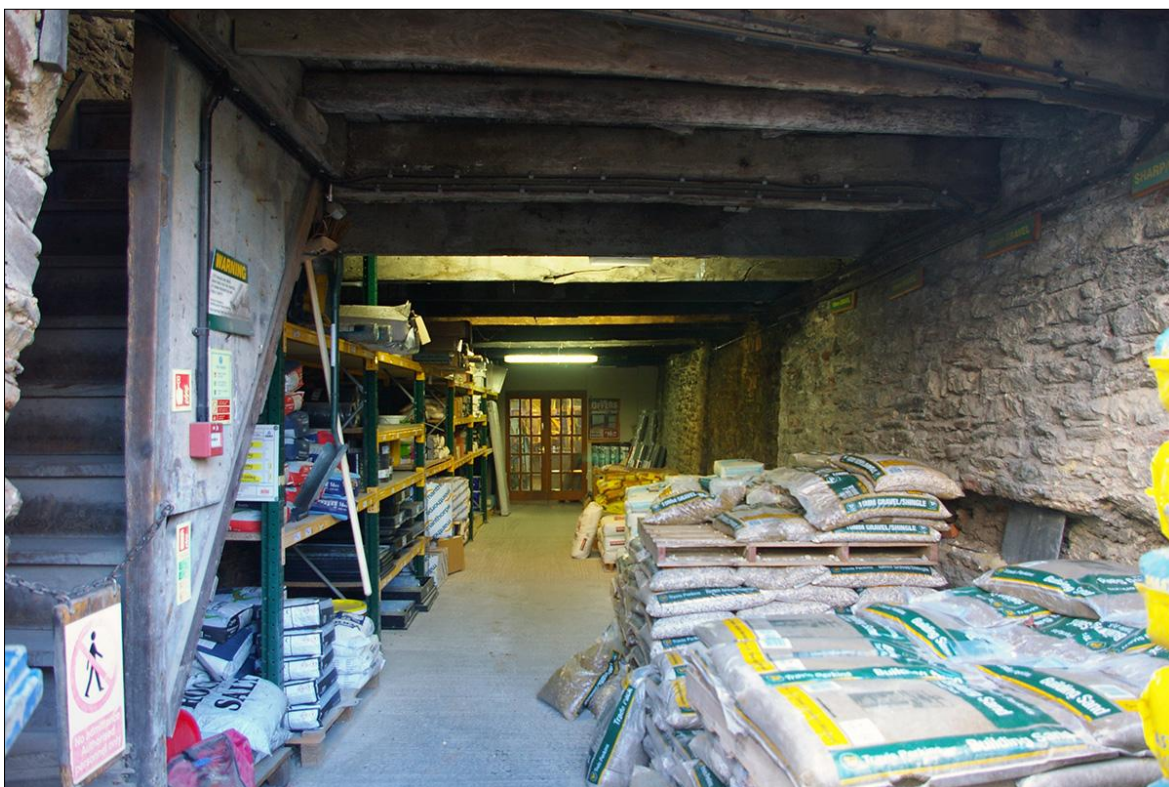
FIGURE 29: THE GROUND-FLOOR INTERIOR OF B3; VIEWED FROM THE SOUTH.

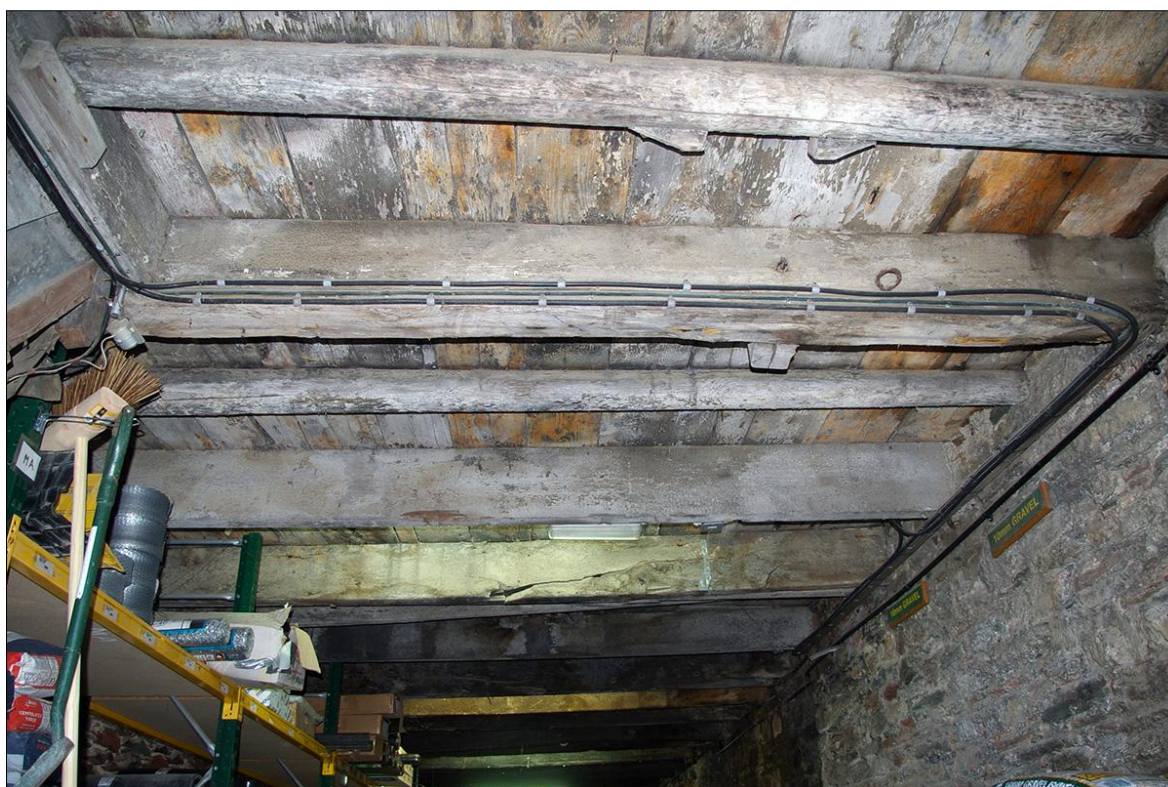
FIGURE 30: SOME OF THE JOISTS IN B3, SHOWING THE REUSE OF SHIPS TIMBERS; VIEWED FROM THE SOUTH.

The joists supporting the first floor contain a range of reused elements, 17th and 18th century in date (S4), with larger beams with deep chamfers and partition slots, peg holes and sockets for timber framing. The heaviest beams are set into the piers in the east wall; less substantial beams, including another ships mast cut in half and another possible base of a ships mast, seen supported within the later stone rubble infill. One heavy beam has anchor graffiti imagery cut into it. The bays in the east wall between the piers are spanned by very heavy chamfered beams; these survive even in those bays now blocked. The simple roof structure or reused timber is bolted and nailed, with tie beams and rafters supported by a range of struts. At the southern end there is a shaped knuckle of wood supports a repaired rafter (S12). Towards the northern end there is a flywheel (marked TANGYES BIRMINGHAM) set into the roof (S24) over a blocked hatch in the floor (S14). The two northern bays contain timber elements, mostly concealed behind building supplies

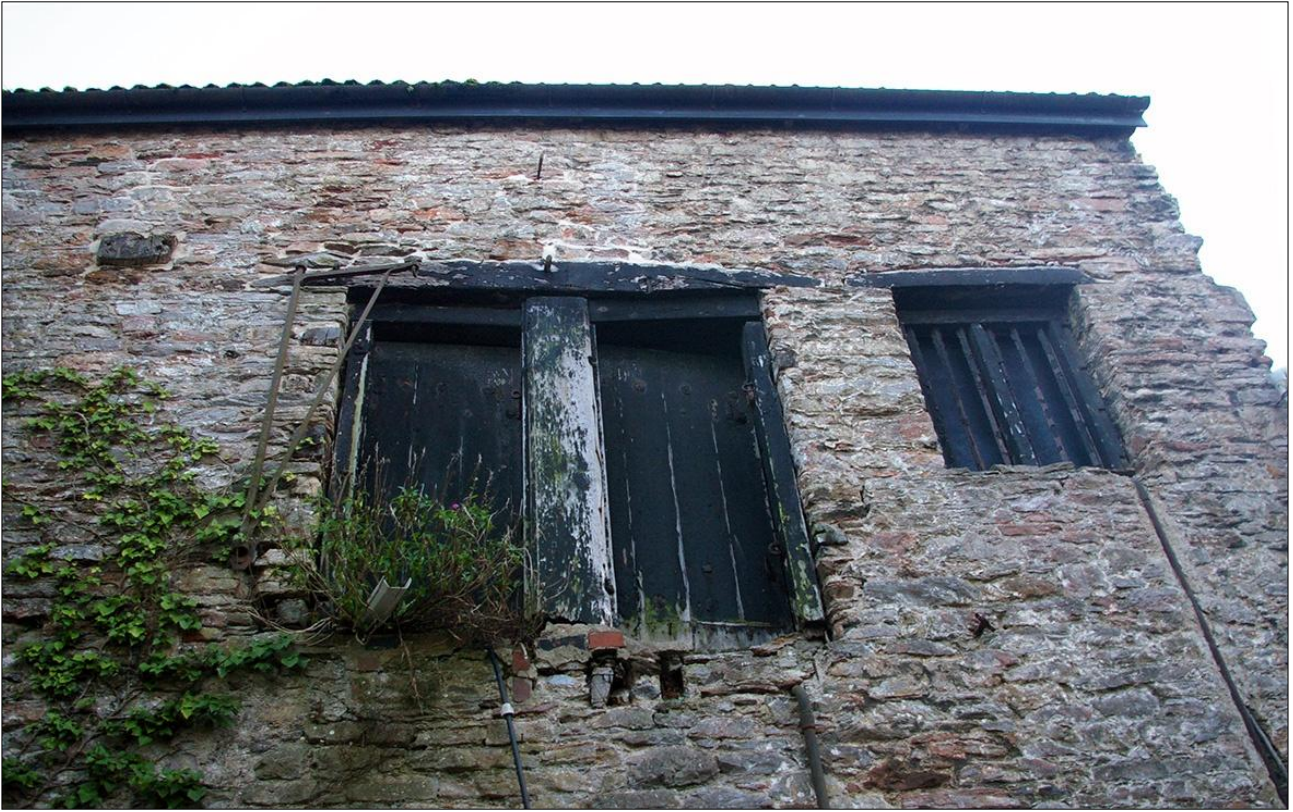
4. THE NORTH ELEVATION OF B1, SHOWING W11 AND FF DOOR 21 (D21) AND DOOR 22 (D22); VIEWED FROM THE NORTH.

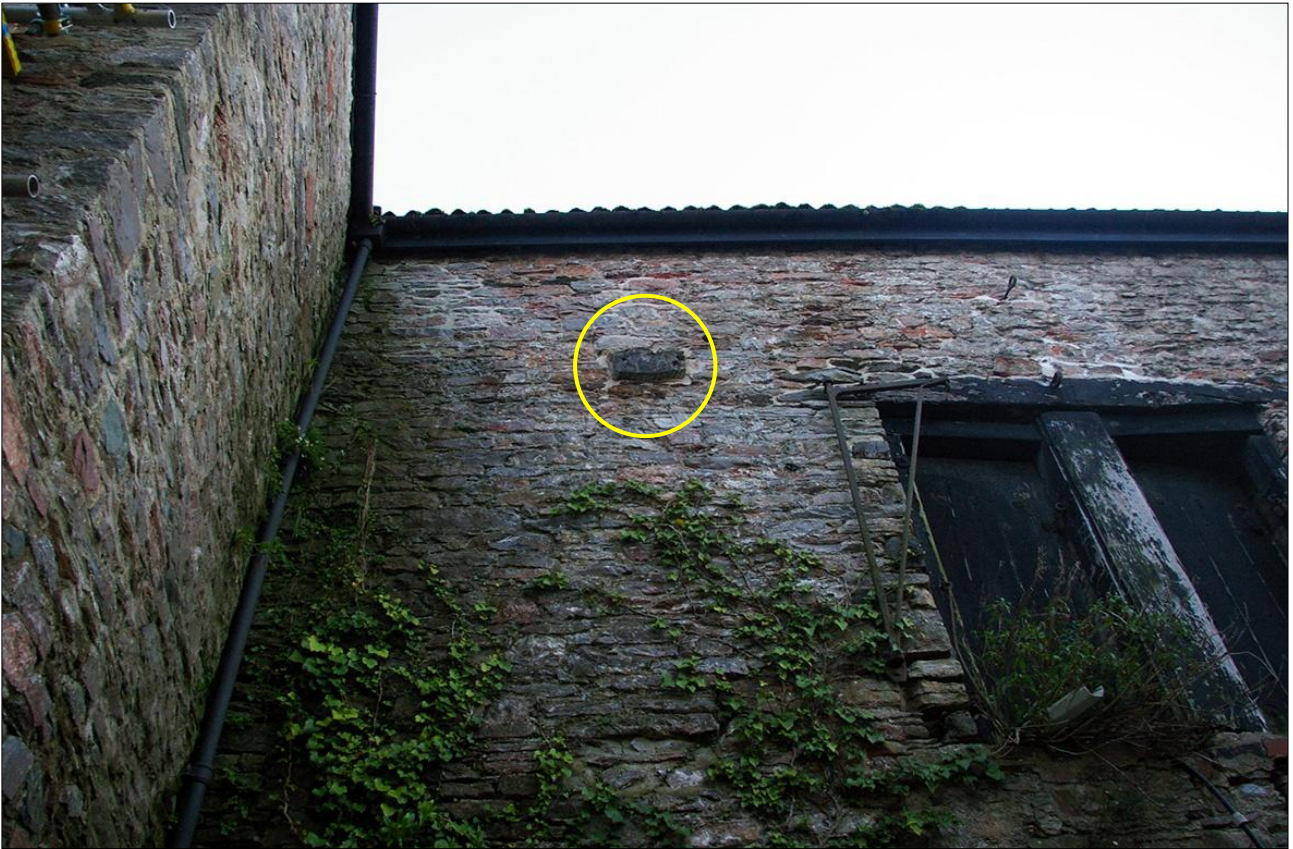
S11	A dragon tie projects into the room from the north elevation; the dragon tie has been sawn off, but features a number of pegged holes on its south-western side.
Room 3		
Function:		Sail-loft, then grain loft, then commercial warehousing.
Walls:		The west and east walls feature a deep structural crack. The late C19 south wall features a wide tall relieving arch of slatestone, and abuts the west wall.
Floor:		Boards over lime and soil, the boards are a mix of wide oak, and elm, and later even-width pine; these date to the C17-C20. As S4 and S9.
Openings – Windows:	W11	FF rectangular window opening with timber lintels. Plains chunky pegged frame with central mullion; the side timbers feature a series of sloping sockets to carry weather boarding (therefore reused from a weather-boarded bay?). Diamond set iron security bars. Thick black paint.
Openings – Doors:	D20	FF narrow doorway to R1, with a chamfered frame and a late C19 heavy framed braced and ledged plank door with heavy strap hinges and a large wooden lock.

5. THE NORTH WALL OF B1, SHOWING THE SHEERLEGS AND THE PROJECTING STUB OF THE DRAGON TIE S11 (INDICATED); VIEWED FROM THE NORTH.

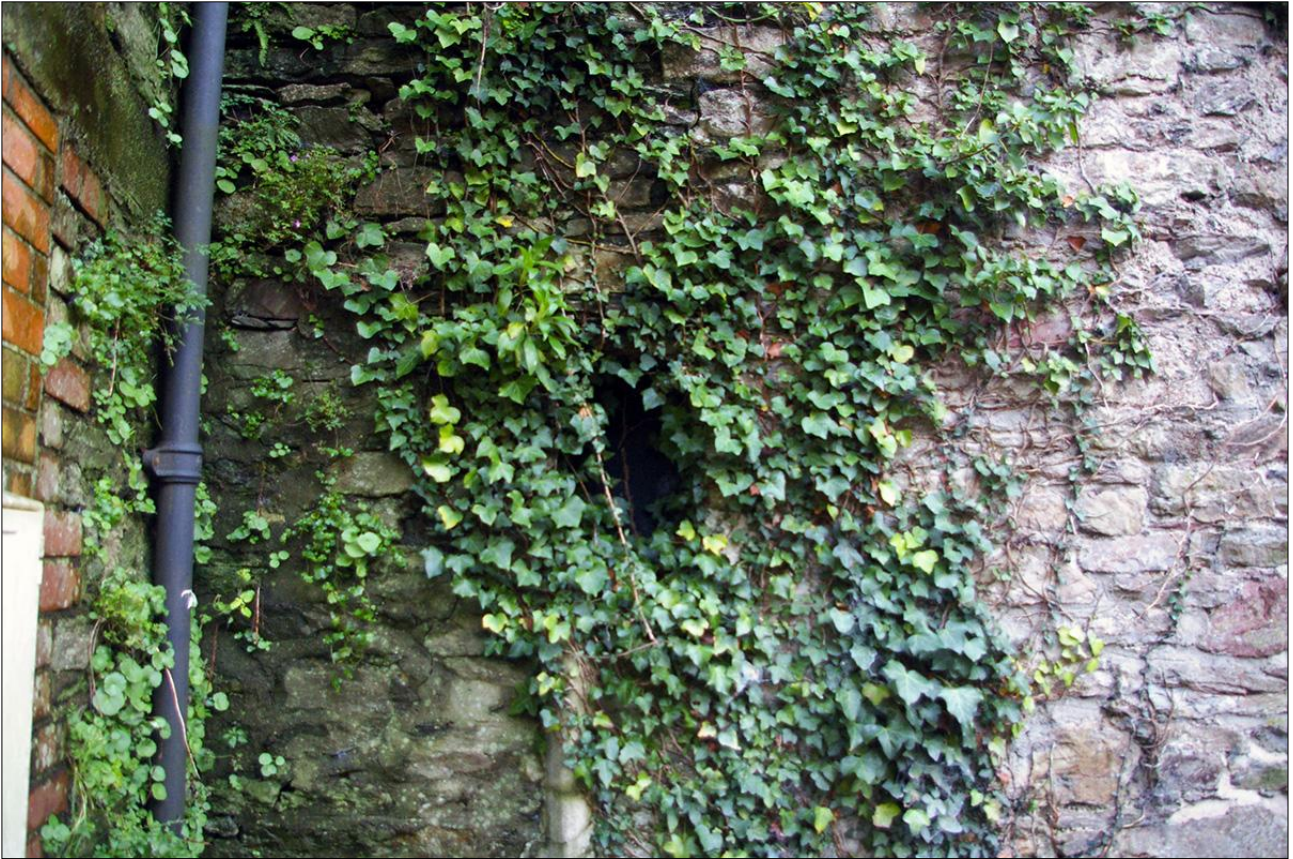
9. THE NORTH WALL OF B1, SHOWING GF WINDOW W8; VIEWED FROM THE NORTH.

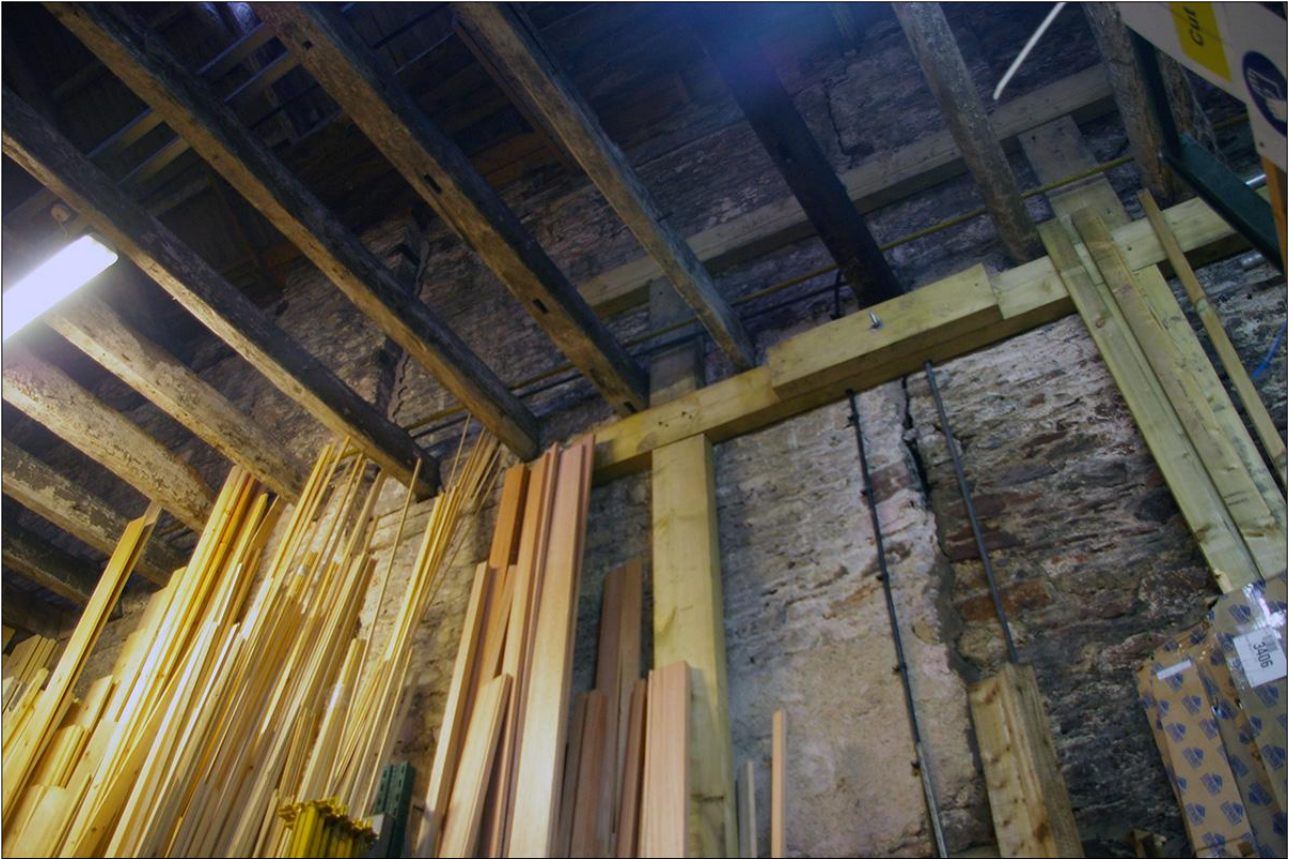
13. THE NORTHERN PART OF THE EAST WALL OF B1; VIEWED FROM THE ENE.

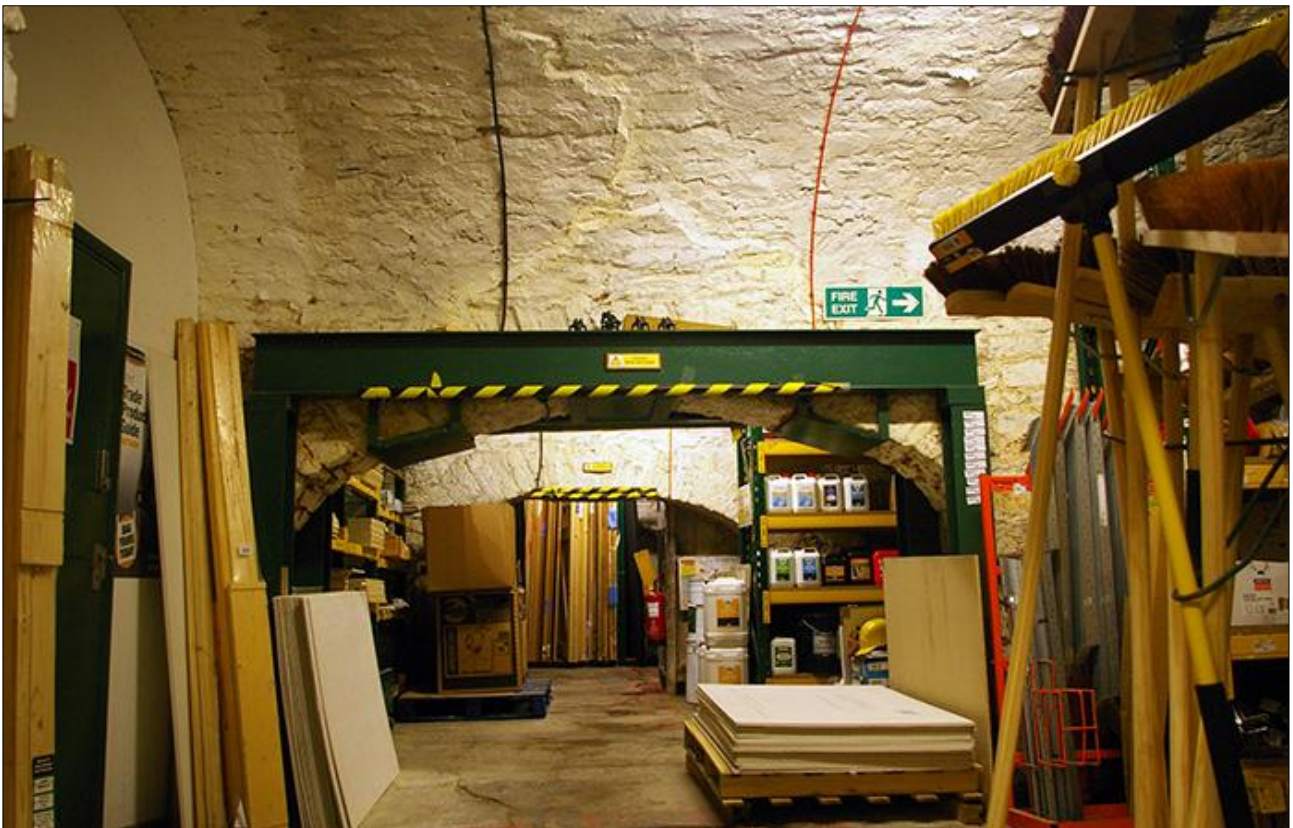
39. B1 GF, LOOKING THROUGH STEEL REINFORCED D4 FROM V3 INTO V4; VIEWED FROM THE SOUTH.

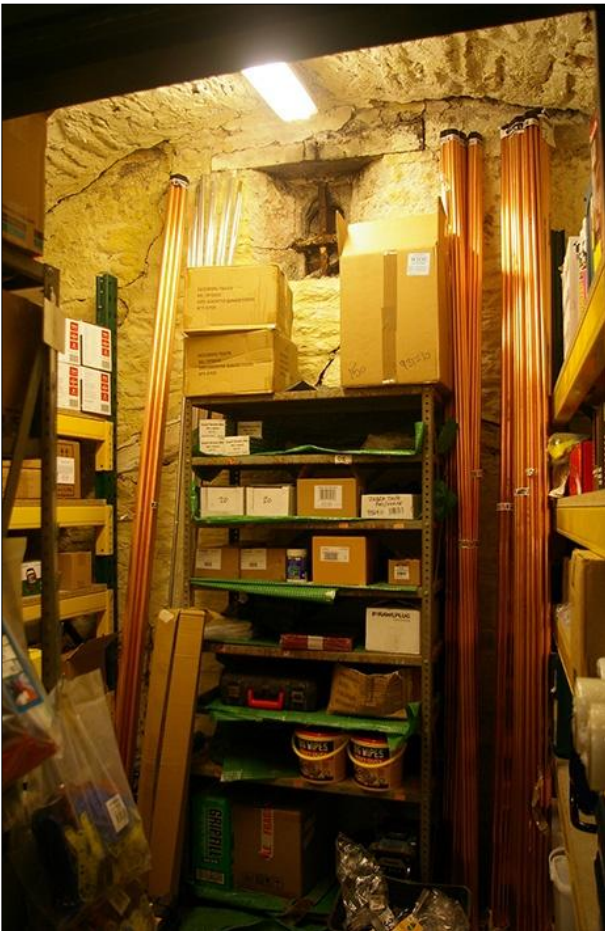
41. B1 GF, THE INTERIOR OF THE MODERN PARTITION IN V3 SHOWING W3; VIEWED FROM THE EAST.

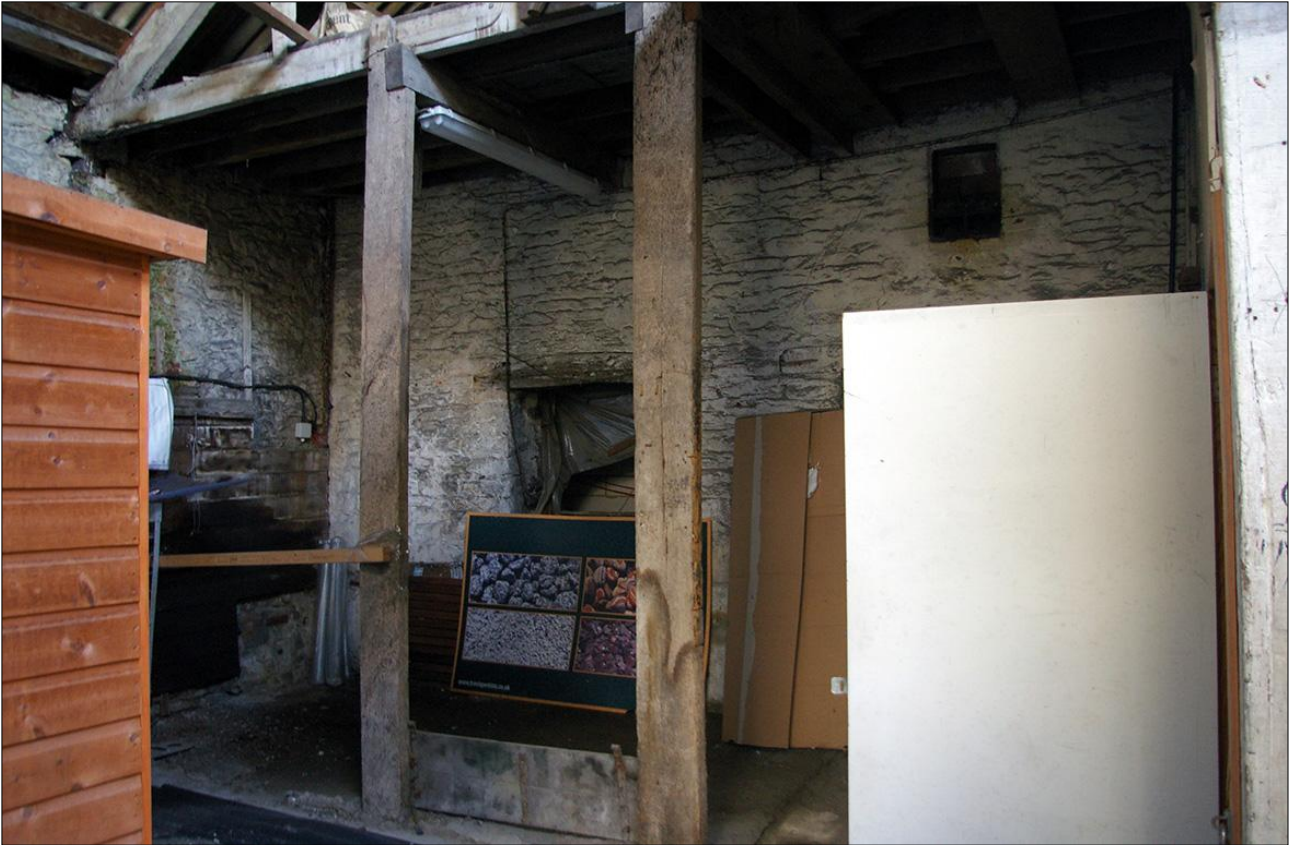
54. RIGHT: B1 FF R1, VIEW TO FF LOADING DOORS D16, WITH FORCED OPENING S15 AND BAG HOIST S16 ABOVE; VIEWED FROM THE NORTH.

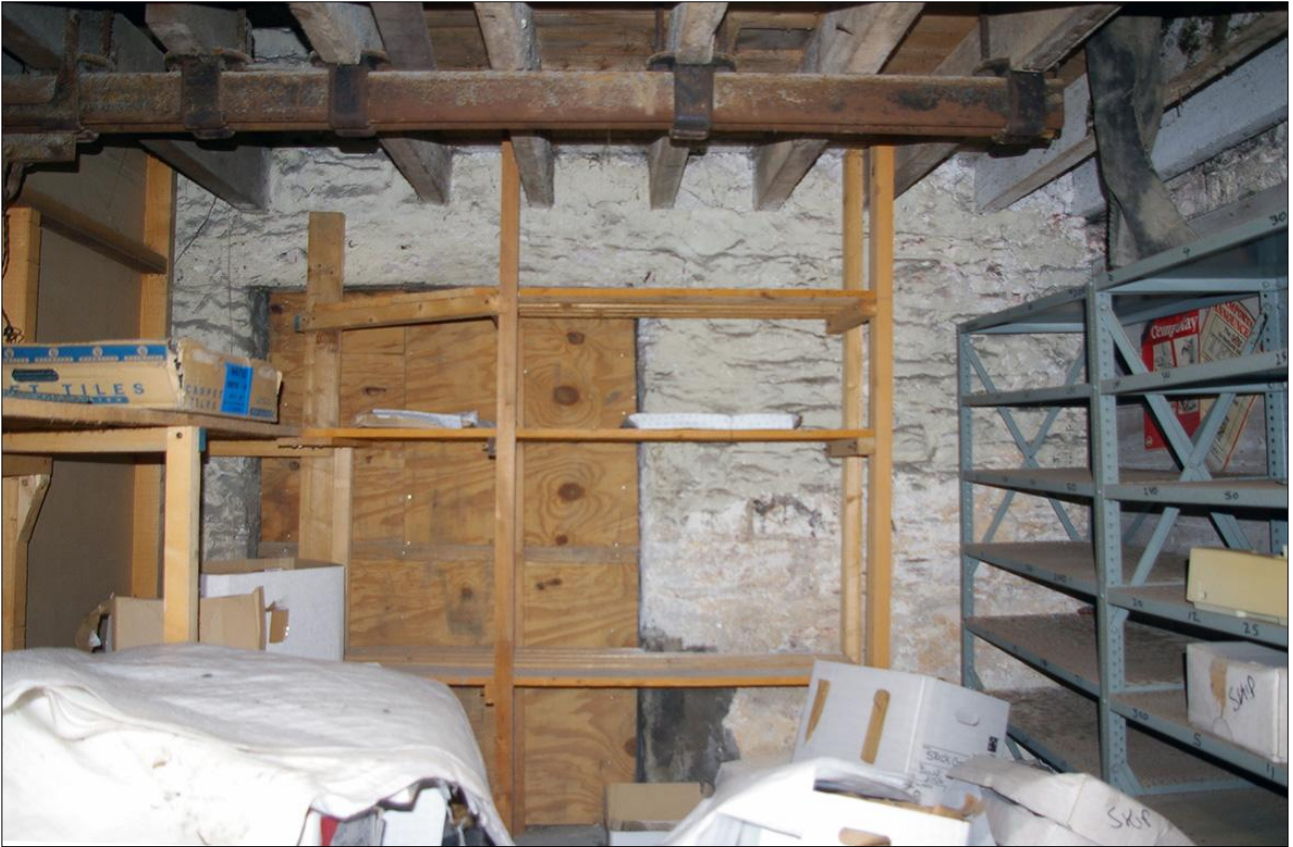
61. B1 FF R1A, VIEW OF BOARDED WINDOW W10, WITH RAIL FOR BAG HOIST AND LEATHER SLEEVE (RIGHT) ABOVE; VIEWED FROM THE NORTH.

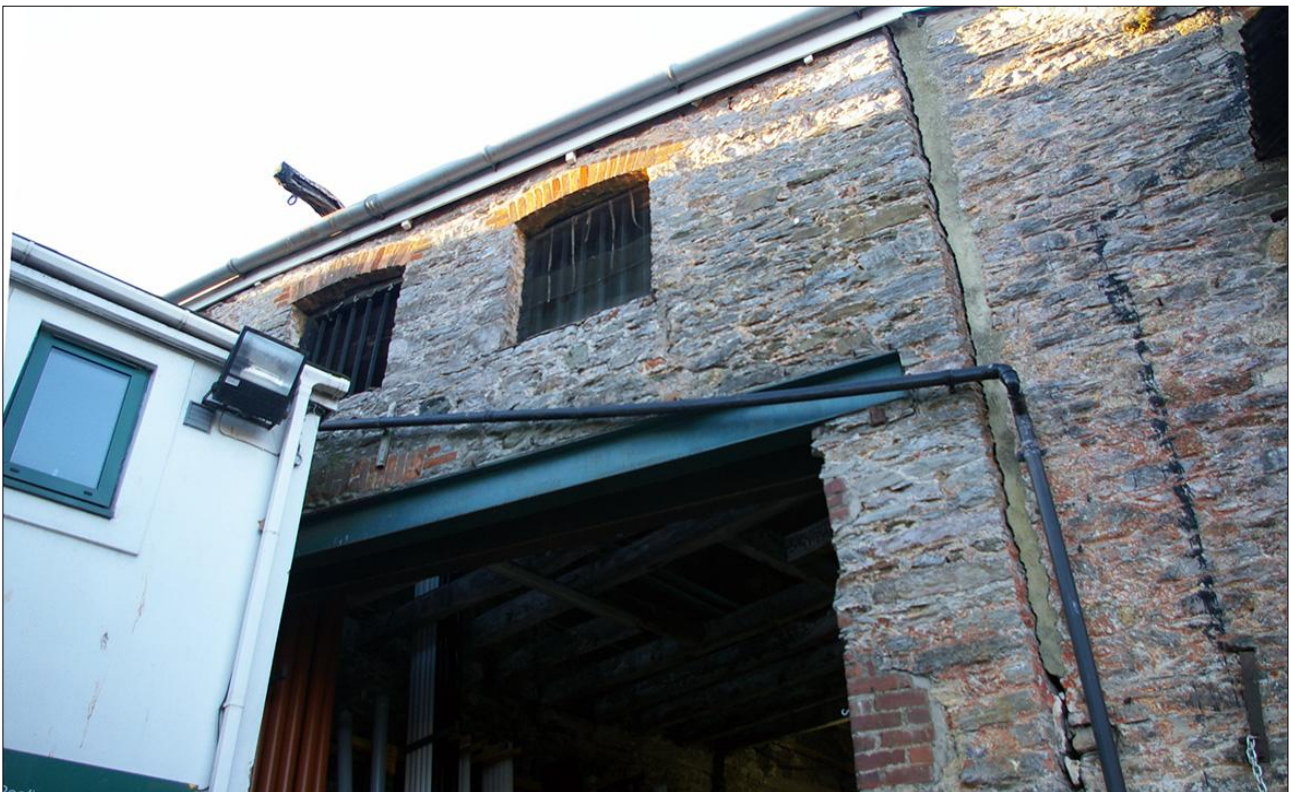
Openings – Doors:	D5	GF forced doorway to B1, repaired in concrete block with a concrete lintel. Probably an opening like BO7-BO8 but much enlarged.
	D12	GF and FF tall wide modern forced opening in the south wall, heavy RSJ lintel, with reveals patched with cement and brick.
Openings – windows:	W12	FF square window opening. Forced or widened, with west reveal rebuilt in brick. Thin timber lintel, pegged frame with central mullion, pintles for shutters, set with thin modern iron bars.
	W13	FF square window opening. Forced or widened, cutting the blocked fireplace FP2. Plains chunky pegged frame with central mullion. Diamond-set iron security bars, pintles for shutters. Thick black paint. Similar to W11 and W21.
	W18	SF square window opening in south wall, paired with W19. Brick segmental arch. The window has a heavy plain frame with pegged joints, six wooden diamond-set security bars, painted black. Covered with modern mesh to prevent pigeons.

94. THE SOUTH ELEVATION OF B2, WITH LARGE FORCED GF OPENING D12 WITH W18 AND W19 ABOVE; VIEWED FROM THE SSE.

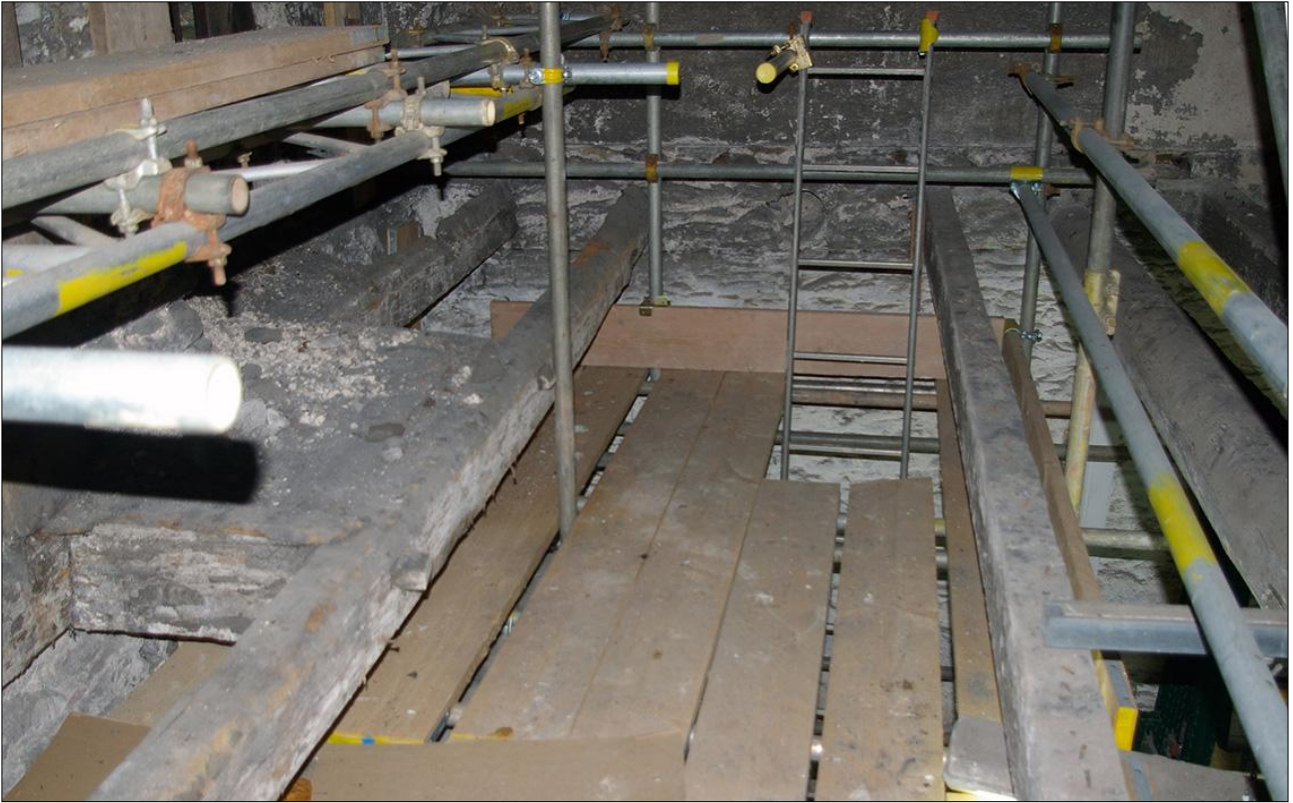
125. B2 SF INTERIOR, DETAIL OF THE BEAMS AT THE SOUTHERN END OF B2; VIEWED FROM THE WEST.

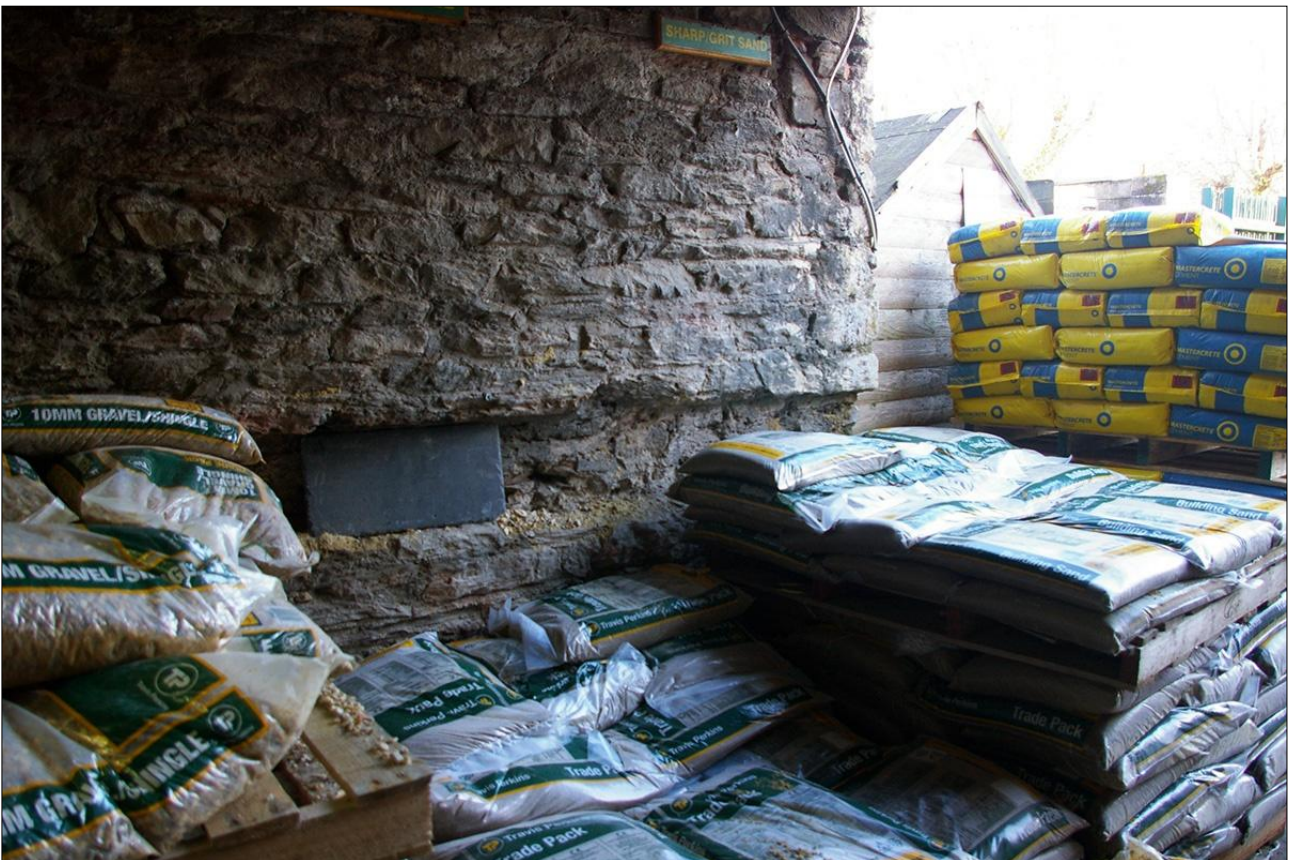
144. B3 GF INTERIOR, DETAIL OF A GROOVE IN THE STONWORK IN THE EAST WALL TO D13; VIEWED FROM THE WNW.

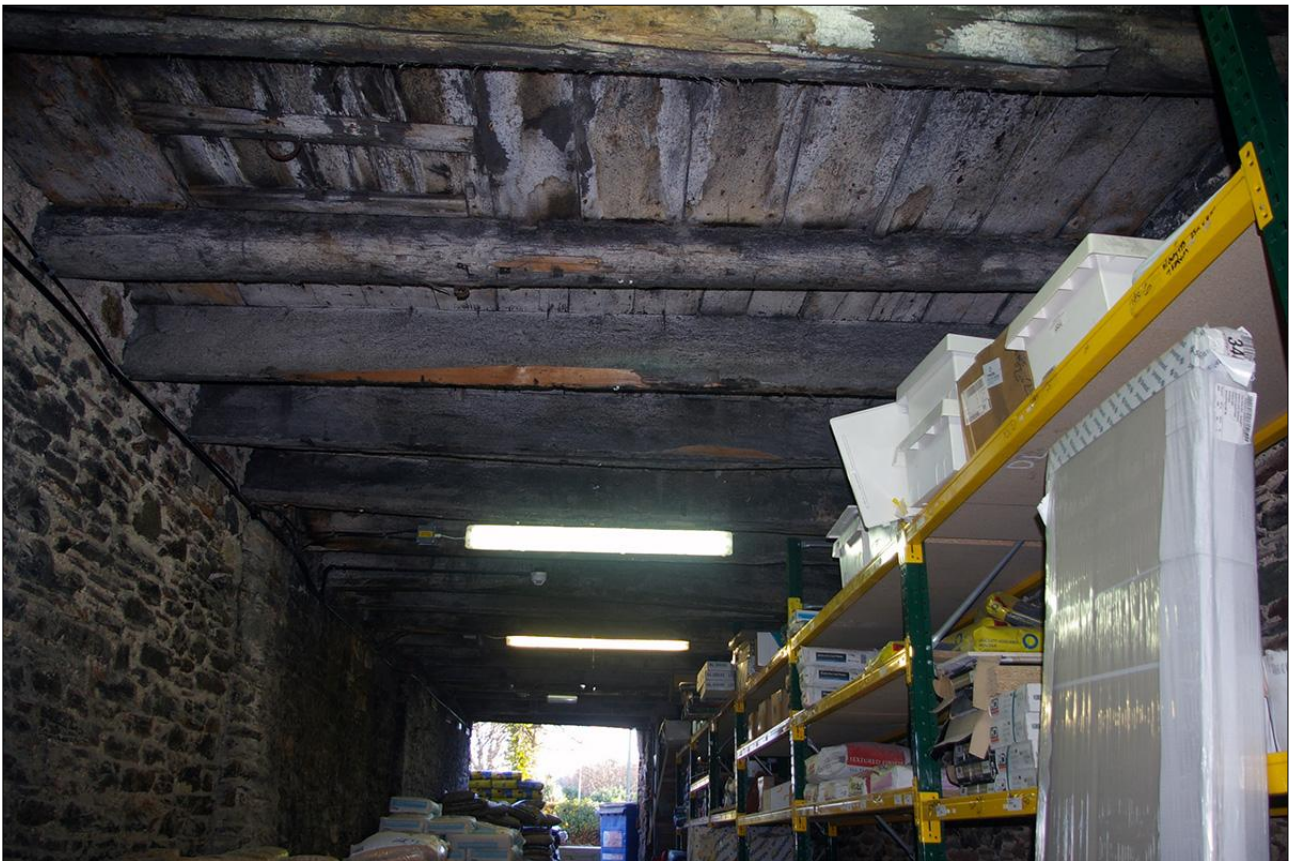
150. B3 GF INTERIOR, DETAIL OF THE MANY RE-USED BEAMS, INCLUDING SHIPS TIMBERS; VIEWED FROM THE NORTH.

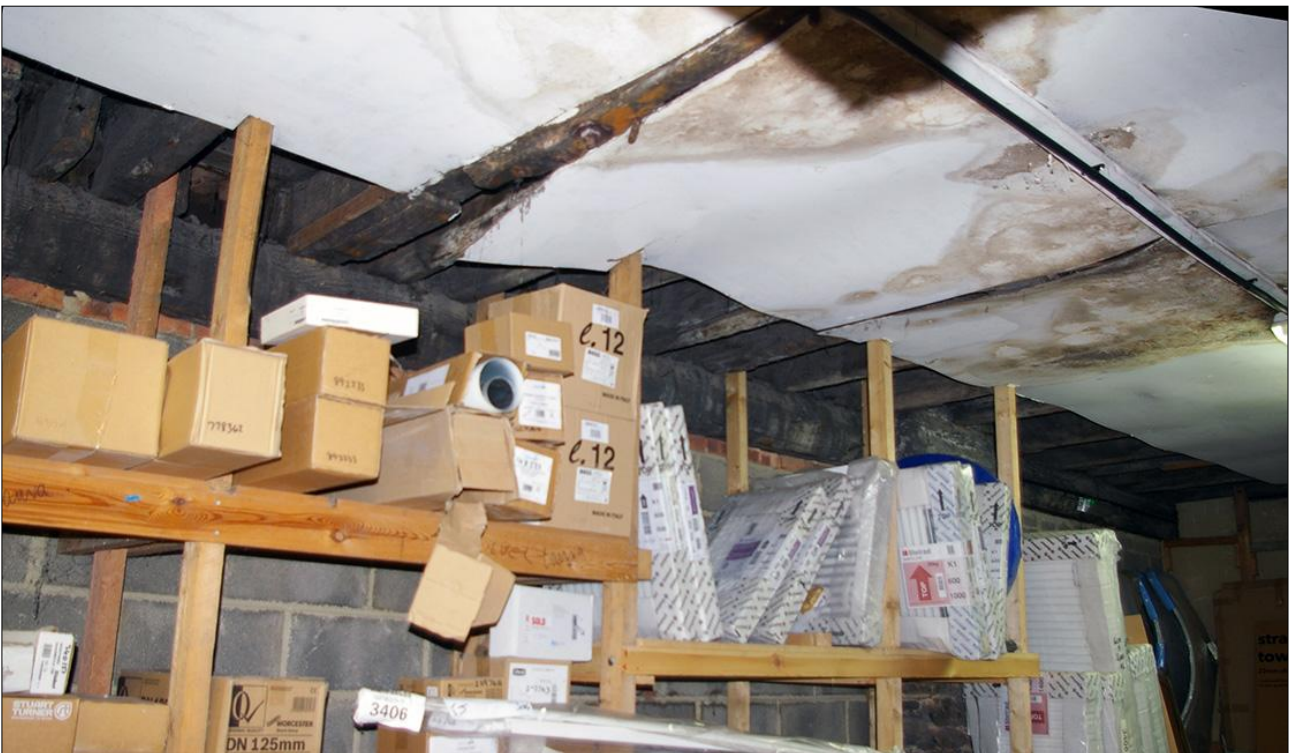
158. B3 GF INTERIOR, THE NORTHERN END, SHOWING MODERN BLOCKING TO THE EAST; VIEWED FROM THE WNW.

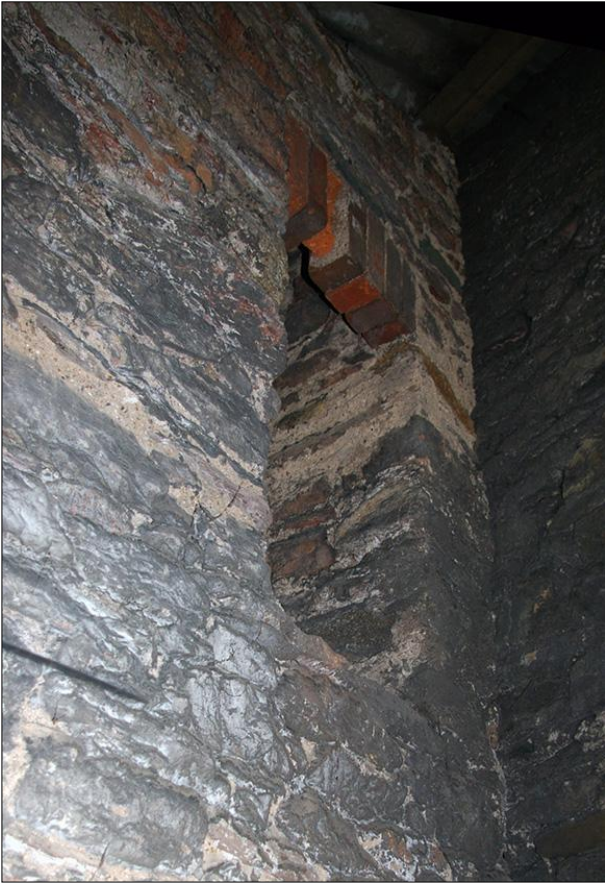
170. B3 SF INTERIOR, DETAIL OF FP4 ABOVE THE STAIRS; VIEWED FROM THE NORTH-EAST.

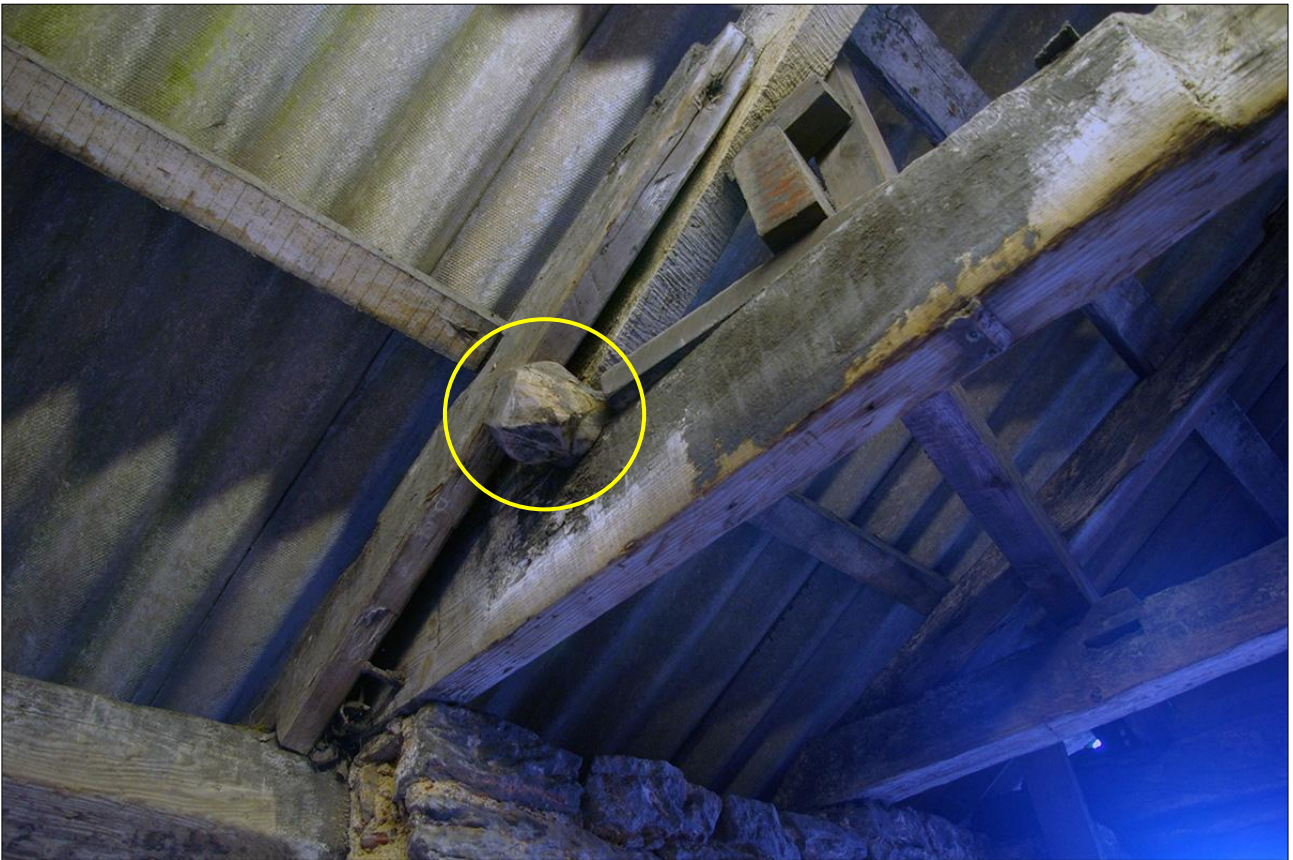
171. B3 ROOF STRUCTURE, SHOWING THE RE-USED SHAPED TIMBER (INDICATED) (S12); VIEWED FROM THE NNW.

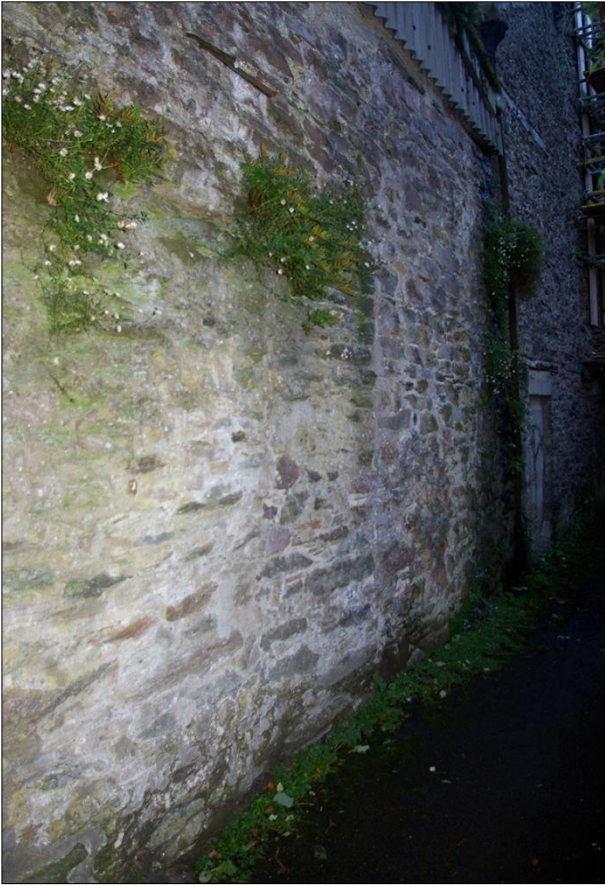
188. THE NORTH WALL OF B4, SHOWING A BLOCKED OPENING; VIEWED FROM THE ENE.
