# GREAT LAKES FARM HOLSWORTHY HAMLETS TORRIDGE DEVON

Desk Based Appraisal and Historic Building Recording

# GREAT LAKES FARM BARNs, HOLSWORTHY HAMLETS, TORRIDGE, DEVON

## HISTORIC BUILDING RECORDING

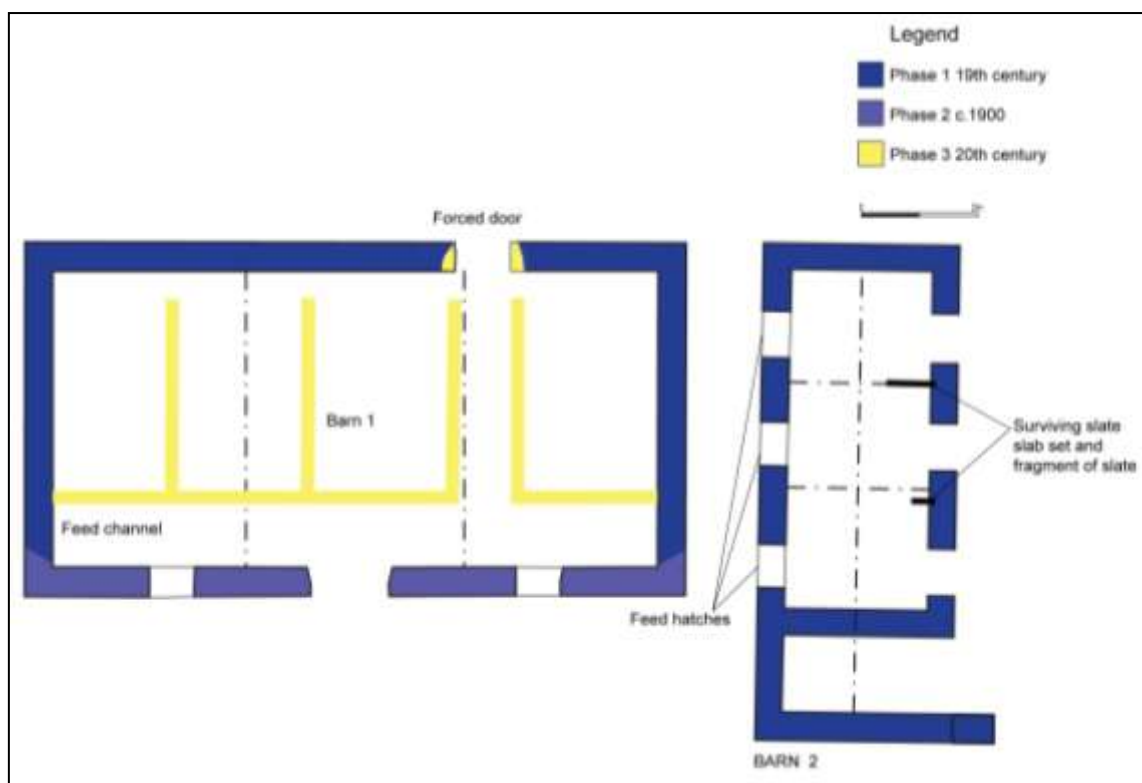
FIGURE 9: PLAN SHOWING THE PHASING OF THE TWO B ARNS

The barn and pigsty are expected to be broadly contemporary in date, although the awkward positioning of Barn 1 against the north elevation of Barn 2 and its feed hatches may suggest it is the slightly later (Figure 9). Barn 2 respects the hedgebank to the south. The historic maps (see above) indicate both structures were built between 1843 and 1883, after the farmhouse and most of the other historic farm buildings.

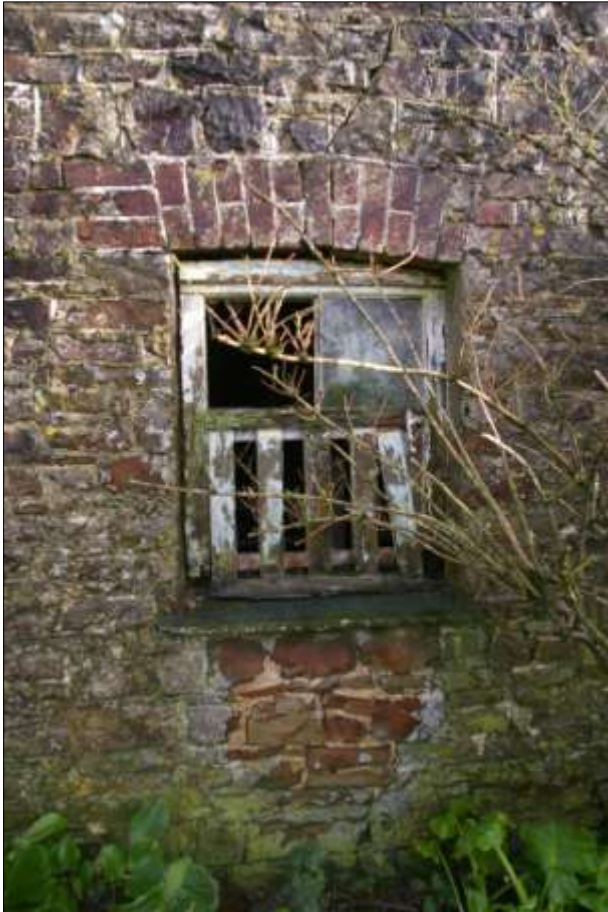
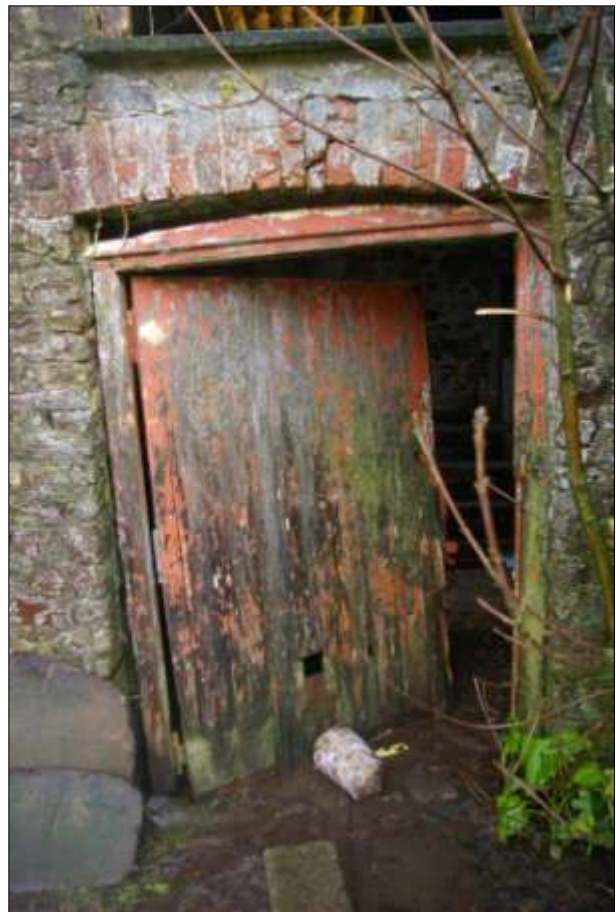
LEFT: THE NORTH WINDOW IN THE WEST ELEVATION OF BARN 1; VIEWED FROM THE WEST.  
RIGHT: THE MAIN DOORWAY IN THE WEST ELEVATION OF BARN 1; VIEWED FROM THE WEST.

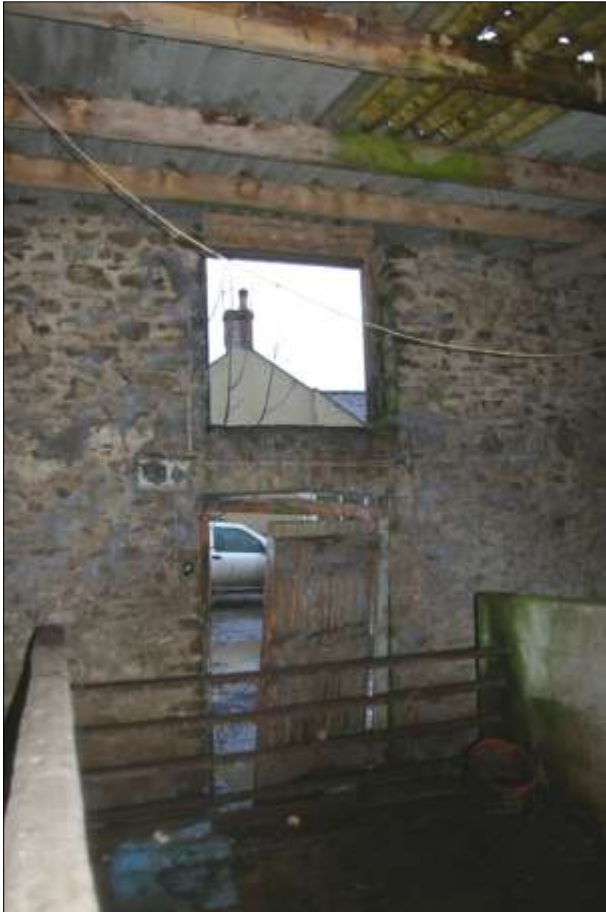
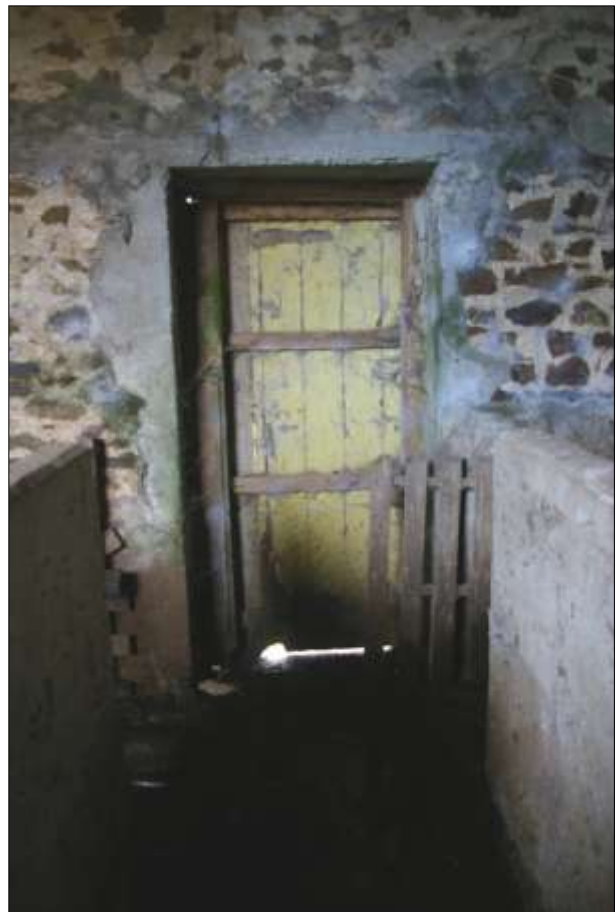
LEFT: THE DOORWAY AND LOADING DOOR IN THE WEST WALL; VIEWED FROM THE EAST-SOUTH-EAST.  
RIGHT: THE FORCED DOORWAY IN THE EAST WALL; VIEWED FROM THE WEST.

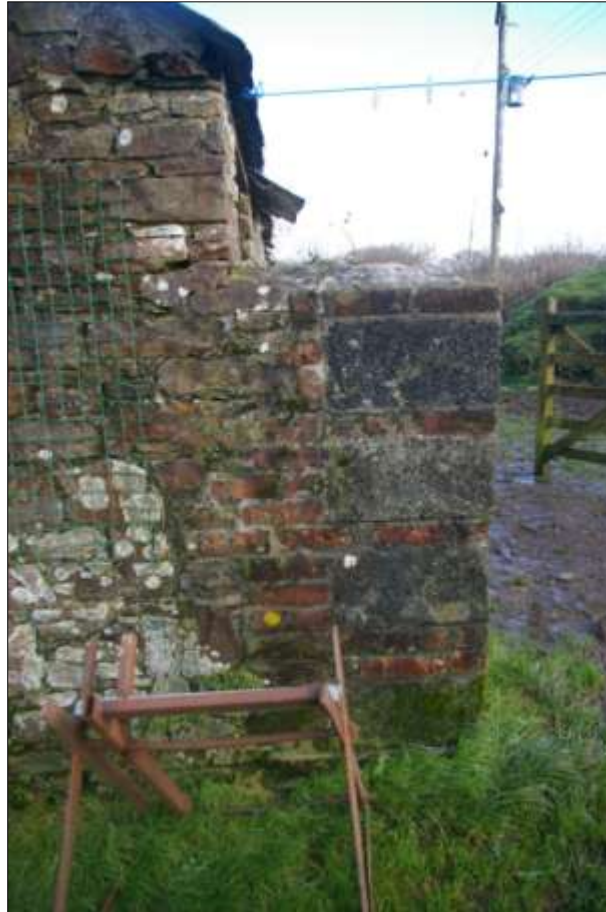
CONCRETE AND BRICK EXTENSION TO THE WEST WALL OF BARN 2, ENCLOSING THE YARD; FROM THE WEST.

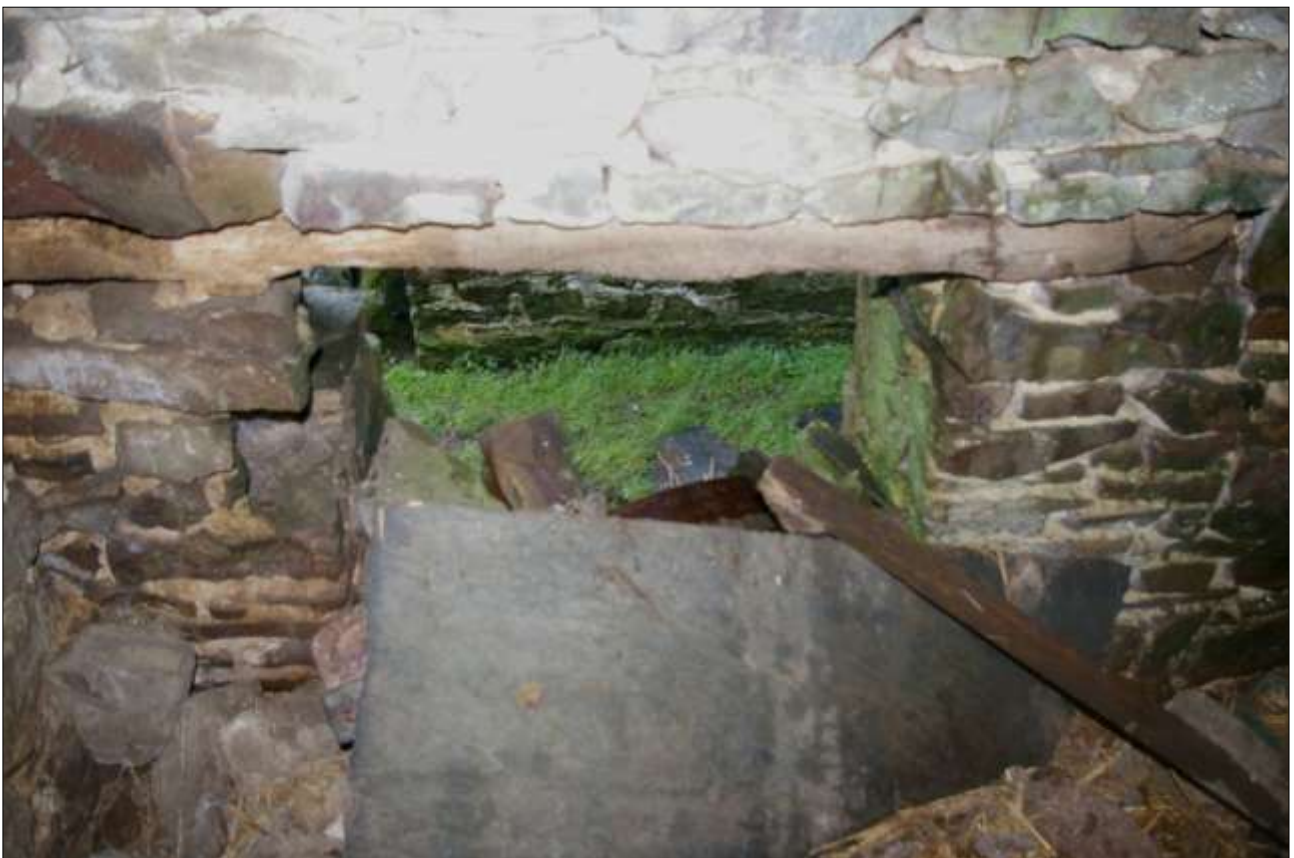
ONE OF THE SMALL FEED HATCHES IN THE NORTH WALL OF THE PIGSTY (BARN 2); FROM THE SOUTH.
