# EMPACOMBE HOME FARM MOUNT EDGCUMBE MAKER CORNWALL

Statement of Significance & Heritage Impact Assessment

South West Archaeology Ltd. report no. 171207

7<sup>th</sup> December 2017

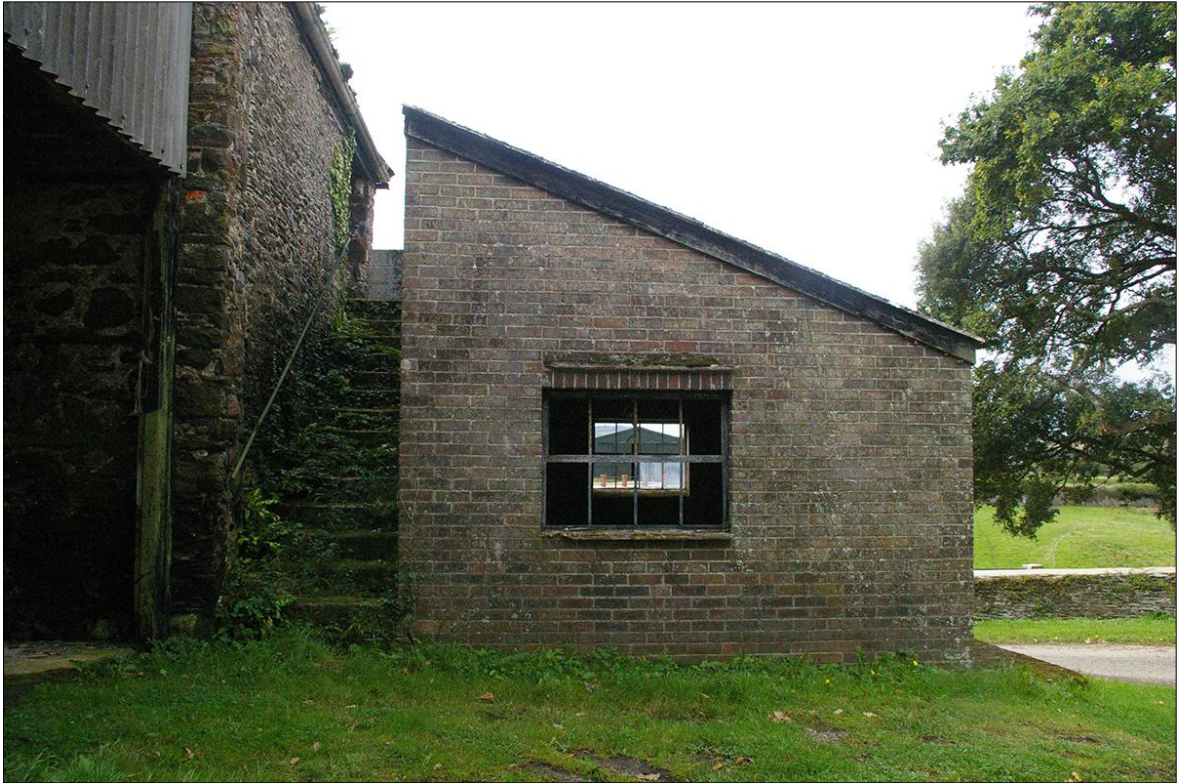
FIGURE 23: THE EAST ELEVATION OF B1.4 AND STAIRS TO THE FIRST FLOOR OF B1.3; VIEWED FROM THE EAST.

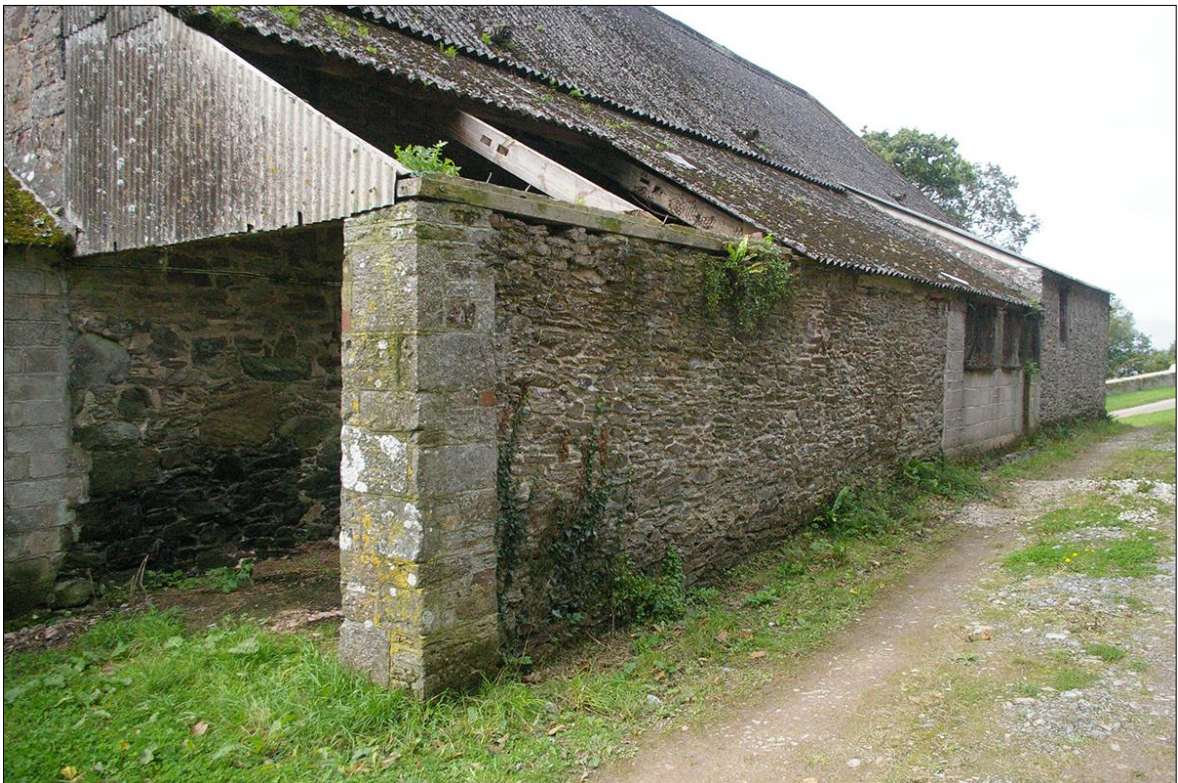
FIGURE 24: THE EAST ELEVATION OF B1.5 (B1.5B IN THE FOREGROUND); VIEWED FROM THE SOUTH-EAST.

B1.3 is a single-storey lean-to running the full length of B1.3, divisible into three main components: a northern cartshed (B1.5a), a southern cartshed (1.5b), and a central machine bay (1.5c). The outer wall of the B1.5a and B1.5b is of stone rubble, with a window in the wall of B1.5a and a pillar with dressed limestone blocks to the south end of B1.5b. The roof of corrugated asbestos sheets is carried on simple timber rafters; these include a number of reused timbers. The roof of B1.5a is a replacement sheet roof and there is evidence of a fire. B1.5a is open at the northern end, and B1.5b is open to the south, with the angle of the roof infilled with timber and asbestos sheet. The east wall of B1.5c is of concrete block with galvanised steel windows. B1.5c is divided off from B1.5a by a later wall of stone rubble with a 19<sup>th</sup> century door, and from B1.5b by a later wall of concrete block with a reset 19<sup>th</sup> century door. B1.5c features two transverse reused beams above head height that support a cast-iron flywheel; the drive shaft goes through the wall into B1.3. Beneath the flywheel is a narrow forced doorway with an iron girder for a lintel. The wall of B1.5a has been raised slightly, and its floor lowered. There are concrete floors throughout.

Cartsheds with access for a machine/engine to drive the flywheel in B1.5c, probably replaced with a fixed engine when the concrete block walls were built.

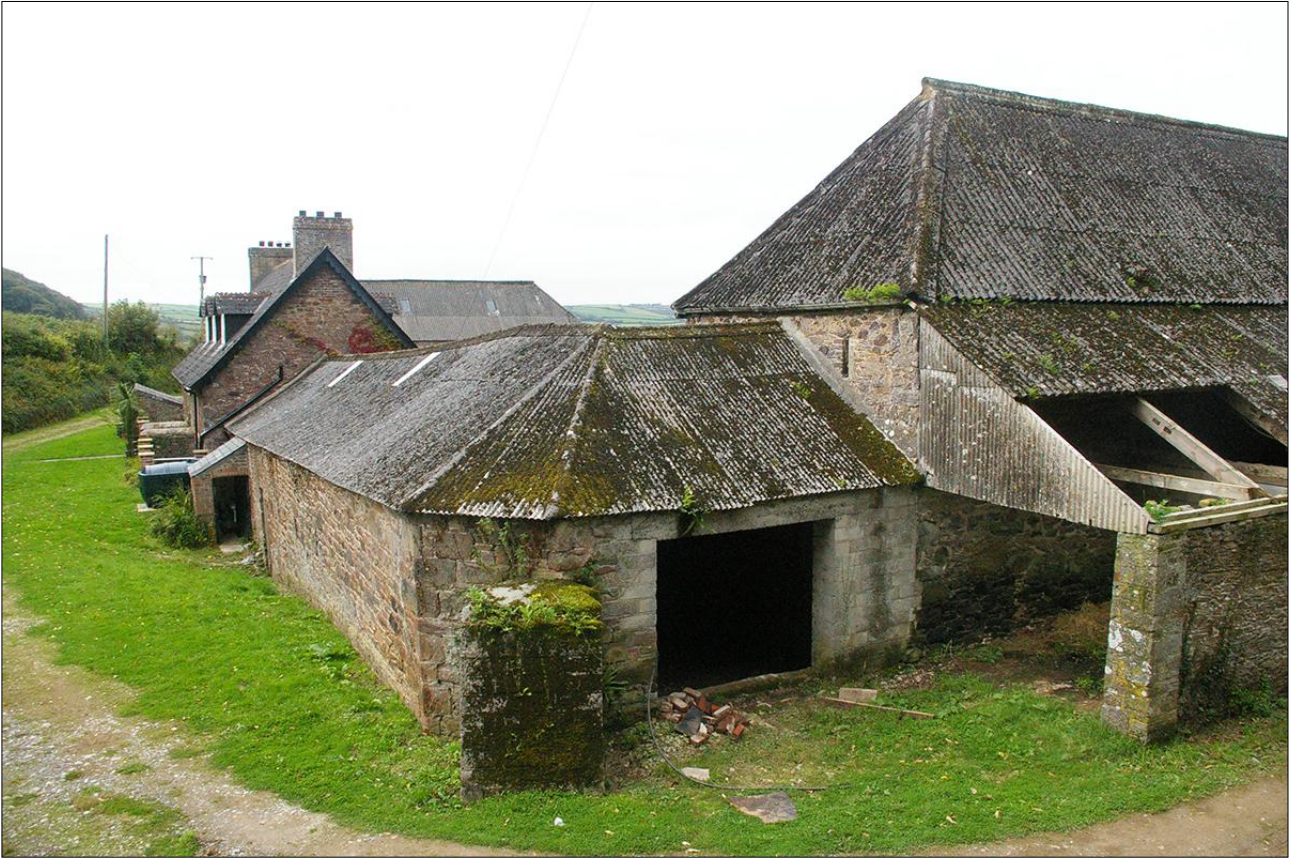
B1.1 AND B1.2 VIEWED FROM THE EAST.

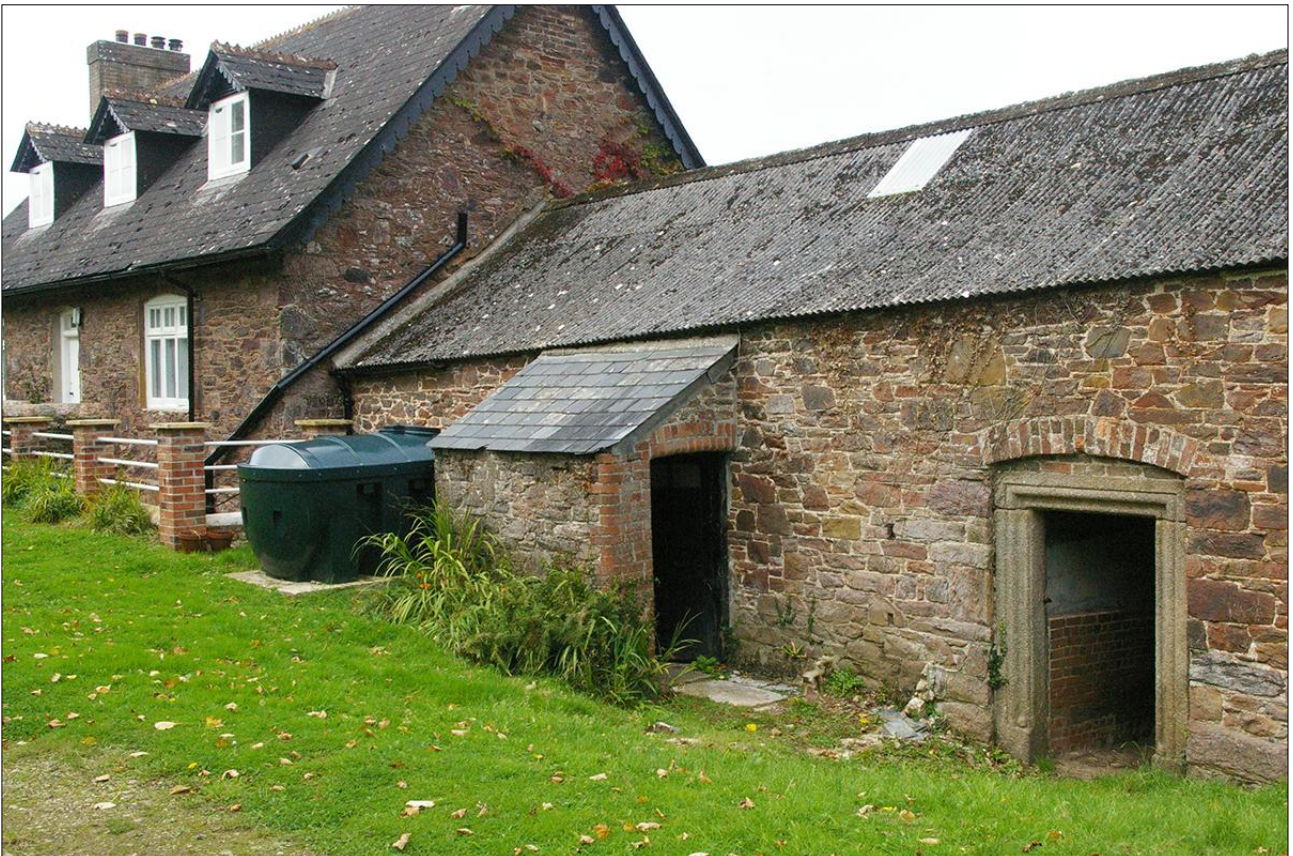
THE REAR (SOUTH) WALL AND DOORWAY OF B1.1, WITH LEAN-TO AND B3; VIEWED FROM THE SOUTH-EAST.

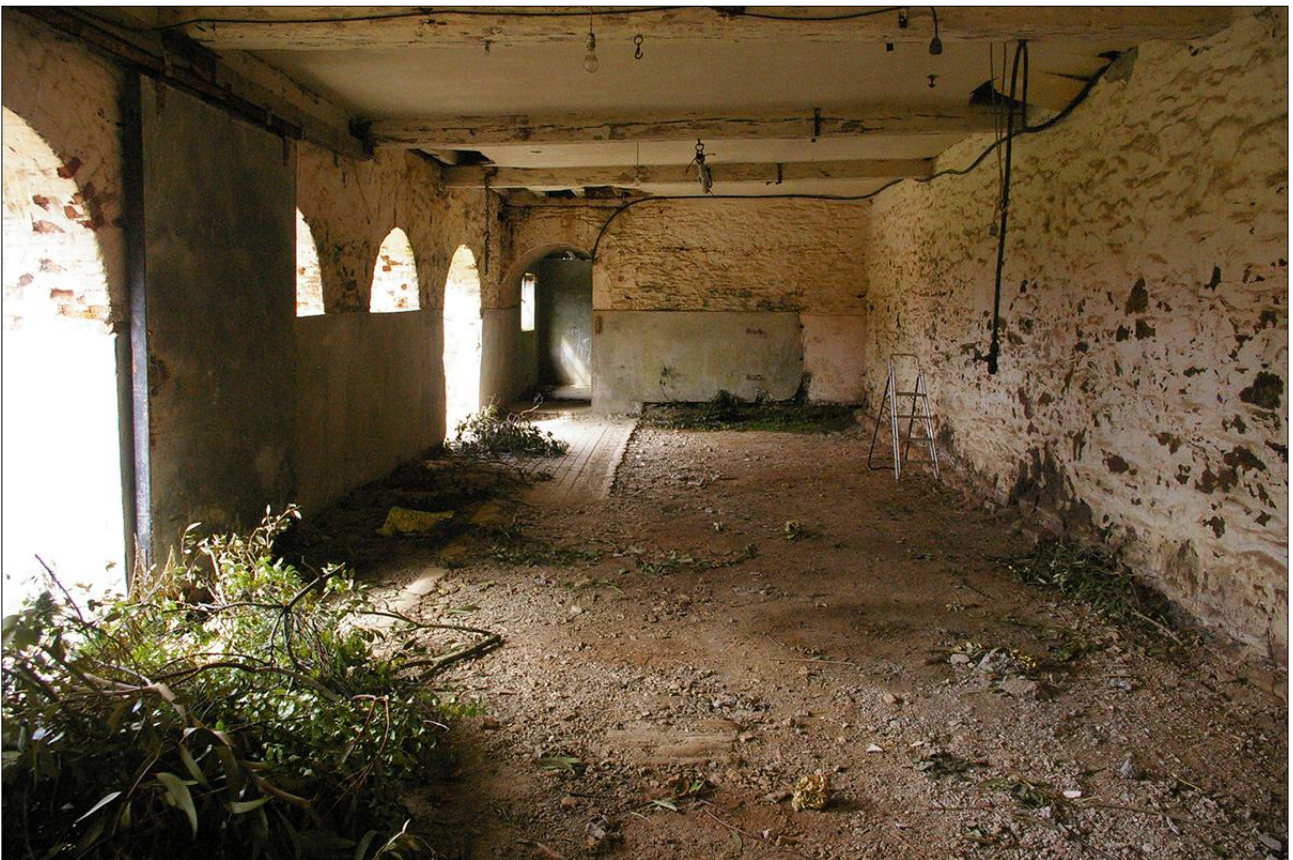
THE GROUND-FLOOR INTERIOR OF B1.3; VIEWED FROM THE SOUTH.

It is recommended that a level 2/3 building survey (Historic England 2015) is undertaken prior to work commencing, and that should historic fabric be revealed during the course of the work (e.g. granite setts in B1.3 etc.) that this is also recorded. As this is a *de novo* site of the 1770s it is unlikely any significant early archaeological remains survive below the site. However, any works to the central yard area or to the rear of B3 should be monitored in case structural evidence relating to the original (1780s) layout of the farm survives.

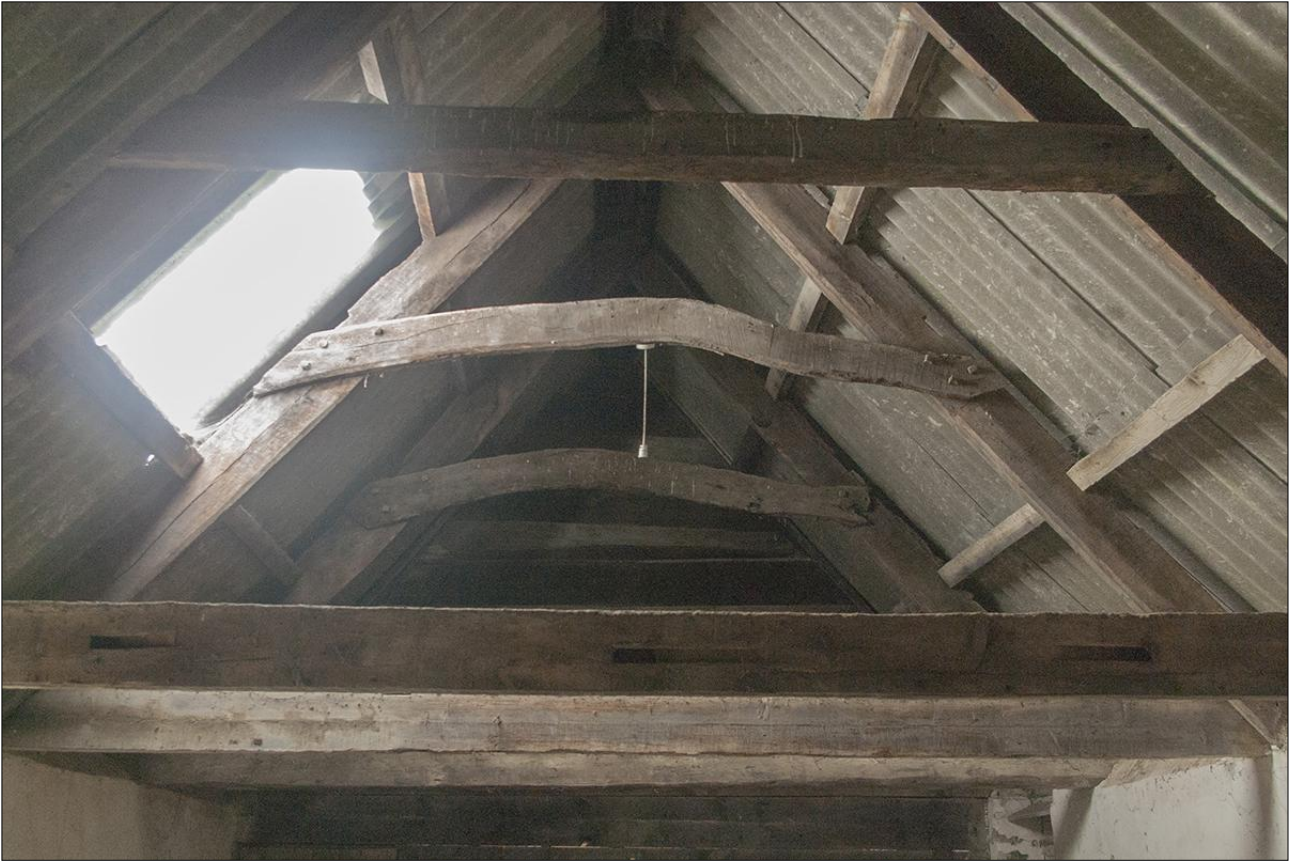
THE FIRST-FLOOR ROOF STRUCTURE IN B1.3 (SOUTH ROOM); VIEWED FROM THE SOUTH.

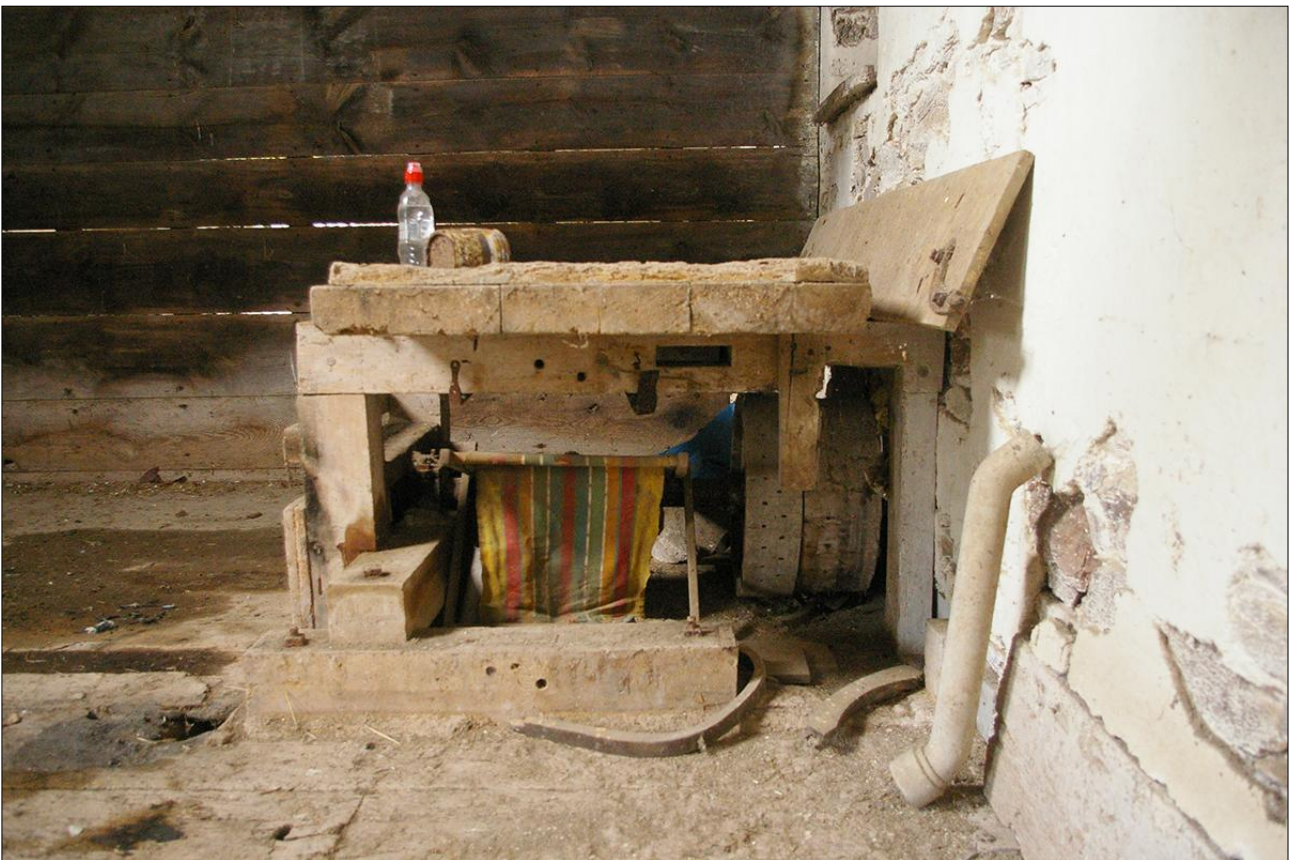
THE FLYWHEEL AT FIRST-FLOOR LEVEL IN B1.3, WITH SCREEN BEHIND; VIEWED FROM THE SOUTH.

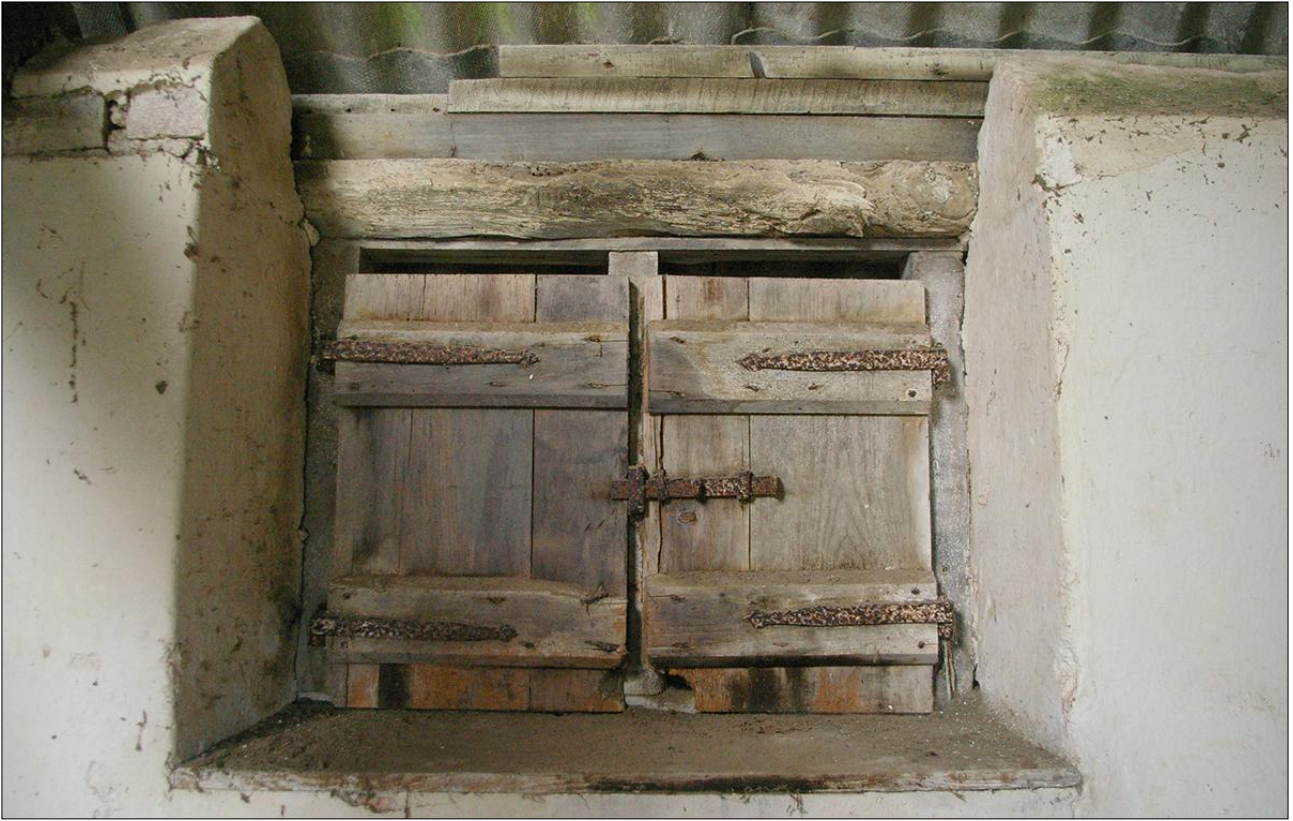
ONE OF THE TWO SHUTTERED WINDOWS AT FIRST-FLOOR LEVEL IN B1.3 (THIS IS THE EXAMPLE IN THE SOUTH ROOM); VIEWED FROM THE WEST.

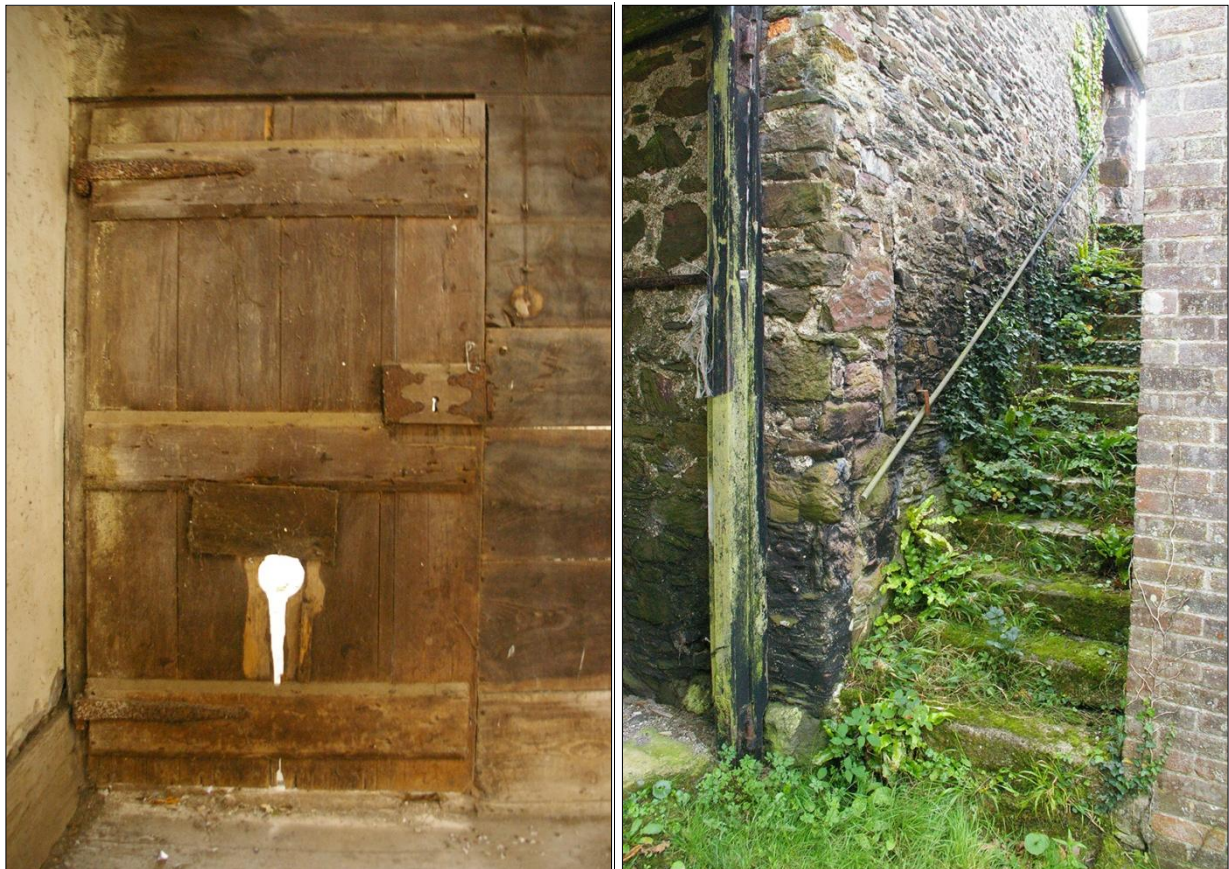
LEFT: THE DOOR AT FIRST-FLOOR LEVEL IN B1.3; VIEWED FROM THE SOUTH.

RIGHT: THE EXTERNAL STAIRS LEADING UP TO THE FIRST FLOOR IN B1.3; VIEWED FROM THE EAST.

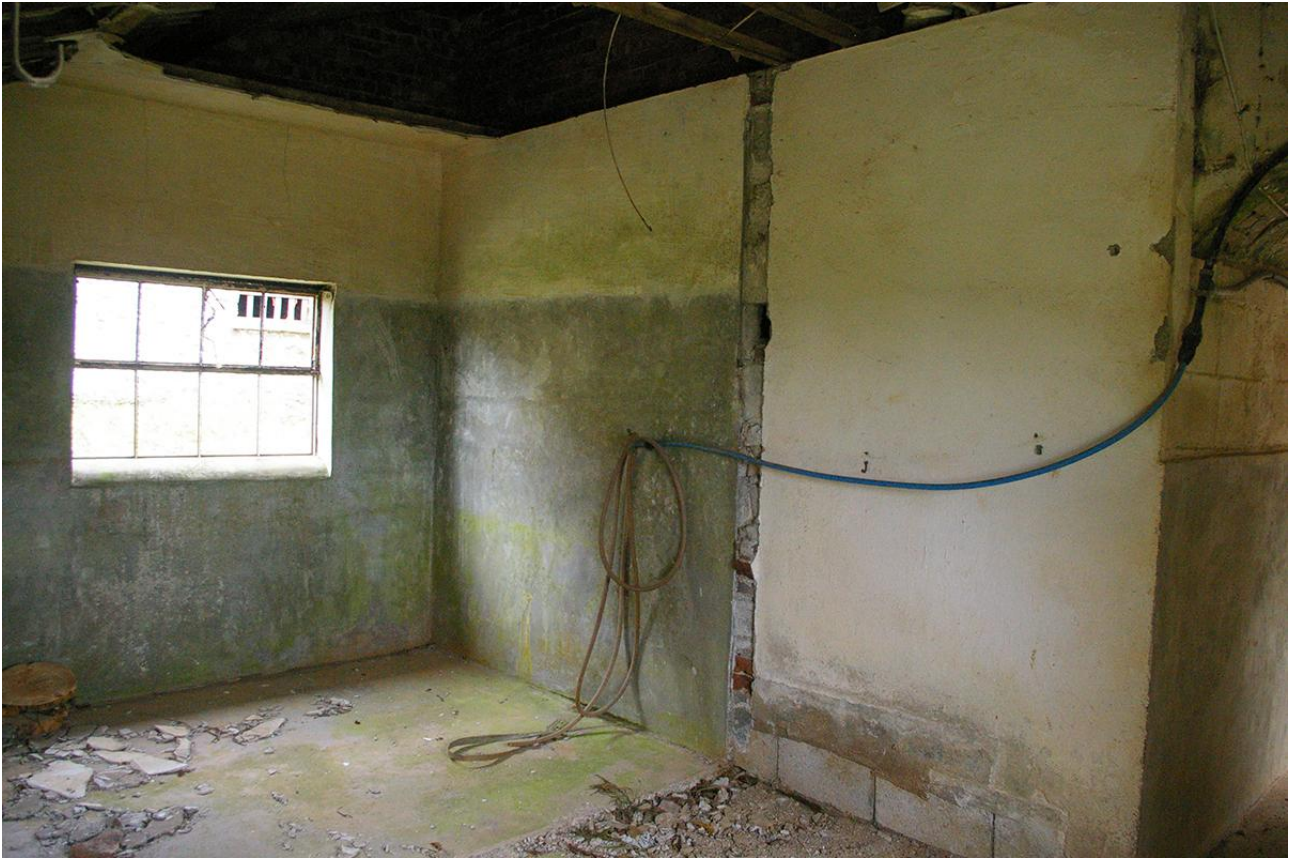
THE INTERIOR OF B1.4; VIEWED FROM THE NORTH-WEST. THE PASSAGEWAY TO B1.3 IS ON THE RIGHT.

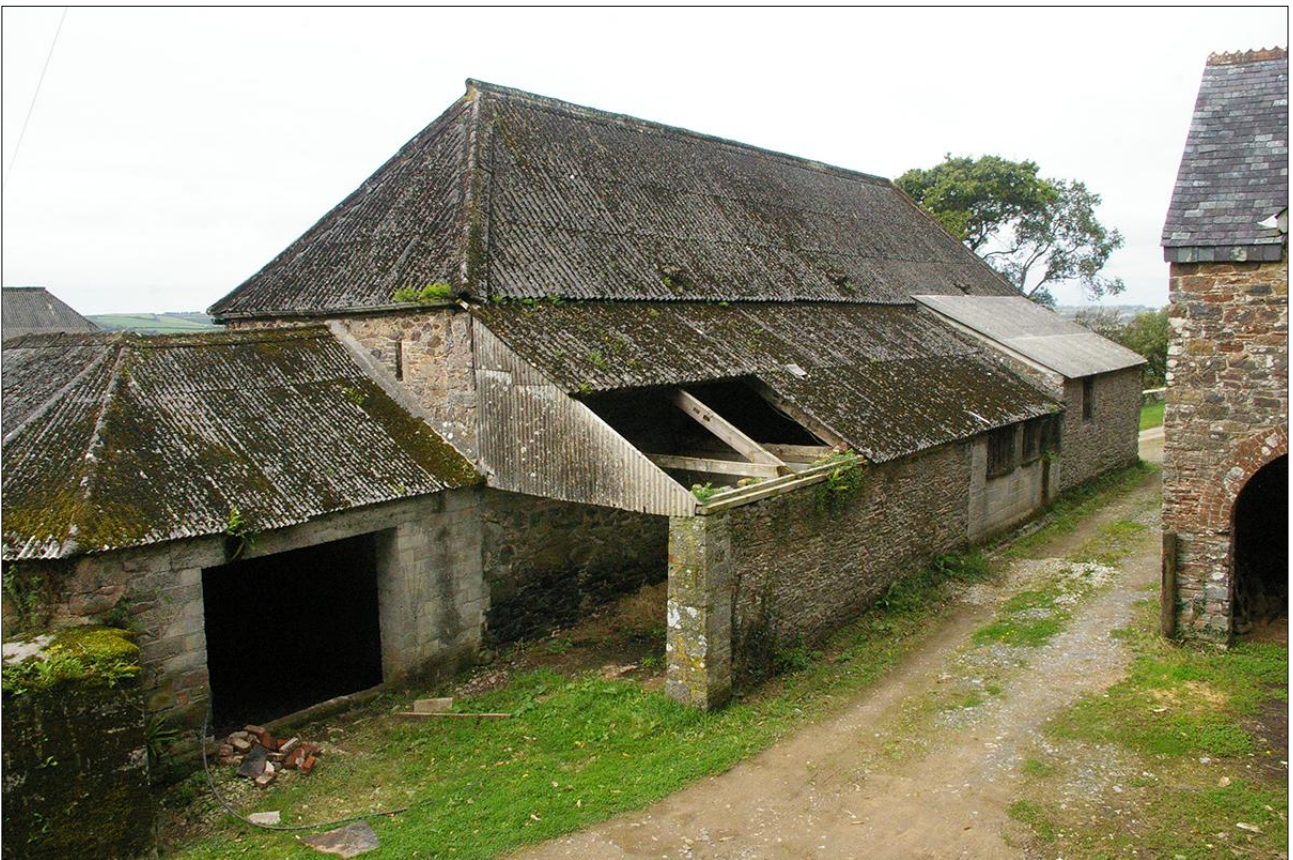
THE EAST ELEVATIONS OF B1.2, B1.3 AND B1.5; VIEWED FROM THE SOUTH-EAST.

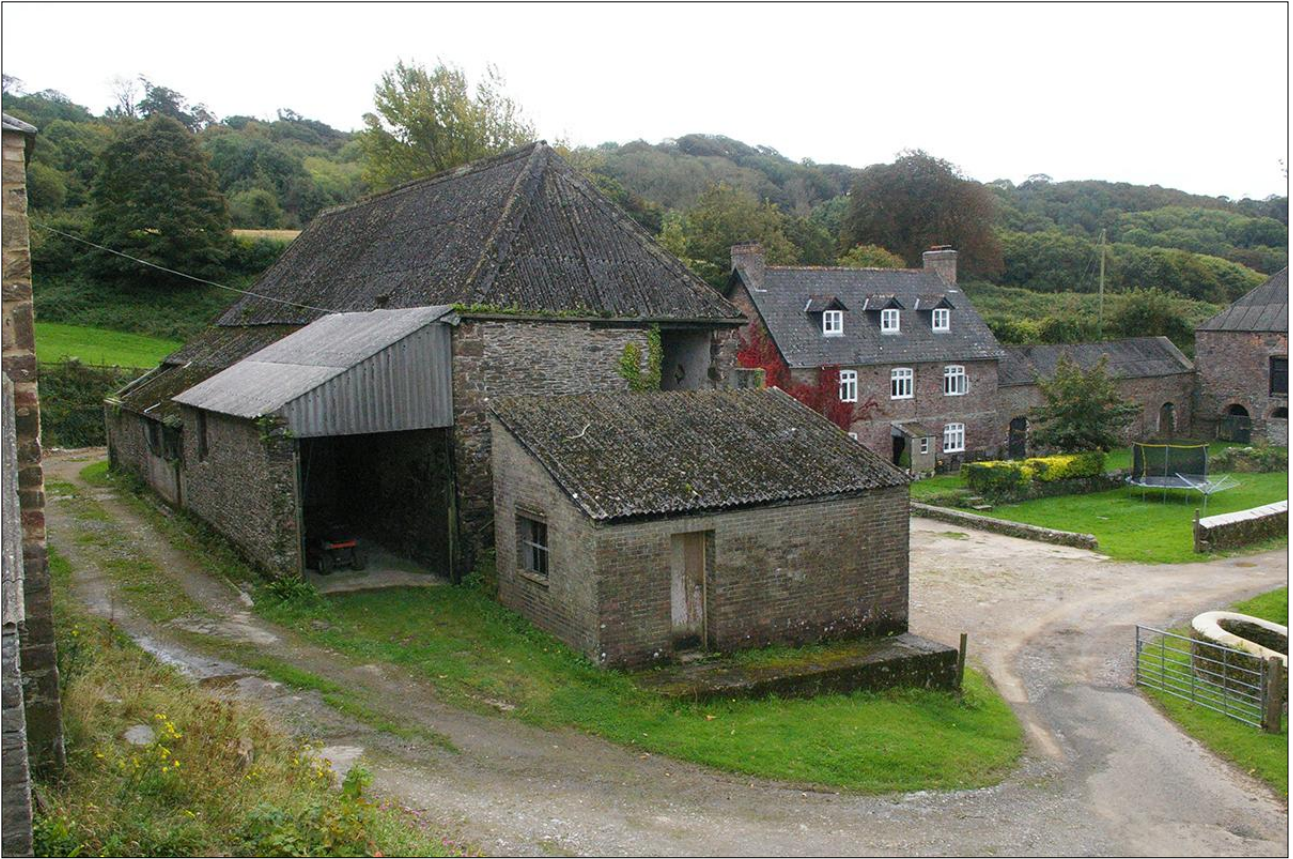
THE EAST AND NORTH ELEVATIONS OF B1.3, B1.4 AND B1.5, WITH B3 AND B4 IN THE BACKGROUND; VIEWED FROM THE NNE.

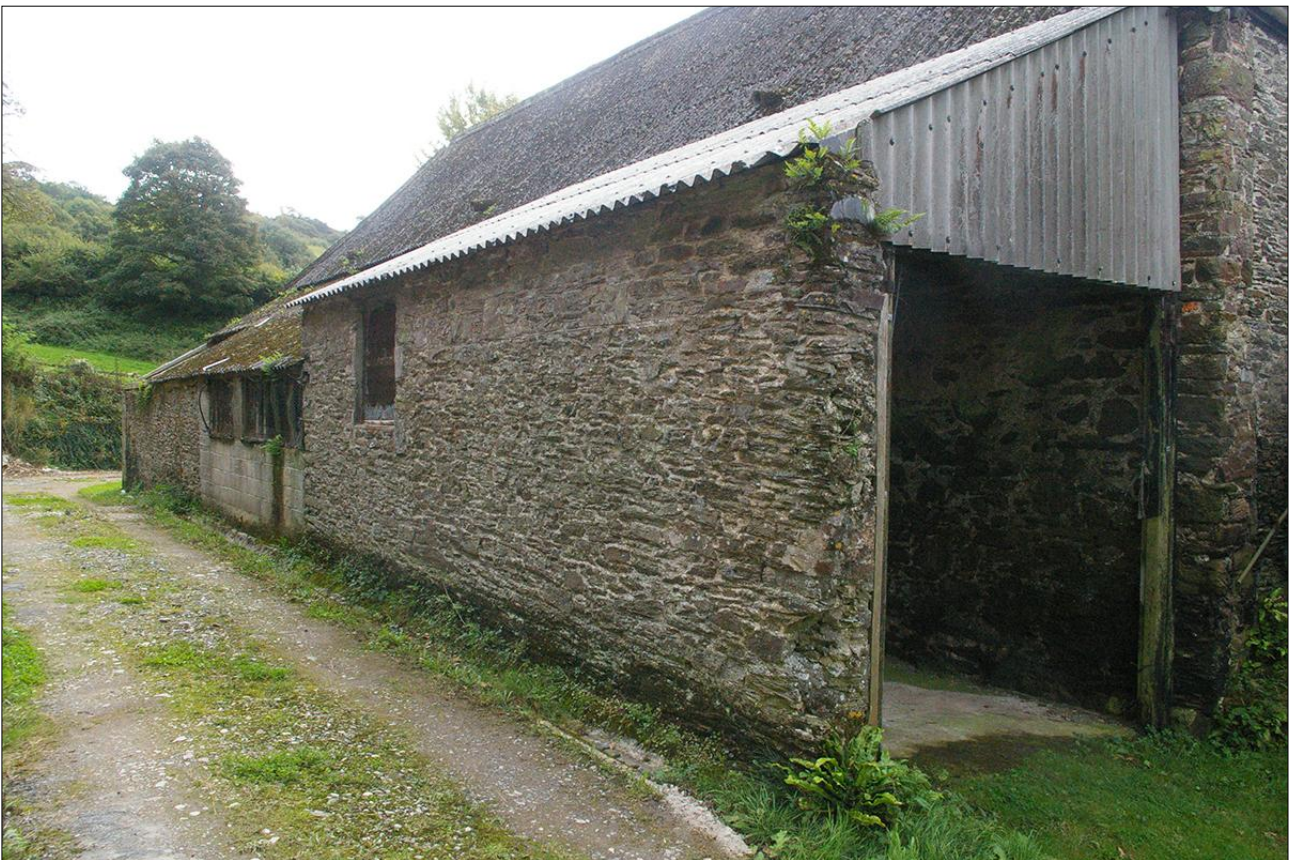
THE EAST WALL OF B1.5A; VIEWED FROM THE NORTH-EAST.

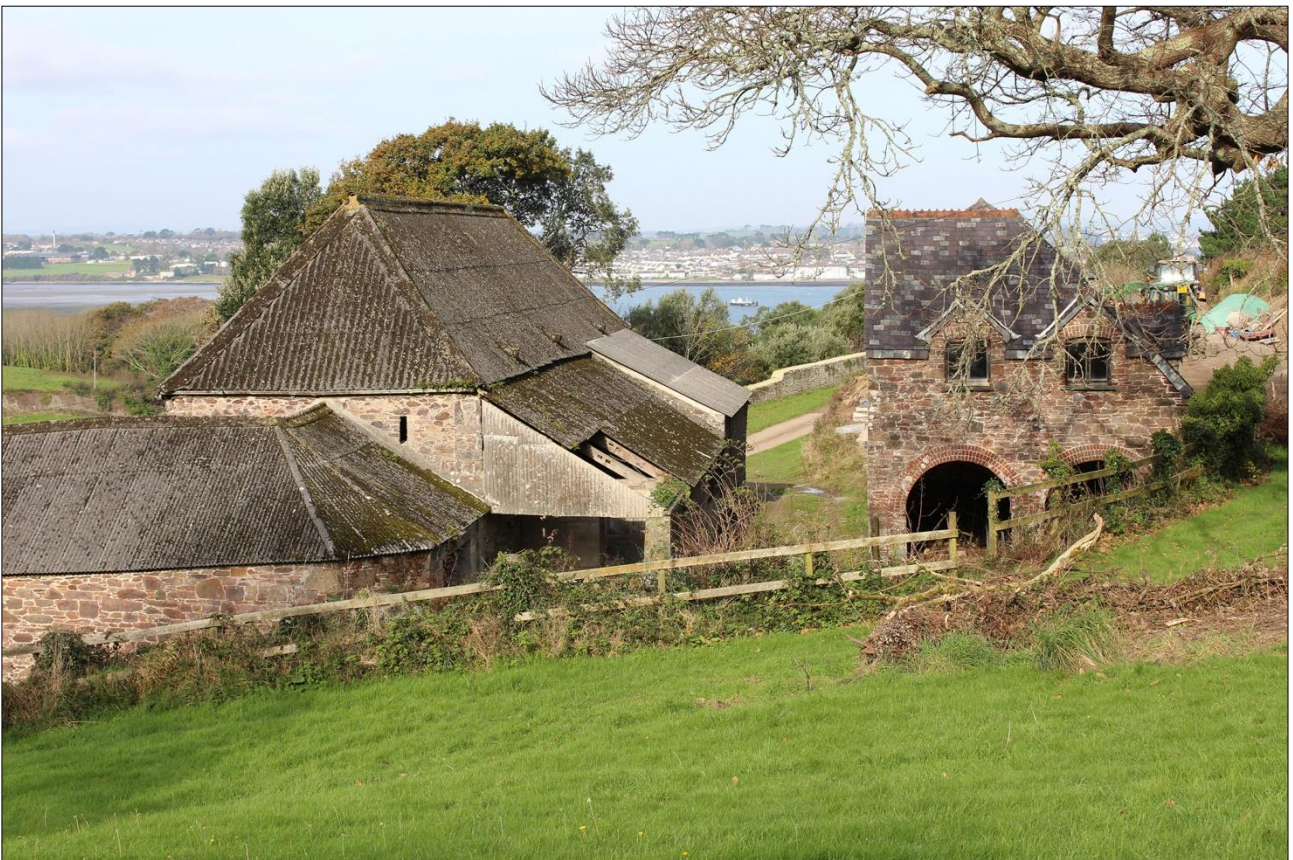
VIEW SHOWING B1.3 AND B1.5 IN RELATION TO B2.2; VIEWED FROM THE SOUTH.

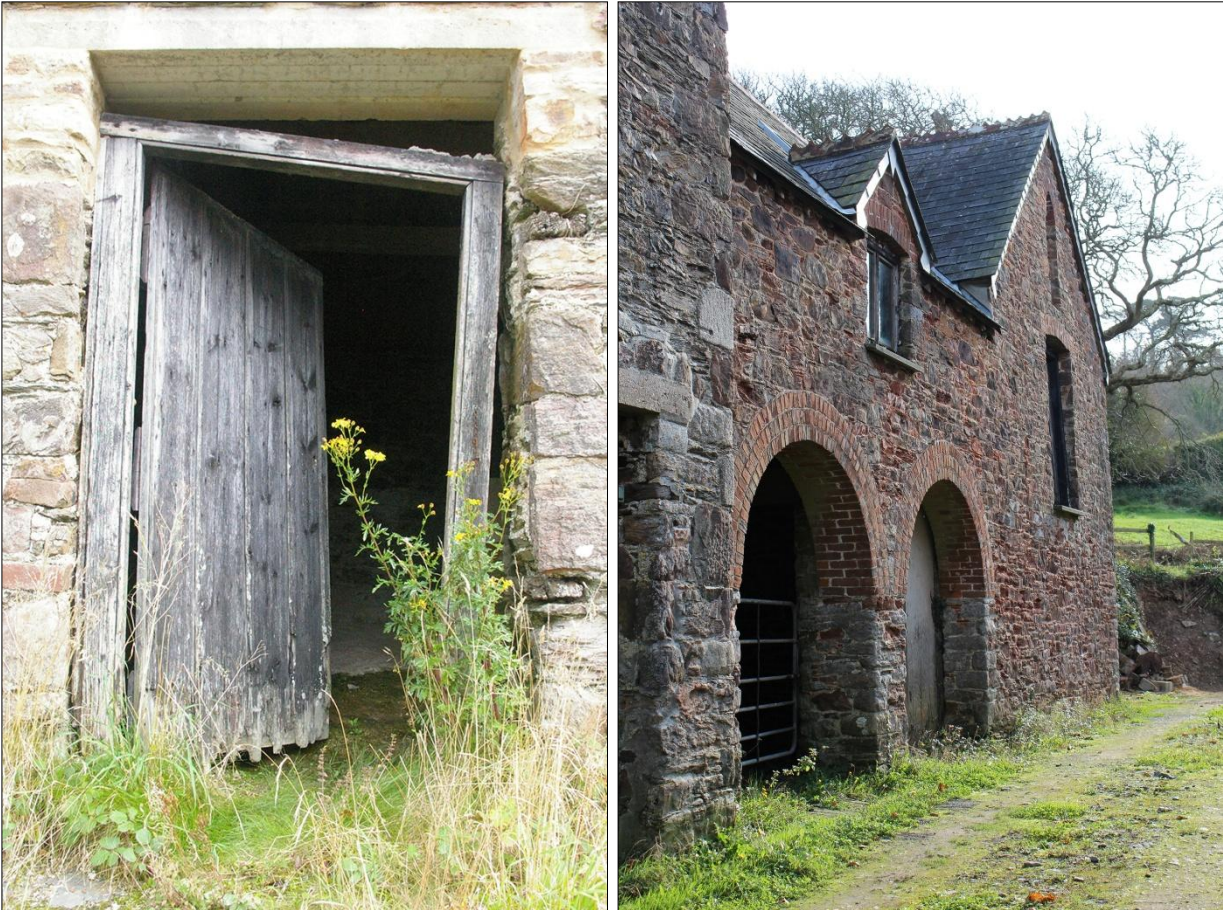
B2.1 is a two-storey bank barn built of slate and shale rubble cut back into the solid rock; the north-west corner above the door has been recently rebuilt and the lintels replaced. The hipped roof of blue slate is carried on 20<sup>th</sup> century roof trusses with tie beams and queen posts. The principal elevation is to the west, with two doors and two windows at ground floor level opening onto a single room. The openings have flat lintels of thin timber; some have been replaced in concrete. The north-west door has a weathered oak frame with beaded moulding. At first floor level there are two glazed timber windows in the west elevation, and one in the north elevation. Access to the first floor is from ground level to the east via a wide loading door next to a blocked window, or from a forced doorway in the south wall into B2.2. The internal east wall at ground floor level steps back at ceiling height, supporting very heavy, but rather crude, transverse beams; these beams go into the west wall, but are now supported on heavy timber uprights. There is a blocked doorway into B2.2, with a timber shelf above, and the remnants of a stone-rubble trough along the base of the east wall. Next to the blocked opening within B2.2 an architectural fragment has been incorporated into the stonework. The first floor has been converted and is used as an artist's studio.

LEFT: THE SURVIVING DOOR AND FRAME IN B2.1; VIEWED FROM THE WEST.  
RIGHT: THE WEST ELEVATION OF B2.2; VIEWED FROM THE NORTH-WEST.
