FOXHOLE FARM HALWILL BEAWORTHY DEVON

Desk-Based Assessment & Historic Building Recording

South West Archaeology Ltd. report no. 180404

By E. Wapshott & B. Morris
Report Version 01
04th April 2018

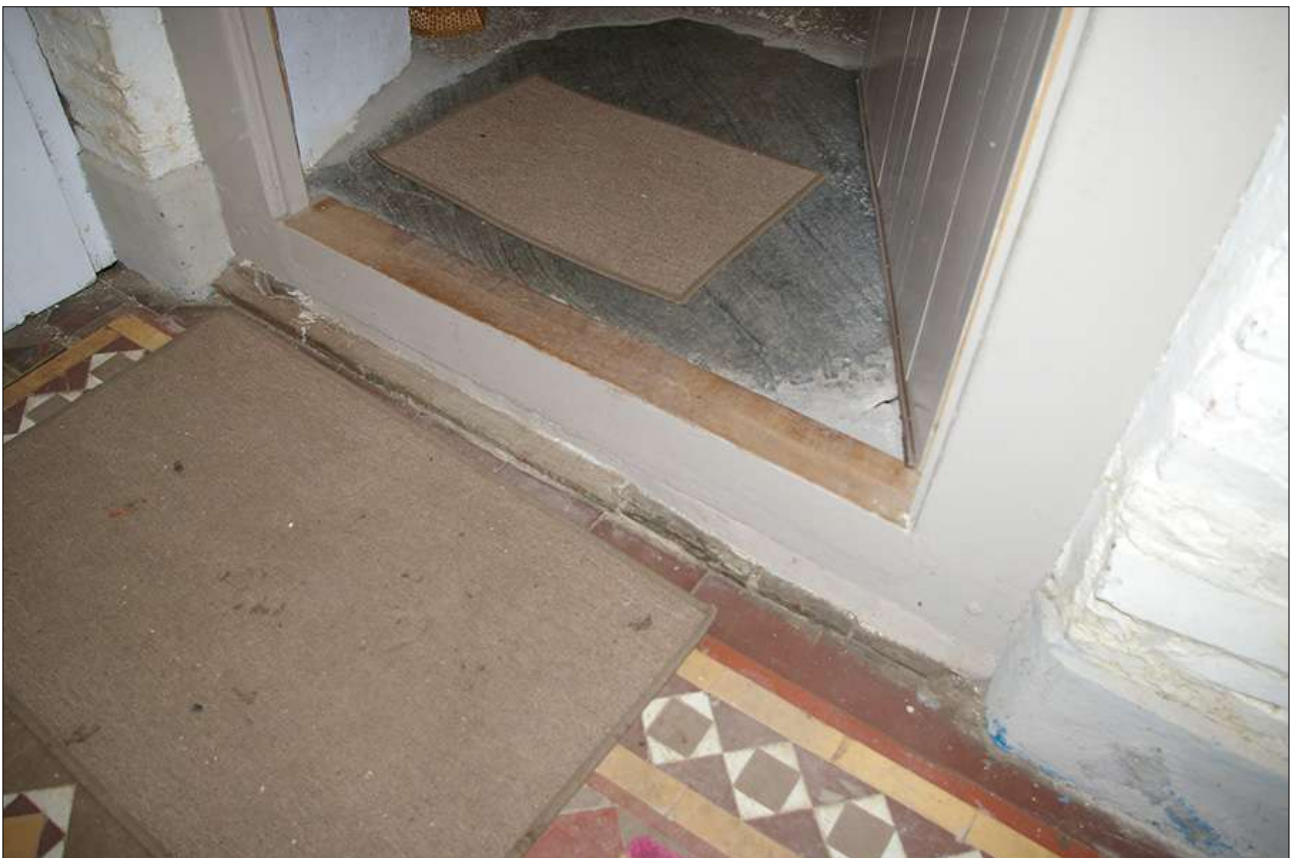
RIGHT: WEST END BEHIND THE PARTITION, SHOWING THE BLOCKED WEST DOOR D4; VIEWED FROM THE EAST.

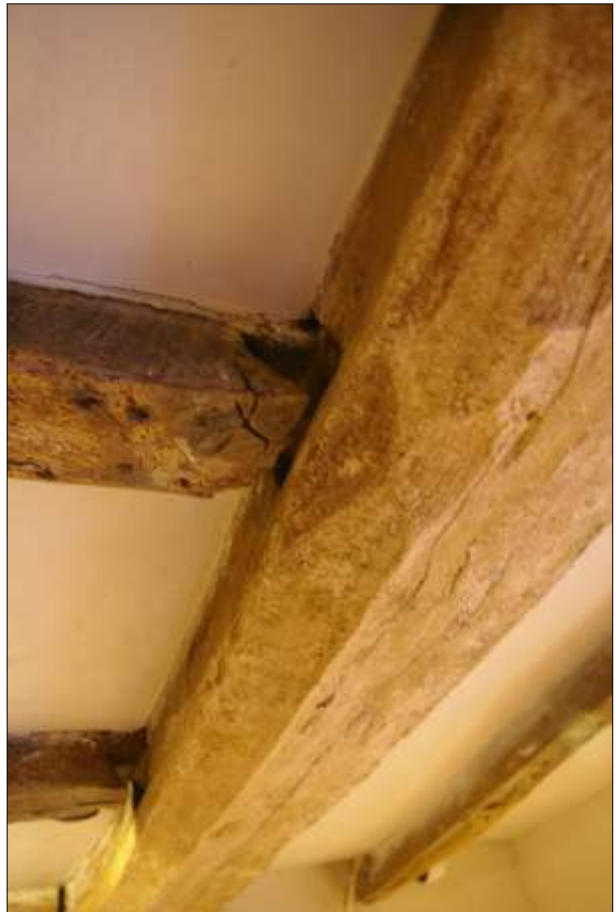
LEFT: PARLOUR, THE ORIGINAL BEAM (RIGHT) WITH ROUGH JOISTS IN THE GAP BETWEEN THE BEAM AND THE EAST WALL; VIEWED FROM THE NORTH.
RIGHT: PARLOUR, THE ORIGINAL BEAM SHOWING THE JOISTS PULLING OUT; VIEWED FROM THE SOUTH.

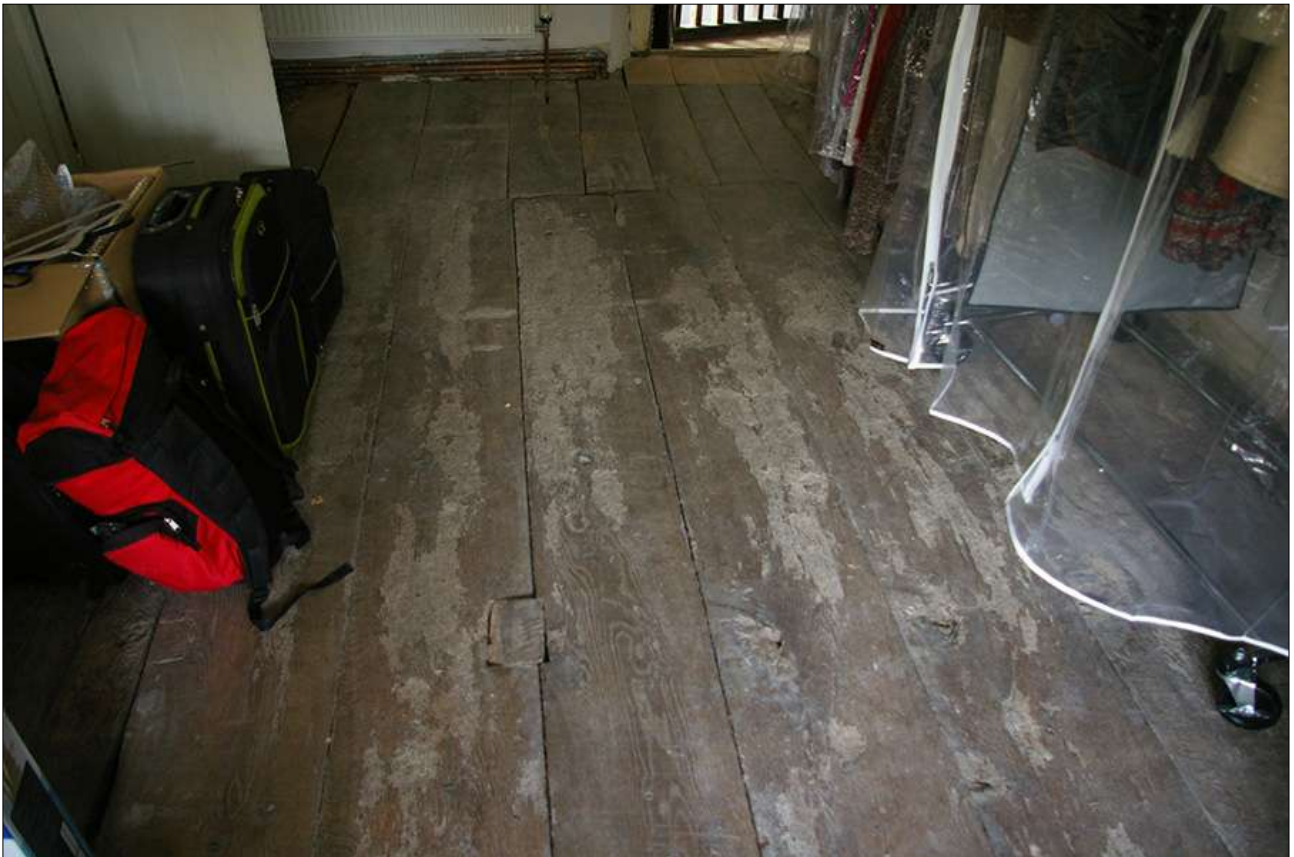
Very little work took place during in the 20th century. On the first floor Bedroom 3 was split into two by a plank partition in the early 1900s, with a cupboard against the stack. A bathroom was installed in the Pump Room. The roof of the farmhouse and Shippon were re-slatted. Significant change occurred c.1998-2000 when the house was renovated prior to re-sale. The floor in the Hall and Kitchen was taken up and replaced, a beam in the Kitchen replaced and the one in the Hall repaired, treads replaced on the stairs, and the floor replaced in the Apple Store. The north gable cob wall was painted or possibly rendered/pebbledashed, ground levels to the rear lowered and a concrete plinth installed to protect the base of the historic walls. The (probably ruinous) bakehouse was repaired and a gabled roof erected.

BEDROOM 3, THE 20TH CENTURY PLANK PARTITION WALL WITH BEDROOM 4; VIEWED FROM THE NORTH-EAST.

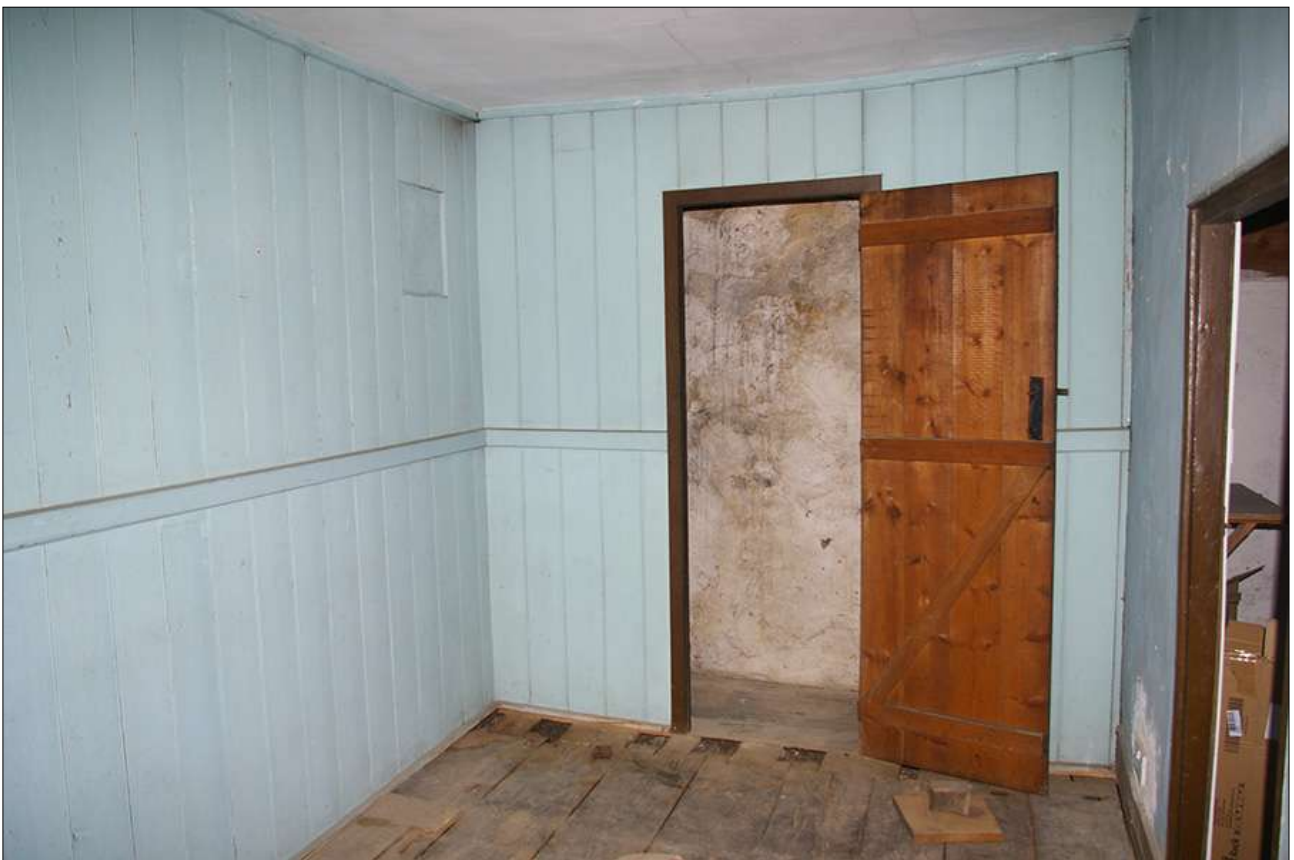
Openings – Doors:	D16	19 th century four-panel beaded door, in a narrow beaded frame, set into the partition. Underneath the door is a heavy pegged timber threshold, worn with wear, to an earlier doorway.
Openings – Windows:	W7	One recent oak copy casement, a modern 21 st century repair.
Significant Features:		One bracket-shaped pegged timber is fixed to the east side of the partition.
Roof Structure:		Description
		Large but simple A-frame trusses, surprisingly lightweight scantling. Crudely-shaped timbers, half-lapped low collars and overlapping ridge. All joints are spiked and pegged. The rafters and some of the purlins are more modern, with new felt under the slates. The A-frames over the crosswing have larger truss blades which taper to the apex, possibly earlier and reset in an 18 th century roof remodel. As the north end there is a modern owl box.

BEDROOM 4, SHOWING THE DOORWAY (D16) INTO THE APPLE STORE; VIEWED FROM THE NORTH-EAST.

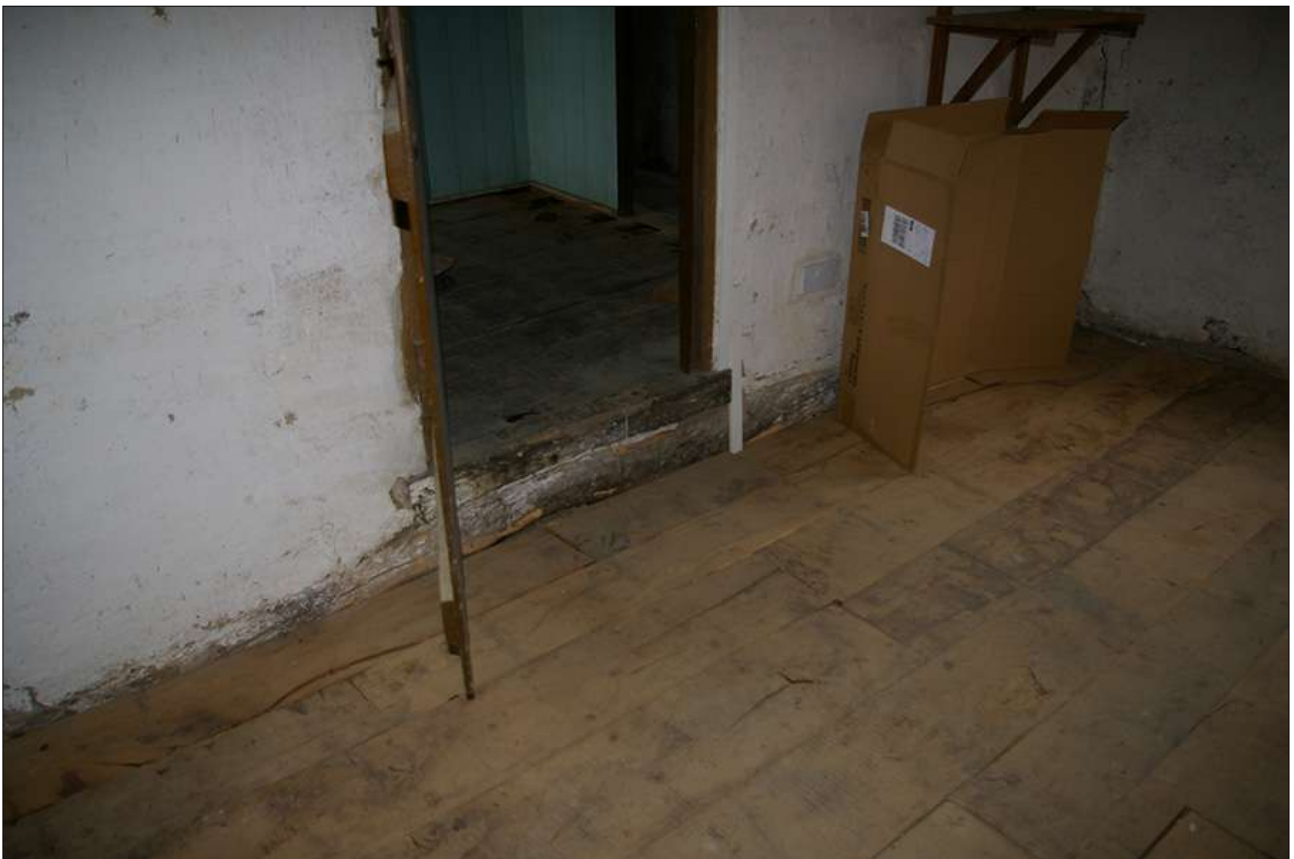
APPLE STORE, DOORWAY (D16) INTO BEDROOM 4; VIEWED FROM THE SOUTH-SOUTH-WEST.

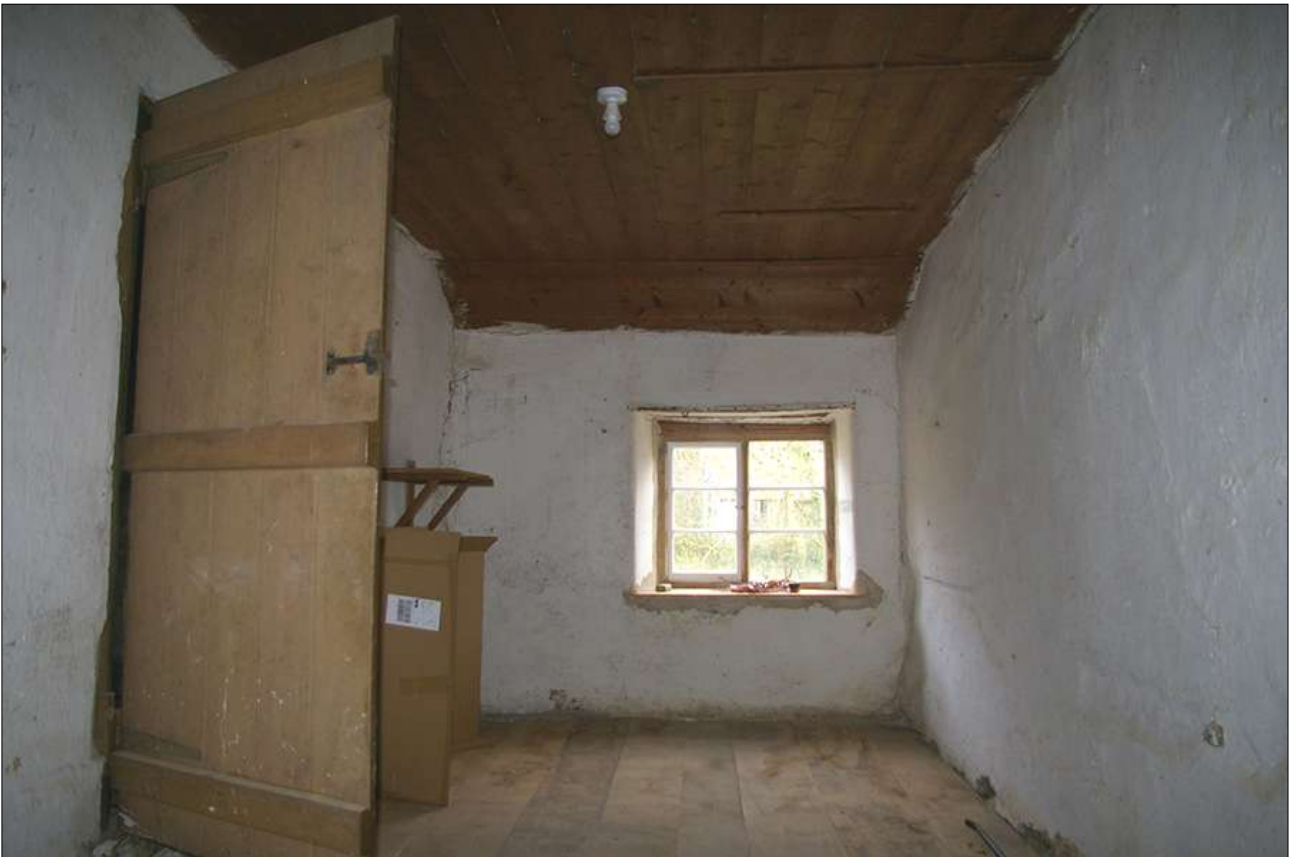
APPLE STORE, DETAIL OF THE NEW OAK FLOORBOARDS AND HATCH INTO THE PASSAGE; VIEWED FROM THE SOUTH.

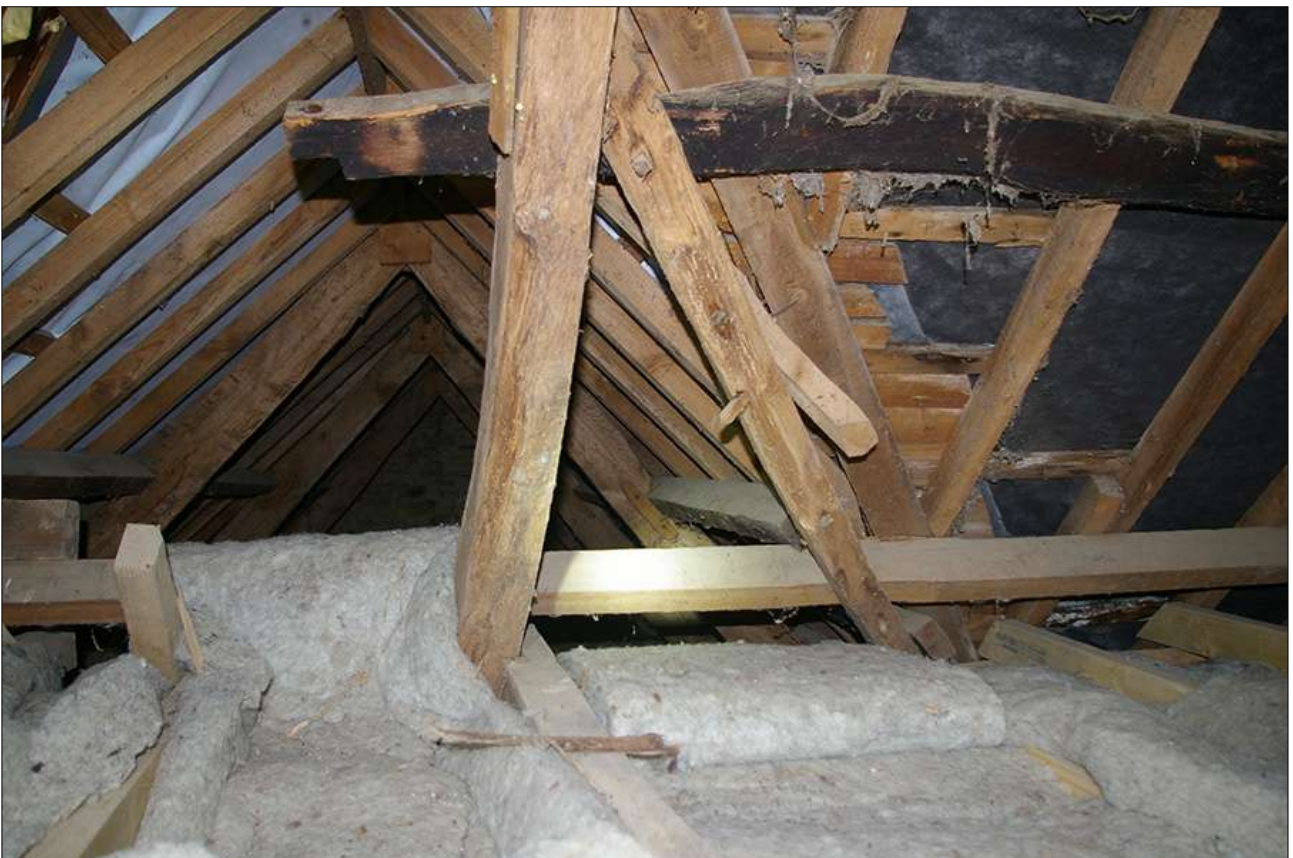
THE ROOF ABOVE BEDROOM 2, WEST PITCH, AT THE JUNCTION WITH THE CROSSWING, SHOWING THE SINGLE SMOKE-BLACKENED REUSED RAFTER; VIEWED FROM THE EAST.

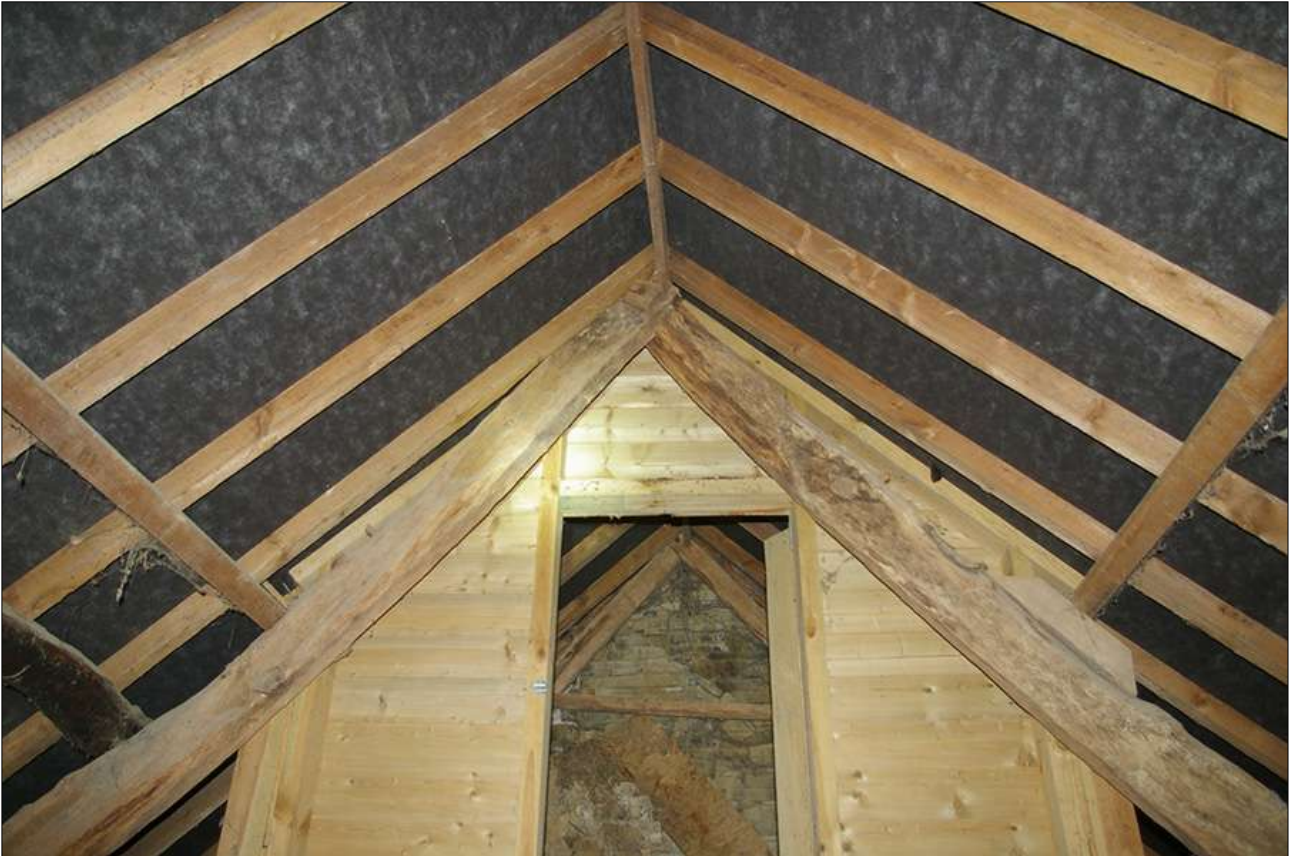
AS ABOVE, DETAIL OF THE SMOKE-BLACKENED PURLIN.

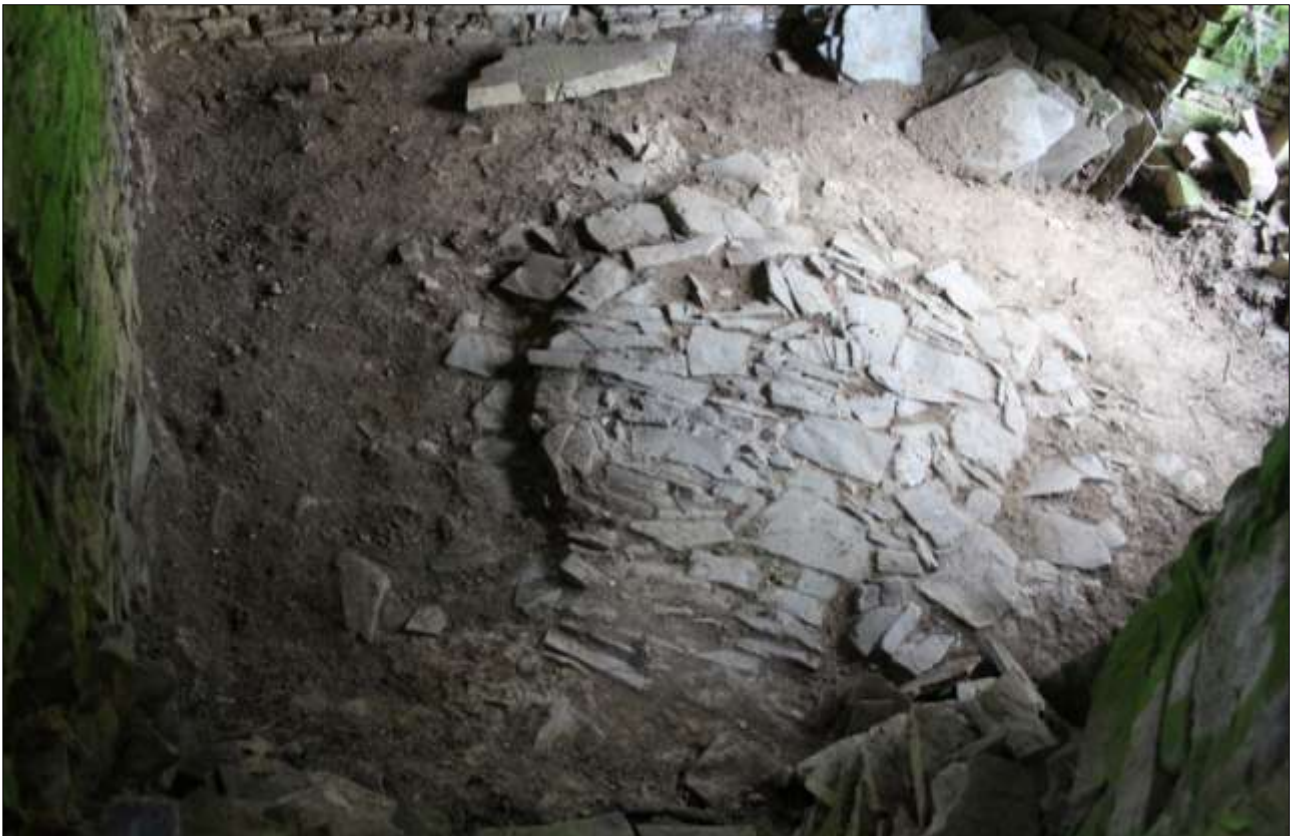
THE FLOOR OF THE MALTING KILN, SHOWING THE CIRCULAR PATCH OF COBBLES AND FRAGMENTARY WALLS; VIEWED FROM THE SOUTH-EAST.

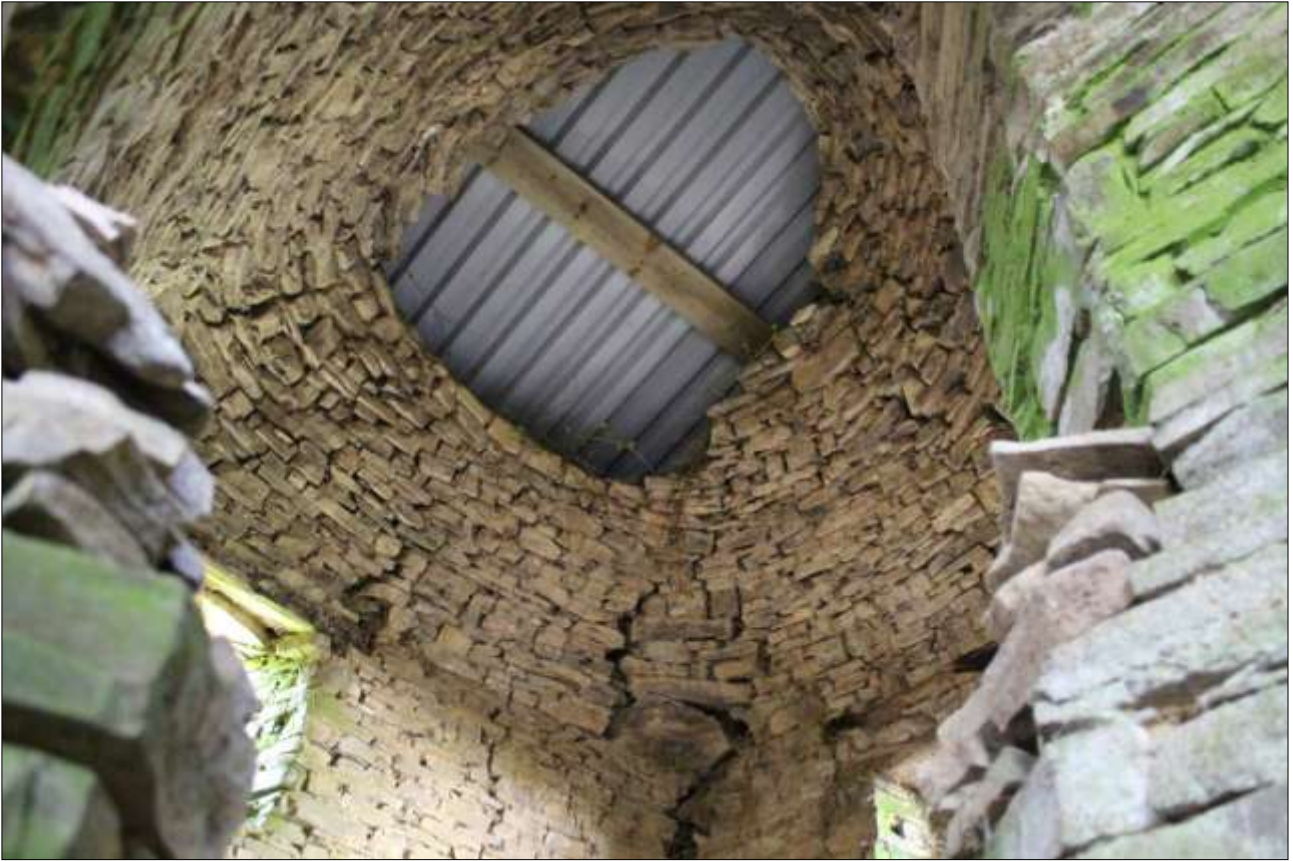
THE CORBELLED ROOF OF THE MALTING KILN, FROM THE ENTRANCE OF THE FLUE IN THE BACK OF THE FIREPLACE; VIEWED FROM THE SOUTH-EAST.
