PENDREA BARNs
St BURYAN
PENZANCE
CORNWALL

Historic Building Recording

South West Archaeology Ltd. report no. 200514

14th May 2020

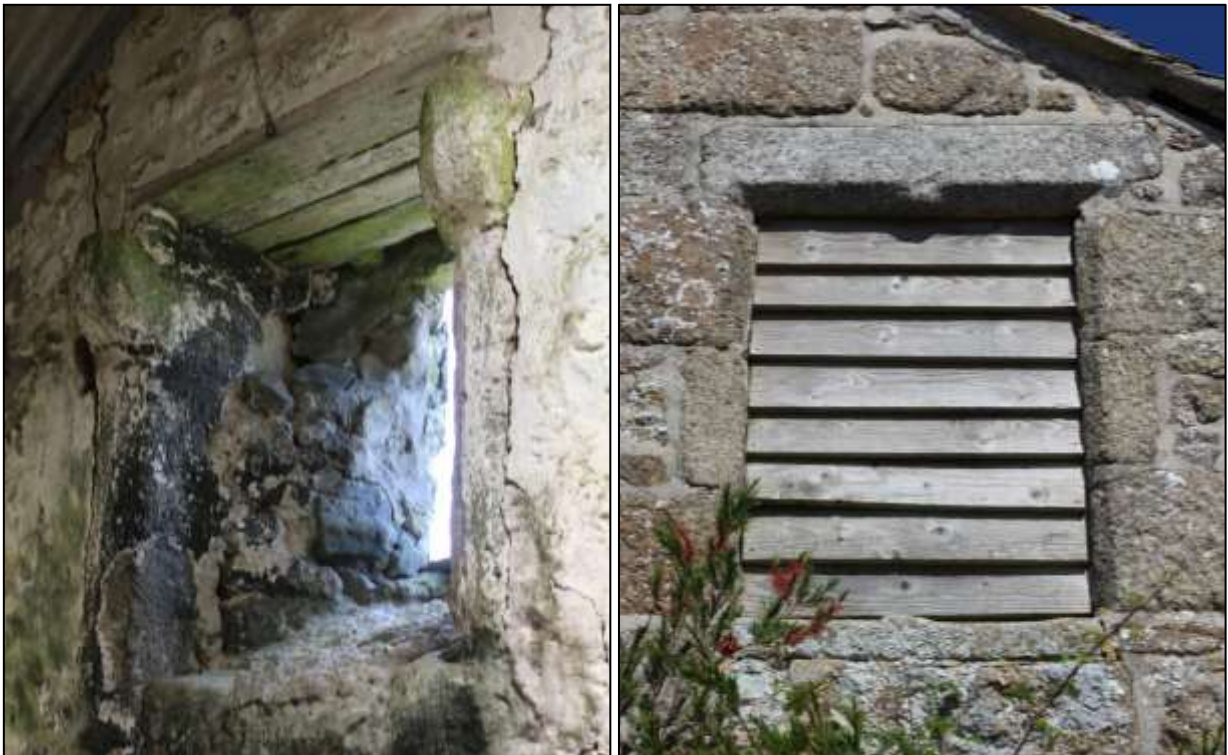
- 17th century granite chamfered and corbelled fireplace surround with different mouldings on each side, reused as a stone frame for a ventilation slit in the north-east gable of B2A.
- Two 17th century granite window mullions re-used as a door lintel and step.
- Massive granite posts dividing pens are faced on one side and may be re-used floor slabs.

LEFT FIGURE 11: INTERIOR OF B2A; WINDOW IN NORTH-EAST GABLE RE-USING PARTS FROM A 17TH CENTURY GRANITE FIREPLACE; VIEWED FROM THE SOUTH.

RIGHT FIGURE 12: RE-USED 17TH CENTURY CARVED GRANITE COMPONENTS IN UPPER FLOOR WINDOW OF B3; VIEWED FROM THE SOUTH-EAST.

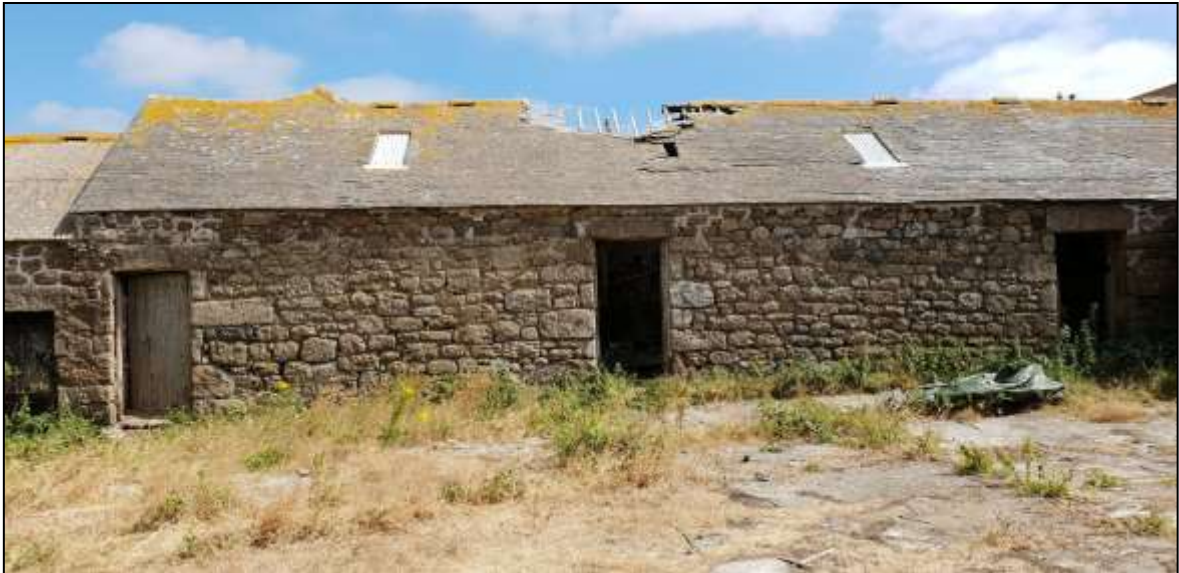
FIGURE 15: B4, FRONT ELEVATION IN NORTH YARD; DOOR TO LEFT IS TO PASSAGE. VIEWED FROM THE NORTH-WEST.

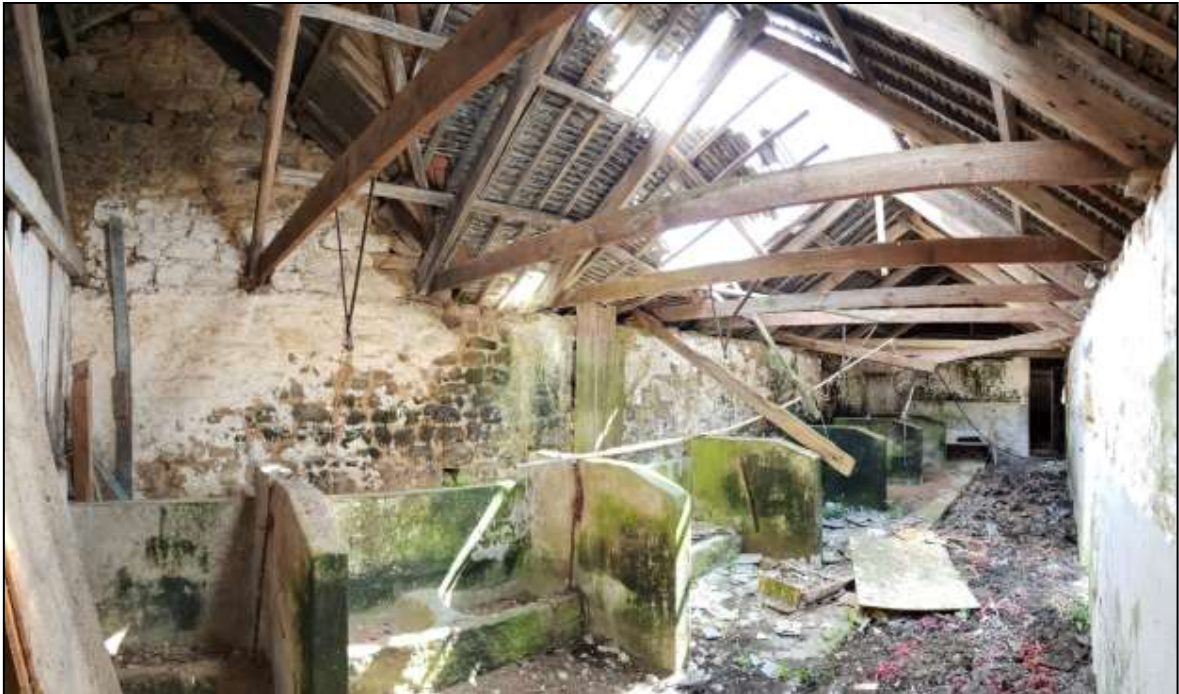
Single storey cow byre built of neat granite rubble stone. Shallow pitched slate roof with gable to the north-east end, terracotta ridge tiles, raised to form air vents at regular intervals. Two 20th century roof-lights in the north-west pitch, the roof partly collapsed to the centre. The roof is carried on eight collarless tiebeam trusses with halved nailed joints, two purlins per side on backs of blades and ridgepole, common rafters and battens, all of sawn pine. The roof and wall at the apex against B3 appear blackened, as if by fire. The building appears to have been constructed within the remains of an earlier structure: the south-east wall includes much heavier stonework towards its south-west end, continuing into the base of the north-east wall of B7, which is slightly battered. This earlier building was truncated at the north end but when B3 was added to its north-east corner it was extended north-east again for a short distance to cover the access passage from the North Yard.

FIGURE 16: B4, PARTLY COLLAPSED 19TH CENTURY ROOF AND MID-20TH CENTURY CONCRETE CATTLE STALLS. NOTE ADDED INTERNAL GABLE OF B3 AT UPPER LEFT. VIEWED FROM THE NORTH.

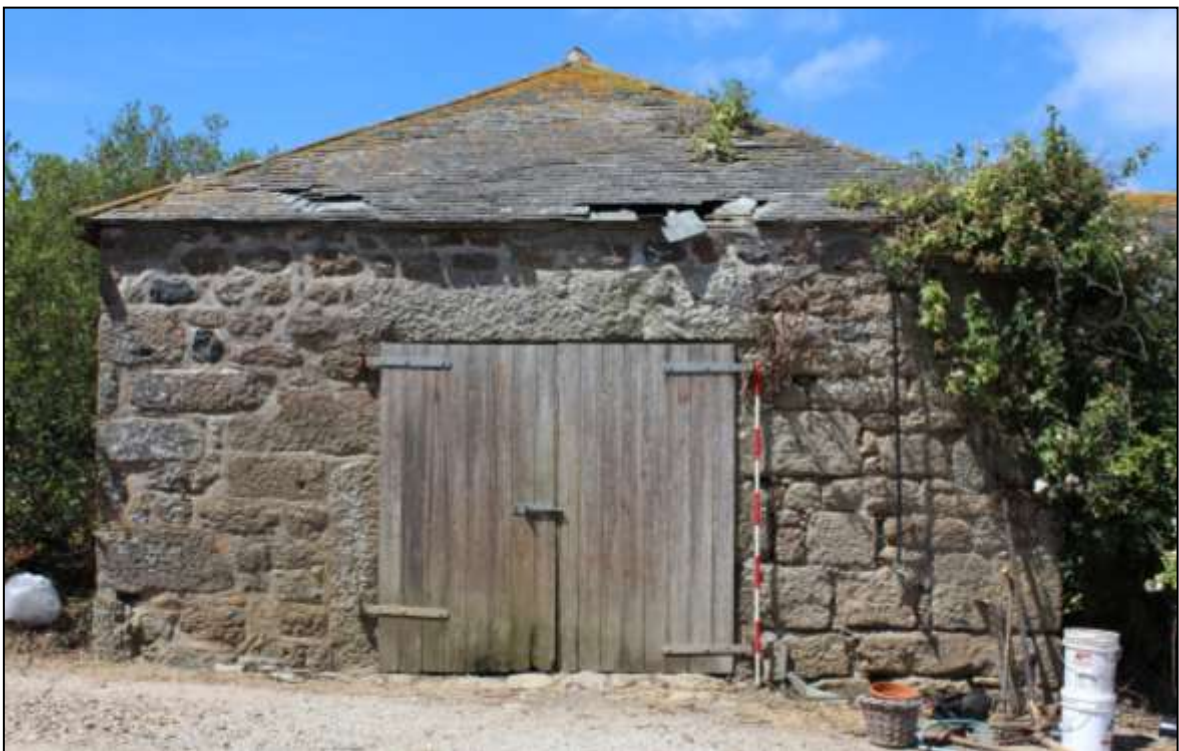
FIGURE 22: B7, THE SOUTH-EAST END, NOTE LARGE RE-USED GRANITE BLOCKS AND ENORMOUS GRANITE LINTEL; VIEWED FROM THE SOUTH-EAST (SCALE 2M).

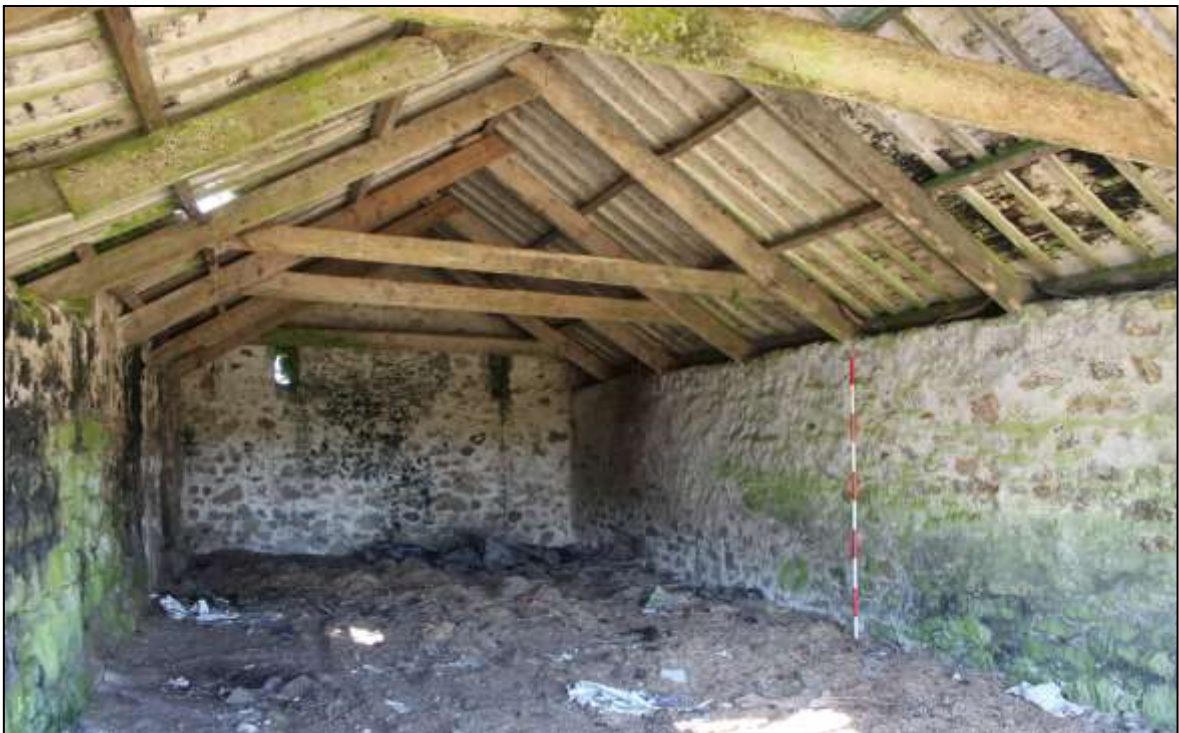
FIGURE 35: B11, INTERIOR, NOTE PLASTER TORCHING BETWEEN COMMON RAFTERS; VIEWED FROM THE SSE (SCALE 2M).

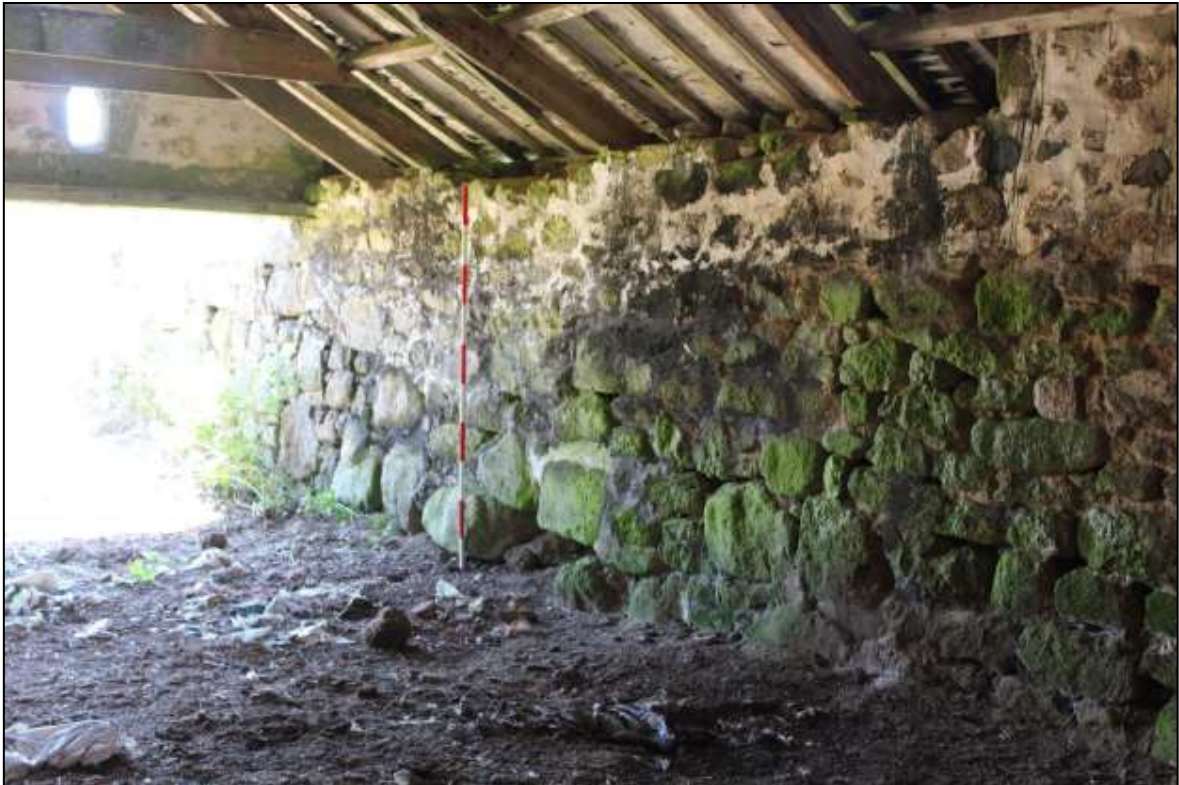
FIGURE 36: B11, INTERIOR, SHOWING THE MORTARED RUBBLE WALL SITTING ON AN OLDER YARD WALL OF MASSIVE BOULDERS; VIEWED FROM THE NORTH (SCALE 2M).

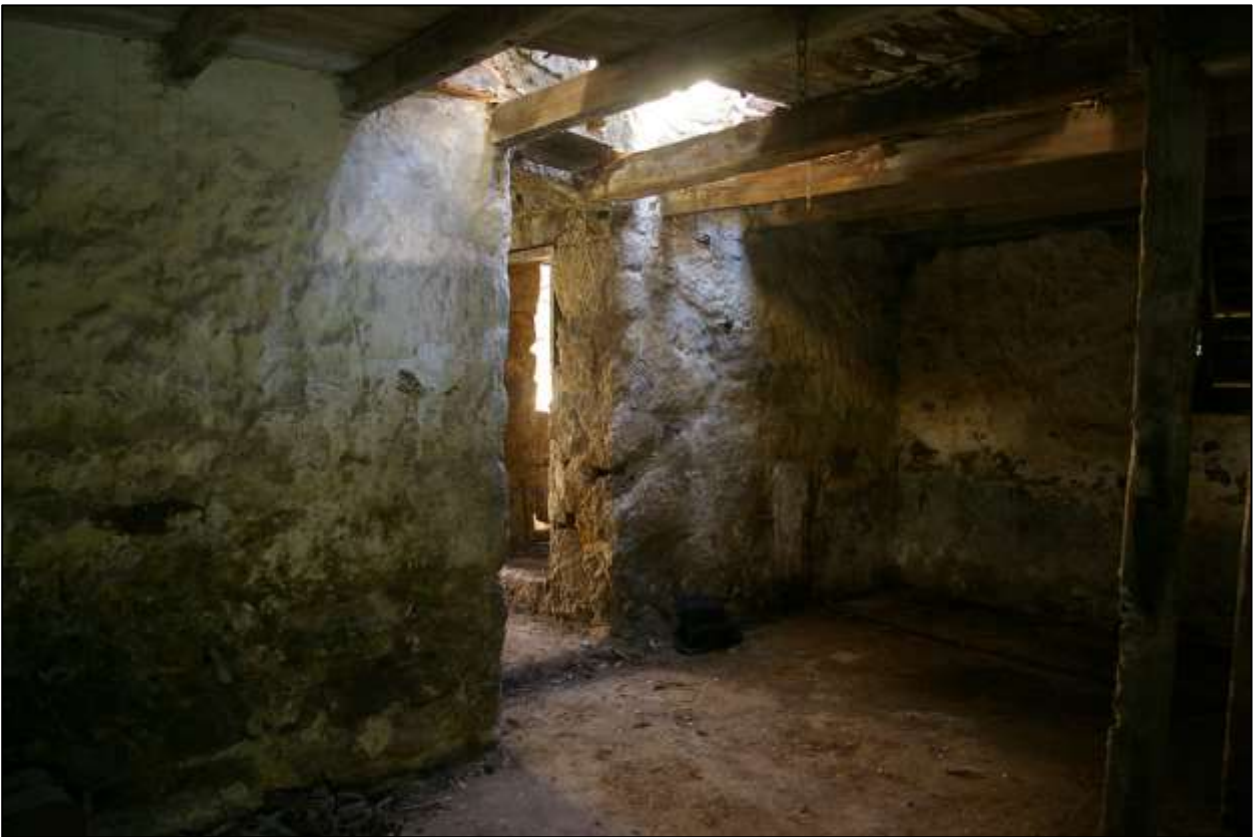
123. B3 GF INTERIOR, CLEARED OF RUBBISH; VIEWED FROM THE SOUTH.

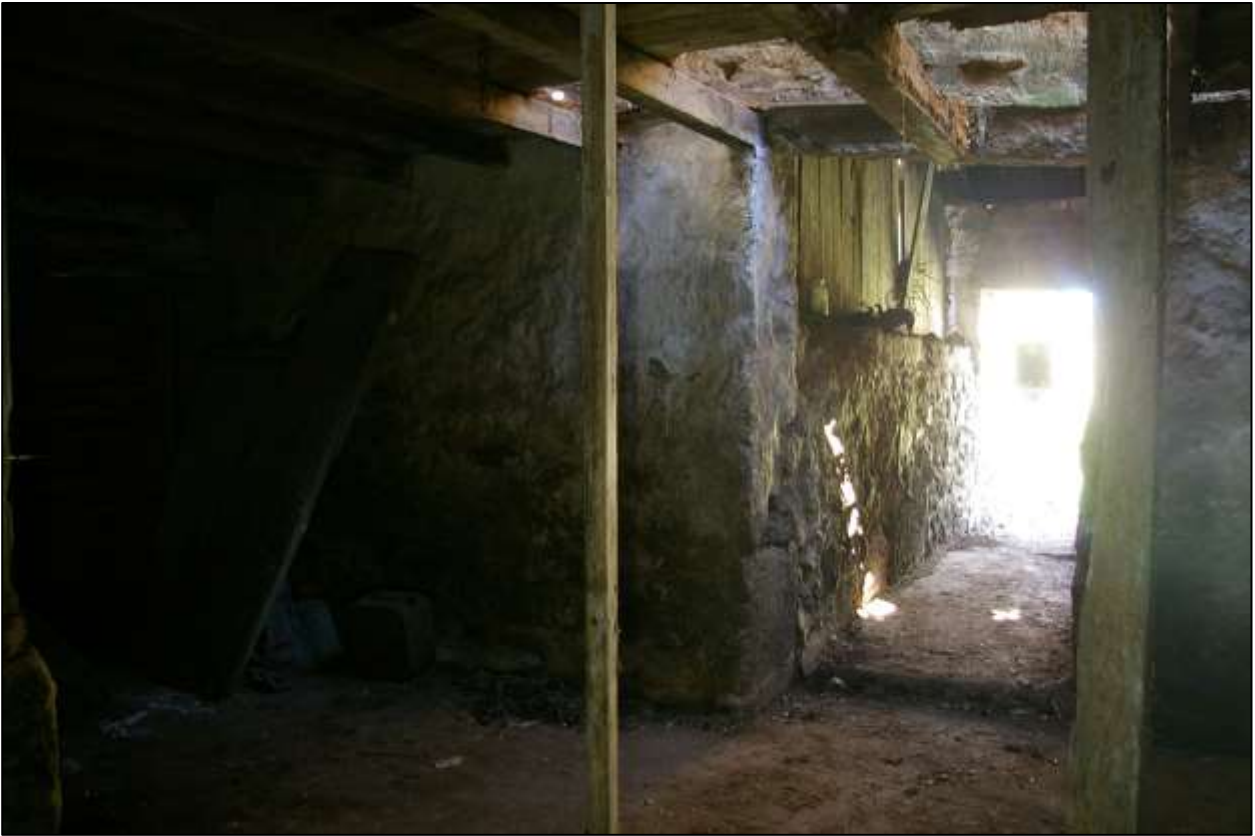
124. B3 GF INTERIOR, CLEARED OF RUBBISH, LOOKING BACK ALONG THE PASSAGE IN B4; VIEWED FROM THE SOUTH-EAST.

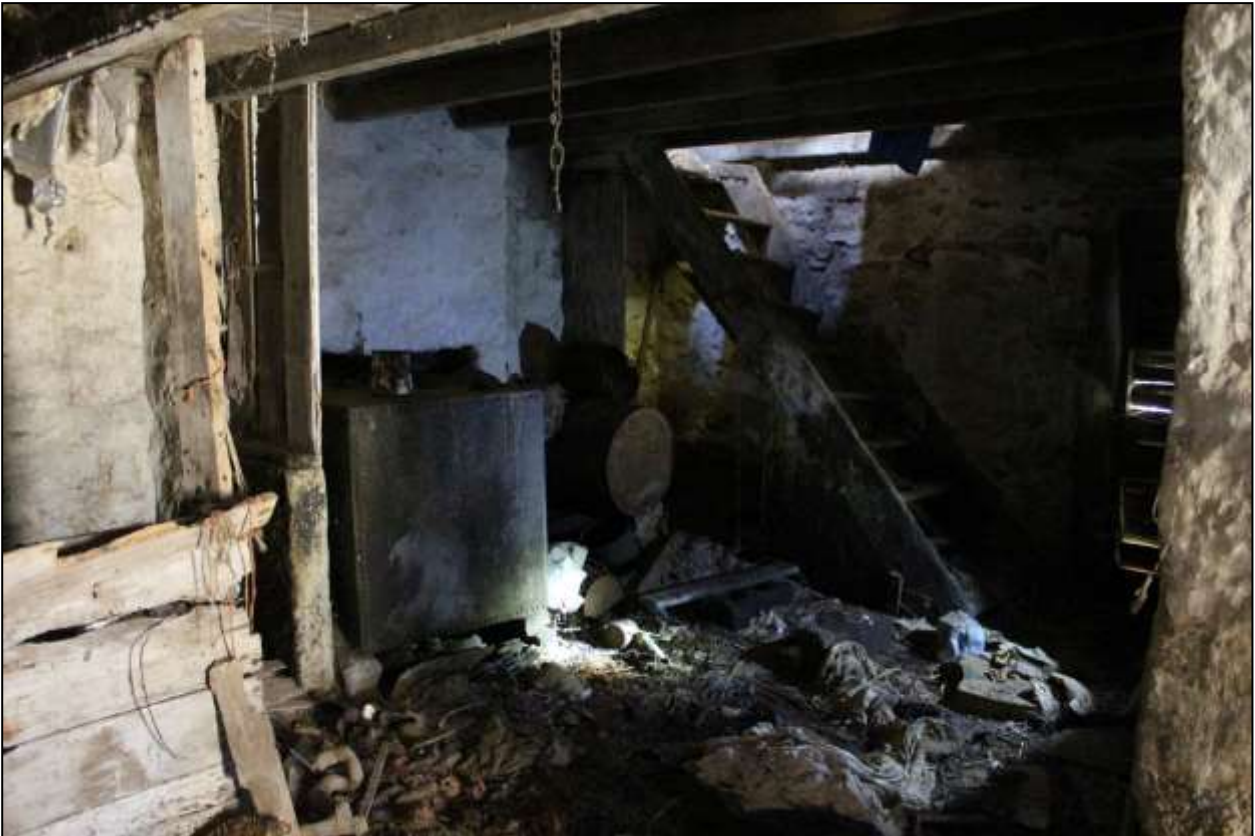
125. B3 GF INTERIOR; VIEWED FROM THE NORTH.

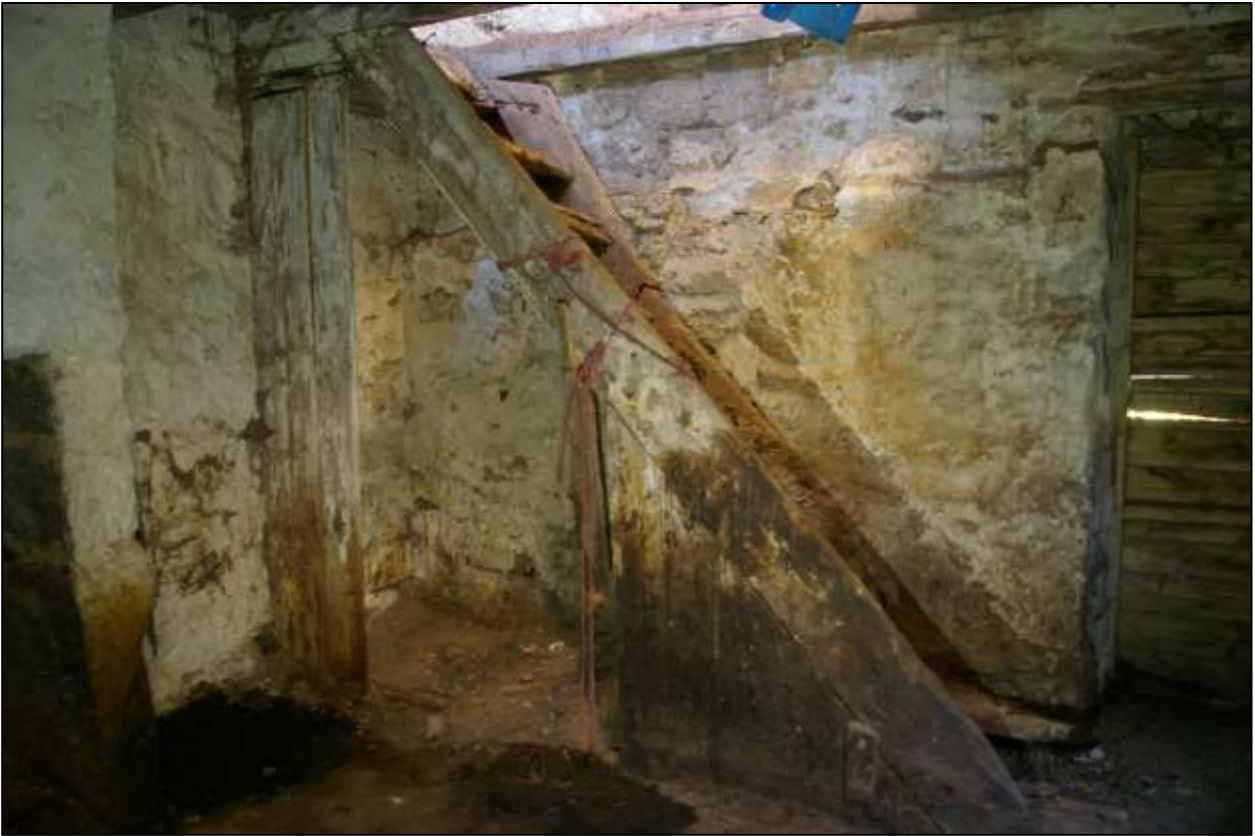
126. B3 GF INTERIOR, CLEARED OF RUBBISH, DETAIL OF THE STAIR; VIEWED FROM THE NORTH.

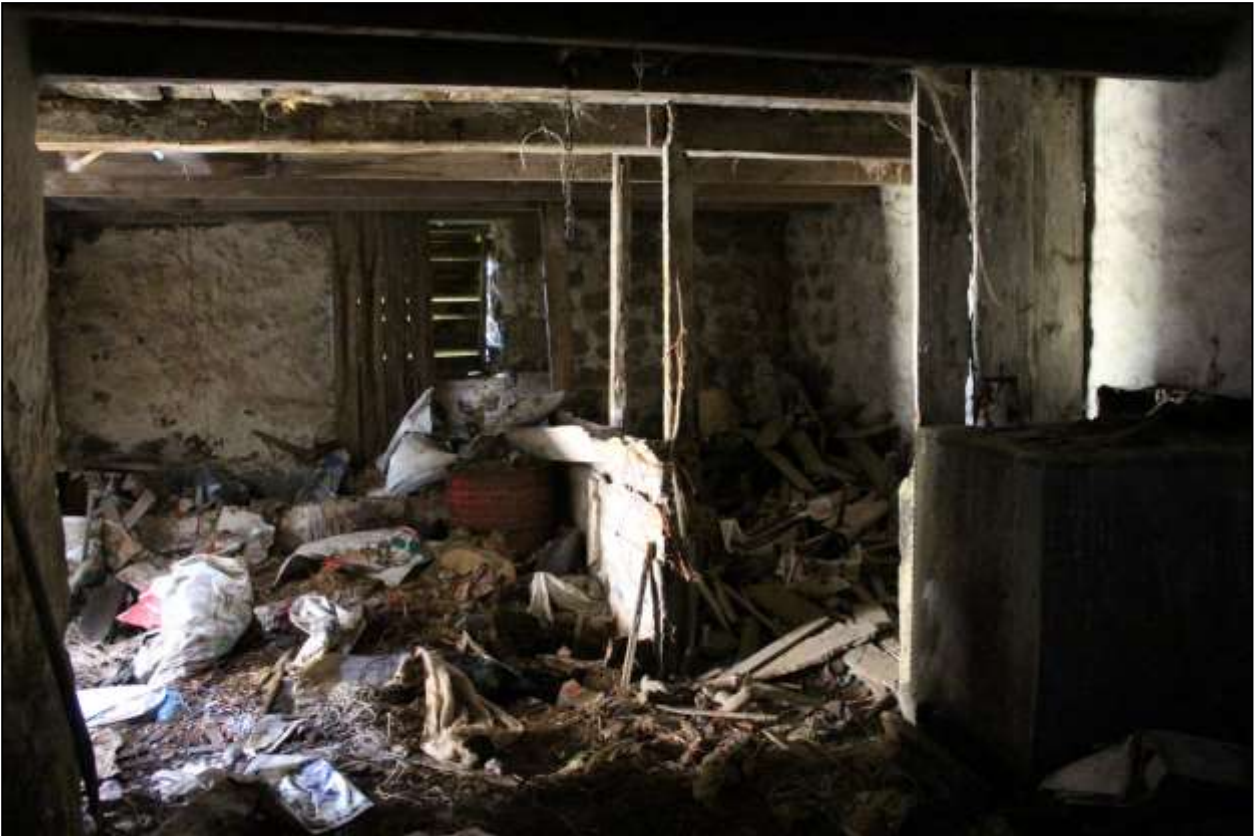
127. B3 GF INTERIOR, VIEWED FROM THE SOUTH-WEST.

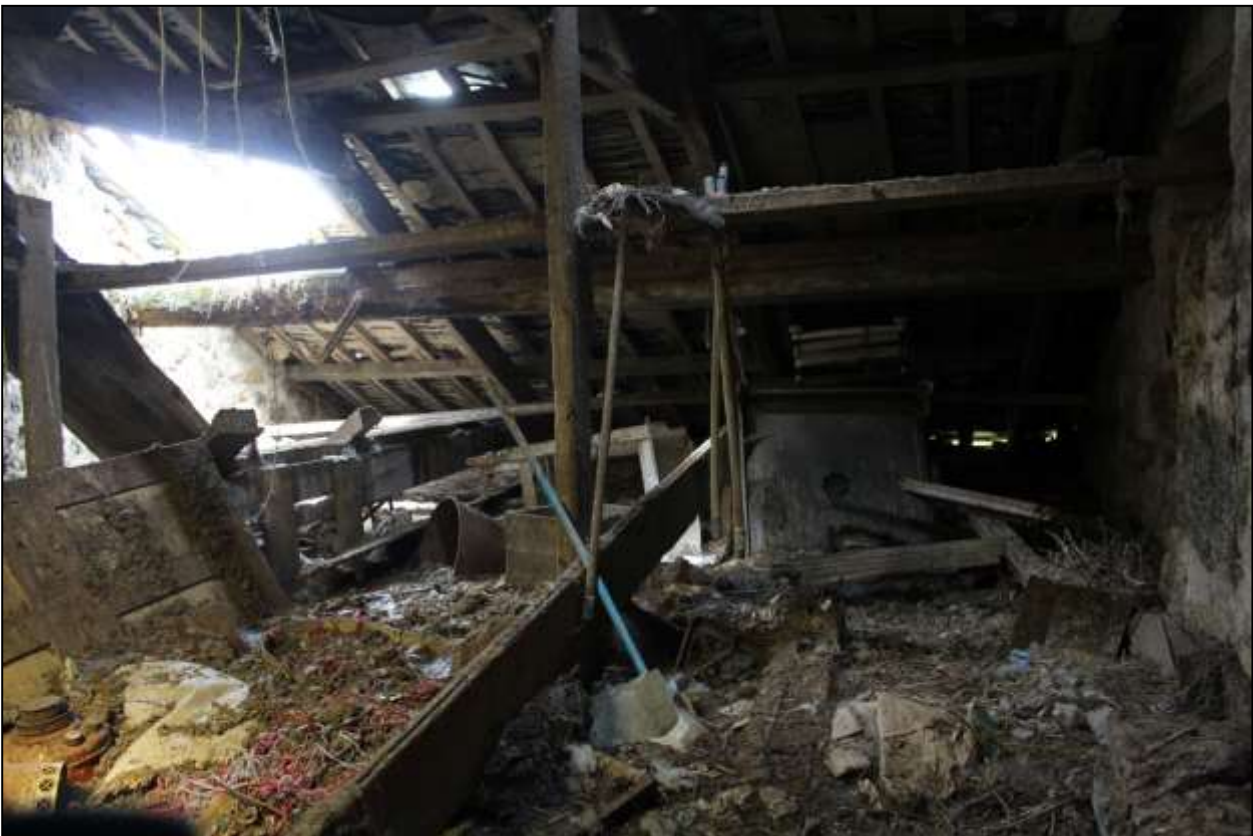
130. B3 FF INTERIOR, VIEWED FROM THE SSW.

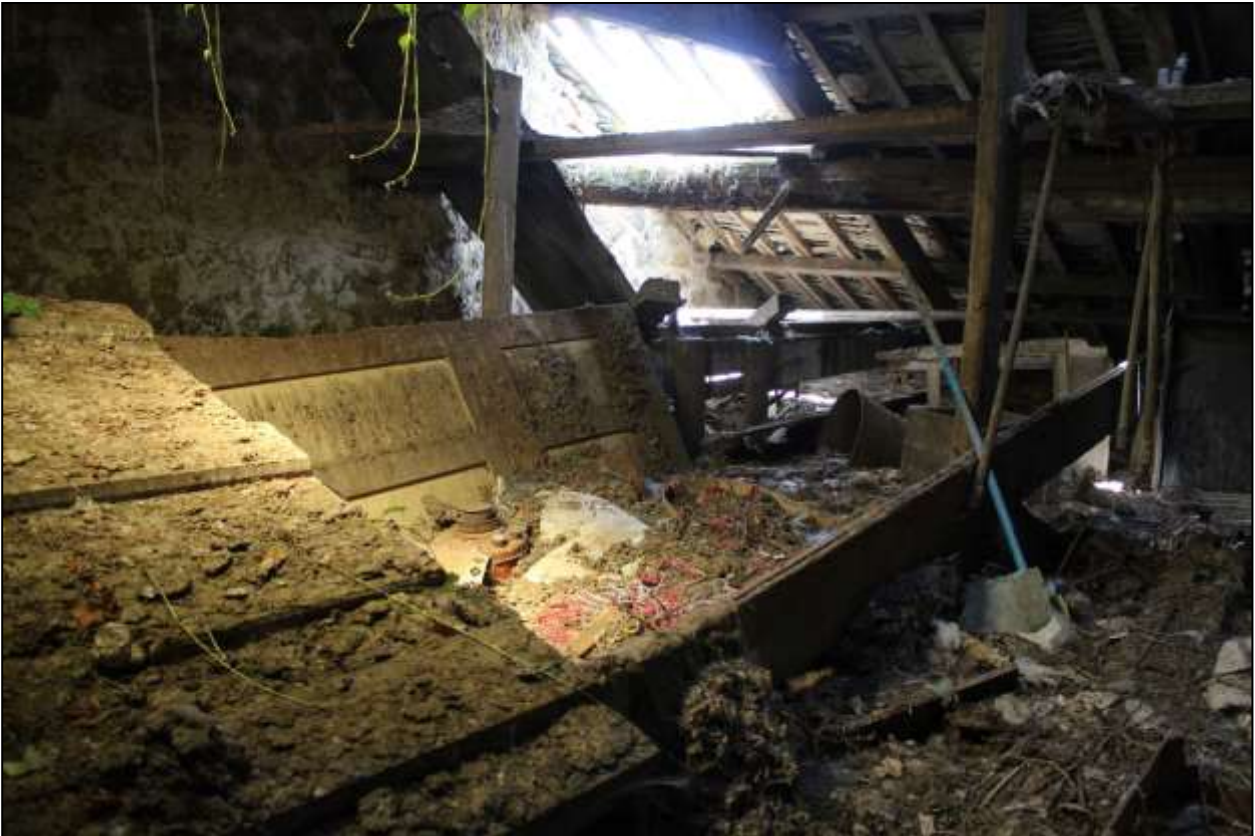
131. B3 FF INTERIOR, VIEWED FROM THE SOUTH.

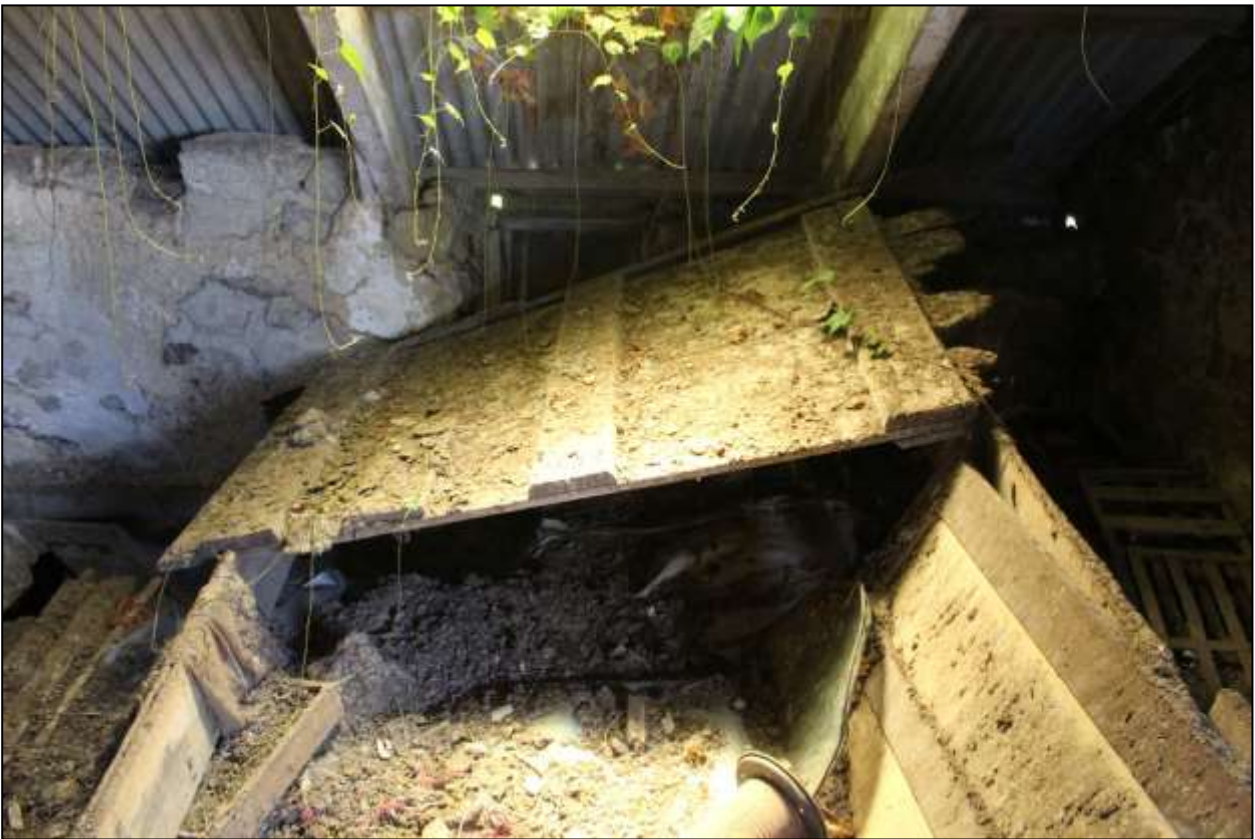
132. B3 FF INTERIOR, THE SOUTH-WEST WALL WITH DETAIL OF FW3; VIEWED FROM THE NORTH-EAST.

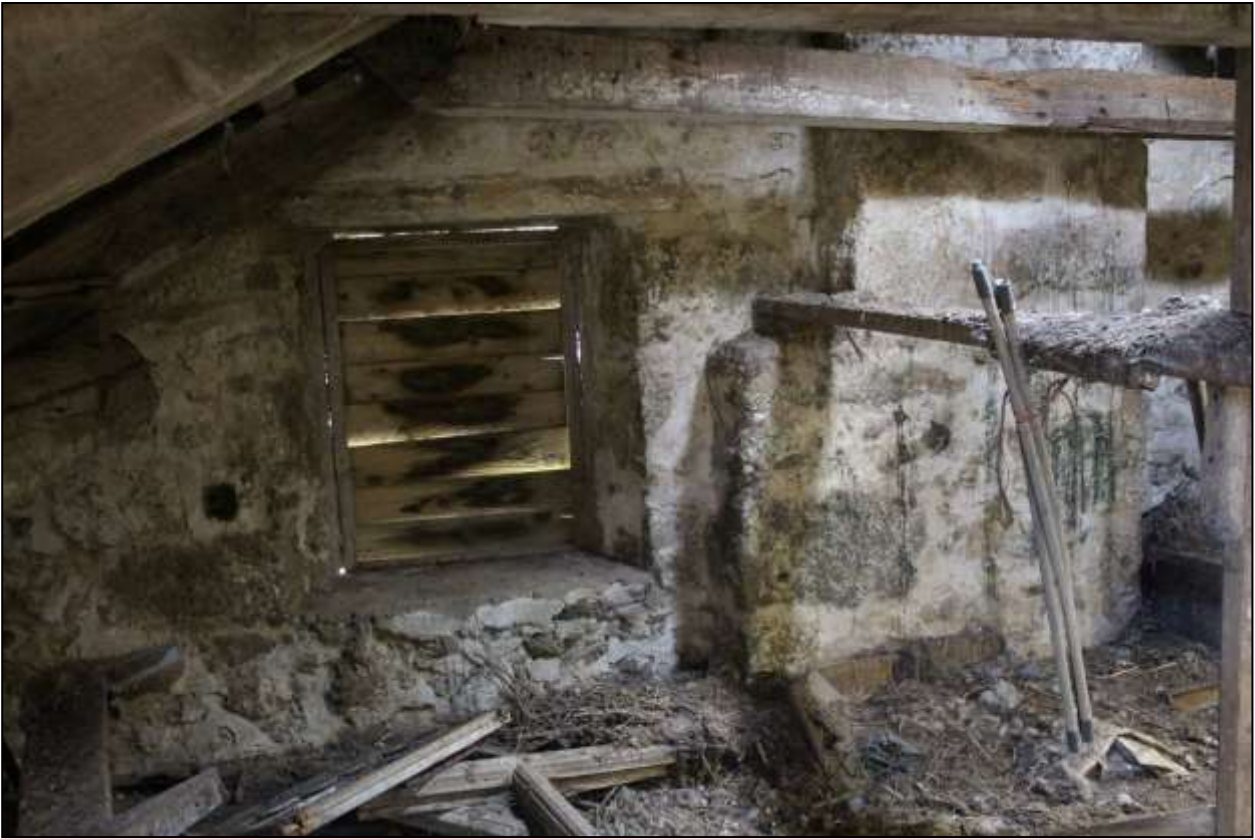
133. B3 FF INTERIOR, THE SOUTH-EAST WALL WITH FW2 AND STACK; VIEWED FROM THE NORTH-WEST.

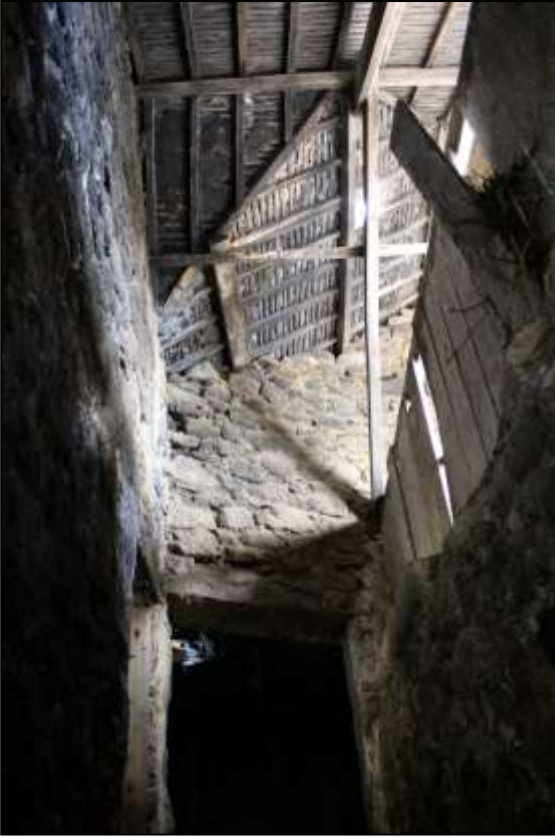
141. B4 INTERIOR, VIEW ABOVE THE CORRIDOR TO THE (SCORCHED?) UNDERSIDE OF THE ROOF; VIEWED FROM THE NORTH-WEST.

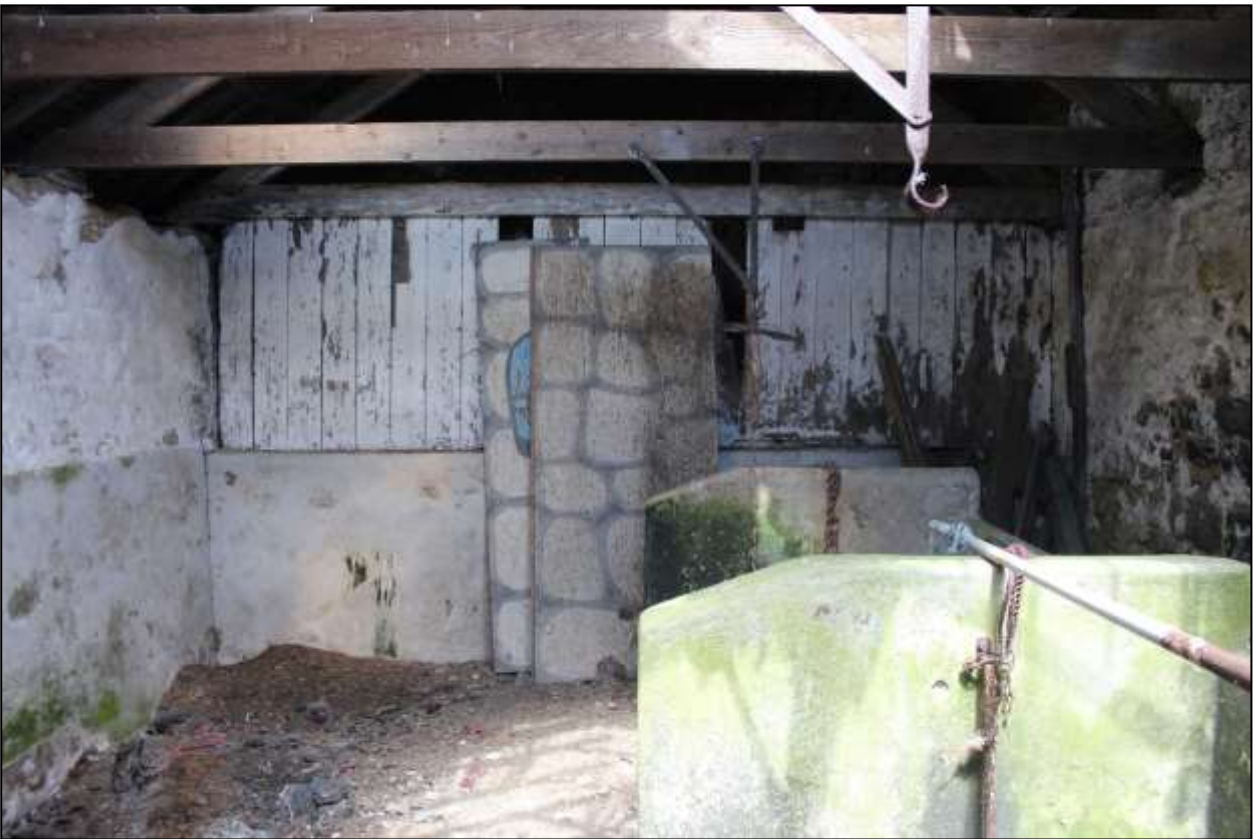
142. B4 INTERIOR, THE PARTITION WALL AGAINST THE CORRIDOR; VIEWED FROM THE SOUTH-WEST.

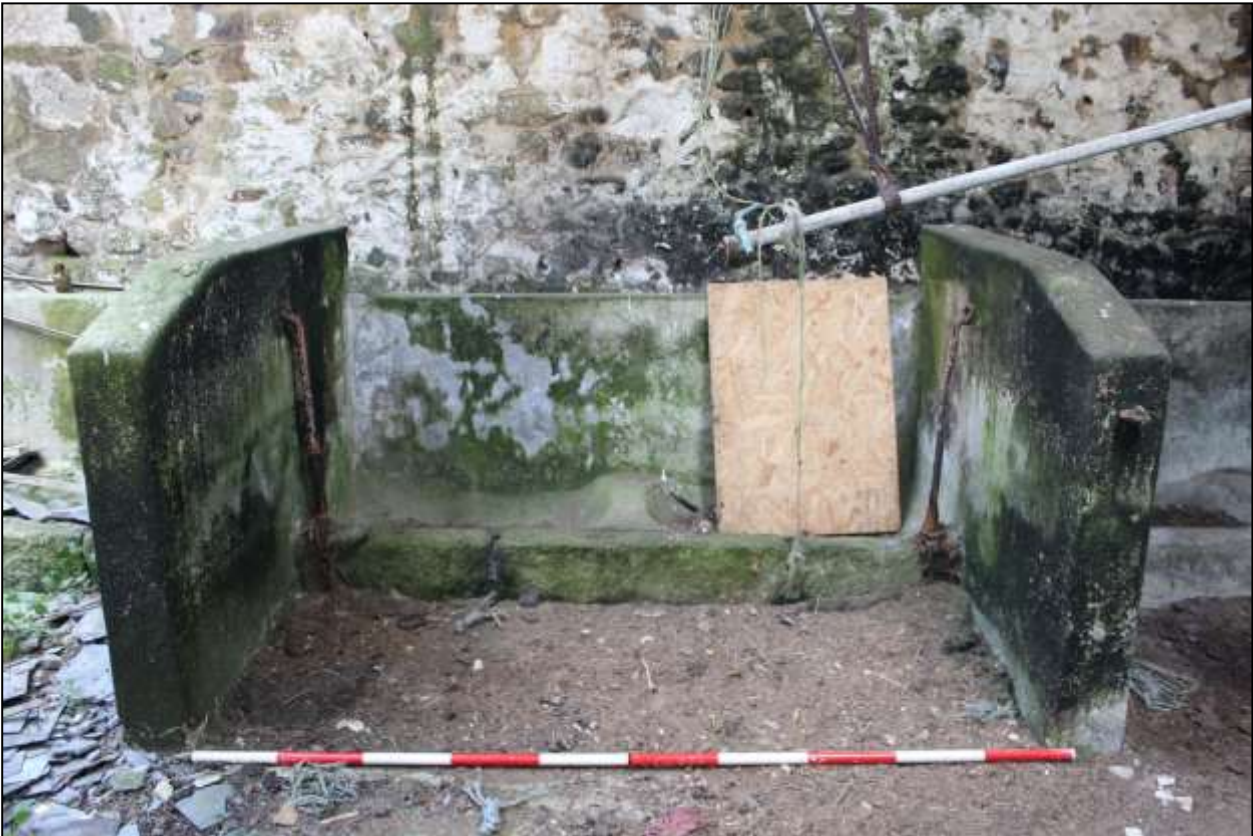
148. B4 INTERIOR, DETAIL OF A CATTLE STALL; VIEWED FROM THE NORTH-WEST (SCALE 2M).

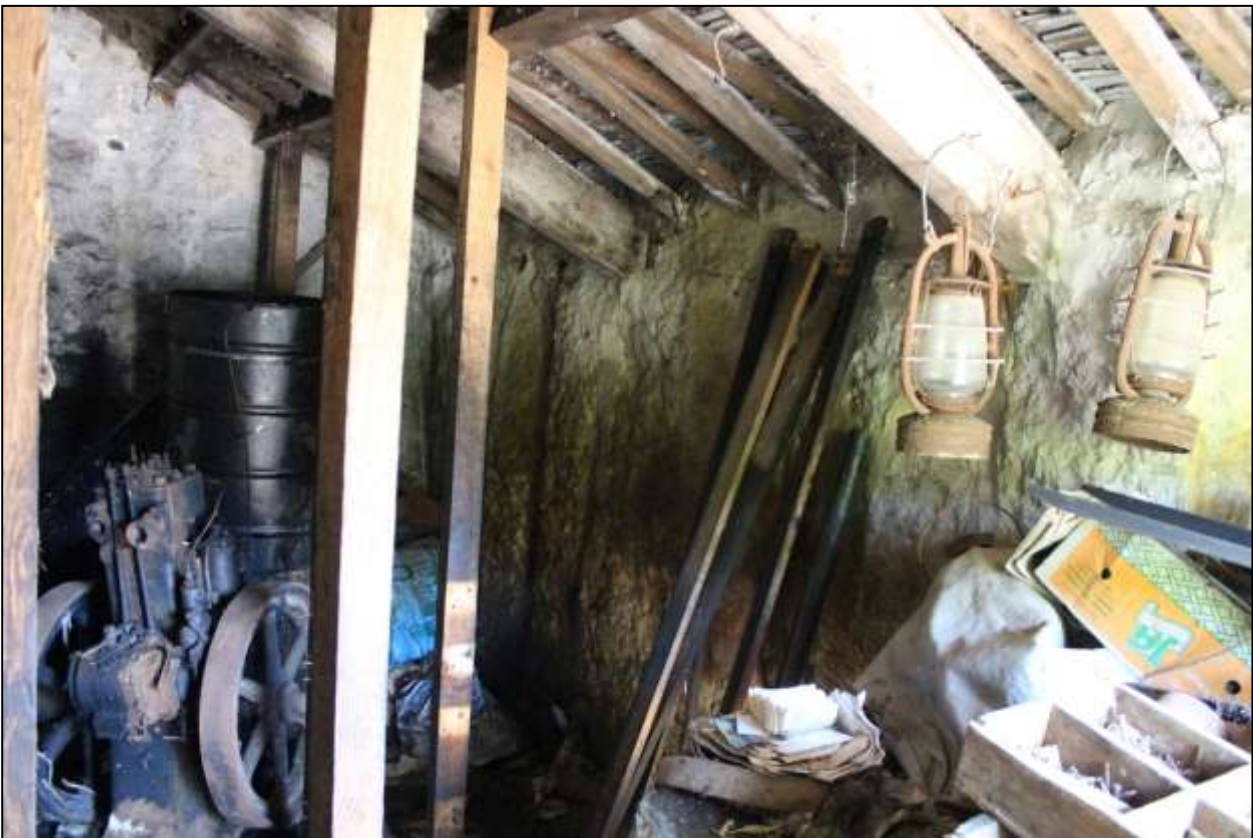
159. B6 INTERIOR, THE NORTH-EAST WALL COMPRISED OF GRANITE ORTHOSTATS; VIEWED FROM THE SSE.

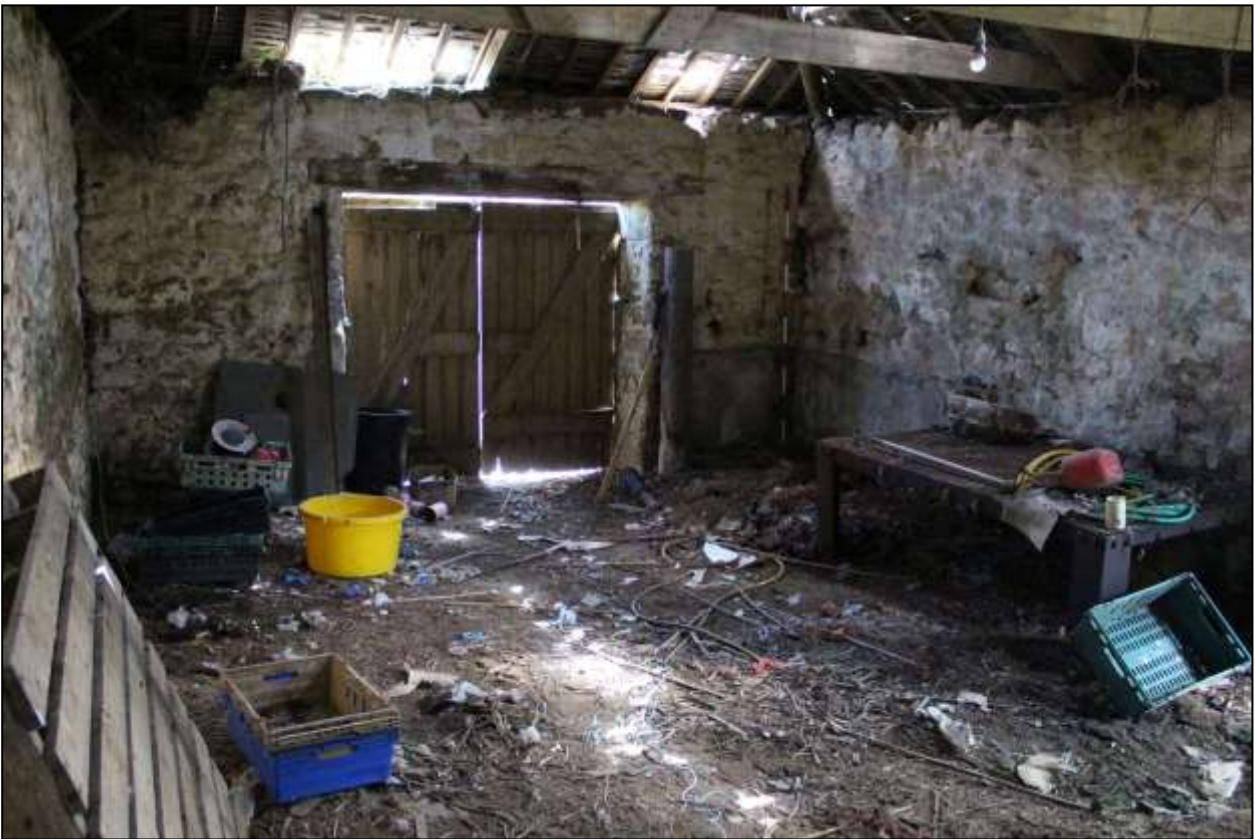
161. B7 INTERIOR, THE SOUTH-EAST WALL WITH GD4; VIEWED FROM THE NORTH-WEST (SCALE 2M).
