# ASHREIGNEY METHODIST CHAPEL

HISTORIC BUILDING RECORDING

SOUTH WEST ARCHAEOLOGY LTD. REPORT NO. 181102

*South West Archaeology Ltd. was commissioned to undertake historic building recording for the Ashreigney Methodist Chapel. This work was undertaken in advance of the conversion of the building to a residential property.*

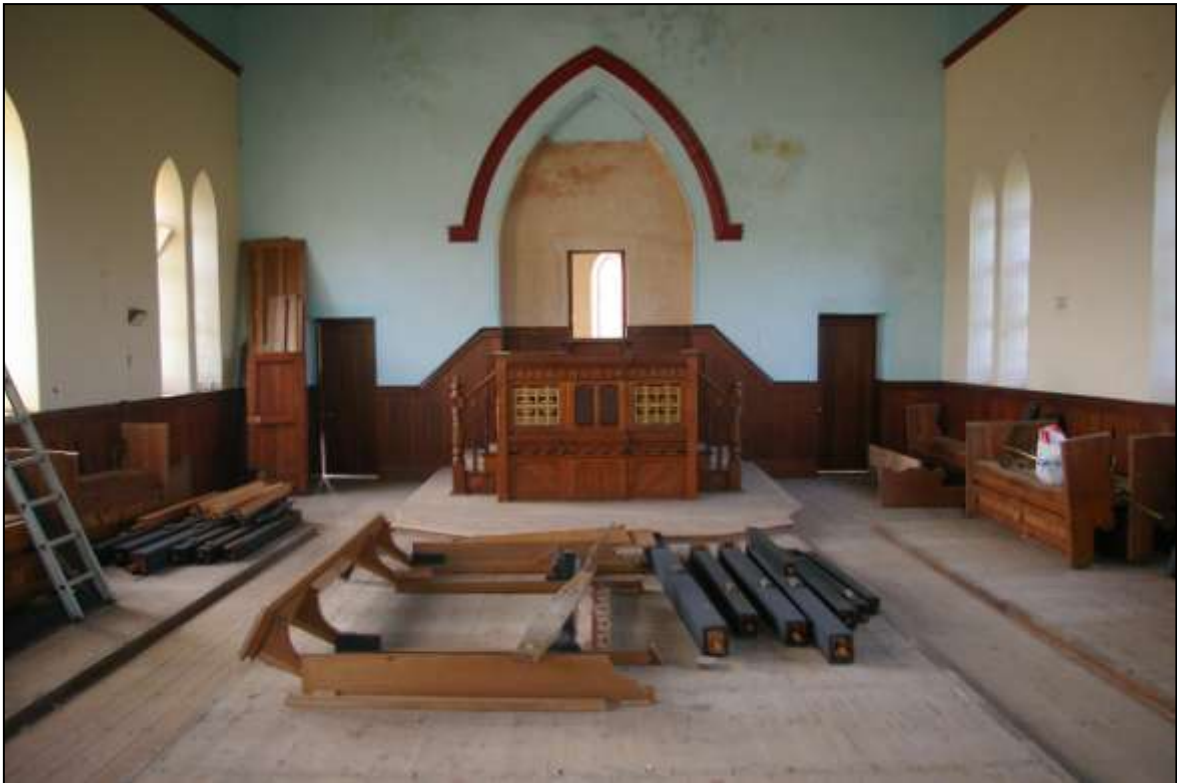
FIGURE 3: THE SOUTH WALL OF THE CHAPEL, WITH ALCOVE BEHIND THE PULPIT WITH FINE HOODMOULD OVER; FROM THE NORTH.

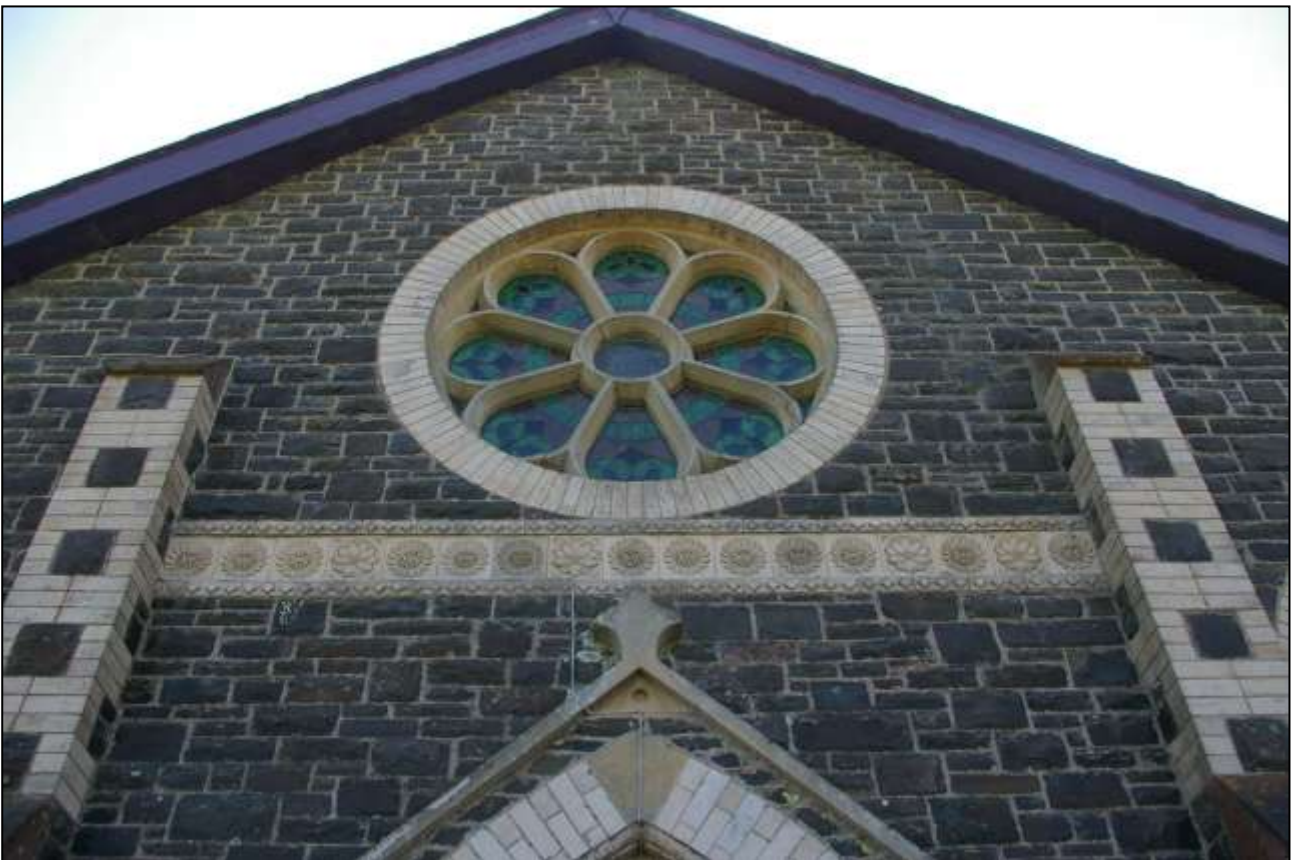
Roof Covering		Gable end of building, slated roof, deep ogee moulded barge boards to boxed eaves.
Opening – Windows:	3	<p>W1 – Rose window to apex of gable. Brick segmental contiguous round reveal. Dressed stone window, with slight hollow chamfer moulding. Stained glass panels, striking Art Nouveau design of turquoise, blue green and red, geometric lily foliate motif. Central painted roundel. Image of a small church with squat tower and short spire, in a wooded setting next to a muddy track, location unknown.</p> <p>W2 – Gothic arched window, one of a pair which flank central bay. Brick segmental arched reveals, with dressed stone keystone. Stone dressed chamfered sill, possibly reused from previous chapel (present as reused lintels). Stone two light lancet style windows, with slight hollow chamfered moulding. Pastel tinted textured leaded glass, red and green geometric outer banding, metal framed windows, central lozenge of painted countryside scene; two views of the same tall church with three stage crenellated tower, set against a sunset.</p> <p>W3 - Gothic arched window, one of a pair which flank central bay. Brick segmental arched reveals, with dressed stone keystone. Stone dressed chamfered sill, possibly reused from previous chapel (present as reused lintels). Stone two light lancet style windows, with slight hollow chamfered moulding. Pastel tinted textured leaded glass, red and green geometric outer banding, metal framed windows, central lozenge of painted countryside scene; one a moss and ivy covered damaged church and tower in a darkened landscape, one a brighter image of a smaller church with narrow three stage tower and pointed spire, set against a sunset.</p>

8. THE ROSE WINDOW IN THE APEX OF THE NORTH ELEVATION; FROM THE NORTH.

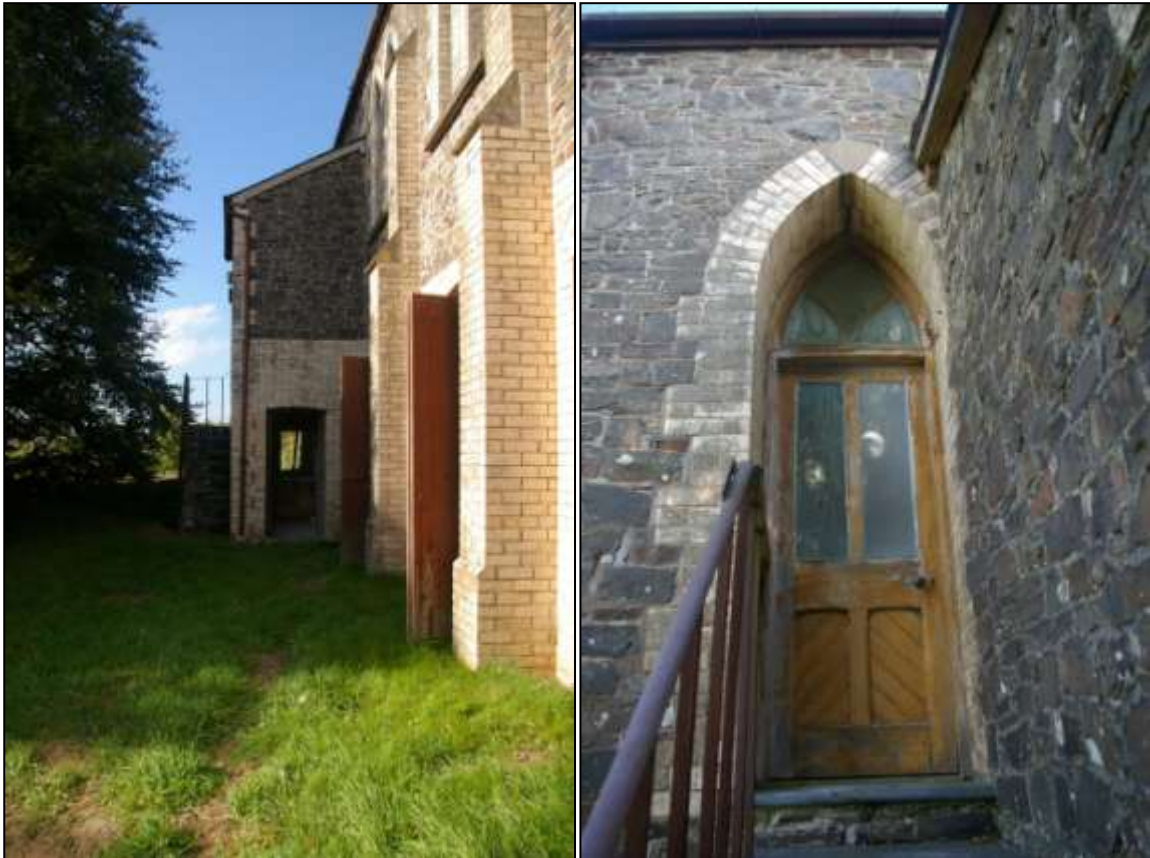
Roof Covering:		Steeply pitched slate roof, terracotta ridge tiles, roll-moulded, broken finial to west, survives to east end. Deep ogee moulded barge boards.
Openings – Doors:	6	D10 – West end, ground (upper) floor, there is a fine arched door with ceramic brick segmental arched reveals and boarded and framed door with diagonal boarded panels and upper glazed panels, serving the office/vestry. Served by the stone and slate steps. There are three matched large double width carriage doors on the basement floor. D12, 13 and 14 - These have cream ceramic brick reveals and round-headed segmental relieving arches. Each has a wide chamfered doorframe, boarded arched fillets above square headed boarded and framed doors, on massive iron strap hinges, with iron bolts. D15 - There is a narrow square-headed door to the basement floor of the projecting service block in its east wall, boarded and framed door. D16 – Wide tall blocked doorway to services, brick reveals, now blocked with

23. LEFT: THE EAST ELEVATION OF THE SMALL PROJECTING SERVICE BLOCK, WITH 2M SCALE; FROM THE EAST.

24. RIGHT: THE GOTHIC TIMBER BOARDED AND FRAMED DOOR WITH ARCHED GLAZED PANELS, D10; FROM THE SOUTH.

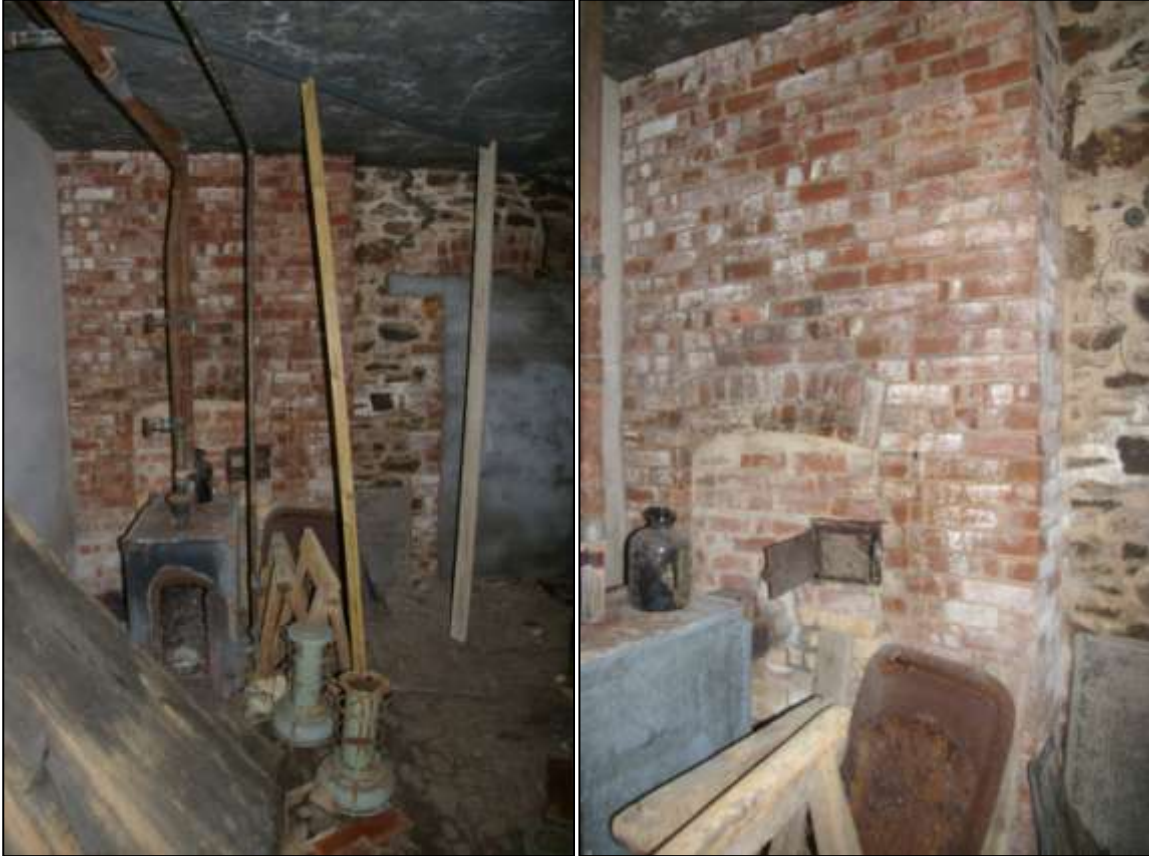
Openings Windows:	– 1	W22 - Fine arched tripartite window to the east wall, described with elevation.
Significant Details:		Britannia cast iron boiler and heavy duty pipes to the south-east corner, standing next to earlier brick flue for presumably wood heating?

29. LEFT: THE BOILER WITH ITS BRICK FLUE; FROM THE NORTH.

30. RIGHT: THE BRICK STACK, WITH BLOCKED FIREPLACE AND INSET IRON HATCH; FROM THE NORTH-WEST.

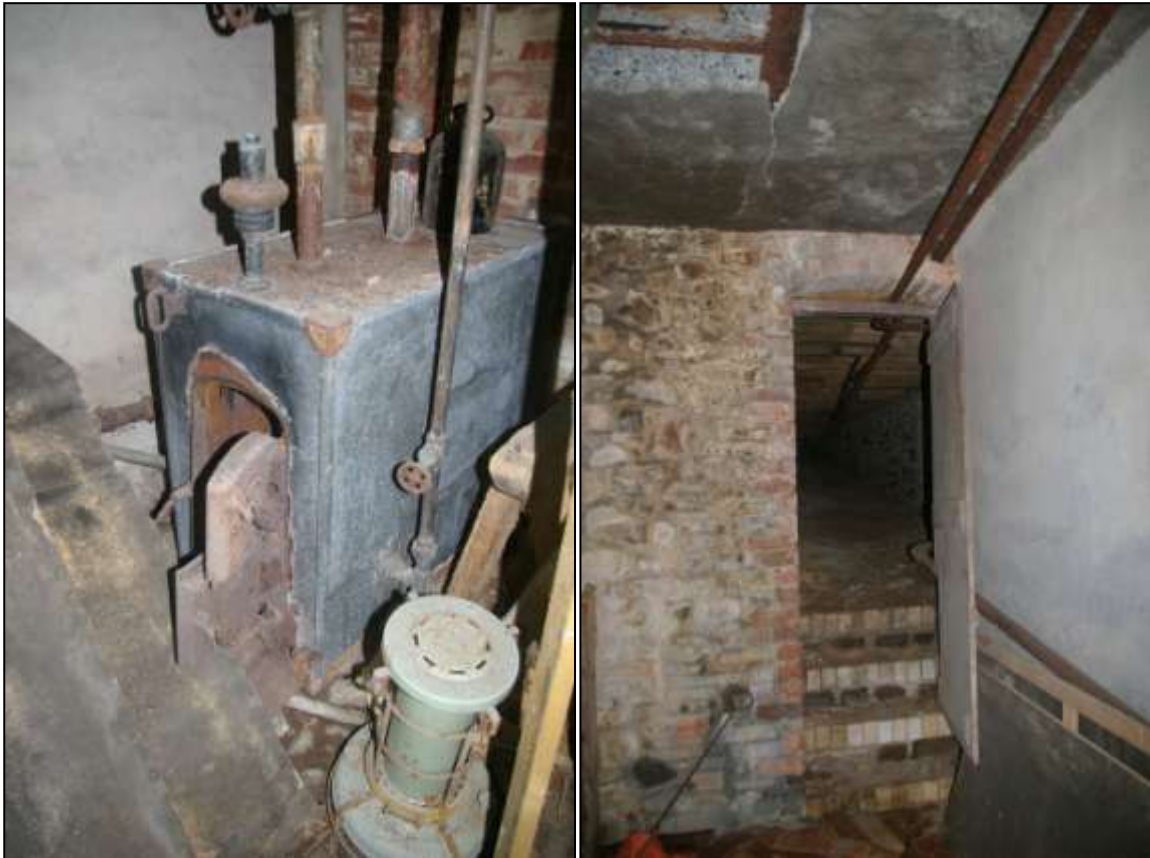
34. LEFT: THE BOILER; FROM THE NORTH-WEST.

35. RIGHT: THE DOORWAY FORCED THROUGH TO THE UNDERCROFT; FROM THE SOUTH-SOUTH-WEST.

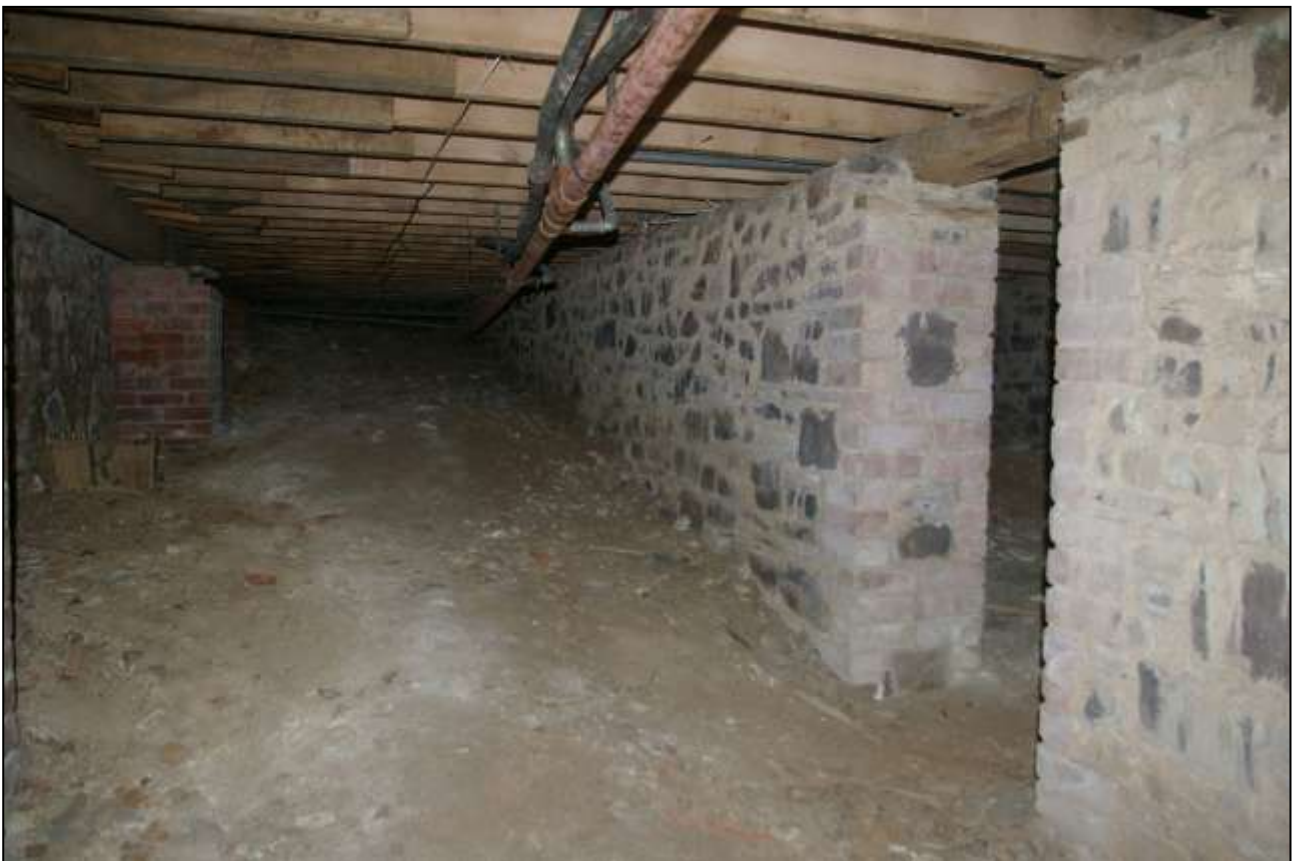
- In the undercroft basement new brick piers carry heavy oak beams installed to support the floor along the west elevation where driving weather has caused damp to the walls and rotted out the ends of the floor joists.

36. THE WESTERN COMPARTMENT WITHIN THE UNDERCROFT; FROM THE SOUTH.

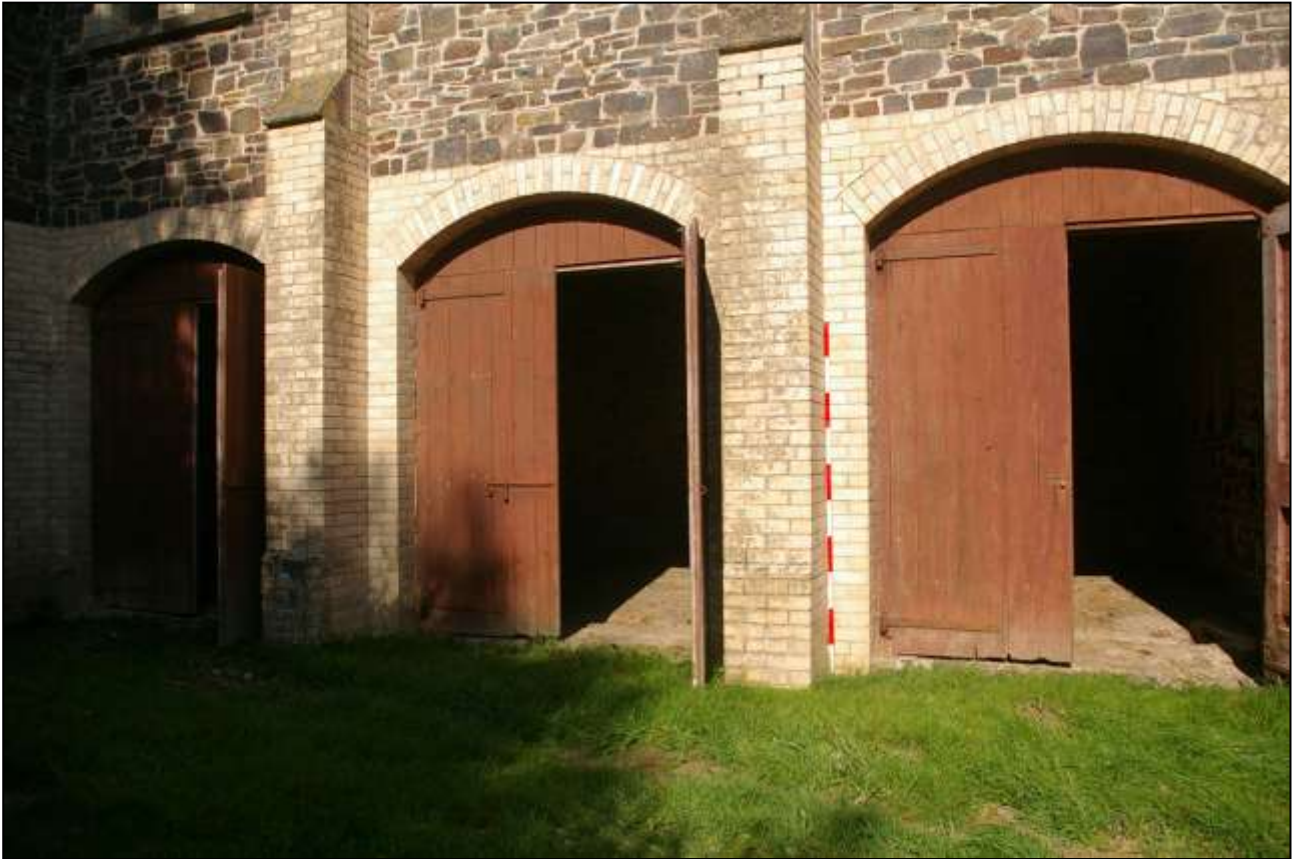
42. THE THREE CARRIAGE DOORS, D12, D13 AND D14, WITH 2M SCALE; FROM THE SOUTH, SOUTH-EAST.

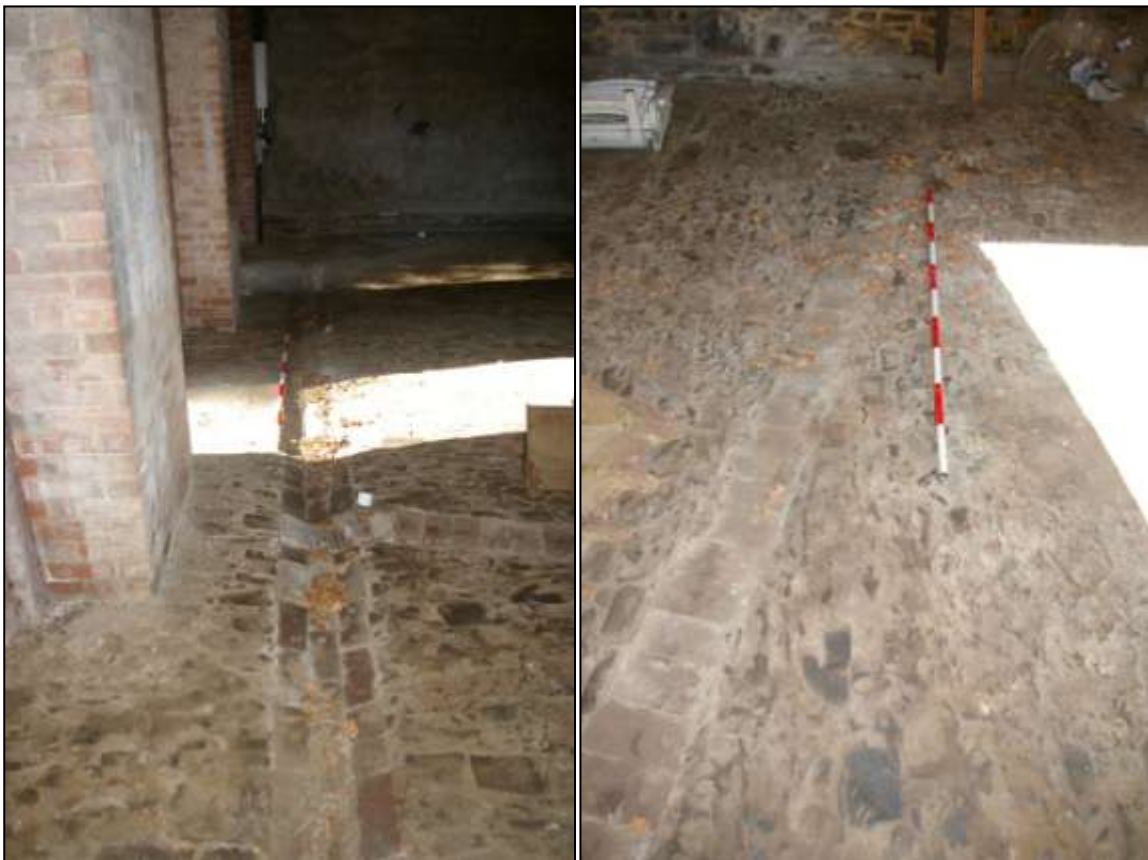
48. LEFT: THE BRICK DRAIN TO THE SOUTH SIDE OF THE COBBLED FLOOR IN THE CARRIAGE HOUSE, 2M SCALE; FROM THE EAST.

49. RIGHT: THE LATER CUT INTO THE FLOOR TO SERVE THE BOILER PIPES, 2M SCALE; FROM THE SOUTH.

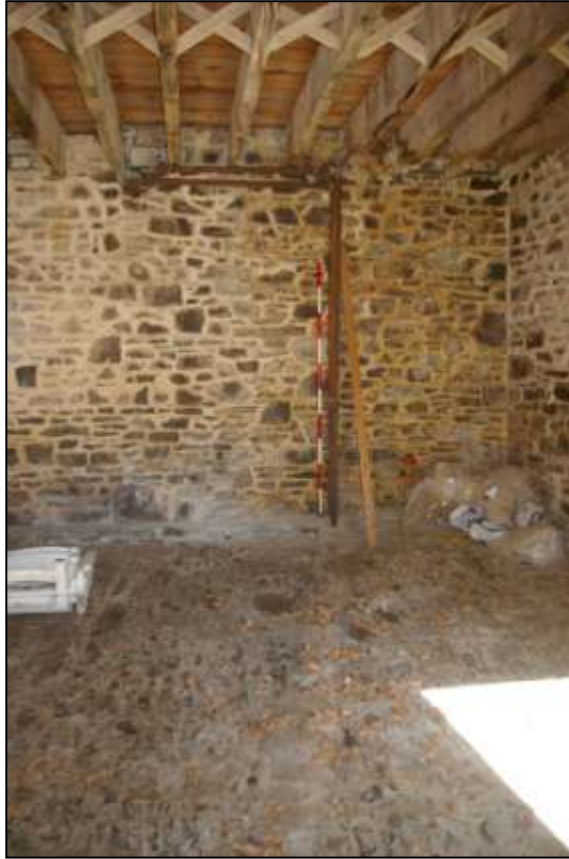
50. THE BOILER PIPES, WHERE THEY BREACH THE WALL OF THE CARRIAGE HOUSE, WITH 2M SCALE; FROM THE SOUTH.

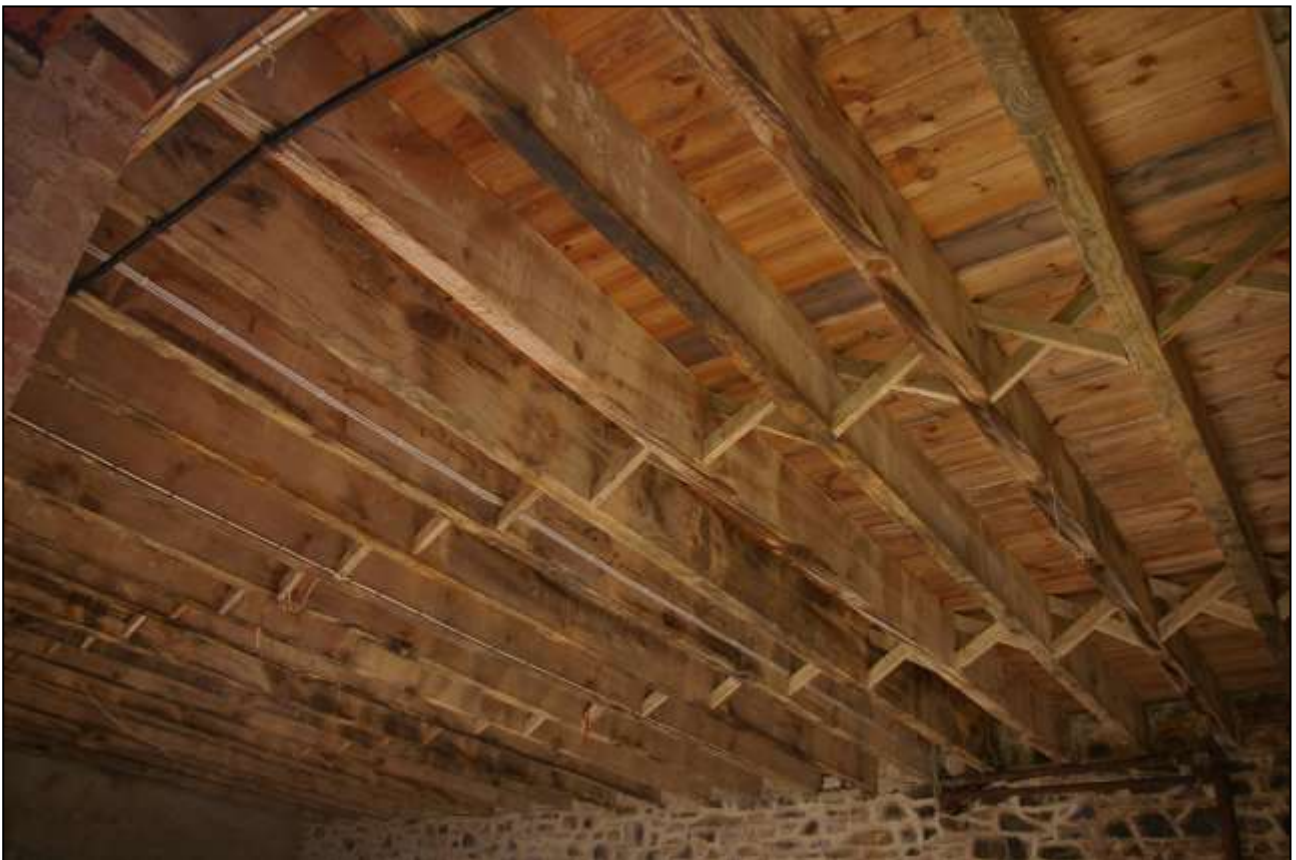
53. THE HEAVY JOISTS WHICH CARRY THE SUSPENDED FLOOR ABOVE WITH NOGGIN BRACES BETWEEN; FROM THE SOUTH-EAST.

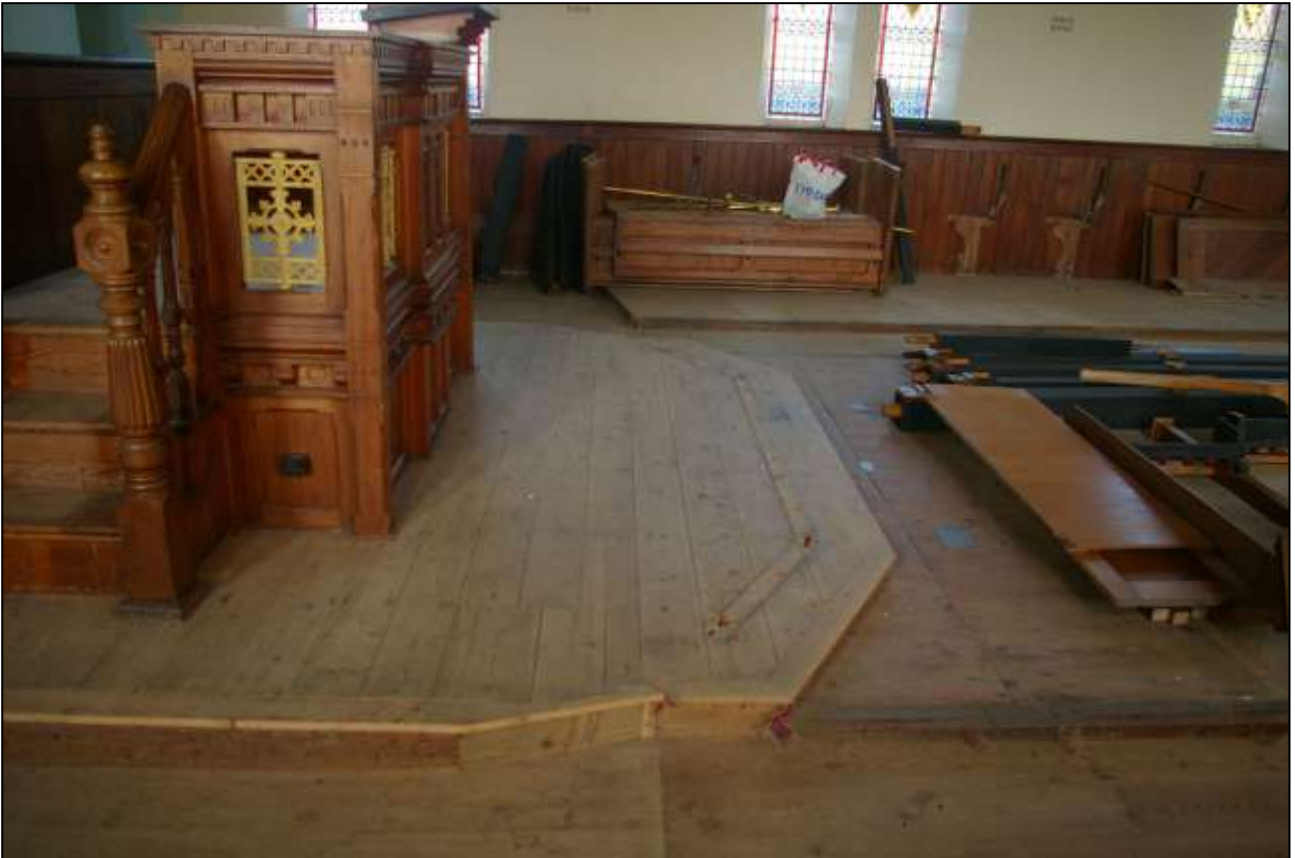
- The original air vents to the west wall have been replaced with modern plain grills, a noticeable style change to the plain plastered walls.
- The pulpit has been brought forward to incorporate the organ, which was obviously a later addition, with lots of modern woodwork, dated 1995, installed beneath and around the pulpit to brace the floor for the heavier weight.

72. THE SLIGHT RAISED DAIS ON WHICH THE PULPIT STANDS; FROM THE EAST.

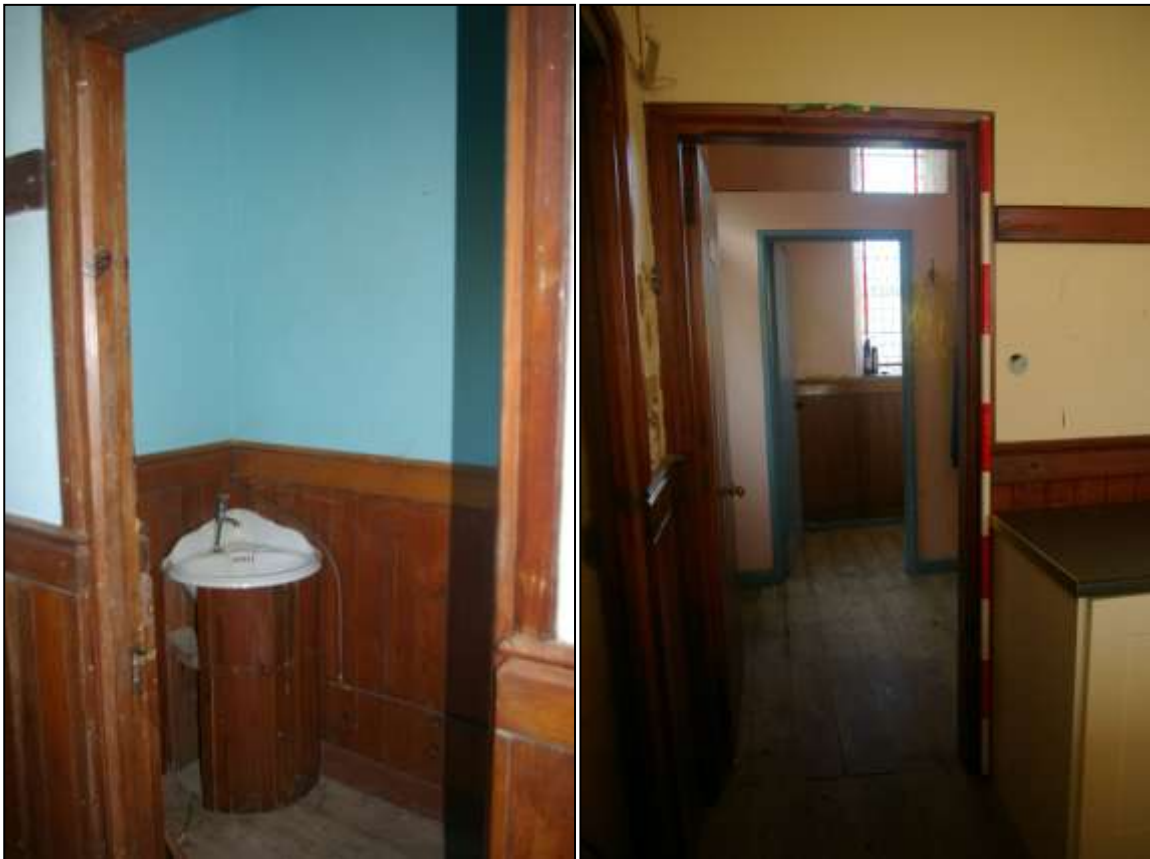
113. RIGHT: THE INSERTED PARTITION, REUSING SOME RESET WINDOWS AND A DOOR, WITH 2M SCALE; FROM THE NORTH-WEST.
