# TRELEW FARM MYLOR CORNWALL

Historic Building Recording

South West Archaeology Ltd. report no. 180910

## Trelew Farm, Mylor, Cornwall Historic Building Recording

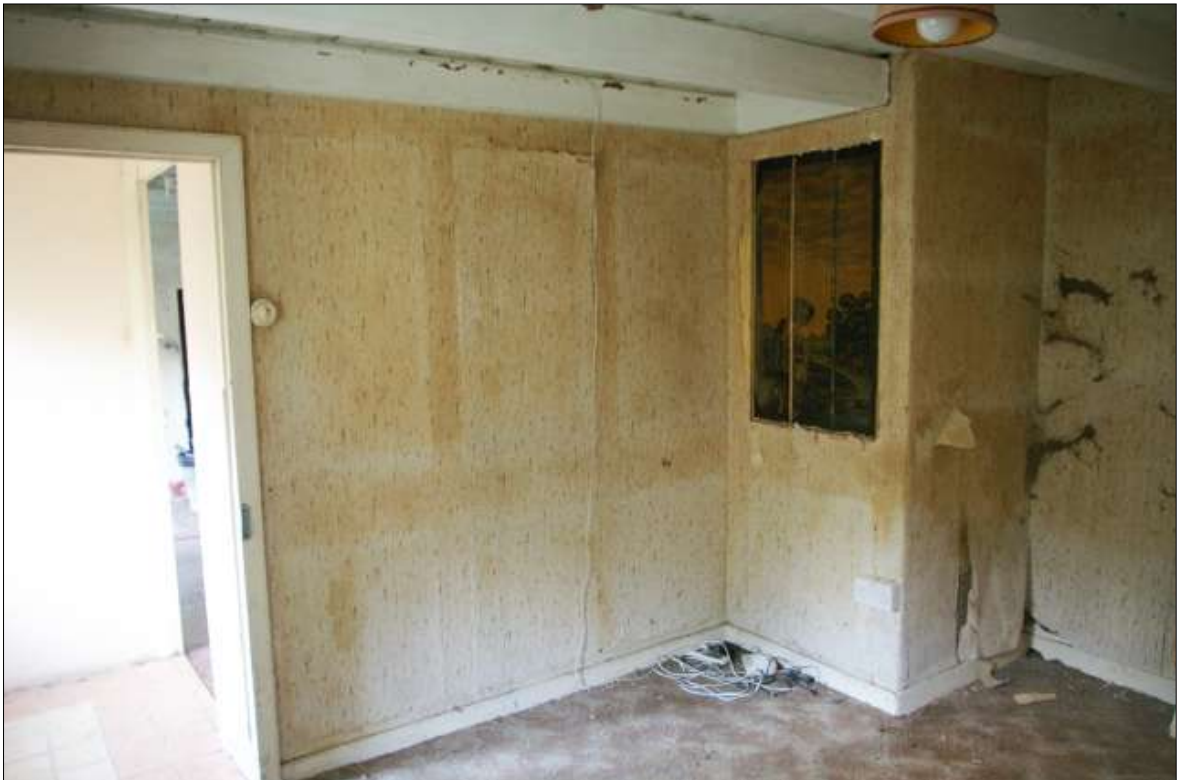
R2 is a small formal withdrawing room (Figures 14-15); the timber screen separating this room from R1 has raised and fielded panels on this side; the wall to R3 is of wide planks. The panels have been covered with hardboard and wallpapered; prior to the site visit one of these hardboard panels had been removed, revealing the painting of a monkey or baboon crouched next to a river, with trees in the background (Figure 38). At least one other panel is painted in a similar style, and the boarded wall beneath the wallpaper appears to have been painted as well, although survival appears fragmentary. The fireplace in the north wall has a reset grand eared fire surround, the stack flanked to either side by alcoves set with 18<sup>th</sup> century shelves and panelled doors. R3 is a small narrow room behind R2 fitted out as a kitchen with mid 20<sup>th</sup> century kitchen units and sink. There is a window and a forced door in the west wall, and a doorway with a reset 18<sup>th</sup> century door in the north wall that opens into the lean-to. There is a coal hatch under the stairs accessed by a pair of 18<sup>th</sup> century panelled doors.

FIGURE 15: THE 18<sup>TH</sup> CENTURY PARTITION WALL BETWEEN R1 AND R2, FROM R2; VIEWED FROM THE NORTH-EAST (NO SCALE). THE COVERED PANELS ARE VISIBLE, WITH THE EXPOSED PANEL TO THE RIGHT.

- Works to the Cottage should seek to retain and conserve the 18<sup>th</sup> century features, and sensitively restore areas of loss (i.e. fireplace in R1) based on comparable structures;
- Further study of the painted wall panels should be undertaken in order to fully define the paint schema, conserve those damaged elements that can be saved, and determine how they might best be preserved (i.e. covered over again or revealed?);
- Work should attempt to locate the panels described in the *Listing* as 'now in Truro Museum';
- Monitoring work should be undertaken in order to record any historic fabric that might be revealed during the works, especially during any demolition works (e.g. the fireplaces and oven);

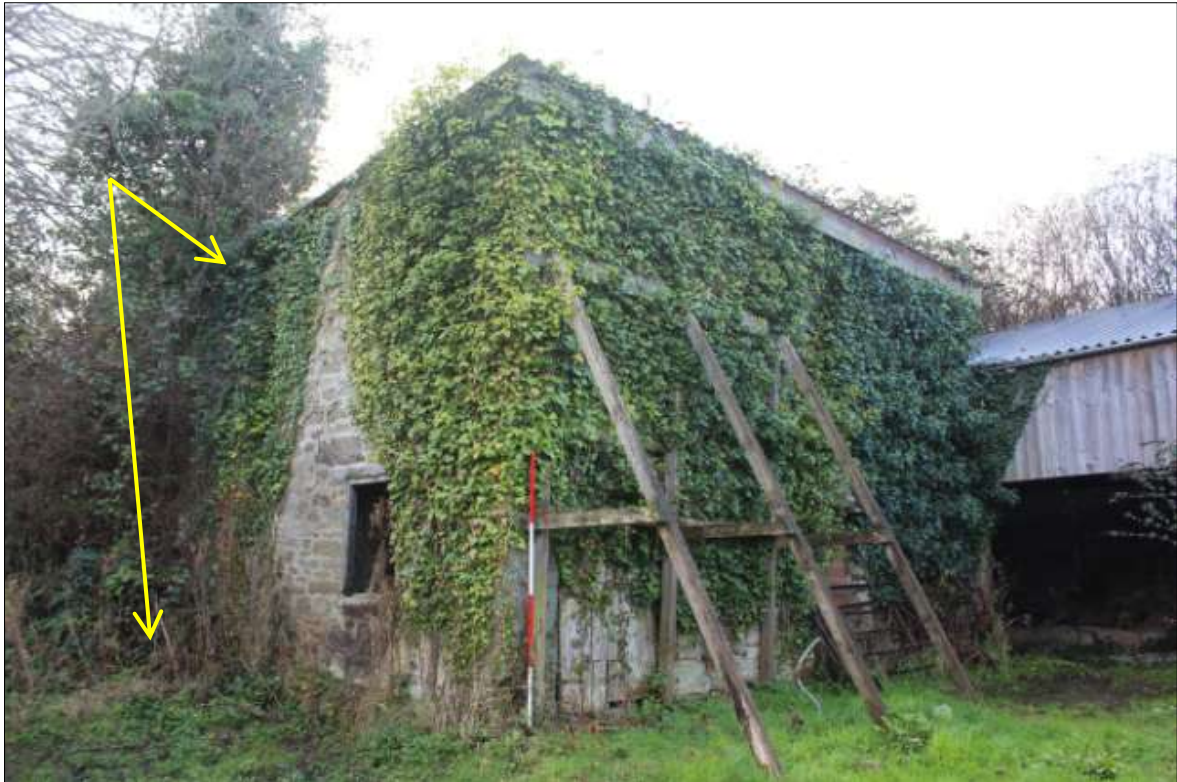
FIGURE 20: THE NORTH AND EAST ELEVATIONS OF FB1; VIEWED FROM THE NORTH-EAST (SCALE 2M). THE EXTERNAL BUTTRESS IS INDICATED.

The Cottage is in fairly good condition. Parts of the farm buildings are stable, but much of FB1 and parts of FB2 are structurally unsafe and in poor condition; the loss of internal features and historic roof coverings has negatively affected the integrity of most of the buildings.

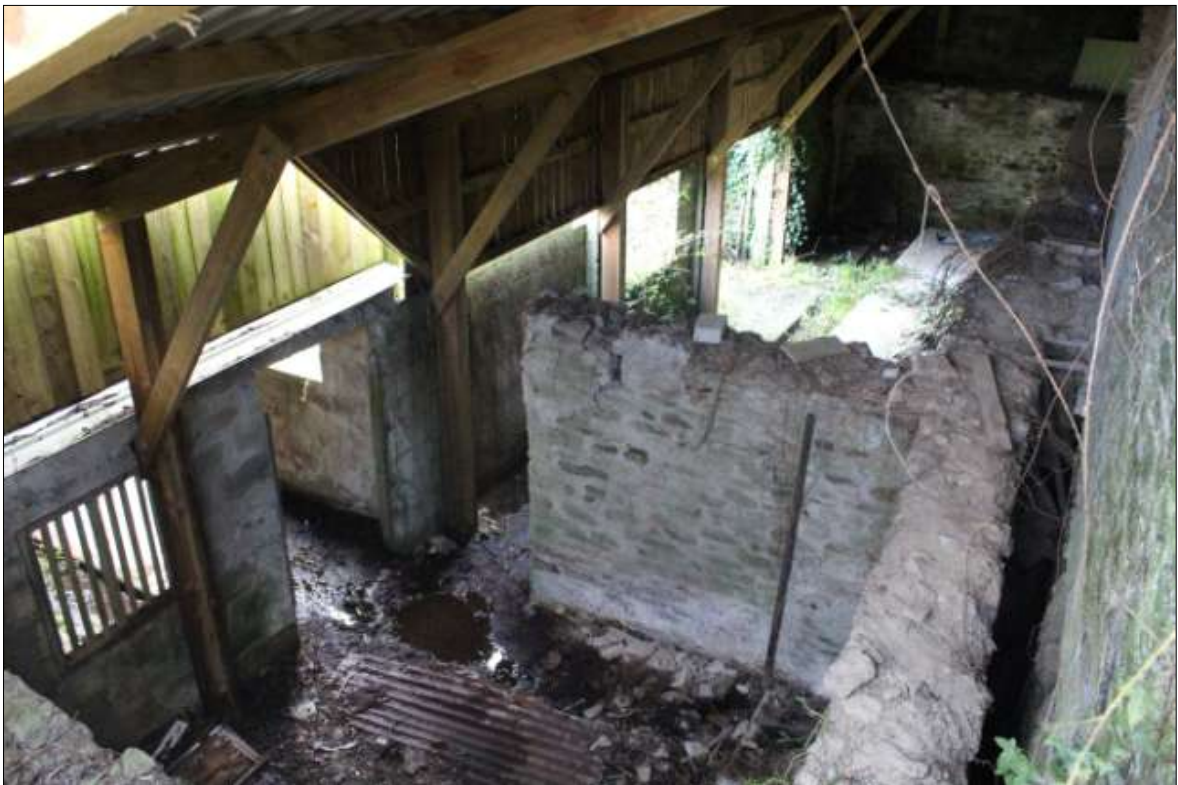
FIGURE 24: THE INTERIOR OF FB2, LOOKING DOWN INTO THE STRUCTURE; VIEWED FROM THE NORTH (NO SCALE).

The east wall of the building abuts FB1 (described above) and FB3 (described below); in between these structures there are four tall (c.2.2m) squared granite posts forming three bays; at first-floor level the elevation is infilled in modern timber. The southernmost bay is open; the other two bays are infilled in concrete block, with a window opening to the central bay. The interior has concrete floors and partly-demolished mid 20<sup>th</sup> century concrete cow cubicles. FB2a contains some roof

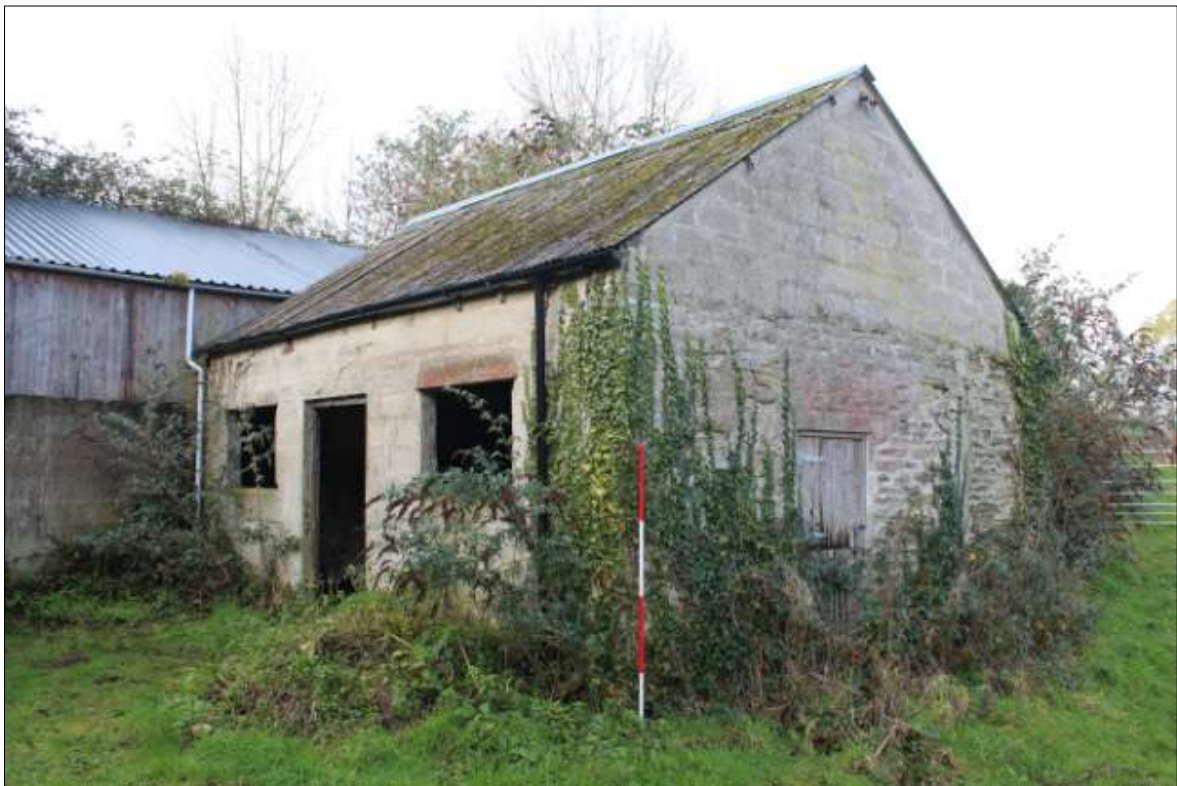
FIGURE 27: THE SOUTH AND EAST ELEVATIONS OF FB3; VIEWED FROM THE SOUTH-EAST (SCALE 2M).

The stonework is superficially similar to that of FB1 and FB2, but is poorly-coursed, incorporates a tall upright granite post, and abuts the north wall. There is a narrow off-centre forced doorway with a 19<sup>th</sup> century plank ledged and braced stable door, and a small blocked window. The north wall is of stone rubble, possibly partly rebuilt to the north-east corner, and steps back internally from a wall of concrete blocks. It is set into the terrace in the slope, and may sit on above a rock face, as seen elsewhere. The west wall is of concrete block with modern timber infilling the gable. This block wall features a wide doorway and a reset 19<sup>th</sup> century pegged timber window frame with vertical square wooden slats. The interior is open to the roof and the floors are concrete. The walls are rendered to c.1.5m above internal floor level, and there are three concrete cow cubicles; some of the fitments (e.g. cow chains) survive, but most have gone.

The north wall is probably integral to FB2. The east wall has been rebuilt in stone, and is probably 19<sup>th</sup> century in date; the building may have been shortened. The concrete walls and internal concrete cubicles date to the mid 20<sup>th</sup> century. The roof was repaired in the 21<sup>st</sup> century.

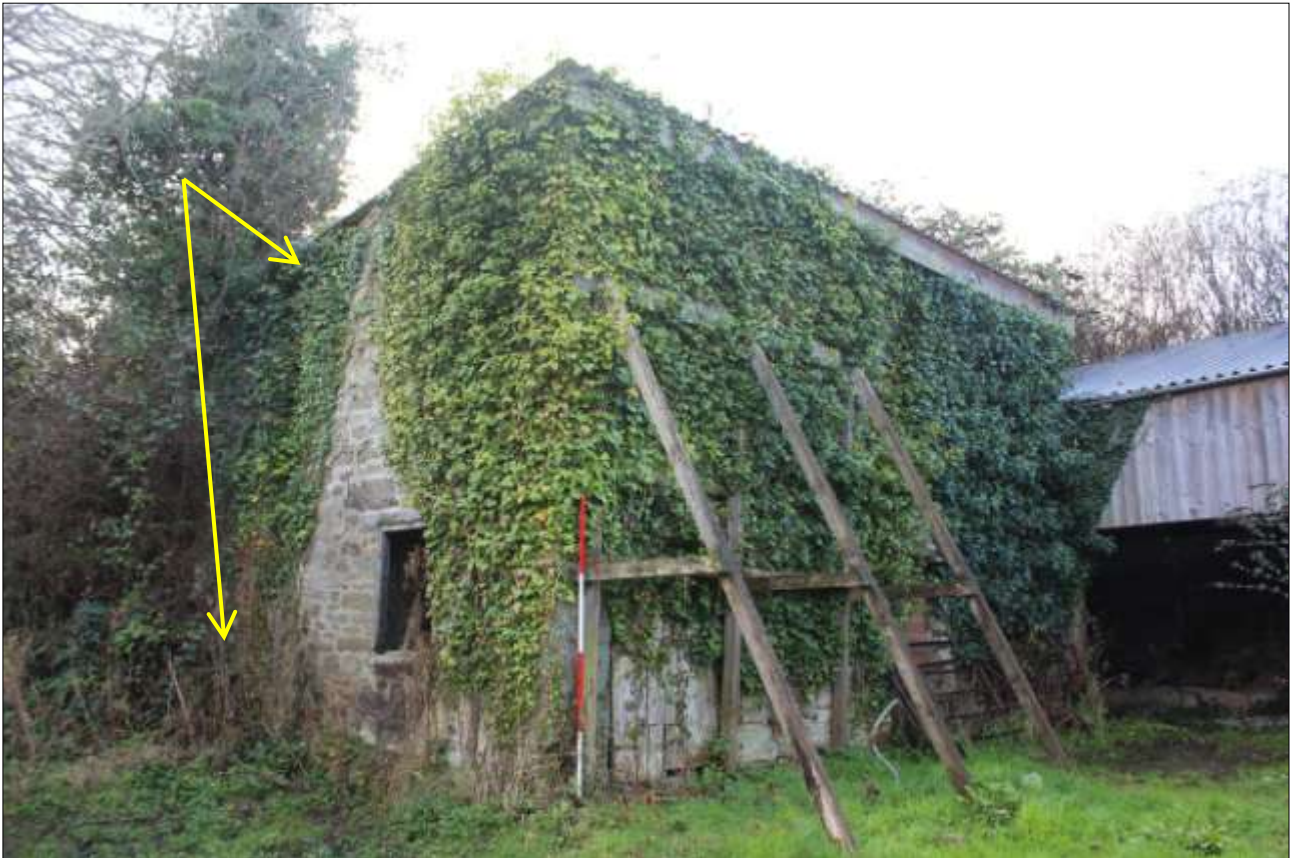
Other Details:		Elevation mainly concealed by vegetation (ivy). The wall is failing and is supported by C21 timbers.

THE NORTH AND EAST ELEVATIONS OF FB1; VIEWED FROM THE NORTH-EAST (SCALE 2M). THE EXTERNAL BUTTRESS IS INDICATED.

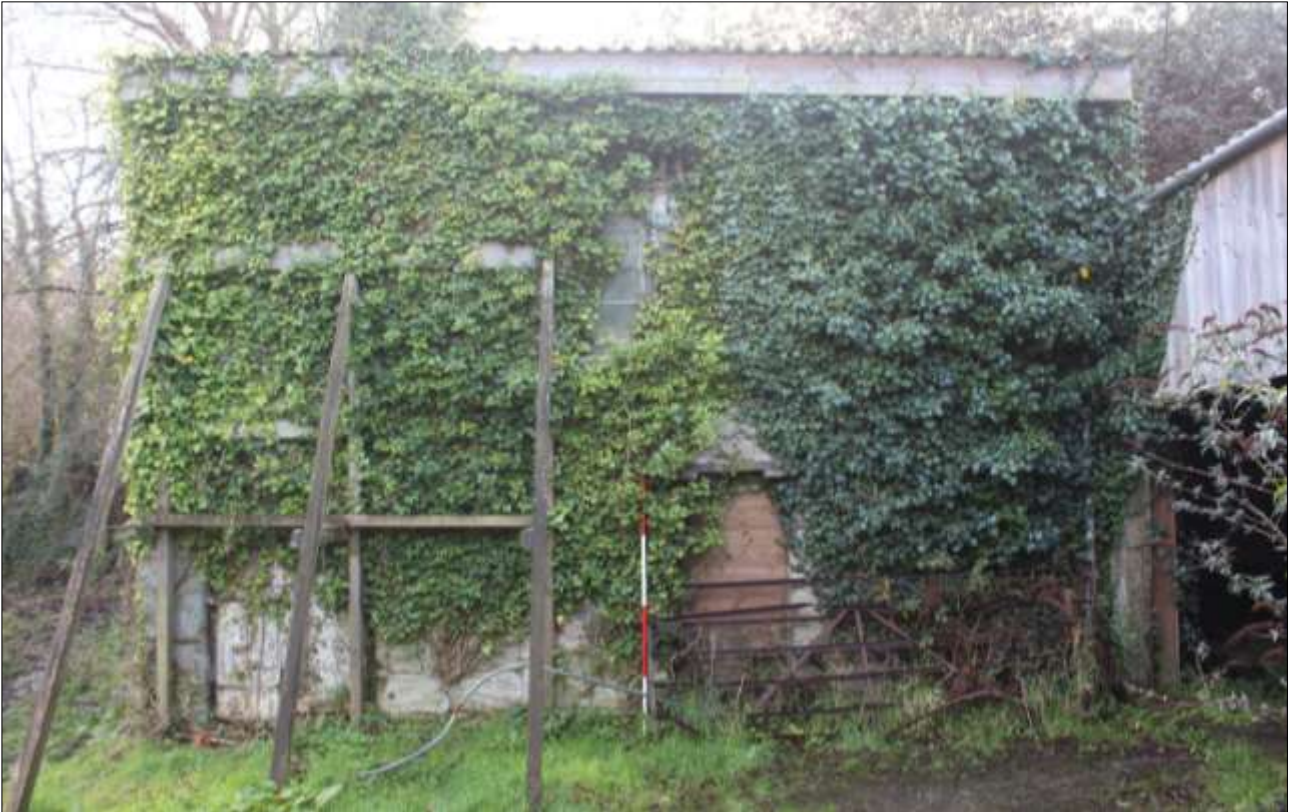
THE NORTH ELEVATION OF FB1; VIEWED FROM THE NORTH (SCALE 2M).

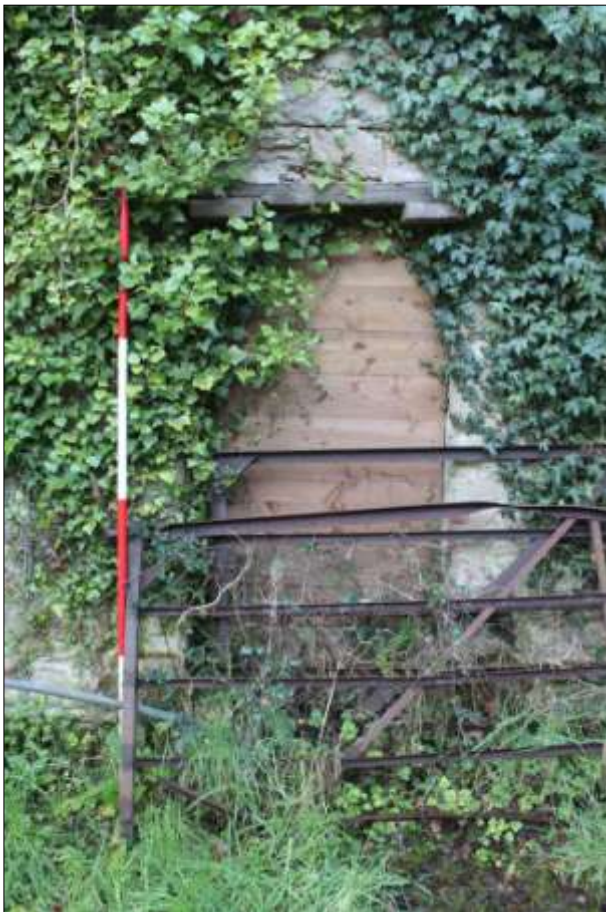
LEFT: FORCED DOORWAY D2; VIEWED FROM THE NORTH (SCALE 2M).

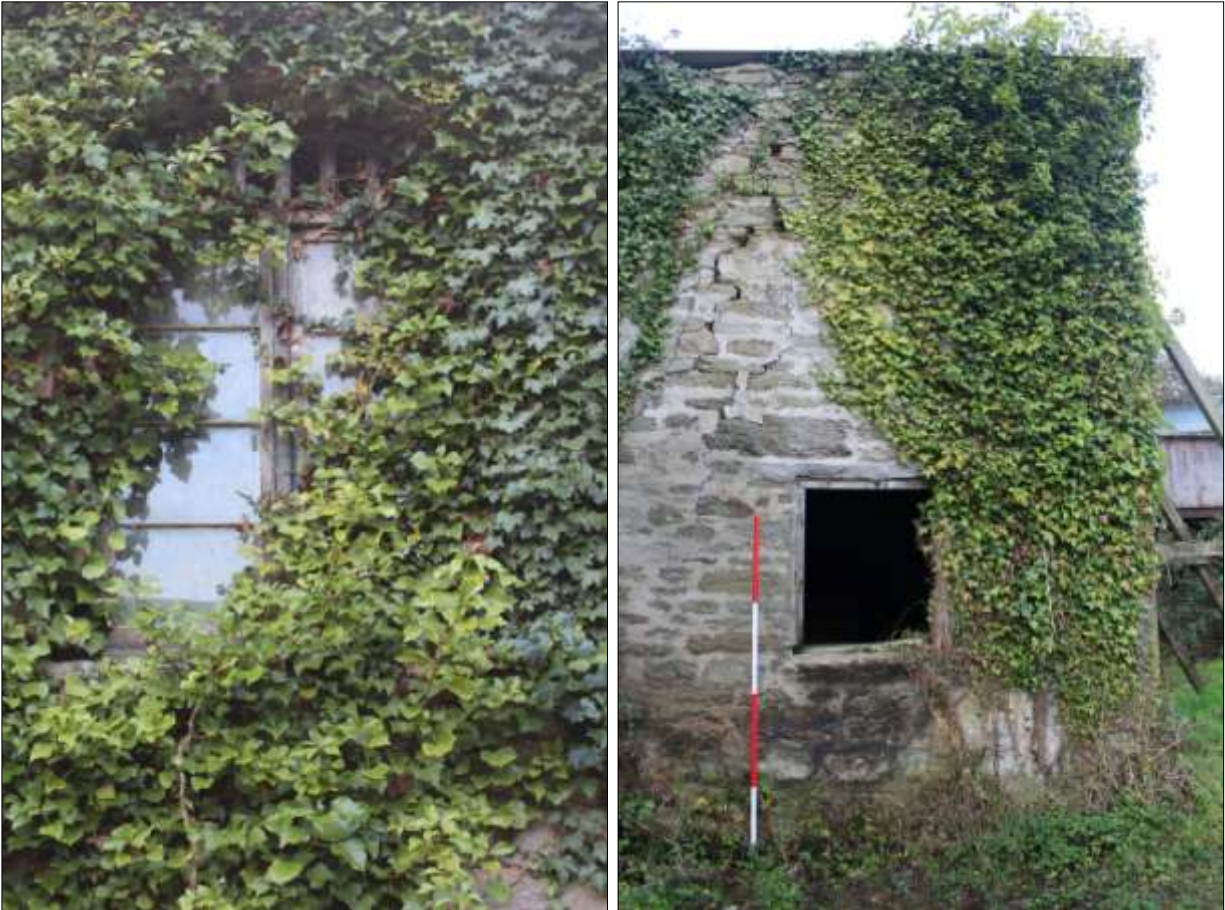
FB1 Elevation EAST		Description
Opening – Windows:	W1	GF window. Thin timber lintel. Modern pine frame.
Other Details:		Elevation partly concealed by vegetation. Large structural cracks visible above the window.
Significant Features:		To the south side is a substantial and well-built buttness with good blocky quoins. It appears truncated by the lowered roofline and is mainly concealed by vegetation.
FB1 Elevation SOUTH		Description

LEFT: D9 IN THE NORTH ELEVATION OF FB1 AT FF LEVEL; VIEWED FROM THE NORTH.  
RIGHT: THE EAST ELEVATION OF FB1, SHOWING W1; VIEWED FROM THE EAST (SCALE 2M).

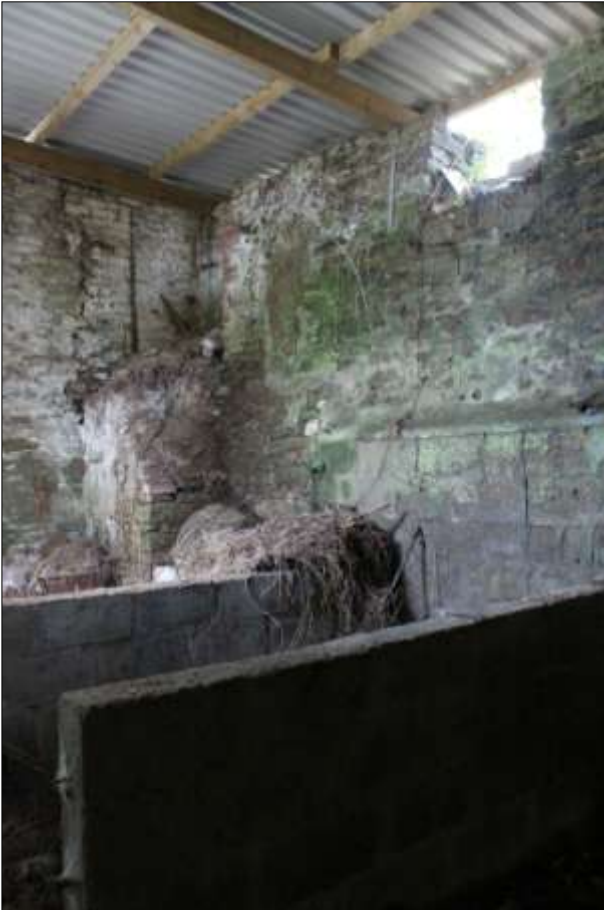
THE INTERIOR OF FB1; VIEWED FROM THE NORTH-WEST.

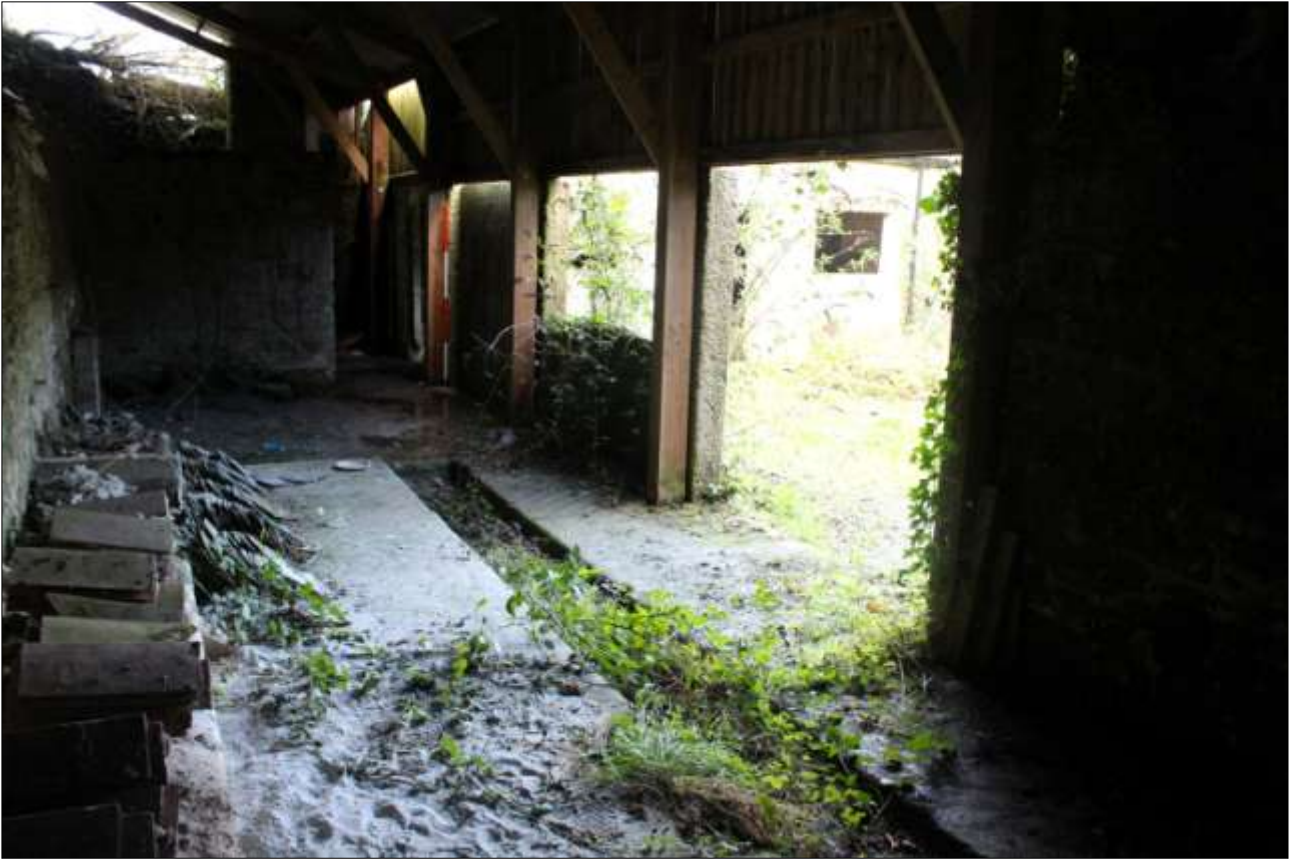
THE INTERIOR OF FB2A; VIEWED FROM THE SSW (SCALE 2M).

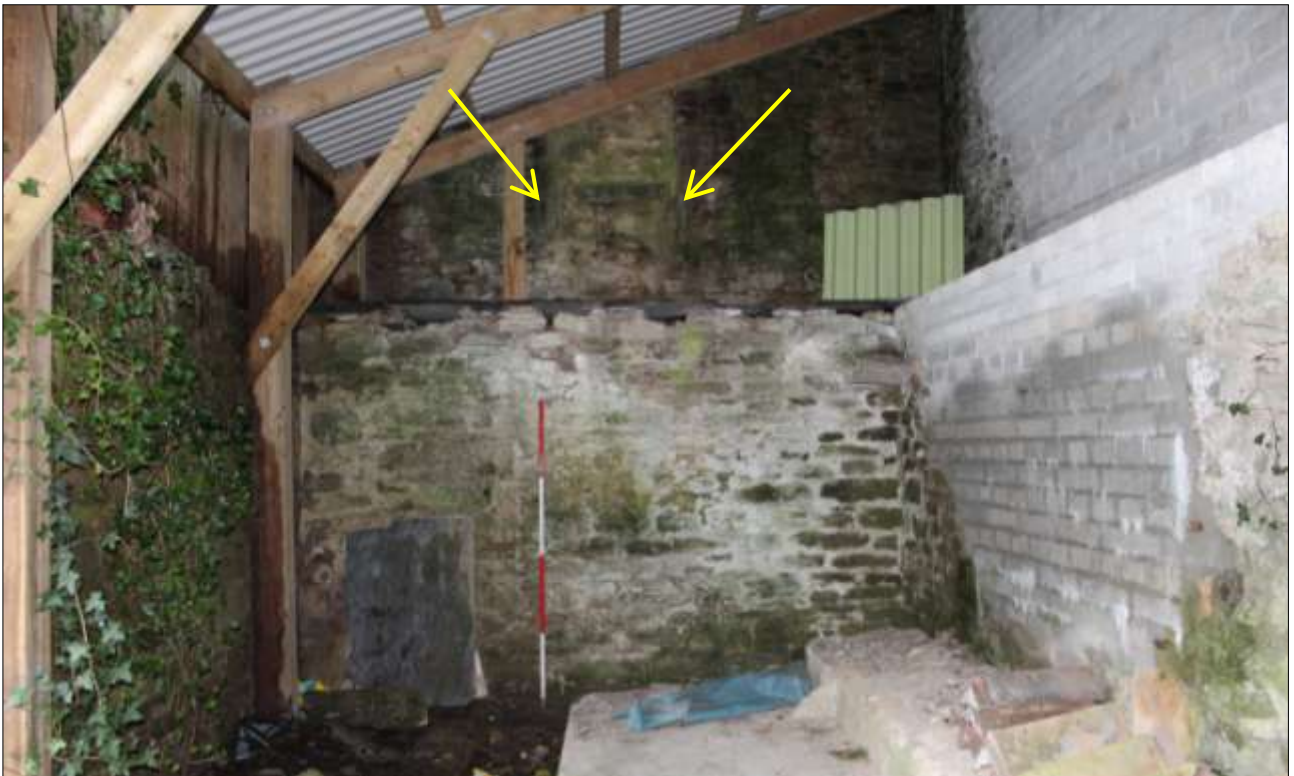
THE SOUTH END OF FB2A, BO2 IS INDICATED; VIEWED FROM THE NORTH (SCALE 2M).

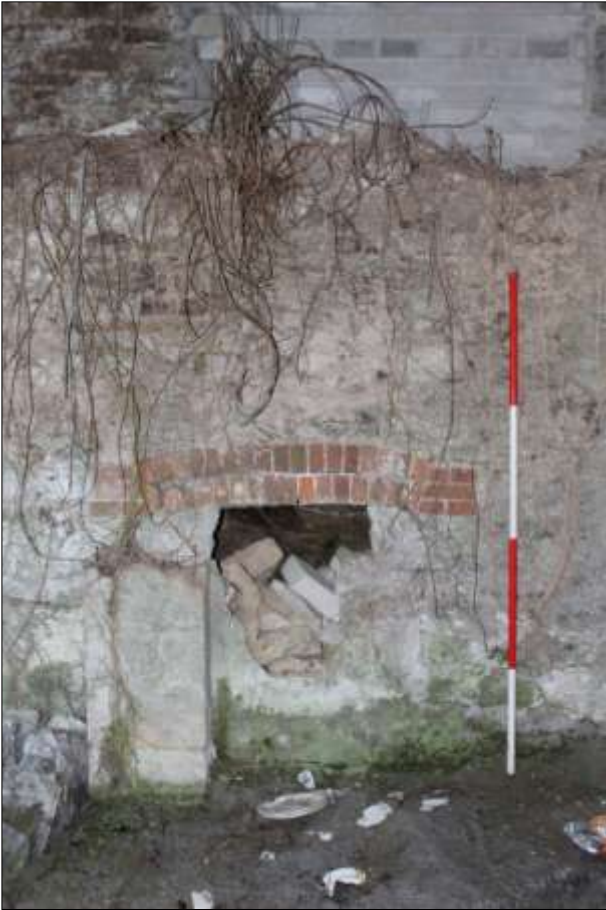
BO4	GF blocked opening in the west wall north of BO3. The former opening is 0.9m high and 1.0m wide, with a segmental brick arch with brick springers. This is likely to have been a three-centred arch similar to D9, but appears to have failed and flattened. Blocked in concrete, the blockage has been smashed and there is a wide flue to the west that rises up to FF level; it is not clear where this flue went, as the FF wall above has been rebuilt in concrete block. Possible hearth?
	BO6	GF blocked opening. Blocked in concrete block.
Other Details:		The interior of FB2a has been repurposed as a milking parlour and dairy. The southern (larger) part of the space has the remains of four cattle stalls with integral concrete feed troughs, with space for eight cows. The walls of the concrete stalls have been demolished and removed, leaving the concrete floor with drain and troughs. The northern (smaller) part of this space has a level concrete floor, and it is probable that this was the dairy.

LEFT: BO4; VIEWED FROM THE EAST (SCALE 2M).

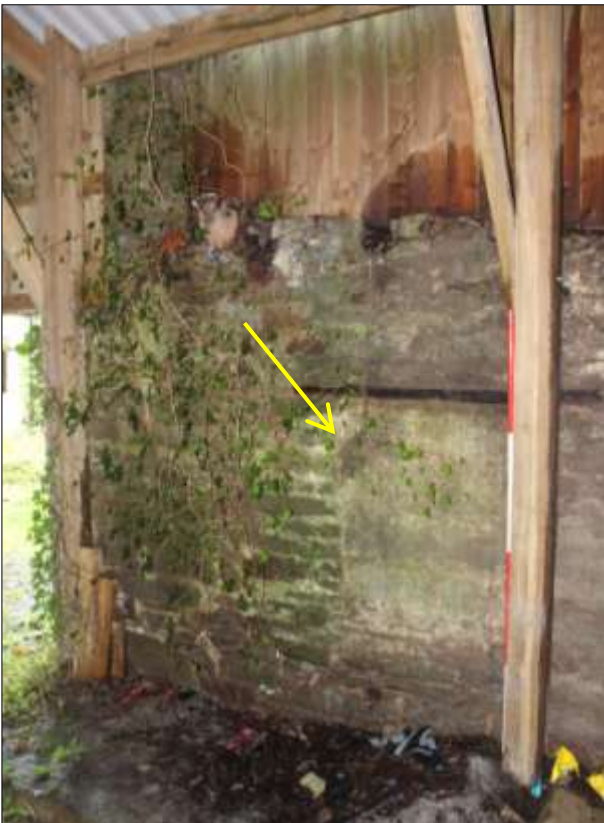
THE SHARED WALL BETWEEN FB1 AND FB2A, SHOWING BO1 (INDICATED); VIEWED FROM THE SOUTH-WEST (SCALE 2M).

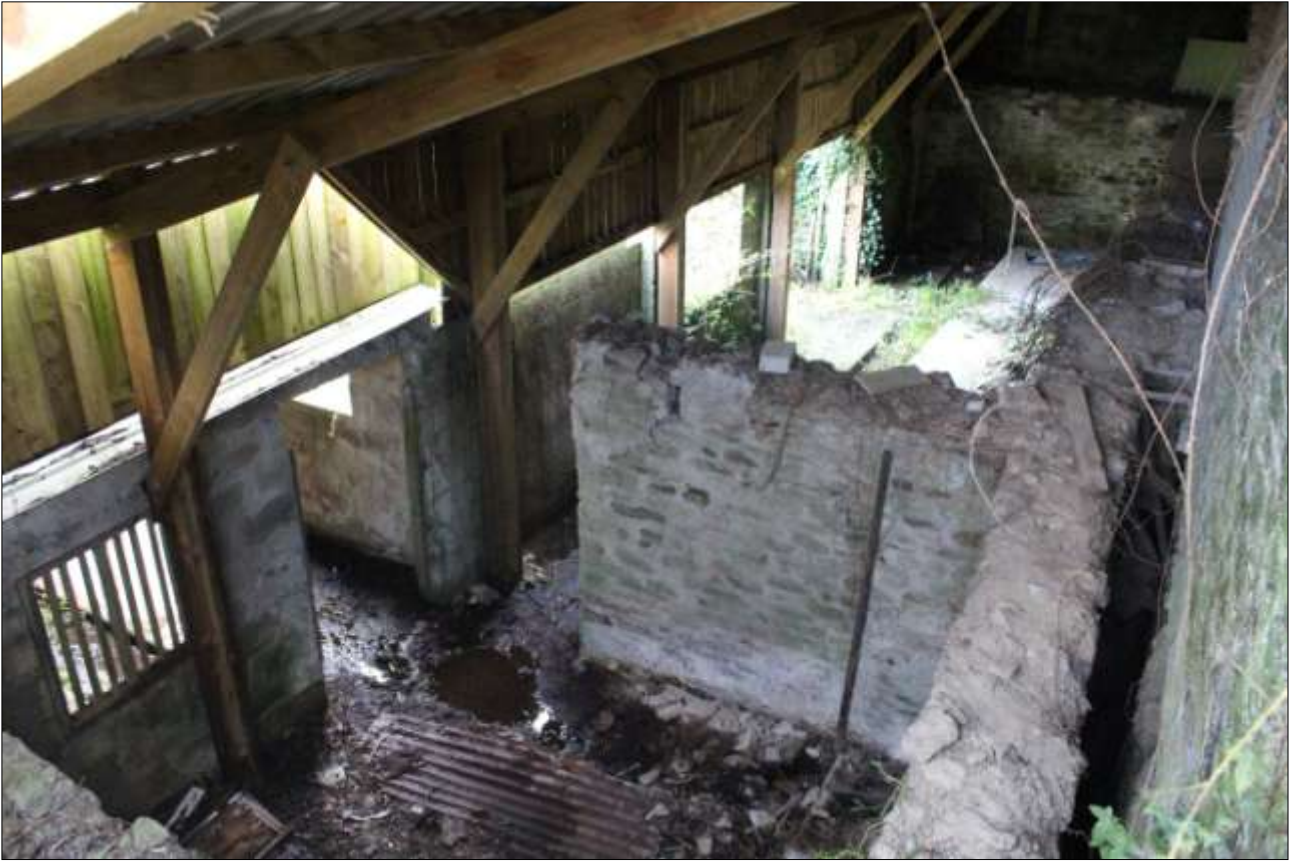
THE INTERIOR OF B2, LOOKING DOWN INTO THE STRUCTURE; VIEWED FROM THE NORTH.

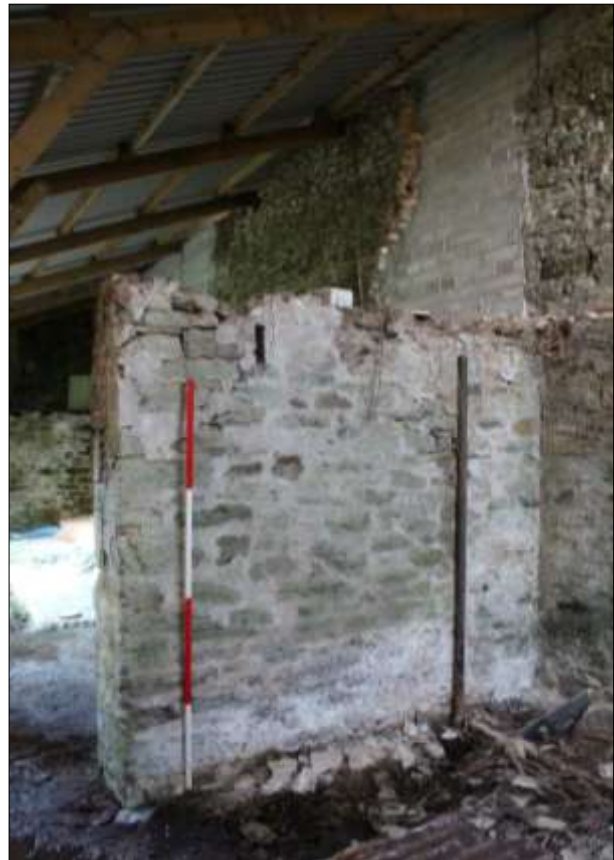
RIGHT: THE GF WALL BETWEEN FB2A AND FB2B; VIEWED FROM THE NNE (SCALE 2M).

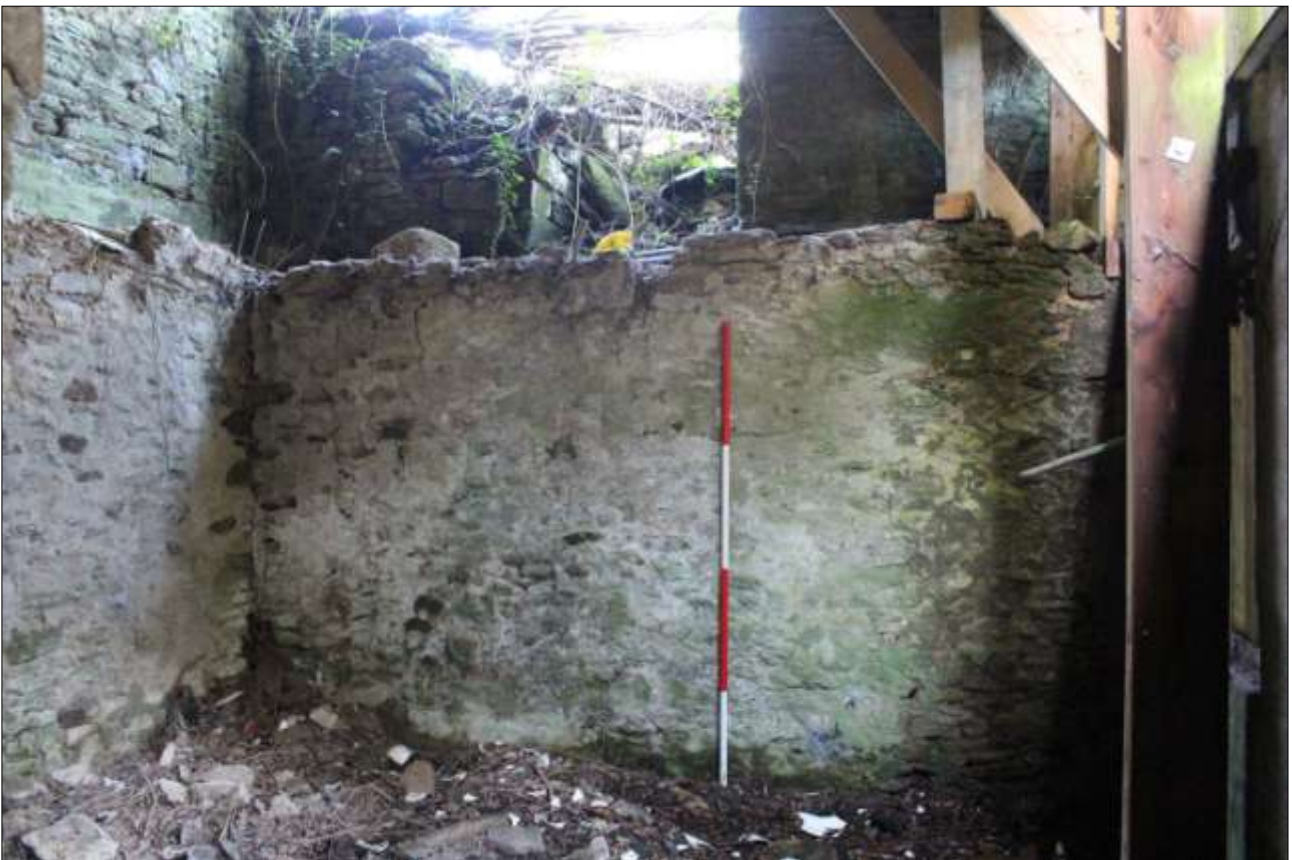
THE GF NORTH WALL OF FB2B; VIEWED FROM THE SOUTH (SCALE 2M).

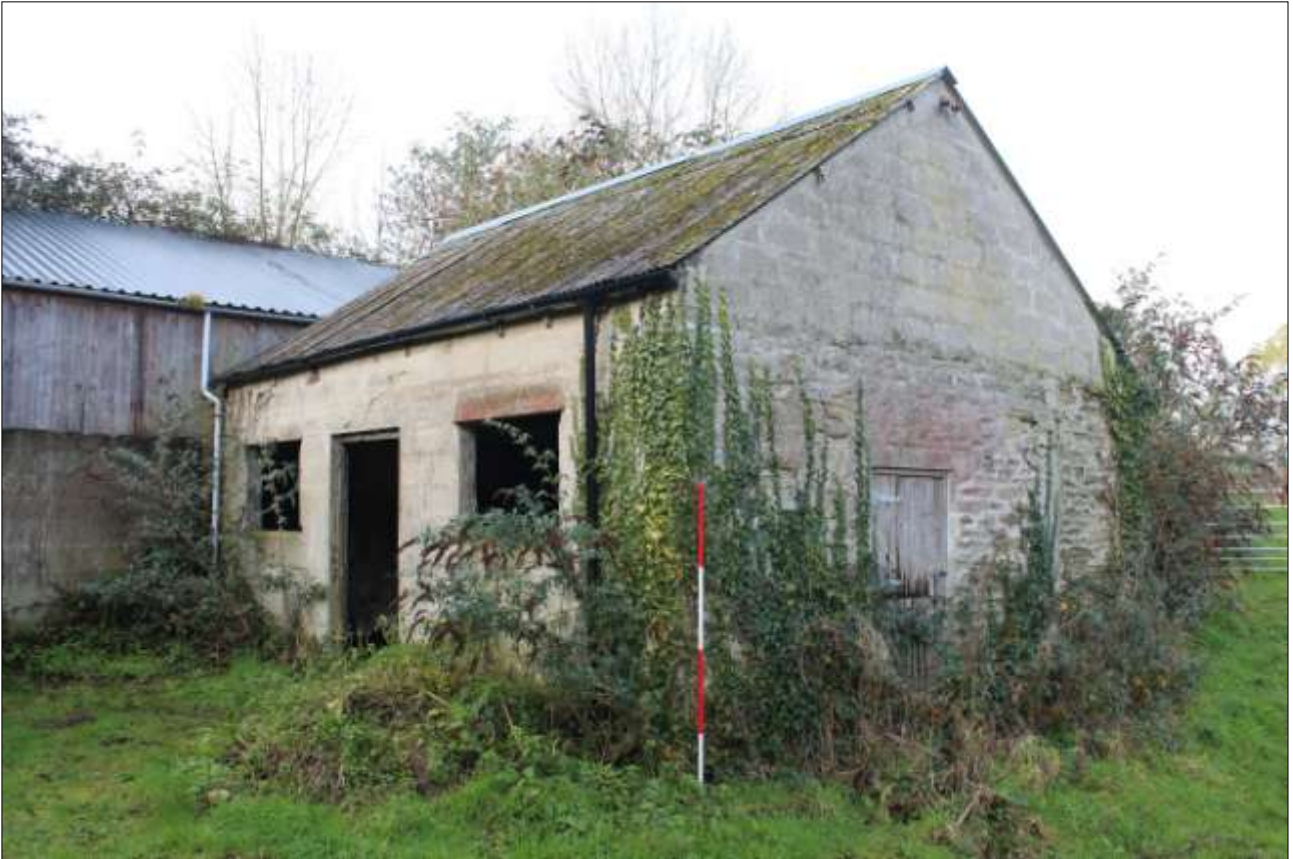
THE SOUTH AND EAST ELEVATIONS OF FB3; VIEWED FROM THE SOUTH-EAST (SCALE 2M).

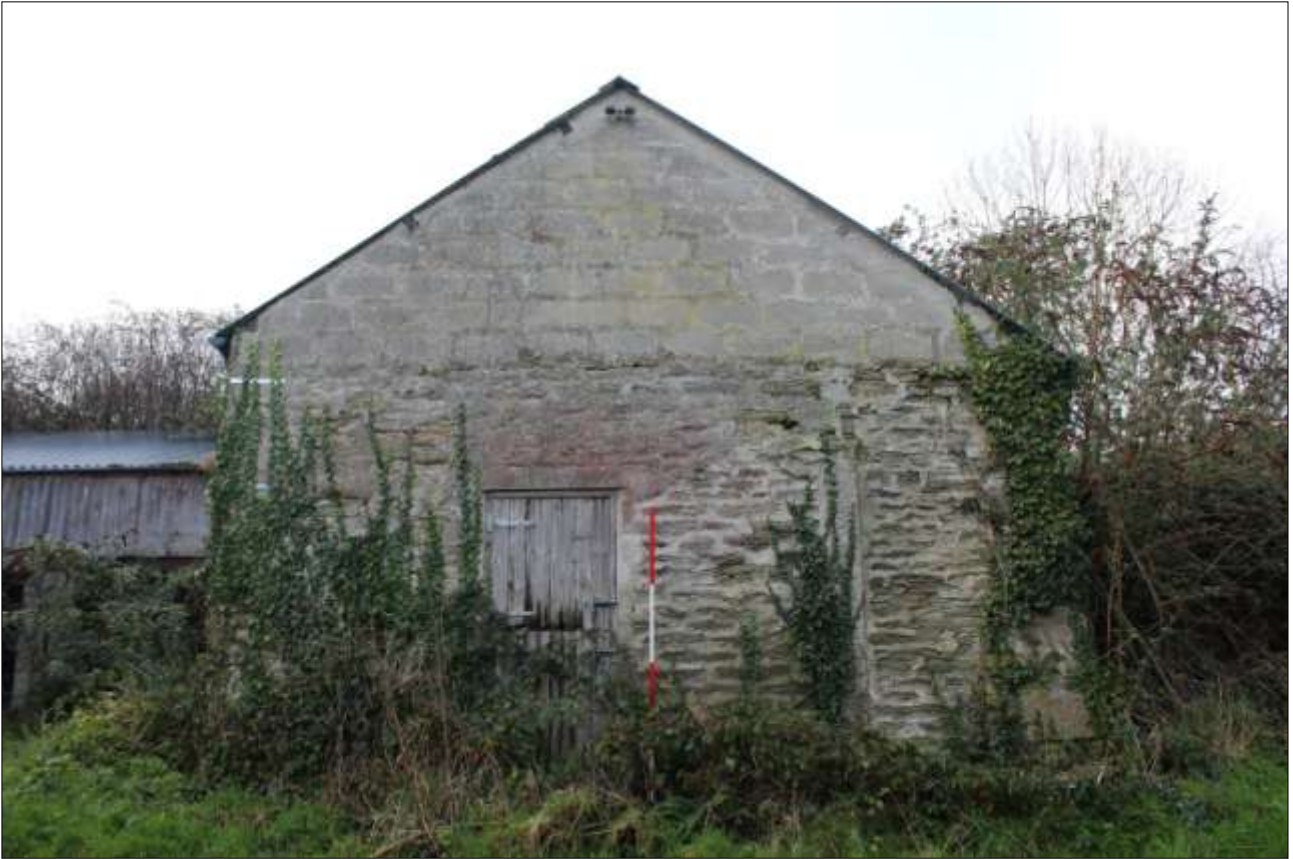
THE EAST ELEVATION OF FB3; VIEWED FROM THE EAST.

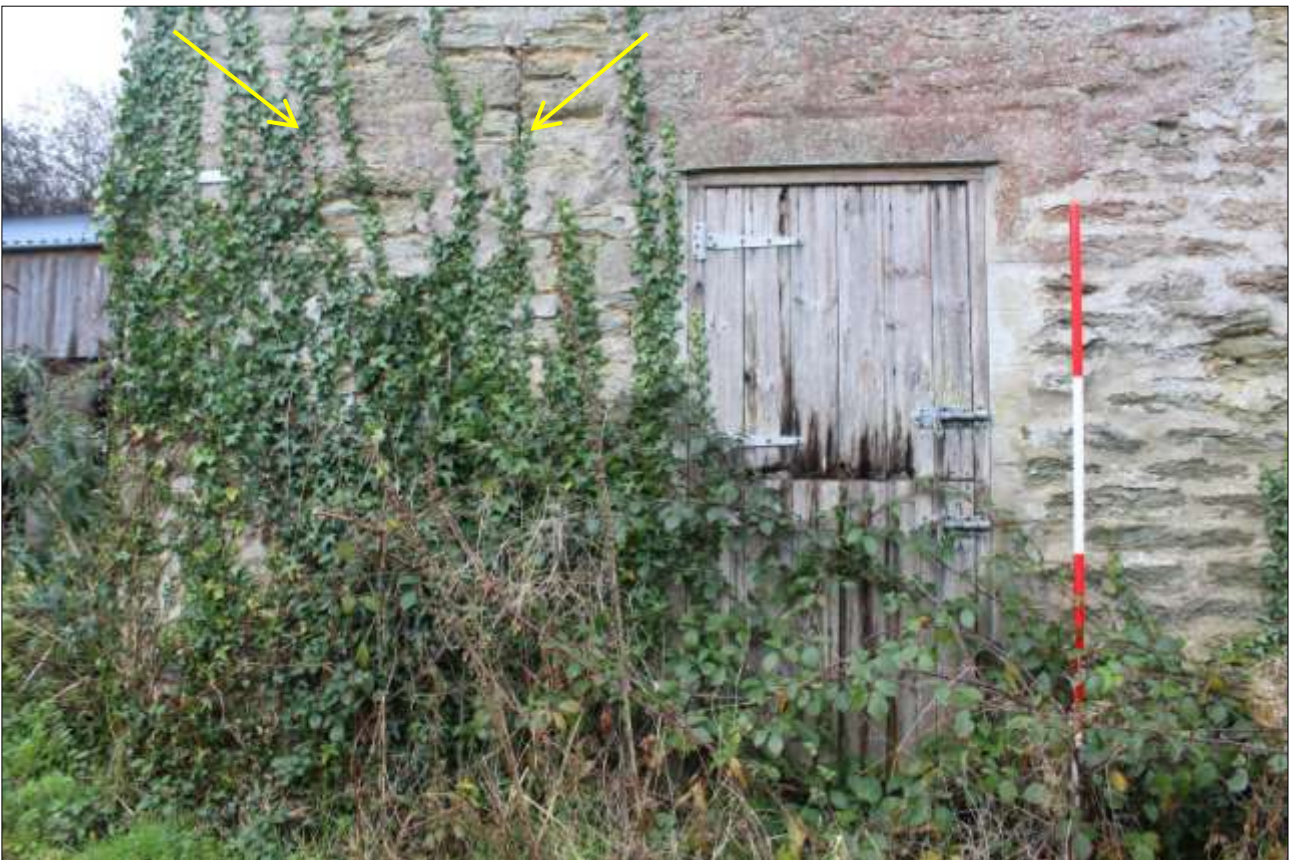
AS ABOVE, DETAIL OF D8 AND BO7 (INDICATED); VIEWED FROM THE EAST (SCALE 2M).

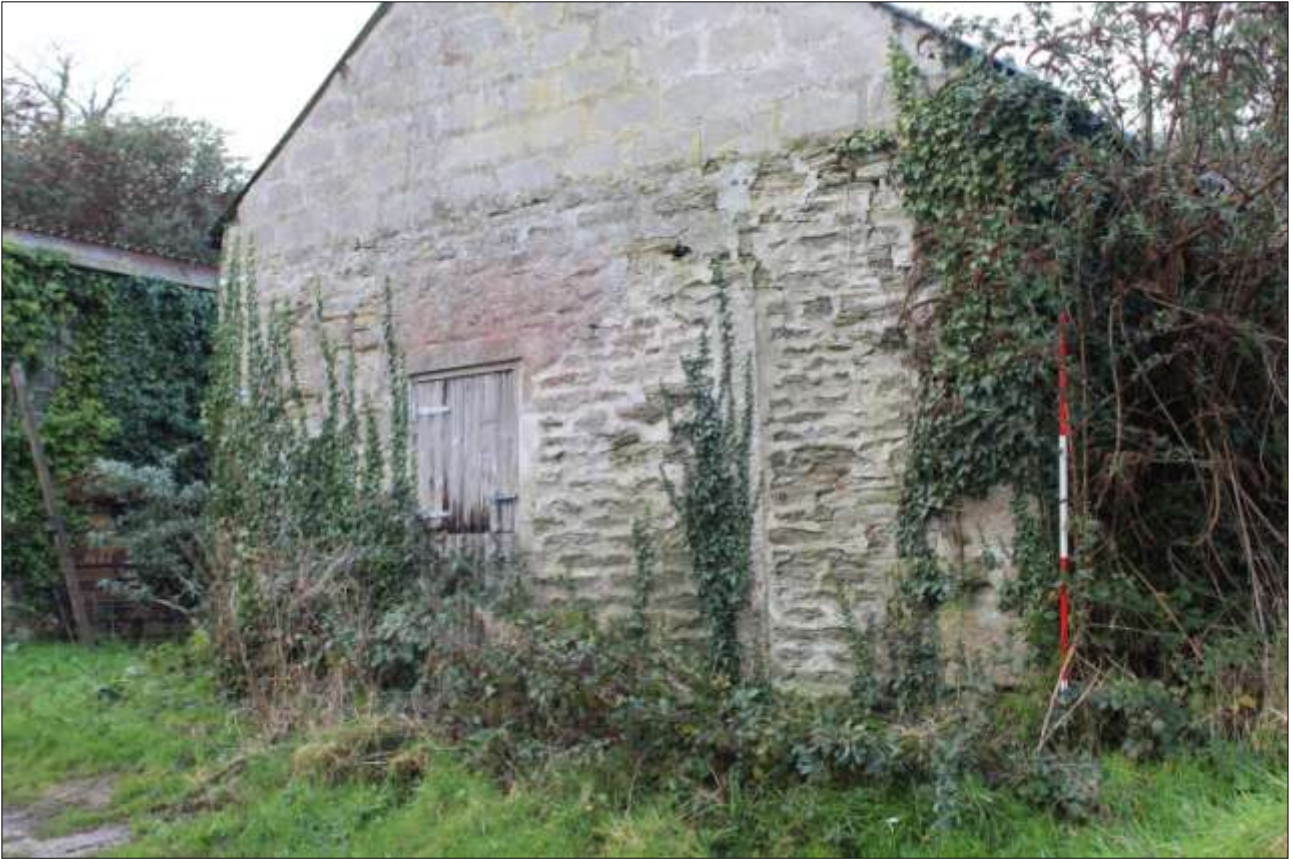
THE EAST ELEVATION OF FB3; VIEWED FROM THE NORTH-EAST (SCALE 2M).

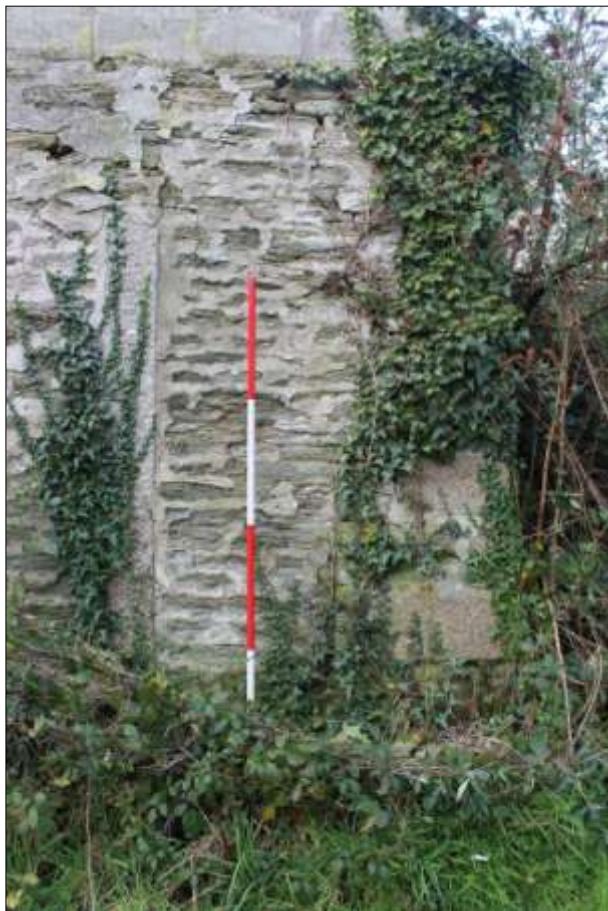
AS ABOVE, DETAIL OF THE NORTH-EAST CORNER AND GRANITE POST; VIEWED FROM THE EAST (SCALE 2M).

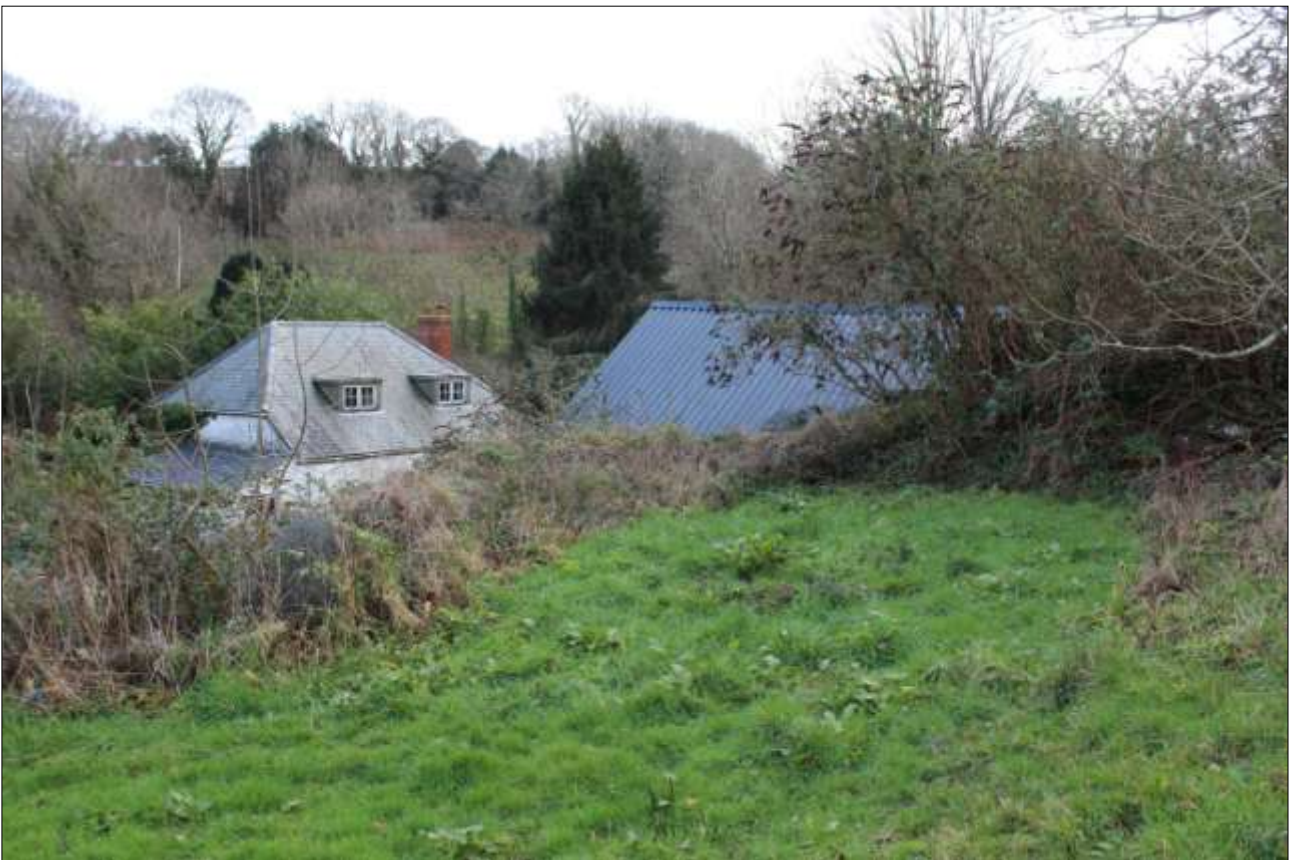
LOOKING BACK OVER THE ROOF OF FB3 (RIGHT) TOWARDS THE COTTAGE; VIEWED FROM THE NORTH-WEST.
