# TRELEW FARM MYLOR CORNWALL

Historic Building Recording

South West Archaeology Ltd. report no. 180910

## Trelew Farm, Mylor, Cornwall Historic Building Recording

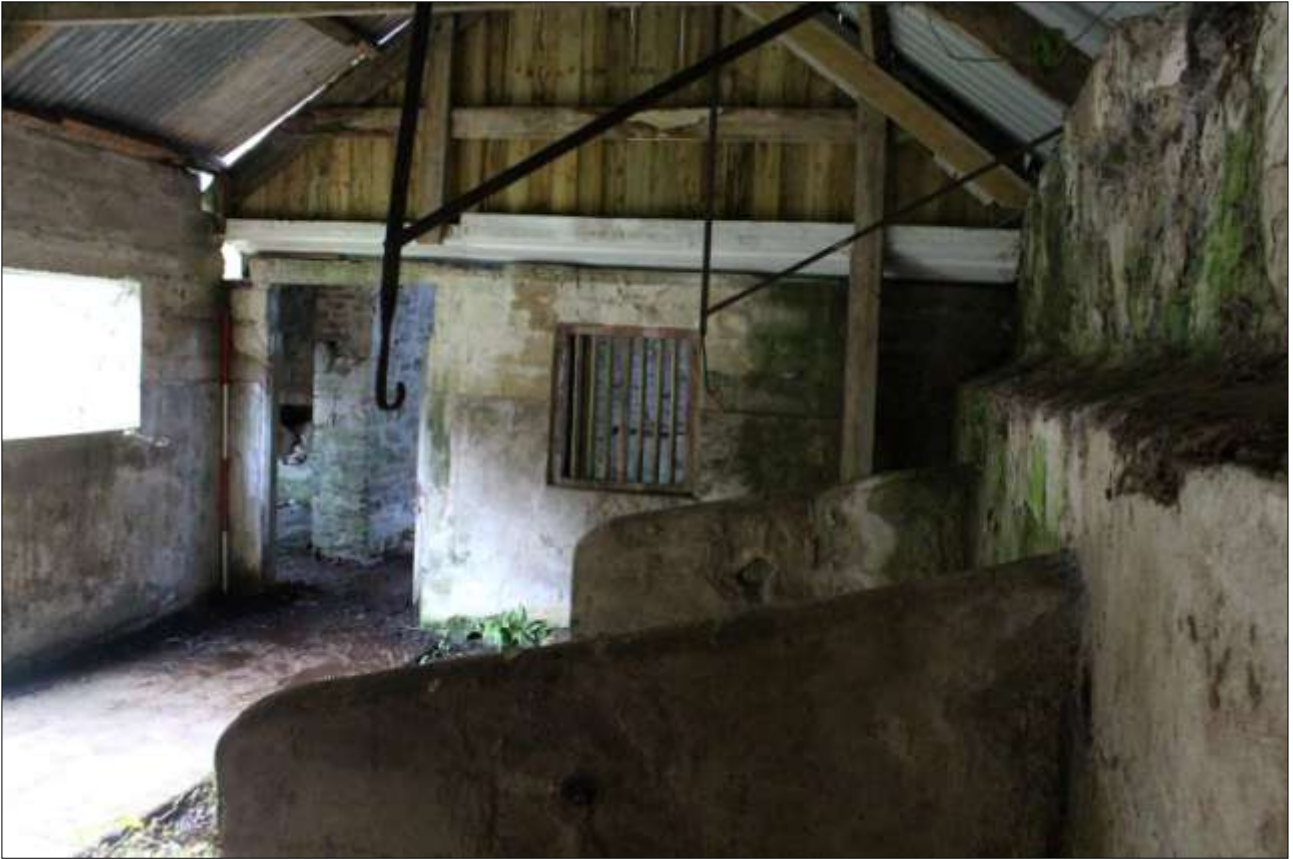
THE INTERIOR OF FB3; VIEWED FROM THE SOUTH.

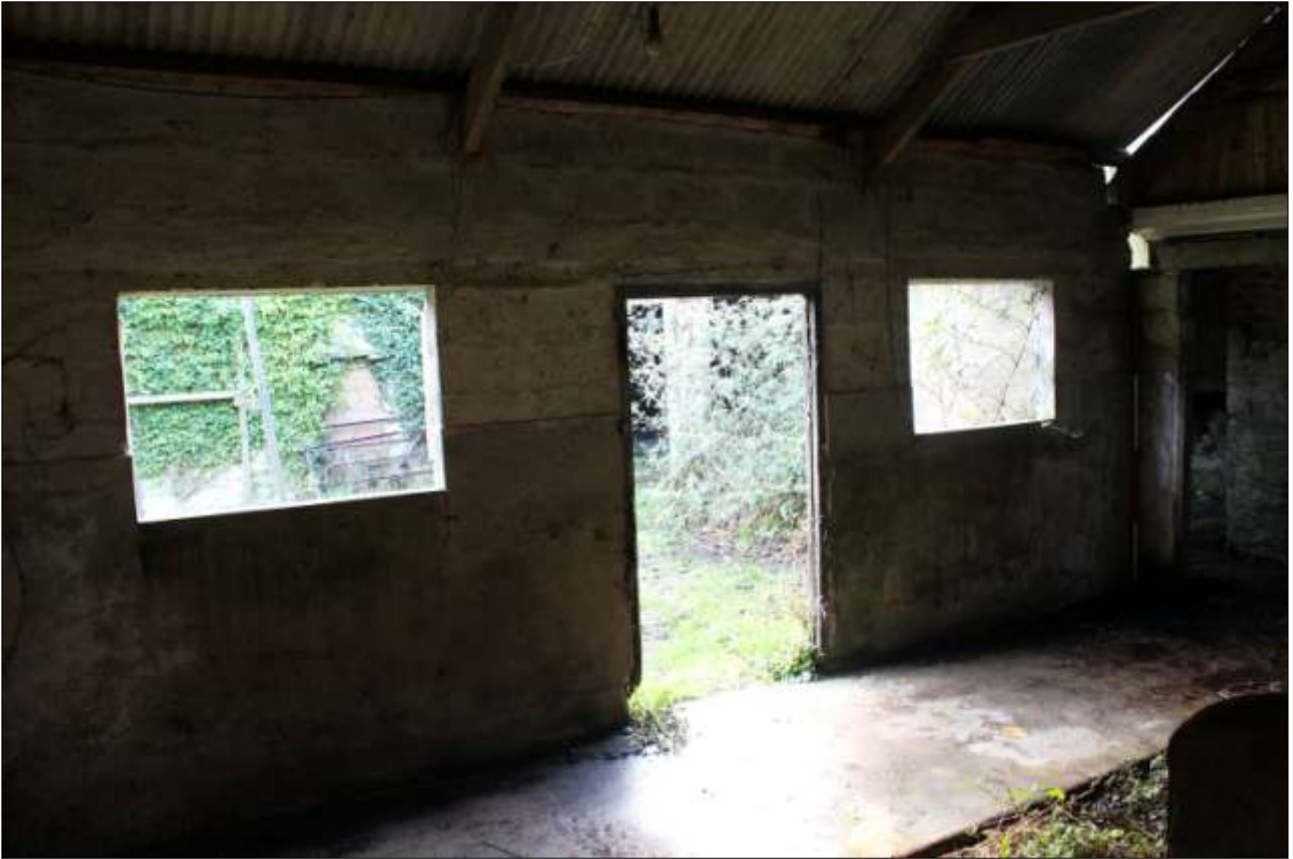
THE SOUTH WALL OF FB3; VIEWED FROM THE NORTH-EAST.

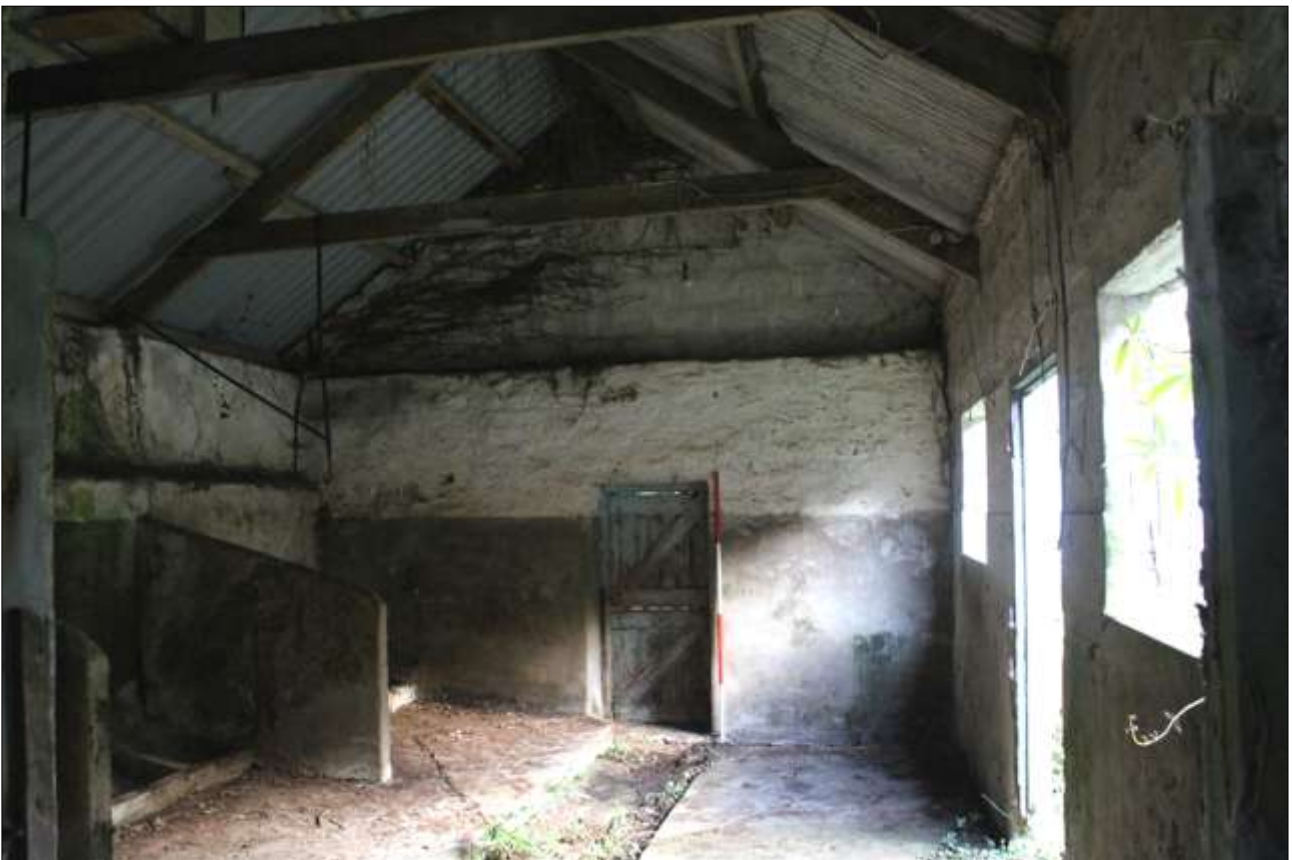
THE INTERIOR OF B3; VIEWED FROM THE WEST (SCALE 2M).

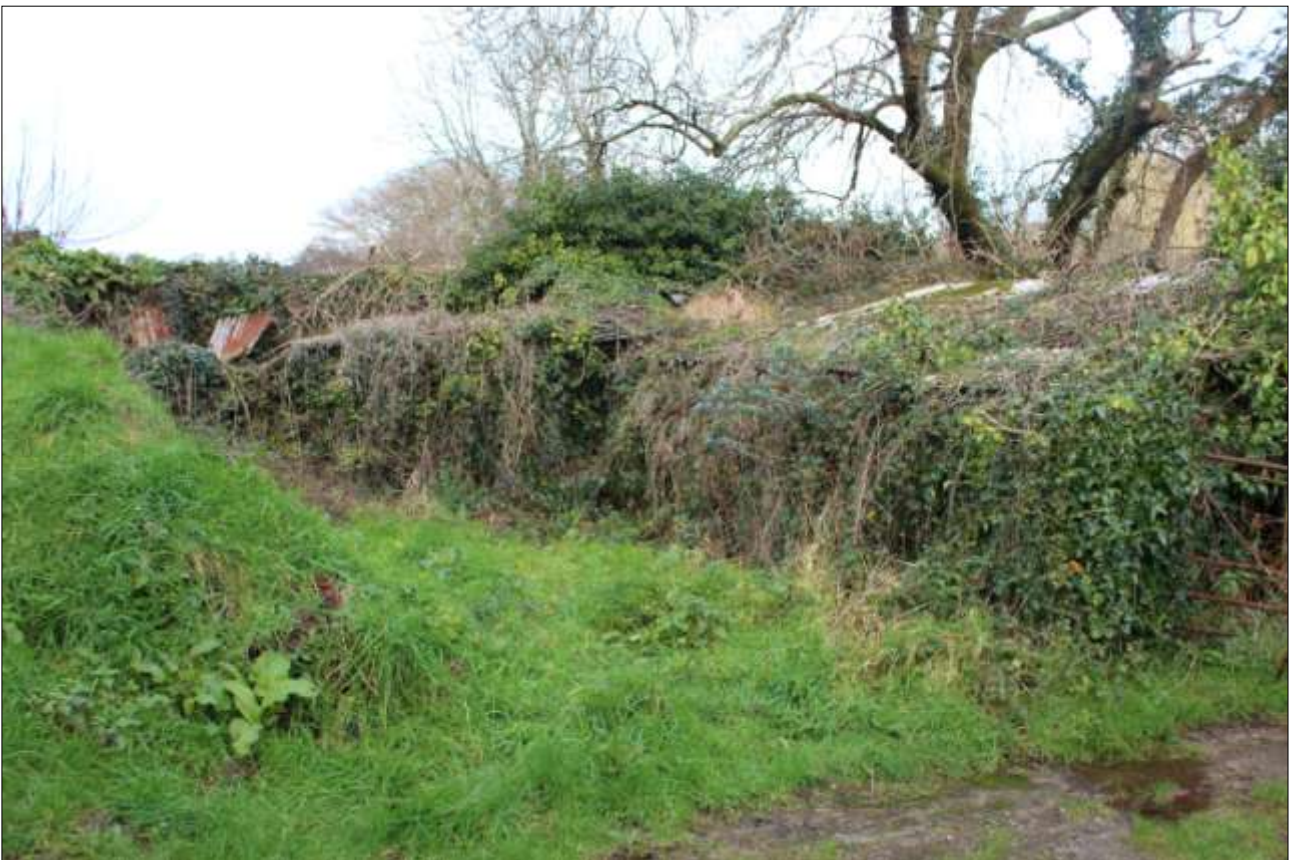
THE YARD IN FRONT OF FB4A; VIEWED FROM THE SSW.

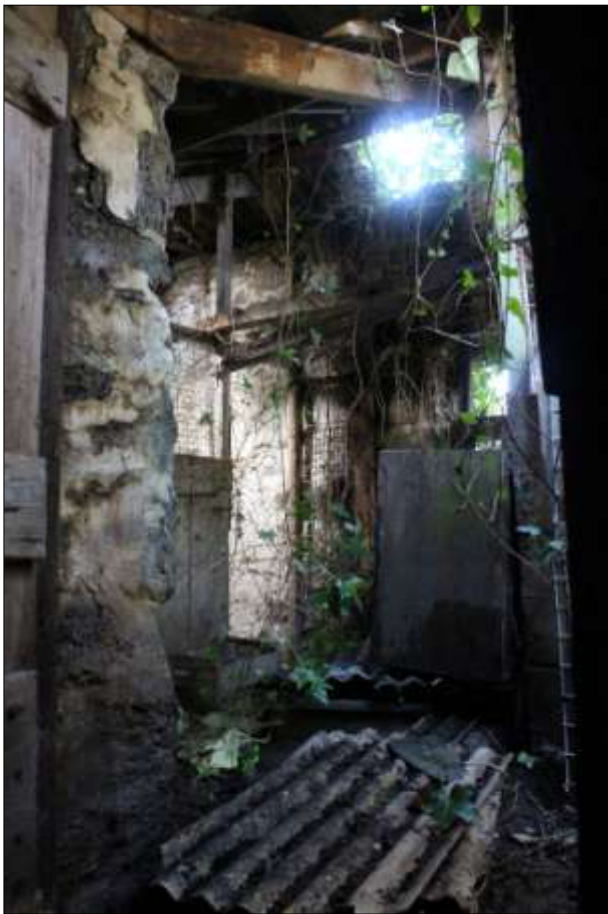
LEFT: THE INTERIOR OF FB4B, LOOKING THROUGH D13; VIEWED FROM THE SOUTH.

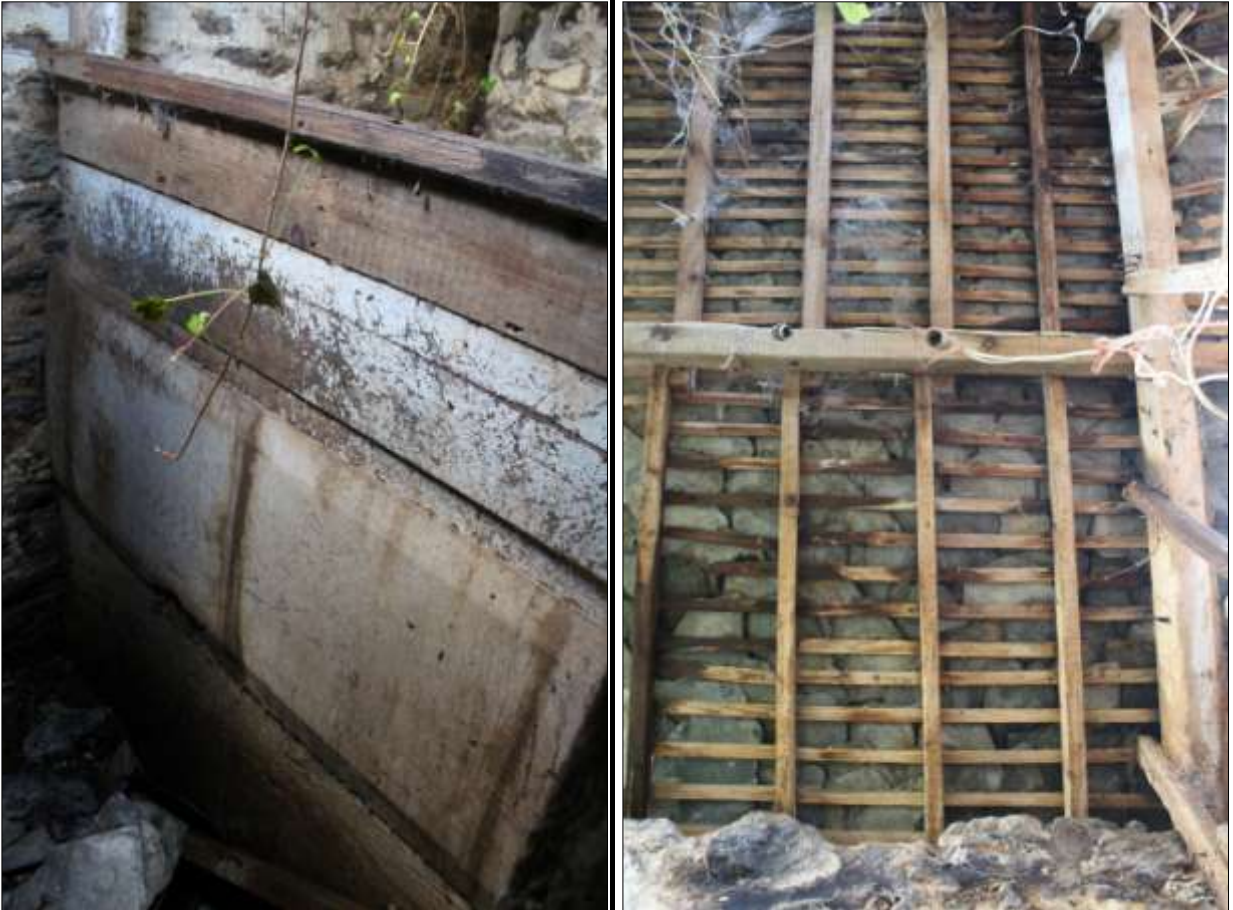
LEFT: THE REUSED RAISED AND FIELDED PANELS IN FB4B; VIEWED FROM THE SOUTH-EAST.  
RIGHT: THE ROOF OF FB4B; VIEWED FROM BENEATH.
