**TOWN BARTON
BEAWORTHY
WEST DEVON
DEVON**

Historic Building Recording

South West Archaeology Ltd. report no. 190620

01.07.2019

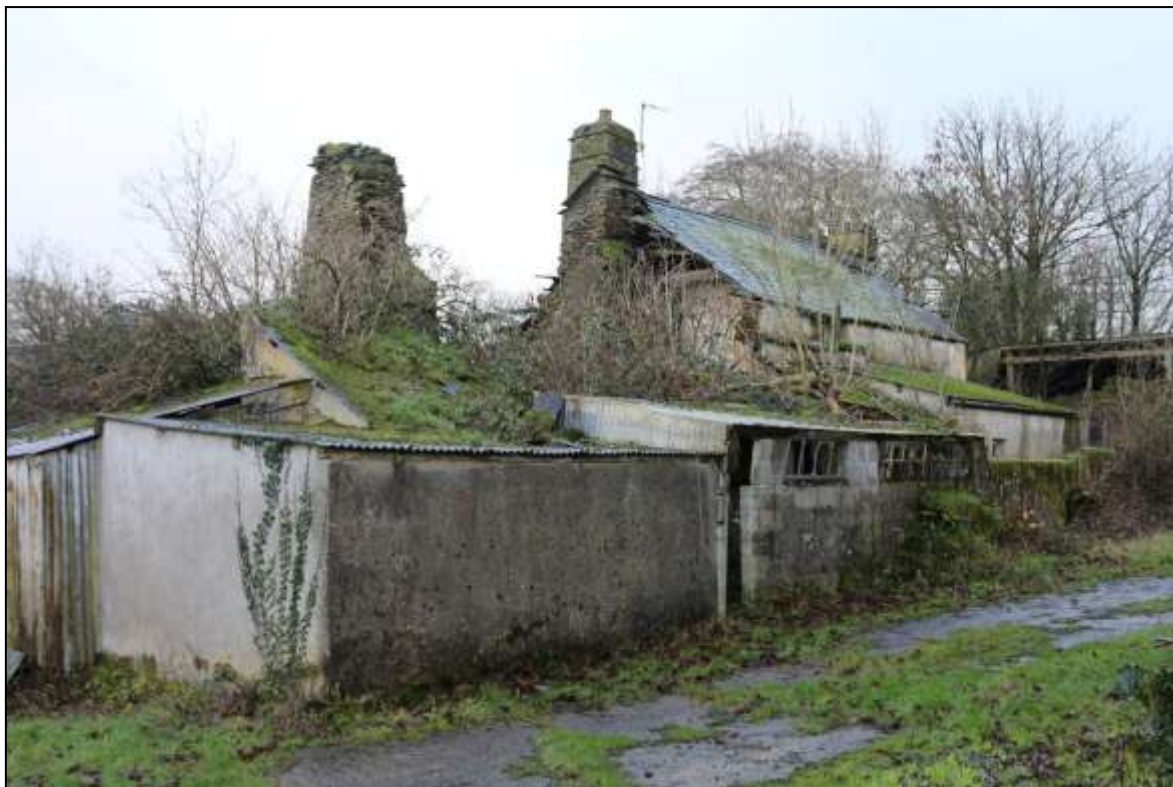
The north-west facing elevation of the main range is abutted by a range of historic single-storey mono-pitch outshuts with roofs of corrugated iron or cement fibre. The walls of the main range are a similar mix of stone and cob, with some significant areas of rebuild in brick, to the north-eastern side and at first-floor level. There is a single window at first-floor level towards the western end of

the elevation, a late 19th century three-light casement like those in the south-east elevation, with a possible blocked window above the stair. The wall is pierced at ground-floor level by two doors: an original with good wide splays set with a fine beaded plank door of 18th or early 19th century date opening onto the cross passage, and a second forced doorway to the east. There are also several possible blocked openings in this wall.

FIGURE 8: THE REAR ELEVATION OF THE FARMHOUSE AT TOWN BARTON SHOWING THE LEAN-TO ADDITIONS; FROM THE NORTH.

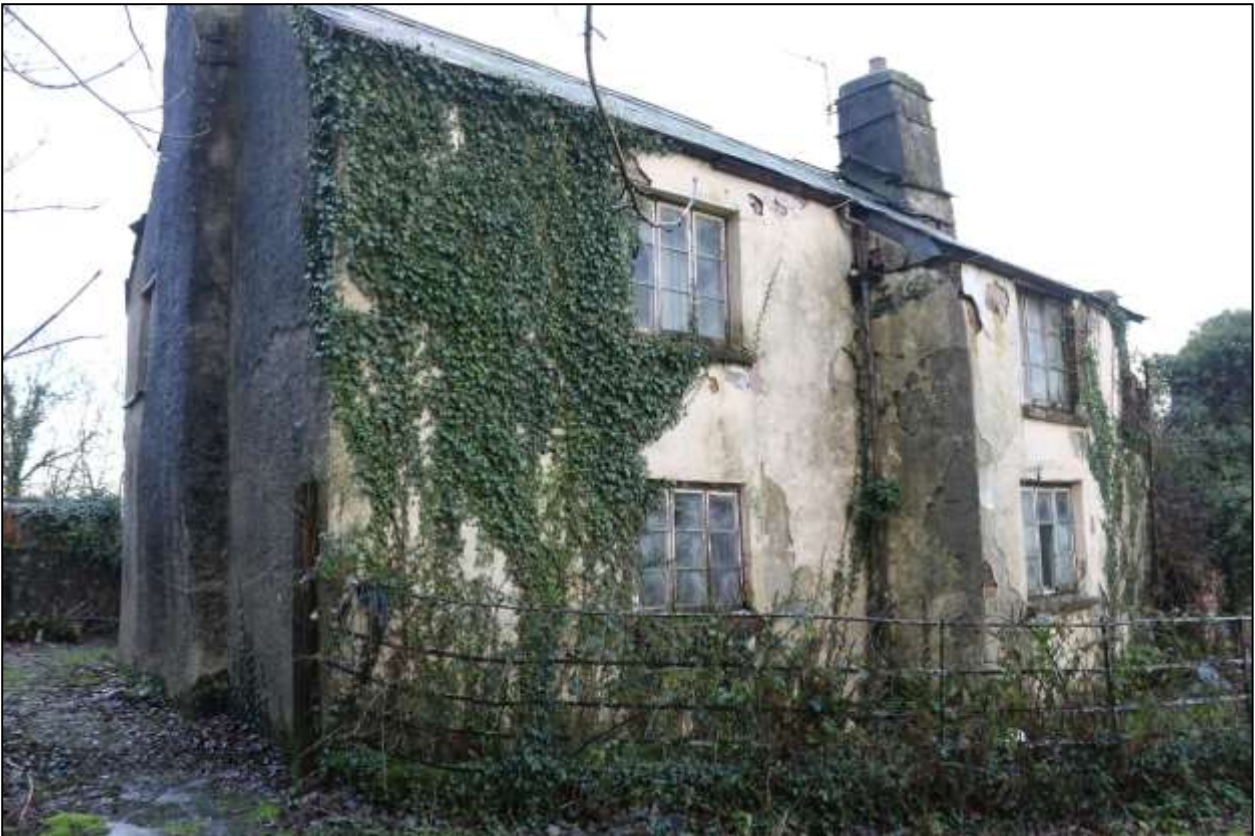
2. SOUTH-EAST ELEVATION OF R4 WITH 'HALL PROJECTION' FRONTING R3 TO RIGHT. NOTE RAISED SLATE WEATHERINGS ON EARLIER CHIMNEY FOR THATCHED ROOF. VIEWED FROM THE SOUTH.

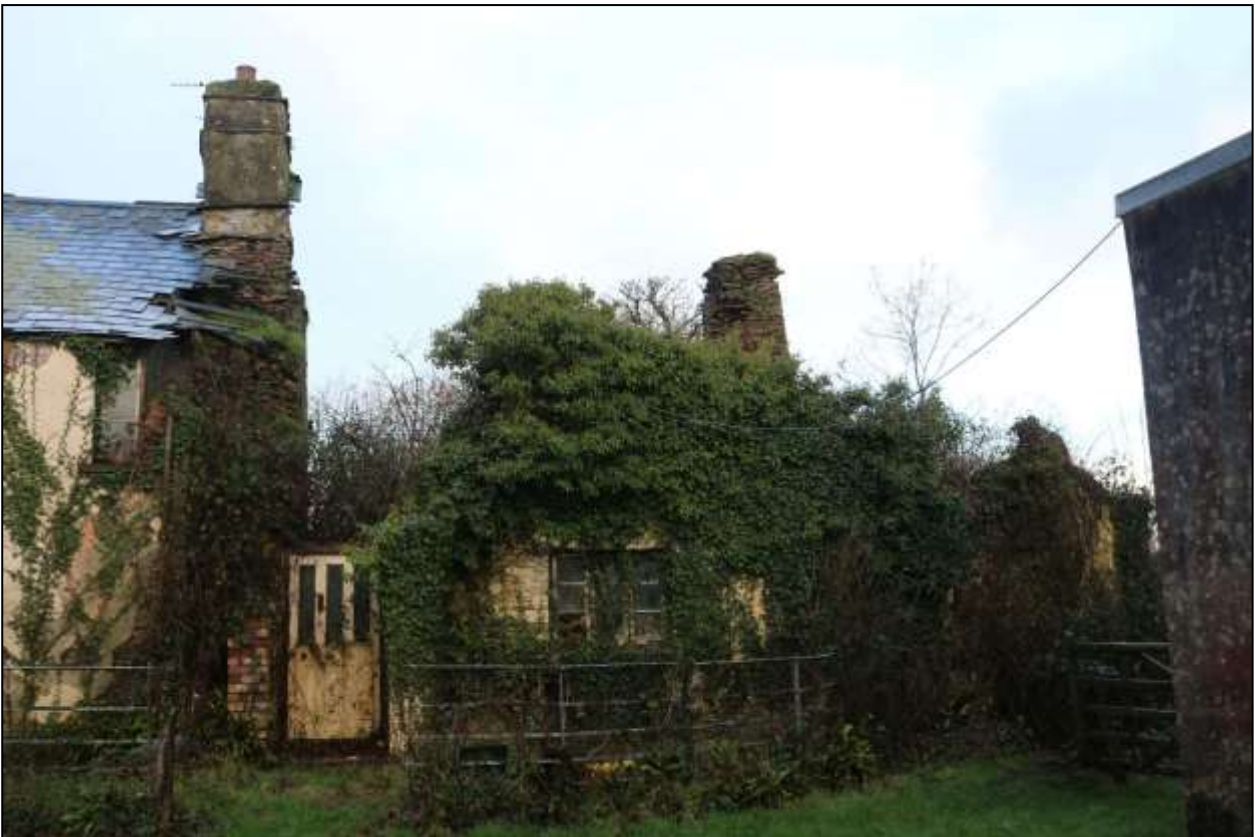
4. SOUTH-EAST ELEVATION OF COLLAPSED PART OF HOUSE, WITH SOUTH WINDOW OF R2 TO RIGHT OF FRONT DOOR. EASTERN AXIAL STACK VISIBLE BEHIND IVY, AND REMAINS OF COB WALLS OF R1 TO RIGHT. VIEWED FROM THE SSE.

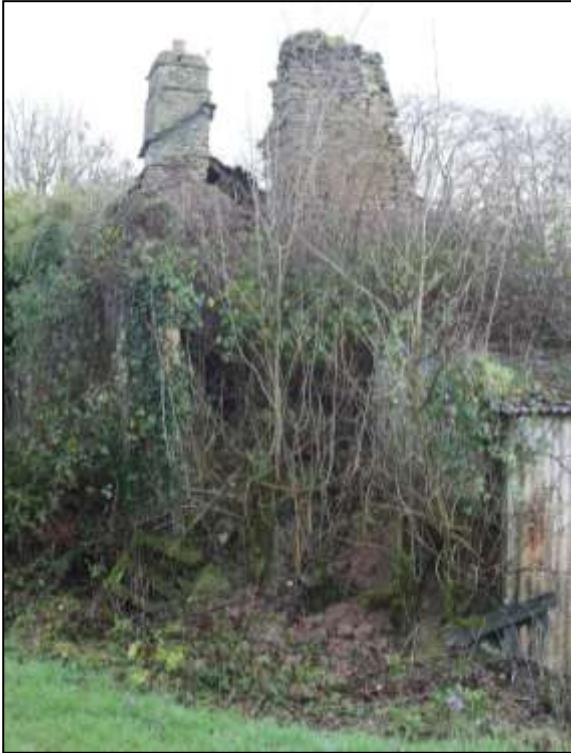
9. WESTWARD VIEW INTO PARTLY COLLAPSED AND OVERGROWN REMAINS OF R1; CREAM-PAINTED FRONT WALL IS JUST VISIBLE IN IVY ON LEFT; VIEWED FROM THE EAST.

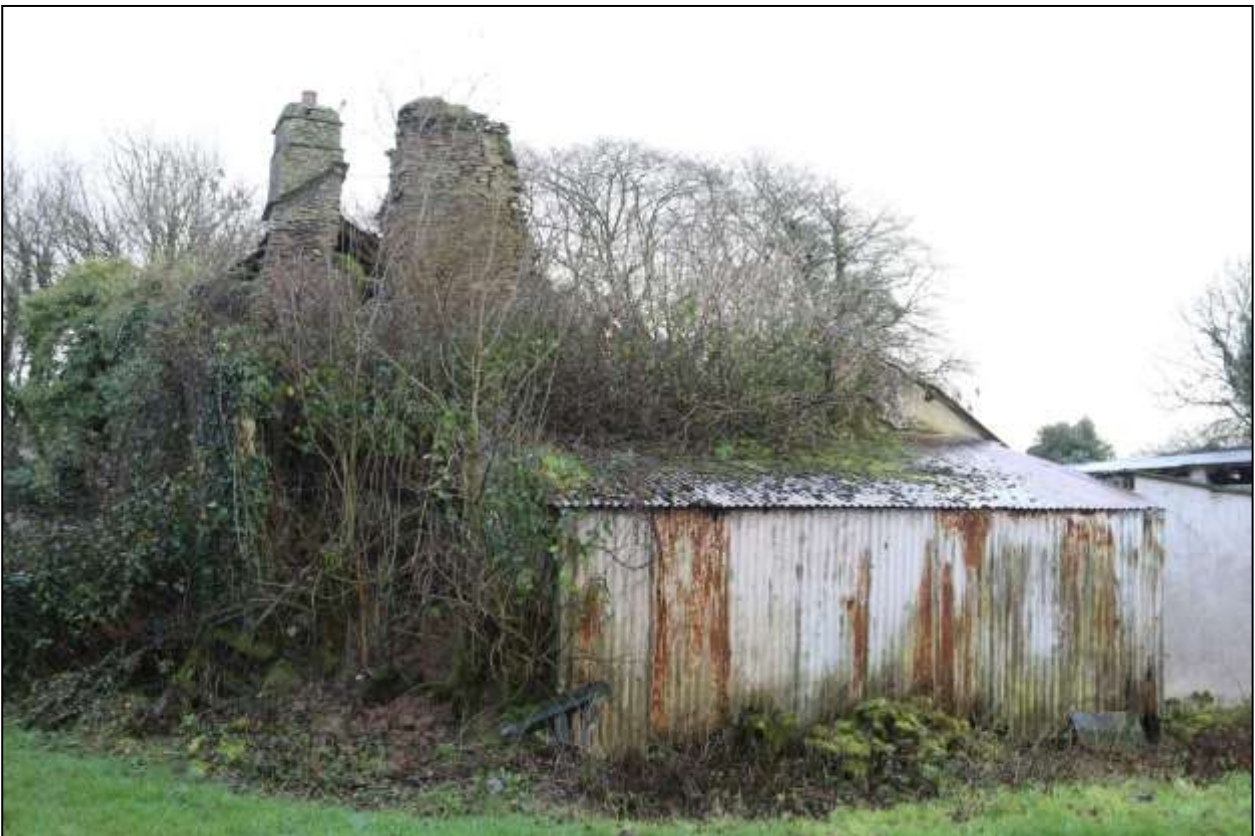
10. NORTH-EAST END OF FARMHOUSE, R1 IS IN THE THICK VEGETATION BEHIND THE 20TH CENTURY CORRUGATED IRON LEAN-TO IN THE FOREGROUND; VIEWED FROM THE EAST.

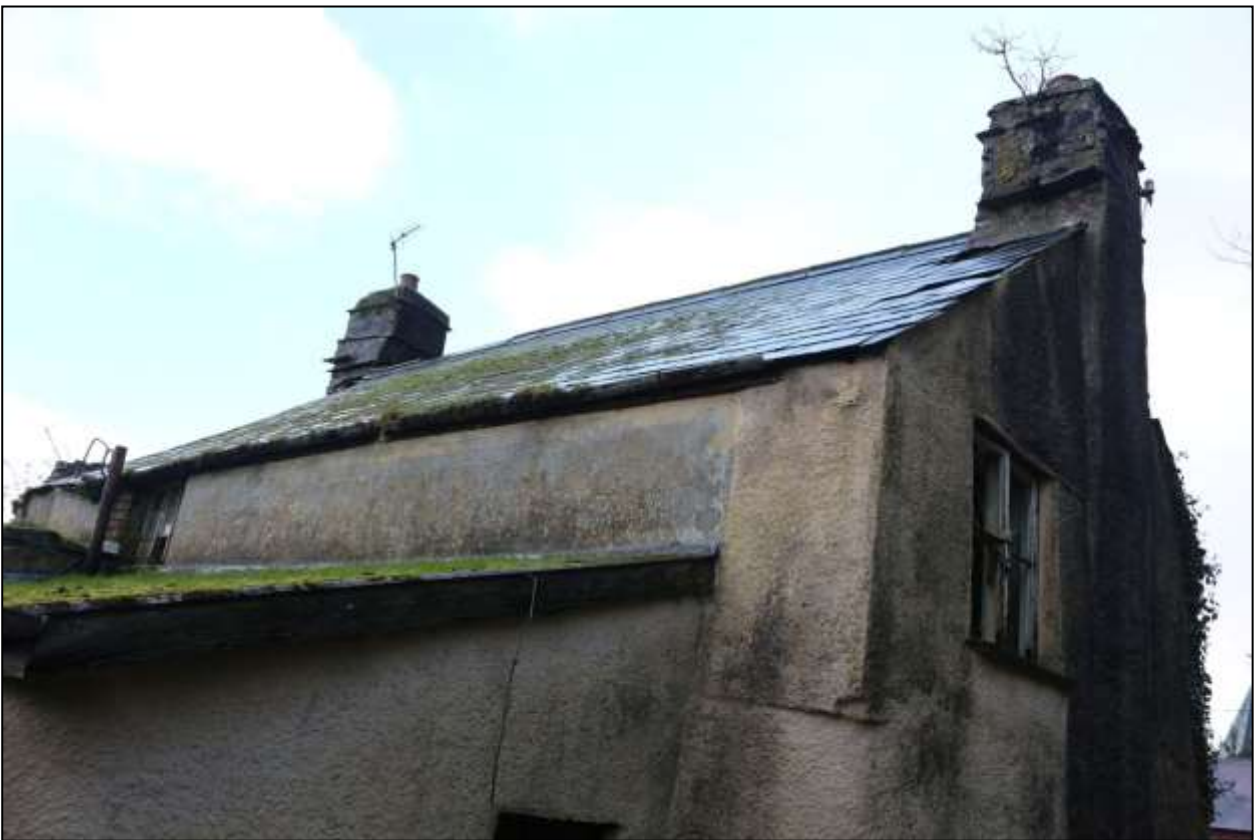
18. NORTH-WEST CORNER OF HOUSE. CURVED CORNER FORMERLY CONTAINED NEWEL STAIRCASE OF 17TH CENTURY DATE. REGULAR CORNER ABOVE IS PROBABLY A BRICK REPAIR. WINDOW (W12) LIGHTS FIRST FLOOR R13. NOTE RAISED WEATHERING ON CHIMNEY AT TOP RIGHT FOR FORMER THATCH ROOF COVERING. VIEWED FROM THE NORTH-WEST.

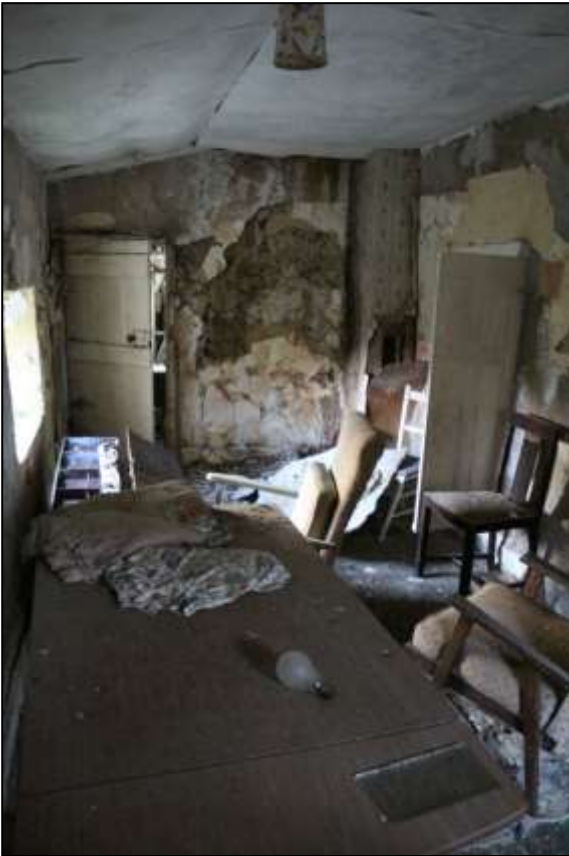
24. LEAN-TO R5 WITH DOOR (D9) TO R6 AT FAR LEFT; NOTE COB IN WALL FACE WHERE PLASTER HAS FALLEN AWAY; VIEWED FROM THE SOUTH-WEST.

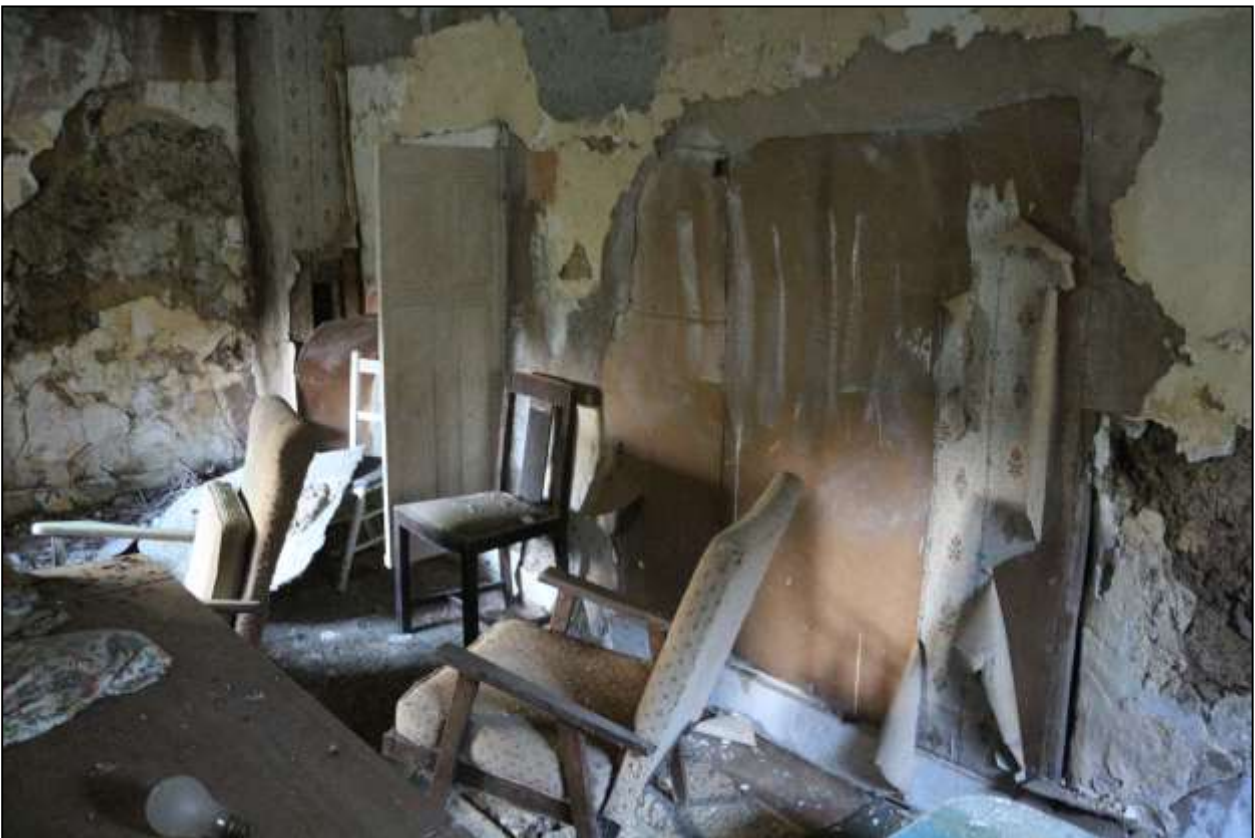
25. DETAIL OF REAR WALL OF HOUSE ON SOUTH SIDE OF R5. LARGE BLOCKED OPENING BEHIND HARDBOARD IN FOREGROUND, 18TH CENTURY PANELLED SHUTTERS RECYCLED AS DOOR TO CUPBOARD BEYOND. BOXING IN CORNER FOR 20TH CENTURY FLUE PIPE. VIEWED FROM THE WEST.

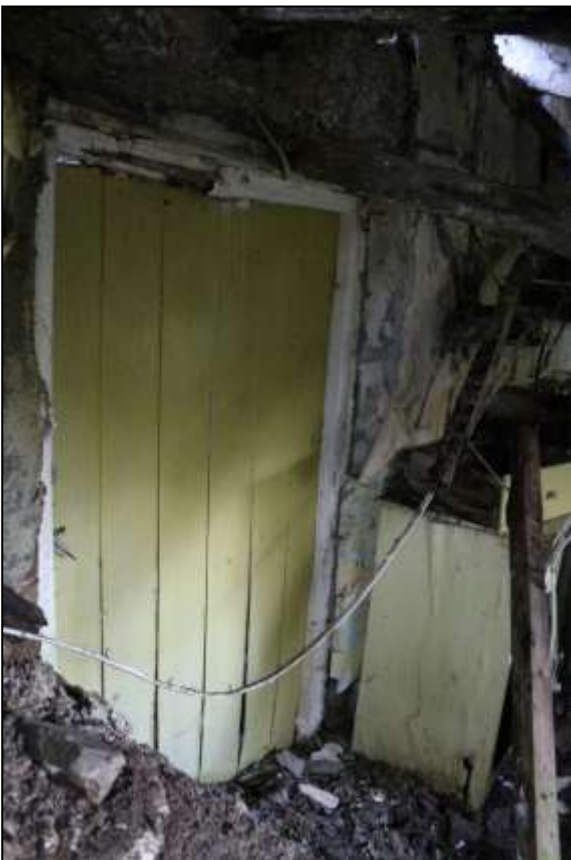
31. LEFT: REAR DOOR TO CROSS PASSAGE FROM R6 (D3); VIEWED FROM THE NORTH.

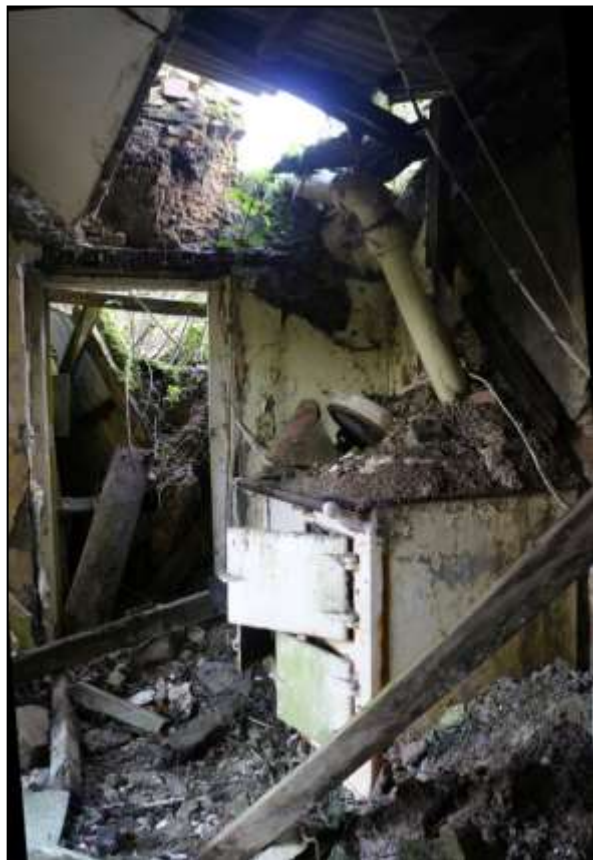
32. RIGHT: COLLAPSED EAST END OF R6 WITH 20TH CENTURY AGA; VIEWED FROM THE SOUTH-WEST.

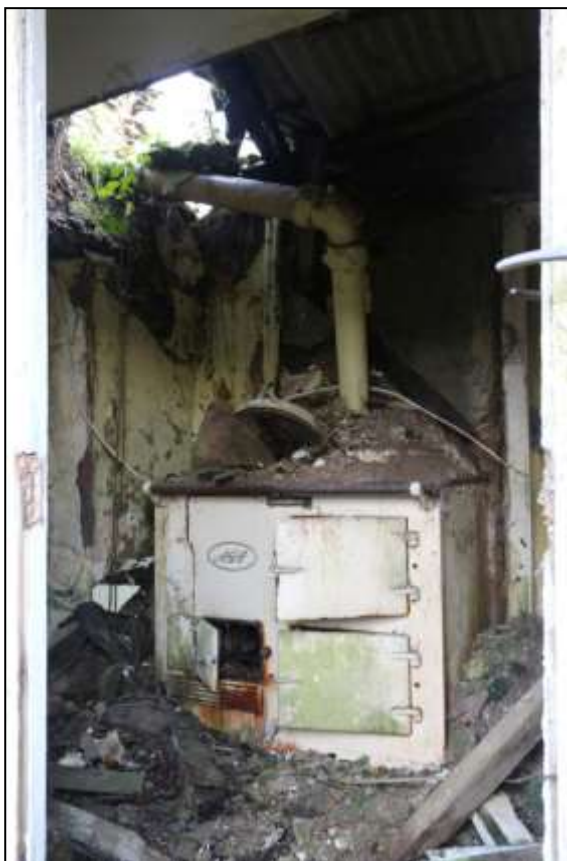
33. LEFT: 20TH CENTURY AGA IN SOUTH-EAST CORNER OF R6, PARTLY BURIED IN COB COLLAPSED FROM MEDIEVAL REAR WALL OF R2; VIEWED FROM THE NORTH-WEST.
34. RIGHT: 1950S FARM BUILDING WITH SIDE WALL OF COB LEAN-TO ON LEFT; VIEWED FROM THE NORTH-EAST.

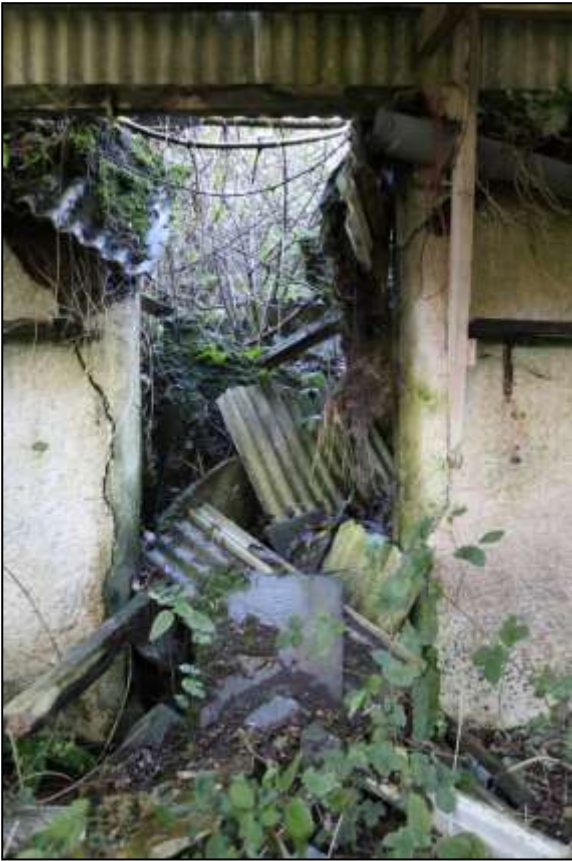
36. LEFT: COLLAPSED LEAN-TO R7 (THROUGH D12); VIEWED FROM THE NORTH-WEST.

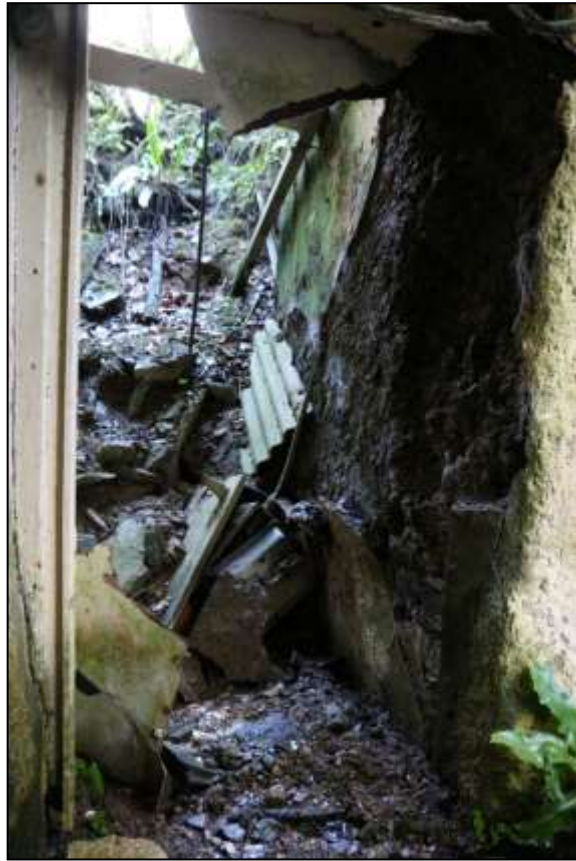
37. RIGHT: PRIVY R8 FILLED WITH COLLAPSED COB FROM BACK WALL OF R1 (THROUGH D13); VIEWED FROM THE NORTH-WEST.

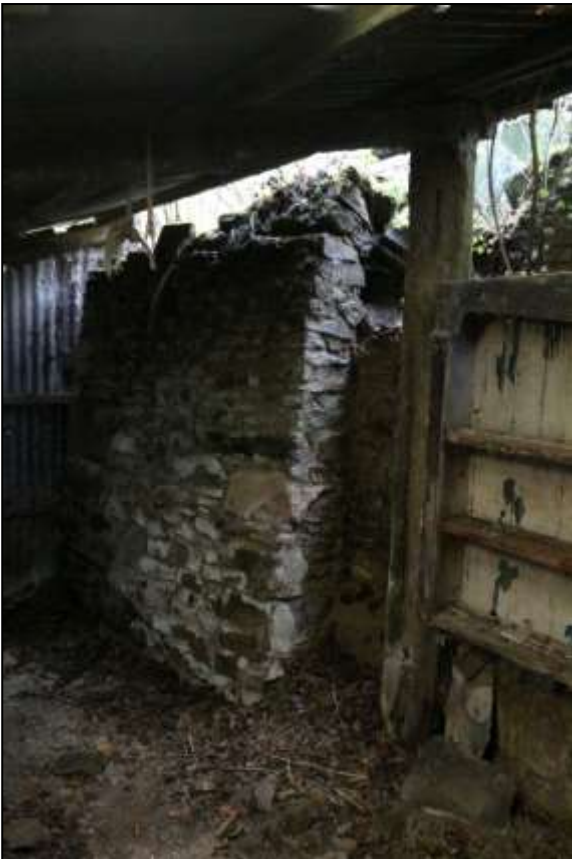
41. RUBBLE BUTTRESS BUILT AGAINST THE NORTH-EAST GABLE; VIEWED FROM THE NORTH.

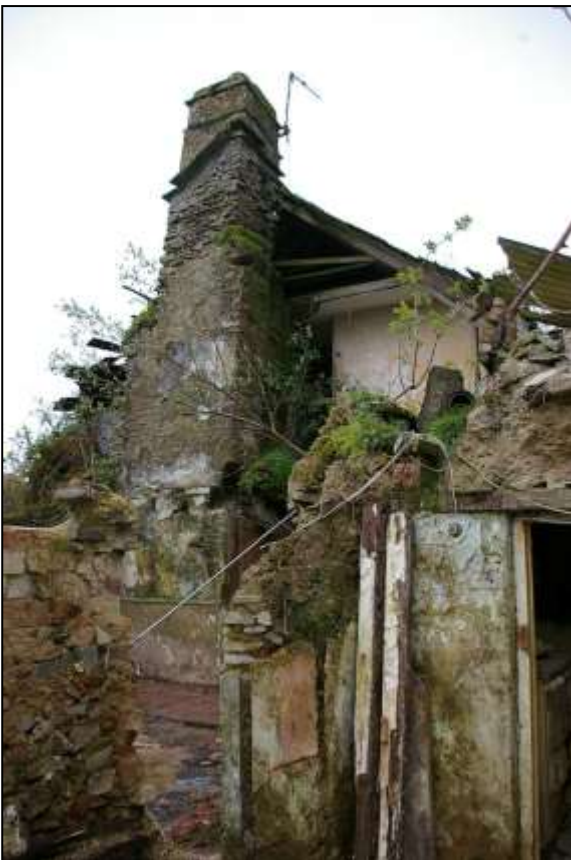
59. LEFT: VIEW FROM R7 INTO R2, SHOWING THE TOWERING INSERTED CHIMNEY STACK; VIEWED FROM THE NORTH.

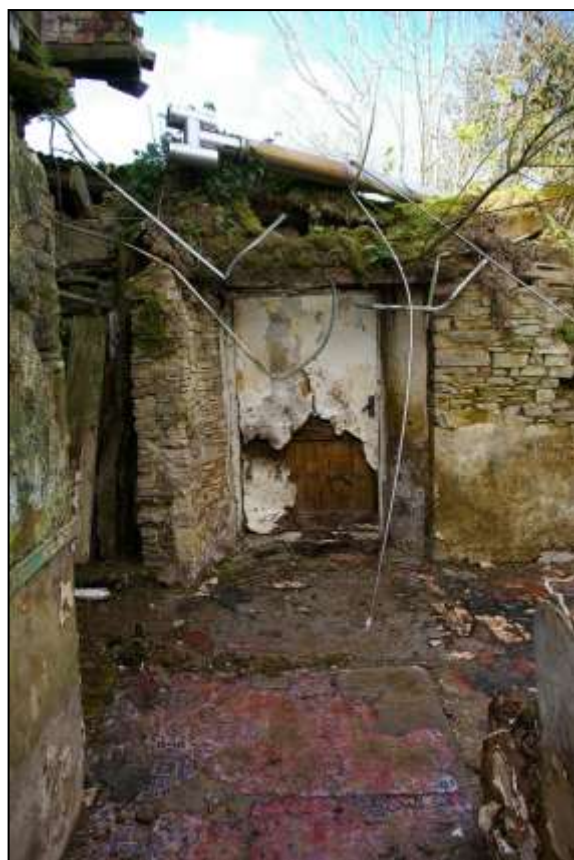
60. RIGHT: VIEW OF THE WIDE SPYLED OPENING WITH HEAVY LINTEL TO THE CROSS PASSAGE REAR DOOR IN R2A (D3); VIEWED FROM THE SOUTH-EAST.

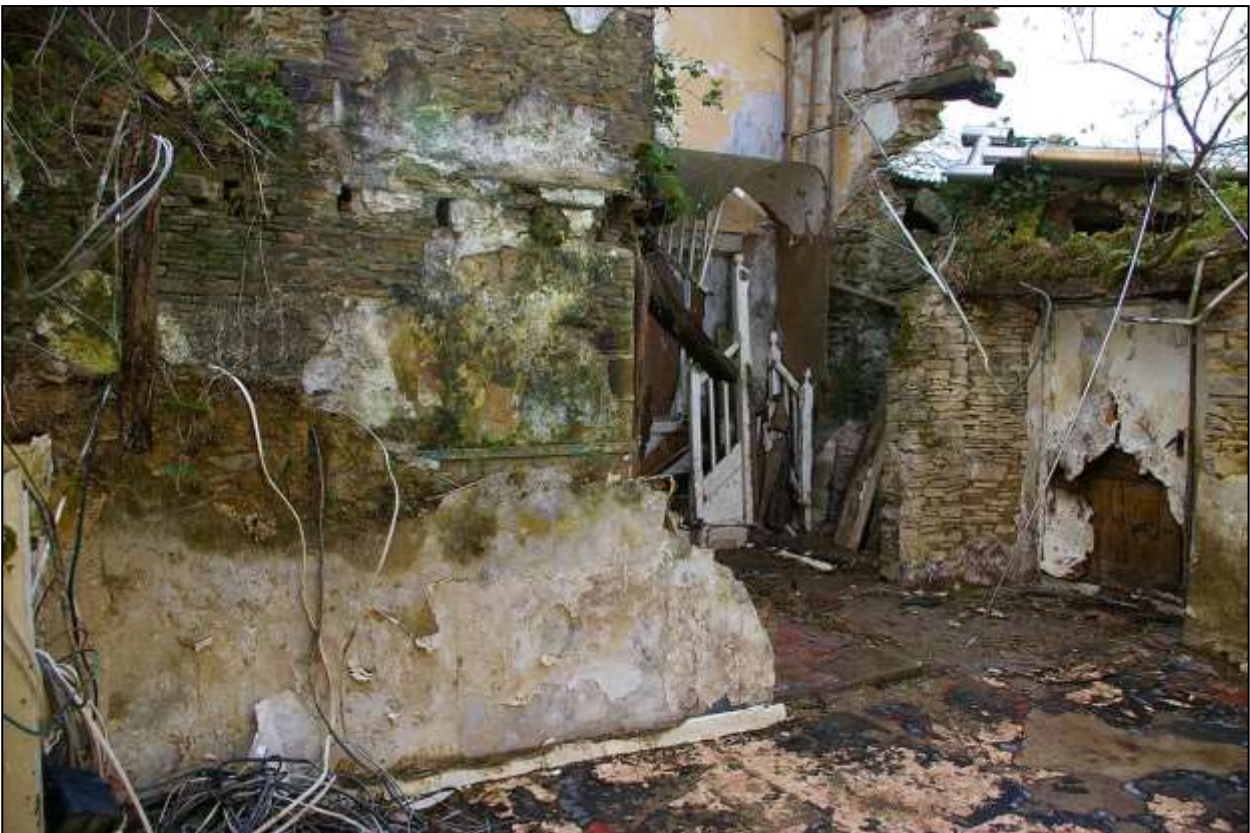
62. VIEW OF THE RUBBLE AXIAL CHIMNEY STACK FORMING THE NORTH-WEST WALL OF THE CROSS PASSAGE R2b. PART OF ITS EASTERN PARTITION TO R2 CAN BE SEEN IN THE LEFT FOREGROUND. NOTE MASONRY PIER PROJECTING BEYOND LINTEL TO LEFT OF CROSS-PASSAGE REAR DOOR. LOBBY BEYOND CONTAINS REMAINS OF LATE 17TH-EARLY 18TH CENTURY STAIRCASE. VIEWED FROM THE EAST.

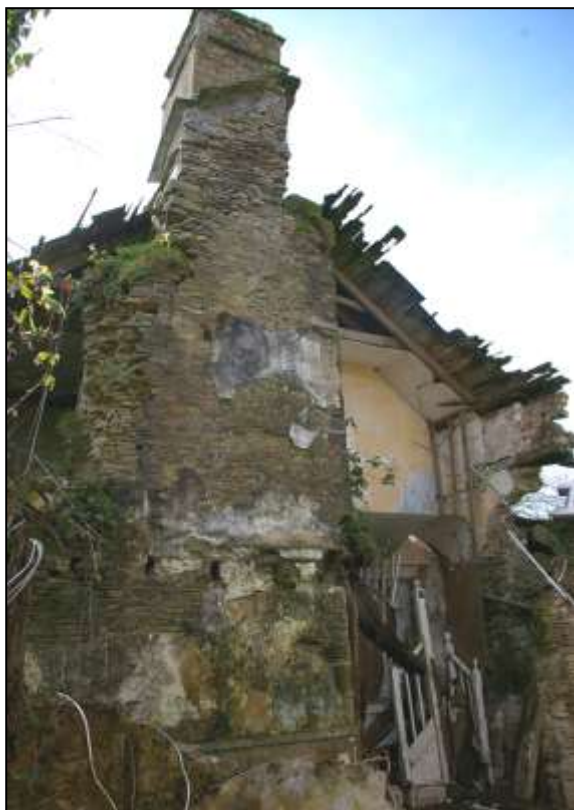
63. LEFT: THE INSERTED 17TH CENTURY WEST STACK WHICH SERVES R3 AND FORMS THE SOUTH-WEST WALL OF ROOM 2A. NOTE RAISED WEATHERING FOR FORMERLY THATCHED ROOF, AND SLIGHTLY TAPERED CAP WITH SLATE DRIP-COURSES. PLANK-COVERED LATE 19TH CENTURY OR LATER ROOF STRUCTURE IS EVIDENT HERE. VERY THIN COB AND LATER BRICK WALL OF STAIR ALCOVE CAN BE SEEN AT MIDDLE RIGHT. VIEWED FROM THE EAST.
64. RIGHT: VIEW DOWN CROSS-PASSAGE R2A, WITH REMAINS OF TIMBER-FRAMED SCREEN ON LEFT WITH BRICK AND STONE RUBBLE INFILL. FRONT DOOR IS A VICTORIAN GLAZED AND PANELLED UNIT (D2), OPENING ONTO A PORCH. VIEWED FROM THE NORTH-WEST.

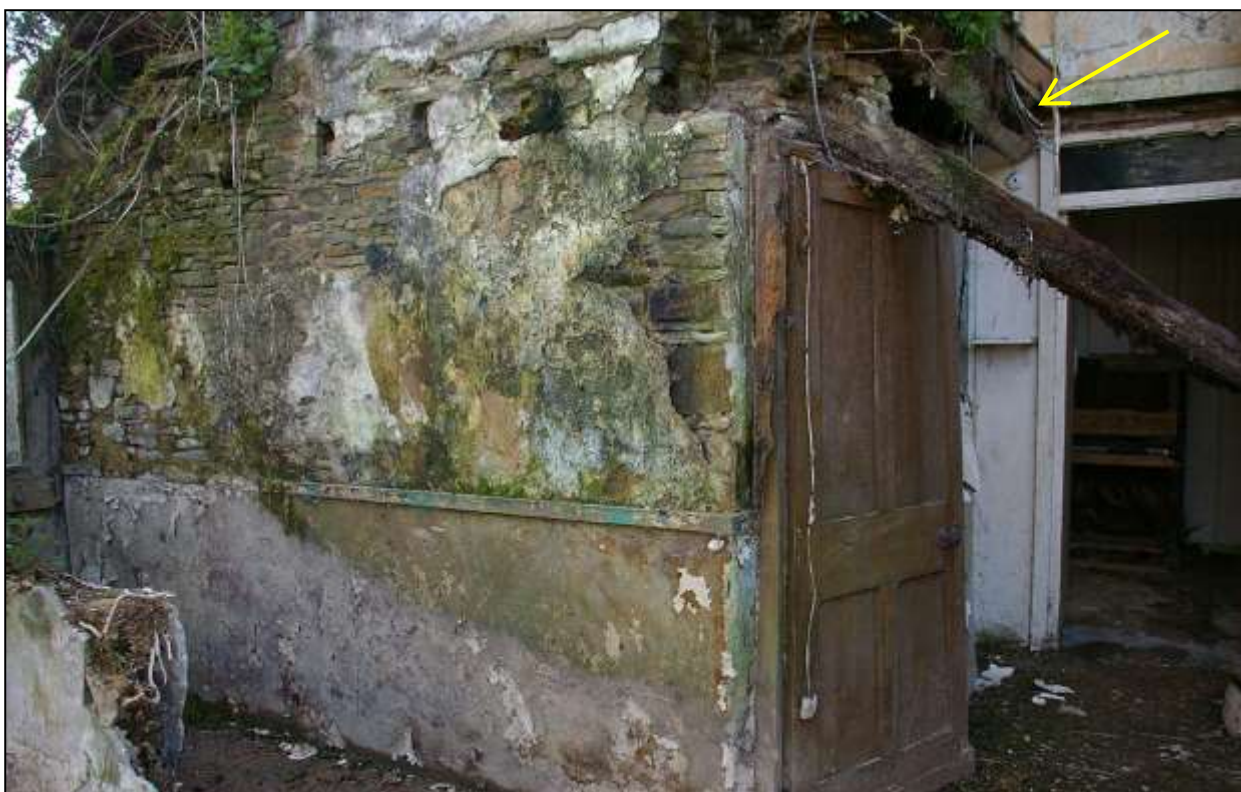
65. DETAIL OF THE STONEMWORK IN THE BACK OF THE AXIAL STACK, WHICH FORMS THE SOUTH-WEST WALL OF CROSS PASSAGE R2A. THE CHAMFERED BEAM FROM R3 CAN JUST BE SEEN ABOVE THE STAIR LOBBY DOOR D5 (INDICATED). VIEWED FROM THE NORTH-EAST

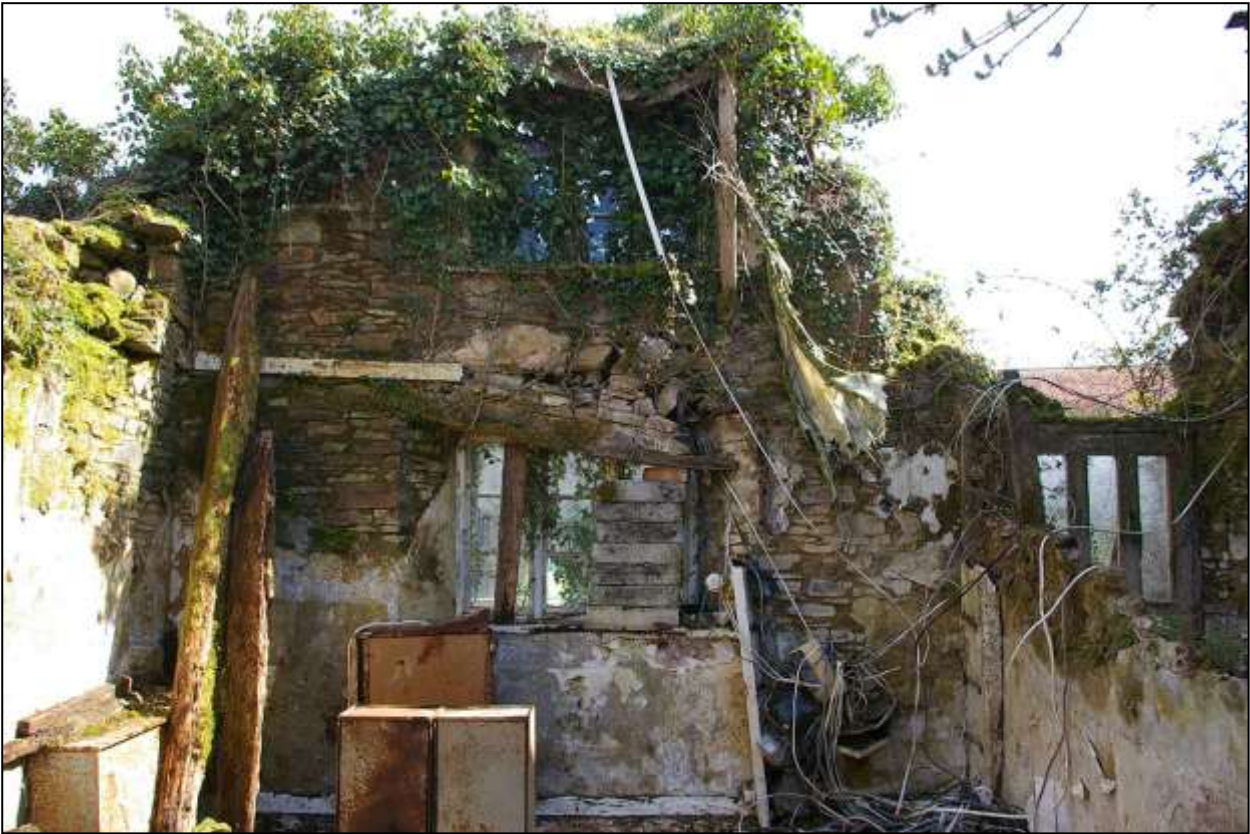
66. SOUTH-EAST FRONT WALL OF HOUSE IN R2 (SHOWING W2 AND W8). REBUILT IN STONE RUBBLE PROBABLY IN THE 17TH CENTURY, RUINOUS PARTITION TO CROSS PASSAGE R2A IS VISIBLE TO RIGHT. VIEWED FROM THE NORTH-WEST.

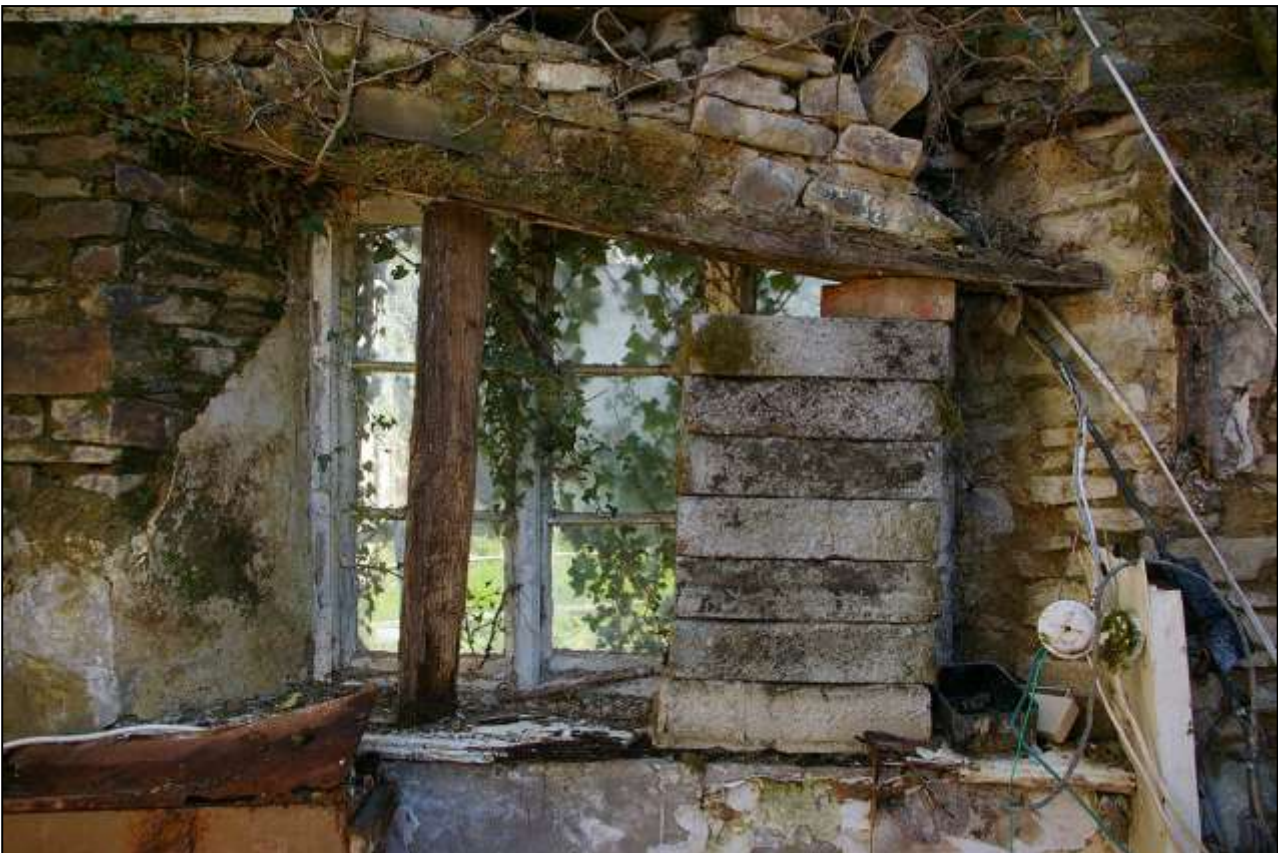
67. DETAIL OF THE GROUND FLOOR WINDOW IN R2 (W2), SOUTH WALL, SHOWING THREE-LIGHT 19TH CENTURY CASEMENT WITH CHAMFERED MULLIONS, WIDE SPLAYED REVEALS AND TIMBER LINTEL. VIEWED FROM THE NORTH-WEST.

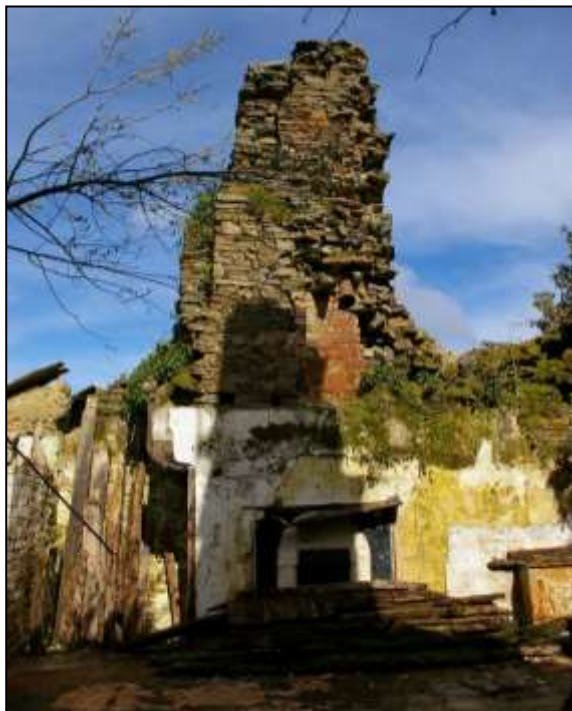
69. LEFT: VIEW OF THE INSERTED 17TH CENTURY EAST STACK IN R2. NOTE RUBBLE THICKENING OF STACK ON LEFT AND LATER BRICK FIRST-FLOOR FIREPLACE. GROUND FLOOR CAST IRON SURROUND ALSO FRONTS A BRICK FIREPLACE (FP1). VIEWED FROM THE SOUTH-WEST.
70. RIGHT: VIEW OF THE LEFT SIDE OF THE STACK IN R2 WHERE THE MASONRY JAMB HAS BEEN REMOVED LEAVING THE 17TH CENTURY LINTEL SUPPORTED ON A 19TH CENTURY BRICK WALL. VIEWED FROM THE WEST.

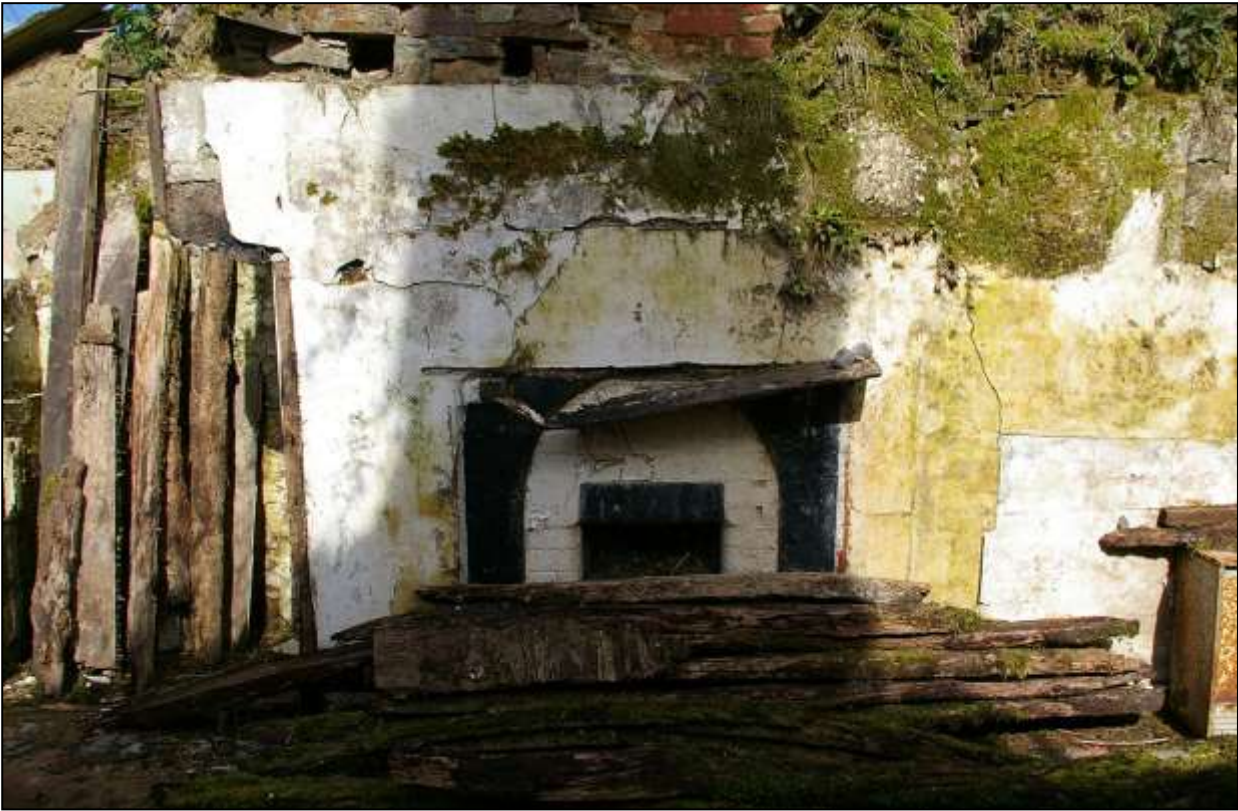
71. VIEW OF THE VICTORIAN FIREPLACE (FP2) SET INTO A MUCH LARGER BLOCKED HEARTH WITH HEAVY CHAMFERED LINTEL, IN THE EASTERN AXIAL STACK THAT SERVES R2. VIEWED FROM THE SOUTH-WEST

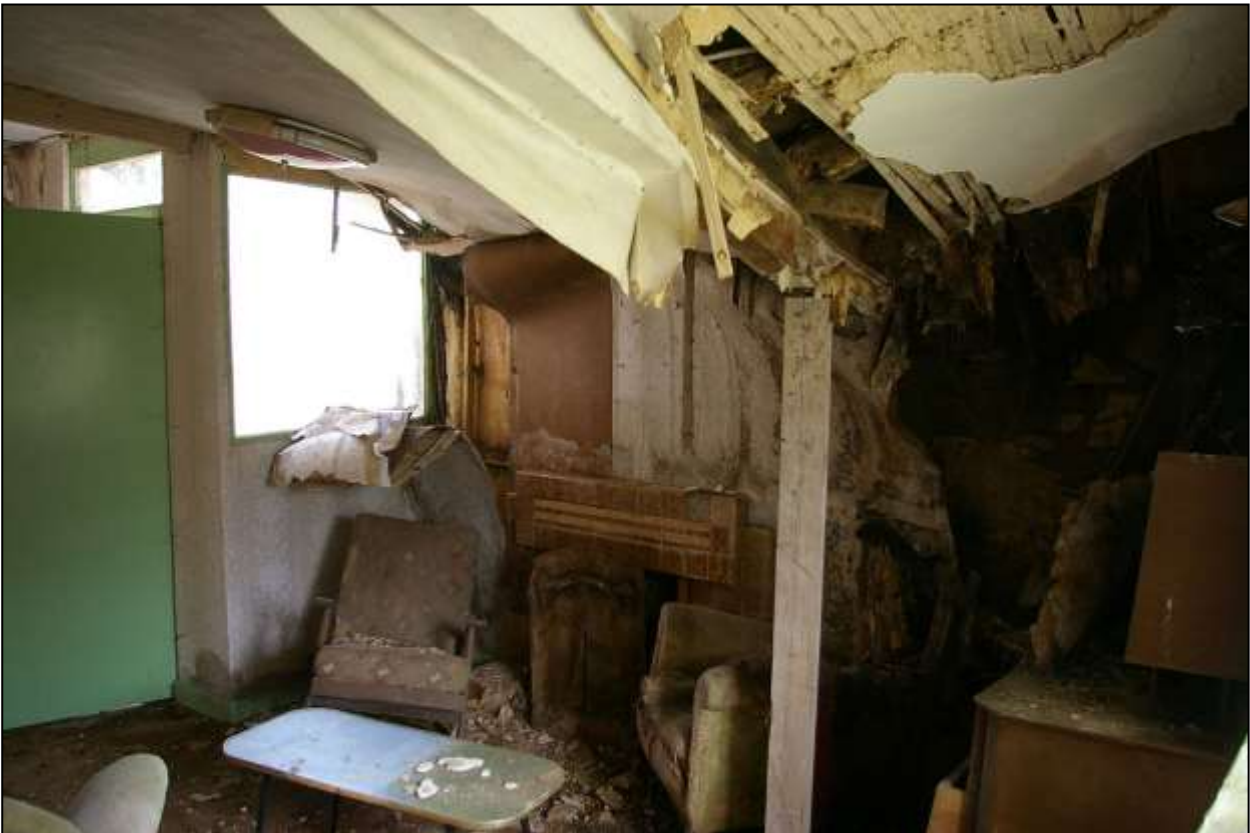
74. R3, WITH 1950S TILED HEARTH AGAINST STACK WALL. SOUTHERN CHAMFERED BEAM IS PROPPED UP ON A POLE IN RIGHT FOREGROUND. VIEWED FROM THE SOUTH-WEST.

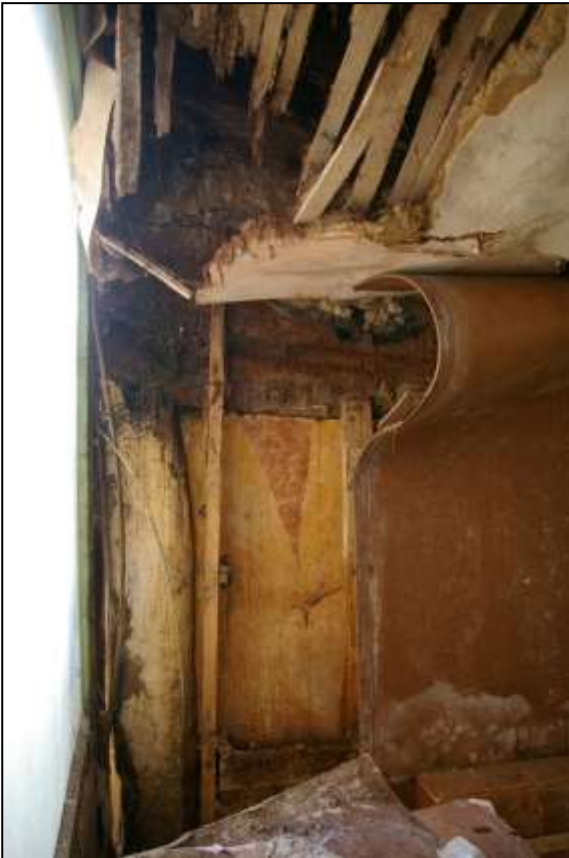
75. DETAIL OF WEST SIDE OF FIREPLACE IN R3, SHOWING HEAVY CHAMFERED TIMBER LINTEL AND GRANITE UPRIGHT SUPPORT; VIEWED FROM THE SOUTH-WEST.

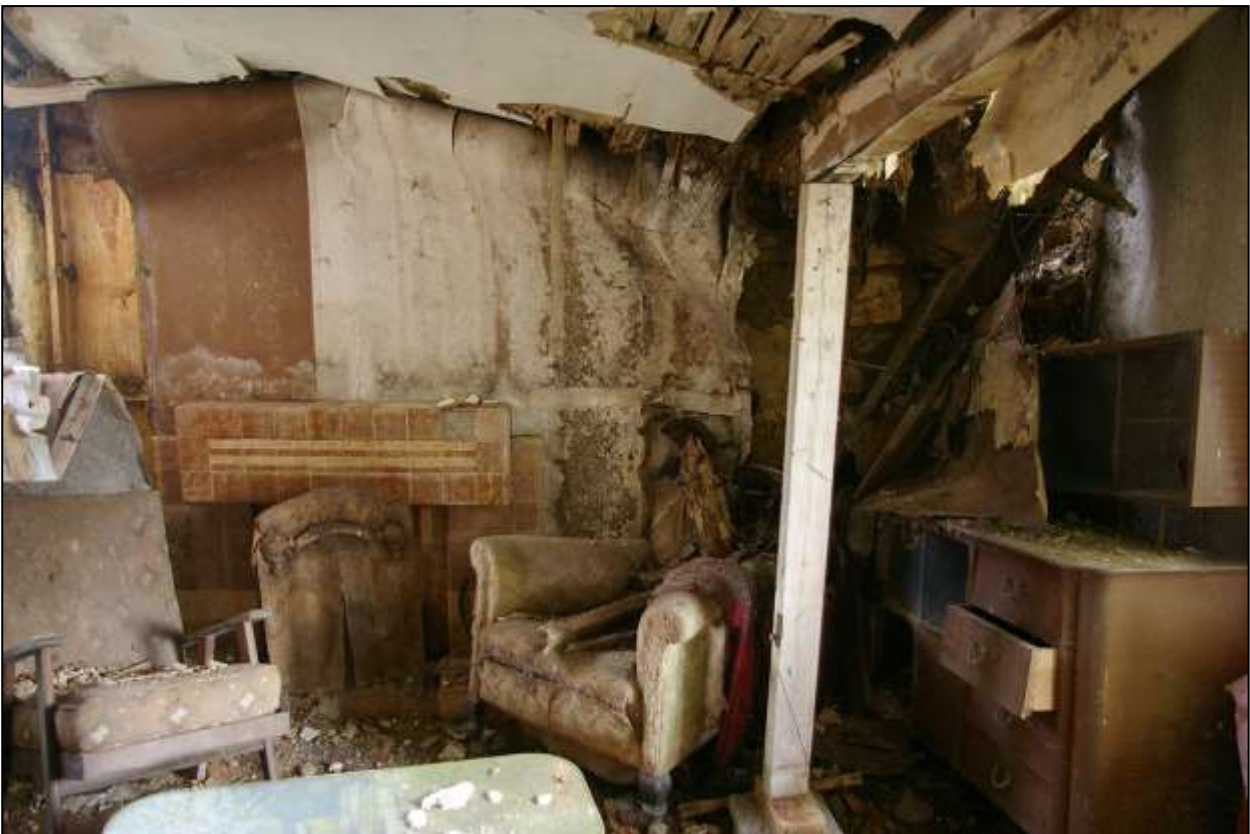
76. THE NORTH-EAST WALL OF R3, WITH THE MASSIVE INFILLED HEARTH, NOW SET WITH SMALL MID-20TH CENTURY TILED FIREPLACE; VIEWED FROM THE SOUTH-WEST. NOTE 19TH CENTURY LATH AND PLASTER CEILING AND BOXED CHAMFERED BEAM SUPPORTED ON POLE.

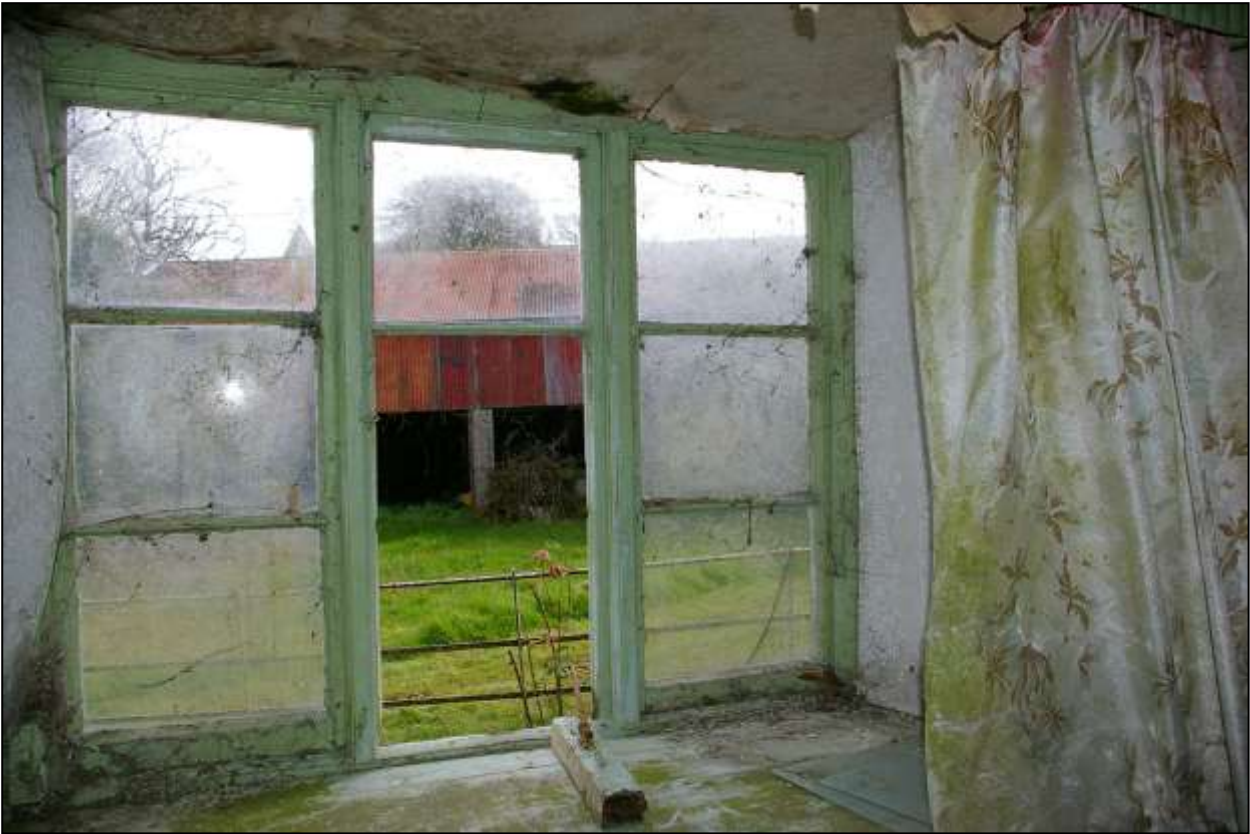
77. THE 19TH CENTURY THREE-LIGHT CASEMENT WINDOW (W3) IN THE SOUTH WALL OF R3, OVERLOOKING THE YARD TO THE SOUTH; VIEWED FROM THE NORTH.
