**TOWN BARTON
BEAWORTHY
WEST DEVON
DEVON**

Historic Building Recording

South West Archaeology Ltd. report no. 190620

01.07.2019

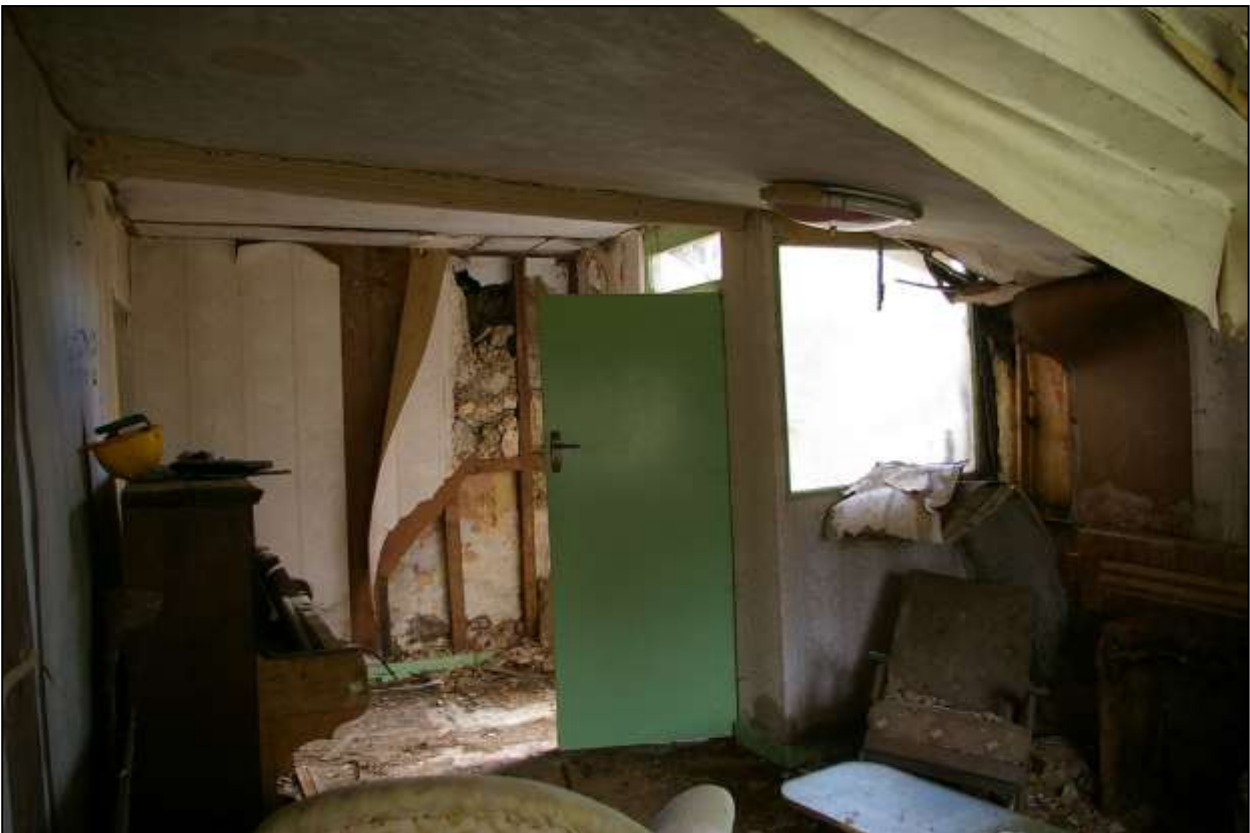
78. R3, SHOWING THE BOARDED NORTH WALL WITH BLOCKED DOORWAY TO R5, PARTITION AND DOOR (D6) TO STAIR LOBBY R2B AND MOULDED NORTHERN BEAM. VIEWED FROM THE SOUTH.

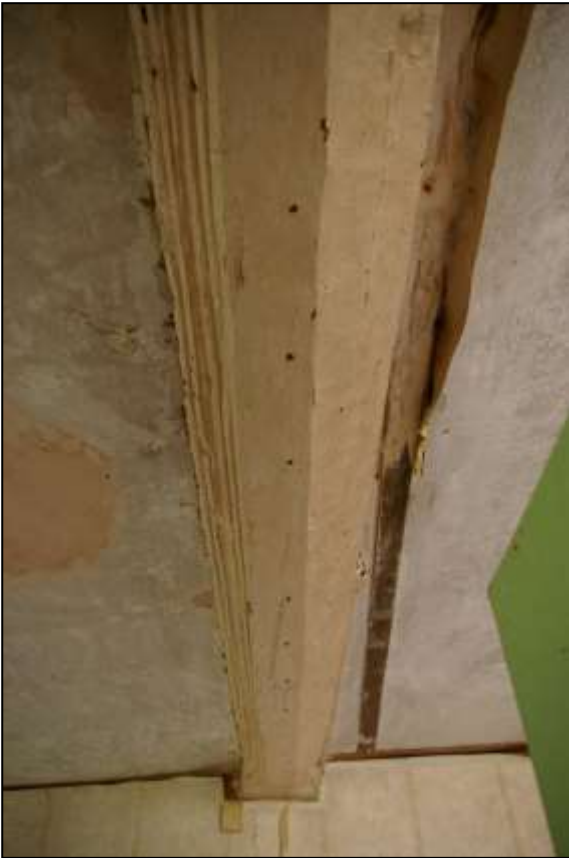
83. LEFT: THE NORTHERN BEAM IN R3, SHOWING DIFFERENCE BETWEEN MOULDINGS TO LEFT (SOUTH-EAST) AND CHAMFER TO RIGHT (NORTH-WEST). VIEWED FROM THE NORTH-EAST.
84. RIGHT: LOOKING INTO R4 FROM R3 THROUGH A NARROW BEADED DOOR FRAME WITH BEADED PLANK DOOR (D7), BOARDED OVER TO LOOK 'MODERN'. THICKER RIGHT DOOR-POST AND LINTEL MAY BE 17TH CENTURY DOOR FRAME ELEMENTS. VIEWED FROM THE NORTH-EAST.

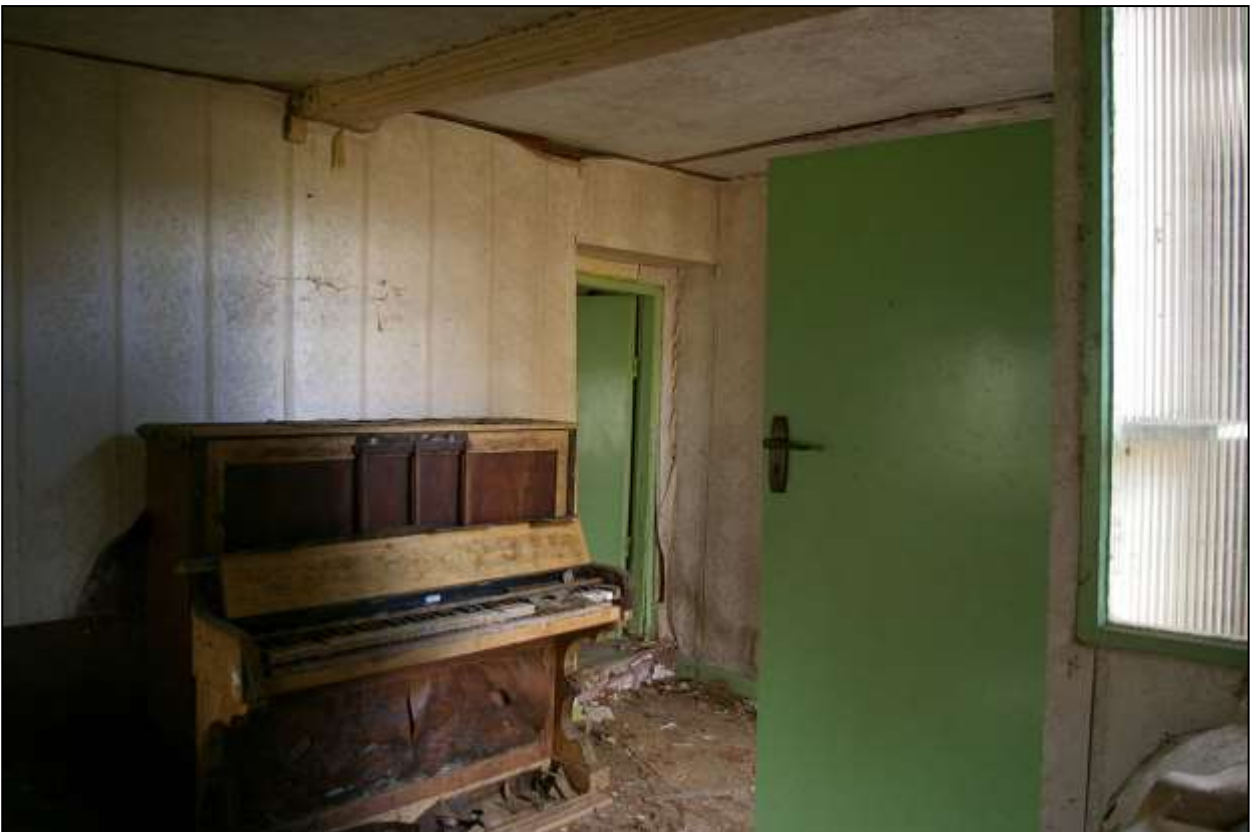
85. R3, SHOWING PARTIALLY REDUCED DOORWAY IN THE COB PARTITION WALL LEADING TO R4; VIEWED FROM THE EAST.

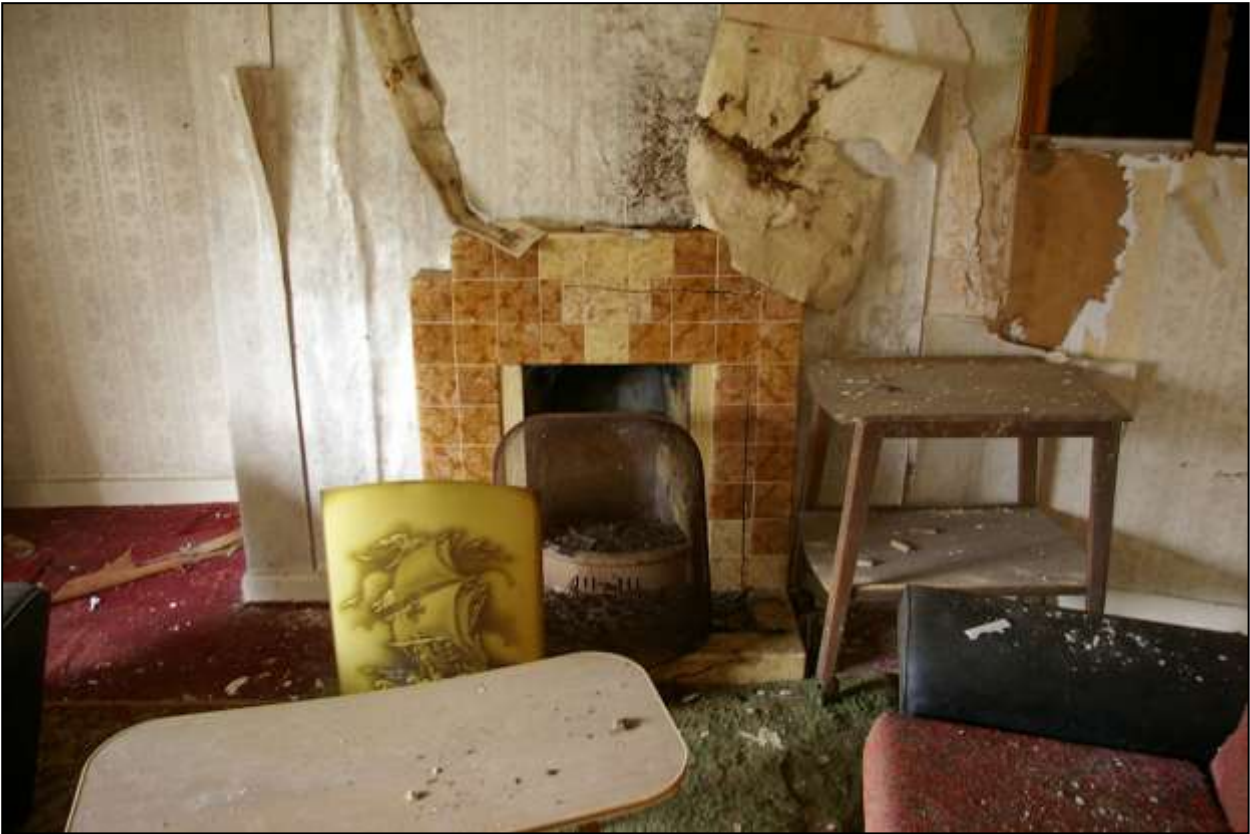
88. R4, 1950s tiled fireplace fronting older blocked fireplace (FP3); viewed from the north-east.

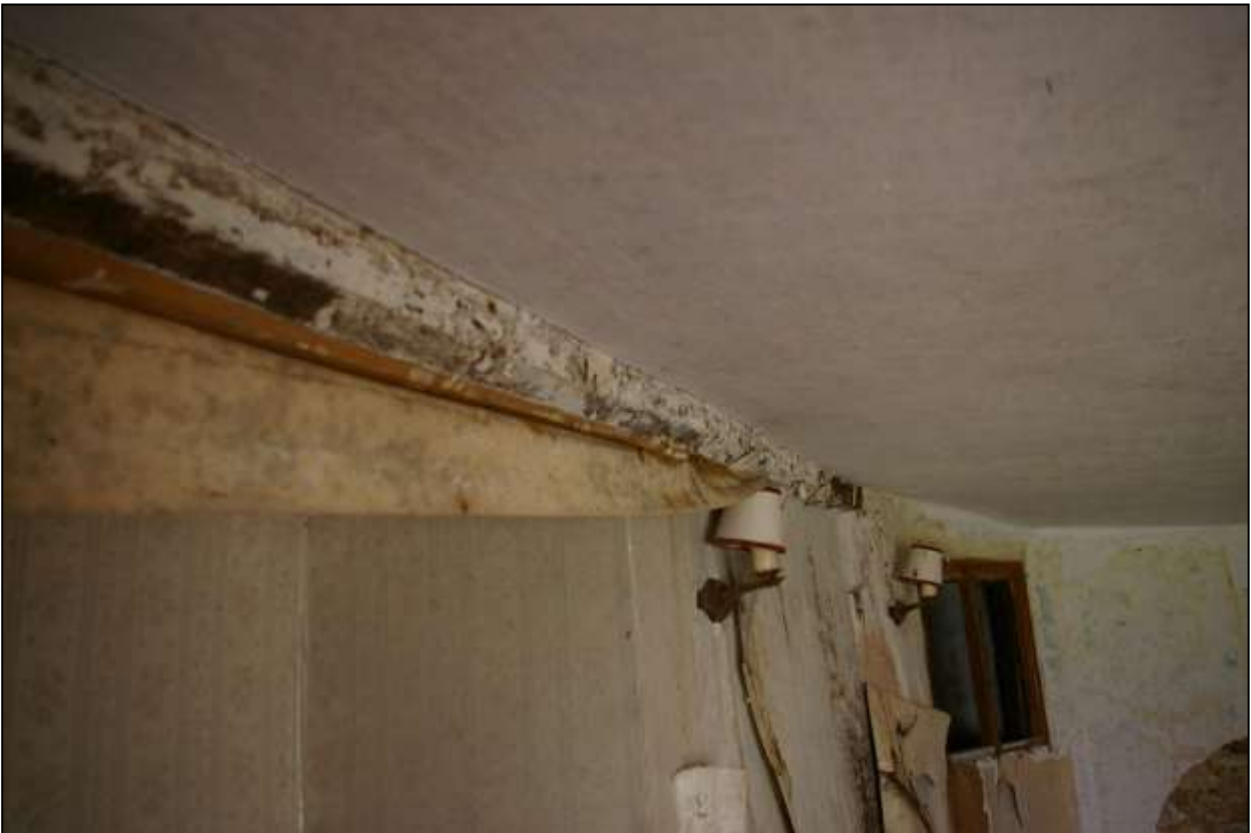
91. DETAIL OF THE NARROW-CHAMFERED CEILING BEAM AGAINST THE CHIMNEY BREAST IN R4; VIEWED FROM THE SOUTH-EAST.

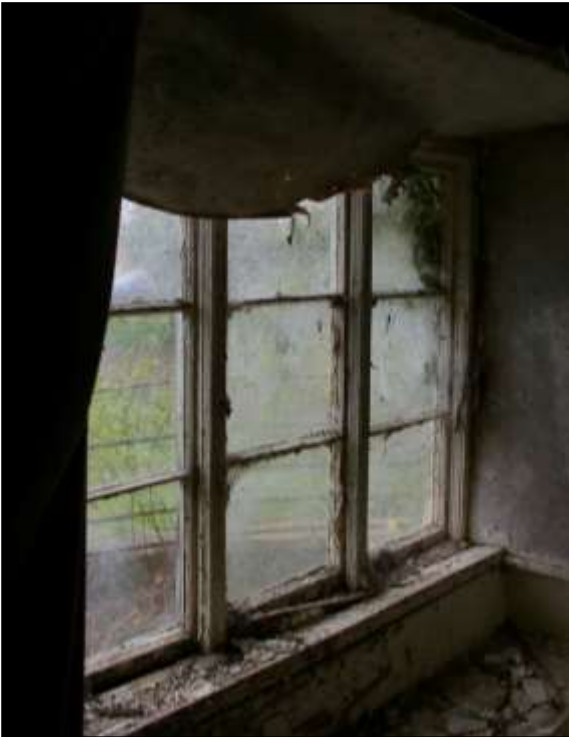
94. 19TH CENTURY THREE-LIGHT CASEMENT WINDOW (W4) IN SOUTH WALL OF R4; VIEWED FROM THE NORTH-EAST.

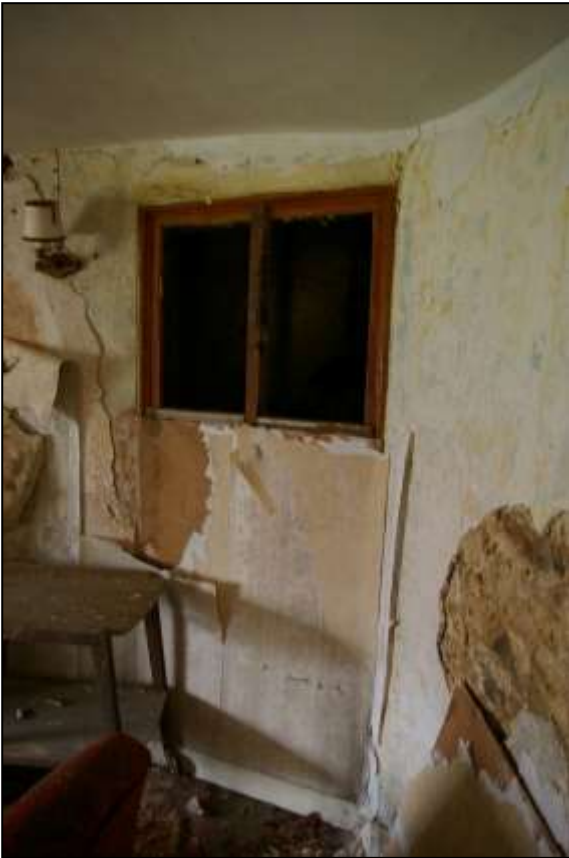
96. LEFT: PART-BOARDED 18TH CENTURY CUPBOARD DOOR FRAME (D8) ON SITE OF WINDER STAIR IN NORTH-WEST CORNER OF R4. VIEWED FROM THE NORTH-EAST.
97. RIGHT: VIEW OF THE STEPPED WEST SIDE OF THE STACK, WITHIN THE FORMER WINDER STAIR AREA; VIEWED FROM THE NORTH.

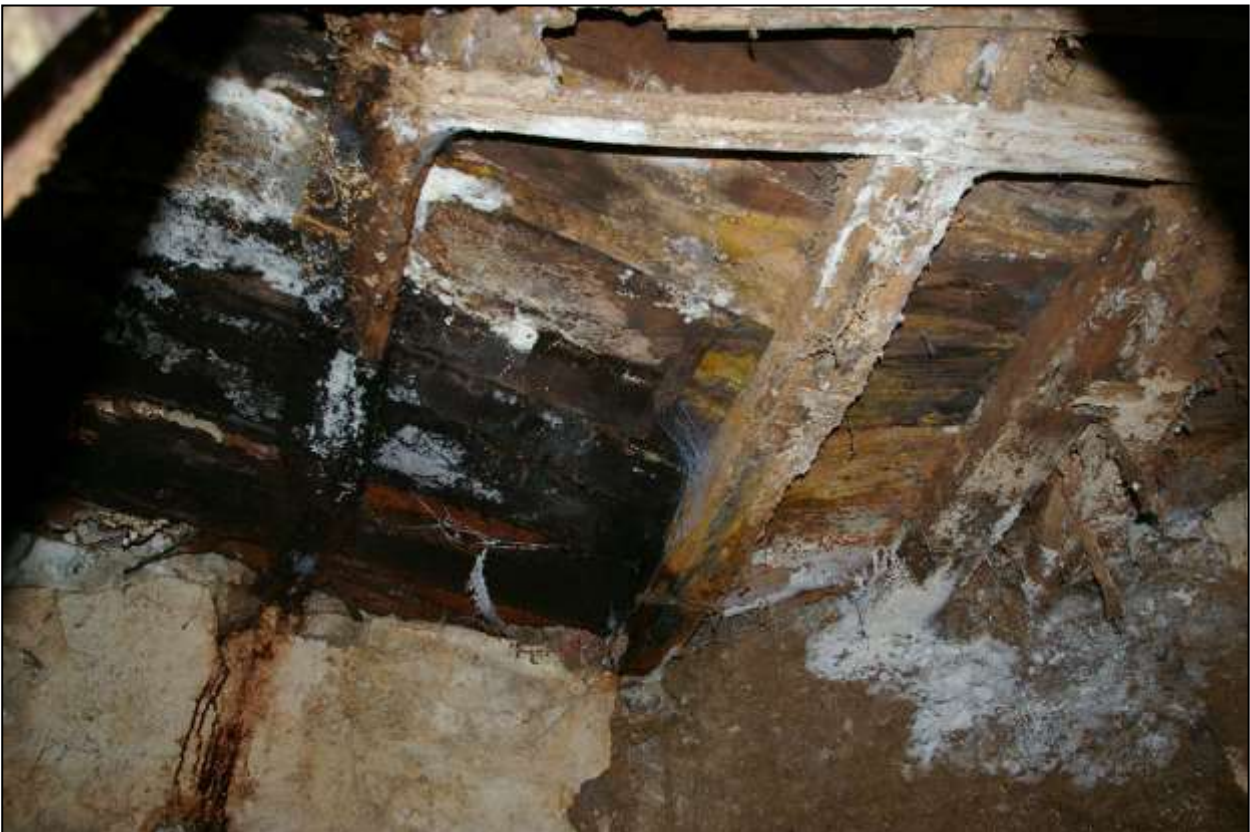
98. INTERIOR OF FORMER STAIR, LOOKING UP TO WEST WITH HEAVY 17TH CENTURY JOISTS AND BOARDS TO THE LEFT AND LIGHTWEIGHT JOISTS AND BOARDS TO THE RIGHT, PERHAPS 18TH CENTURY INFILL AFTER STAIR WAS REMOVED? VIEWED FROM THE EAST.

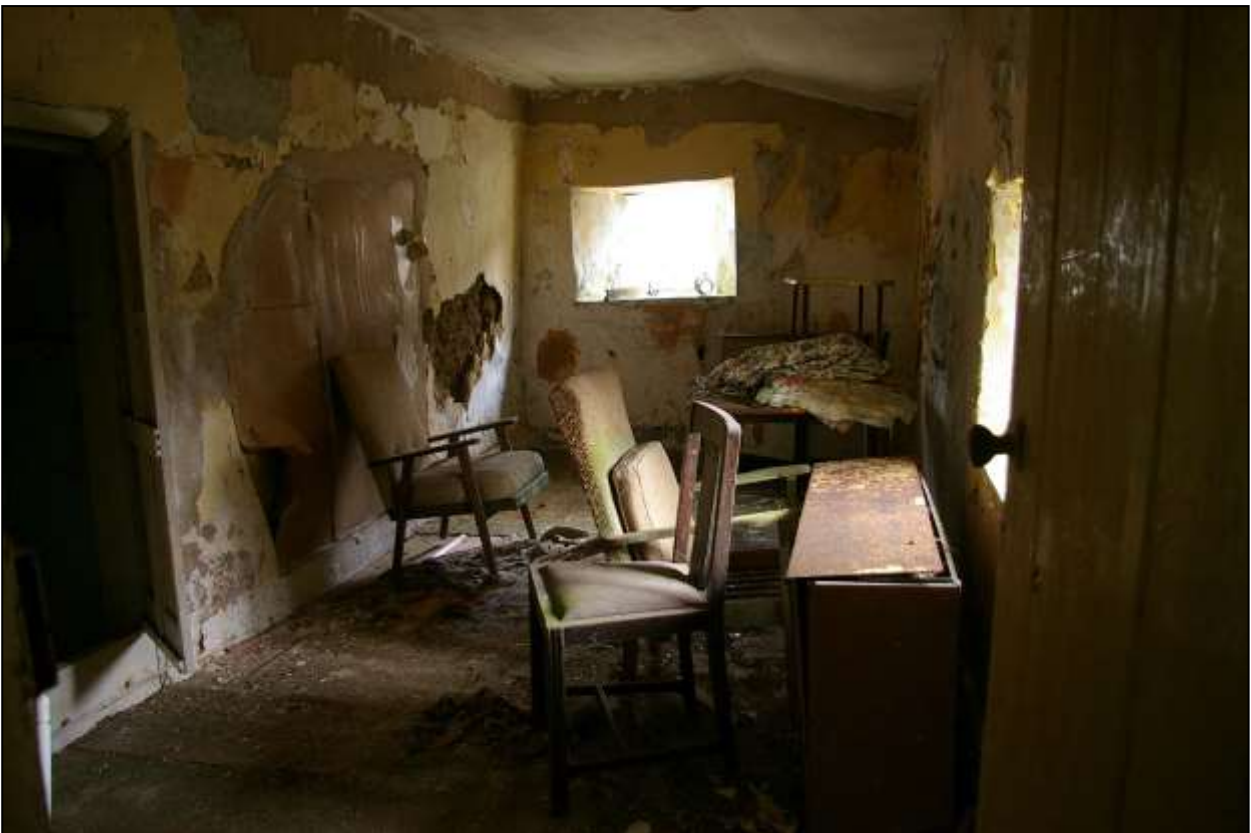
100. R5, A DAIRY OR SERVICE EXTENSION TO THE REAR OF THE FARMHOUSE, LOOKING WEST. BLOCKED DOORWAY ON LEFT, NOW A CUPBOARD, LED TO R3 AND R4. VIEWED FROM THE NORTH.

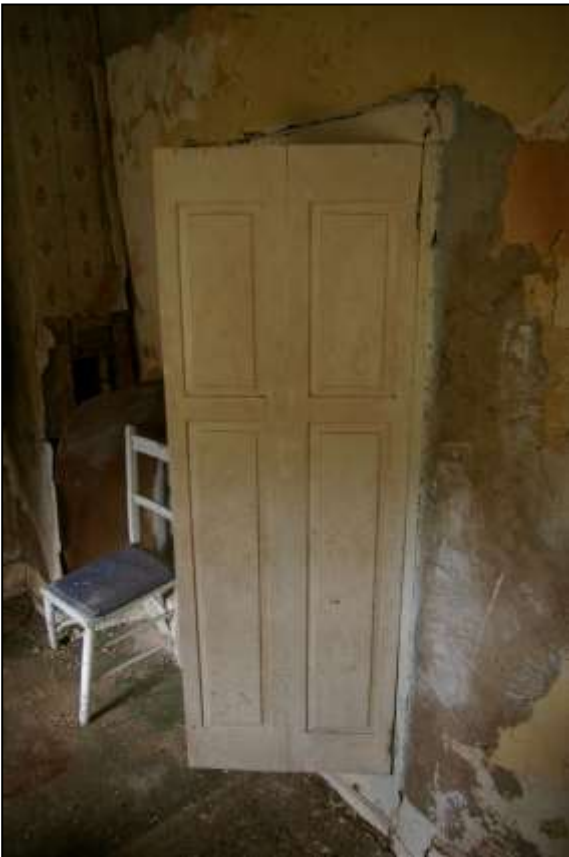
102. LEFT: VIEW OF THE BLOCKED DOOR (BO3) TO R3 IN R5, NOW USED AS A CUPBOARD, WITH RESET RAISED AND FIELDDED LATER 17TH OR EARLY 18TH CENTURY SHUTTERS. VIEWED FROM THE WEST

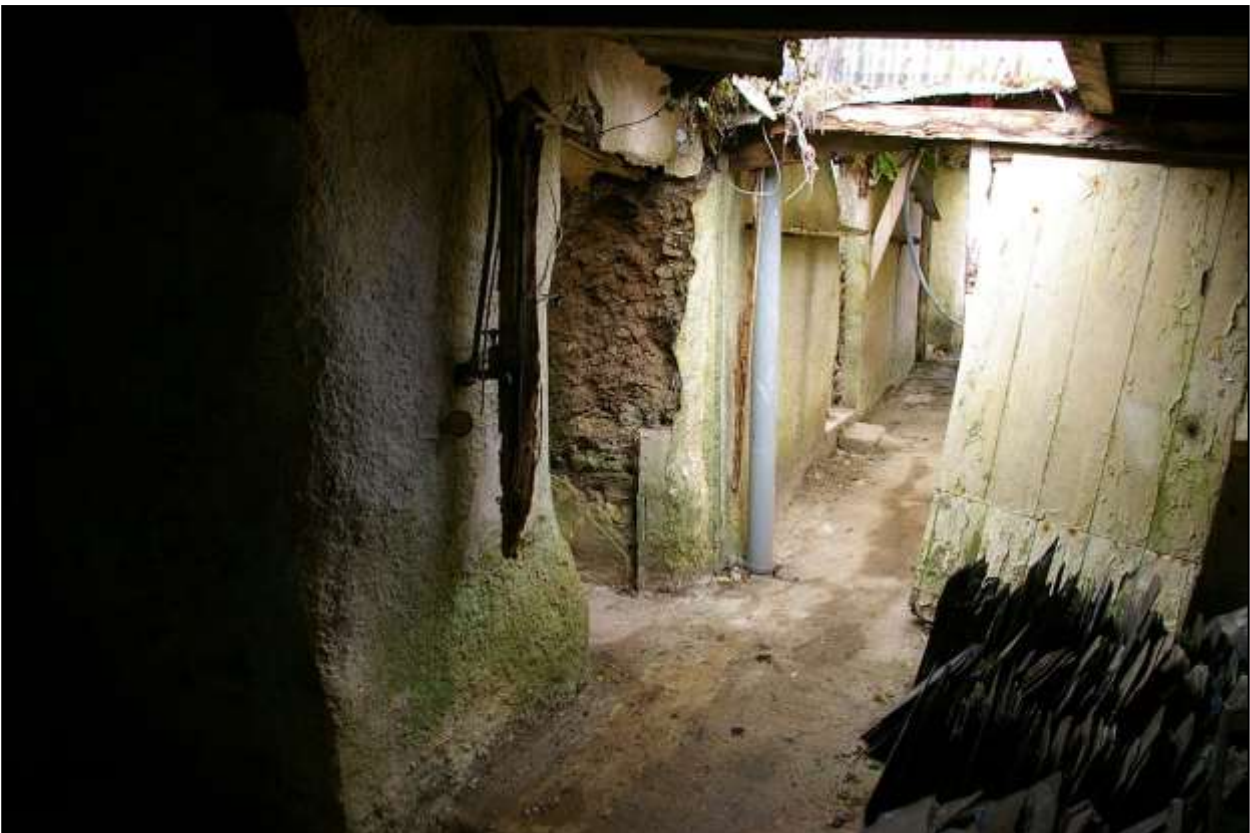
111. LOOKING SOUTH-WEST ALONG THE THICK COB OUTER WALL OF THE OUTSHUTS CONTAINING R7 AND R8. THIS WAS AN OUTSIDE WALL UNTIL CONCRETE FARM BUILDINGS WERE BUILT AGAINST IT IN THE 1950S. VIEWED FROM THE NORTH-EAST.

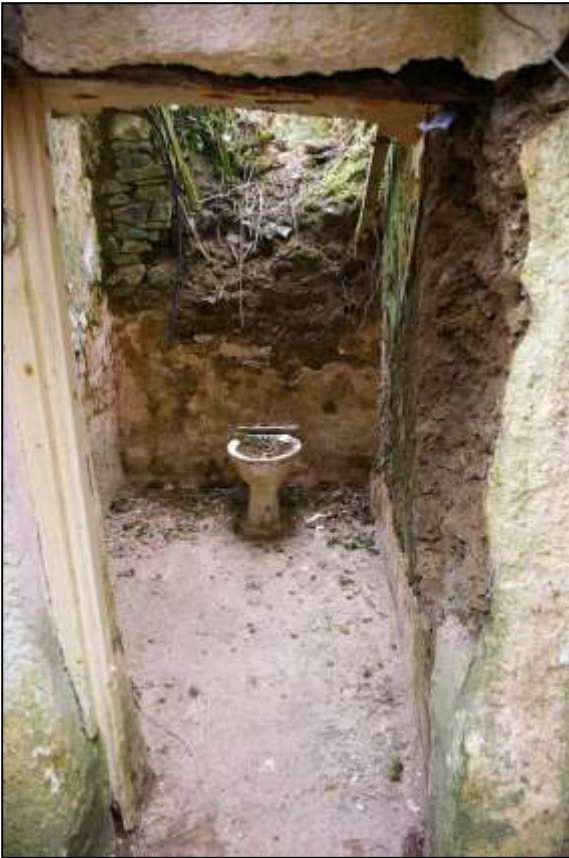
112. LEFT: PRIVY (R8), WITH 20TH CENTURY CONCRETE FLOOR AND WC (SHOWN THROUGH D13); VIEWED FROM THE NORTH-WEST.

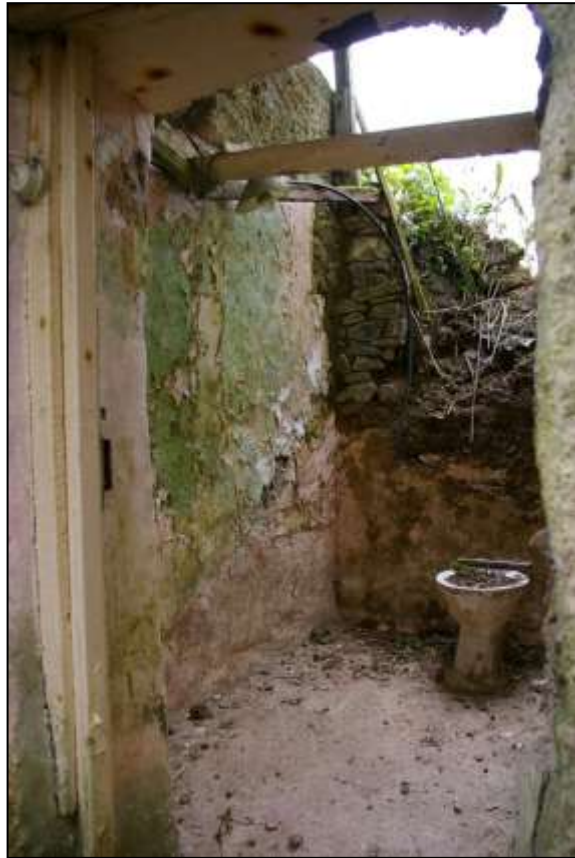
113. RIGHT: AS ABOVE, DETAIL OF THE COB AND STONE RUBBLE WALL OF R1, ABUTTED BY THE COB WALL OF R8; VIEWED FROM THE WNW.

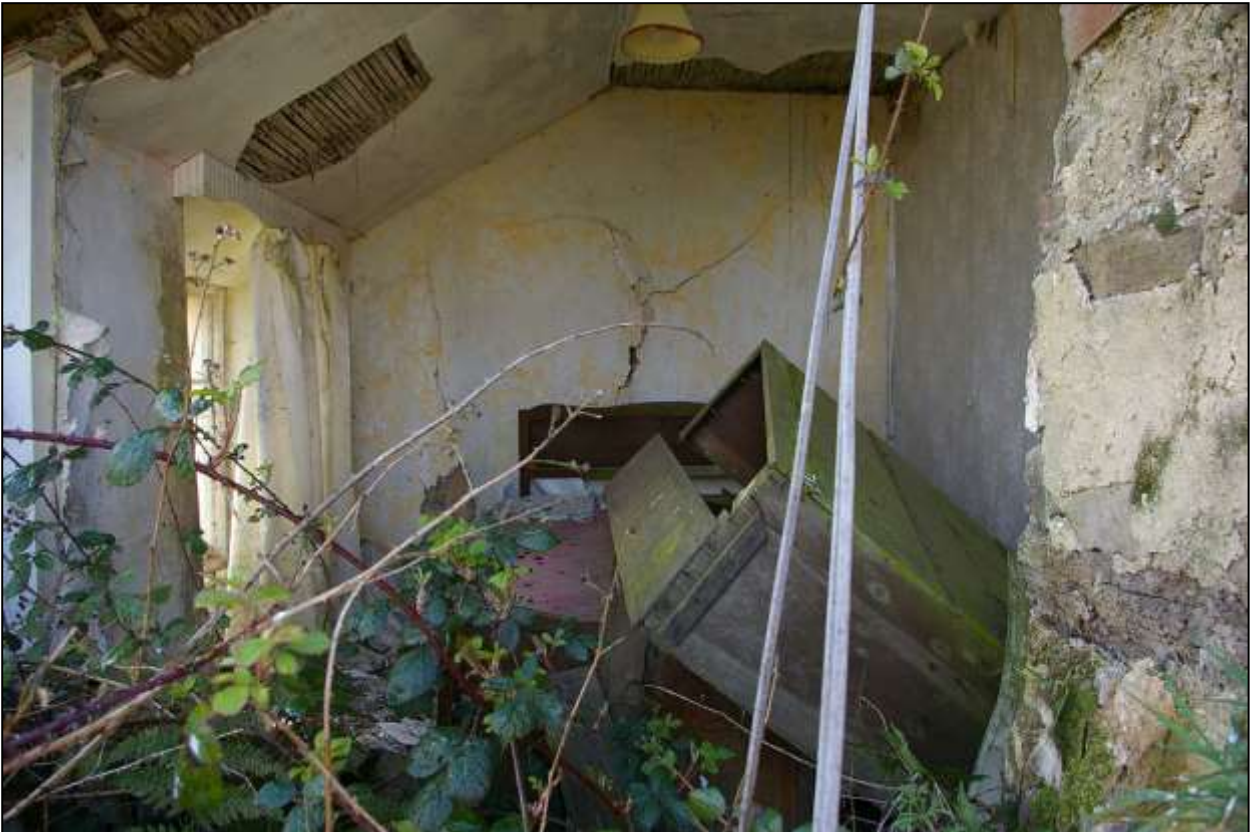
117. R11 FROM R2, DIRECTLY ABOVE R3 WHERE THE CEILING HAS COLLAPSED. TIMBER LACING AND PLASTER IN THE SIDE OF THE CHIMNEY STACK TO THE RIGHT (POSSIBLE CUPBOARD?). VIEWED FROM THE NORTH-EAST.

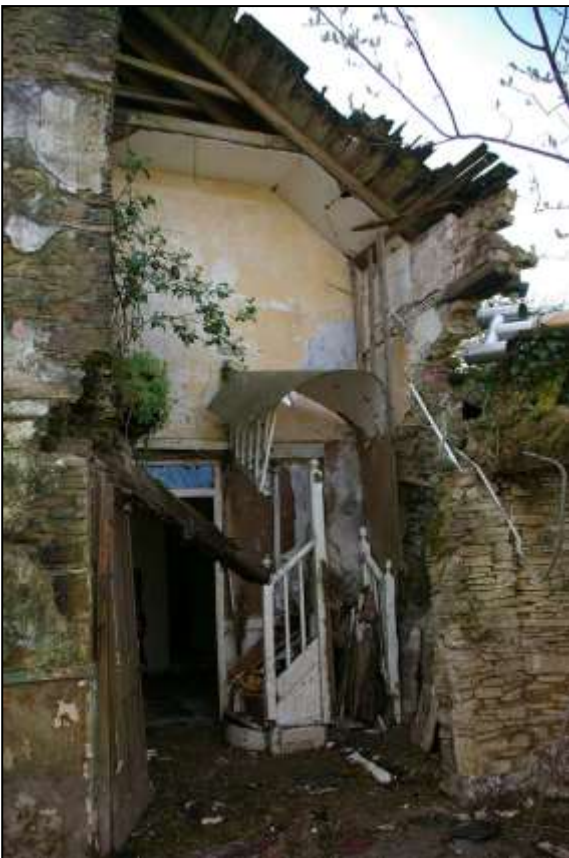
118. LEFT: LATE 17TH OR EARLY 18TH CENTURY-FRAMED STAIR TO THE FIRST FLOOR IN R2B BETWEEN R2 AND R3; VIEWED FROM THE ENE.

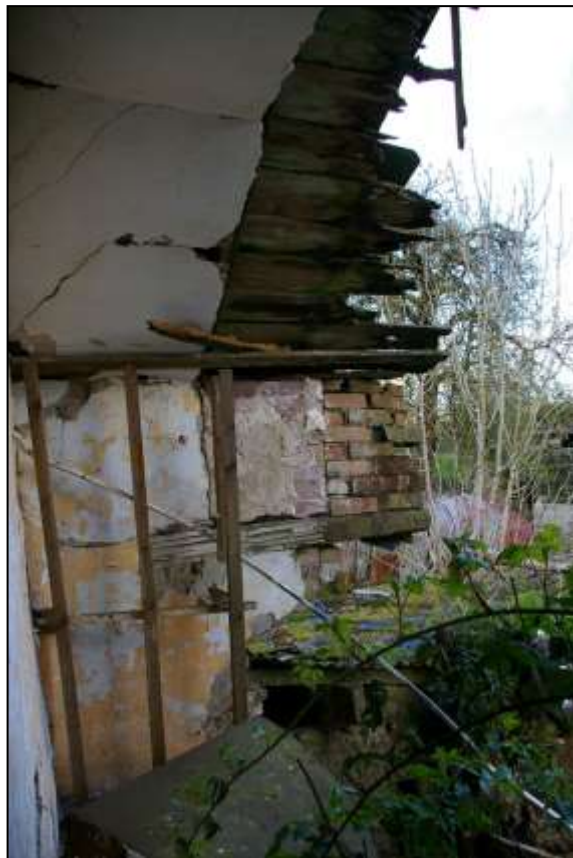
119. RIGHT: VIEW OF STAIR WINDOW IN THE NORTH WALL WITH HEAVY TIMBER LINTEL AND LATER BRICK WINDOW ABOVE. VIEWED FROM THE SOUTH.

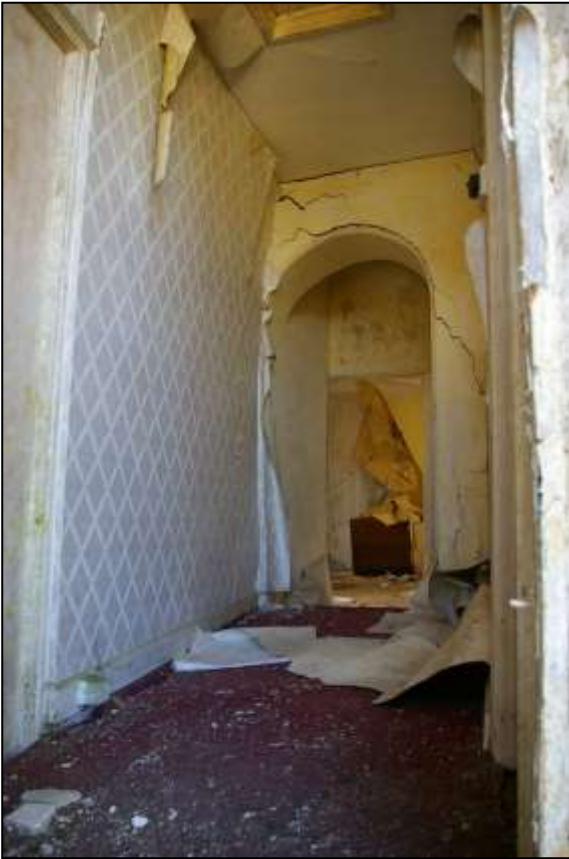
120. LEFT: R9, THE FIRST-FLOOR CORRIDOR, LOOKING THROUGH THE FORCED OPENING IN THE COB WALL BETWEEN THE MEDIEVAL AND THE 17TH CENTURY EXTENSION. VIEWED FROM THE NORTH-EAST.

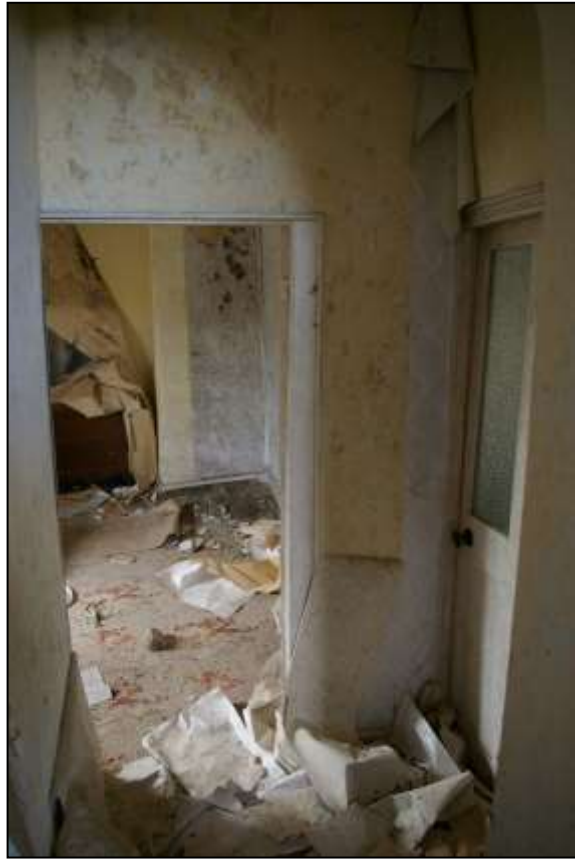
121. RIGHT: THE LOBBY AT THE WEST END OF R9 LOOKING INTO R12; THE DOOR TO THE RIGHT SERVES R13. VIEWED FROM THE NORTH-EAST.

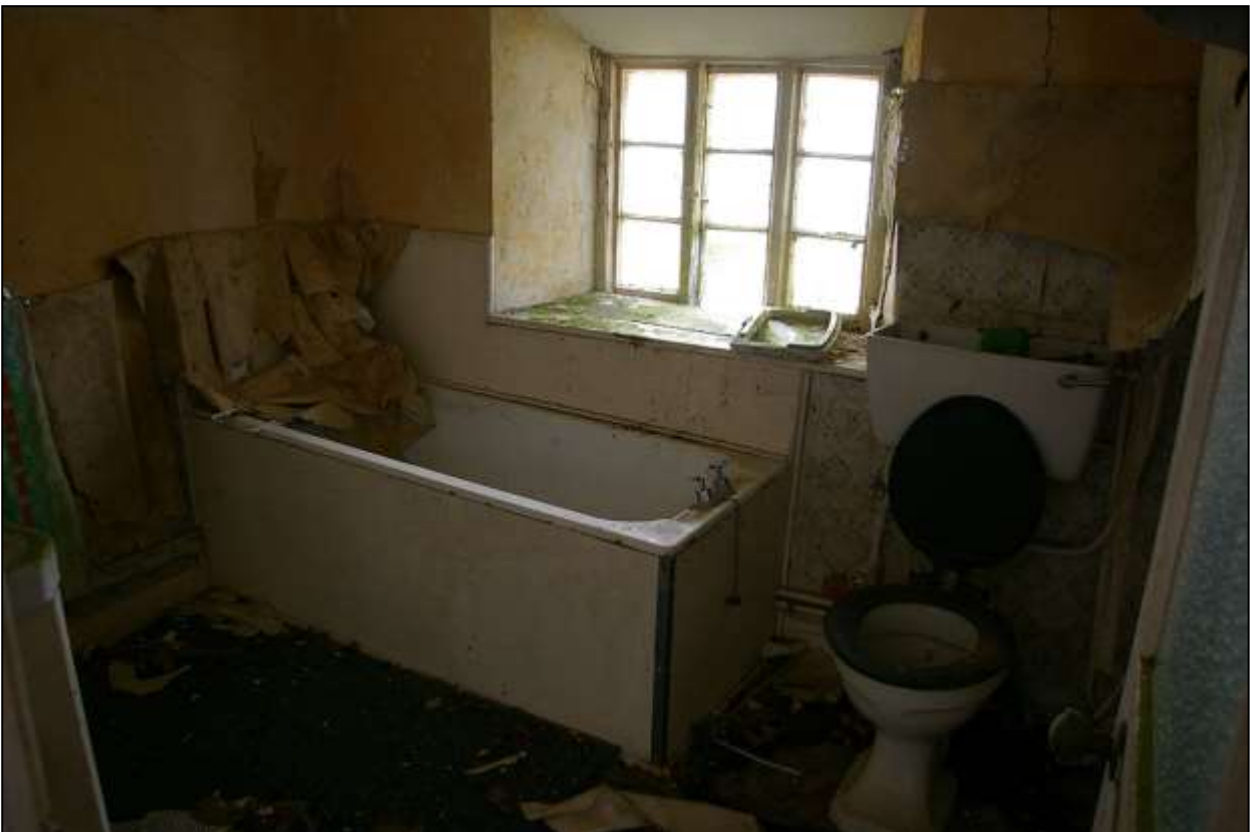
122. R10, WITH 19TH CENTURY THREE-LIGHT CASEMENT (W13) AND MID-20TH CENTURY BATHROOM FITMENTS. VIEWED FROM THE EAST.

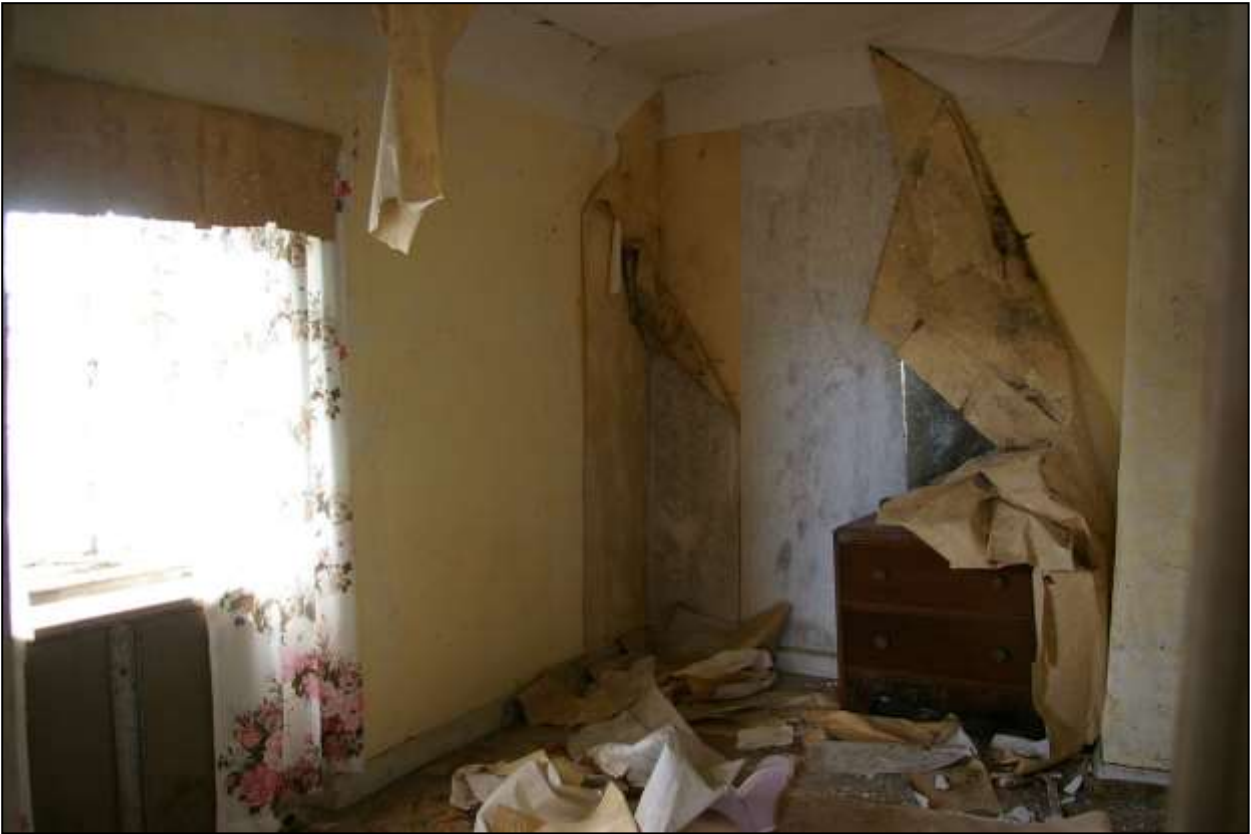
123. R12; VIEWED FROM THE NORTH-EAST.

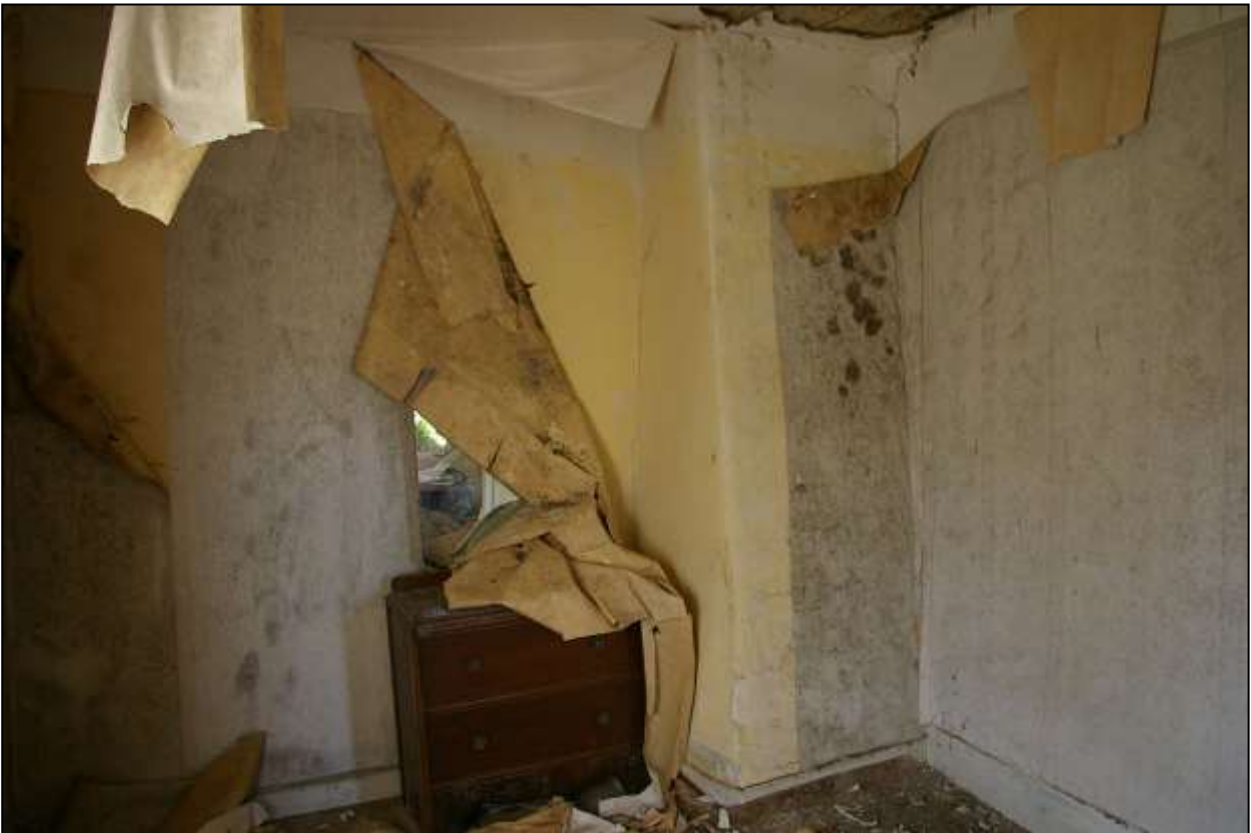
124. SOUTH-WEST WALL OF R12 WITH TAPERED CHIMNEY BREAST; VIEWED FROM THE EAST.

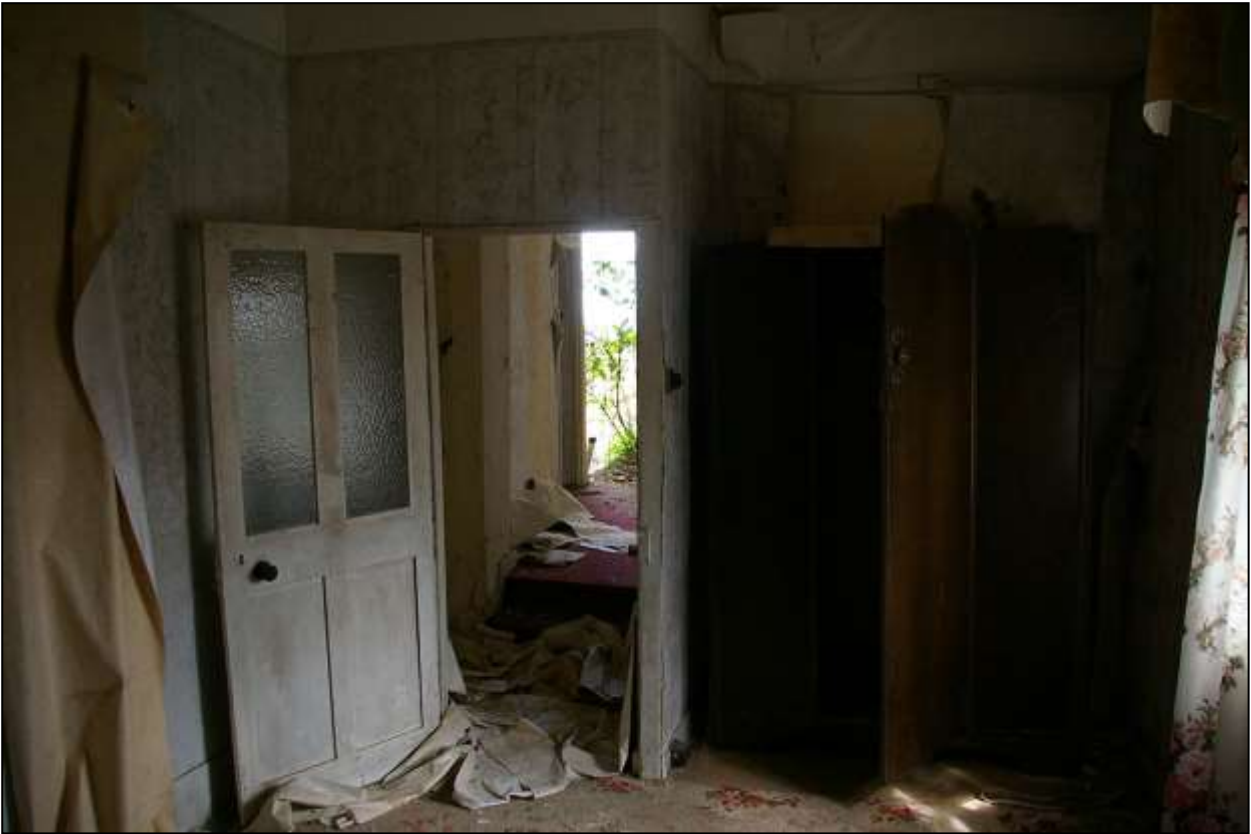
125. R12, LOOKING BACK TO THE LOBBY (R9) (THROUGH D16); VIEWED FROM THE SSW.

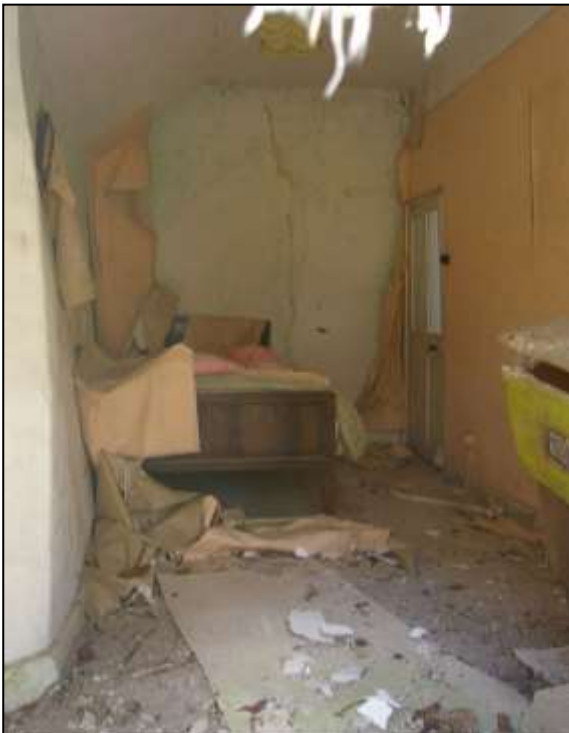
126. LEFT: R13, LOOKING NORTH-EAST WITH STAIR ALCOVE JUST VISIBLE TO LEFT.

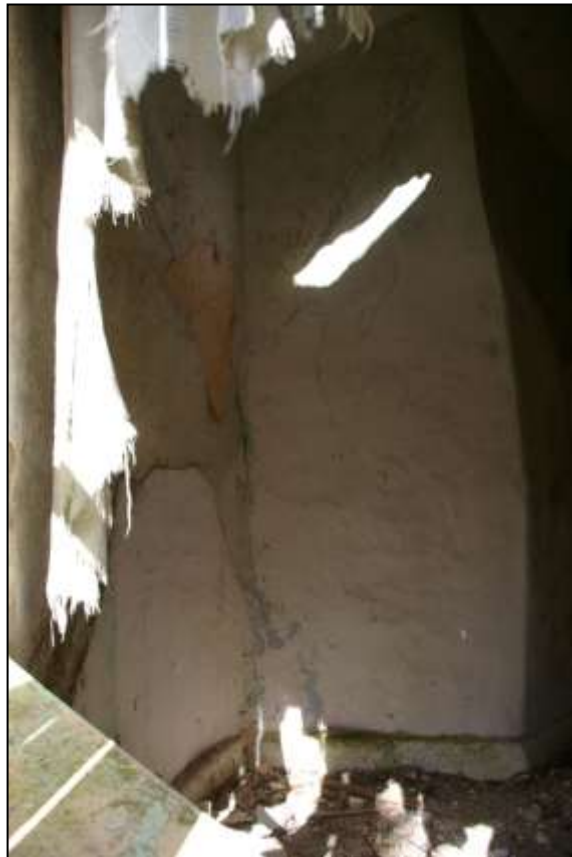
127. RIGHT: R13, THE SIDE OF THE STAIR ALCOVE; LOOKING NORTH.

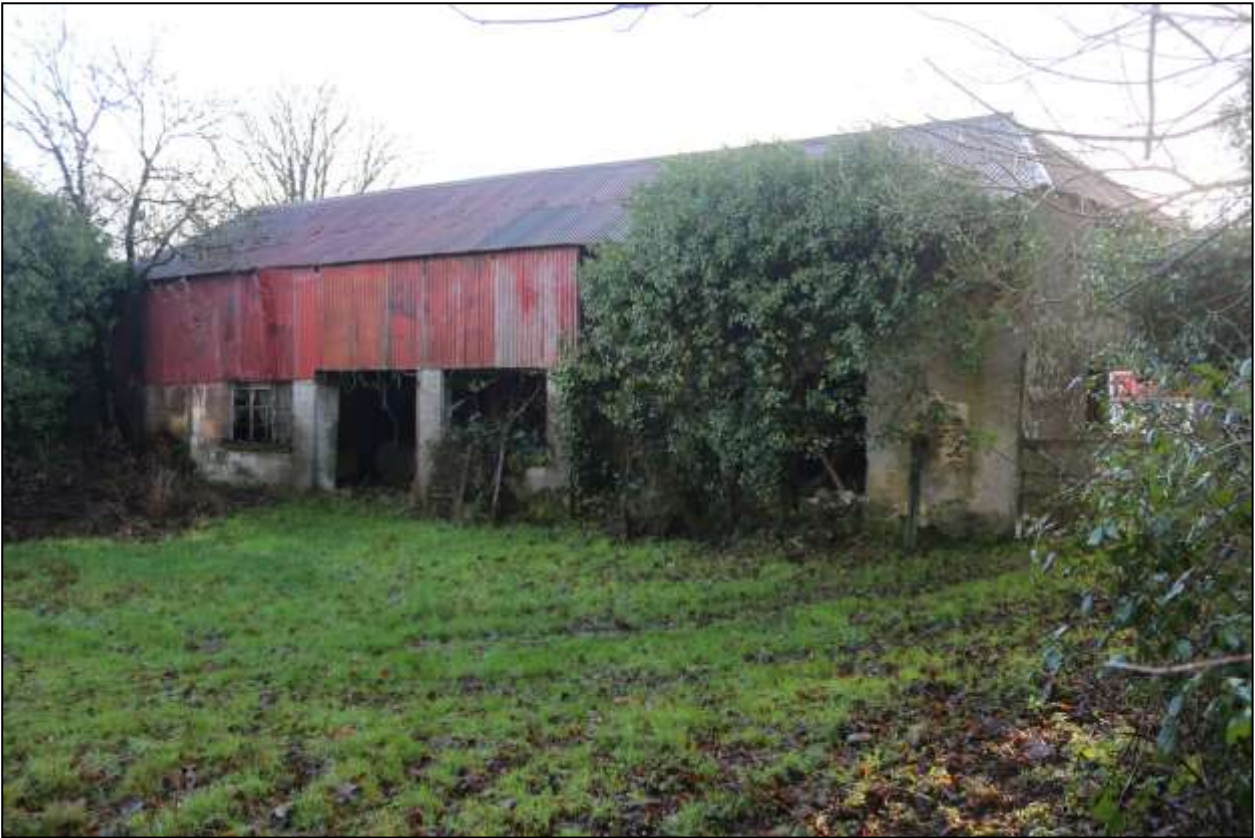
128. LINHAY RANGE ALONG THE ROAD. RUBBLE AND COB CONSTRUCTION; FRONTAGE REBUILT IN MID-20TH CENTURY. VIEWED FROM THE NORTH-WEST.

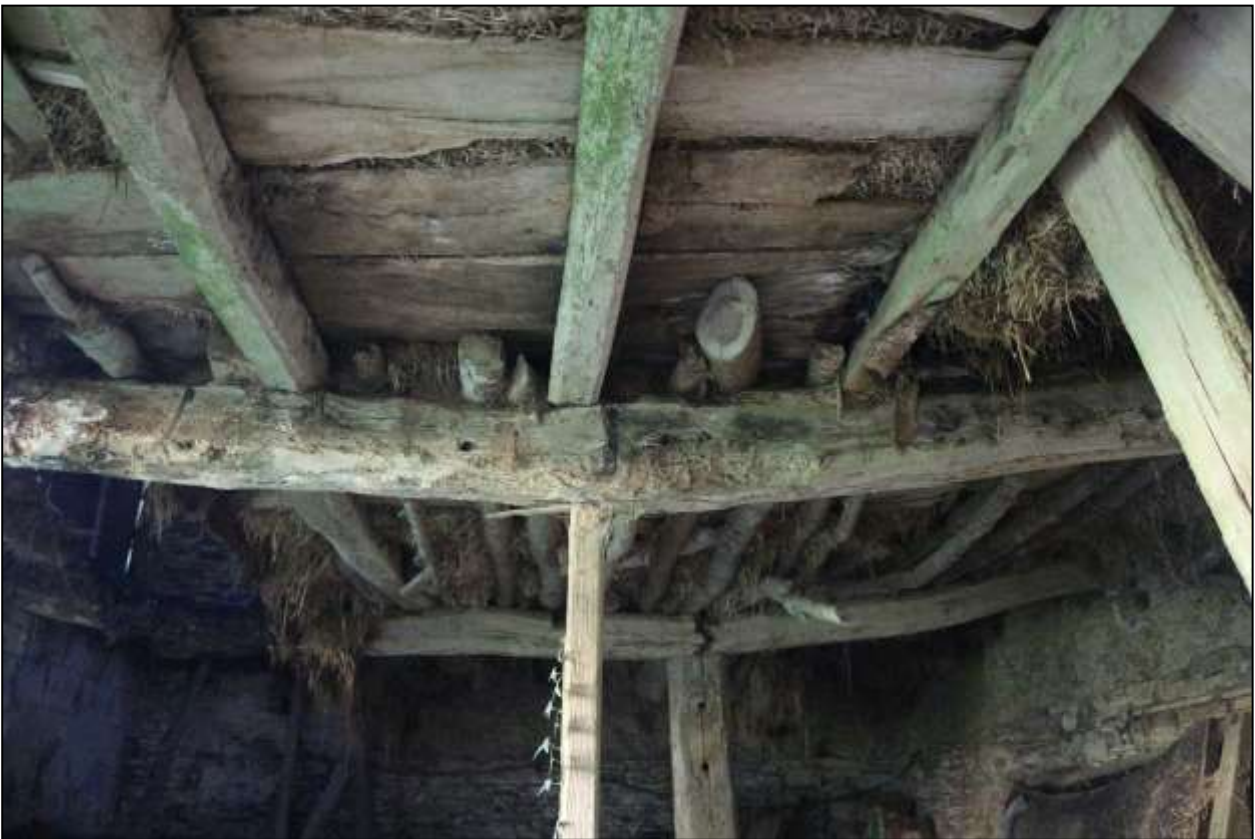
129. GROUND FLOOR OF LINHAY. NOTE RUBBLE WALLS SUPPORTING COB UPPERS. TRANSVERSE BEAMS PRIMARY, PERHAPS CHAMFERED JOISTS ALSO, BUT ROUNDWOOD IS LATER. CONCRETE WALL TO LEFT INFILLS FORMERLY OPEN FRONTAGE. VIEWED FROM THE WEST.

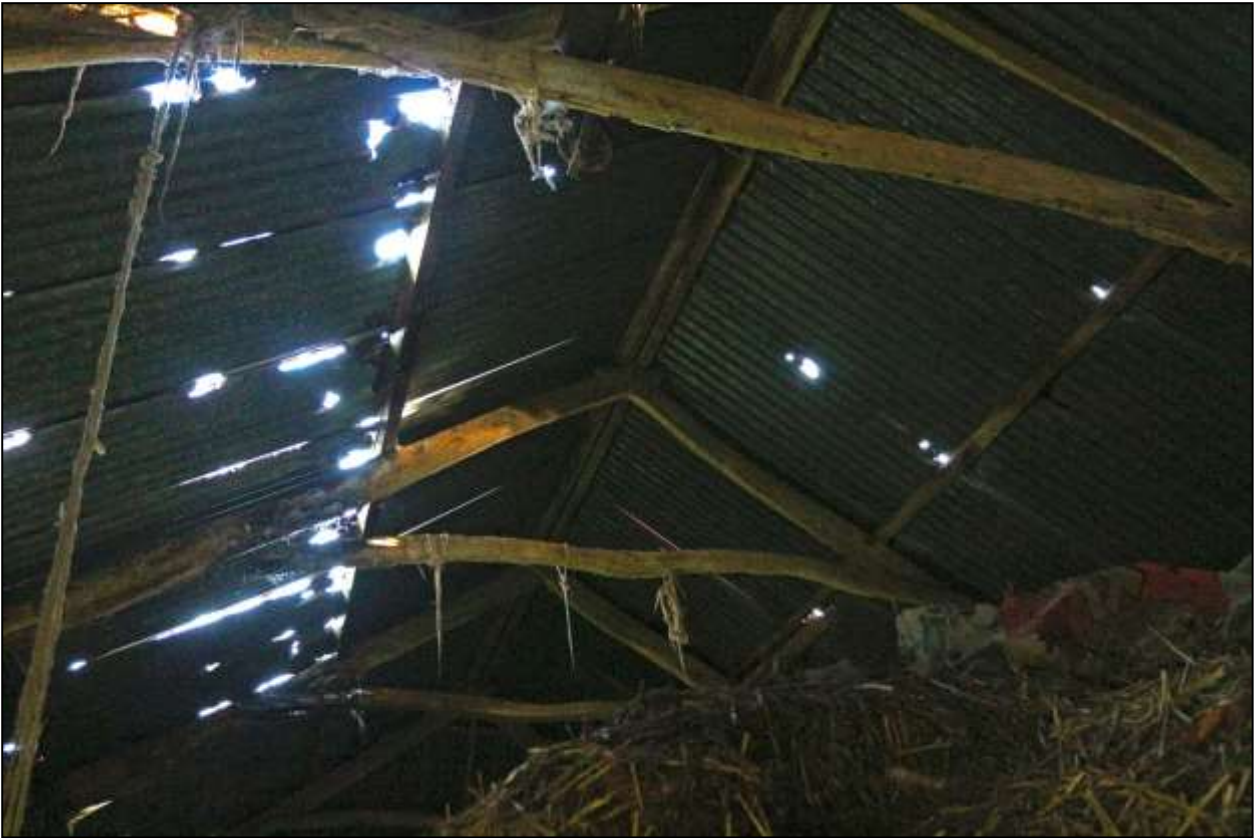
130. ROOF STRUCTURE OF LINHAY. ROUGHLY DRESSED ROUNDWOOD TRUSSES FORMERLY SUPPORTING SLATES. SAWN PURLINS & CORRUGATED IRON ARE MID-20TH CENTURY. VIEWED FROM THE WEST.
